## HARRISON SUB-RESIDENCY FIELD INSPECTION

**Date:** 5/3/13

### Semi-Annual

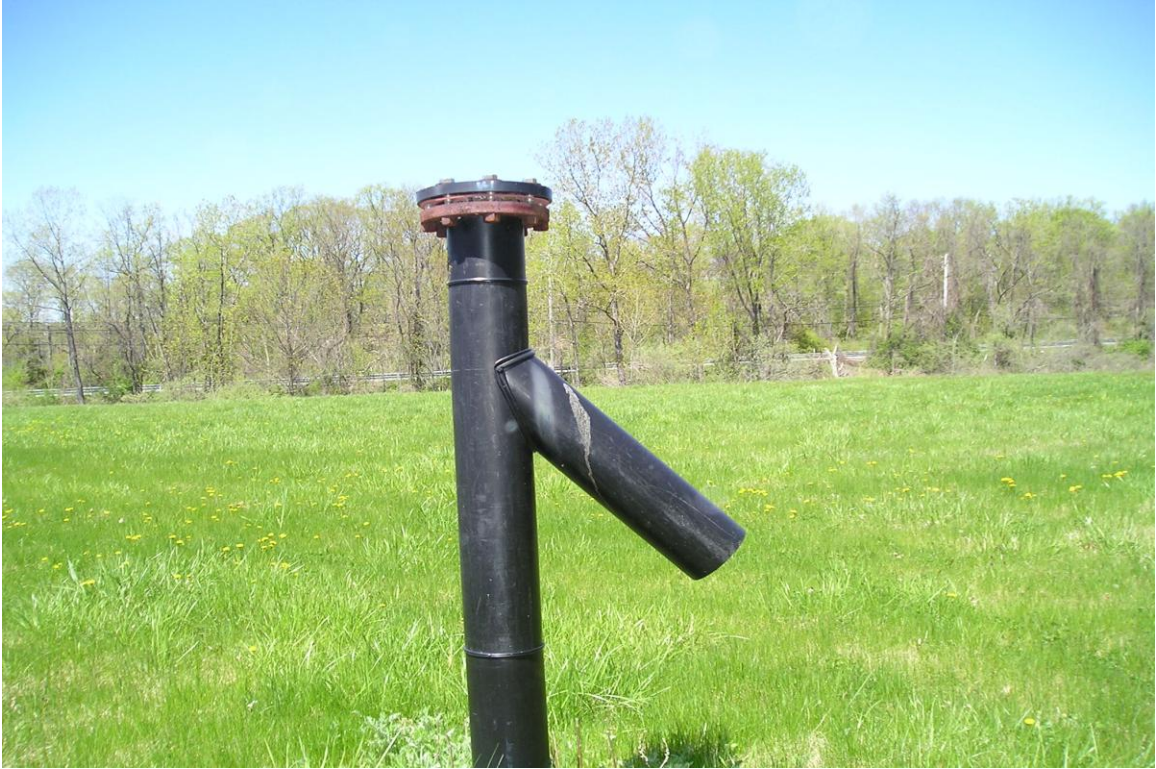
Photo 1: Vent V-1

Four vents (V1 - V4) were inspected and generally found in good condition (neither cracks nor movement was observed) (Photos # 1-4). V-2 leans slightly to the north.

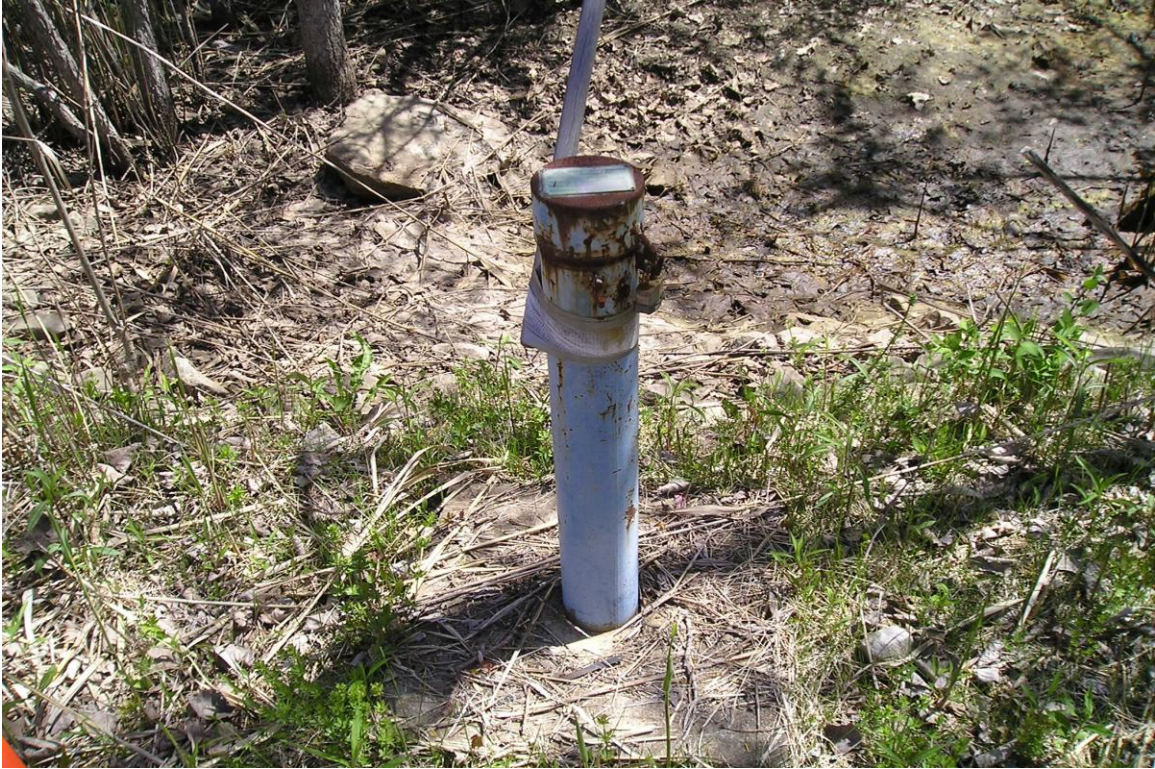
Photo 7: Well PC-1 (with broken key in lock)

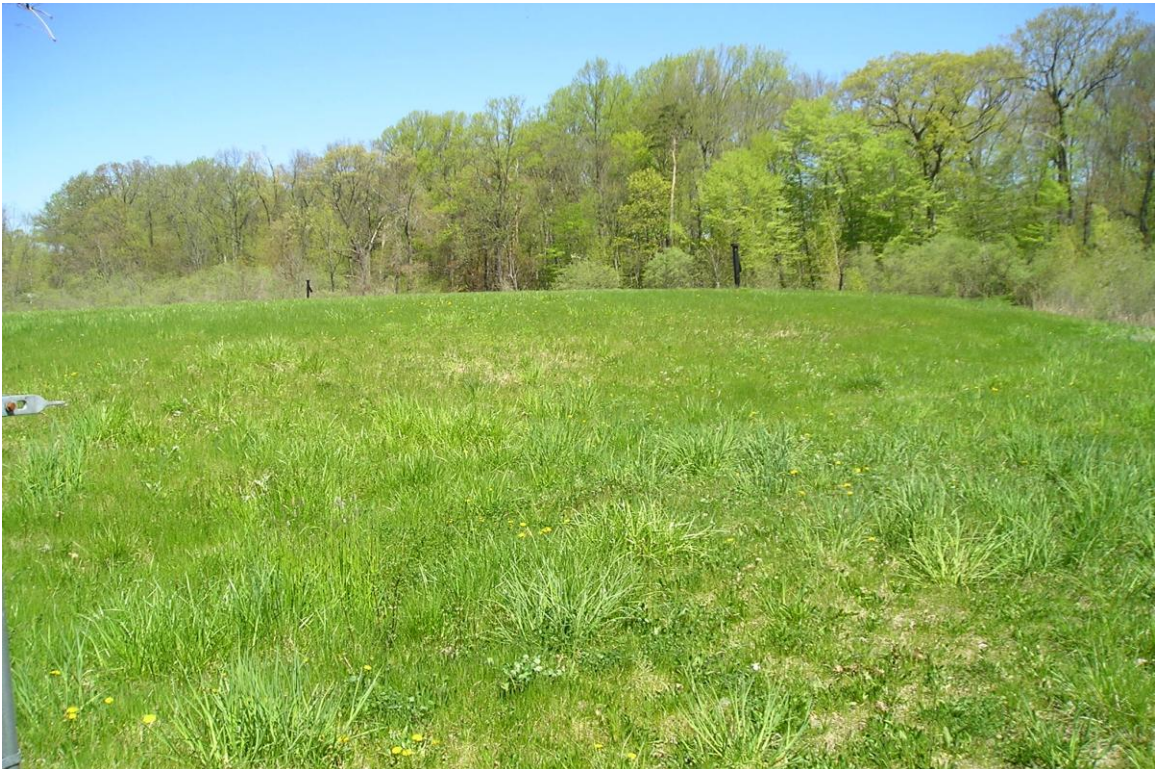
Grass height was good at the time of inspection (Photo #10).

Photo 10: Grass on landfill cap

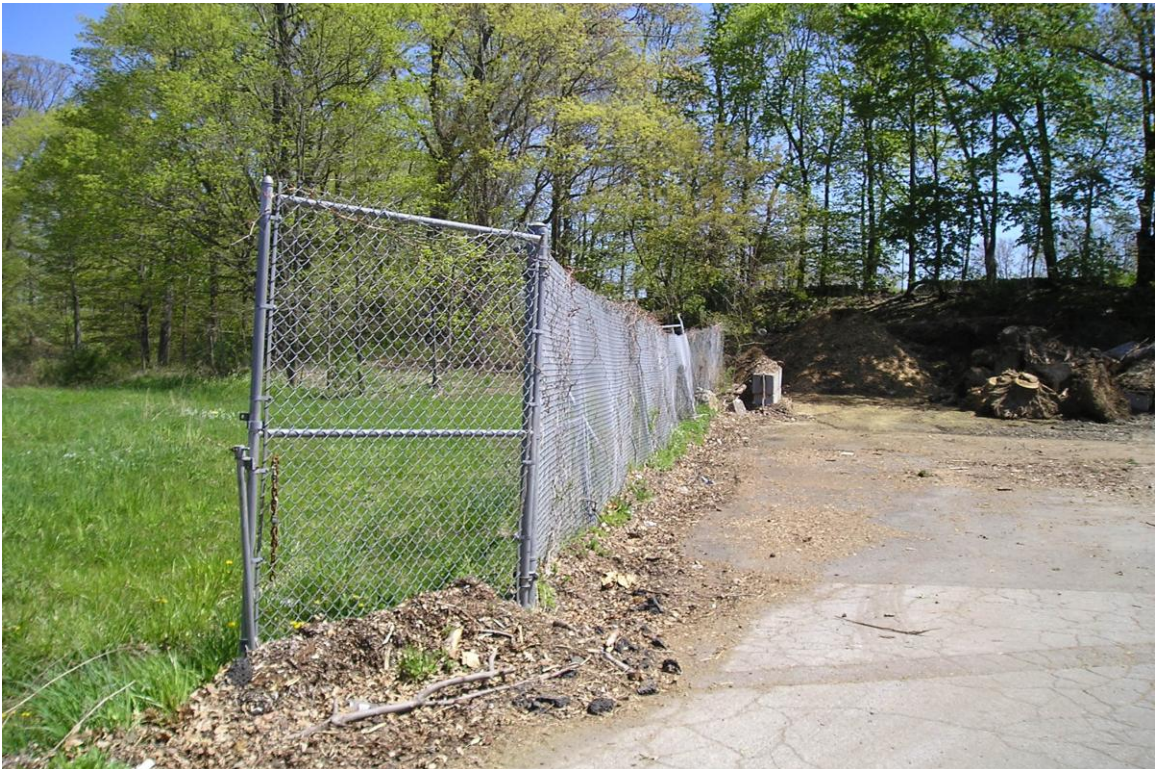
The south fence near the landfill gate appears to be in fair condition. (Photo #12)

Photo 12: South fence damage (looking east)

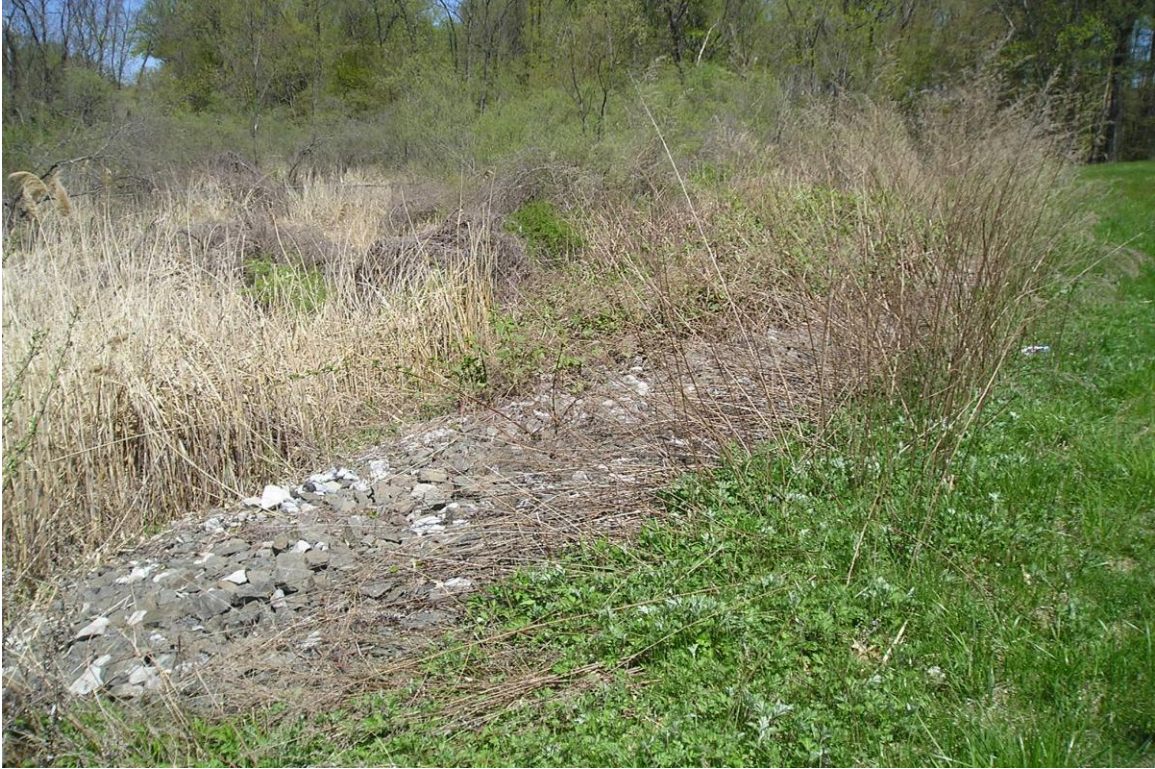
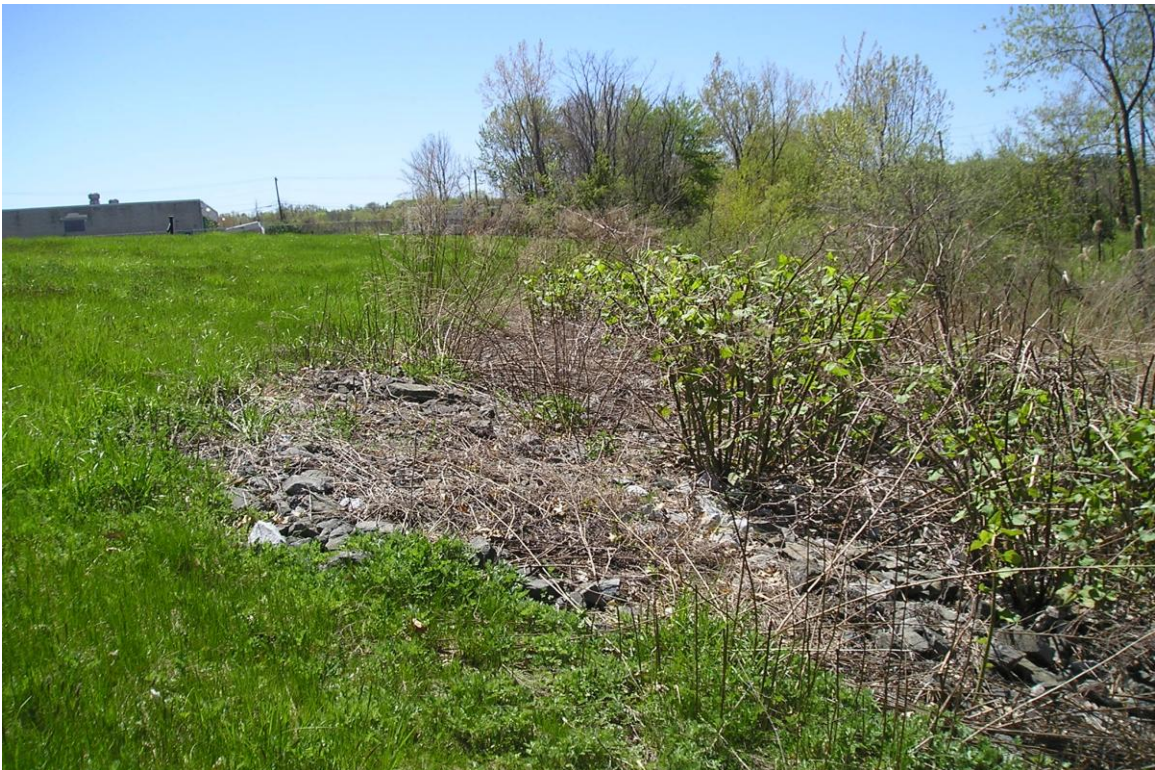
The soil slump on west slope of landfill was repaired in May 2009 by NYSDOT Residency 8-9 personnel. The repaired area is still in good condition (Photos #13 & 14), but old vegetation should be weed-wacked during the next mowing event.

Photo 13: West slope erosion area repair (looking north)

Photo 14: West slope erosion area repair (looking south)

1. The cap should continue to be mowed every June and September.
2. Old vegetation in the area of the west slope repair should be removed during the next cap mowing.
