## HARRISON SUB-RESIDENCY FIELD INSPECTION

**Date:** 10/22/13

**NYSDOT HARRISON  
SUBRESIDENCY  
WESTCHESTER CO.**

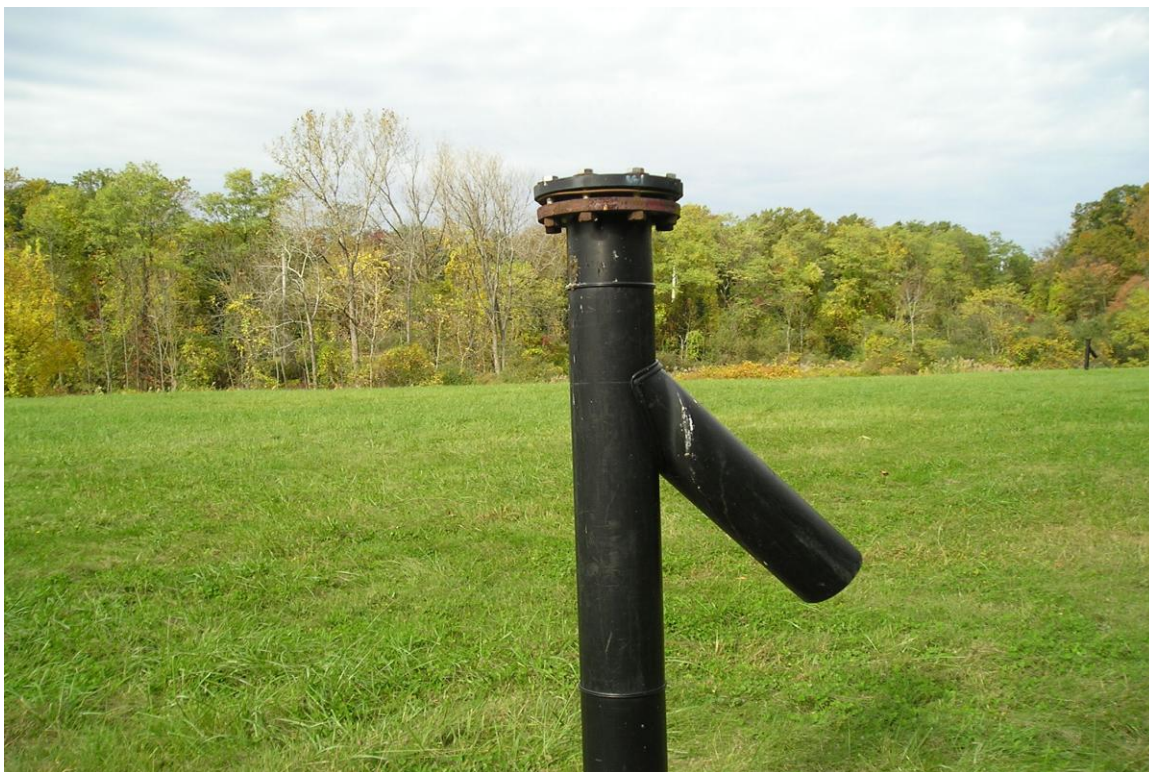
Four vents (V1 - V4) were inspected and generally found in good condition (neither cracks nor movement was observed) (Photos # 1-4). V-2 leans slightly to the north.

Photo 1: Vent V-1

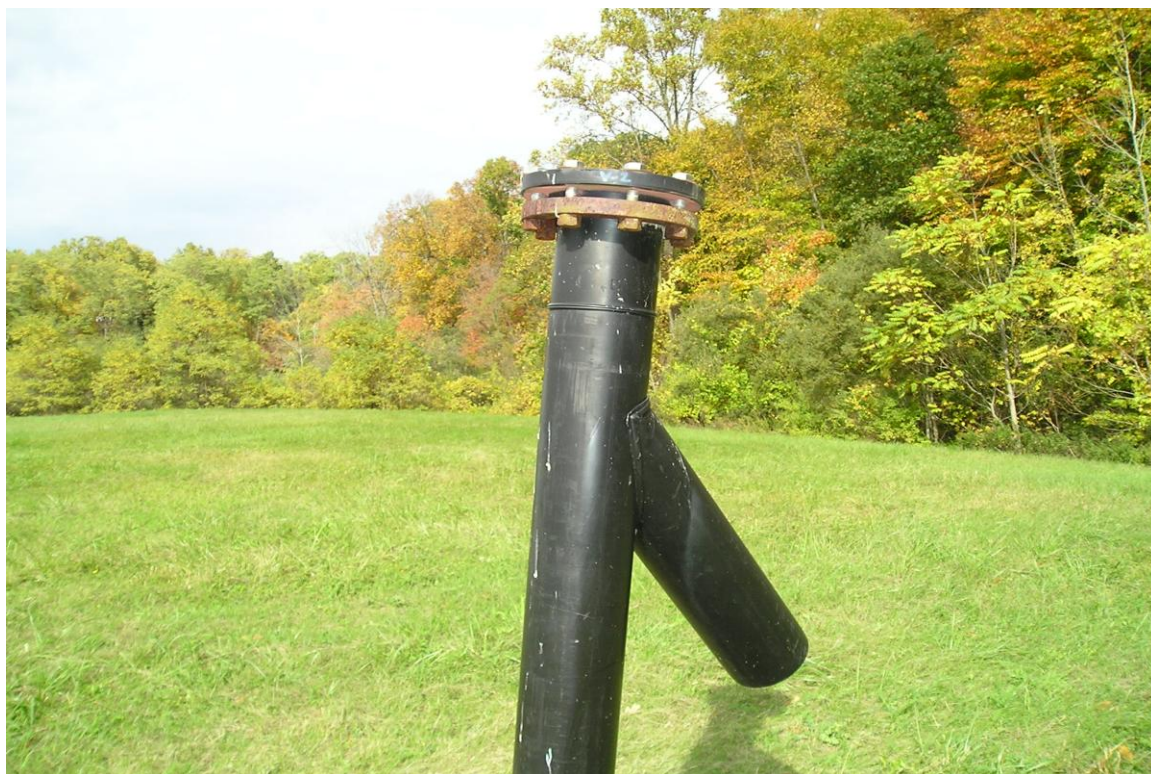
Photo 2: Vent V-2

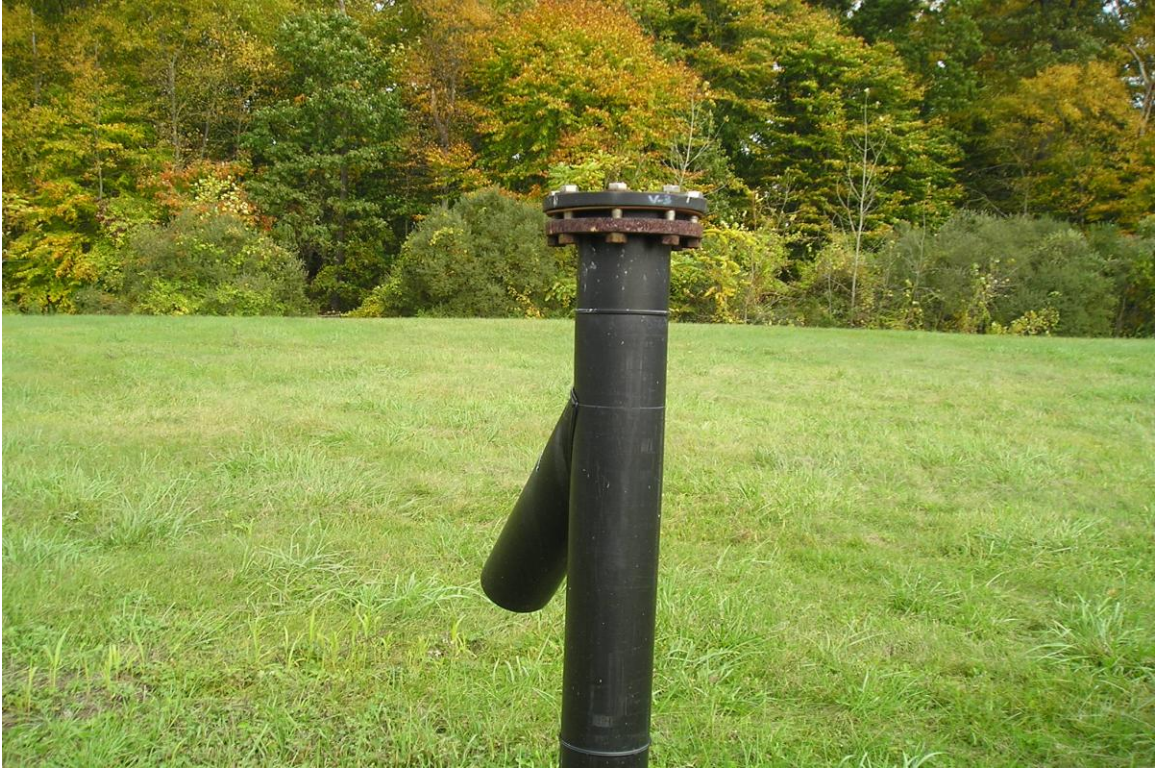
Photo 3: Vent V-3

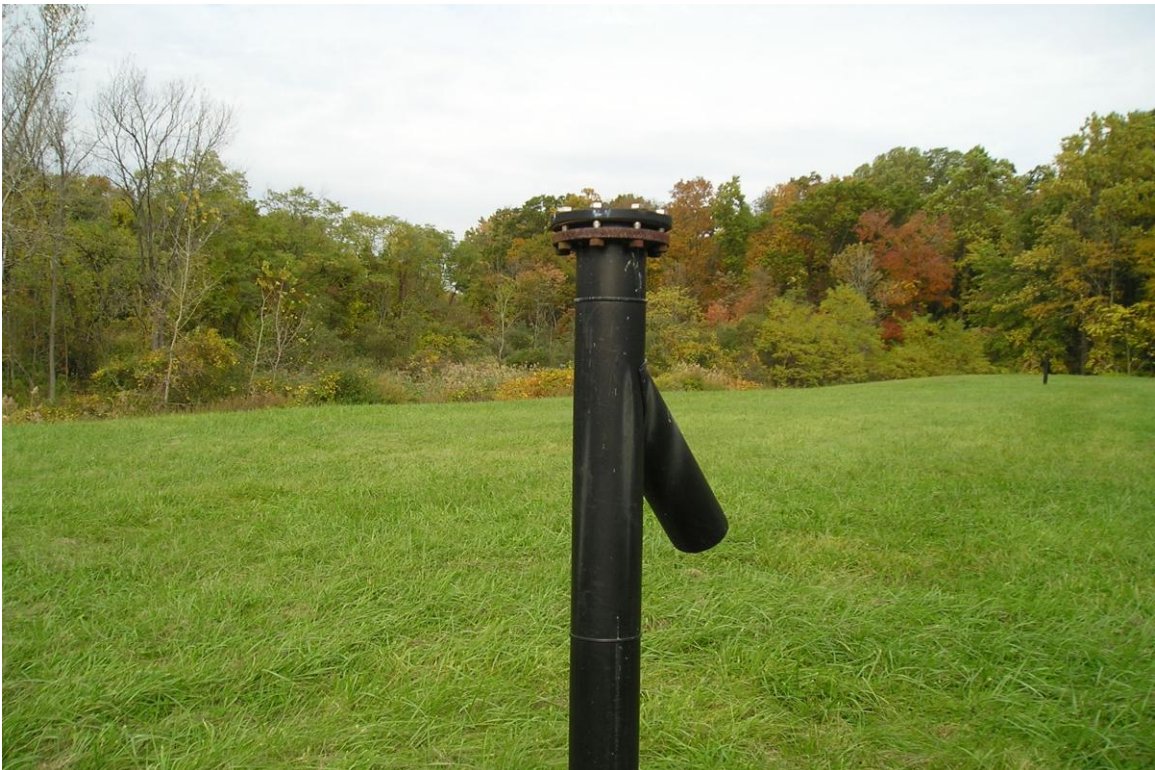
Photo 4: Vent V-4

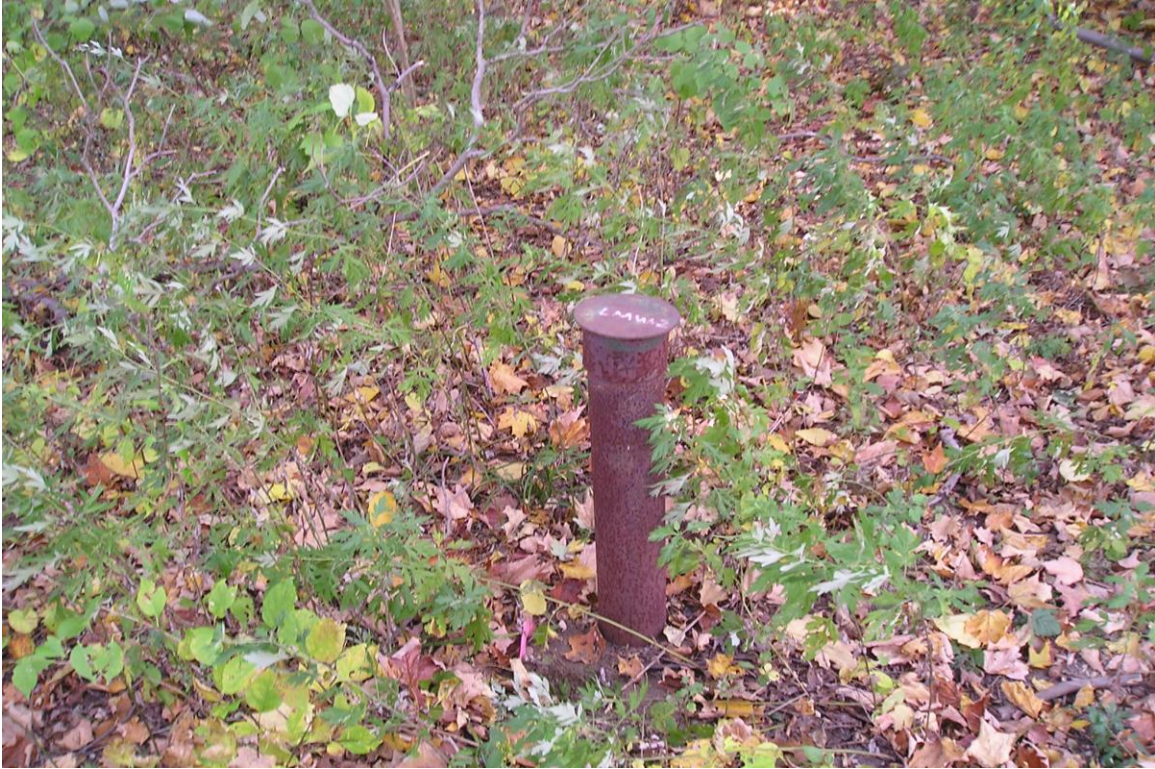
All wells were inspected and found to be in good condition.

Photo 5: Well LMW-2

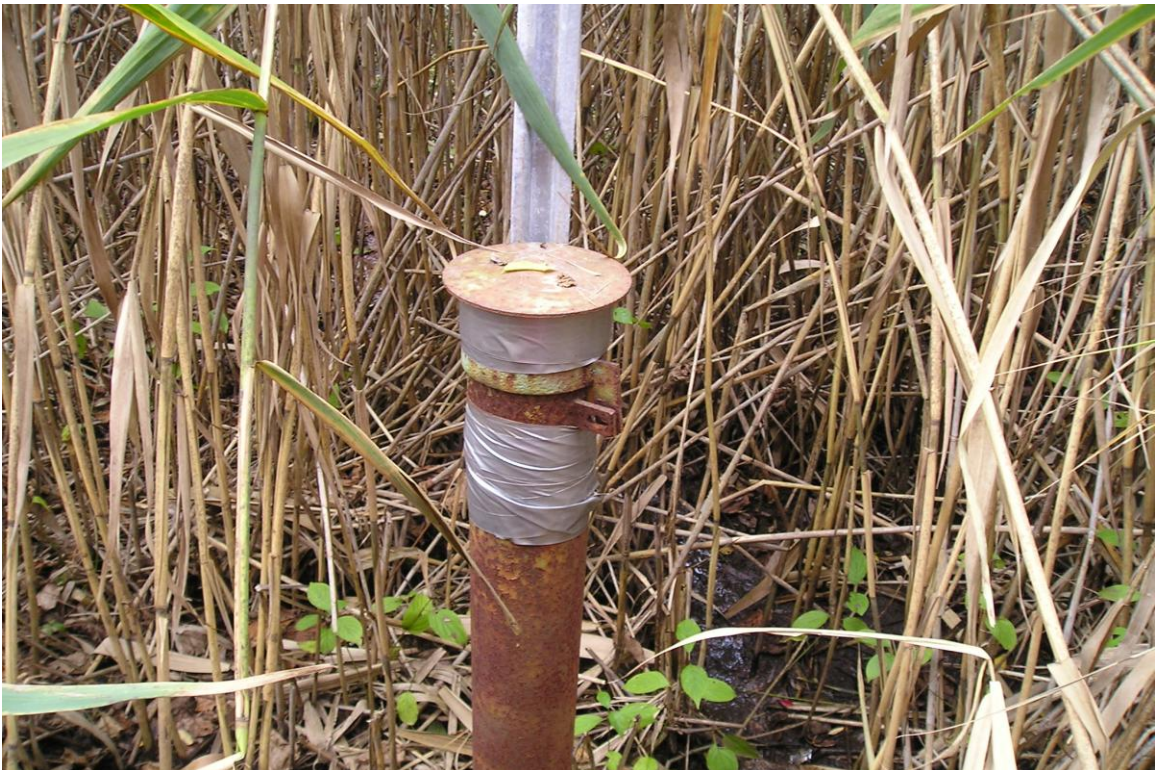
Photo 6: Well LMW-4

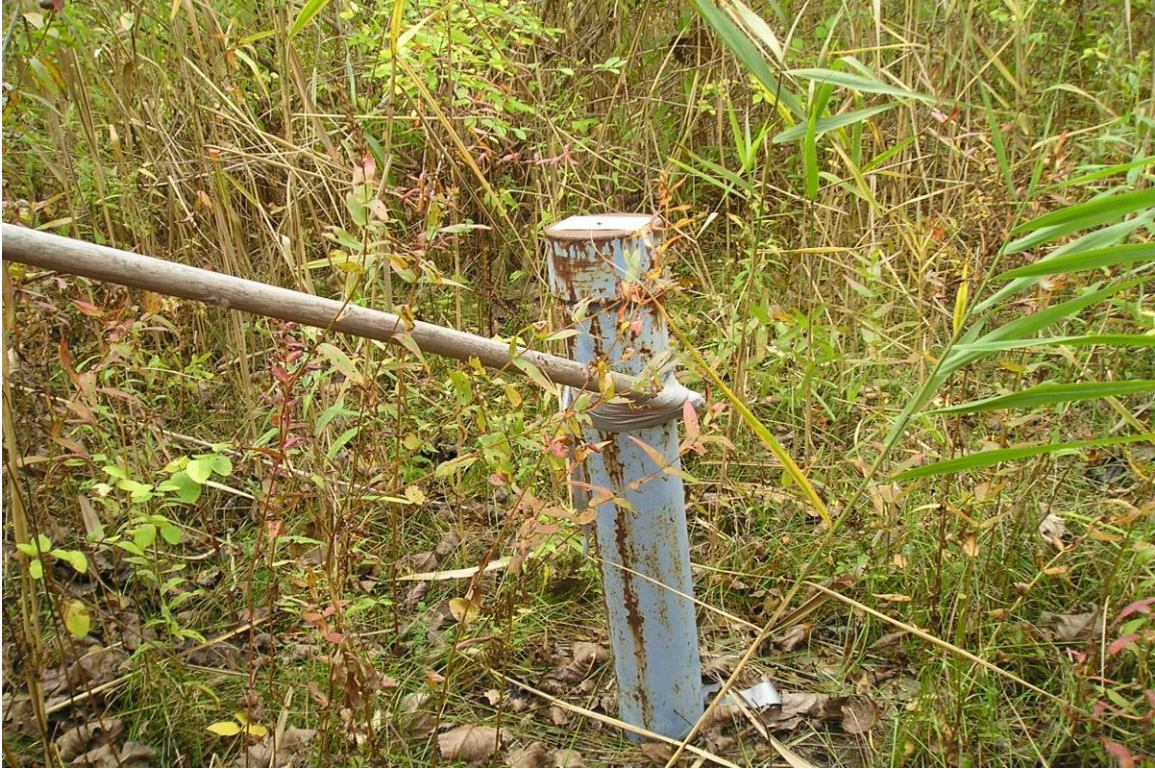
Photo 7: Well PC-1

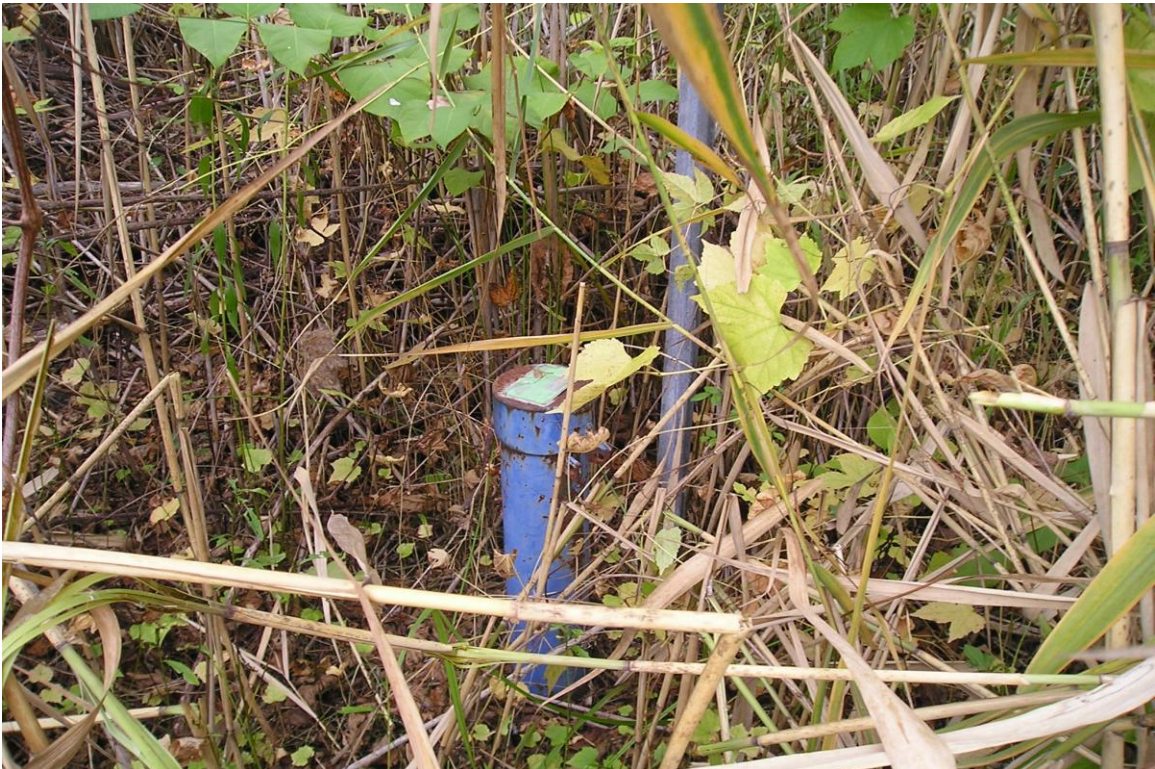
Photo 8: Well PC-2

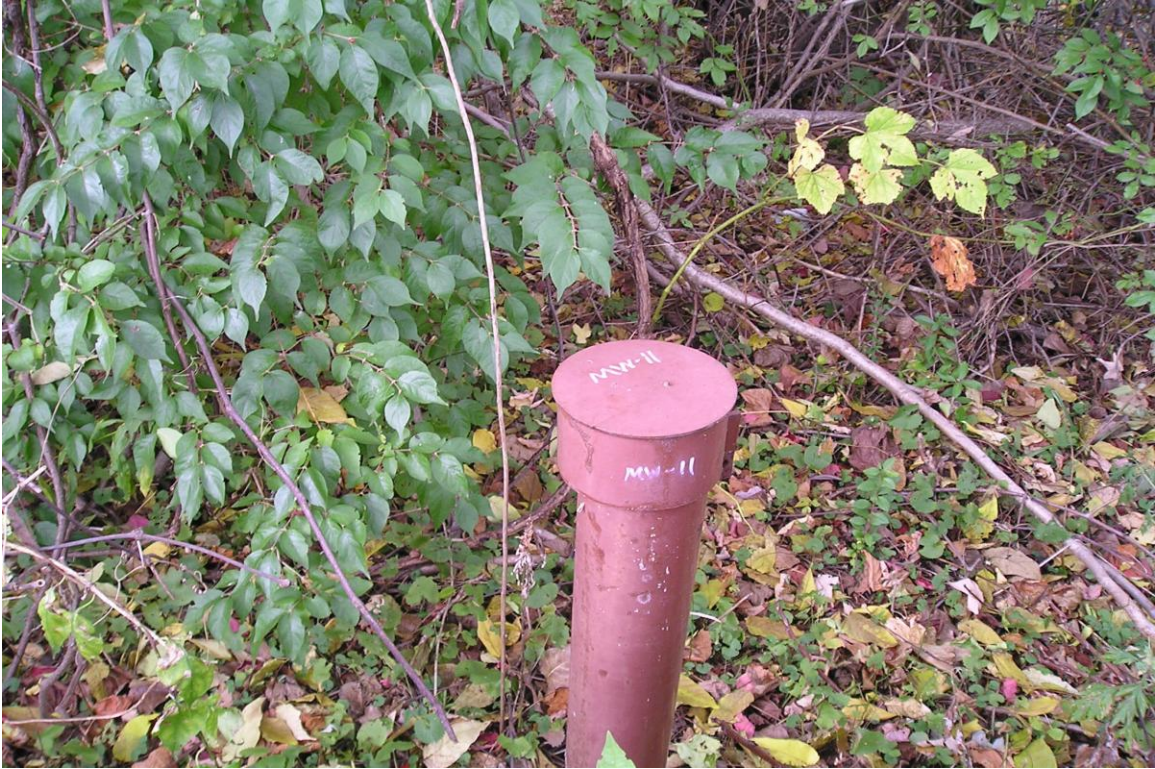
Photo 9: Well MW-11

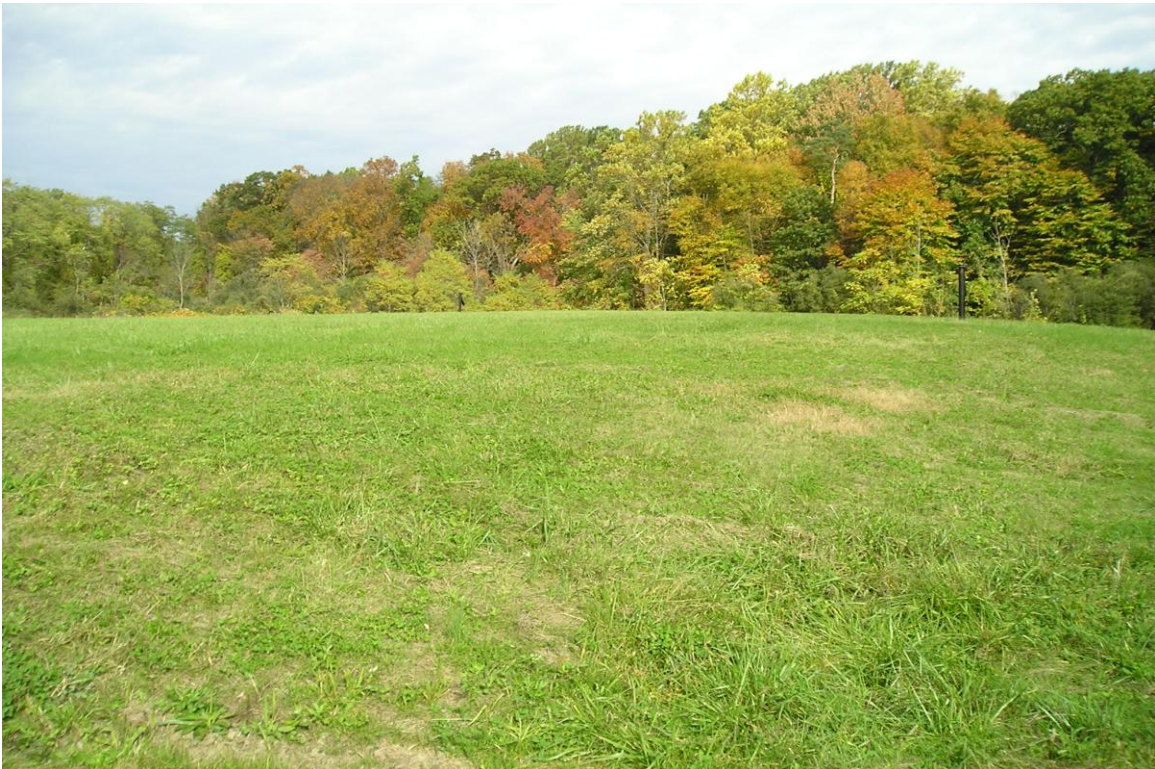
Grass height was satisfactory at the time of inspection (Photo #10).

Photo 10: Grass on landfill cap

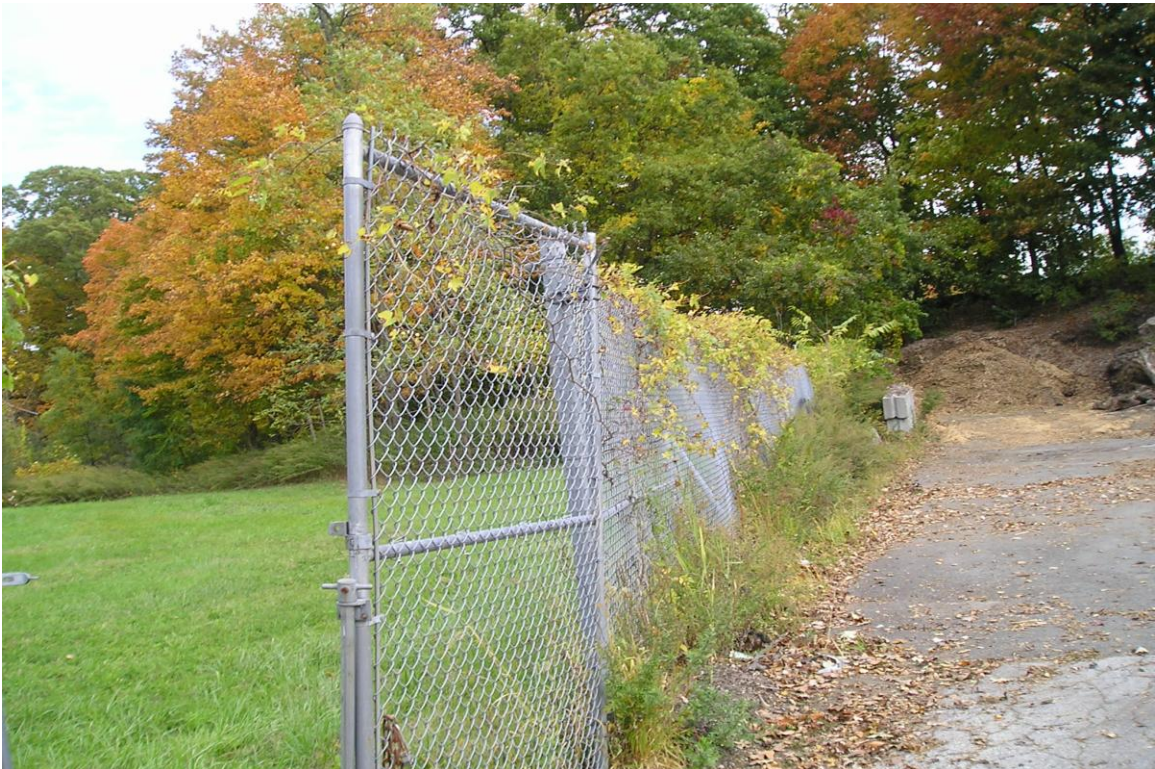
The south fence near the landfill gate appears to be in fair condition. (Photo #12)

Photo 12: South fence damage (looking east)

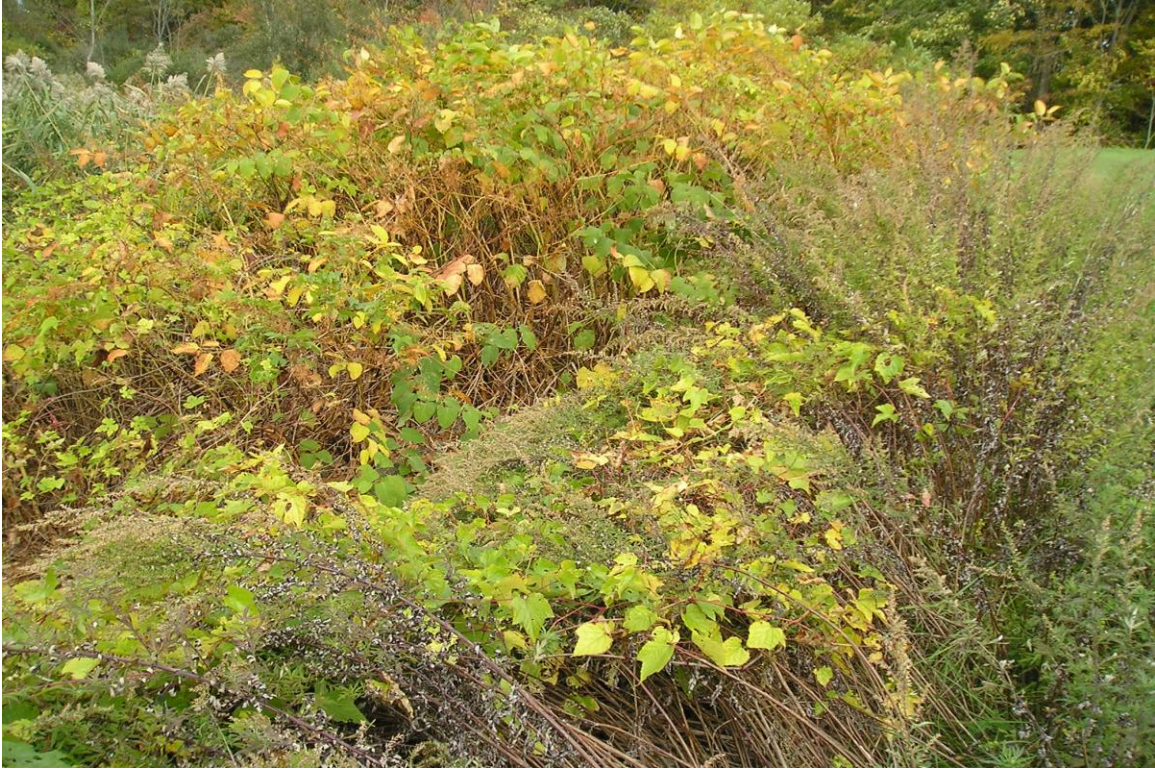
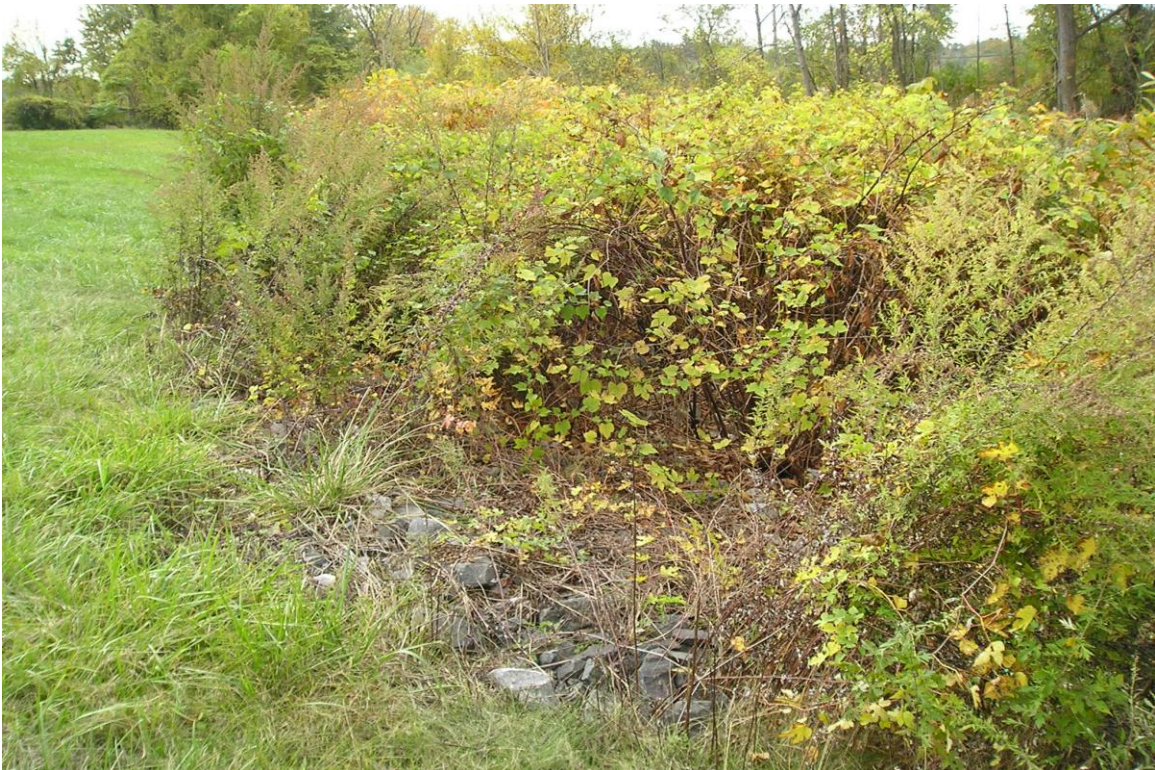
The soil slump on west slope of landfill was repaired in May 2009 by NYSDOT Residency 8-9 personnel. The repaired area is overgrown with invasive vegetation (Photos #13 & 14) and should be weed-wacked during the next mowing event in 2014.

Photo 13: West slope erosion area repair (looking north)

Photo 14: West slope erosion area repair (looking south)

1. The cap should continue to be mowed every June and September.
2. Old vegetation in the area of the west slope repair should be removed during the next cap mowing.
