HARRISON SUB-RESIDENCY FIELD INSPECTION

Name of Inspector(s): Christopher Kappeller

Date: 10/24/14

Semi-Annual

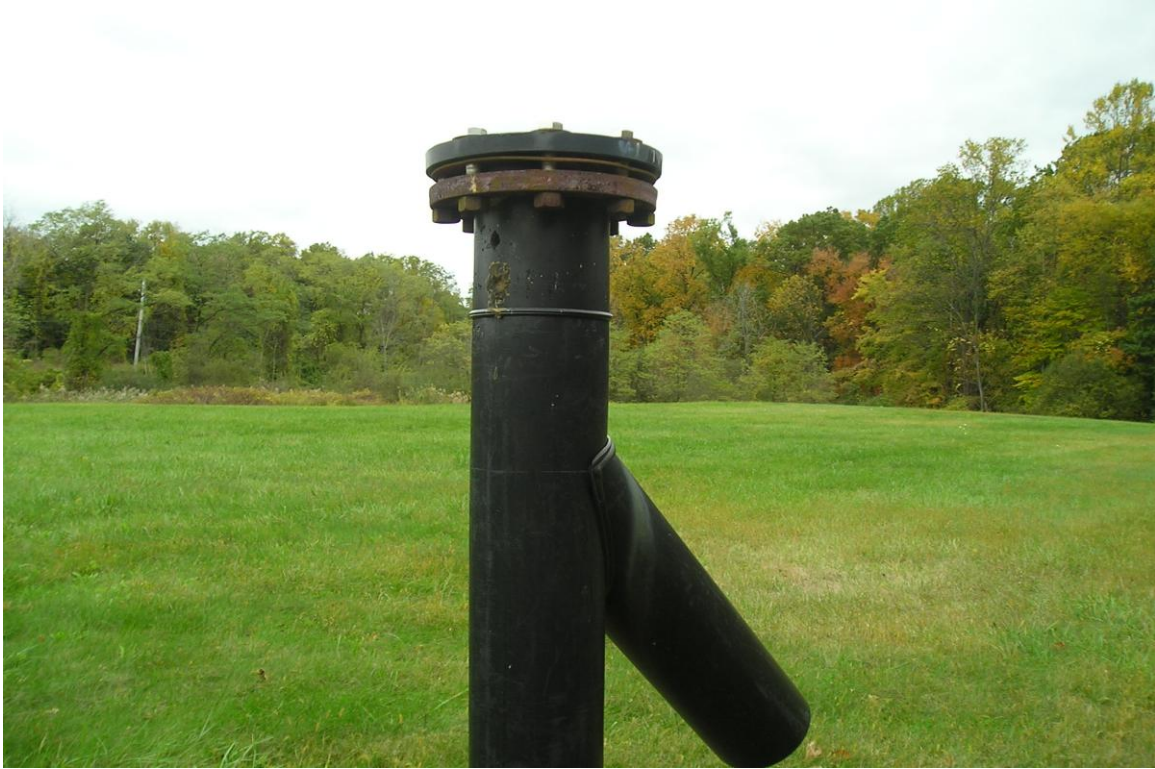
Four vents (V-1 to V-4) were inspected (Photos # 1-4). V-1 was found to have an eraser-sized hole on the side near the top of the vent. V-2 had a quarter-sized hole near the top of the vent. Damage is thought to have been caused by woodpeckers due to evidence of “peck marks” in the vicinity of the holes. The epoxy that was brought to the site to repair the holes ended up not curing properly and could not be used. V-3 and V-4 and generally found in good condition (neither cracks nor movement was observed). V-2 leans slightly to the north.

Photo 1: Vent V-1 (eraser size hole).

1. The well keys are in the office desk. The main gate to the facility is currently locked by on-site personnel at the end of the day. The gate to the landfill is kept closed and locked.
2. Trim trails leading to the wells in the wetland area during the next mowing event.
3. Vents V-1 and V-2 will be repaired with a aptch and tube caulk before the next inspection in April 2015. Epoxy that was brought to site on the day of the inspection ended up being too old and did not harden up when mixed.

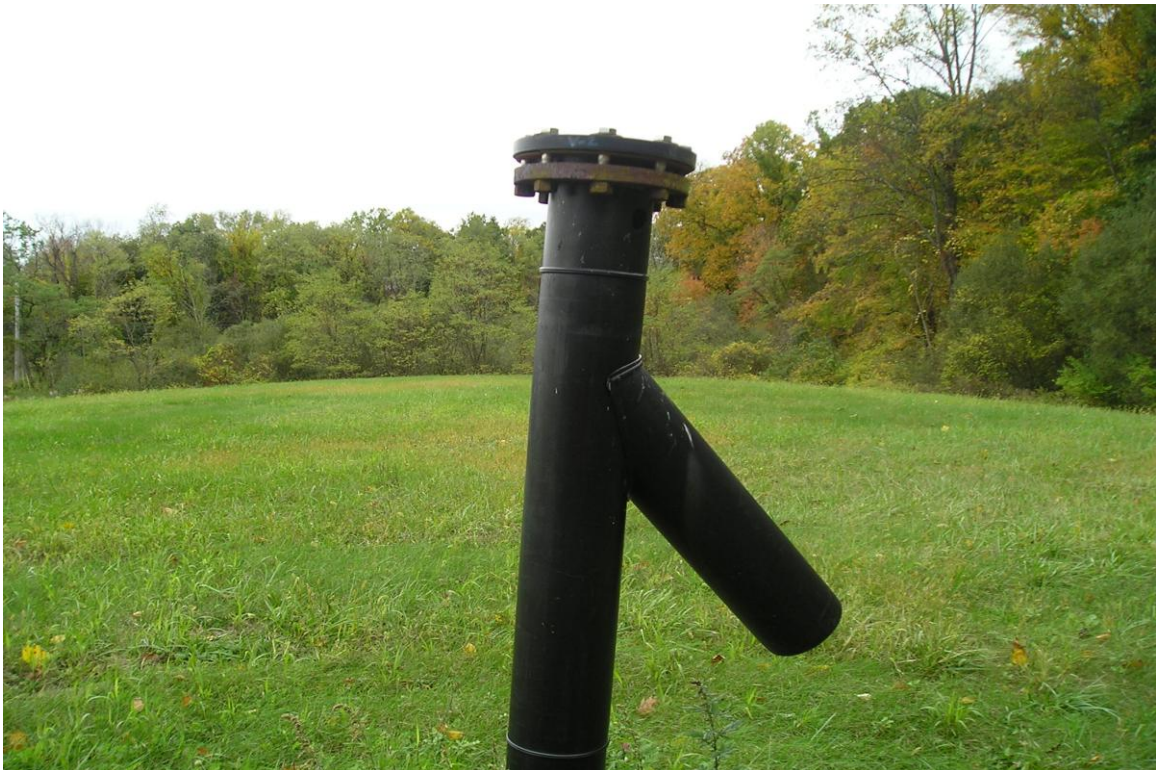
Photo 2: Vent V-2 (quarter size hole near top).

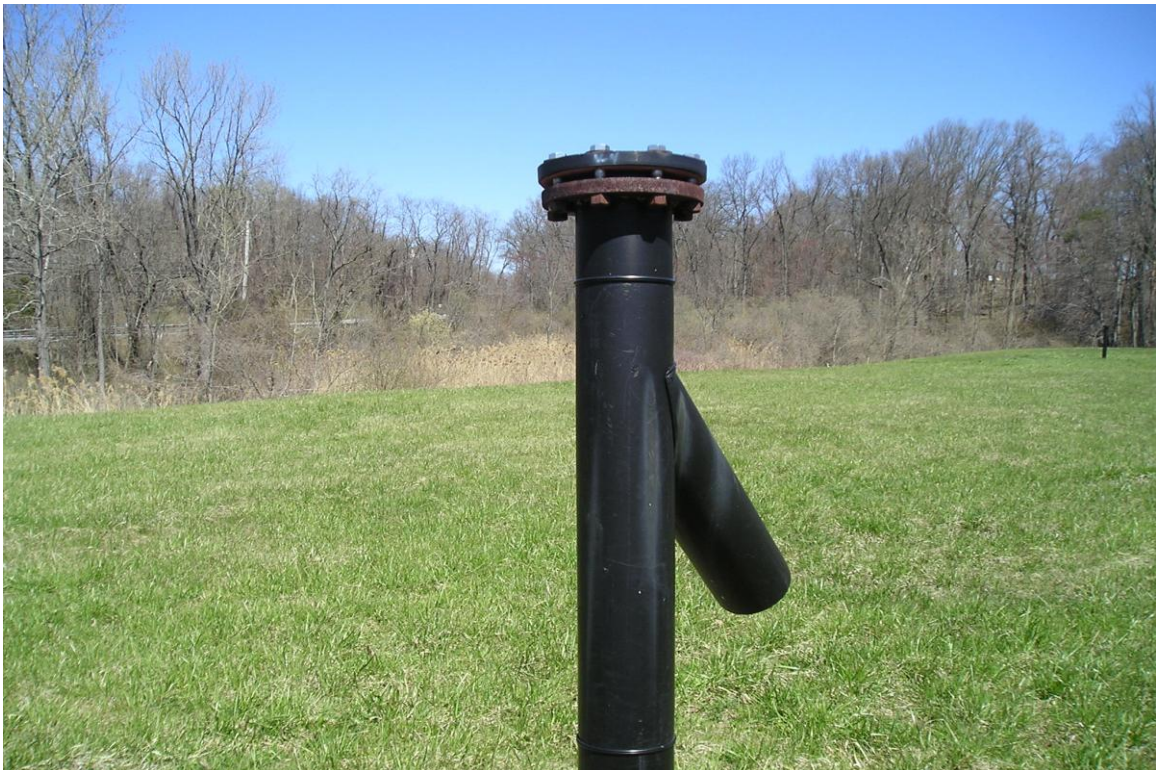
Photo 4: Vent V-4 (Photo from April 2014 inspection. Current inspection photo was not viewable).

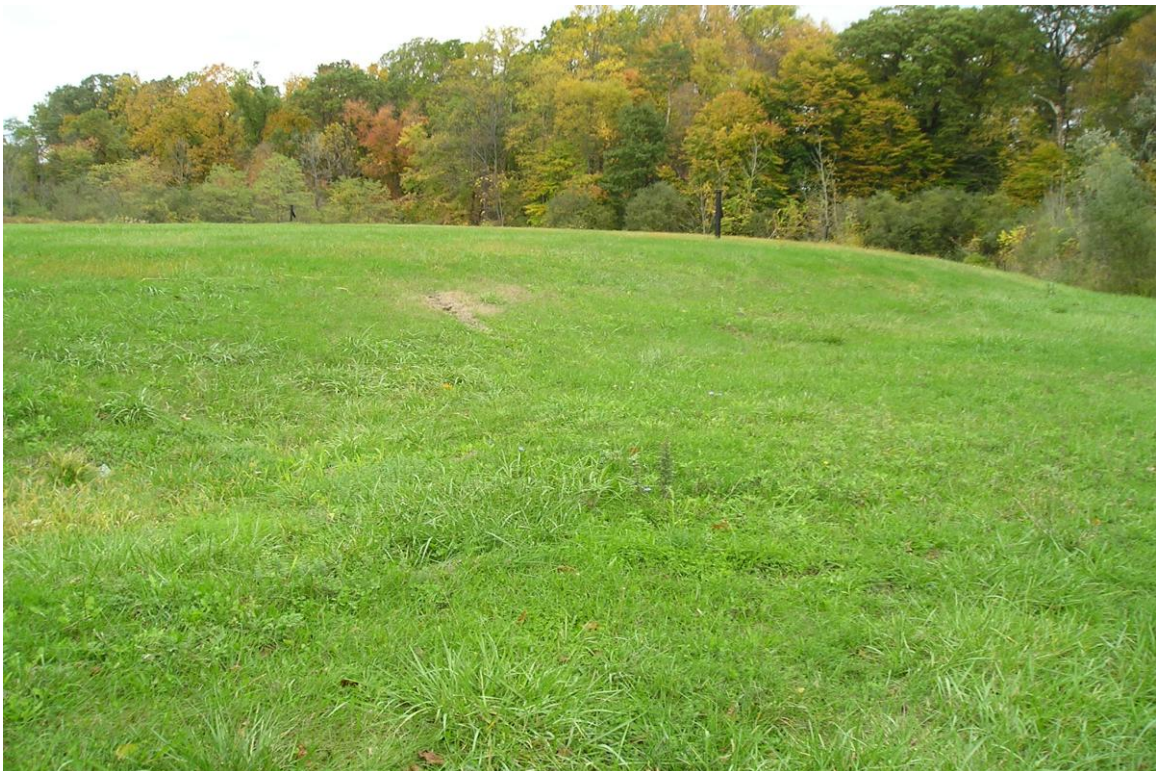
Grass height was satisfactory at the time of inspection (Photo #10).

Photo 10: Grass on landfill cap

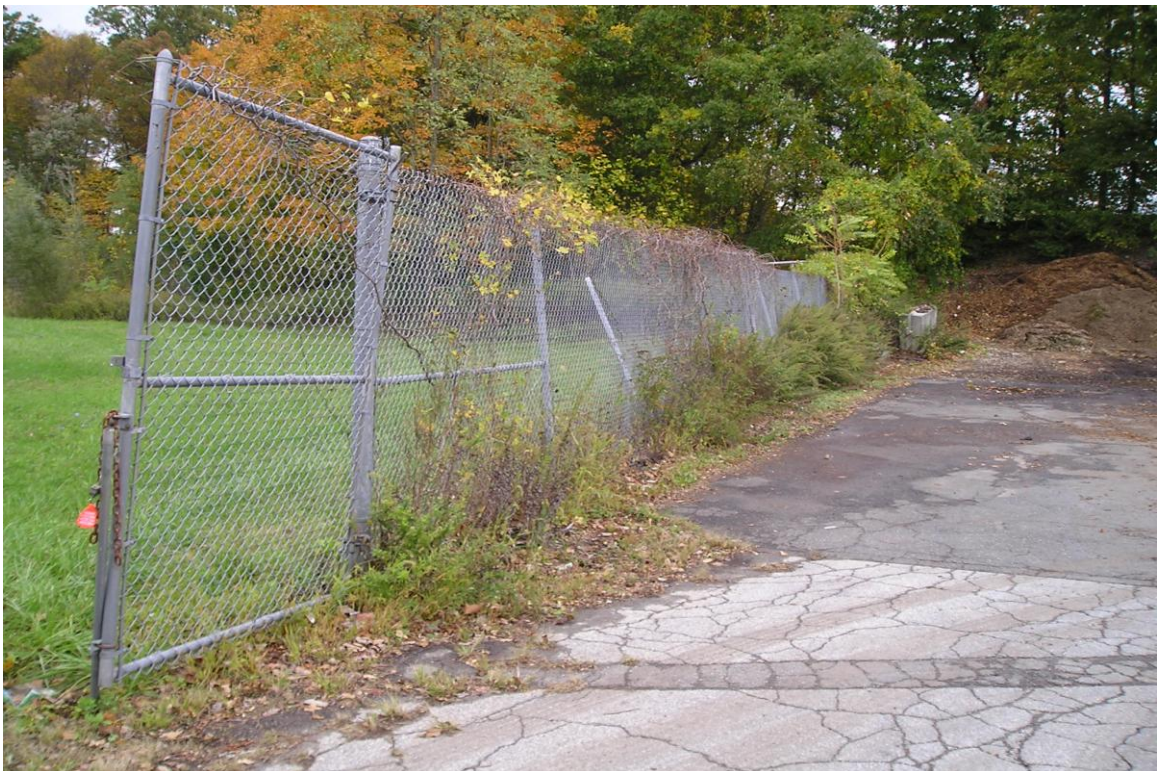
The south fence near the landfill gate appears to be in fair condition. (Photo #12)

Photo 12: South fence (looking east)

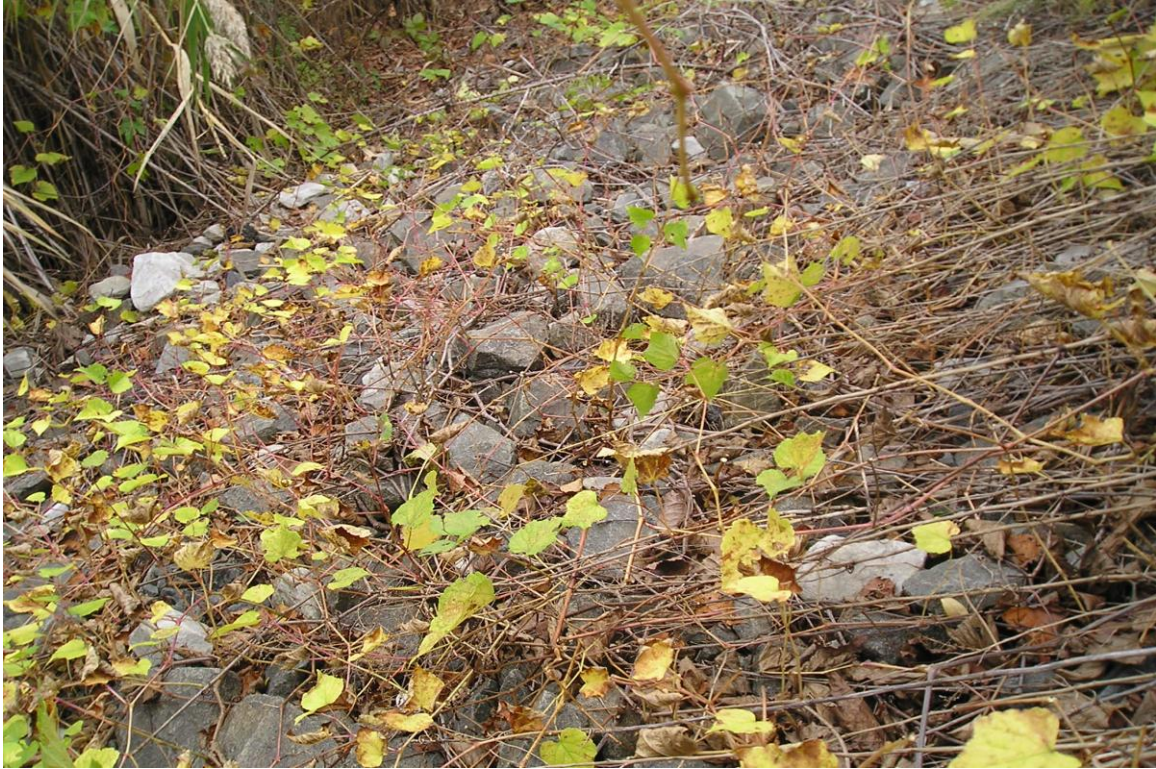
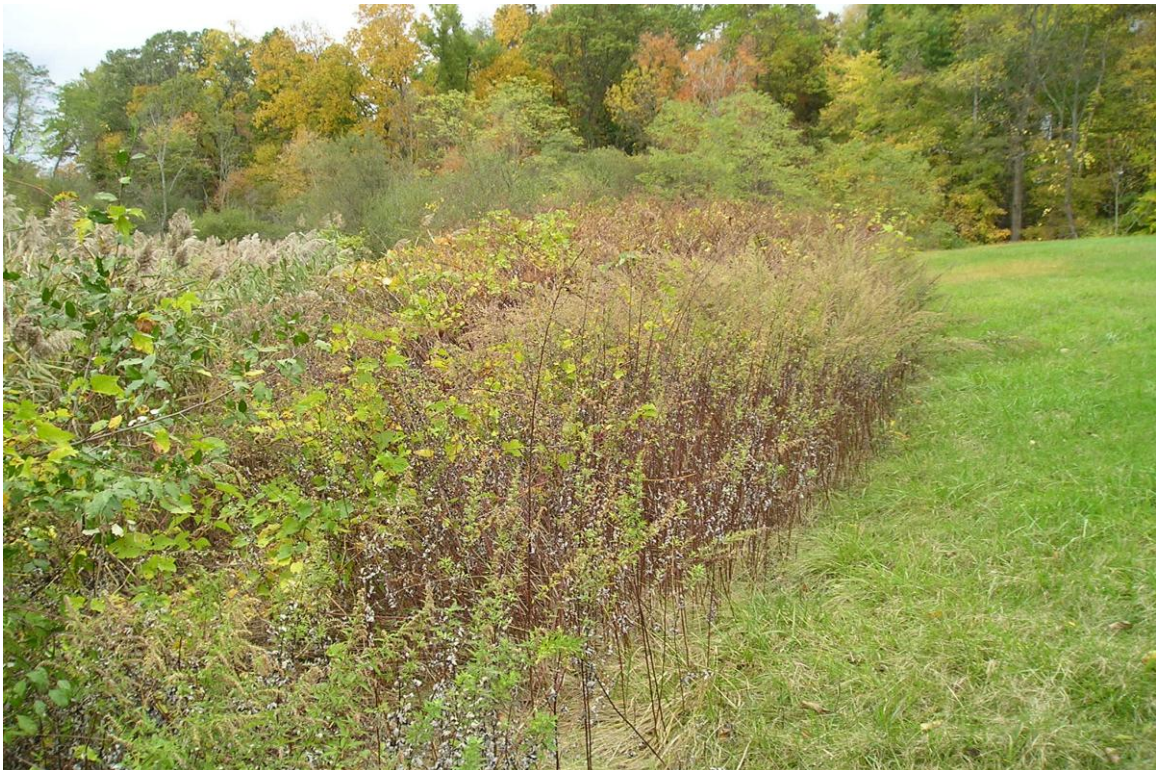
The soil slump on west slope of landfill was repaired in May 2009 by NYSDOT Residency 8-9 personnel. The repaired area is overgrown with invasive vegetation (Photos #13 & 14) and should be weed-wacked during the next mowing event in Spring 2015.

Photo 13: West slope erosion area repair (looking down to the west)

Photo 14: West slope erosion area repair (looking north)

1. Old/tall vegetation in the area of the west slope repair should be removed during the next cap mowing.

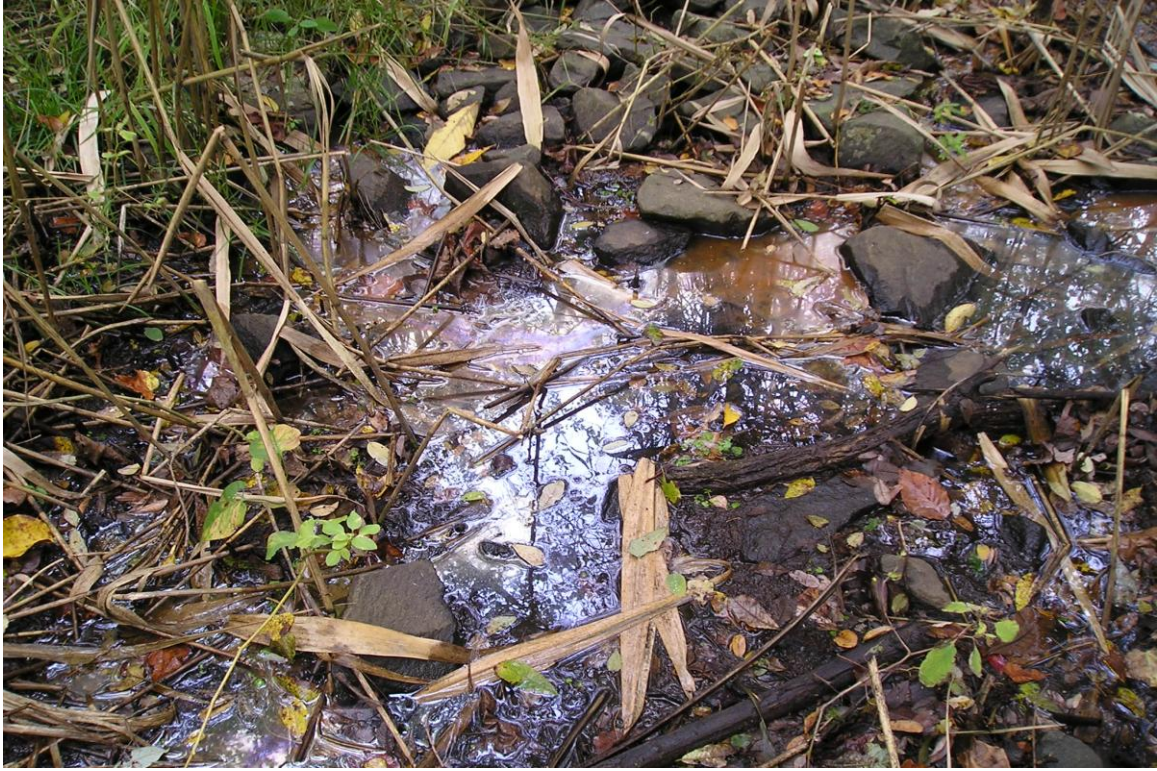
A small area of orange staining and a sheen on the water was noted near the stream in the vicinity of LMW-4. Iron reducing bacteria are believed to cause this periodic staining (Photo # 15).

Photo 15: Orange staining and sheen from iron bacteria near stream around LMW-4.
