HARRISON SUB-RESIDENCY FIELD INSPECTION

Name of Inspector(s): Christopher Kappeller

Date: 04/24/15

Semi-Annual

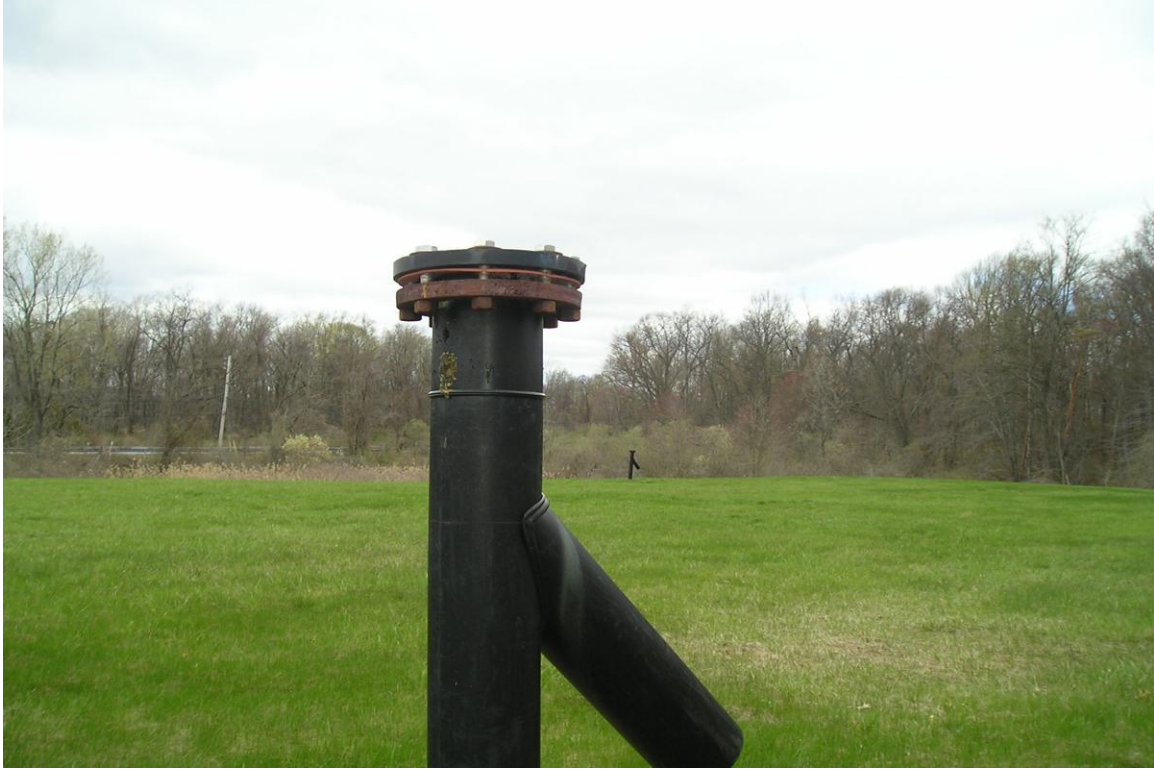
Four vents (V-1 to V-4) were inspected (Photos # 1-4). V-1 was found to have an eraser-sized hole on the side near the top of the vent. V-2 had a quarter-sized hole near the top of the vent. Damage is thought to have been caused by woodpeckers due to evidence of “peck marks” in the vicinity of the holes. V-3 and V-4 and generally found in good condition (neither cracks nor movement was observed). V-2 leans slightly to the north.

Photo 1: Vent V-1 (eraser-sized hole)

1. Old/tall vegetation in the area of the west slope repair should be removed during the next cap mowing.
2. Repair small holes in V-1 and V-2. Holes will be permanently patched by NYSDOT Maintenance by the end of June 2015.

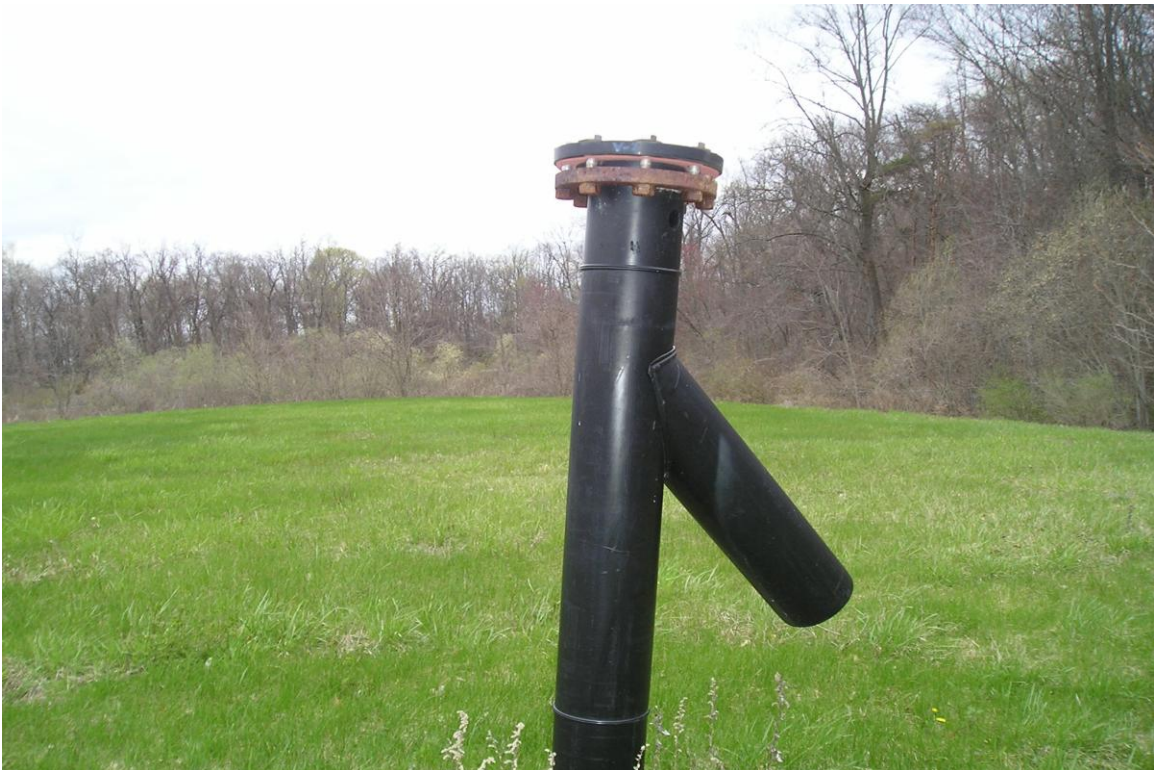
Photo 2: Vent V-2 (quarter-sized hole near top)

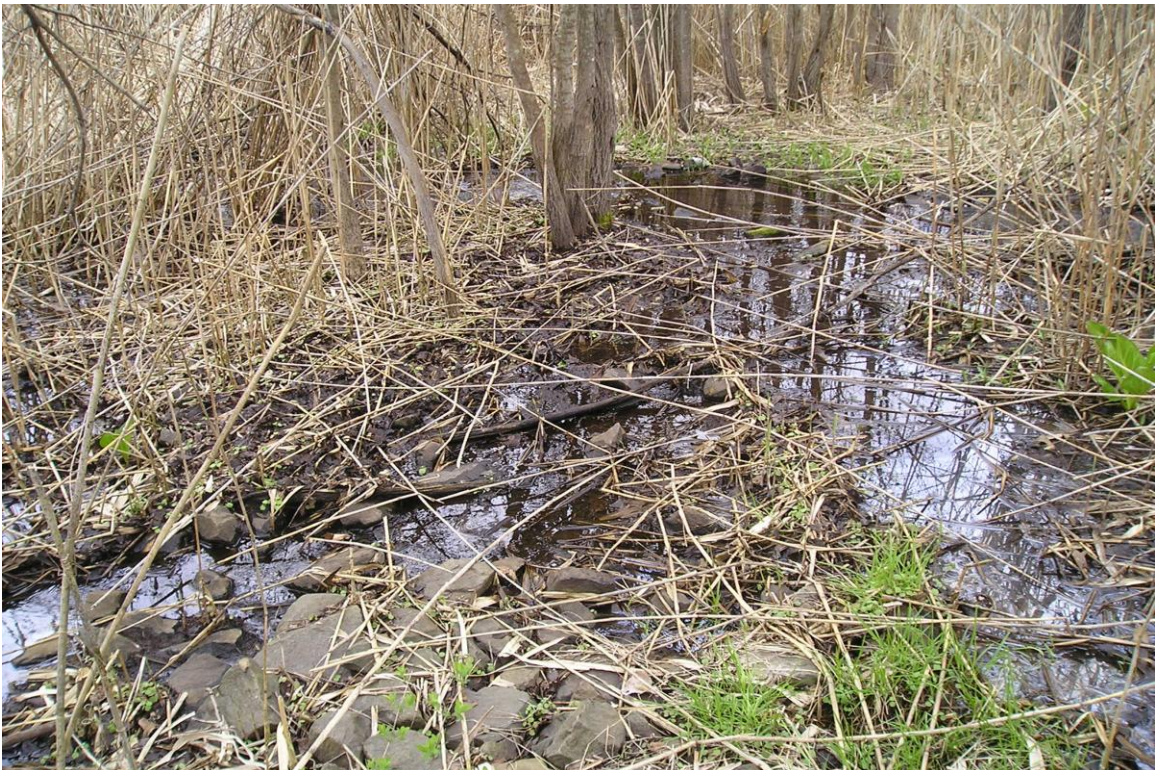
Photo 6: Well LMW-4 (could not check due to high water)

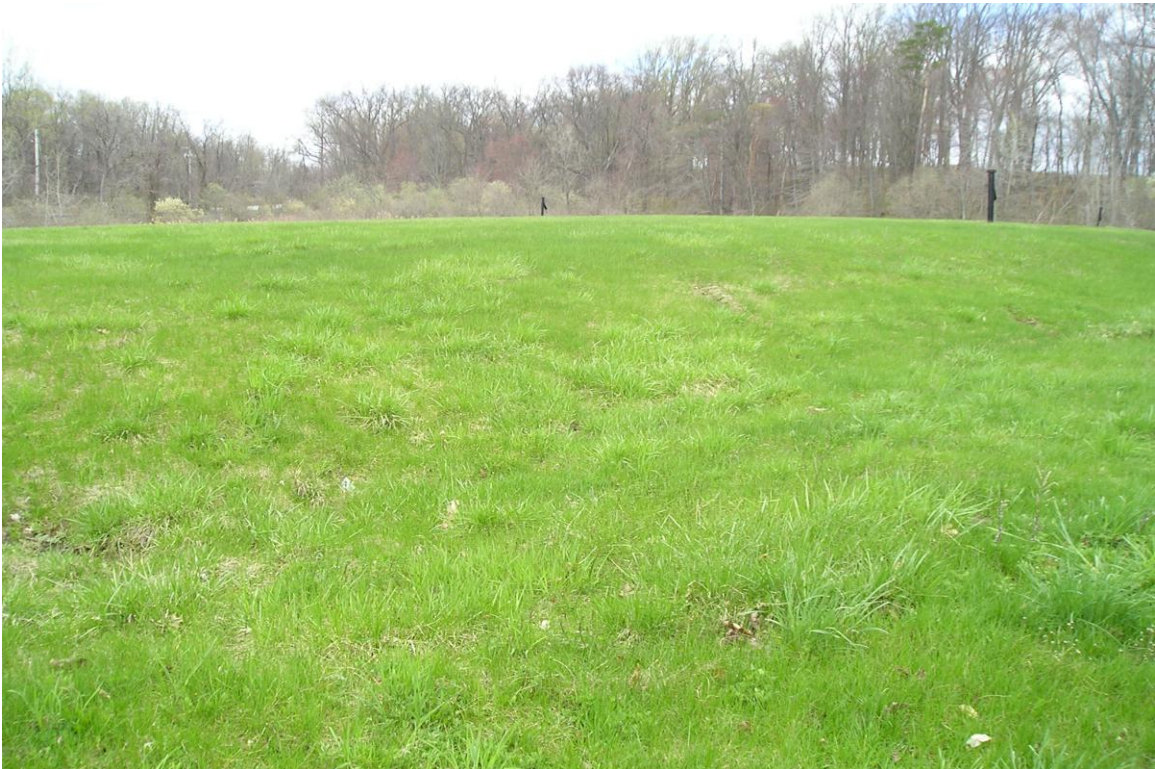
Grass height was satisfactory at the time of inspection (Photo #10).

Photo 10: Grass on landfill cap

The grass appeared to be at a satisfactory height. The cap should be mowed every June and September.

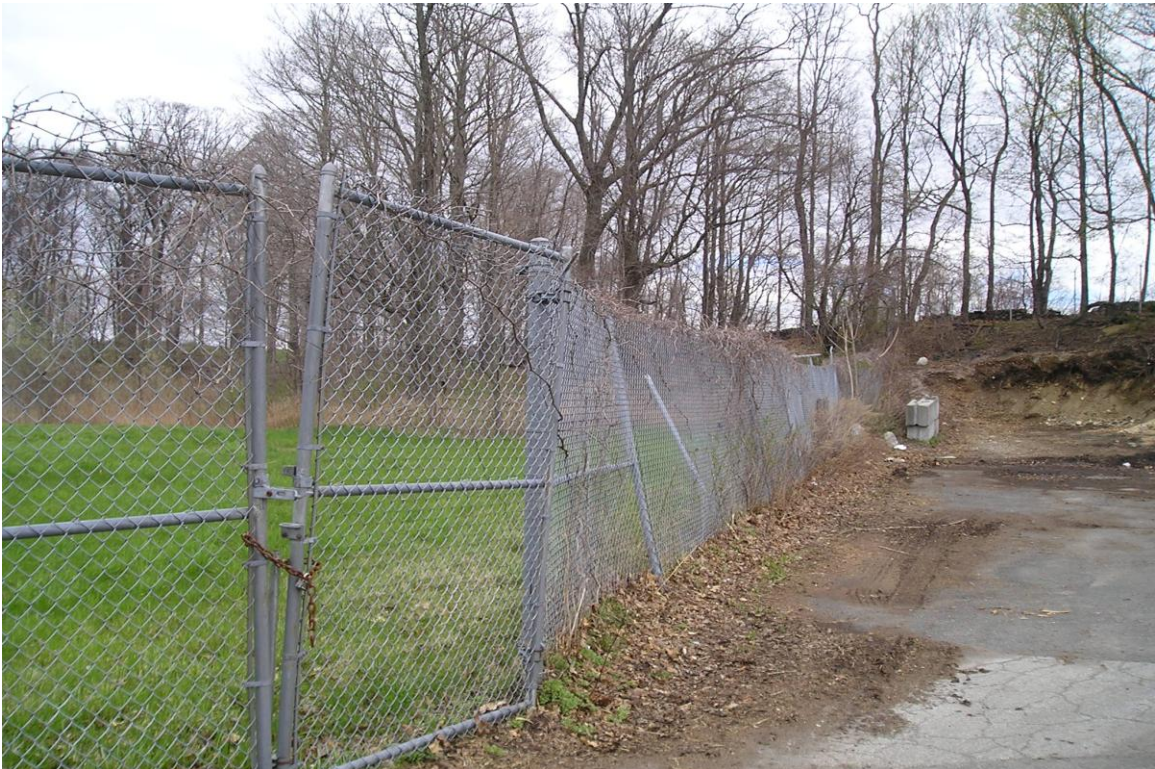
The south fence near the landfill gate appears to be in fair condition. (Photo #12)

Photo 12: South fence (looking east)

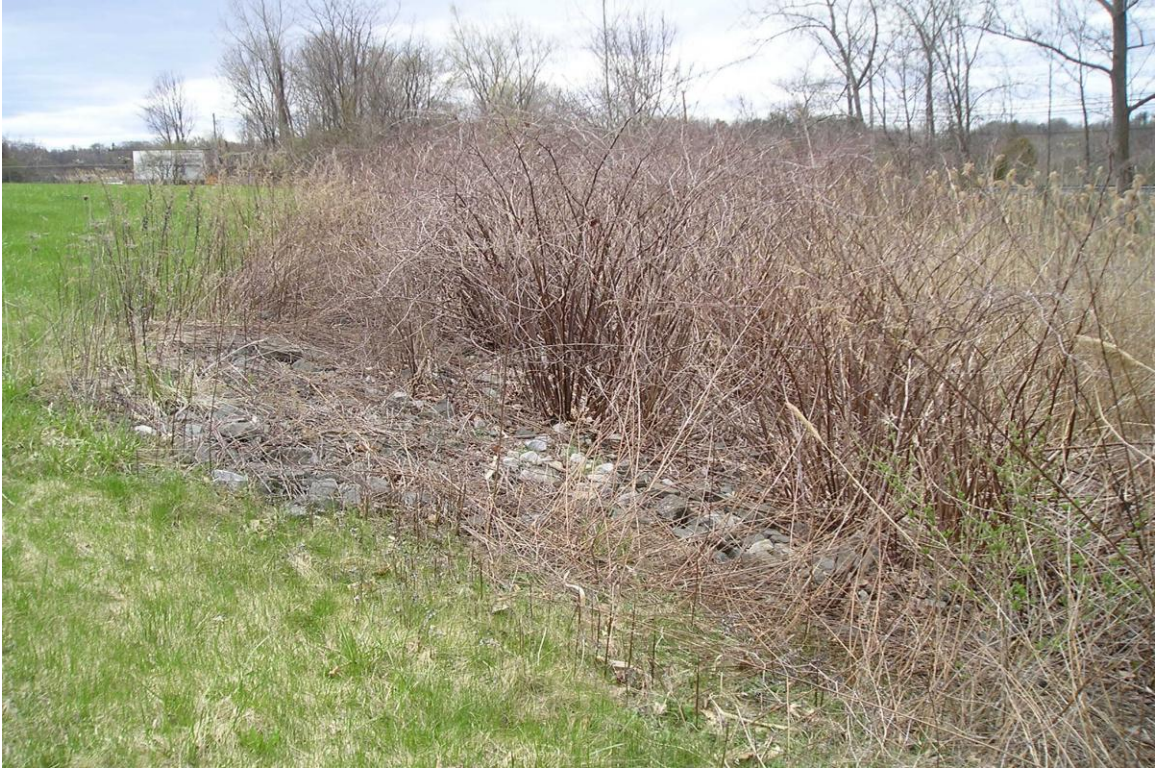
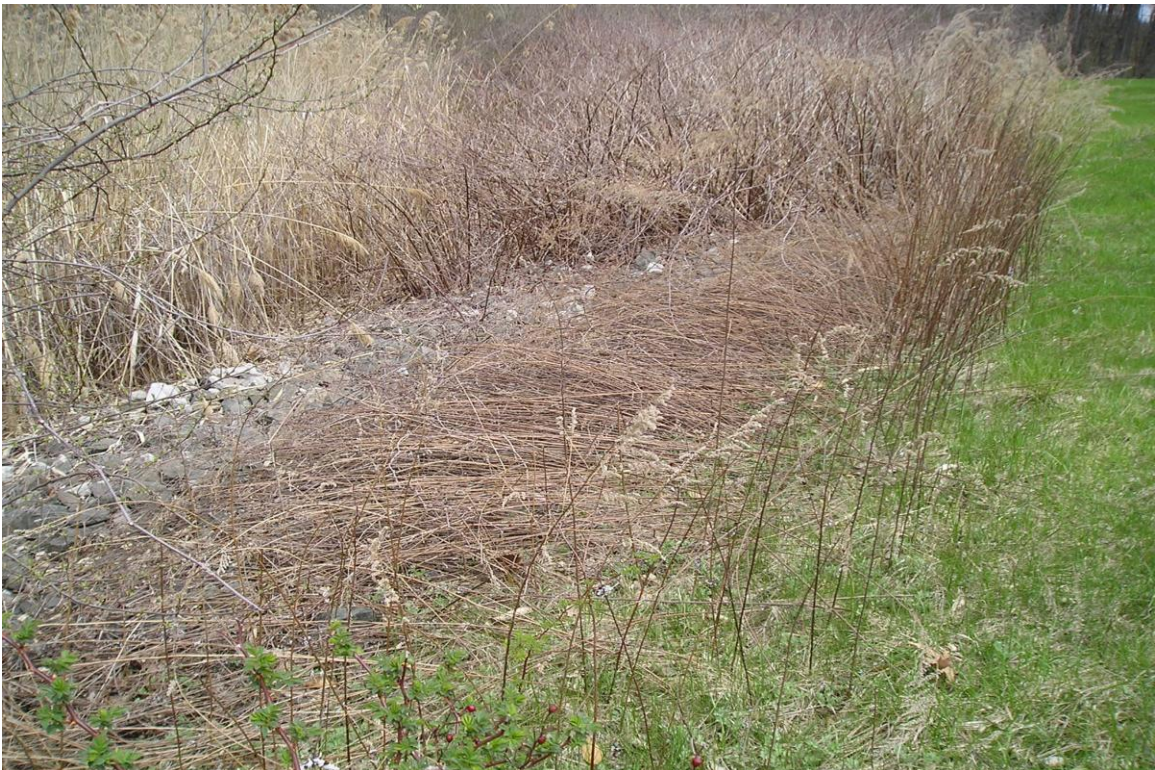
The soil slump on west slope of landfill was repaired in May 2009 by NYSDOT Residency 8-9 personnel. The repaired area is overgrown with invasive vegetation (Photos #13 & 14) and should be weed-wacked during the next mowing event in Summer 2015.

Photo 13: West slope erosion area repair (looking south)

Photo 14: West slope erosion area repair (looking north)

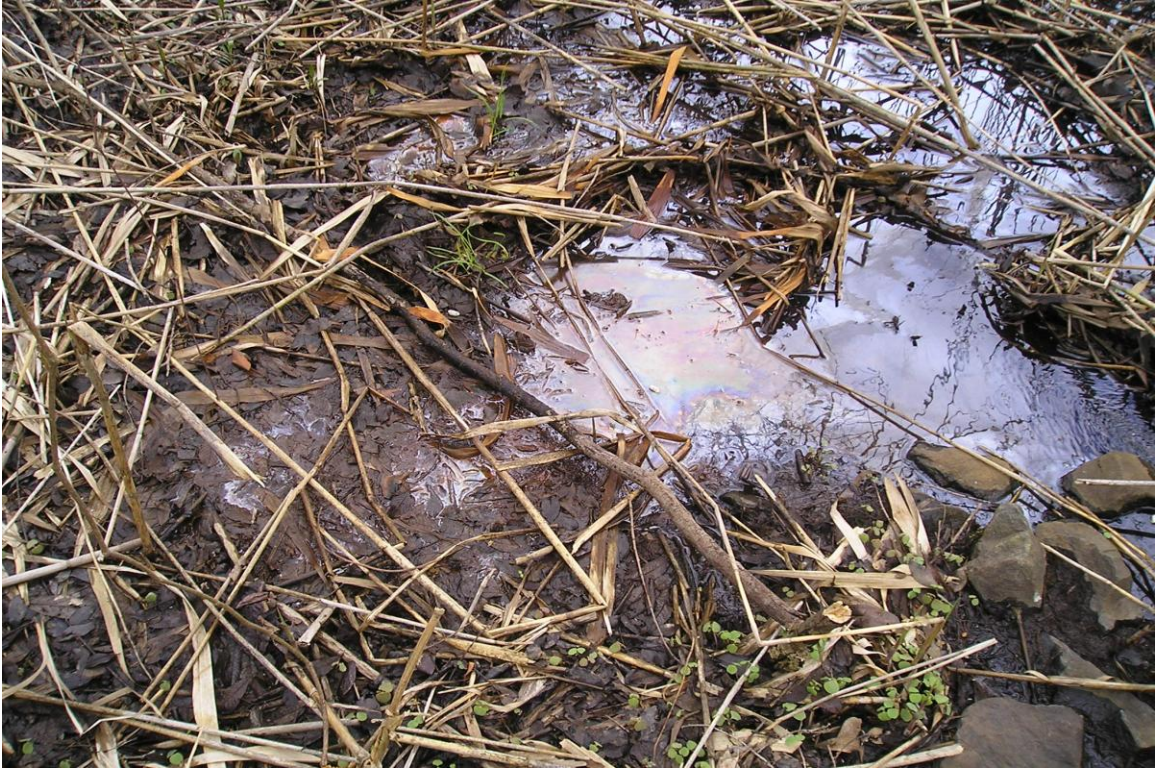
A small area of orange staining and sheen on water was noted near the stream in the vicinity of LMW-4. Iron reducing bacteria are believed to cause this periodic staining (Photo # 15).

Photo 15: Orange staining and sheen from iron bacteria near stream around LMW-4.
