## HARRISON SUB-RESIDENCY SEMI-ANNUAL FIELD INSPECTION

**Name of Inspector(s):** Christopher Kappeller

**Date:** 4/21/15

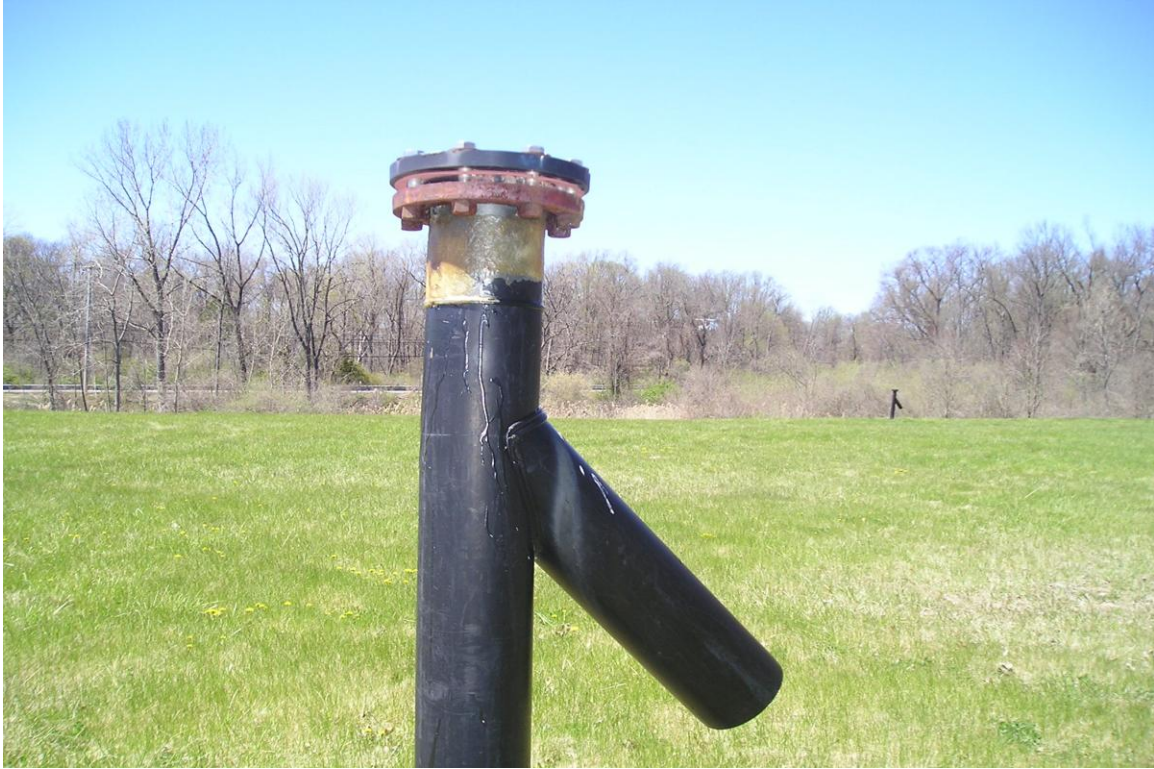
Four vents (V-1 to V-4) were inspected (Photos 1-4). V-1 and V-2 had their plastic casing holes repaired with fiberglass epoxy in August 2015 and were still in good condition. V-3 and V-4 were in good condition (neither cracks nor movement was observed). V-2 leans slightly to the north.

Photo 1: Vent V-1 (hole repair shown)

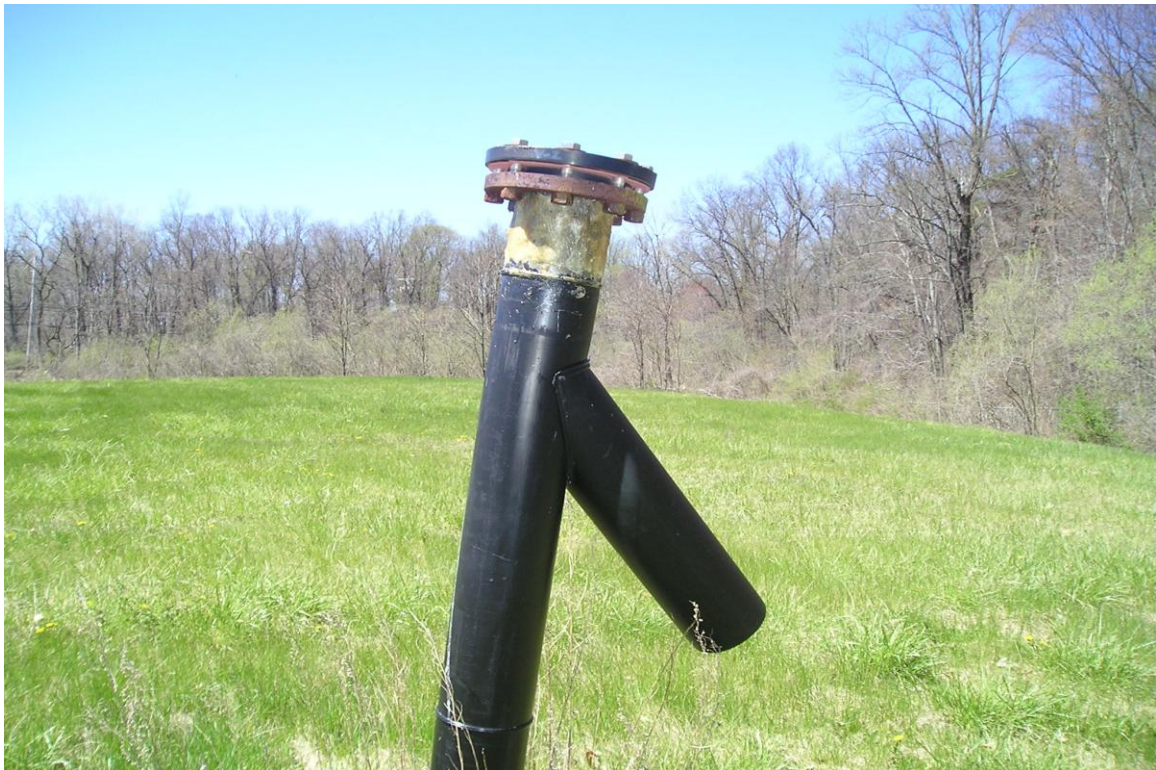
Photo 2: Vent V-2 (repair patch shown)

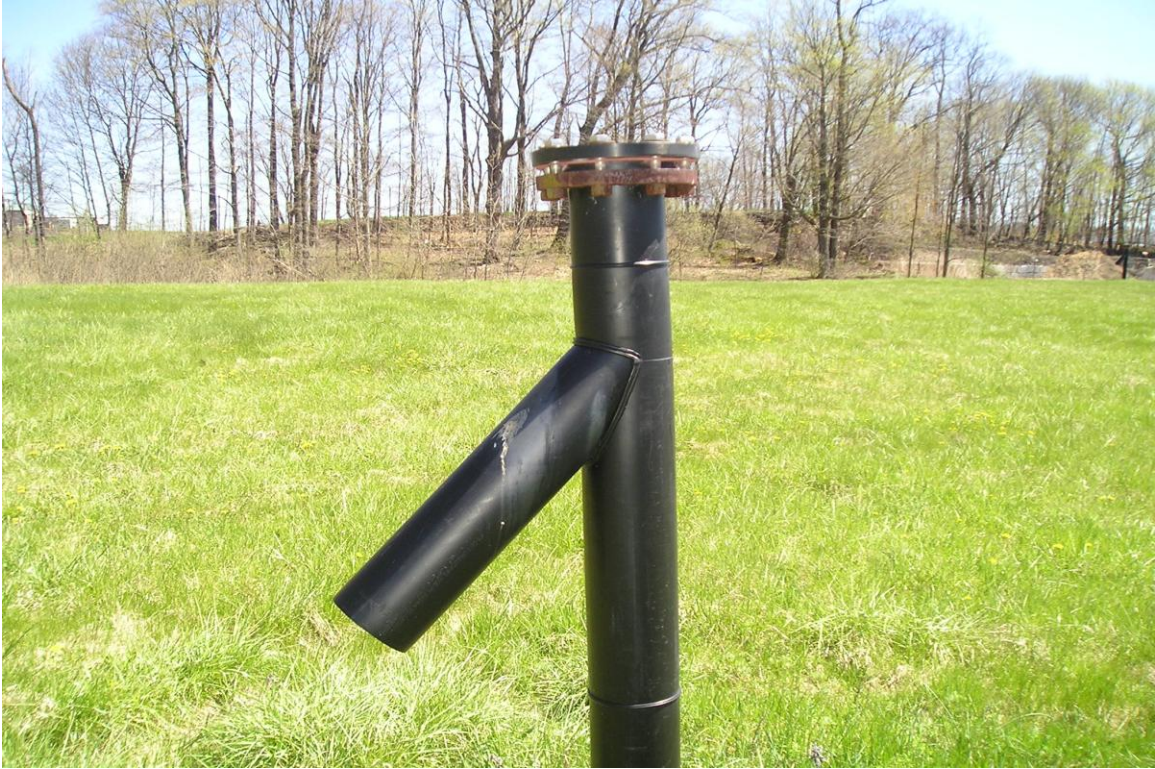
Photo 3: Vent V-3

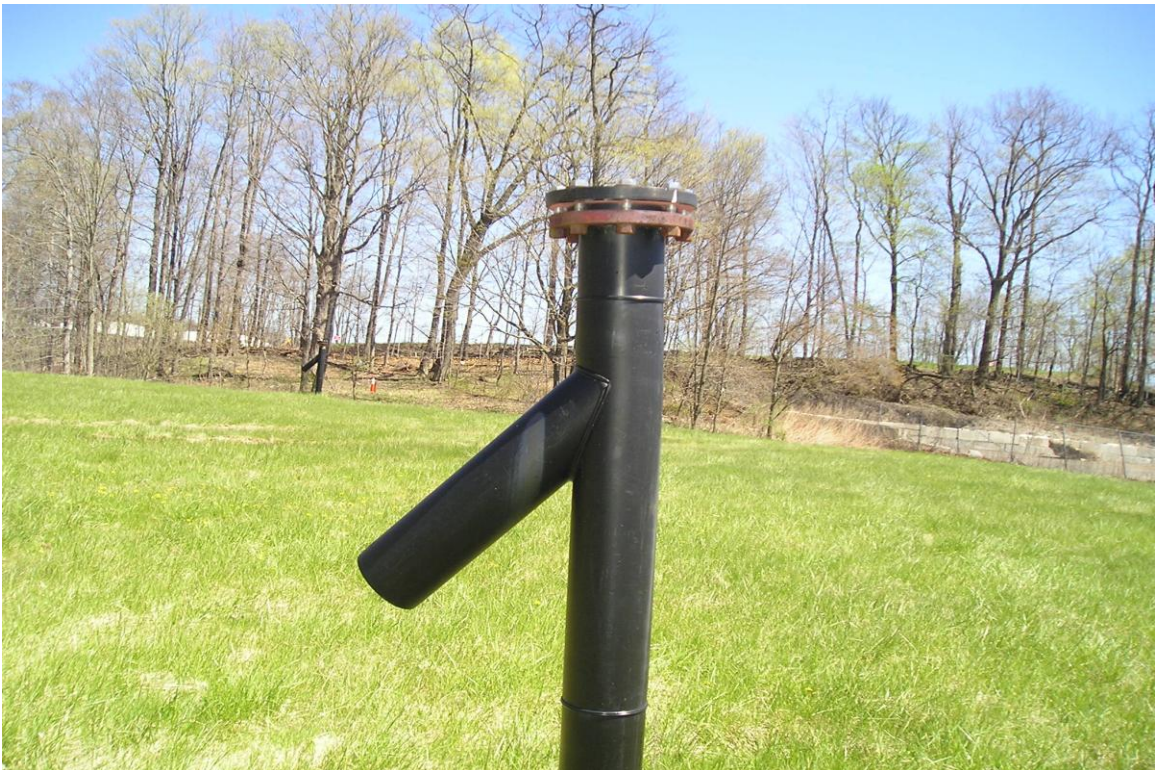
Photo 4: Vent V-4

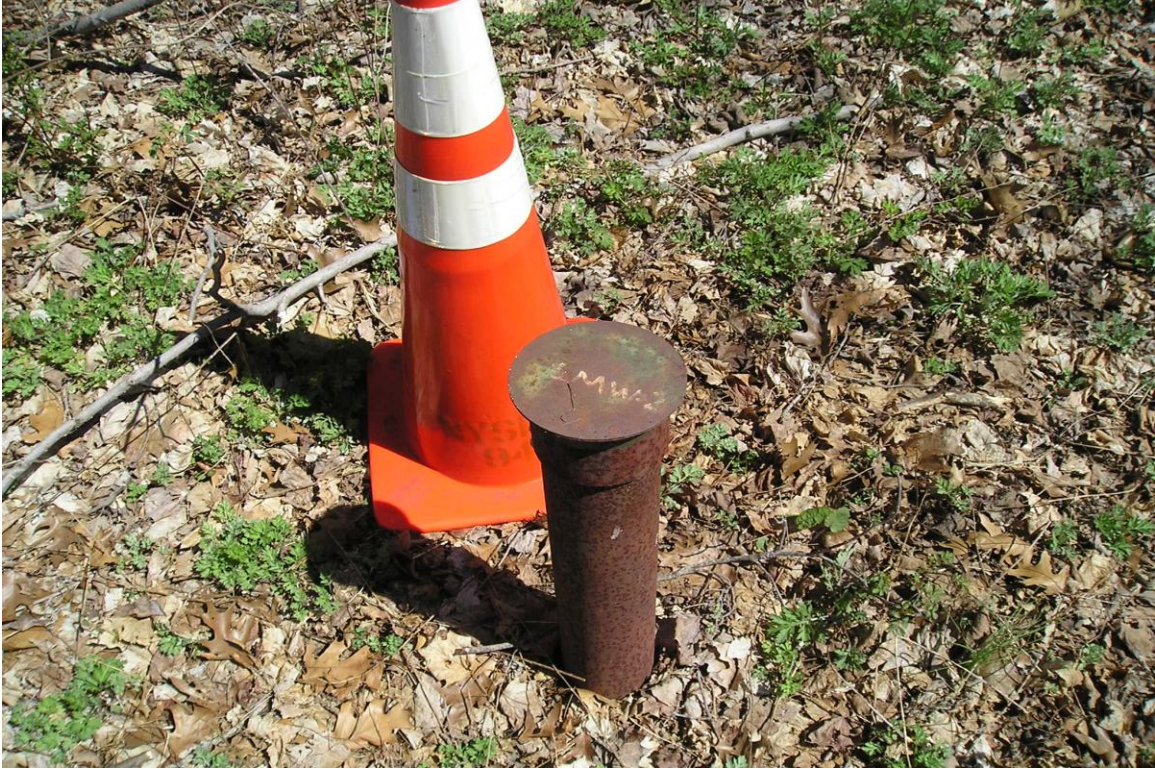
Photo 5: Well LMW-2

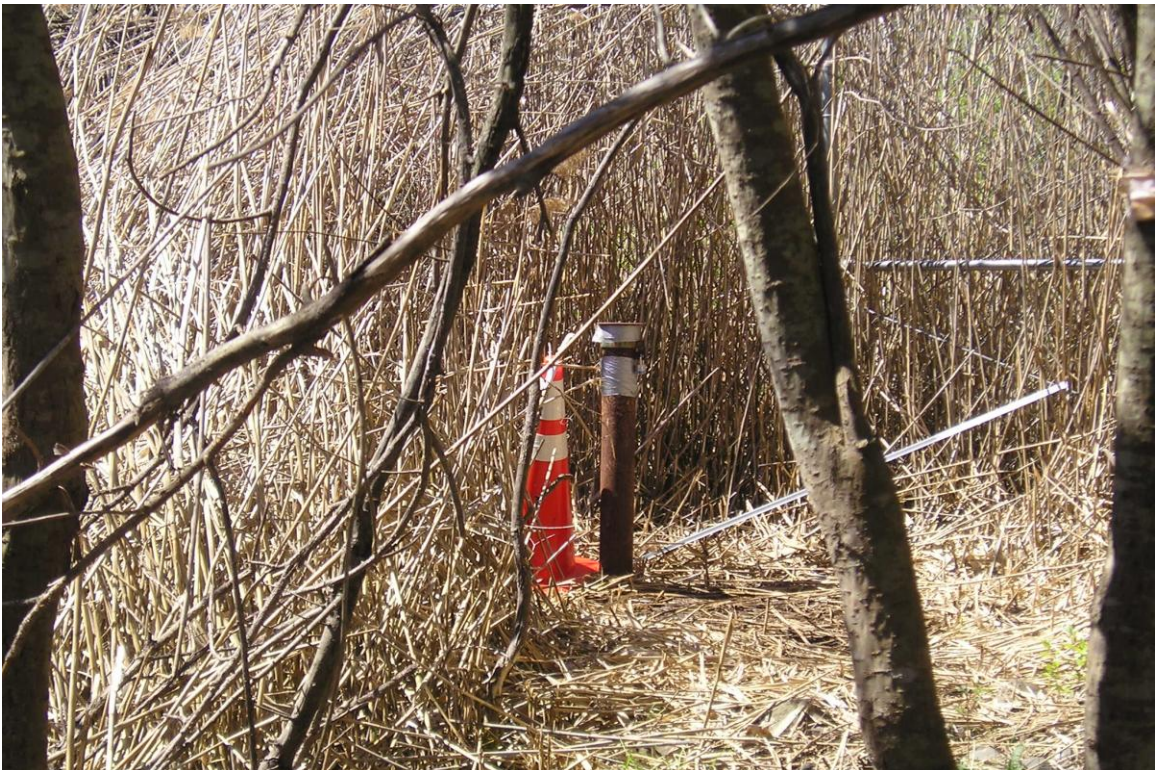
Photo 6: Well LMW-4 area (area is overgrown)

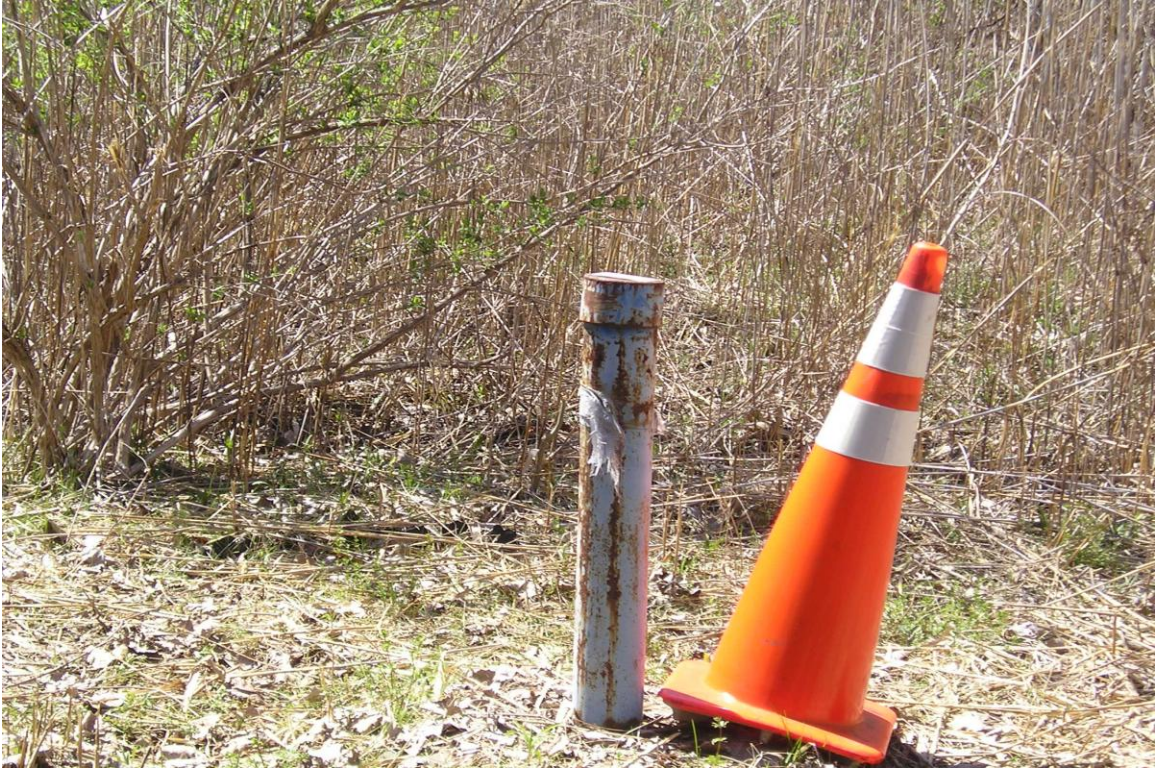
Photo 7: Well PC-1

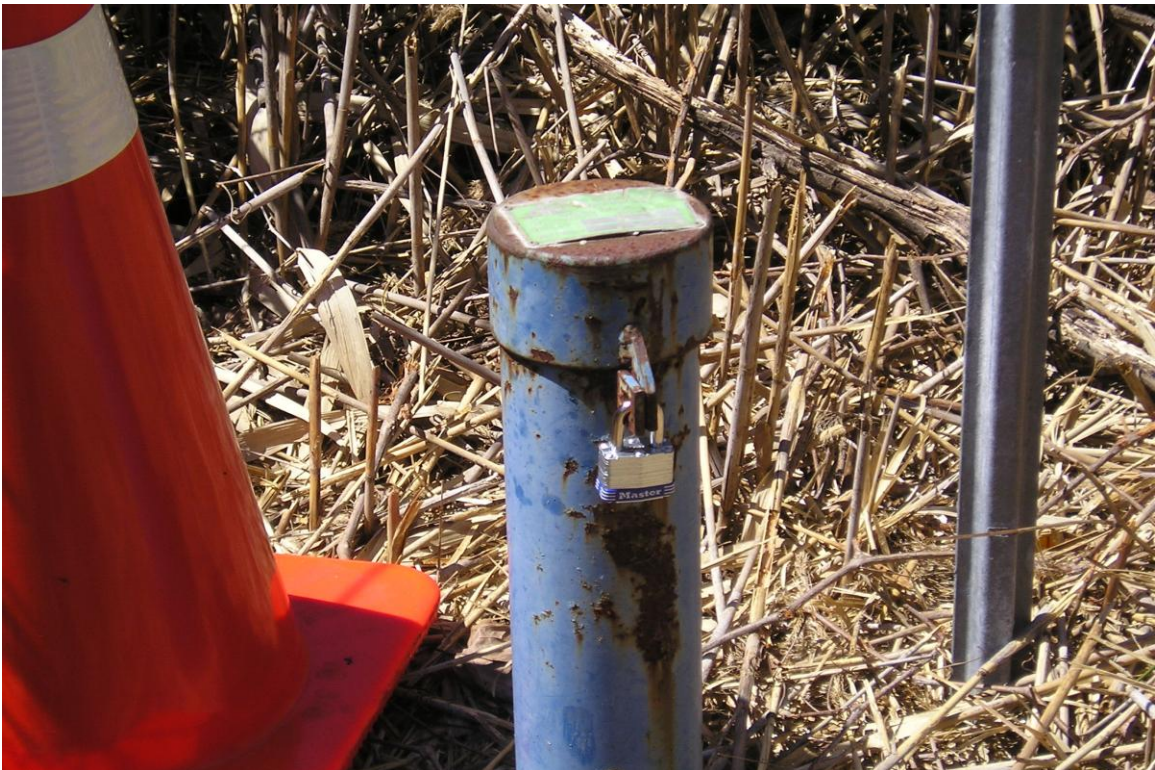
Photo 8: Well PC-2

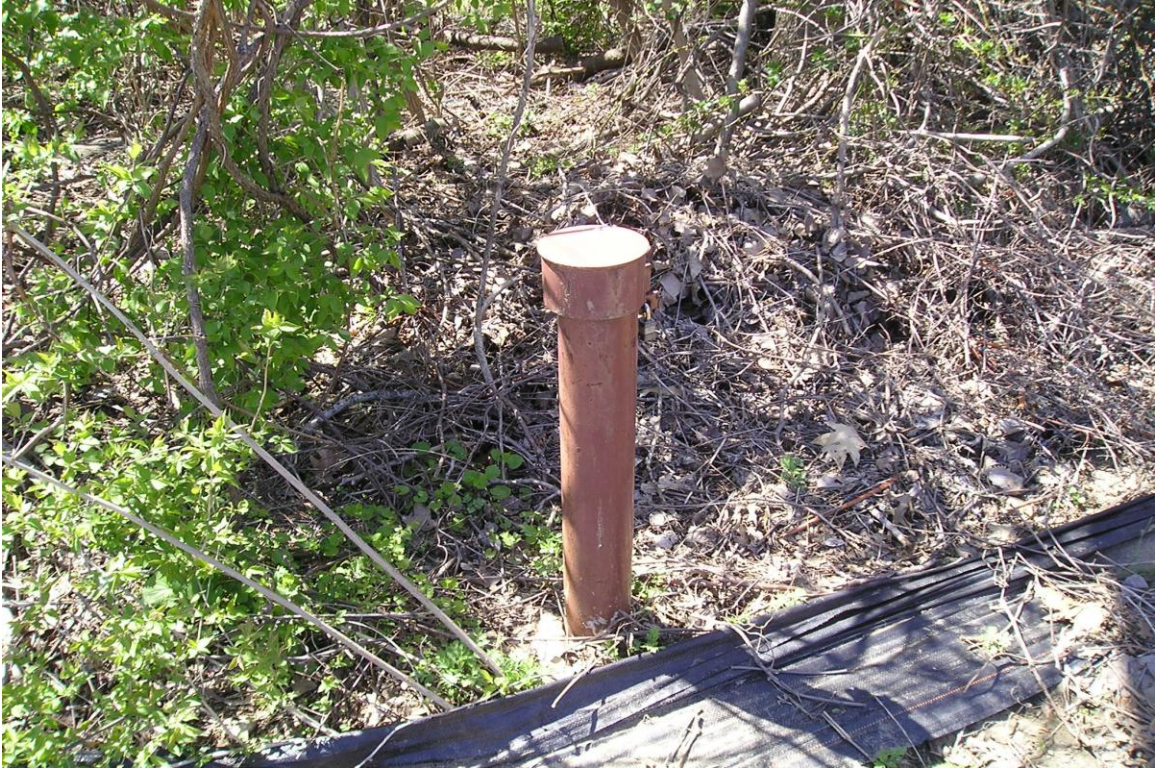
Photo 9: Well MW-11

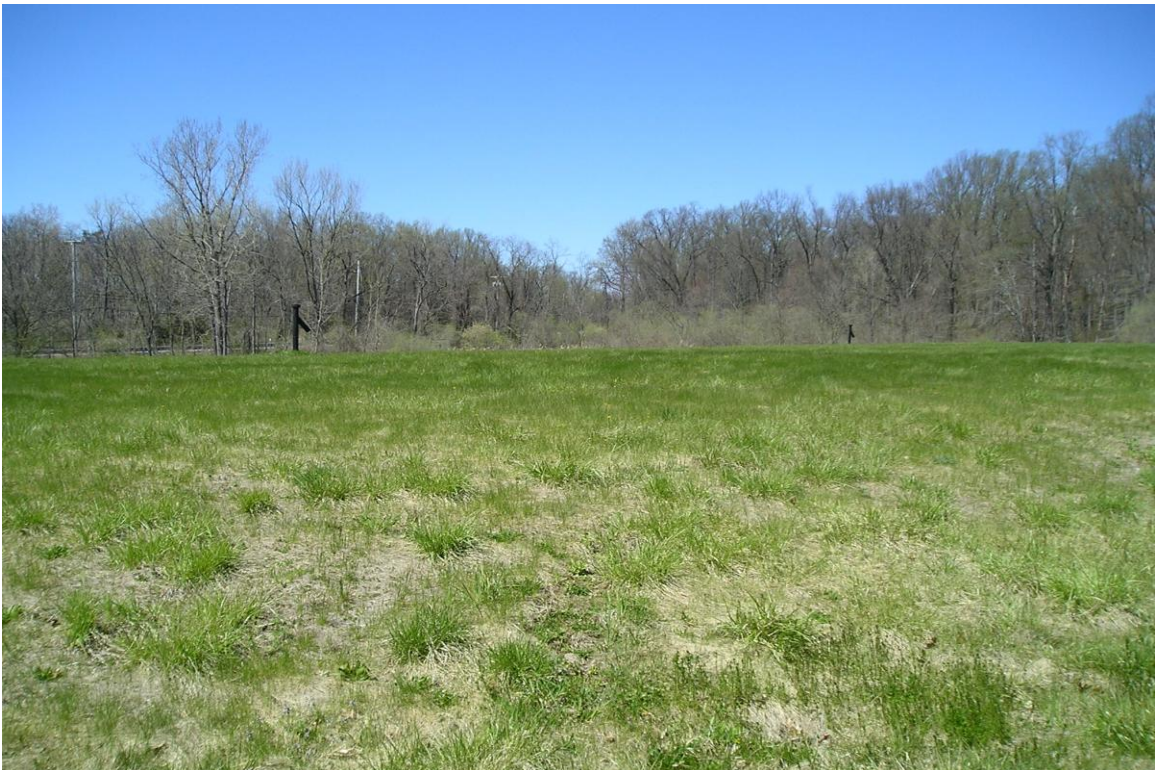
Grass height was satisfactory at the time of inspection (Photo 10). Some channels were created by vehicle tires used to deliver equipment used to cut vegetation on and surrounding the landfill cap (see Photos 14-15). These channels (approx. 6" deep) need to be filled with topsoil and re-seeded.

Photo 10: Grass on landfill cap

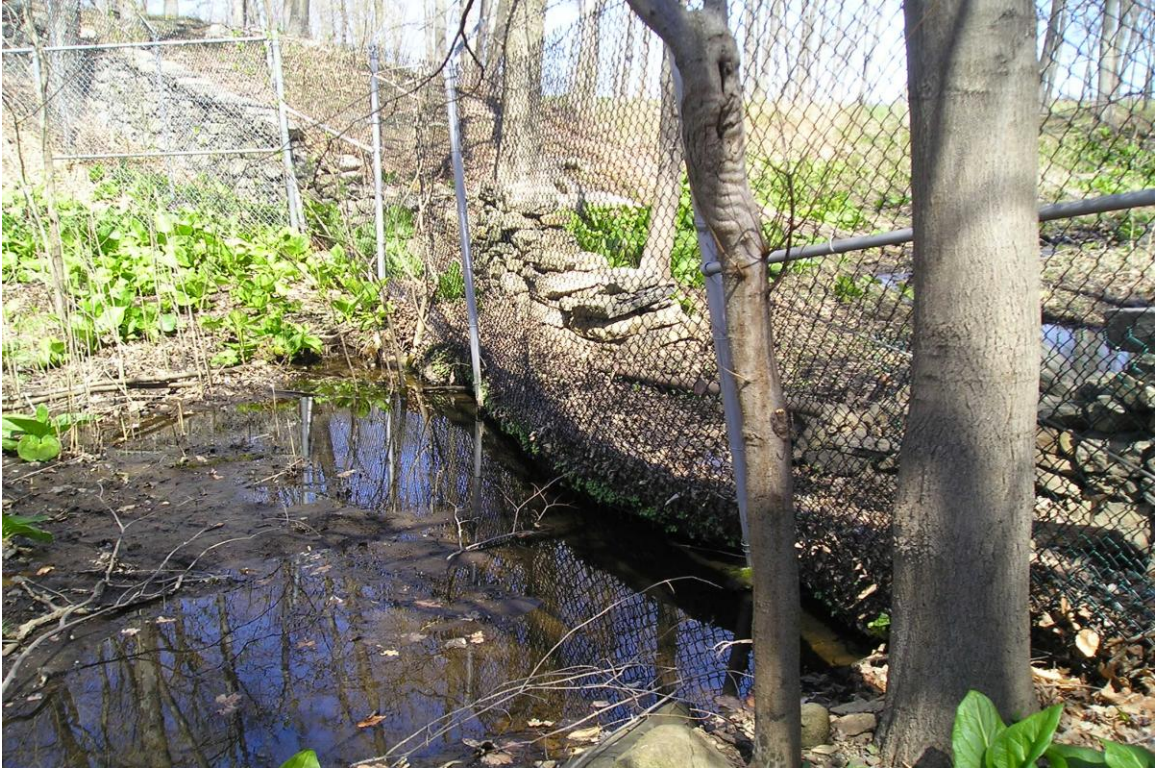
Photo 11: Stream inlet

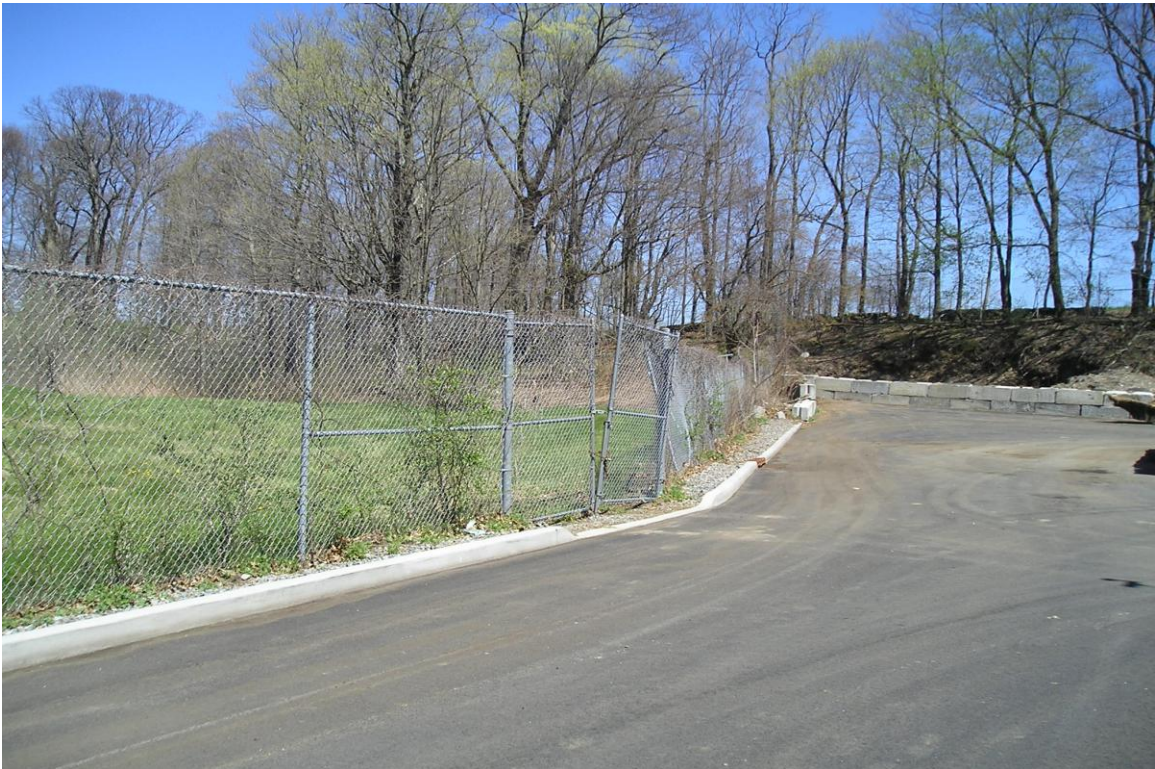
The south fence near the landfill gate appeared to be in fair condition. (Photo 12)

Photo 12: South fence (looking east)

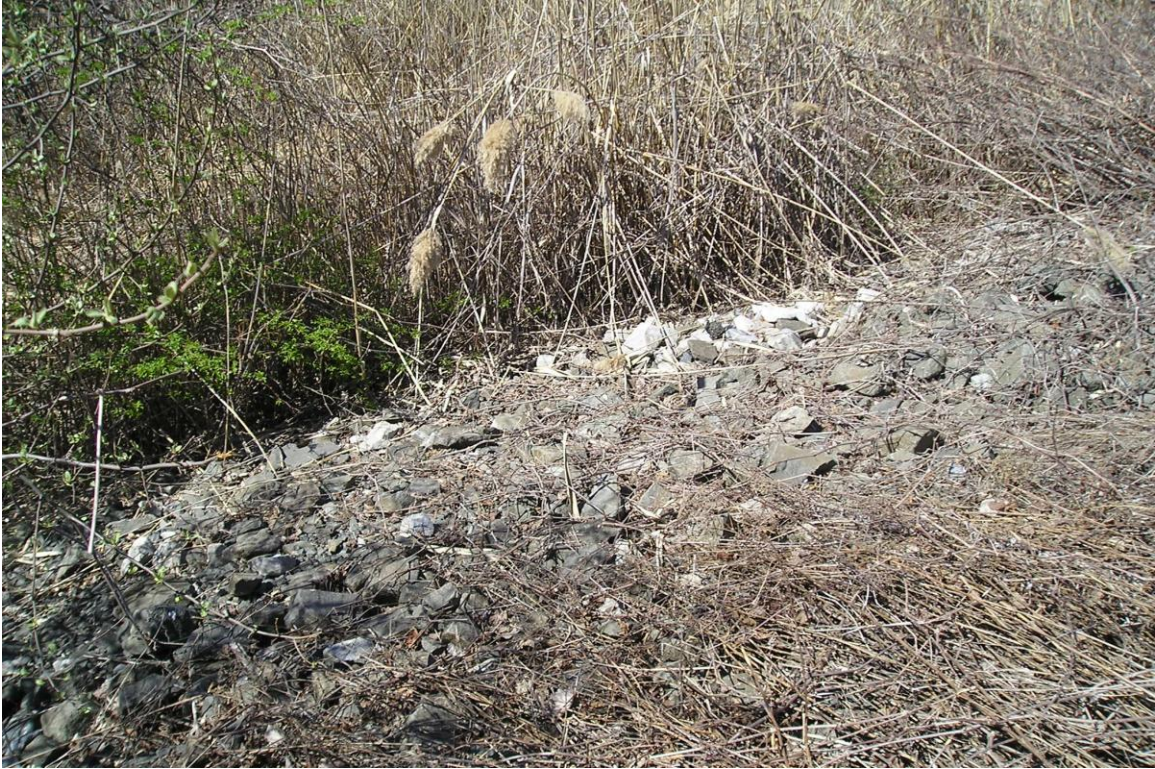
The soil slump on west slope of landfill was repaired in May 2009 by NYSDOT Maintenance Residency 8-9 personnel. The repaired area was trimmed down in April 2016 (Photo 13) and should be weed-wacked during the next mowing event in June 2016.

Photo 13: A portion of the west slope erosion area repair that was cleared

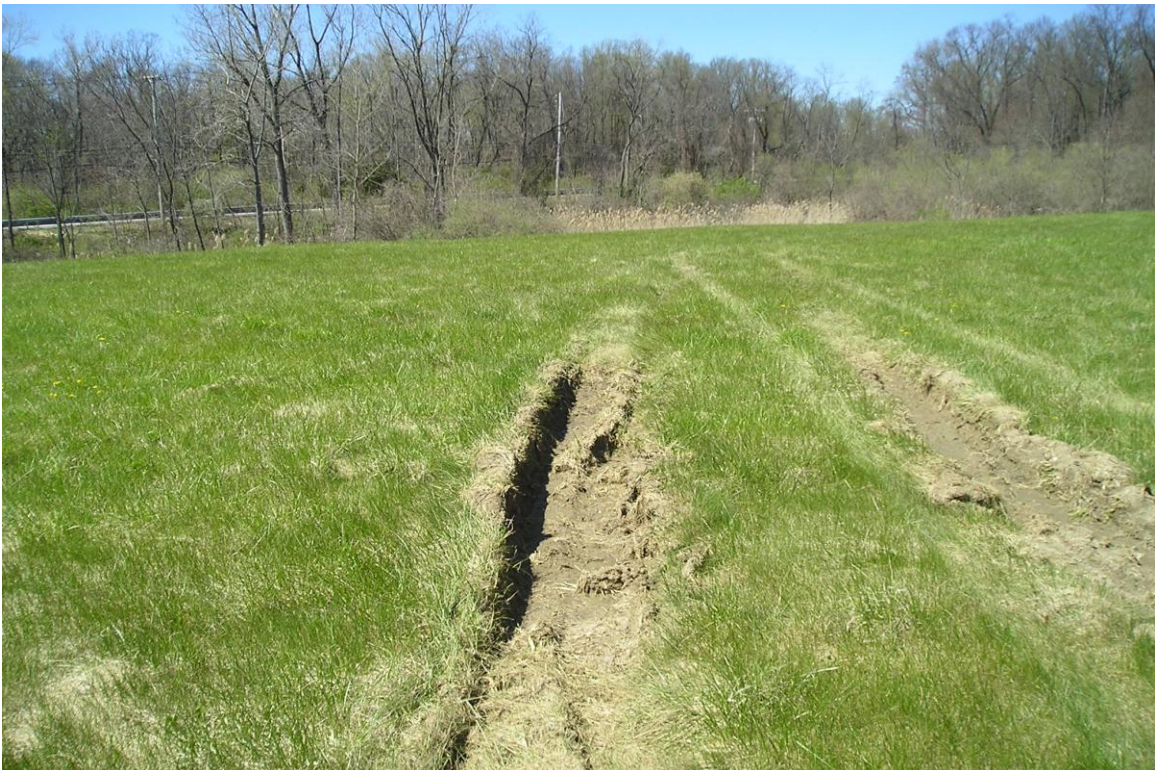
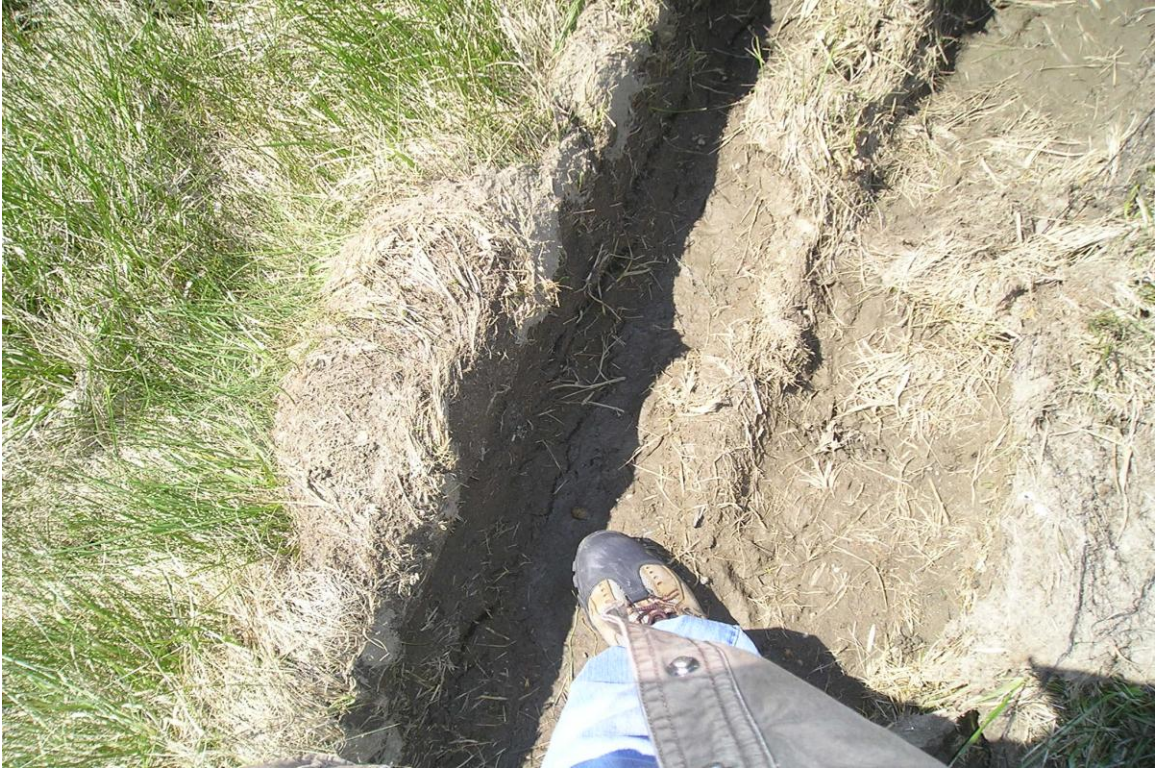
Photo 14: Ruts caused by vehicles carrying equipment

Photo 15: Ruts caused by vehicles carrying equipment

2. NYSDOT Maintenance Residency 8-9 needs to repair the ruts caused by vehicles delivering equipment used to cut vegetation on and surrounding the landfill cap.

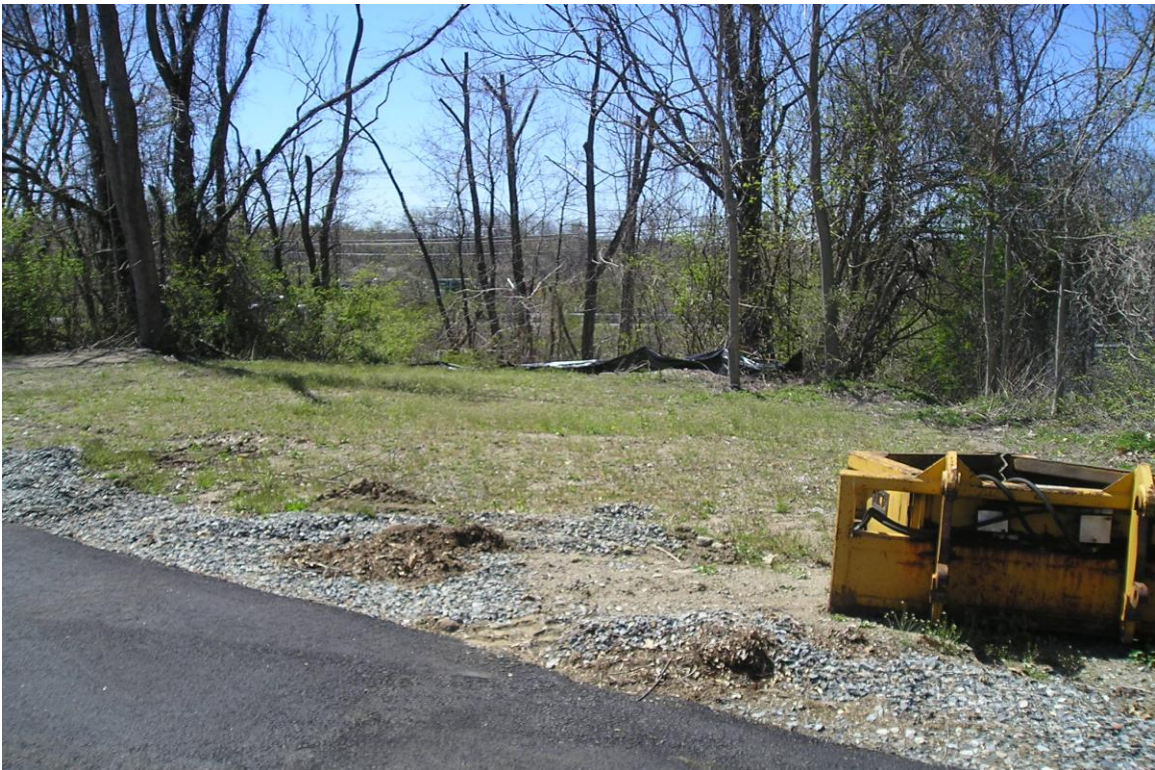
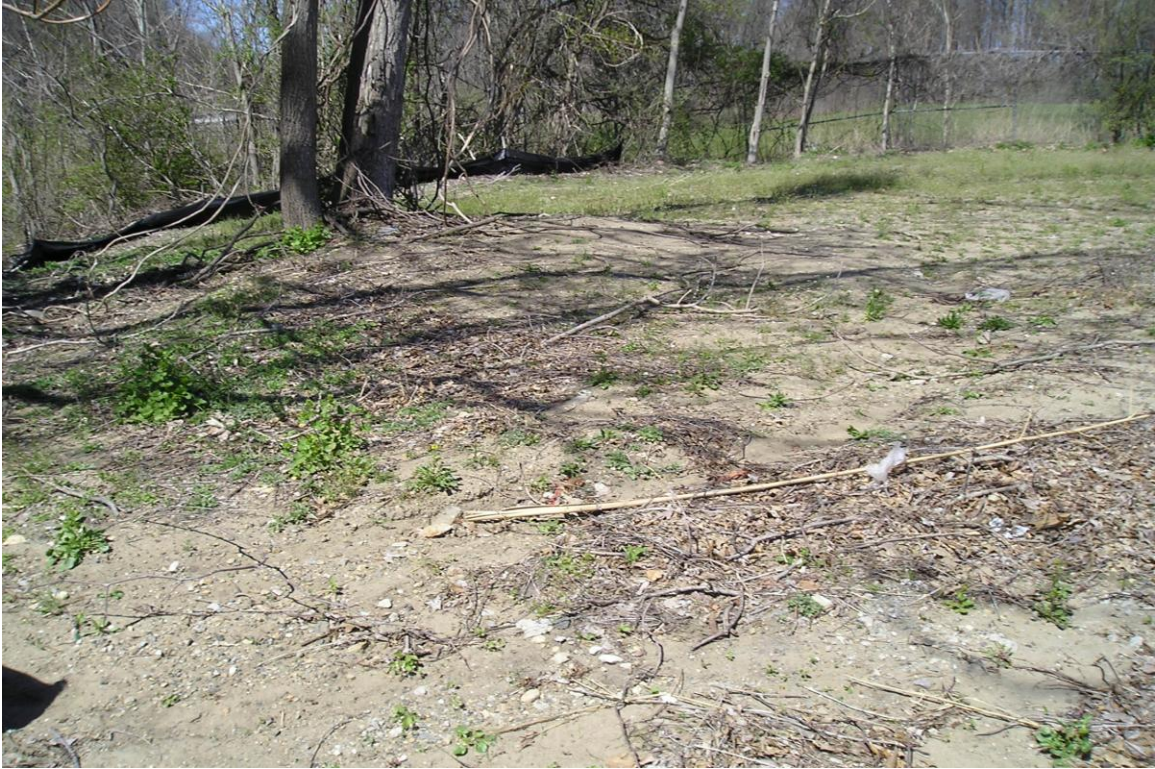
Photo 16: Bare areas and collapsed silt fence in front of the facility

Photo 17: Bare areas and collapsed silt fence in front of the facility

1. The Town of Harrison needs to re-seed the bare areas in front of the facility building where grass failed to establish during the Fall season, and repair the toppled silt fence behind it. These areas were initially disturbed during stormwater drainage work performed by the Town. Once grass becomes established, the silt fence should be removed.
