HARRISON SUB-RESIDENCY SEMI-ANNUAL FIELD INSPECTION

Date: 10/14/16

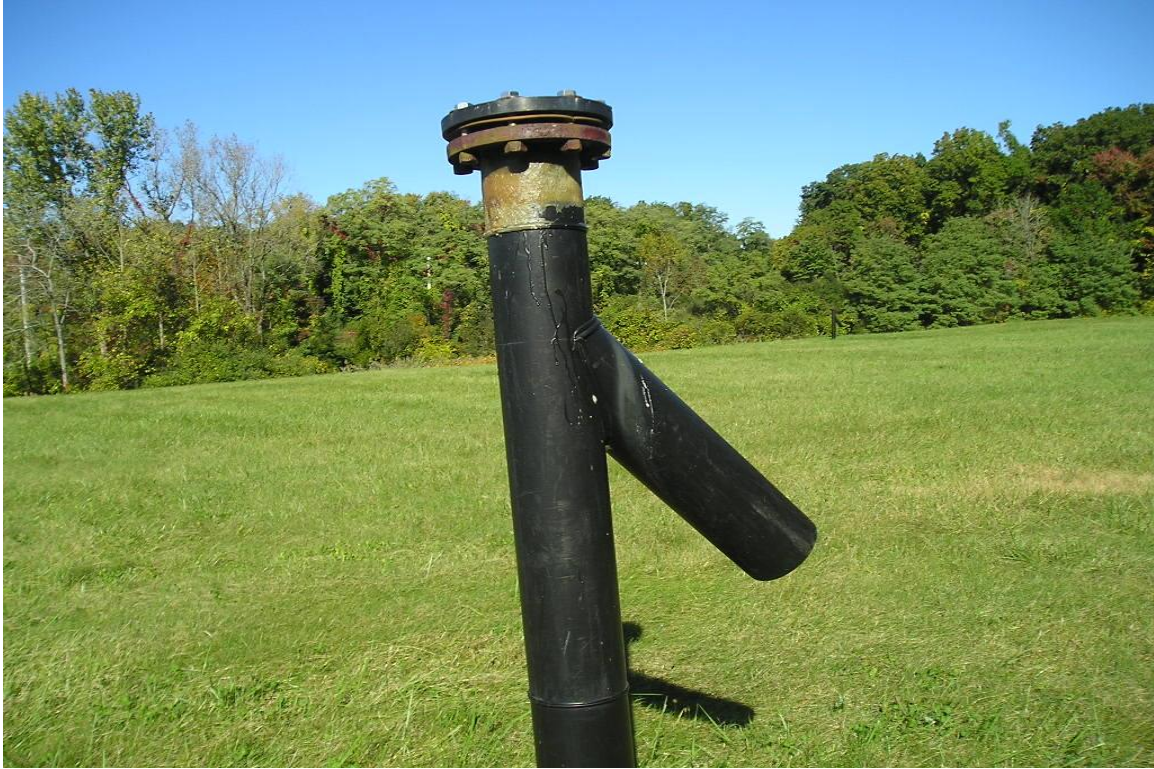
Four vents (V-1 to V-4) were inspected (Photos 1-4). V-1 and V-2 had their plastic casing holes repaired with fiberglass epoxy in August 2015 and were still in good condition. V-3 and V-4 were in good condition (neither cracks nor movement was observed). V-2 leans slightly to the north.

Photo 1: Vent V-1 (hole repair shown)

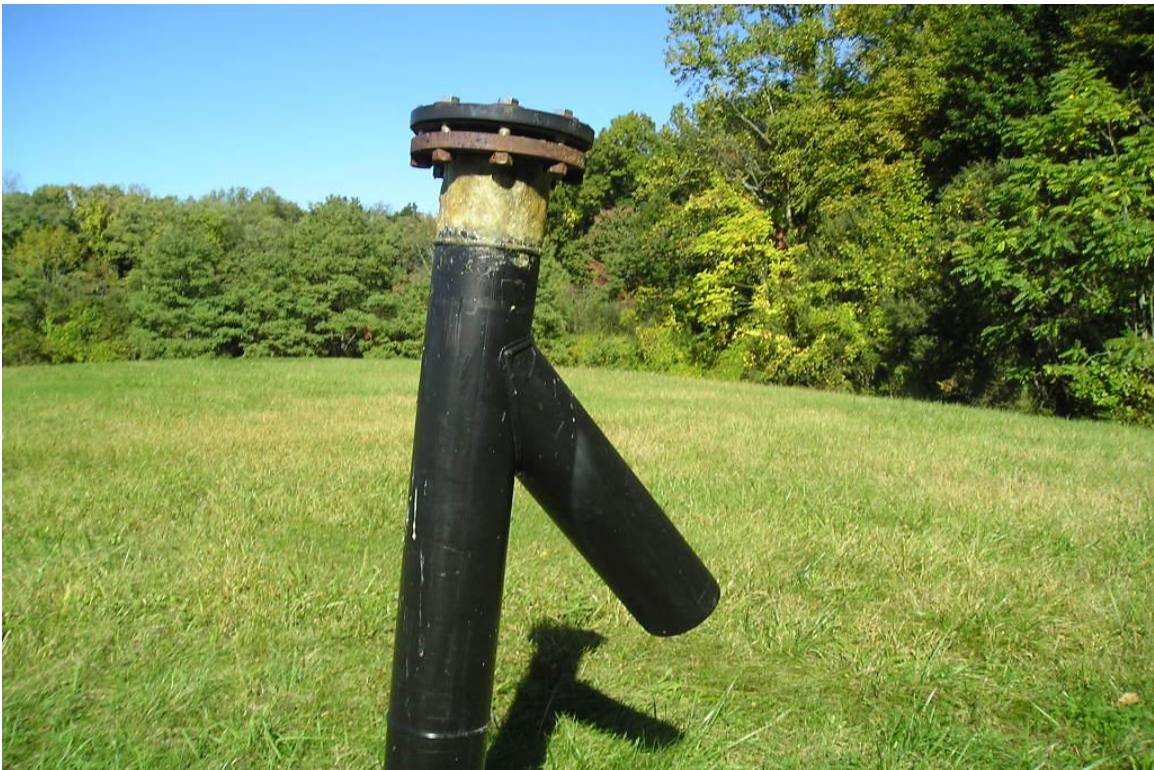
Photo 2: Vent V-2 (repair patch shown)

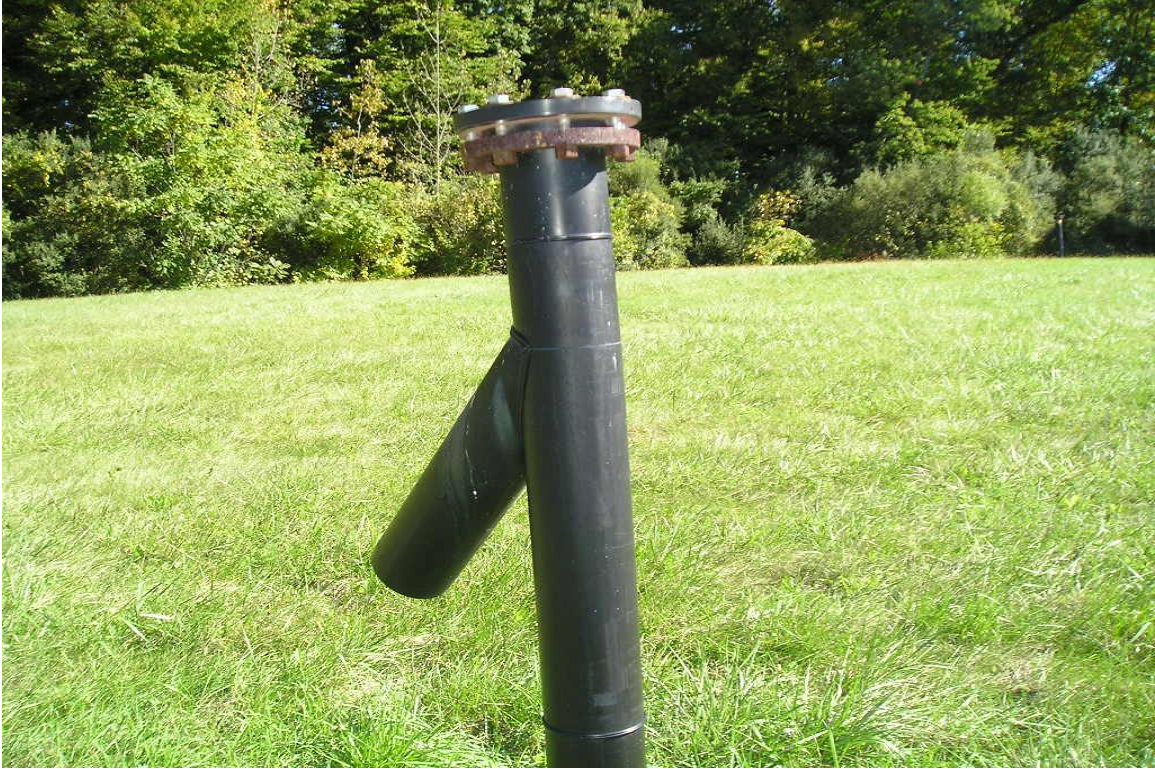
Photo 3: Vent V-3

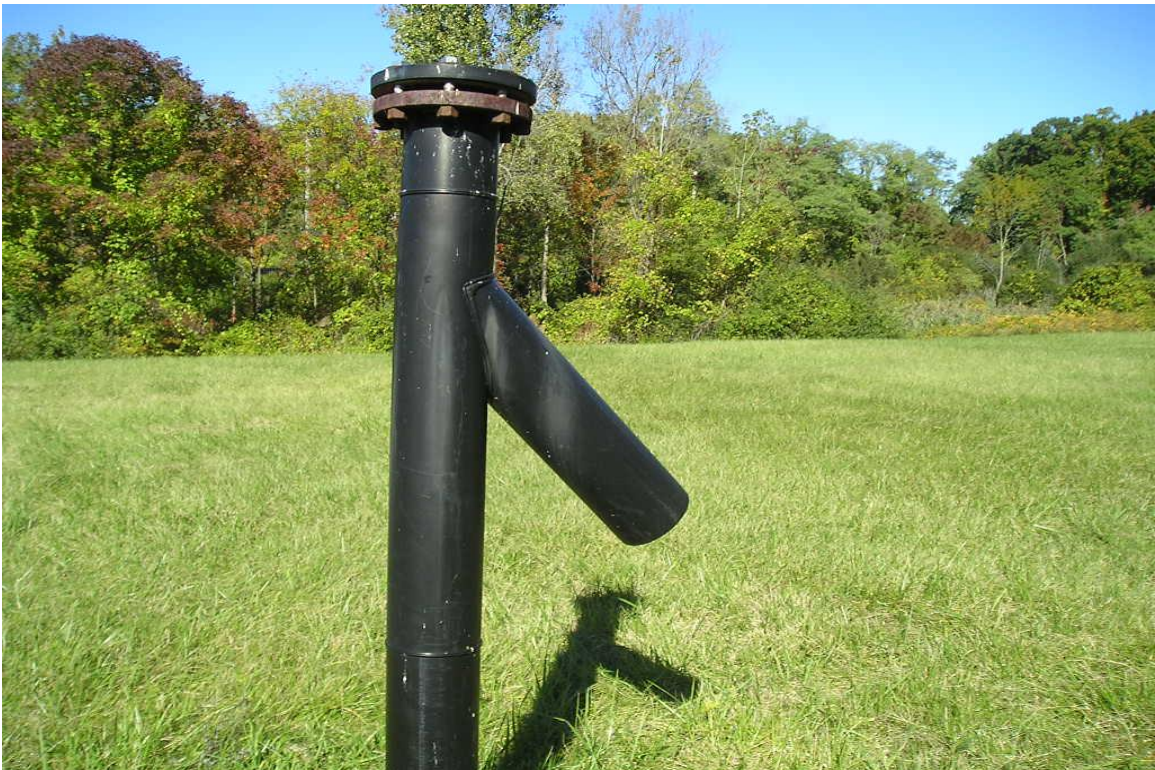
Photo 4: Vent V-4

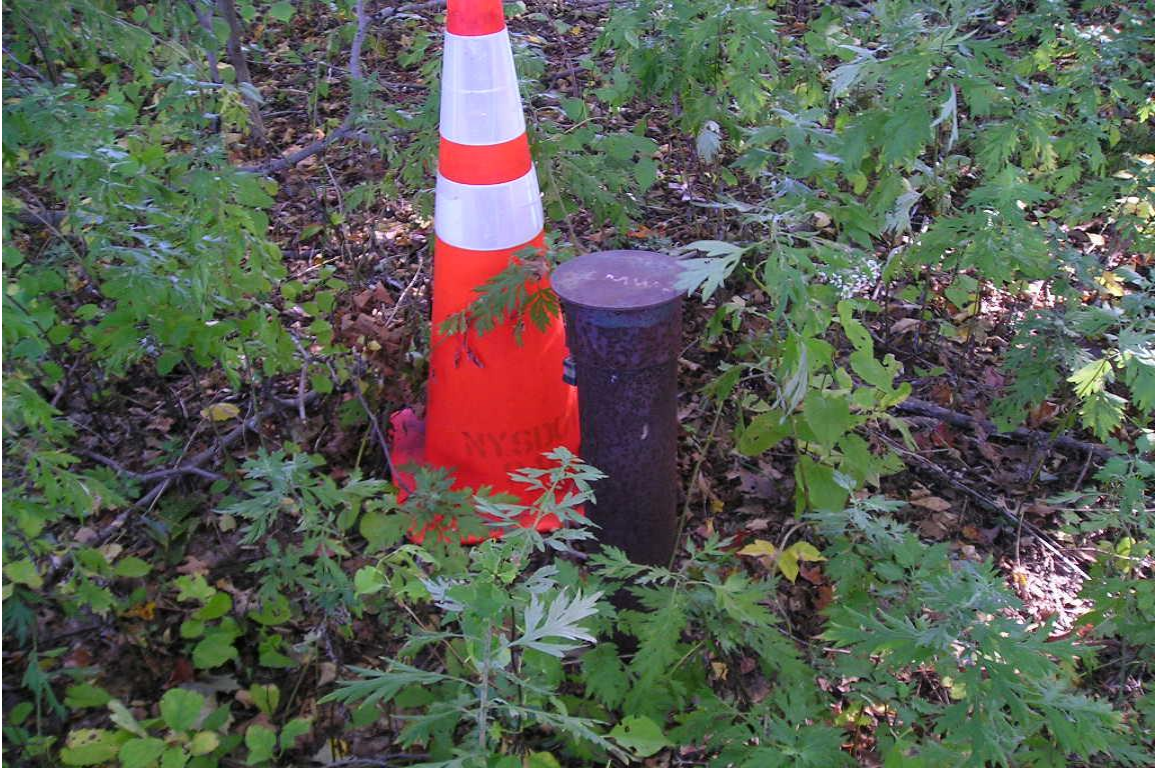
All wells were inspected and found to be in good condition. Paths to these wells need to be weed-wacked (dense vegetation in the way of some of them).

Photo 5: Well LMW-2

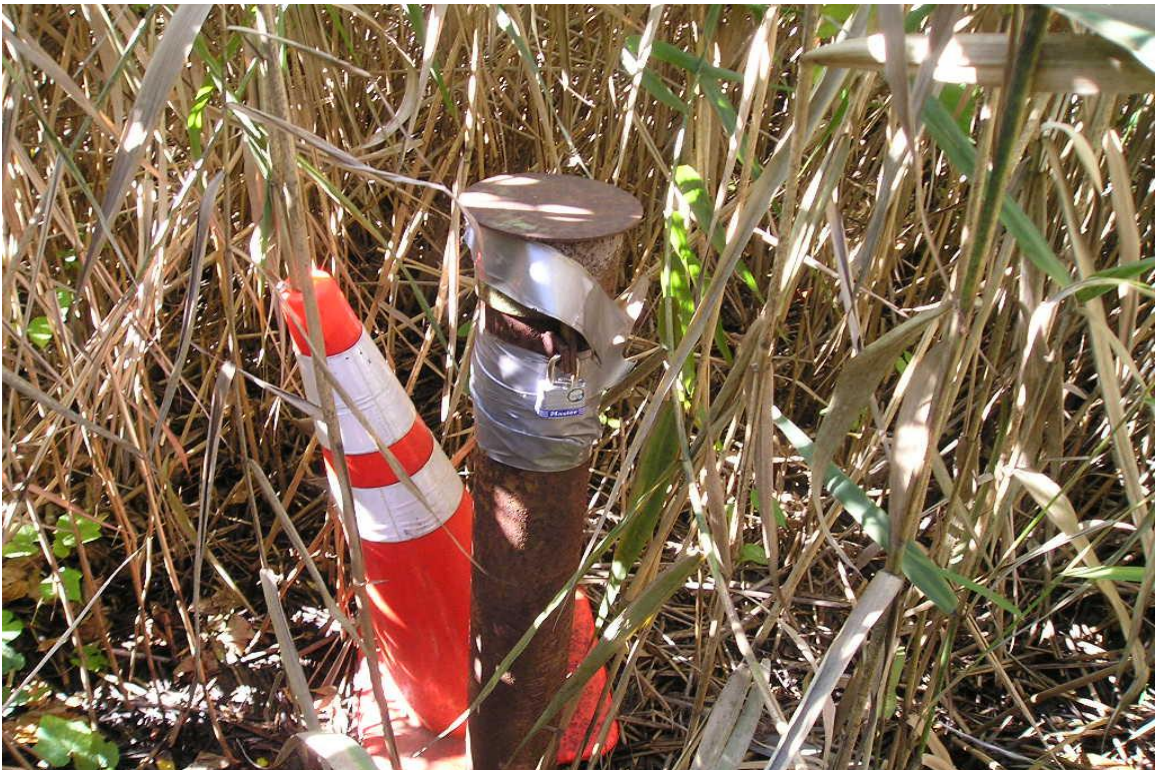
Photo 6: Well LMW-4 (area is overgrown)

4. Weed-wack the repaired area on the western landfill slope and paths leading to the area's monitoring wells.
5. Use herbicide to remove invasive plants on the south fence.

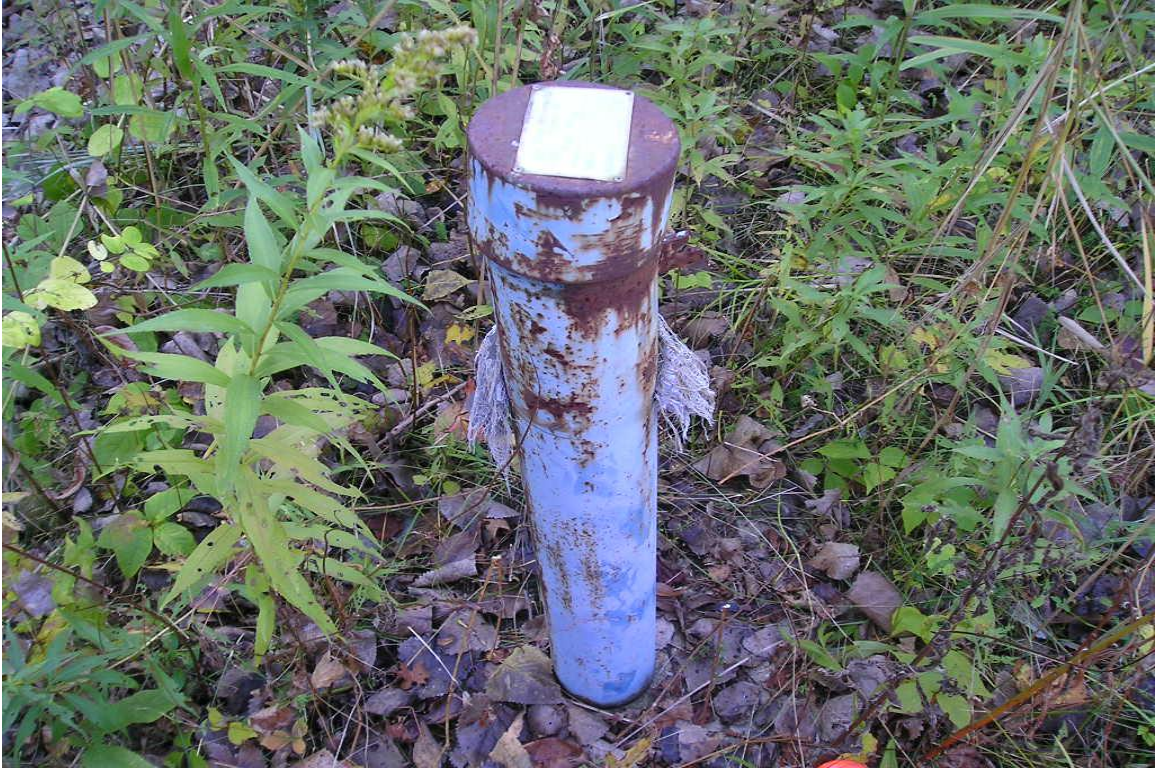
Photo 7: Well PC-1

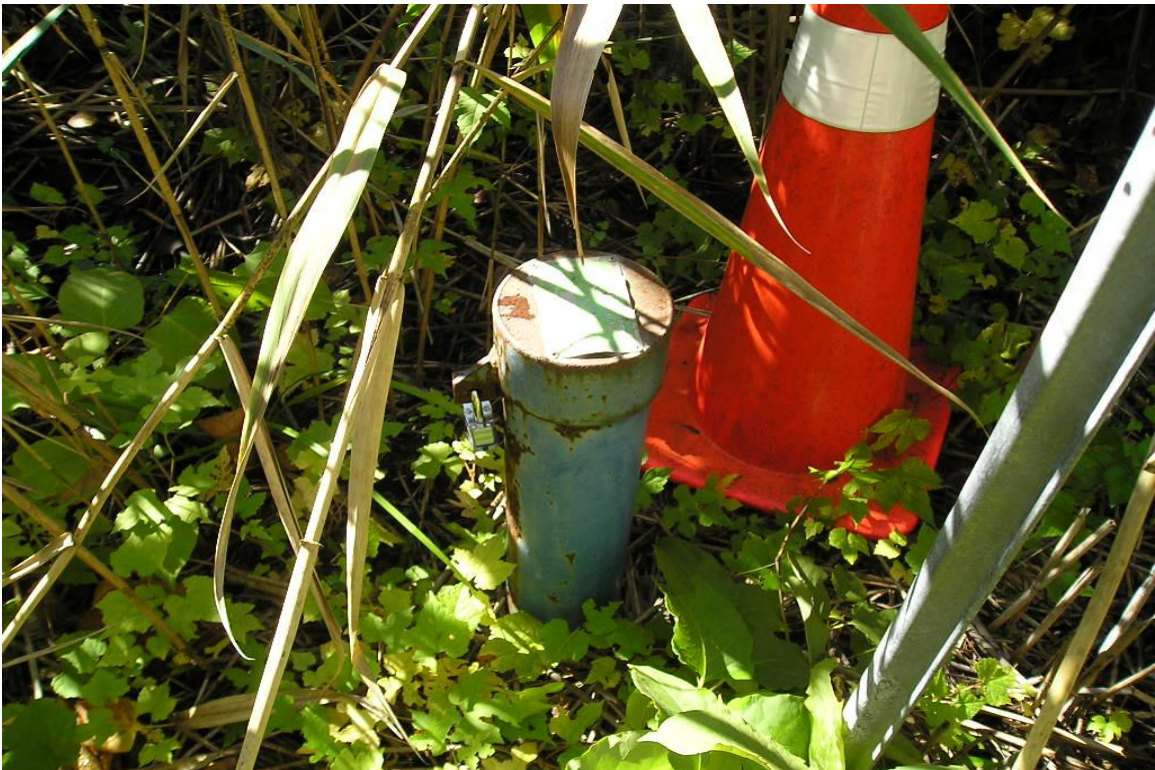
Photo 8: Well PC-2

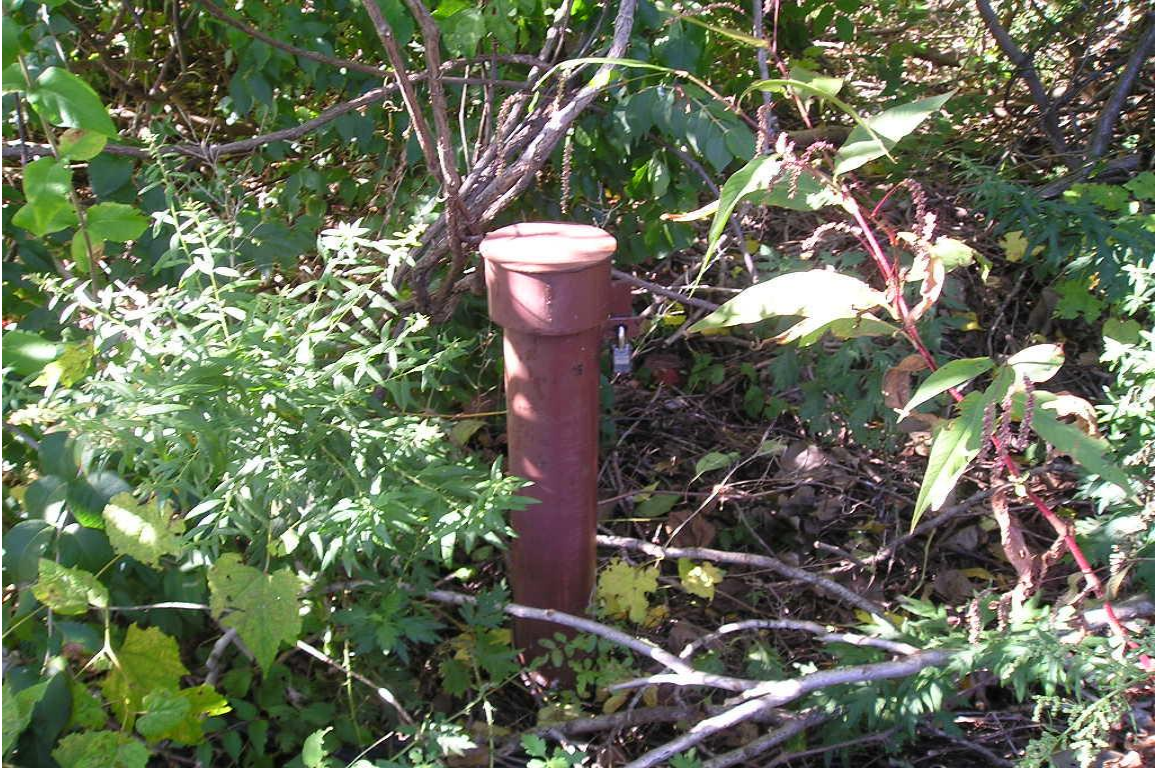
Photo 9: Well MW-11

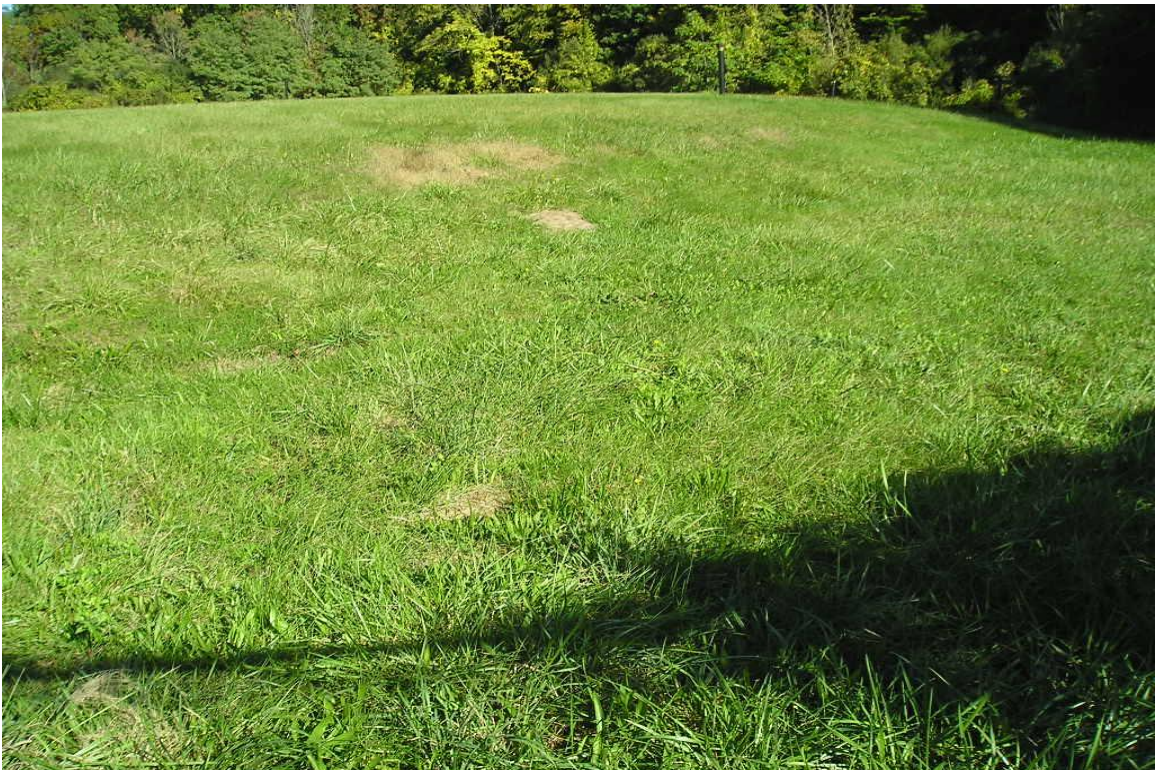
Grass height was satisfactory at the time of inspection (Photo 10). The tire ruts that were created by vehicle tires offloading mower equipment were filled in and reseeded in June 2016 (see Photo 14).

Photo 10: Grass on landfill cap

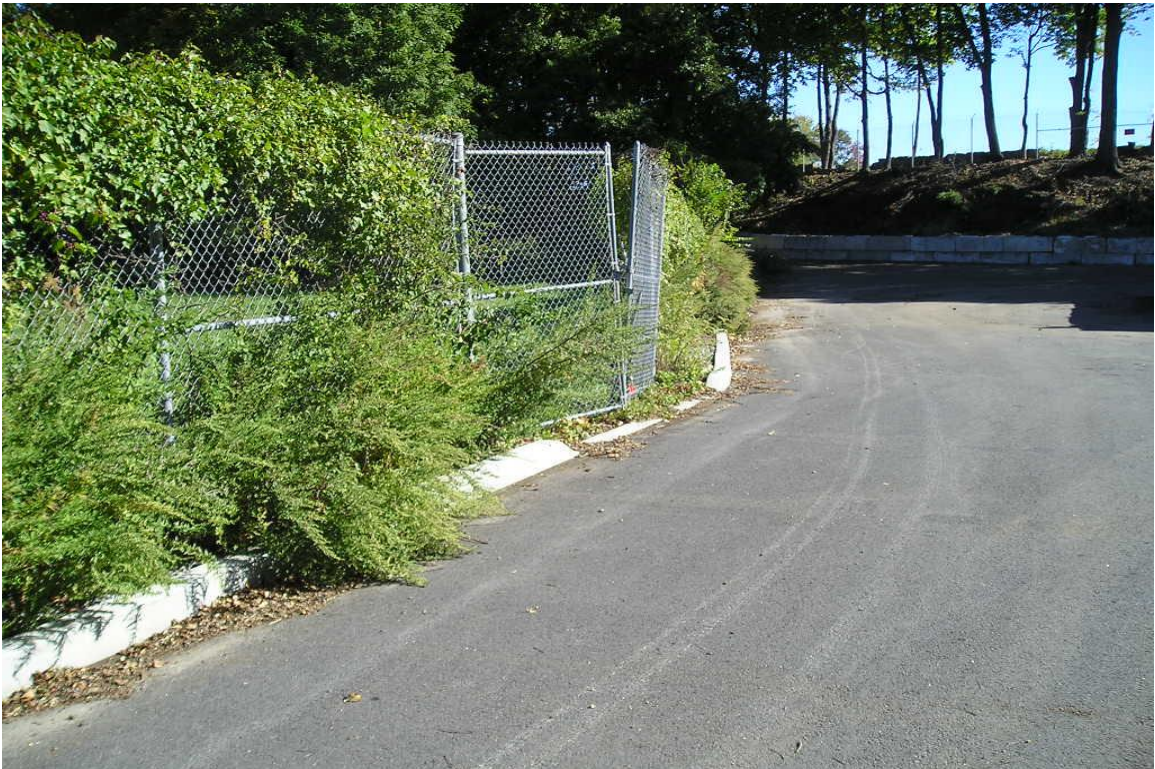
The south fence near the landfill gate appeared to be in fair condition. Porcelain Berry vines have overgrown on the fence in this area (Photo 12). This is a very invasive plant. Herbicide should be applied on the vegetation in May before fruit begins to form. Another application may be needed in July if there is any re-growth (Photo 15).

Photo 12: South fence (looking east)

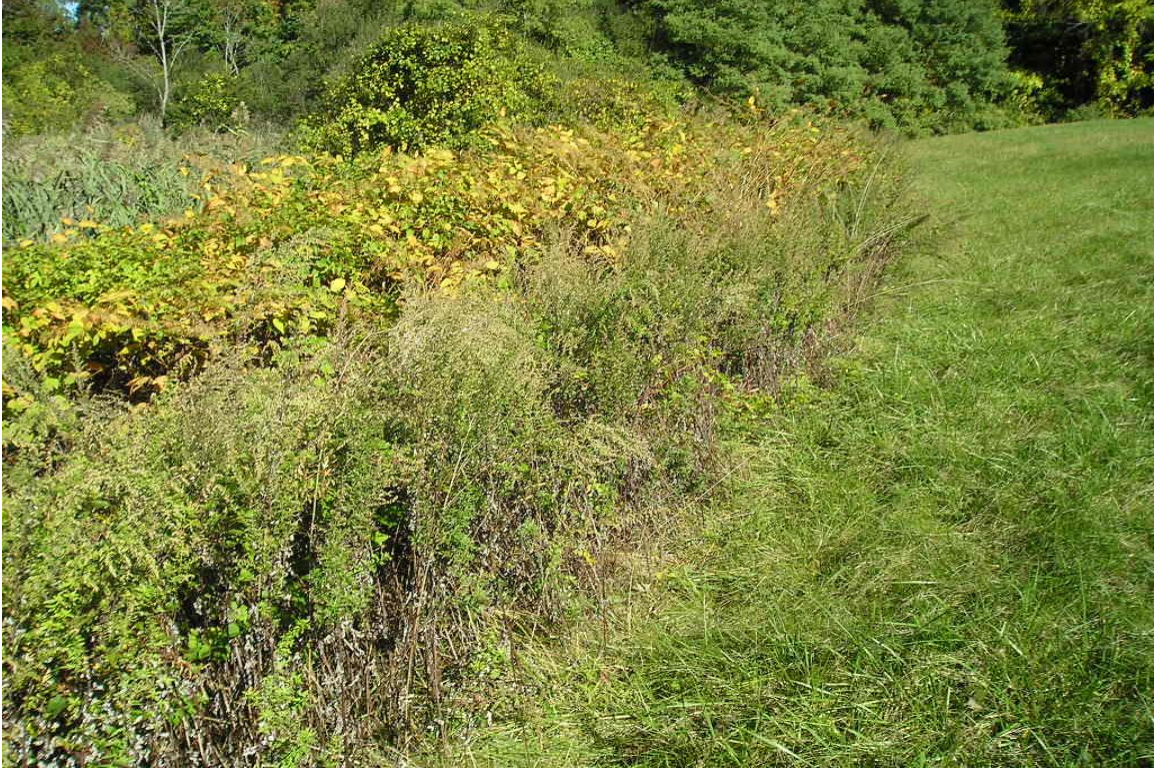
The soil slump on west slope of landfill was repaired in May 2009 by NYSDOT Maintenance Residency 8-9 personnel. The repaired area should be weed-wacked during the next mowing event in June 2016 (see Photo 13).

Photo 13: A portion of the west slope erosion area repair that needs to be cleared

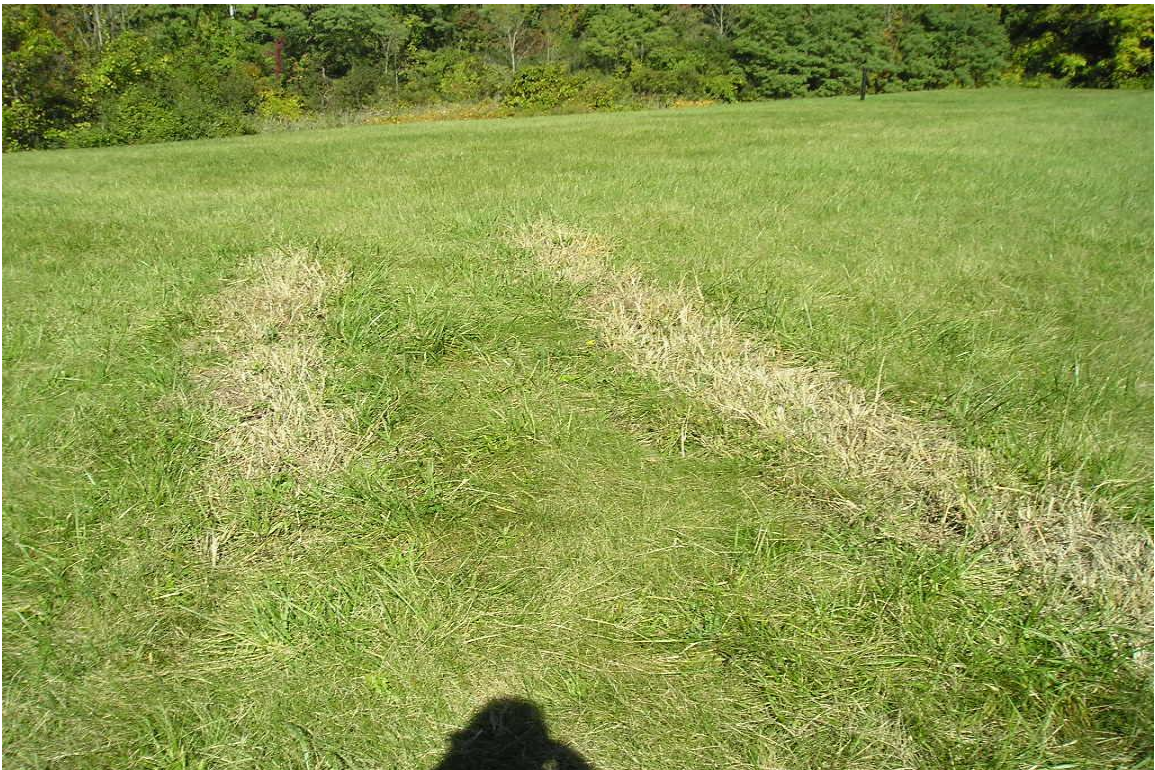
Photo 14: Repaired ruts caused by vehicles carrying equipment

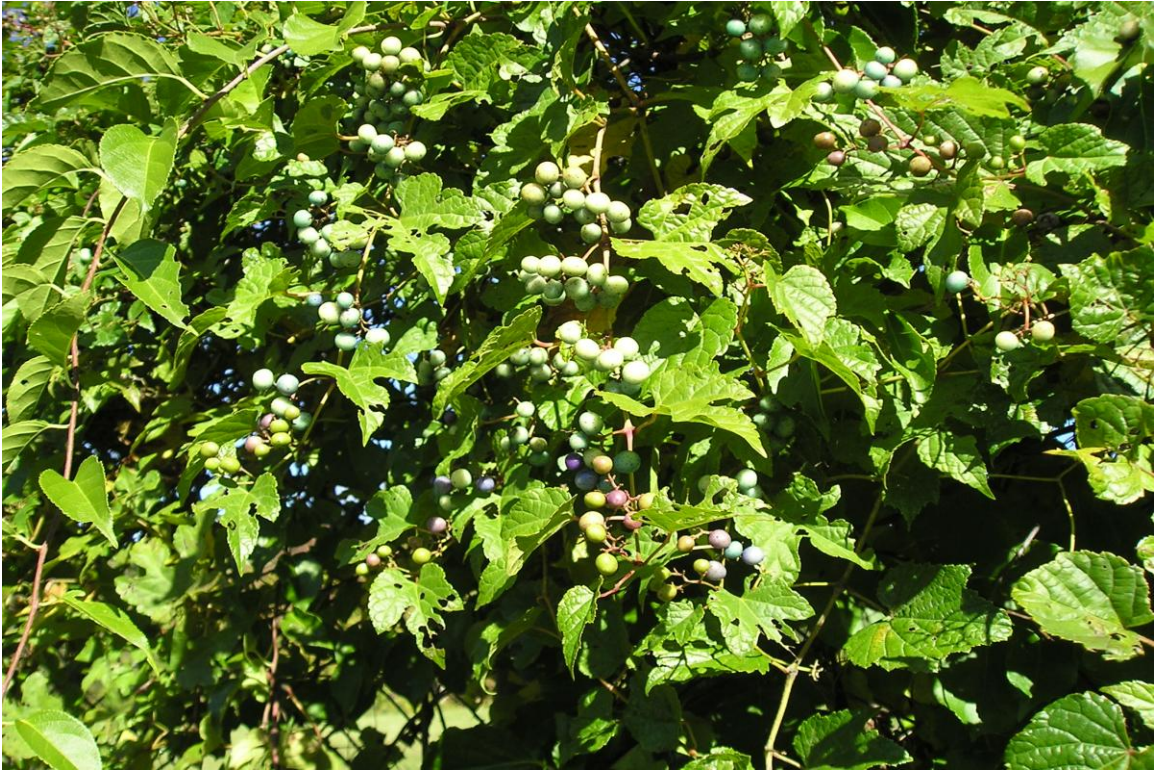
Photo 15: Invasive plants establishing in area west of site building at edge of asphalt

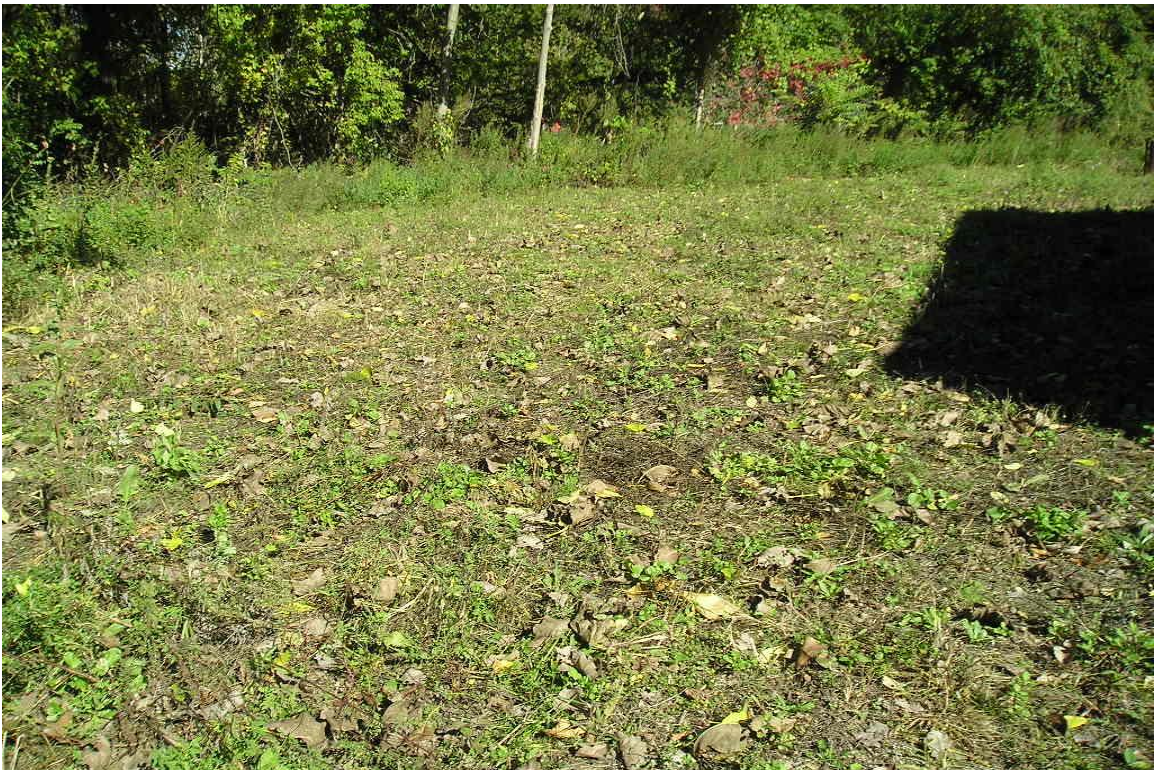
1. Grass has established in the bare area to the west of the building near the edge of the black top (Photo 16). Remove silt fence in late spring.
2. NYSDOT Maintenance Residency 8-9 repaired and re-seeded the ruts caused by vehicles delivering equipment used to cut vegetation on and surrounding the landfill cap.

Photo 16: Grass has established in front of the facility
