## HARRISON SUB-RESIDENCY SEMI-ANNUAL FIELD INSPECTION

**Name of Inspector(s):** Christopher Kappeller

**Date:** 4/27/17

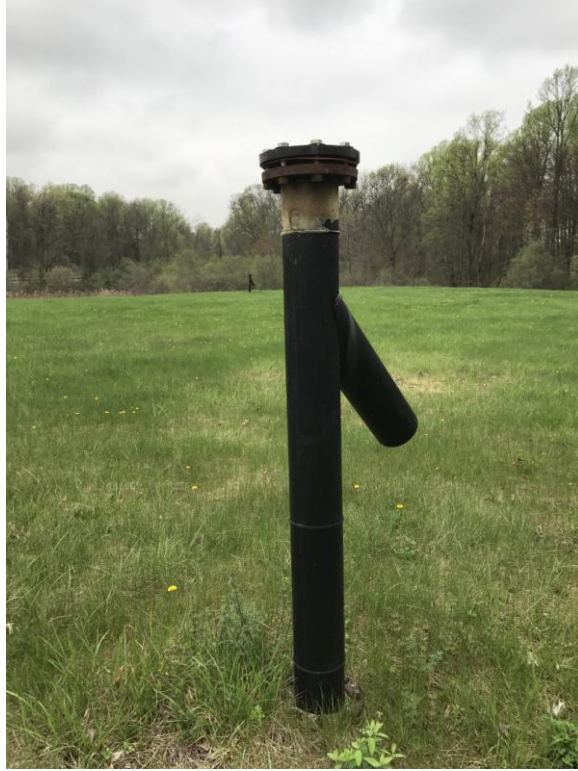
Four vents (V-1 to V-4) were inspected (Photos 1-4). V-1 and V-2 had their plastic casing holes repaired with fiberglass epoxy in August 2015 and were still in good condition. V-3 and V-4 were in good condition (neither cracks nor movement was observed). V-2 leans slightly to the north.

Photo 1: Vent V-1 (hole repair shown)

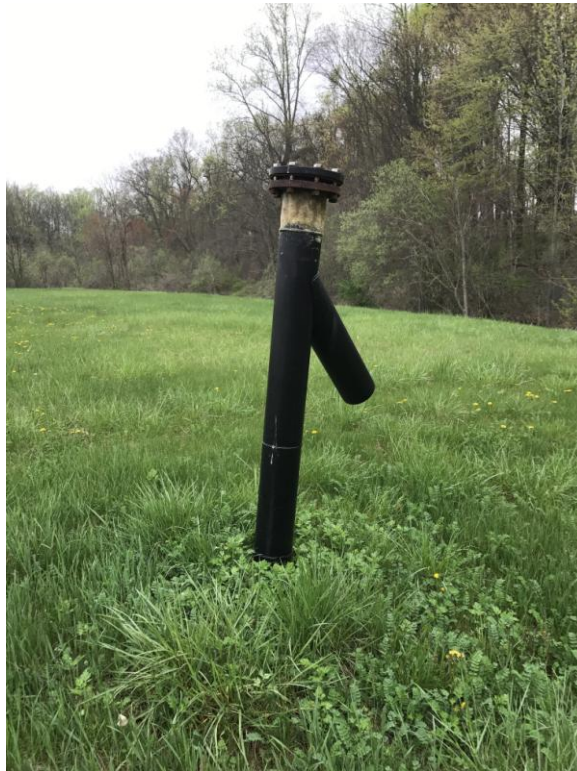
Photo 2: Vent V-2 (repair patch shown)

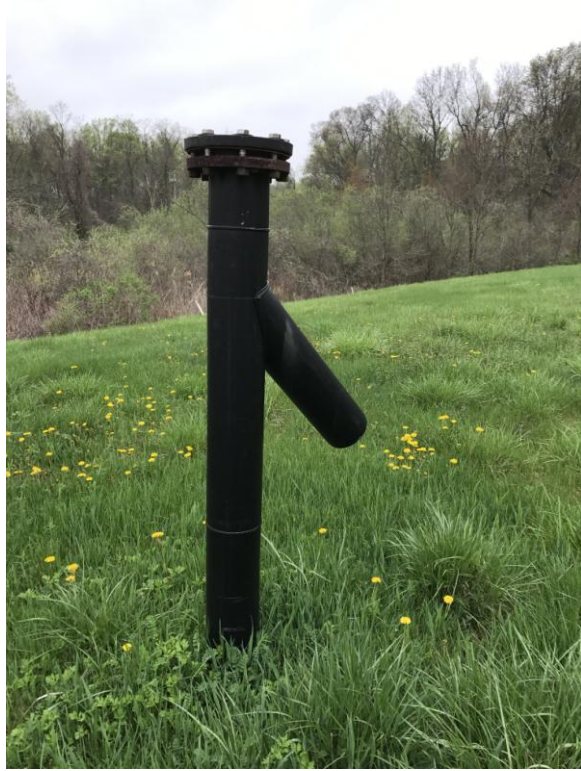
Photo 3: Vent V-3

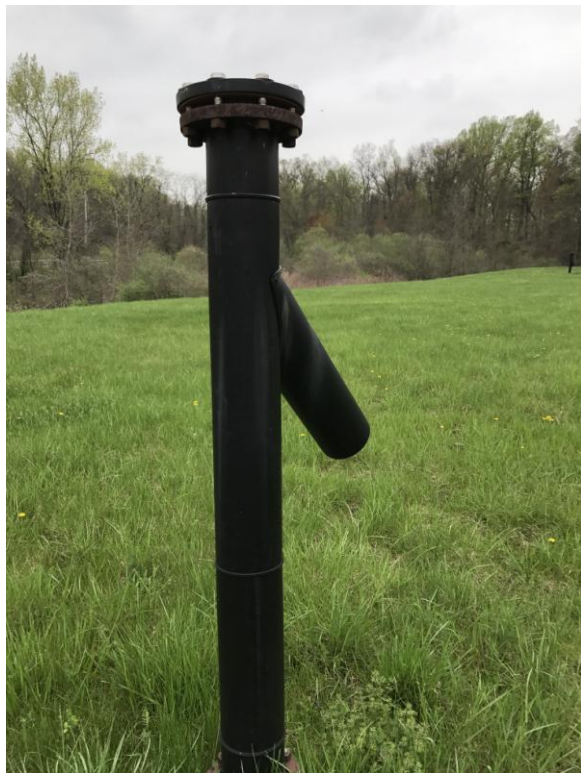
Photo 4: Vent V-4

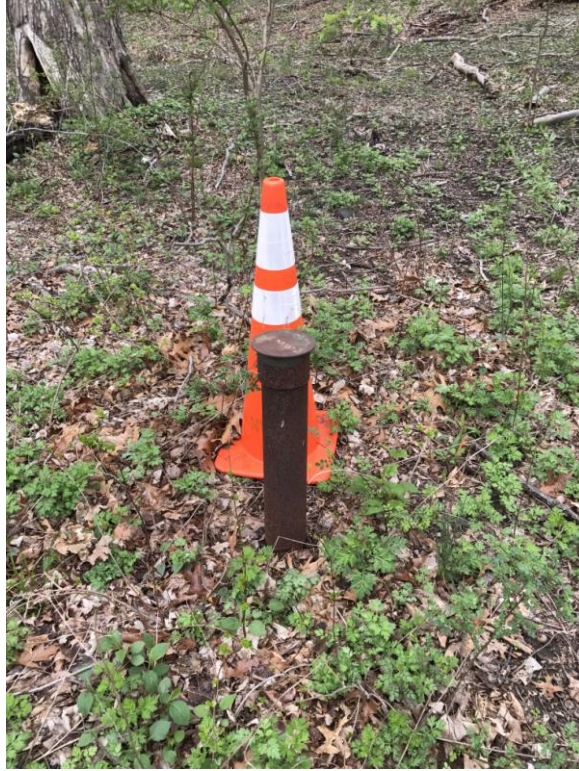
Photo 5: Well LMW-2

All wells were inspected and found to be in good condition. Paths to these wells need to be weed-wacked before the next inspection in October.

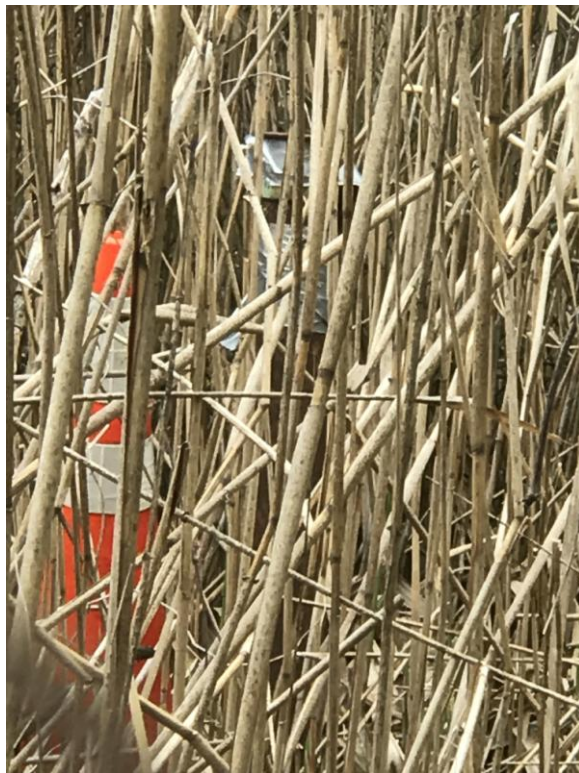
Photo 6: Well LMW-4 area (area was covered in water)

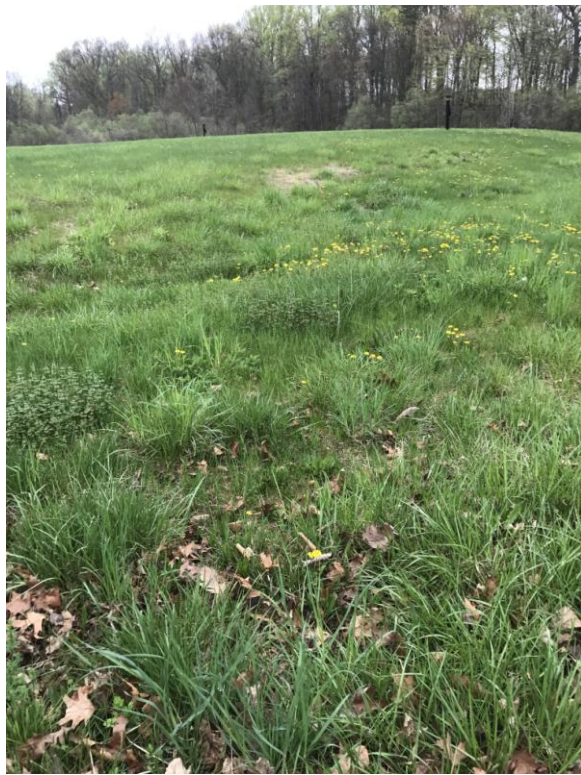
Grass height was somewhat tall (8'+) at the time of inspection (Photo 10). Grass should be cut in June and September.

The grass appeared to be in need of mowing. The cap should be mowed every June and September.

Photo 10: Grass on landfill cap

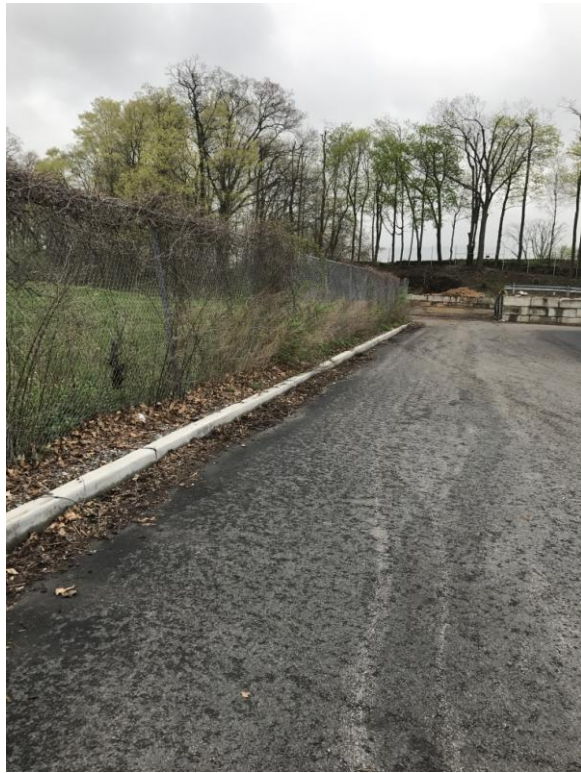
Porcelain Berry vines were overgrown on the fence in this area during the past inspection in October 2017 (Photo 12). This is a very invasive plant. Herbicide should be applied on the vegetation in May/June before fruit begins to form. Another application may be needed in July if there is any re-growth.

Photo 12: South fence (looking east)

3. Weed-wack the repaired area on the western landfill slope and paths leading to the area's monitoring wells
4. Use herbicide to remove invasive plants on the south fence.

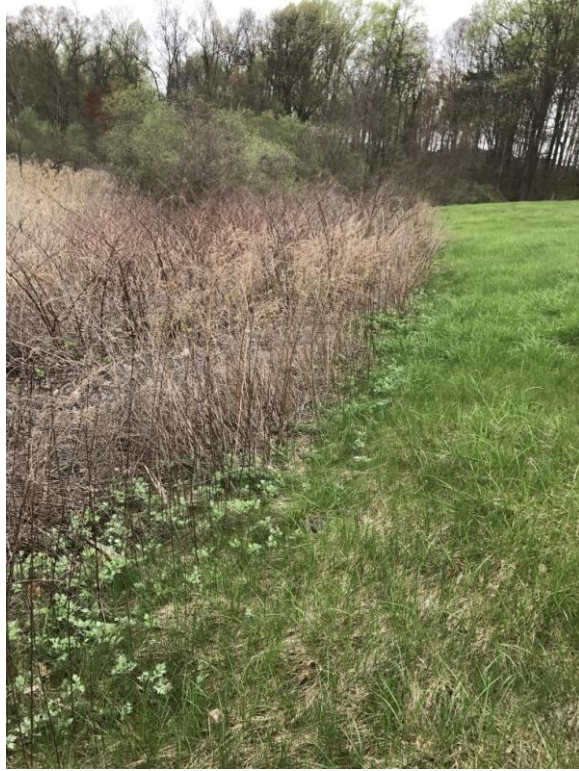
The soil slump on west slope of landfill was repaired in May 2009 by NYSDOT Maintenance Residency 8-9 personnel. The repaired area should be weed-wacked during the next mowing event in June 2017 (see Photos 13 and 14).

Photo 13: A portion of the west slope erosion area repair that needs to be cleared (looking north)

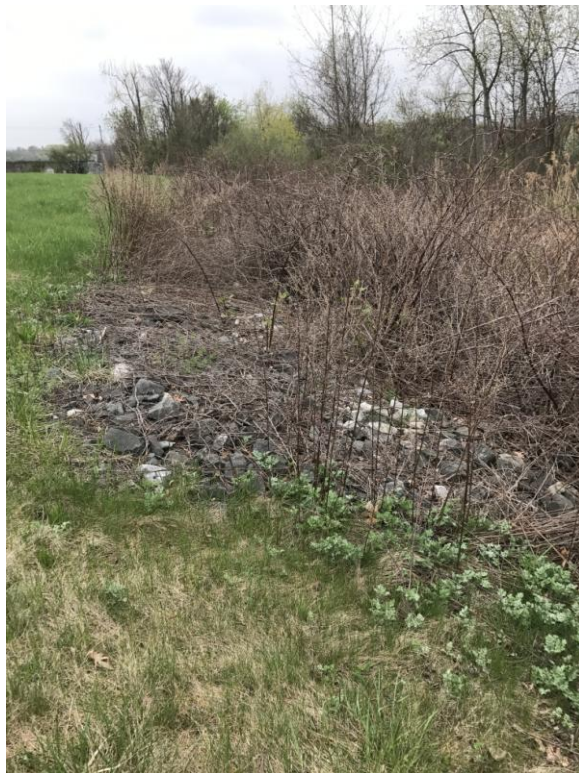
Photo 14: West slope area repair (looking south)

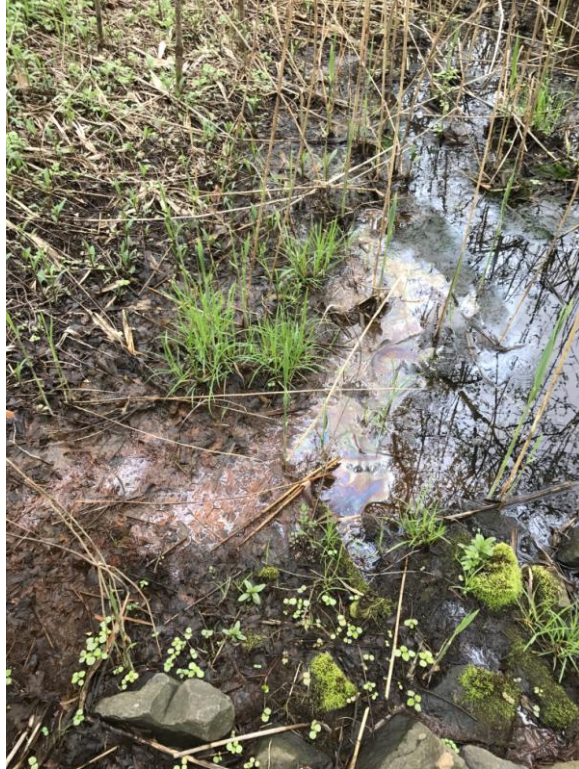
Photo 15: Presumed orange iron bacteria and iridescent biofilm sheen on water (near LMW-4)

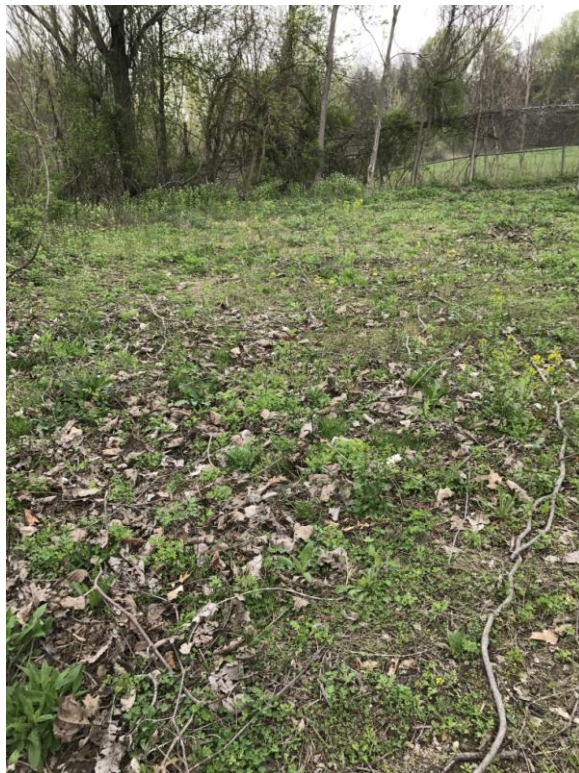
Photo 16: Vegetation establishing in area west of site building at edge of asphalt
