HARRISON SUB-RESIDENCY SEMI-ANNUAL FIELD INSPECTION

Date: 4/30/19

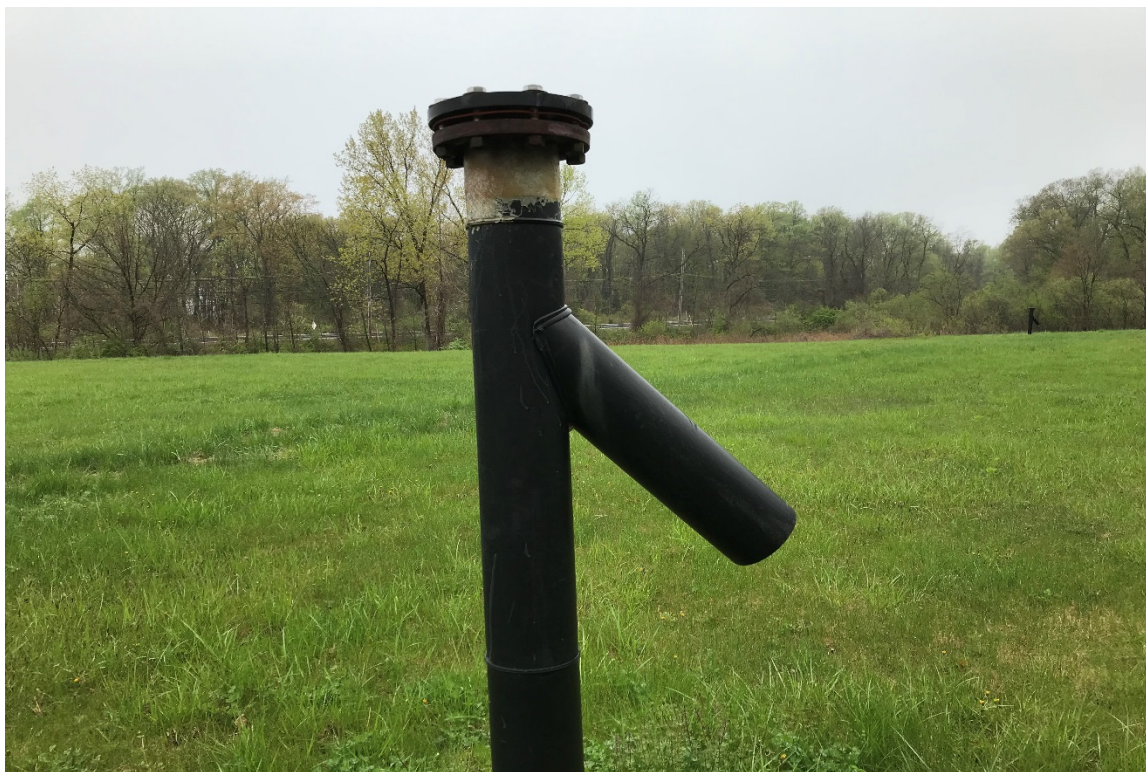
Photo 1: Vent V-1

Four vents (V-1 to V-4) were inspected (Photos 1-4). V-1 and V-2 had their plastic casing holes repaired with fiberglass epoxy in August 2015. A hole presumed to be from a boring insect or woodpecker was made through the previous fiberglass repair in V-2. The hole will be repaired by Summer 2019. V-3 and V-4 were in good condition (neither cracks nor movement was observed). V-2 leans slightly to the north.

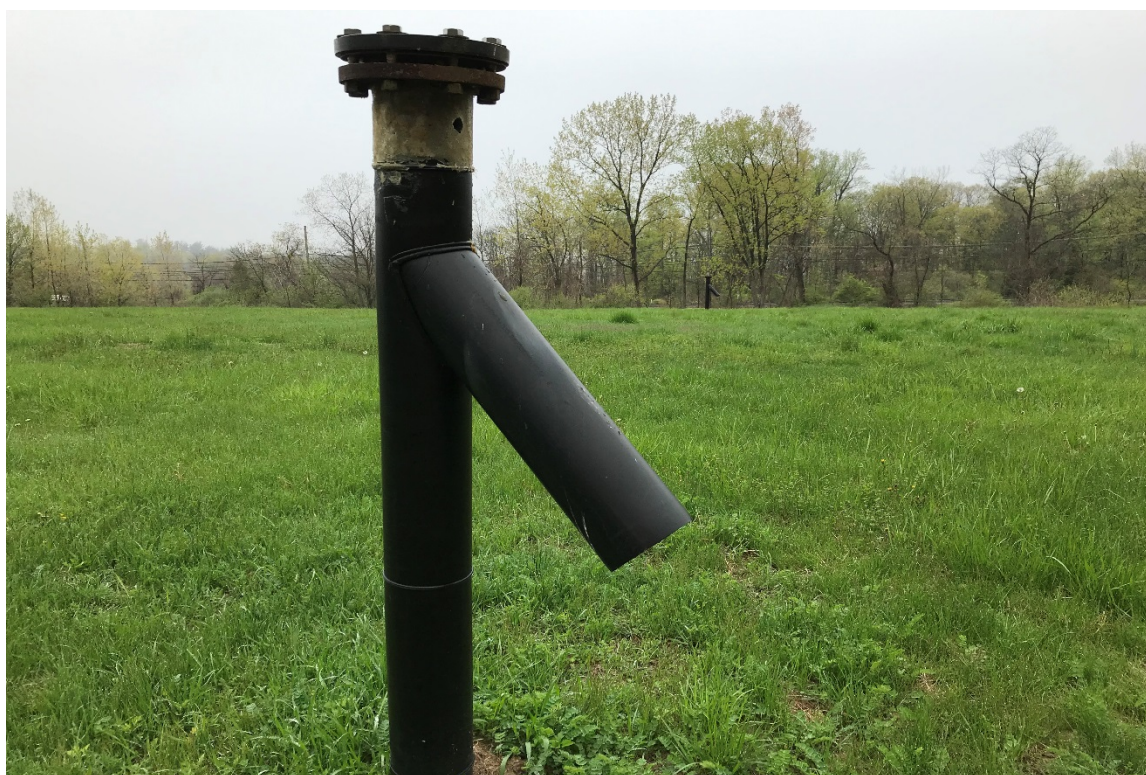
Photo 2: Vent V-2 (hole in repair patch shown)

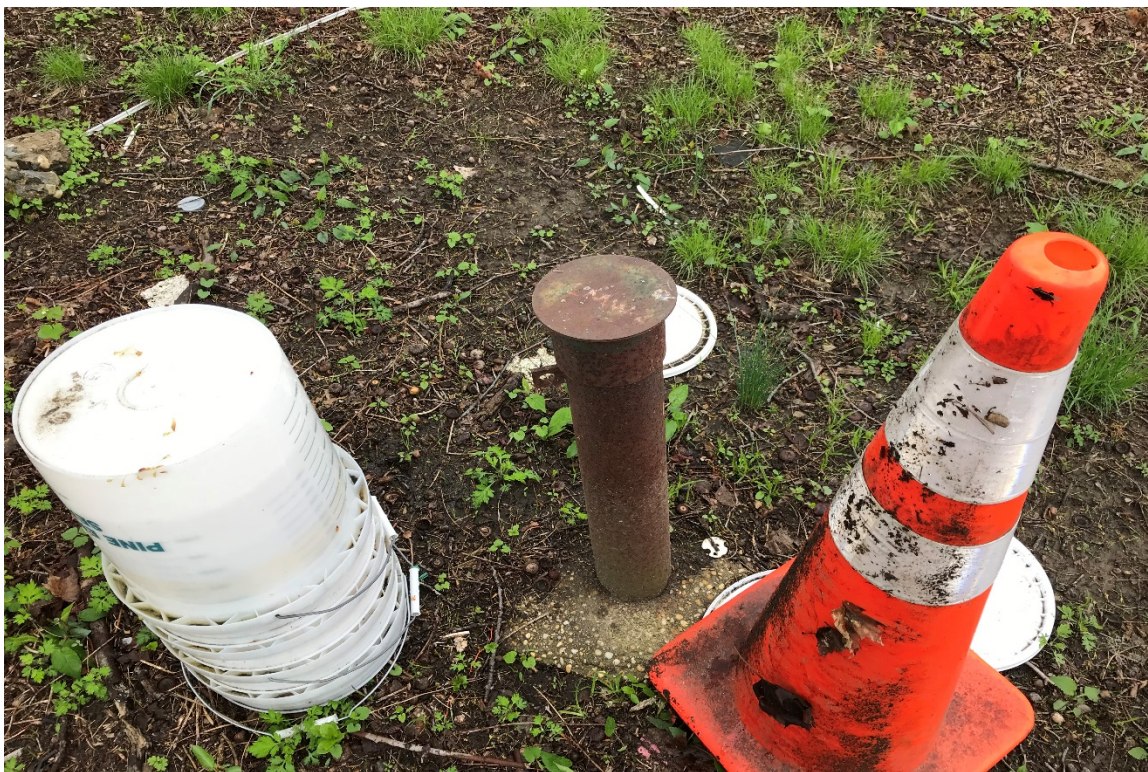
Photo 5: Well LMW-2

All wells were inspected and found to be in good condition. Paths to these wells were weed-wacked prior to inspection.

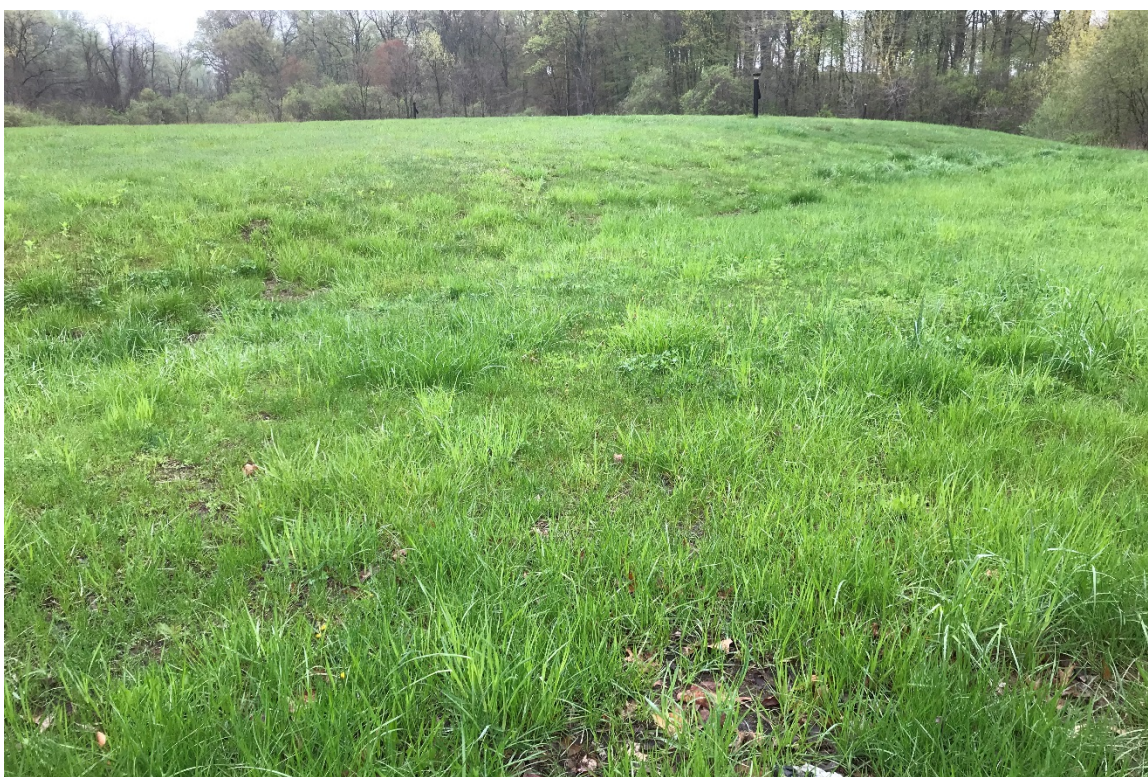
Grass height was satisfactory at the time of inspection (Photo 10). Grass should be cut in June and September.

Photo 10: Grass on landfill cap

The grass length appeared to be satisfactory. The cap should be mowed every June and September.

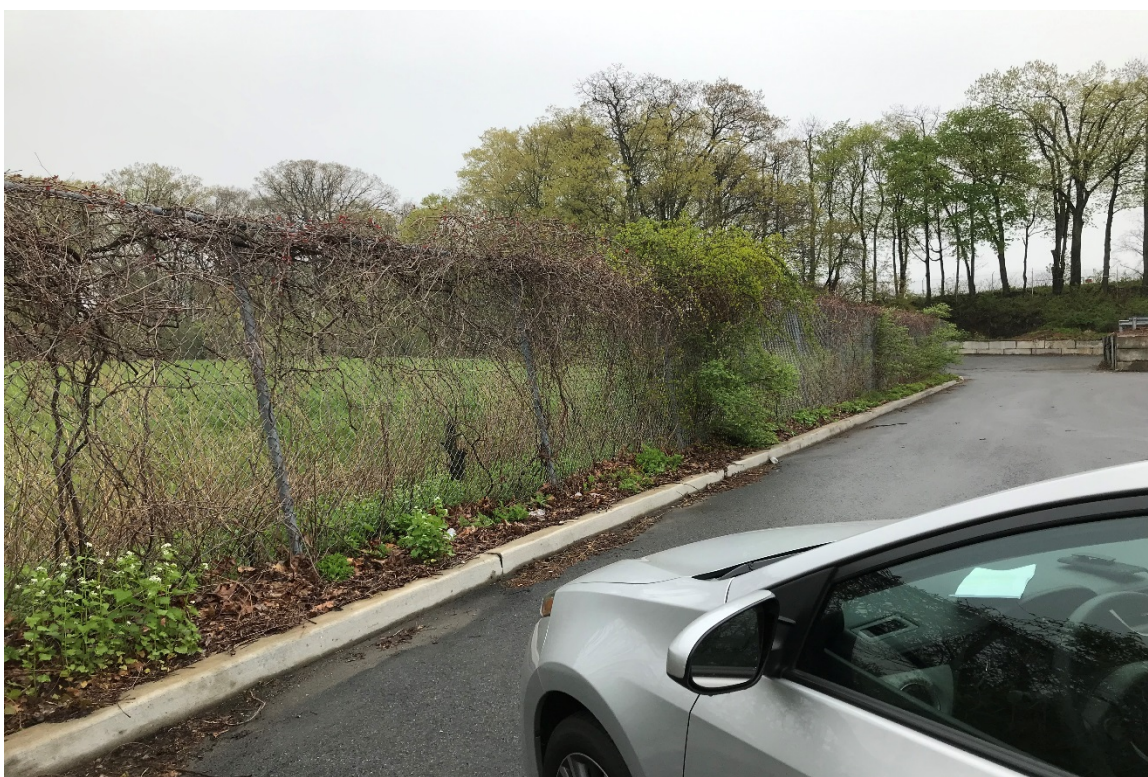
The south fence near the landfill gate appeared to be in fair condition. A new lock and chain were placed on the gate to the landfill by the NYSDOT landfill monitoring consultant. A new key is in the left drawer of the office desk (Key A389).

Porcelain Berry vines were overgrown on the fence in this area during this inspection (Photo 13). This is a very invasive plant. Herbicide should be applied on the vegetation in May/June before fruit begins to form. Another application may be needed in July if there is any re-growth.

Photo 12: South fence (looking east)

3. Weed whack the west slope repair area and possibly spray with herbicide to prevent future weed growth through the stone repair. Weed whack porcelain berry vines on the south landfill fence and apply herbicide as needed. Herbicide will be applied by a NYSDEC licensed applicator.

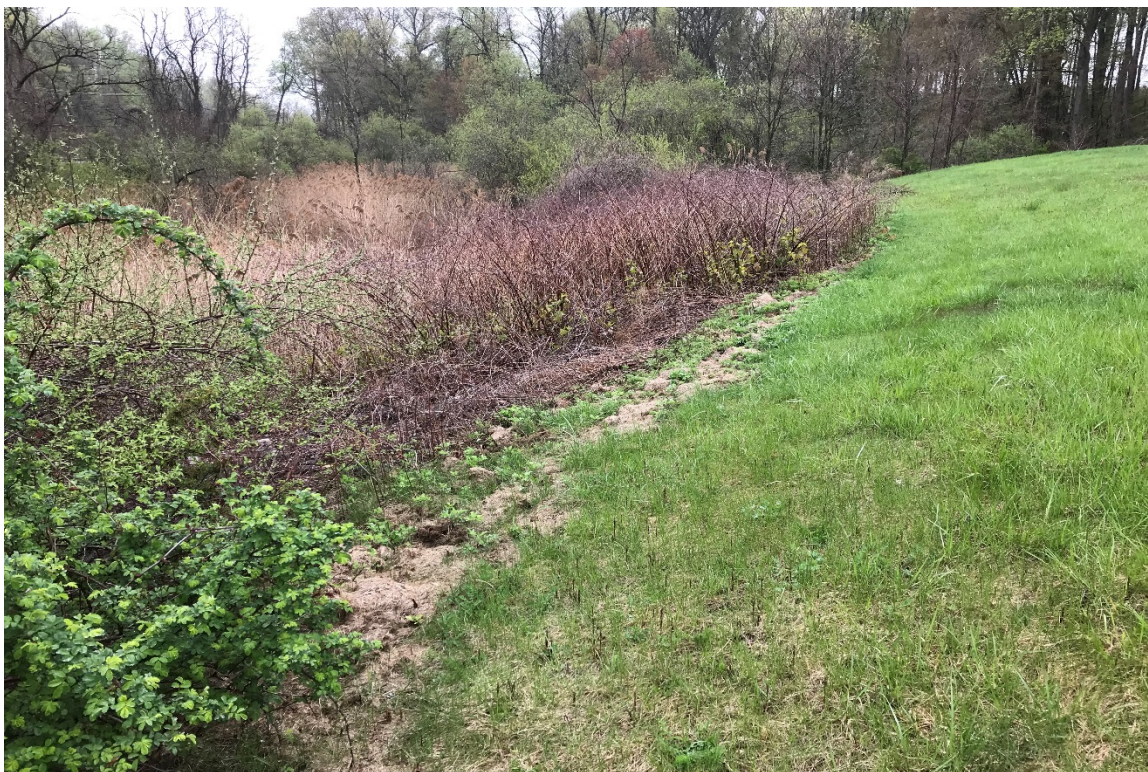
The soil slump on west slope of landfill was repaired in May 2009 by NYSDOT Maintenance Residency 8-9 personnel. The repaired area should be weed-wacked during the next mowing event in June 2019 (see Photos 13).

Photo 13: A portion of the west slope erosion area repair that needs clearing (looking north)

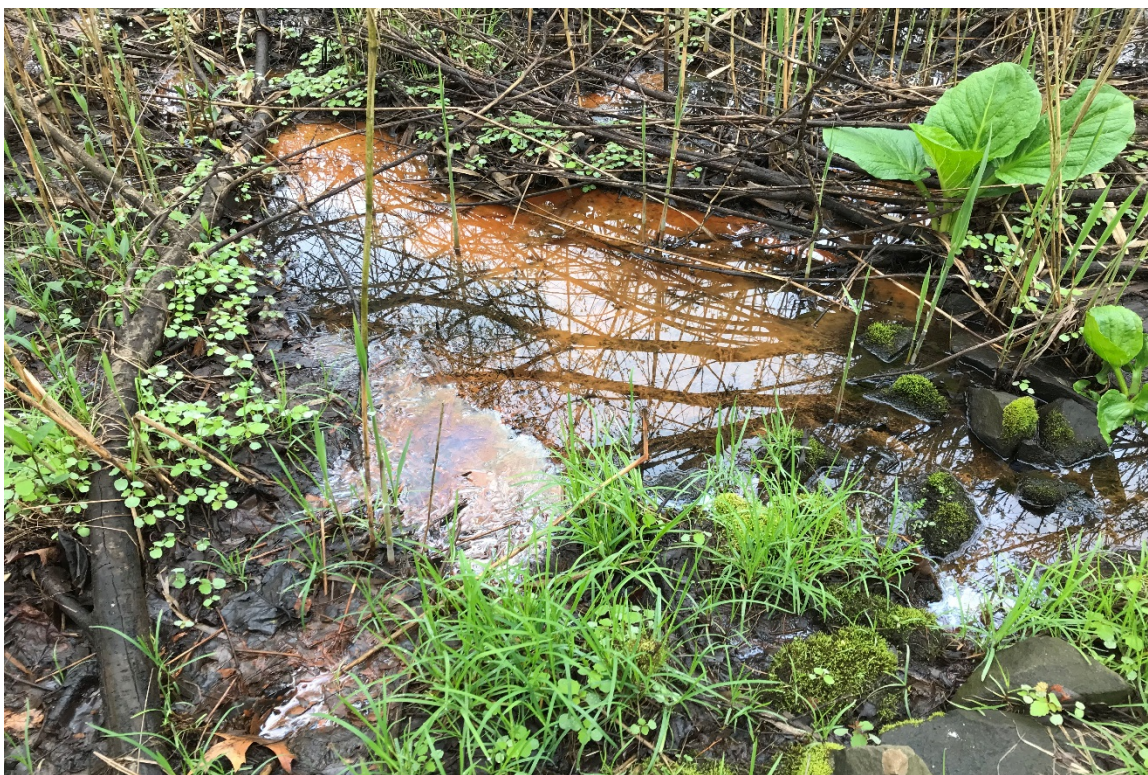
Photo 14: Presumed orange iron bacteria and iridescent biofilm sheen on water (near LMW4)
