HARRISON SUB-RESIDENCY SEMI-ANNUAL FIELD INSPECTION

Name of Inspector(s): Christopher Kappeller

Date: 10/29/19

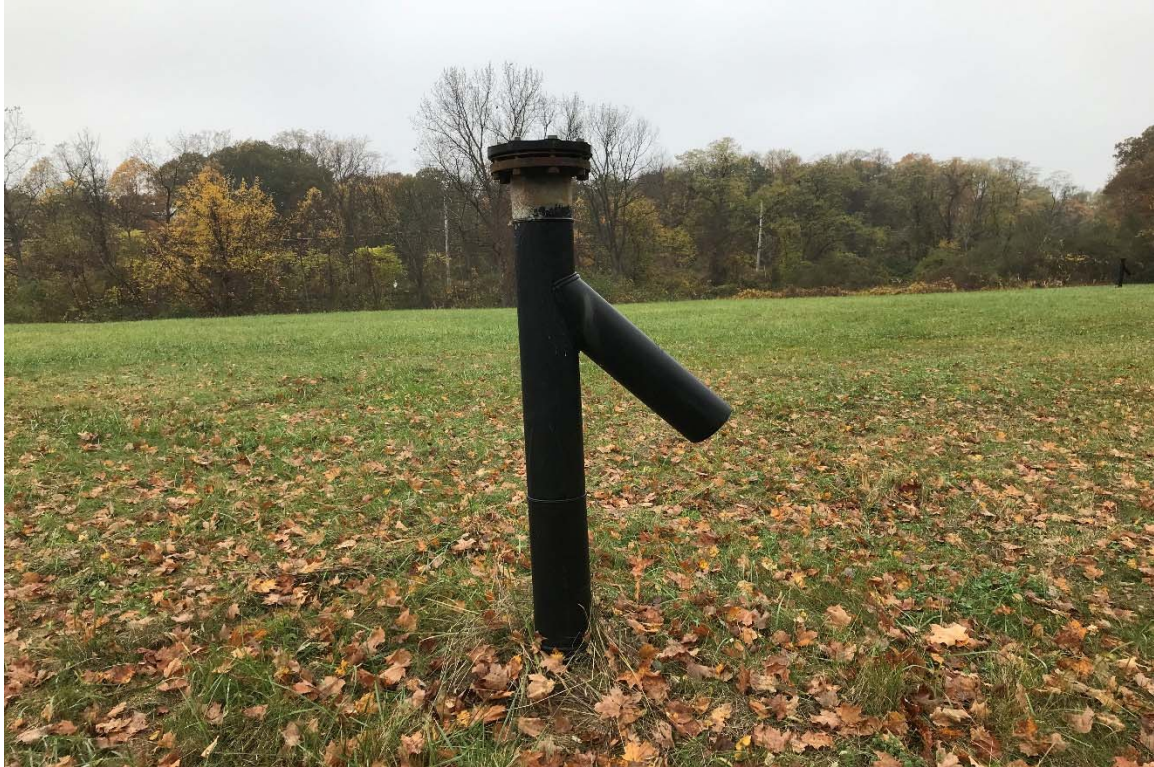
Photo 1: Vent V-1

Four vents (V-1 to V-4) were inspected (Photos 1-4). V-1 and V-2 had their plastic casing holes repaired with fiberglass epoxy in August 2015. A hole presumed to be from a boring insect or woodpecker was made through the previous fiberglass repair in V-2. The hole will be repaired in Spring 2020. V-3 and V-4 were in good condition (neither cracks nor movement was observed). V-2 leans slightly to the north.

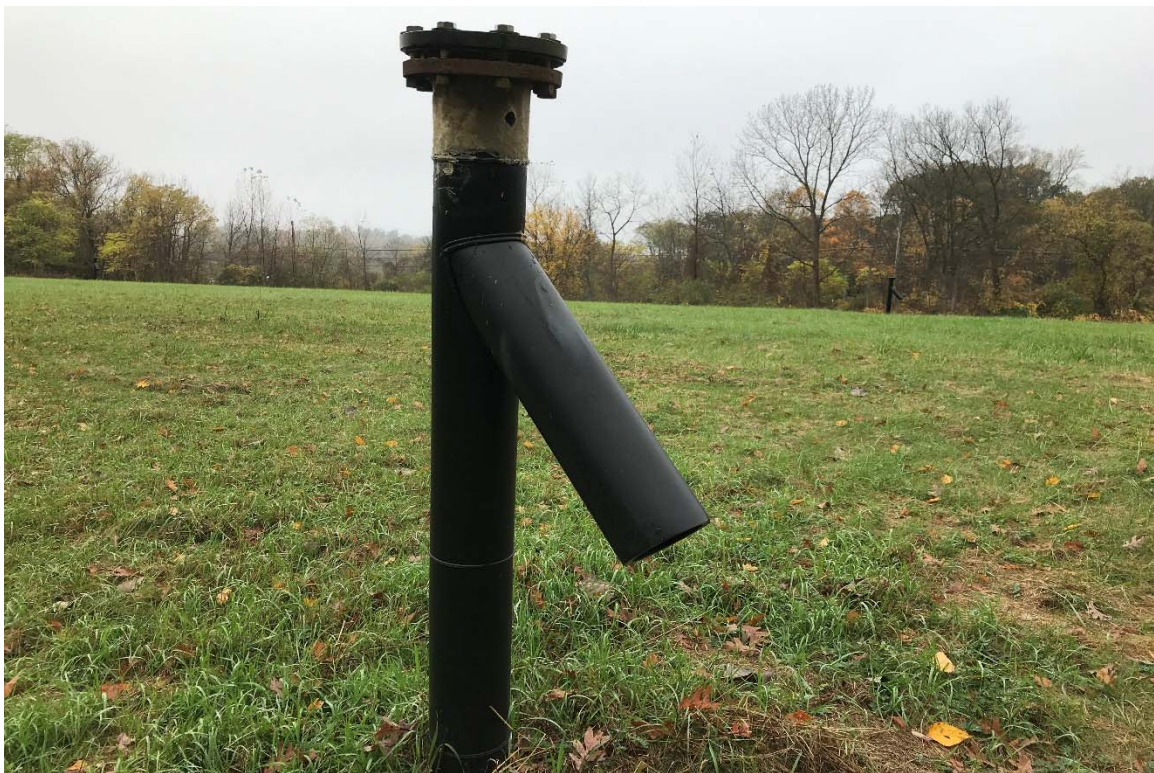
Photo 2: Vent V-2 (hole in repair patch shown)

4. Plug hole in vent V-2 with epoxy.

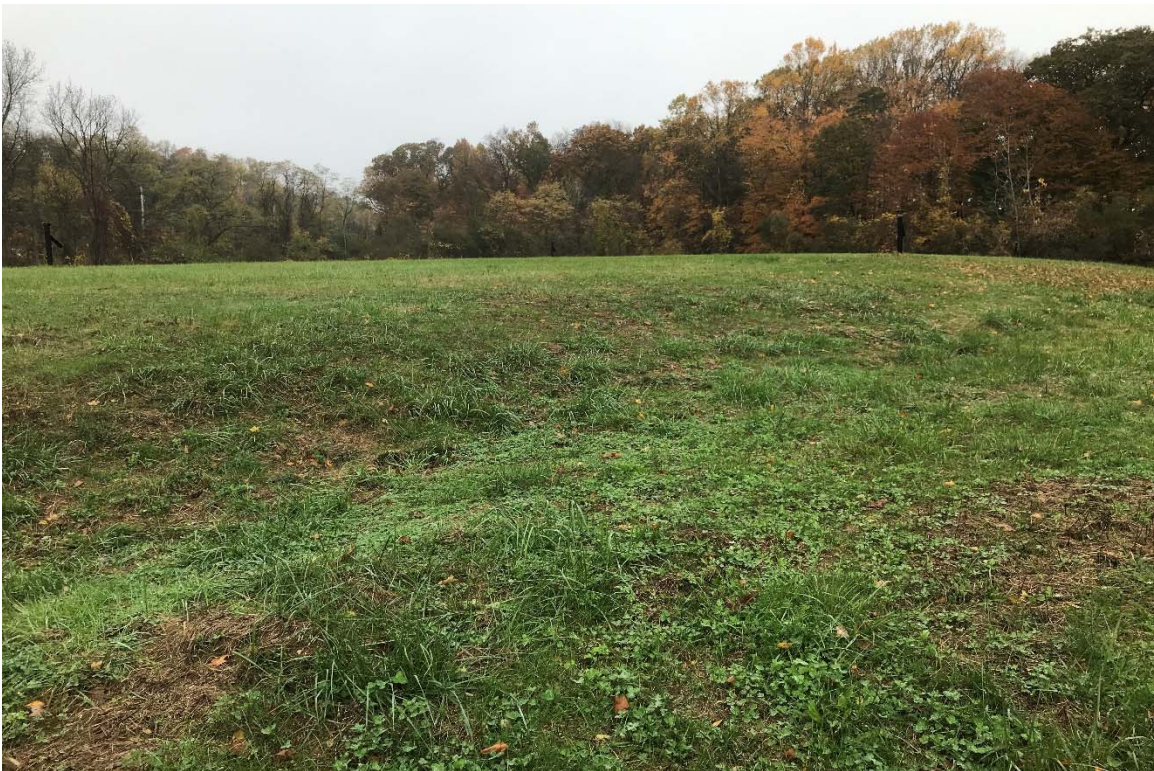
Grass height was satisfactory at the time of inspection (Photo 10). Grass should be cut in June and September.

Photo 10: Grass on landfill cap

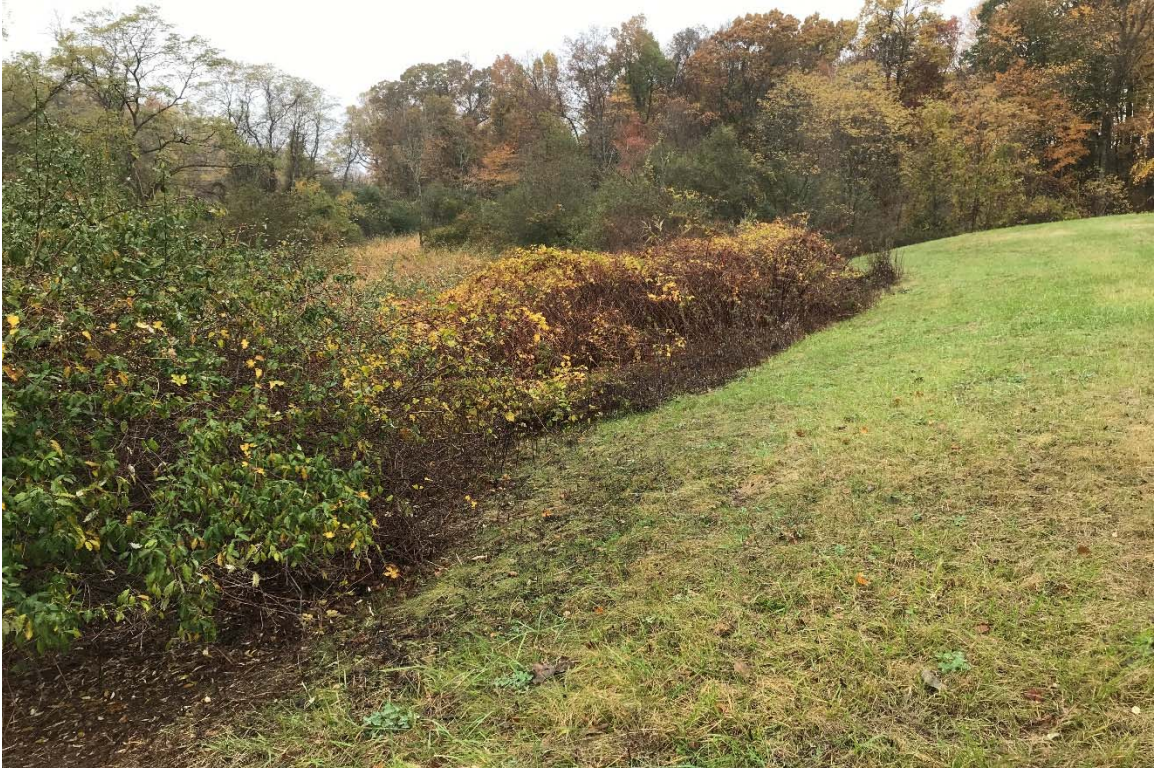
The soil slump on west slope of landfill was repaired in May 2009 by NYSDOT Maintenance Residency 8-9 personnel. The repaired area should be weed-wacked during the next mowing event in July 2020 (see Photos 13-15).

Porcelain Berry vines were overgrown on the fence in this area during this inspection (Photo 13). This is a very invasive plant. Herbicide should be applied on the vegetation in May/June before fruit begins to form. Another application may be needed in July if there is any re-growth.

Photo 13: A portion of the west slope erosion area repair that needs clearing (looking north)

3. Weed whack the west slope repair area and possibly spray with herbicide to prevent future weed growth through the stone repair. Weed whack porcelain berry vines on the south landfill fence and apply herbicide as needed. Herbicide will be applied by a NYSDEC licensed applicator.

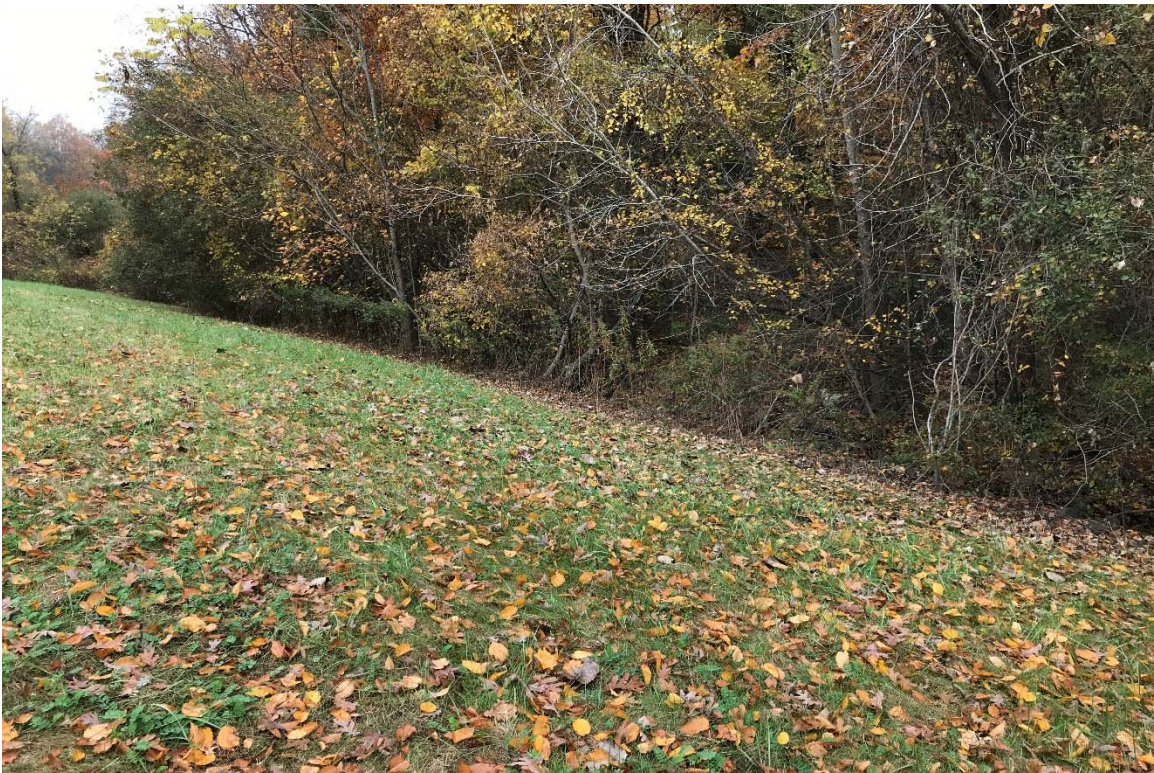
1. On April 2, 2018, Mauricio Roma from the NYS Office of the Attorney General and Steve Parisio from the NYS Department of Environmental Conservation performed an informal inspection of the landfill cap at the Harrison Facility. They suggested that all saplings and small shrubs should be removed to about 5' past the toe of the landfill cap slope to ensure that no root systems compromise the clay liner and geotextile that make up the cap. NYSDOT will have its tree removal crew cut down any shrubs and small trees that are above the toe of slope of the west, north and east sides of the landfill (Photos 13, 14, 15). Work is proposed to take place in Summer 2020.

Photo 14: Portion of the north slope that needs clearing (looking west)

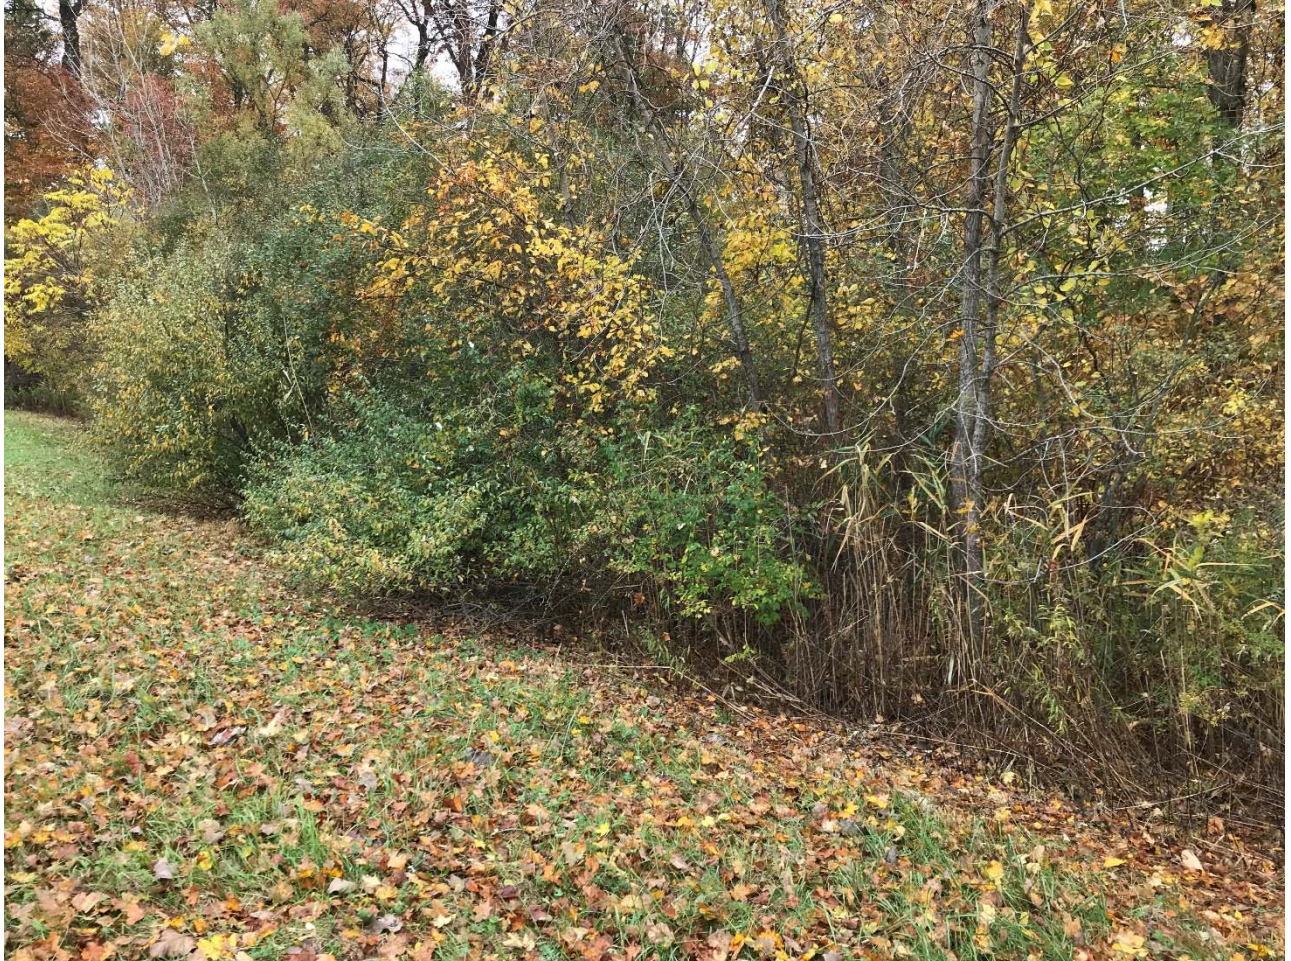
Photo 15: Portion of the east slope that needs clearing (looking north)
