## **HARRISON SUB-RESIDENCY SEMI-ANNUAL FIELD INSPECTION**

**Name of Inspector(s):** Christopher Kappeller

**Date:** 4/29/20

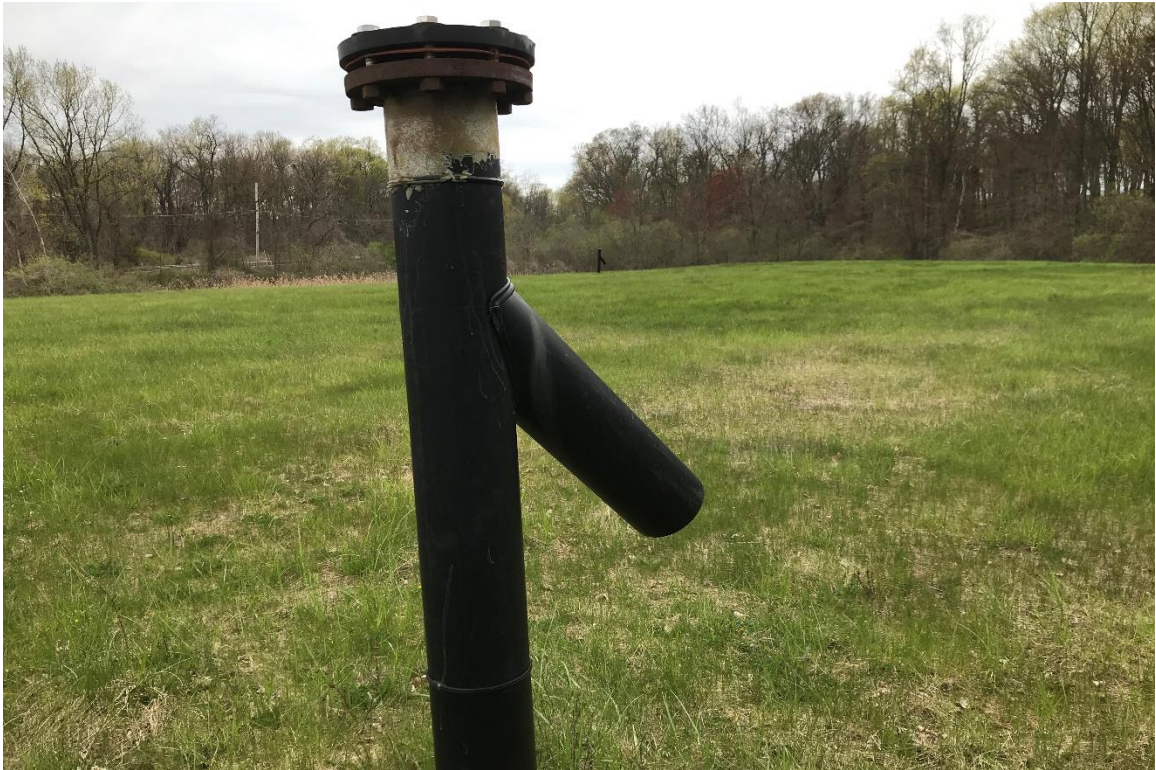
Four vents (V-1 to V-4) were inspected (Photos 1-4). V-1 and V-2 had their plastic casing holes repaired with fiberglass epoxy in August 2015. A hole presumed to be from a boring insect or woodpecker was made through the previous fiberglass repair in V-2. The hole will be repaired in Summer 2020. V-3 and V-4 were in good condition (neither cracks nor movement was observed). V-2 leans slightly to the north.

Photo 1: Vent V-1

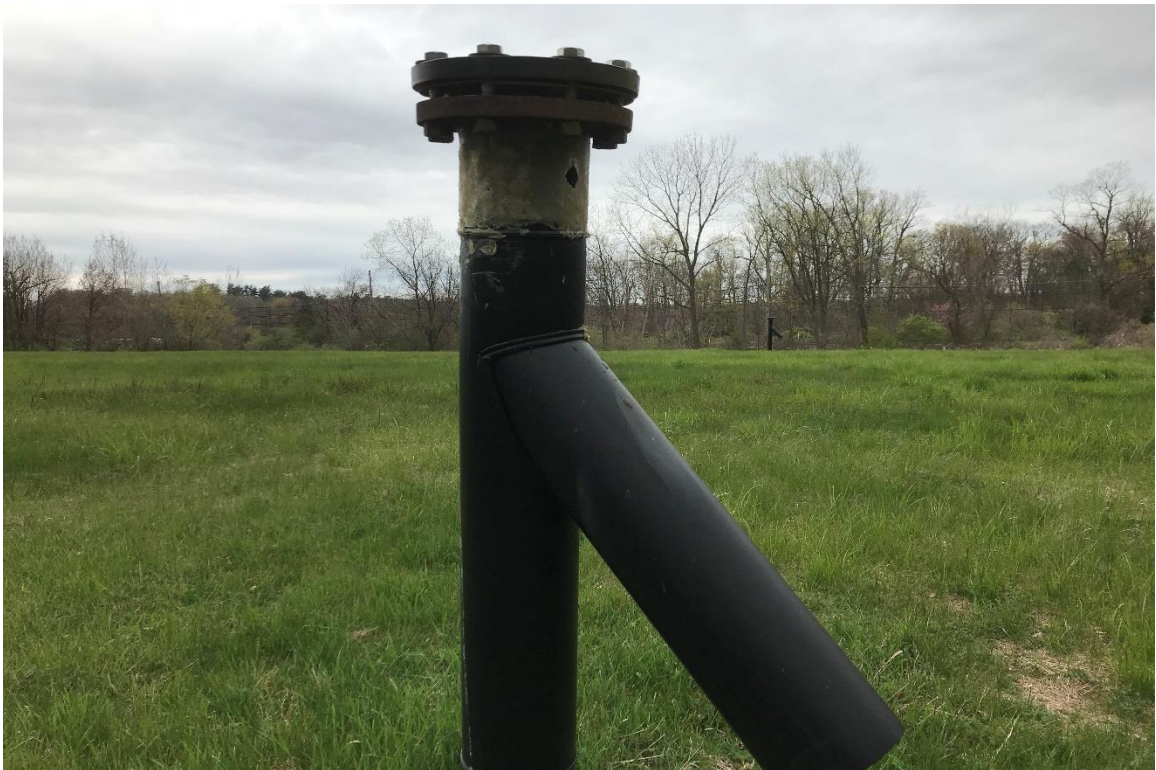
Photo 2: Vent V-2 (hole in repair patch shown)

4. Plug hole in vent V-2 with epoxy.
5. Decommissioning of MW-11 was performed on May 7, 2020 NYSDOT Geotech Department. Well plugging was done in compliance with NYSDEC CP-43: Groundwater Monitoring Well Decommissioning Policy. MW-11 was related to a former spill that was closed out in 2002 (Spill# 94-07349).

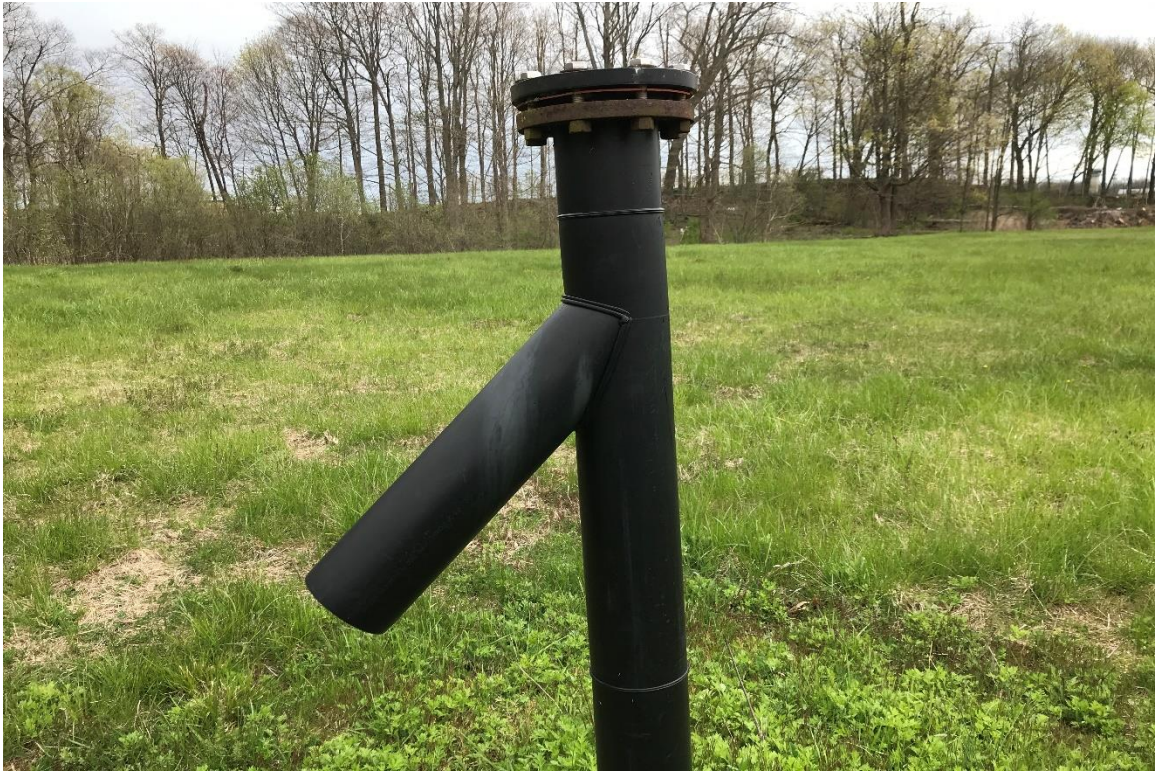
Photo 3: Vent V-3

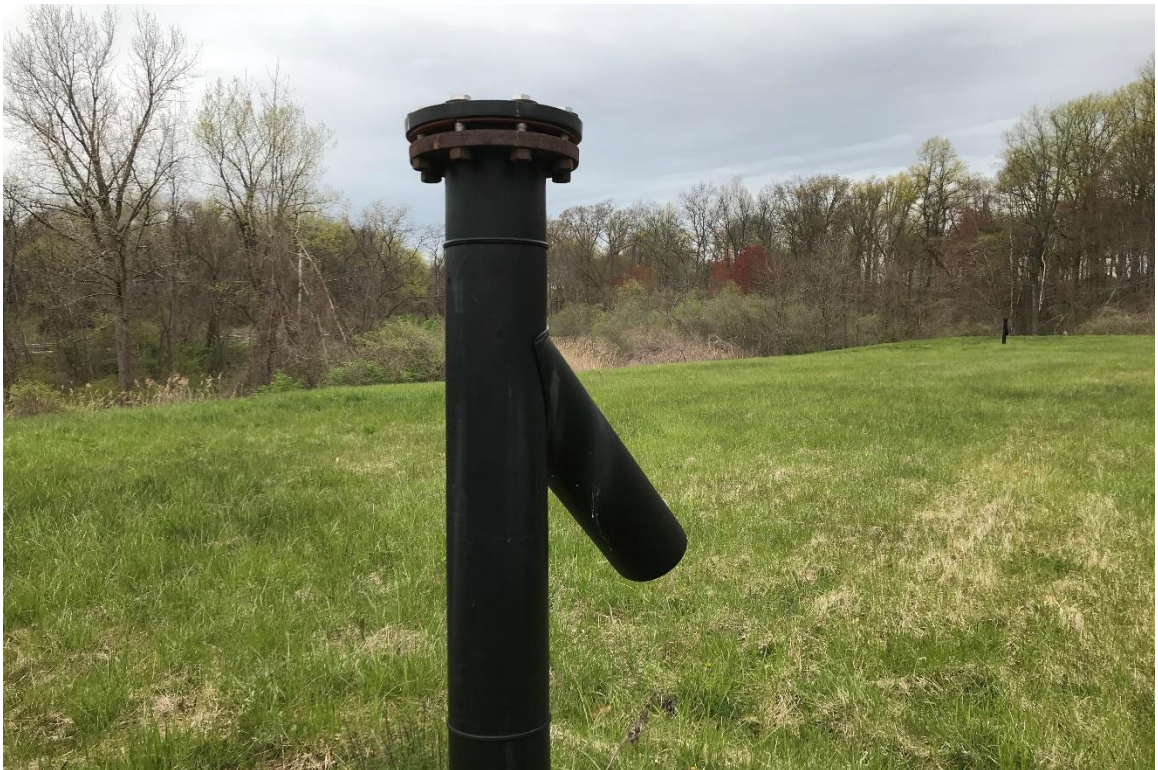
Photo 4: Vent V-4

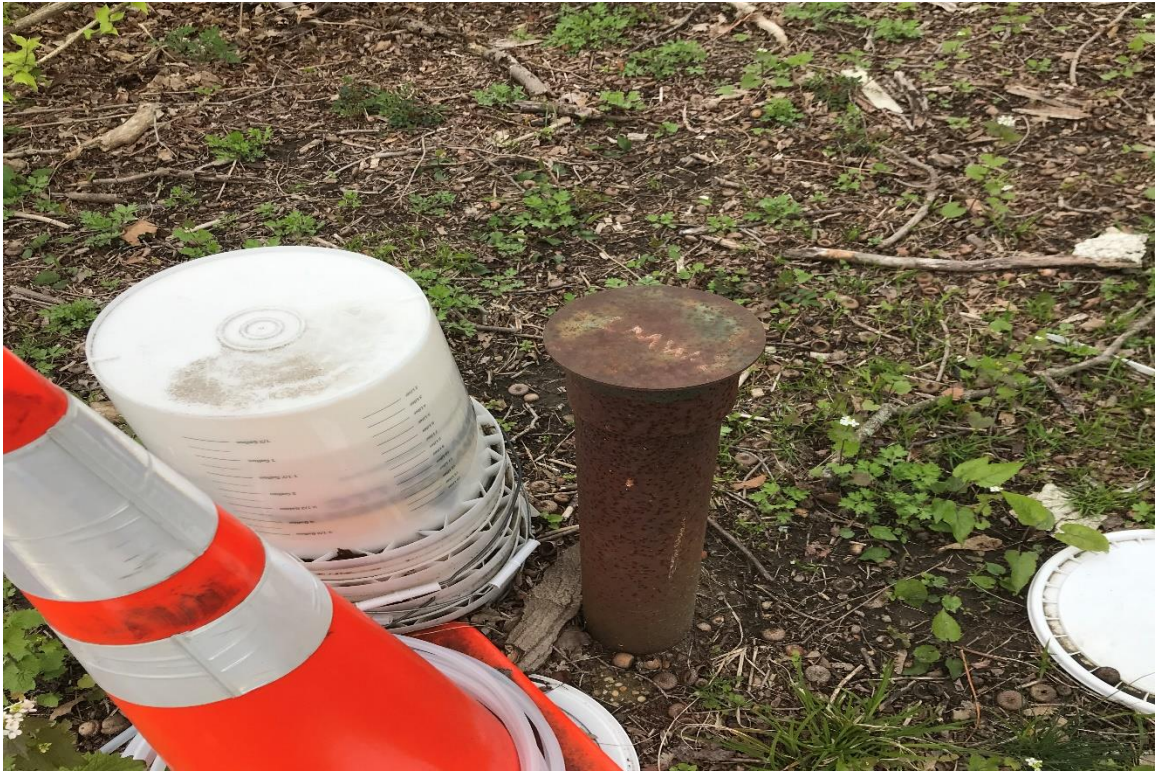
All wells were inspected and found to be in good condition. Paths to these wells were still clear of high vegetation. weed-wacked in Fall 2019.

Photo 5: Well LMW-2

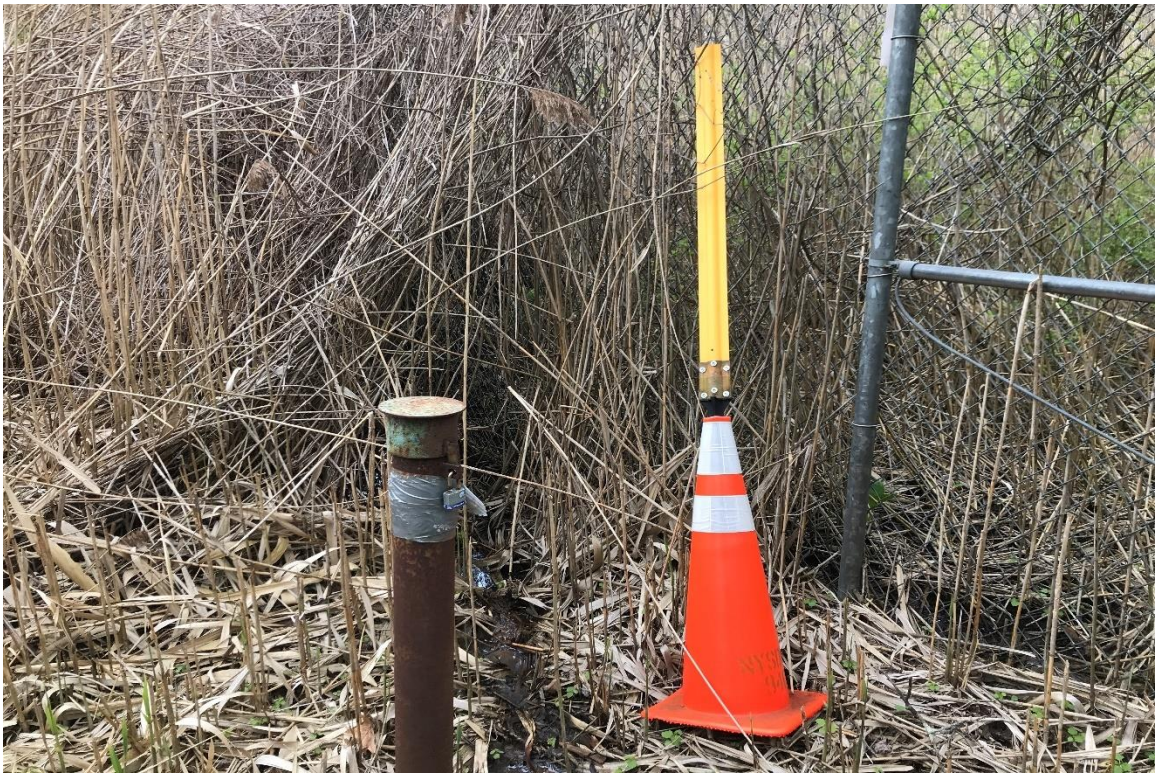
Photo 6: Well LMW-4 area

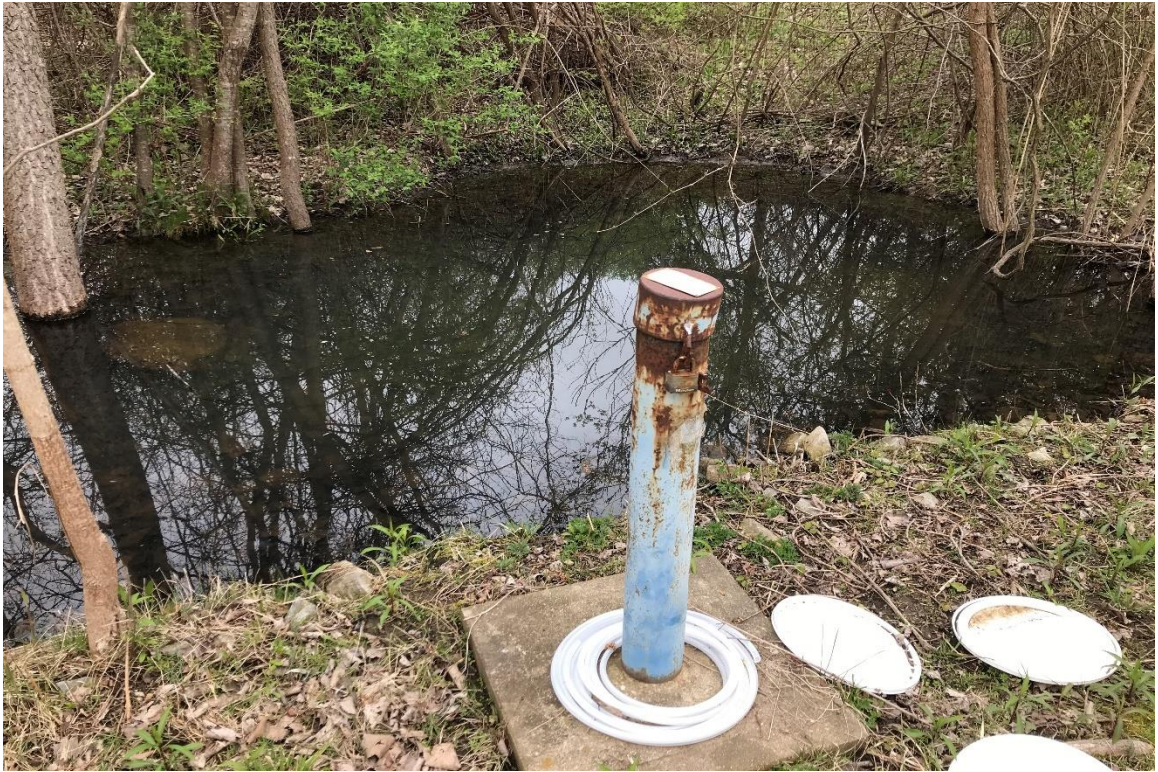
Photo 7: Well PC-1

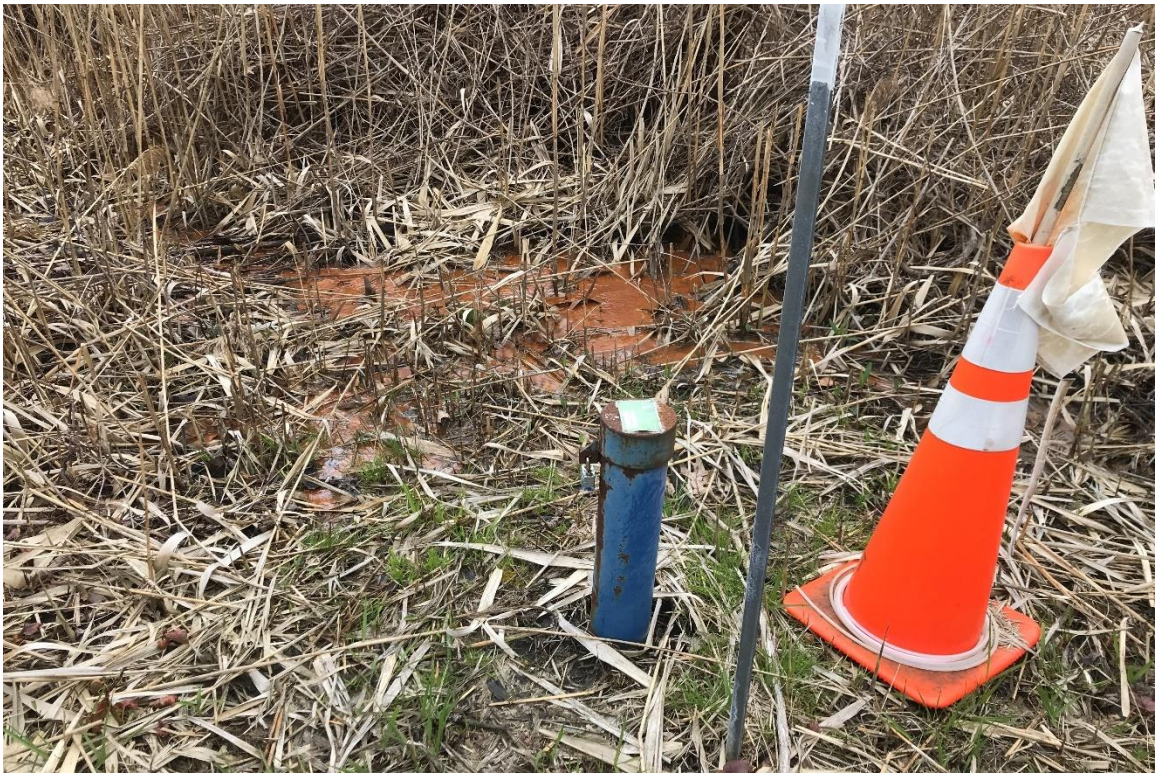
Photo 8: Well PC-2

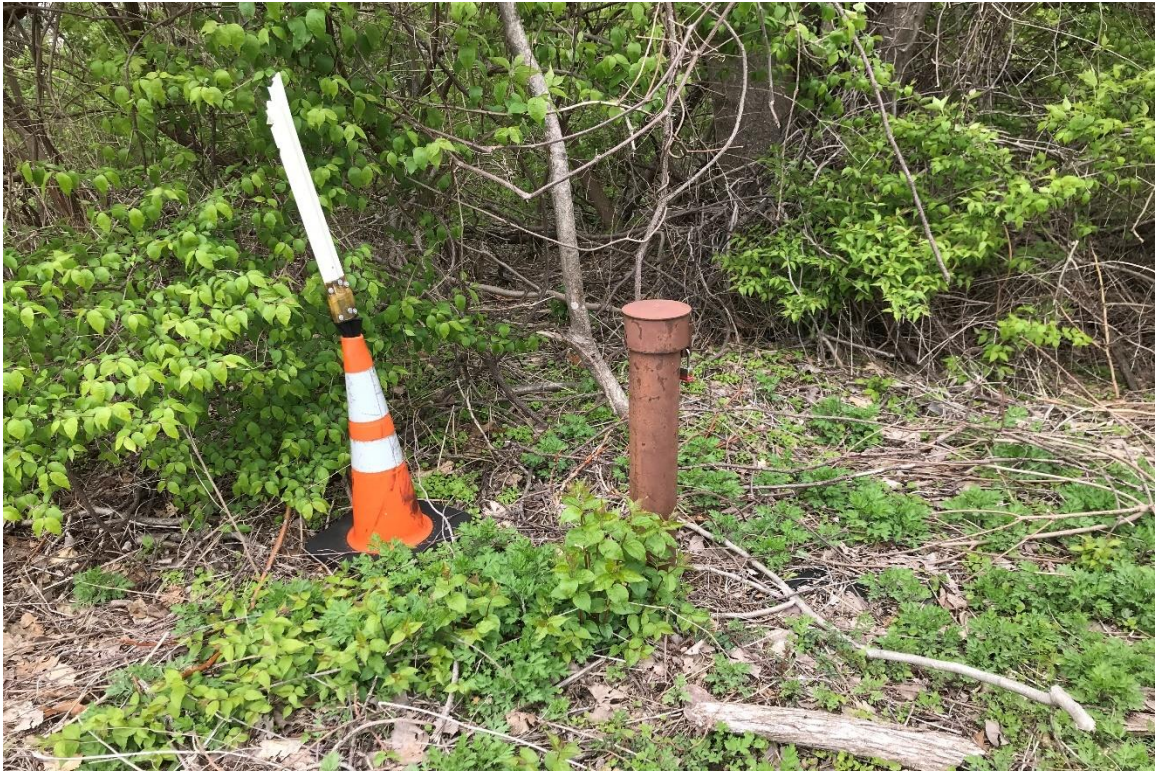
Photo 9: Well MW-11

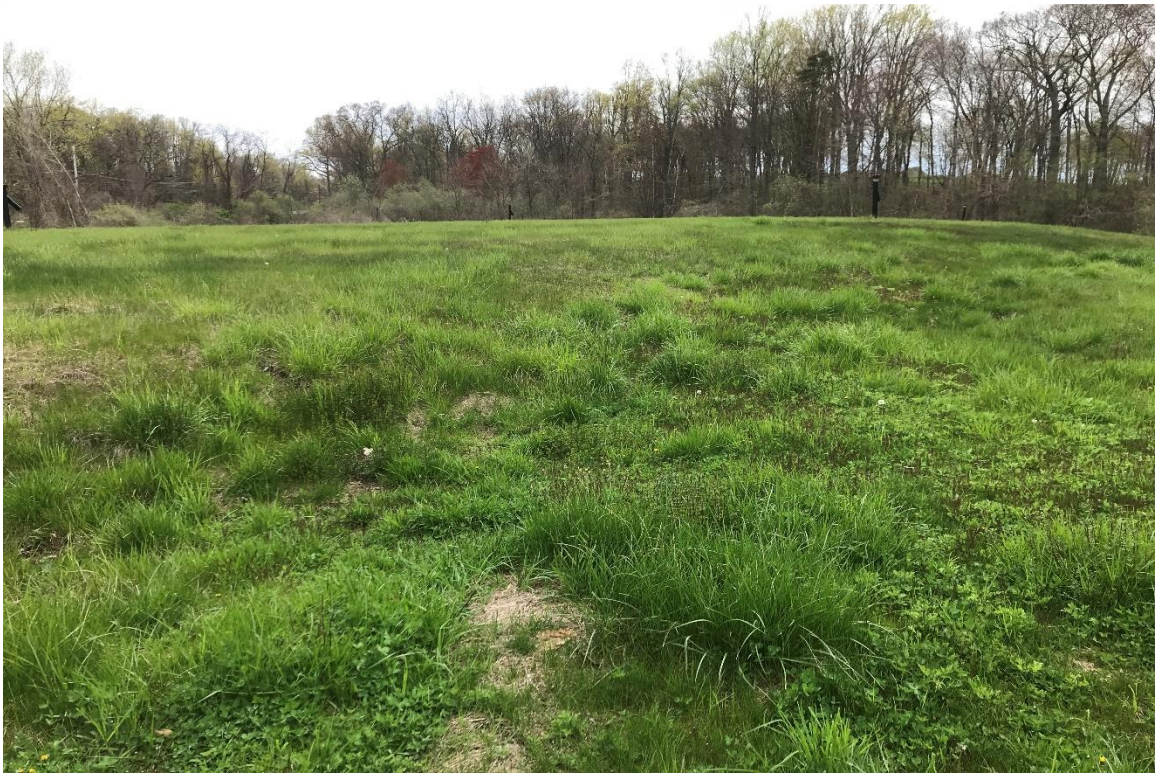
Grass height was satisfactory at the time of inspection (Photo 10). Grass should be cut in June and September.

Photo 10: Grass on landfill cap

The grass length appeared to be satisfactory. The cap should be mowed every June and September.

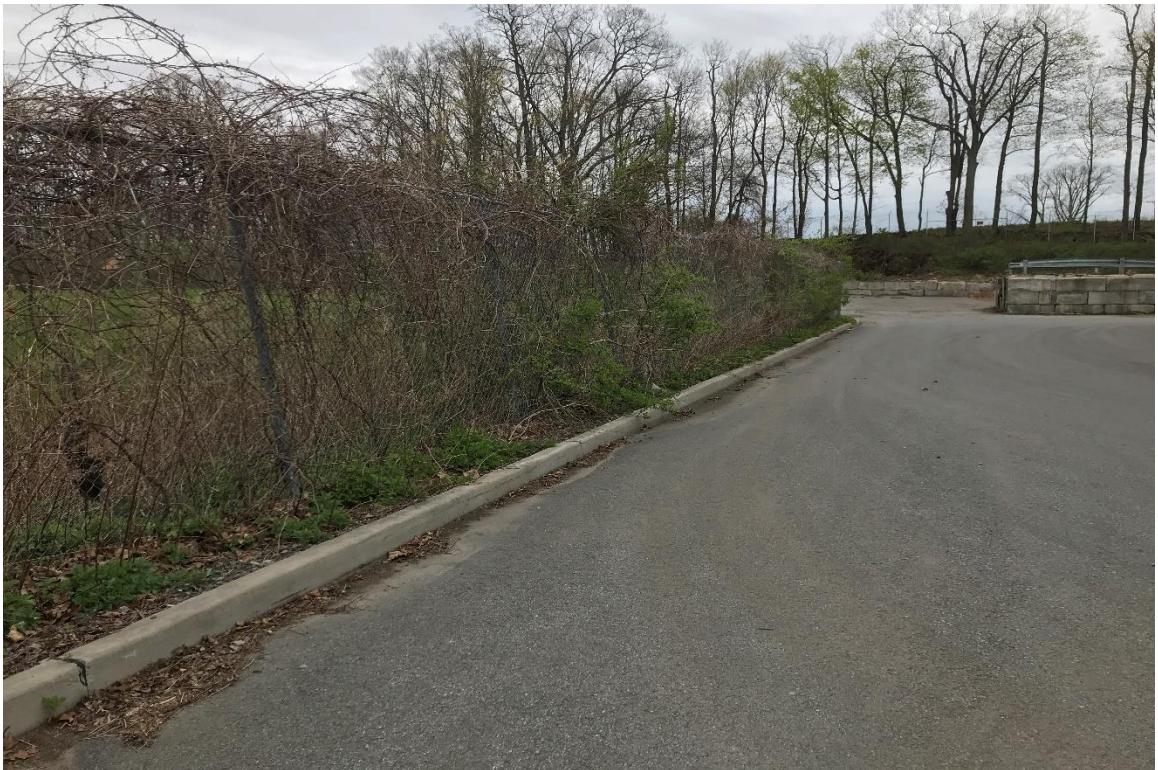
The south fence near the landfill gate appeared to be in fair condition. A monitoring well and landfill gate keys are in left drawer of the office desk. The landfill gate lock should be replaced due to rust/corrosion and hard to open.

Porcelain Berry vines were overgrown on the fence in this area during this inspection (Photo 12). This is a very invasive plant. Herbicide should be applied on the vegetation in May/June before fruit begins to form. Another application may be needed in July if there is any re-growth.

Photo 12: South fence (looking east)

3. Weed whack the west slope repair area and possibly spray with herbicide to prevent future weed growth through the stone repair. Weed whack porcelain berry vines on the south landfill fence and apply herbicide as needed. Herbicide will be applied by a NYSDEC licensed applicator.

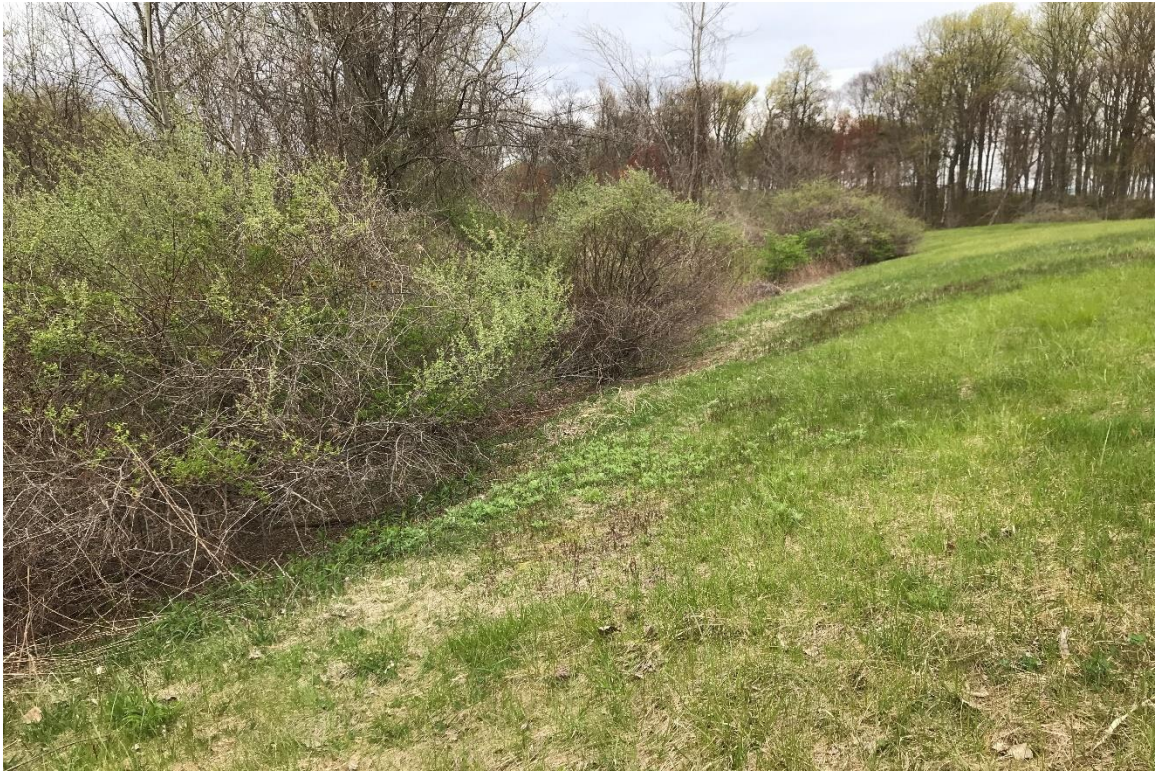
The soil slump on west slope of landfill was repaired in May 2009 by NYSDOT Maintenance Residency 8-9 personnel. The repaired area should be weed-wacked during the next mowing event in July 2020 (see Photo 13).

Photo 13: A portion of the west slope erosion area repair that needs clearing (looking north)

1. On April 2, 2018, Mauricio Roma from the NYS Office of the Attorney General and Steve Parisio from the NYS Department of Environmental Conservation performed an informal inspection of the landfill cap at the Harrison Facility. They suggested that all saplings and small shrubs should be removed to about 5' past the toe of the landfill cap slope to ensure that no root systems compromise the clay liner and geotextile that make up the cap. NYSDOT will have its tree removal crew cut down any shrubs and small trees that are above the toe of slope of the west, north and east sides of the landfill (Photos 13, 14, 15). Work is proposed to take place in Summer 2020.

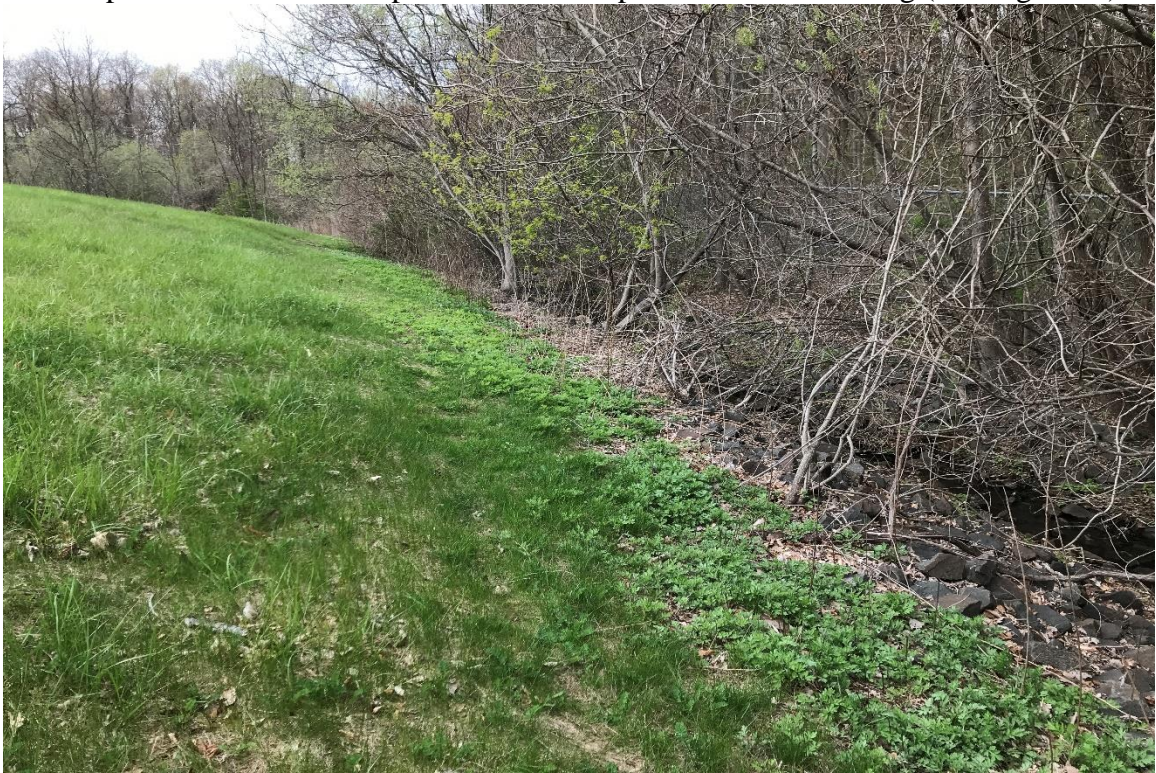
Photo 14: Portion of the north slope that needs clearing (looking west)

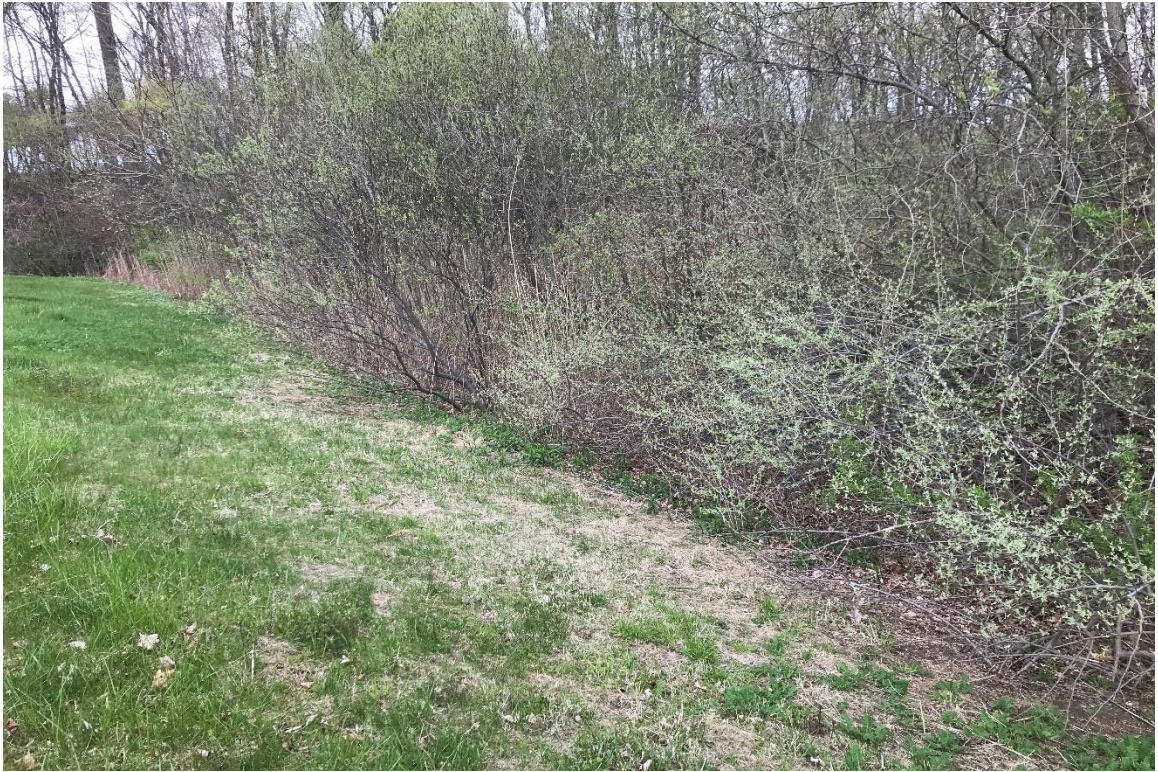
Photo 15: Portion of the east slope that needs clearing (looking north)
