HARRISON SUB-RESIDENCY SEMI-ANNUAL FIELD INSPECTION

Name of Inspector(s): Christopher Kappeller

Date: 10/28/20

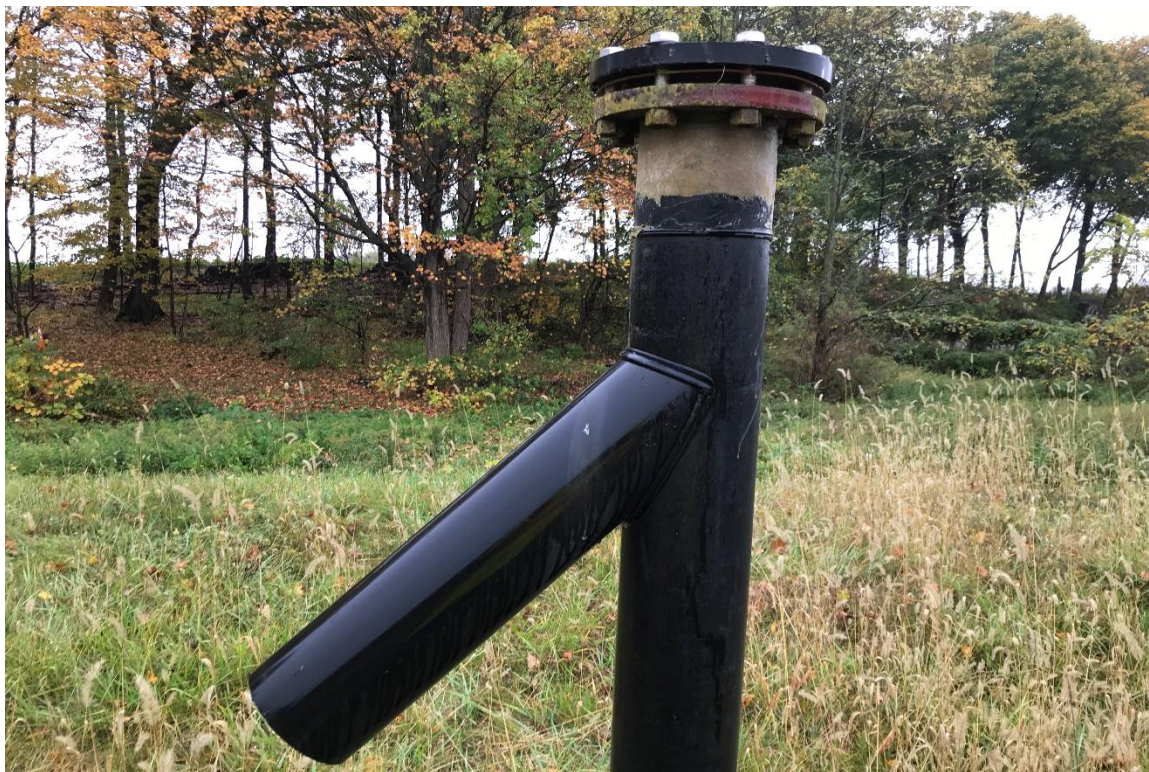
Four vents (V-1 to V-4) were inspected (Photos 1-4). V-1 and V-2 had their plastic casing holes repaired with fiberglass epoxy in August 2015. A hole presumed to be from a boring insect or woodpecker was made through the previous fiberglass repair in V-2. The hole will be repaired in Spring 2021. V-3 and V-4 were in good condition (neither cracks nor movement was observed). V-2 leans slightly to the north.

Photo 1: Vent V-1

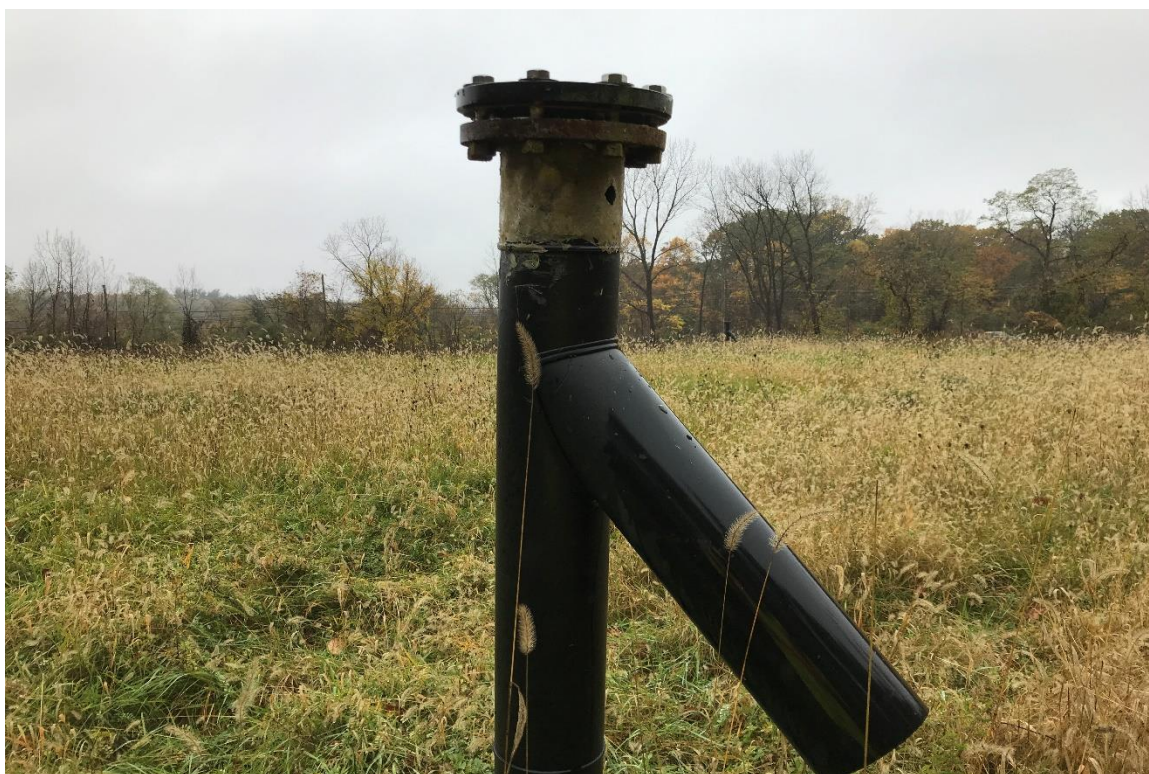
Photo 2: Vent V-2 (hole in repair patch shown)

4. Re-plug hole in vent V-2 with epoxy.
5. Decommissioning of MW-11 was performed on May 7, 2020 NYSDOT Geotech Department. Well plugging was done in compliance with NYSDEC CP-43: Groundwater Monitoring Well Decommissioning Policy. MW-11 was related to a former spill that was closed out in 2002 (Spill# 94-07349).

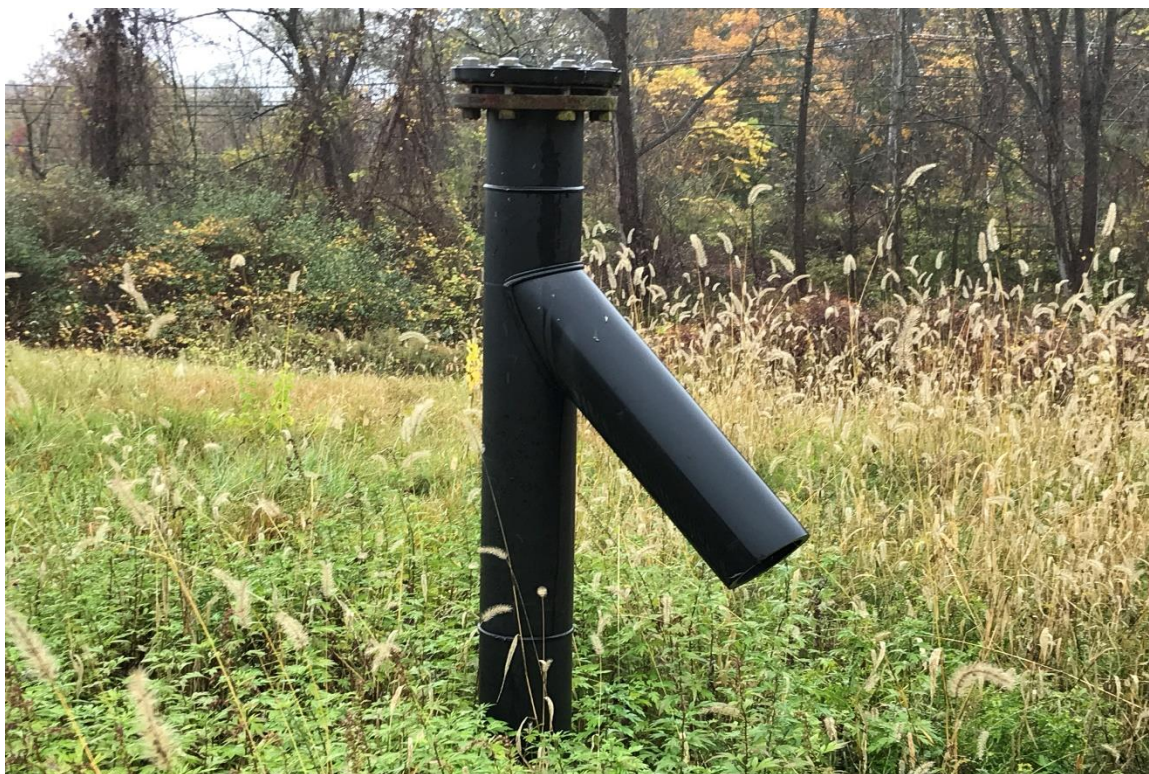
Photo 3: Vent V-3

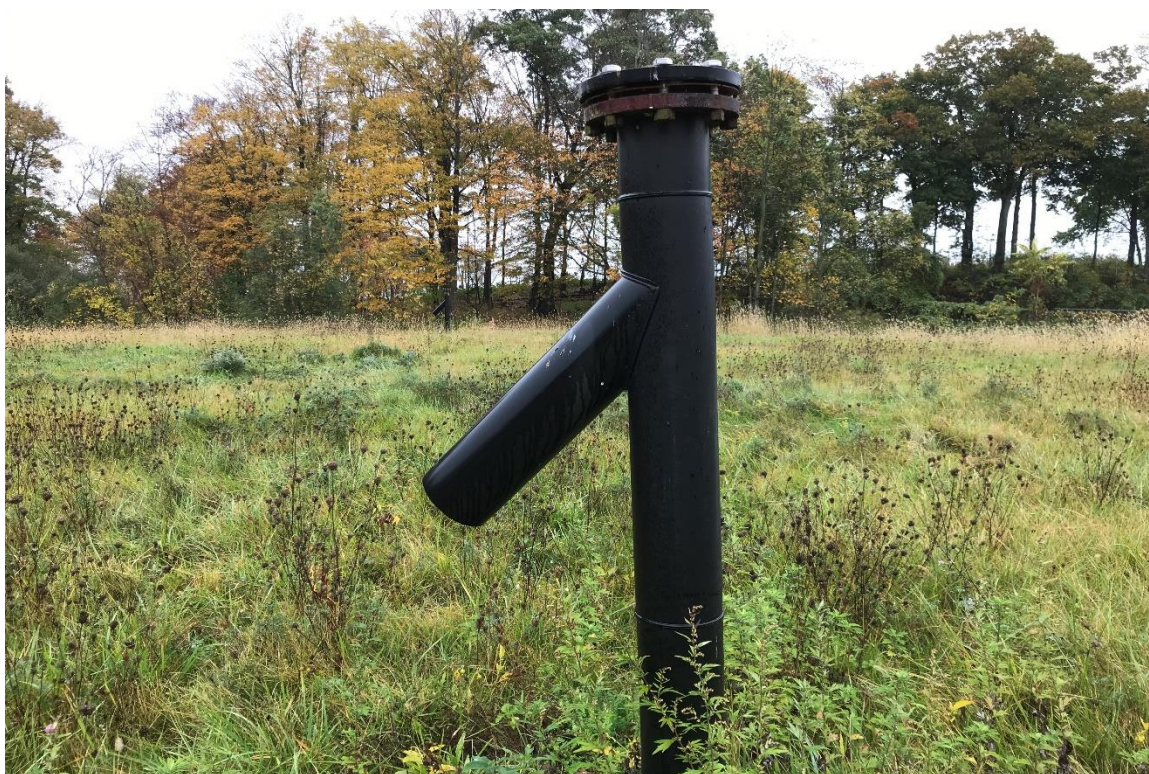
Photo 4: Vent V-4

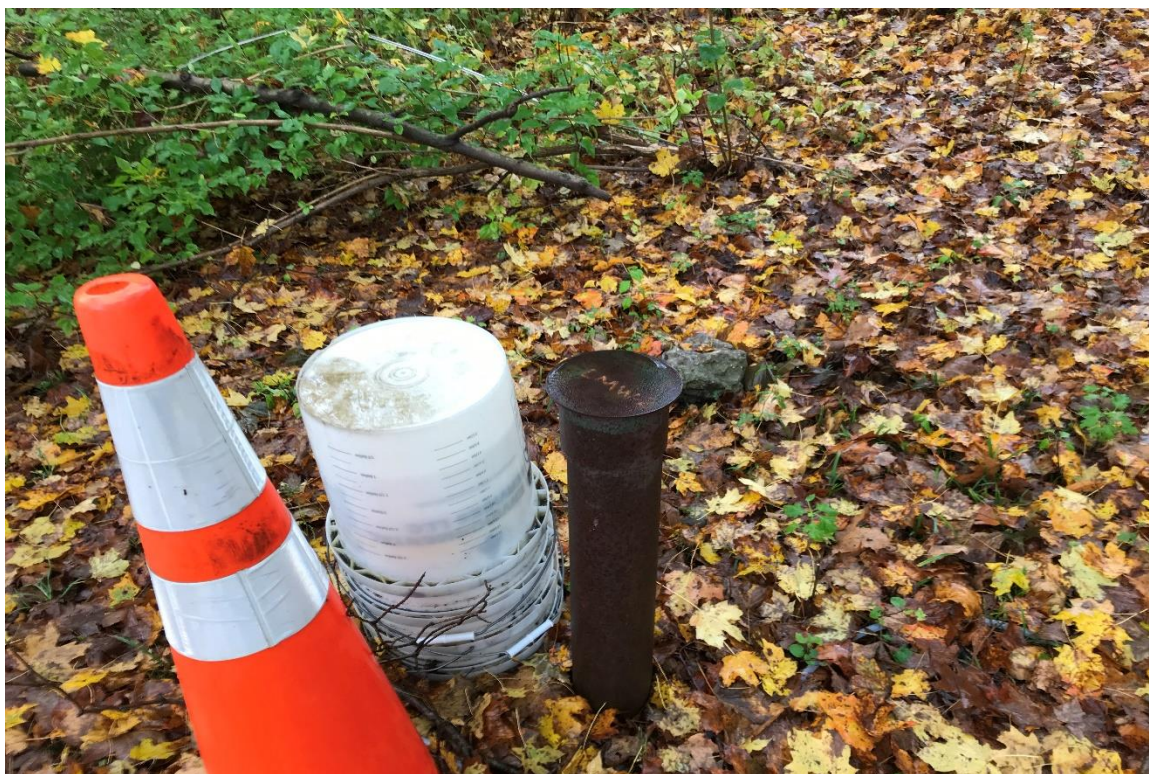
Photo 5: Well LMW-2

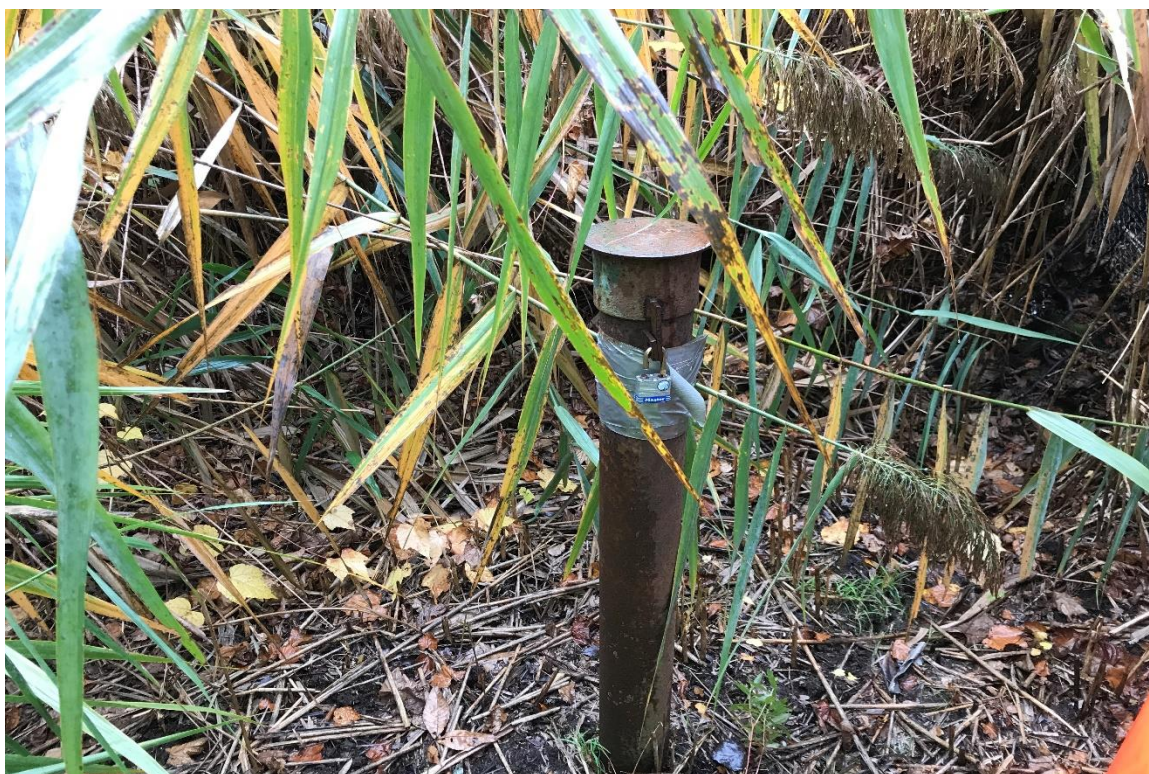
Photo 6: Well LMW-4 area

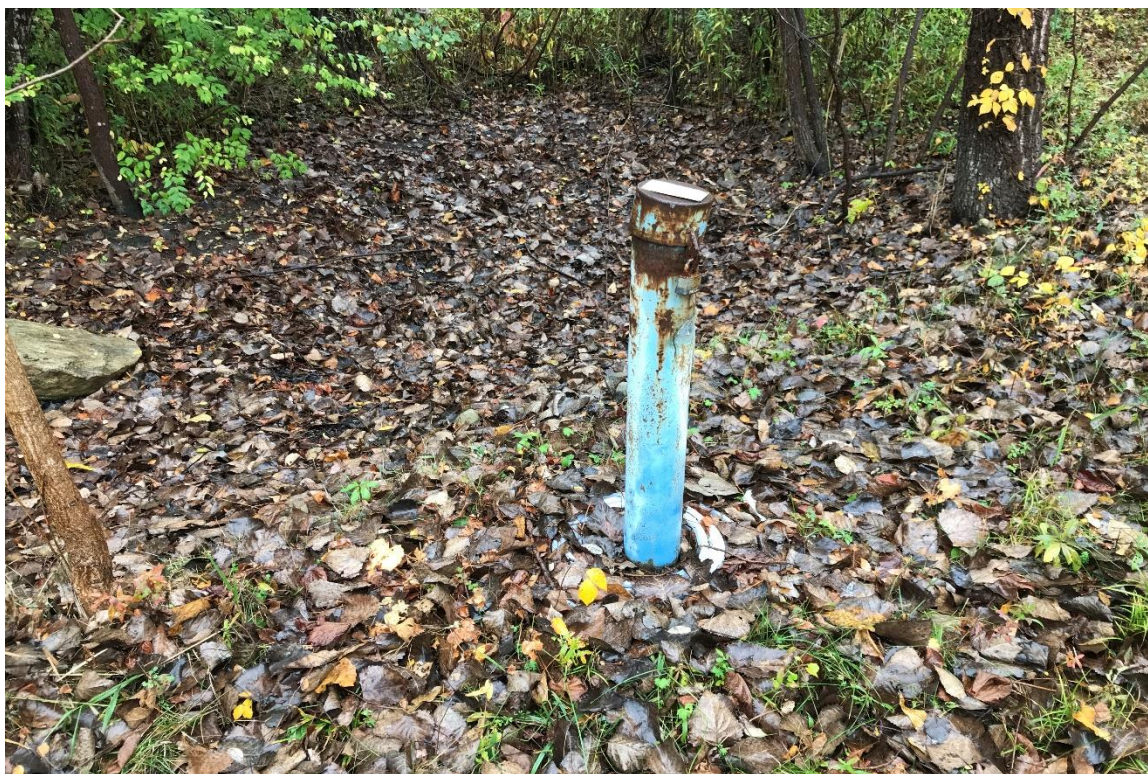
Photo 7: Well PC-1

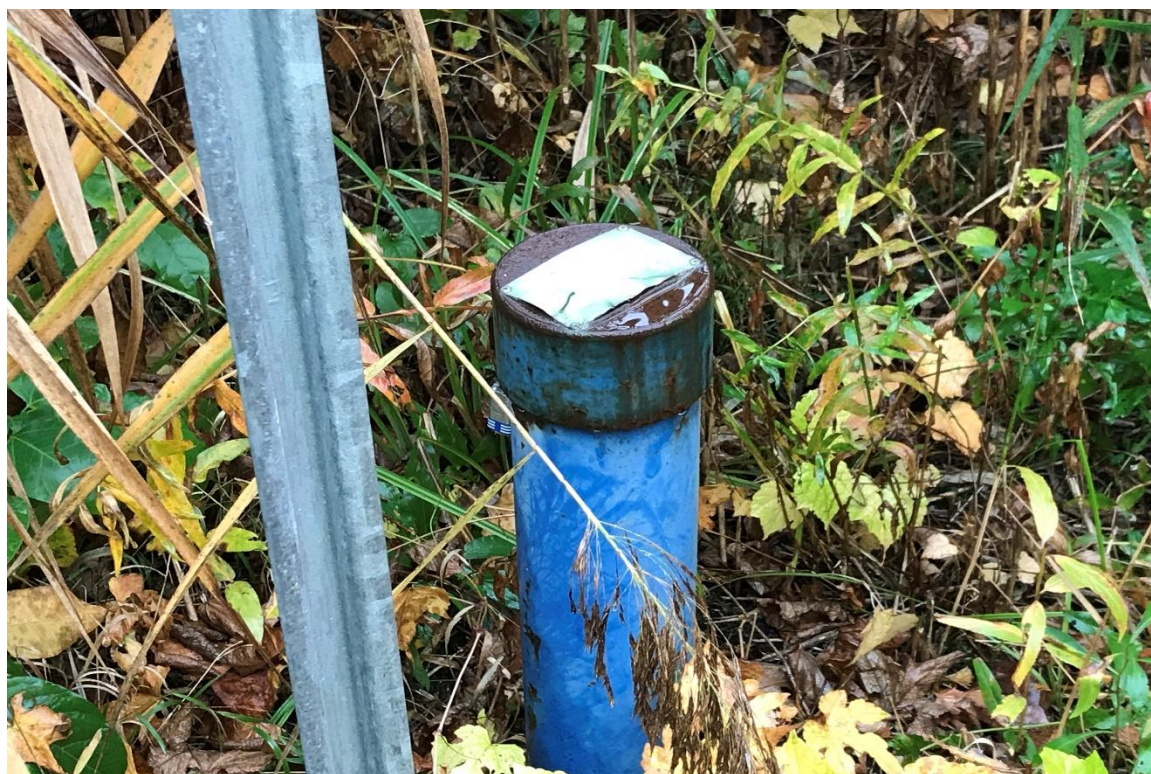
Photo 8: Well PC-2

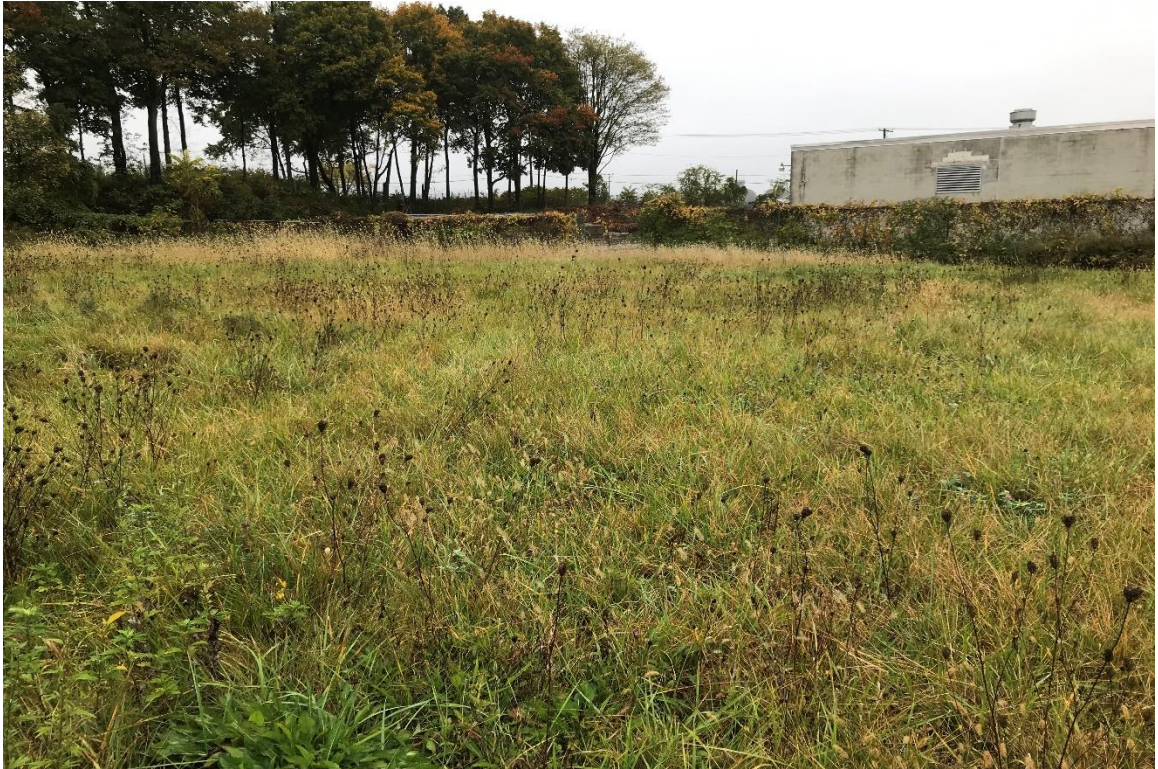
Grass height was high at the time of inspection (Photo 9 and 10). Grass should be cut in June and September.

The landfill grass/vegetation length greater than 1' high. It appears the fall mowing was not performed. Mowing should occur in spring once the landfill cap has dried from winter snow thaw to prevent cap damage from the mower. The cap should be mowed every June and September.

Photo 9: Grass on landfill cap, looking south towards site building.

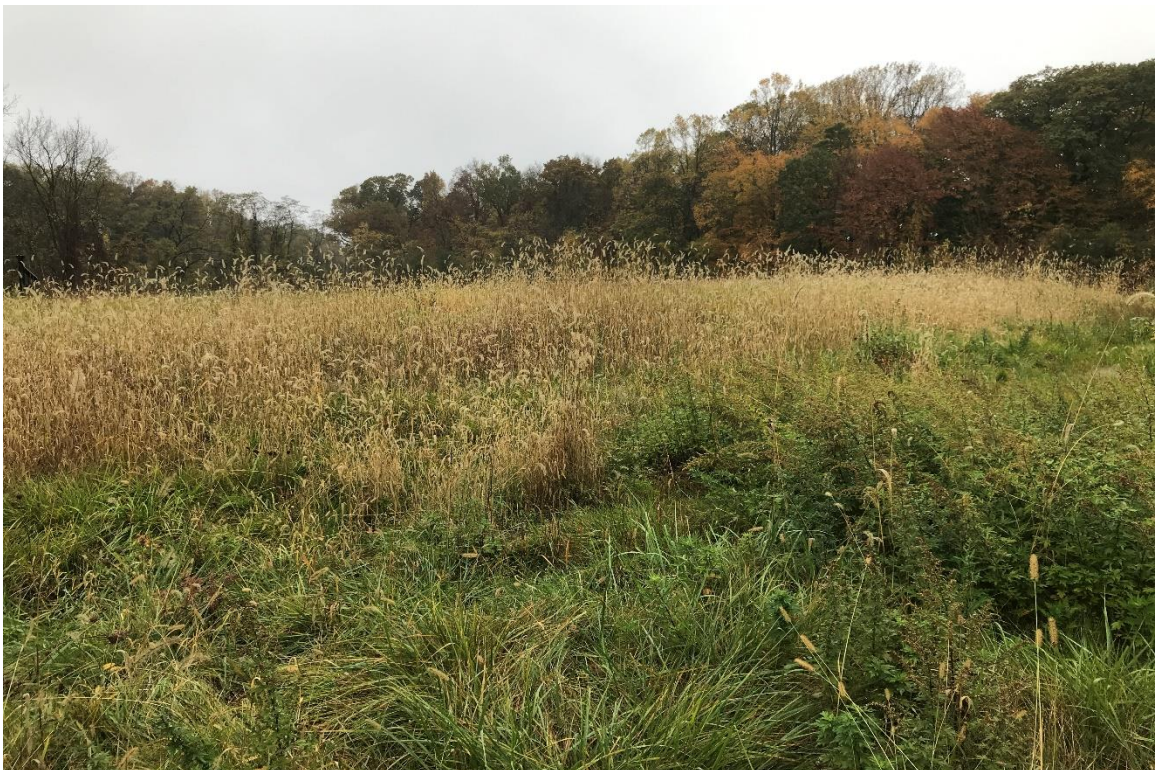
Photo 10: Grass on landfill cap needs cutting (looking north).

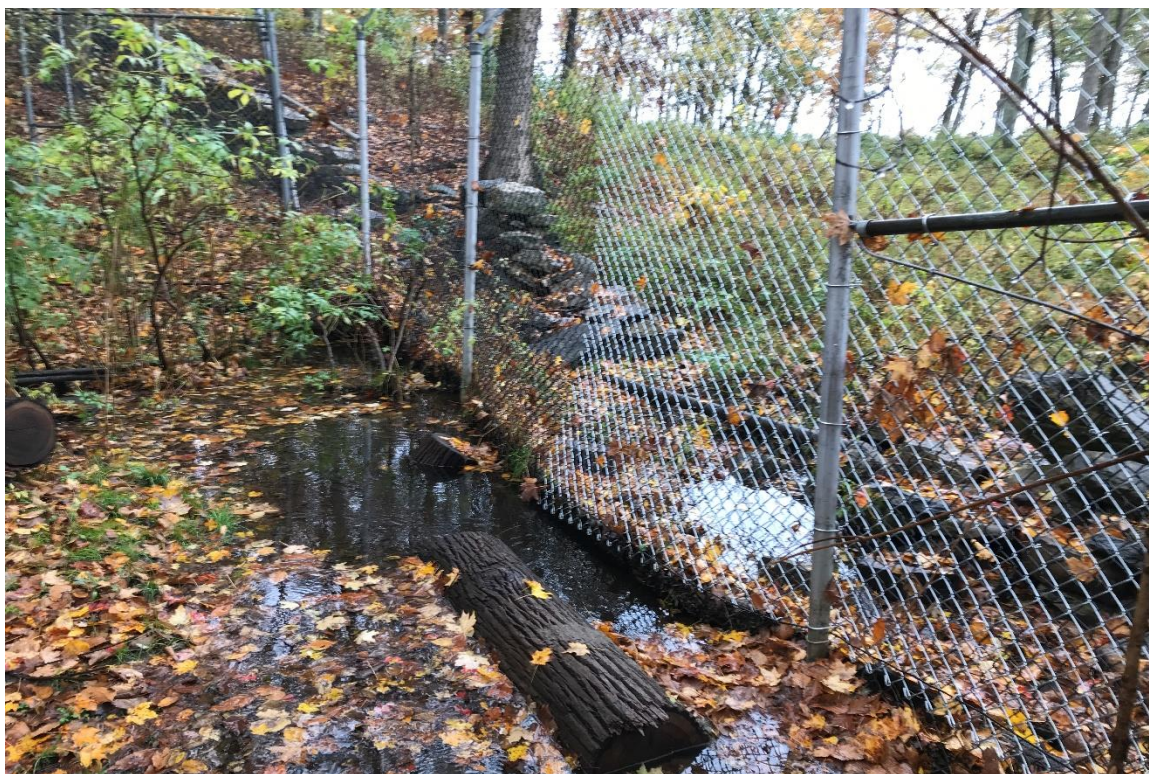
A section of fence was damaged on the south side of the landfill (Photos 14-17). It appears that a vehicle/machine pushed soil and woody debris into the fence and collapsed the section. The 8-9 Residency should contact the Town of Harrison Public Works Department to have them repair the damage since the town has their leaf/wood transfer station operations active at the facility. The south fence near the landfill gate appeared to be in fair condition. Portions of the west landfill fence, near the stream inlet (Photo 11), appear to me new. Replacement was possibly done by the neighboring Westchester County Airport.

Photo 11: Stream inlet with new fence segment.

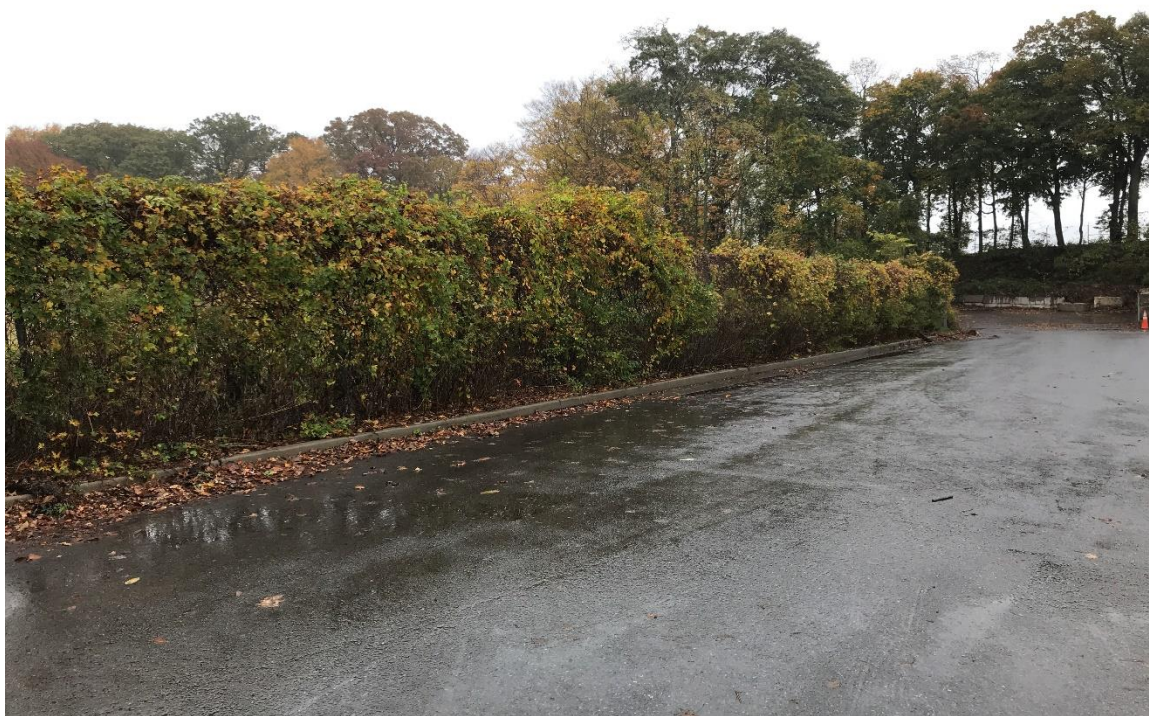
Porcelain Berry vines were overgrown on the fence in this area during this inspection (Photo 12). This is a very invasive plant. Herbicide should be applied on the vegetation in May/June before fruit begins to form. Another application may be needed in July if there is any re-growth.

Photo 12: South fence (looking east) needs vine herbicide.

3. Weed whack the west slope repair area and possibly spray with herbicide to prevent future weed growth through the stone repair. Weed whack porcelain berry vines on the south landfill fence and apply herbicide as needed. Herbicide will be applied by a NYSDEC licensed applicator.

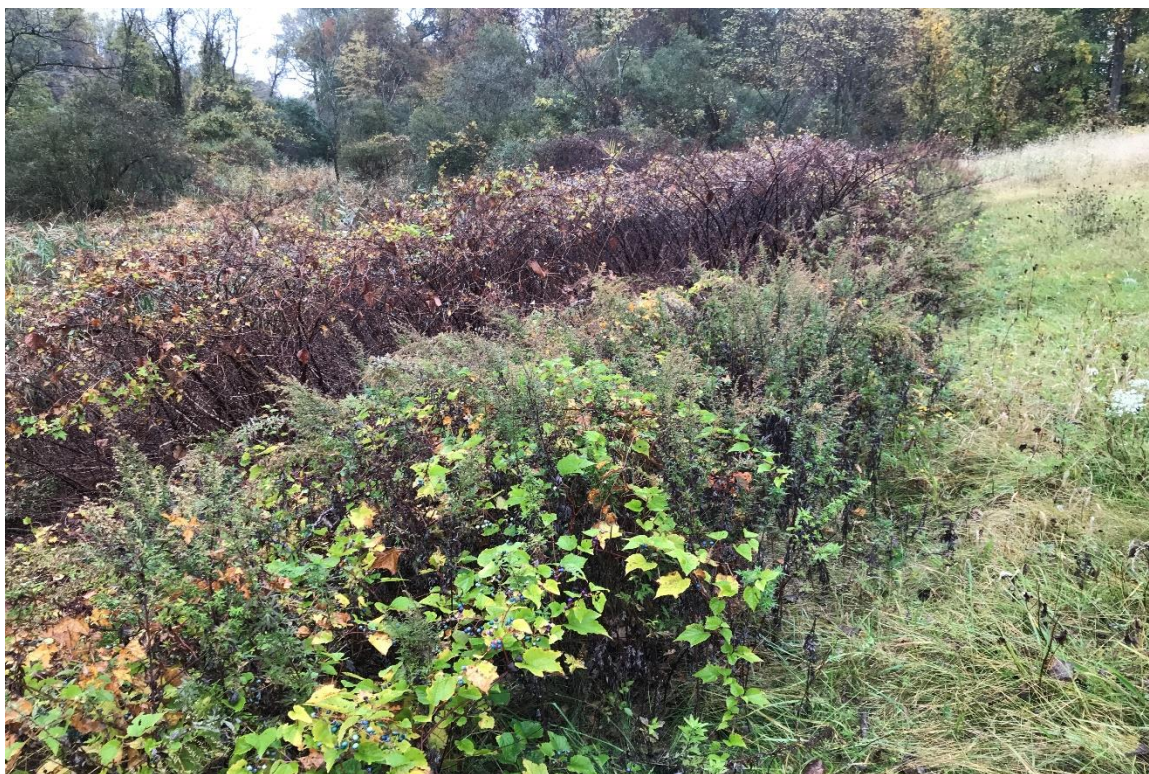
The soil slump on west slope of landfill was repaired in May 2009 by NYSDOT Maintenance Residency 8-9 personnel. The repaired area should be weed-wacked during the next mowing event in June 2021 (see Photo 13).

Photo 13: A portion of the west slope erosion area repair that needs clearing (looking north)

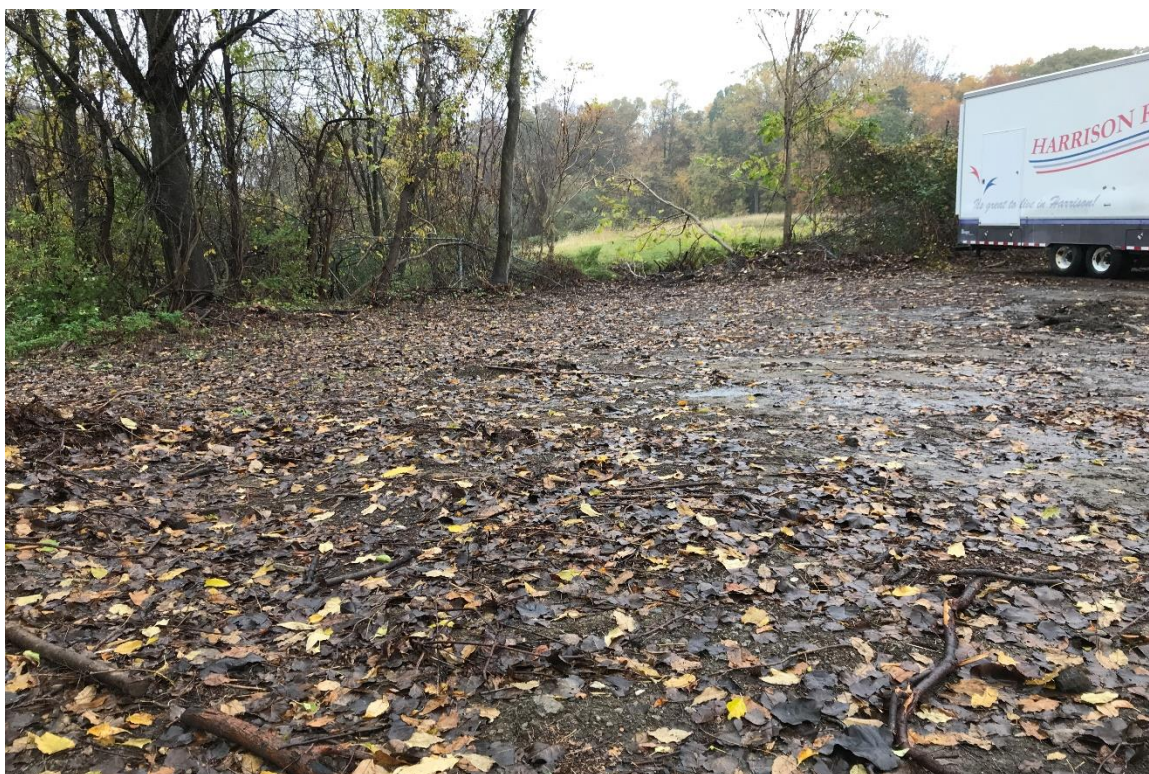
Photo 14: Damaged section of the southern landfill fence near outside storage area (looking north).

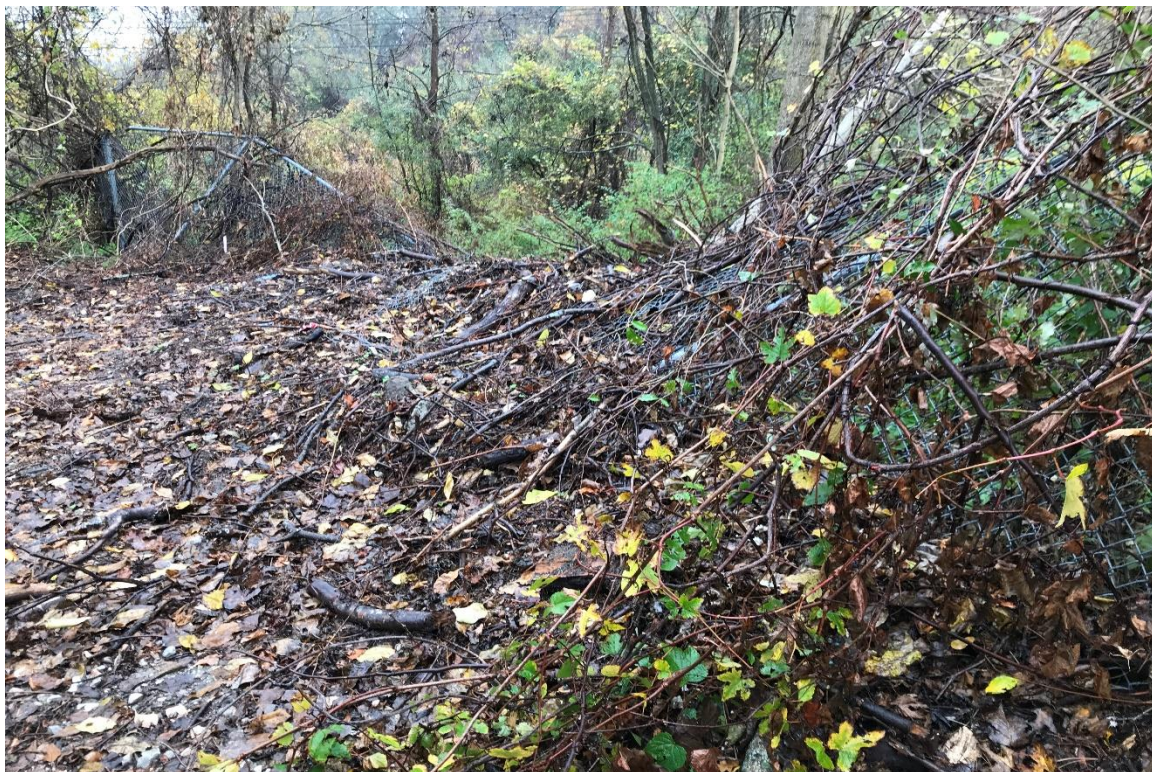
Photo 15: Fence damage closeup (looking west).

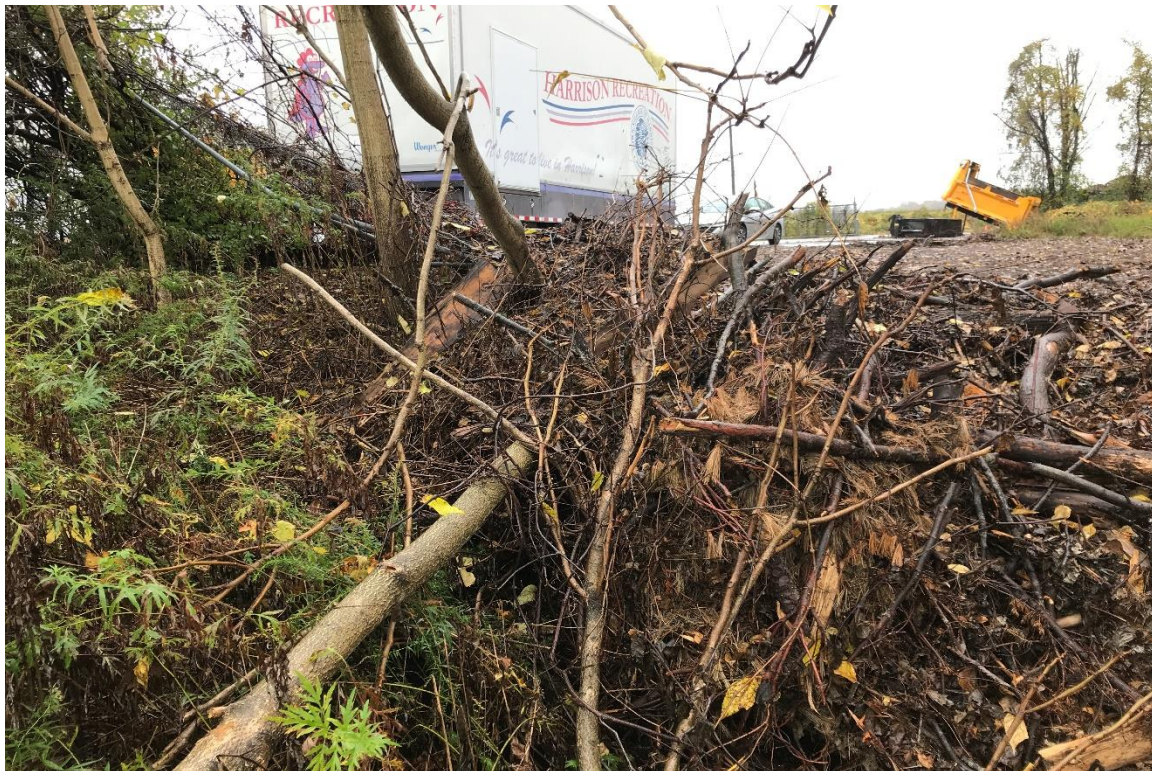
Photo 16: Fence damage closeup (looking south).

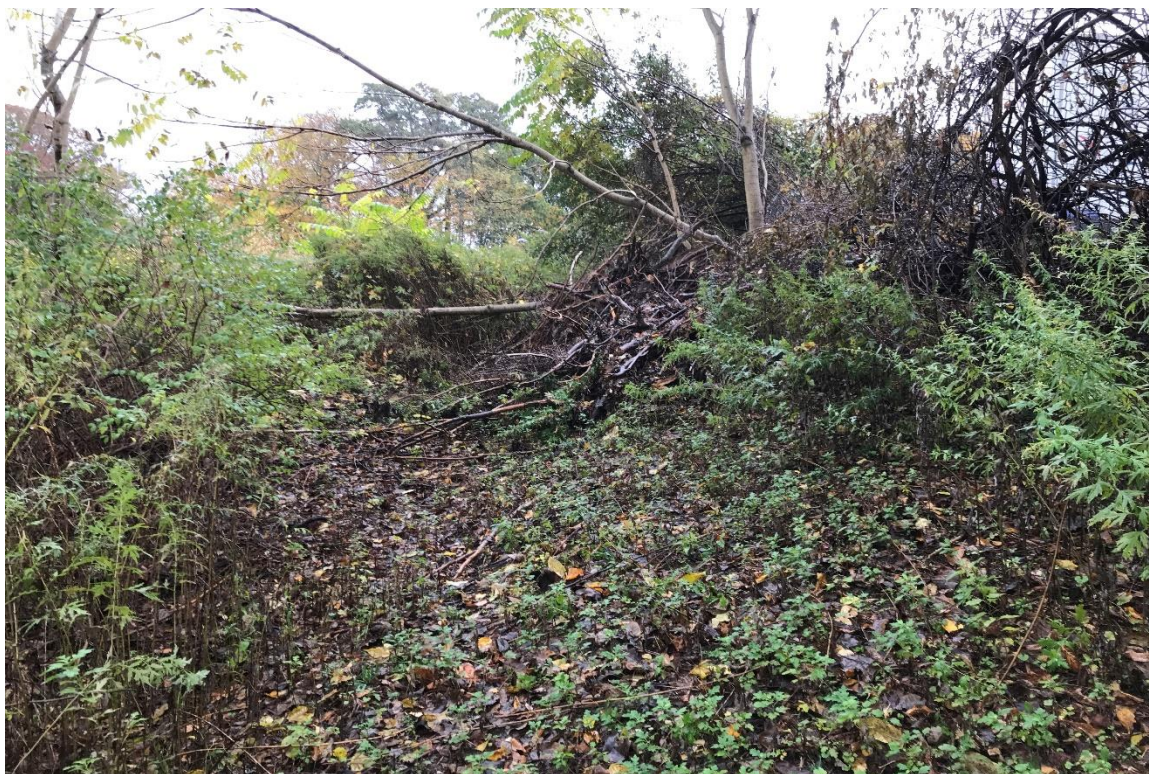
Photo 17: Fence damage closeup (looking south)
