HARRISON SUB-RESIDENCY SEMI-ANNUAL FIELD INSPECTION

Date: 4/14/21

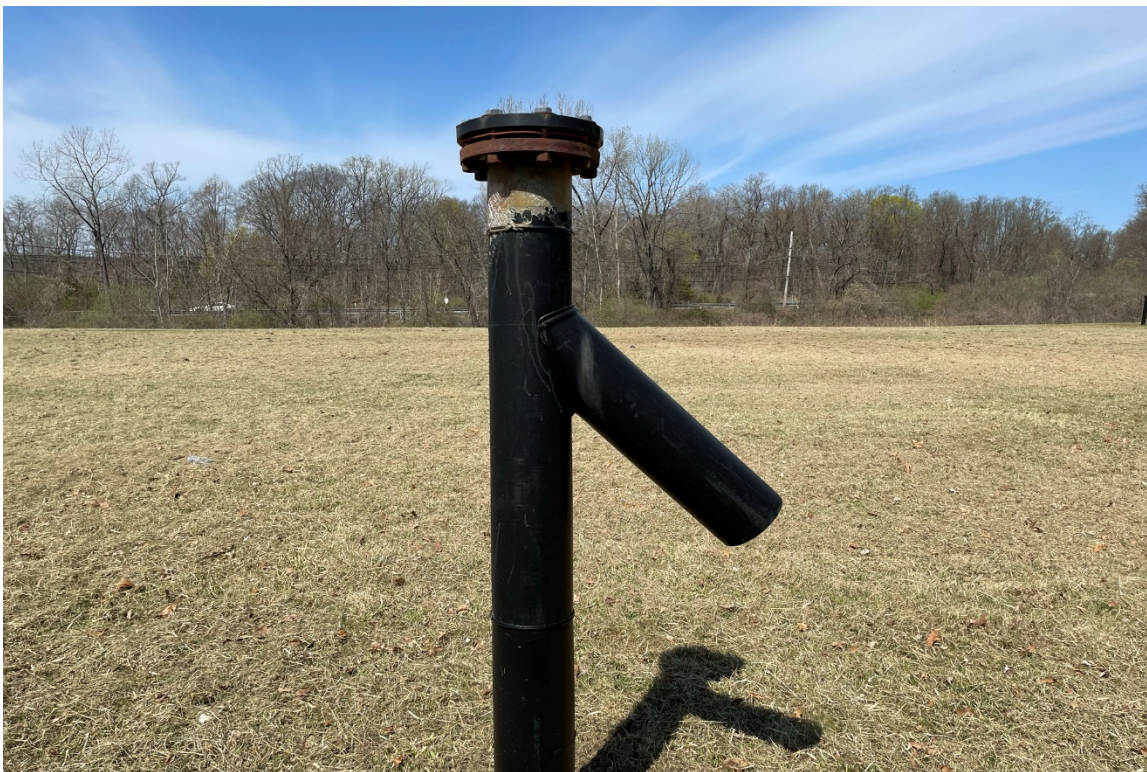
Photo 1: Vent V-1

Four vents (V-1 to V-4) were inspected (Photos 1-4). V-1 and V-2 had their plastic casing holes repaired with fiberglass epoxy in August 2015. A hole presumed to be from a boring insect or woodpecker was made through the previous fiberglass repair in V-2. The hole will be repaired in Spring 2021. V-3 and V-4 were in good condition (neither cracks nor movement was observed). V-2 leans slightly to the north.

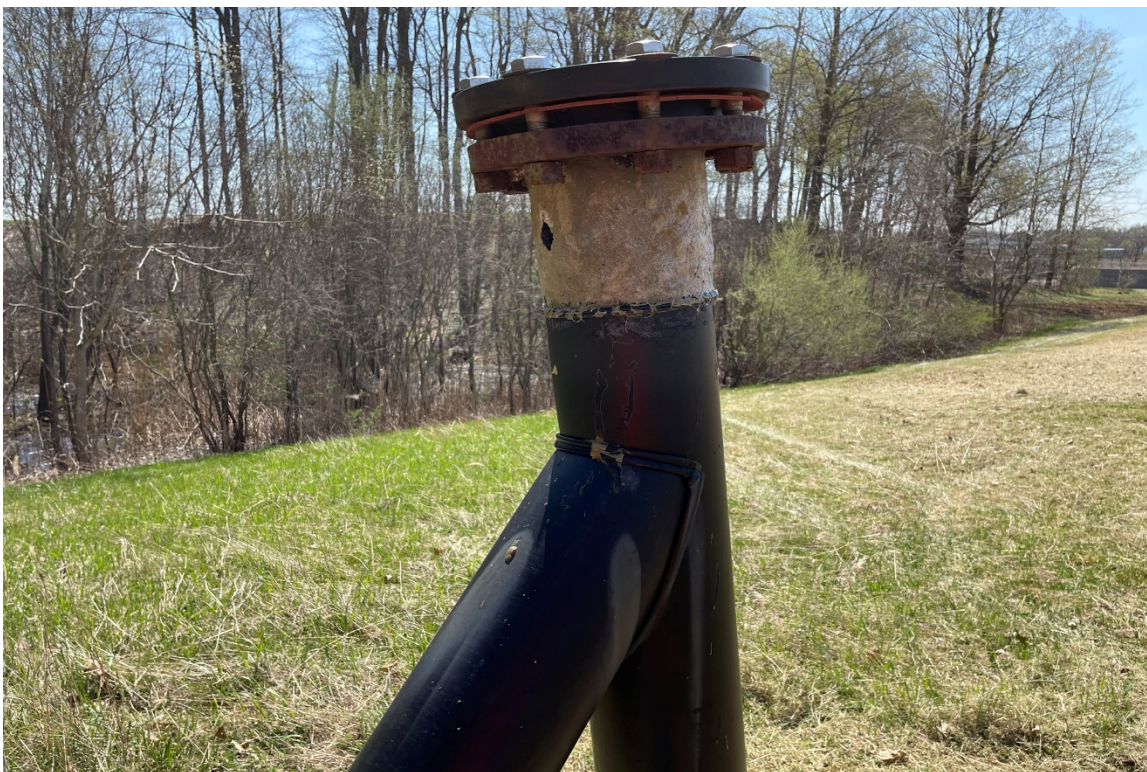
Photo 2: Vent V-2 (hole in repair patch shown)

4. Re-plug hole in vent V-2 with epoxy.
5. Decommissioning of MW-11 was performed on May 7, 2020 NYSDOT Geotech Department. Well plugging was done in compliance with NYSDEC CP-43: Groundwater Monitoring Well Decommissioning Policy. MW-11 was related to a former spill that was closed out in 2002 (Spill# 94-07349).

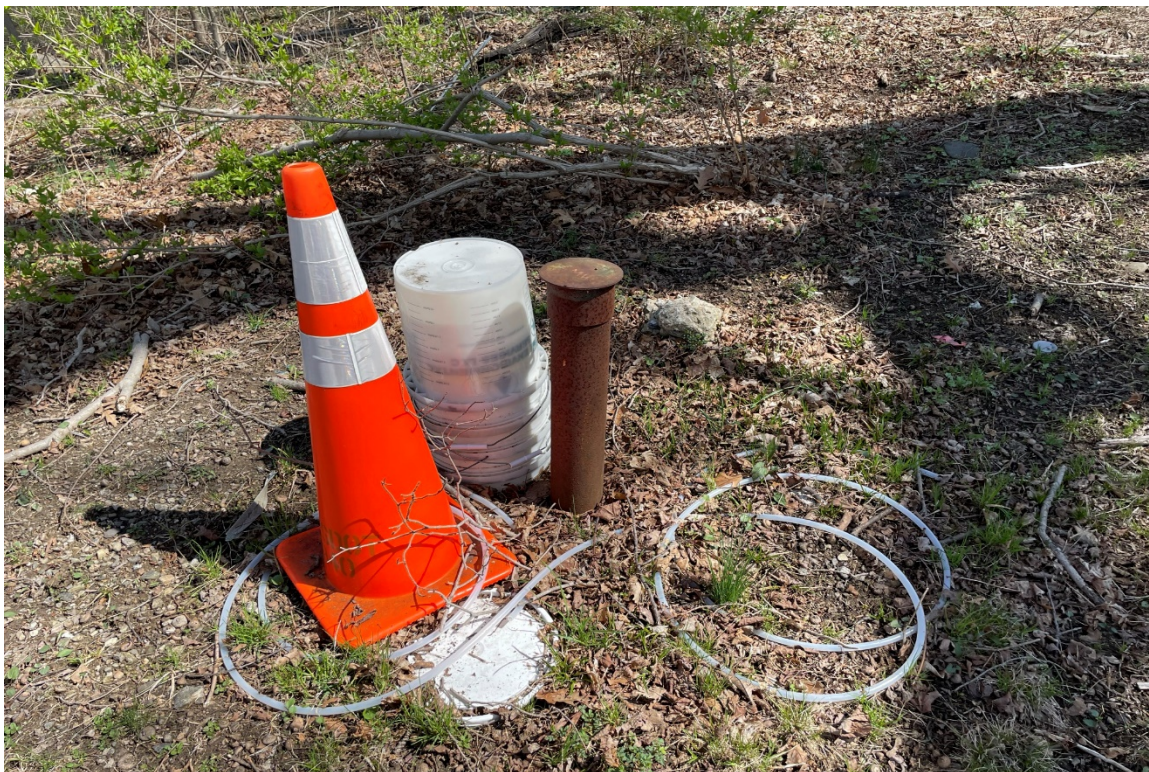
Photo 5: Well LMW-2

All wells were inspected and found to be in good condition. Paths to these wells were still clear of high vegetation.

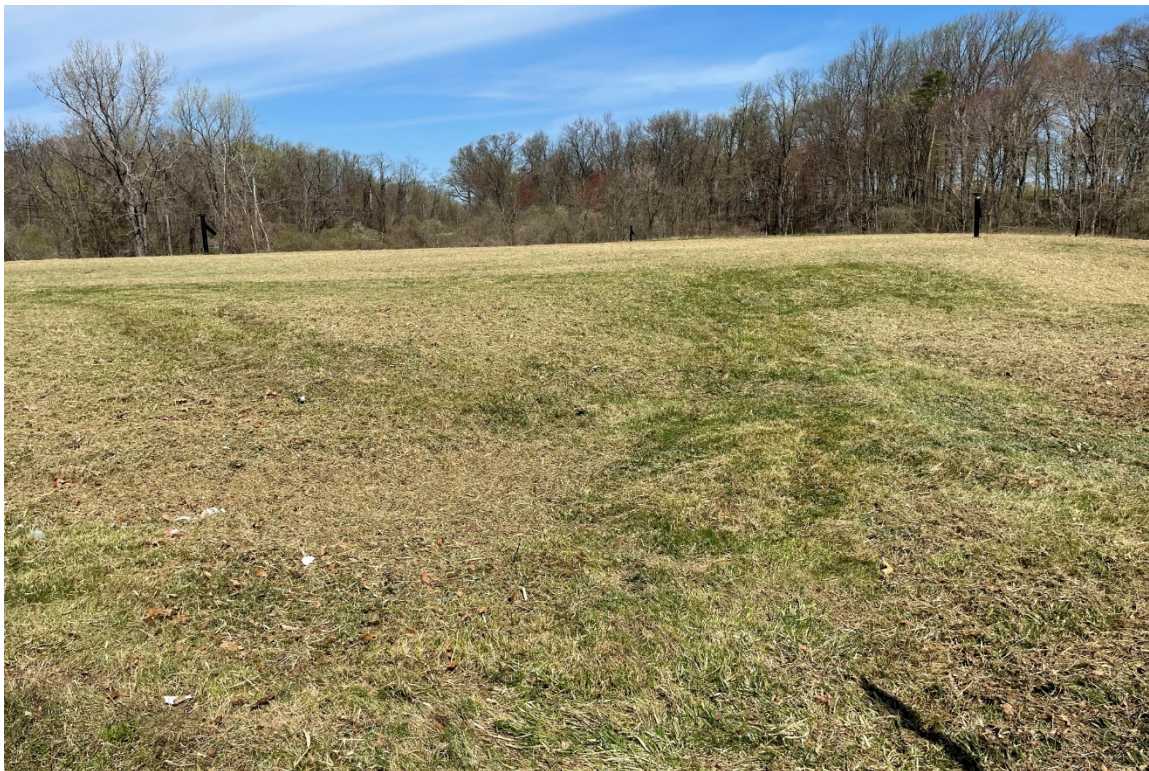
Grass height was satisfactory at the time of inspection (Photo 9). Grass should be cut in June and September.

Photo 9: Grass on landfill cap cut to correct height (looking north).

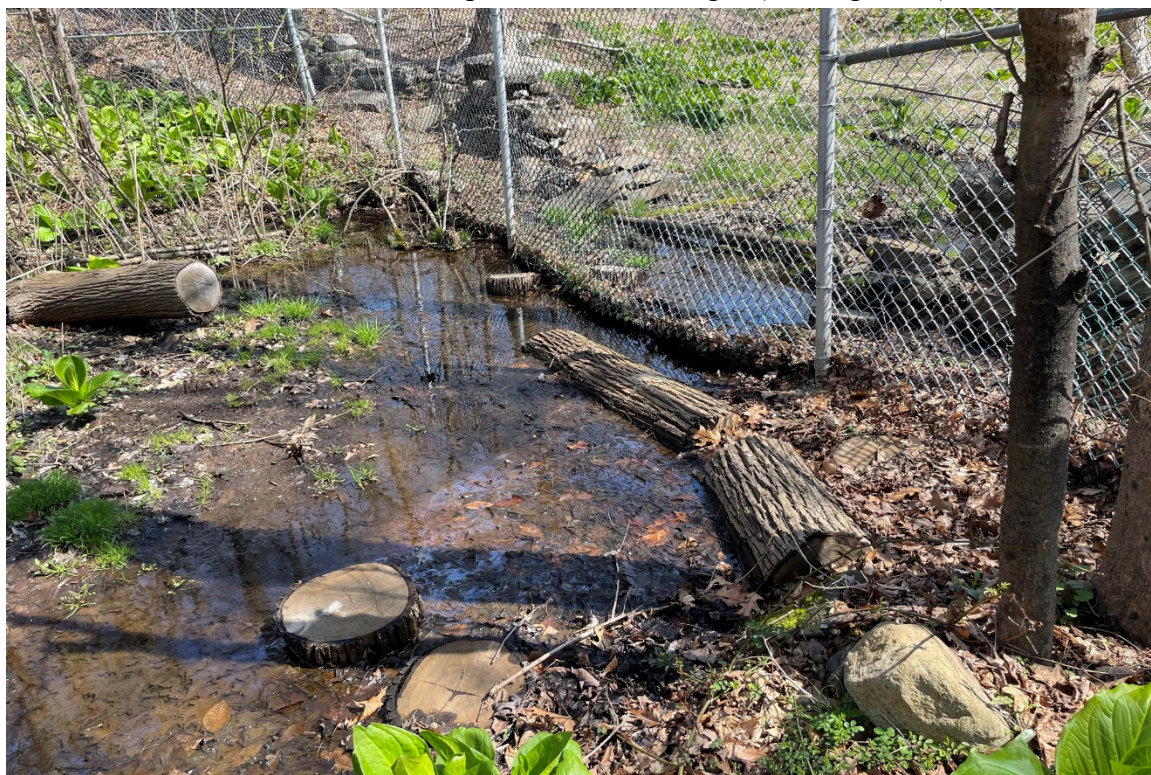
Photo 10: Stream inlet with new fence segment.

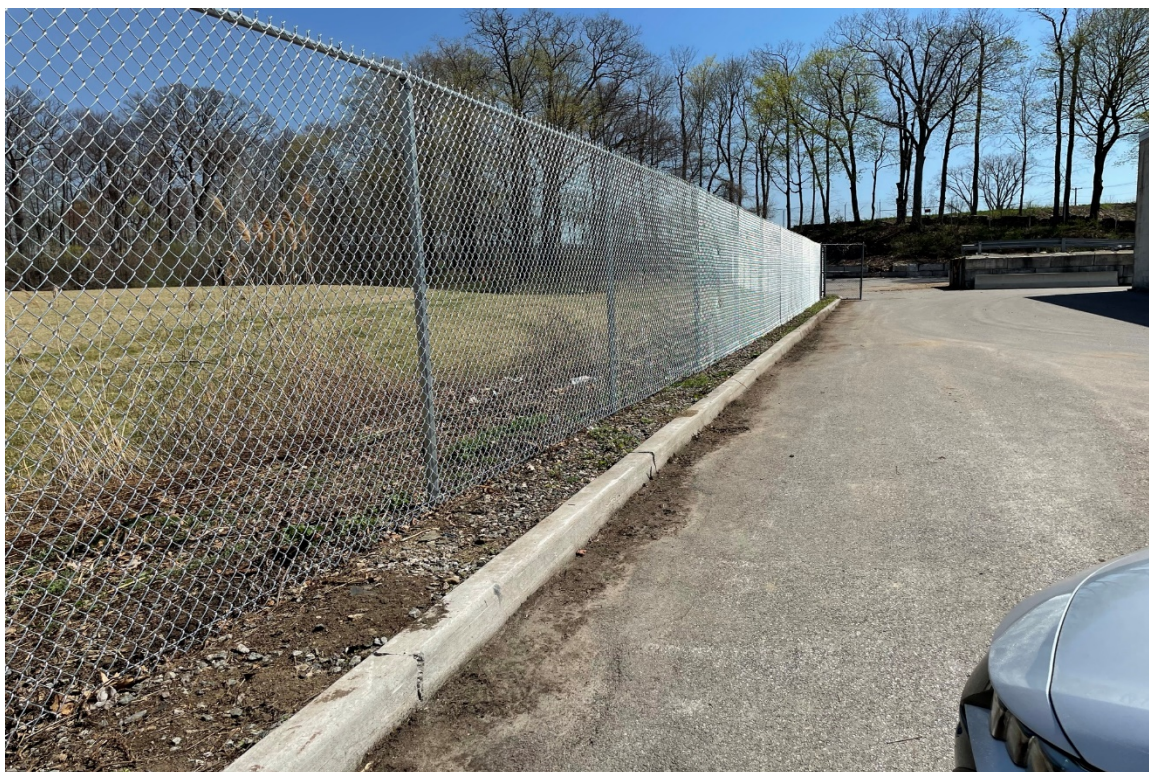
The damage done to the southern landfill fence that was observed in October 2020 was repaired with new material by the Town of Harrison (Photos 11, 13, 14). The south fence near the landfill gate was also replaced with new fence.

Previously established Porcelain Berry vines on the south fence were disposed of during the fence replacement

Photo 11: South fence (looking east) repair, vines removed.

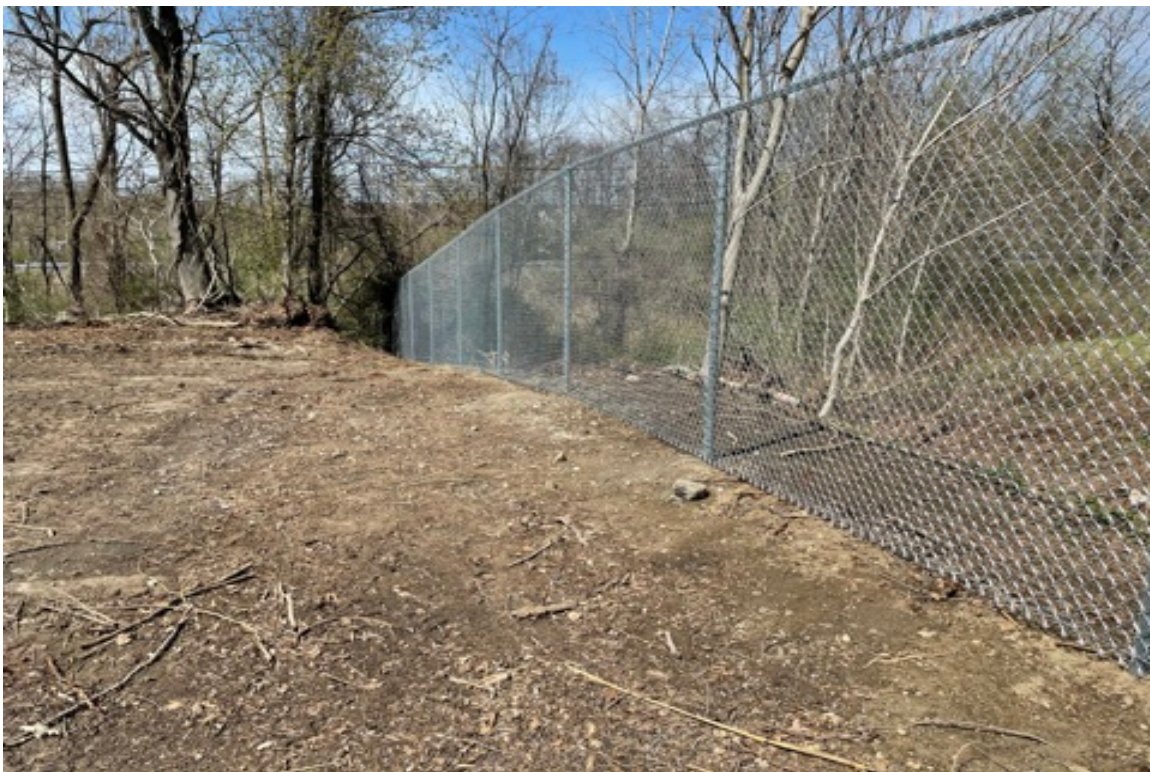
Photo 13: Repaired section of the southern landfill fence near outside storage area (looking west).

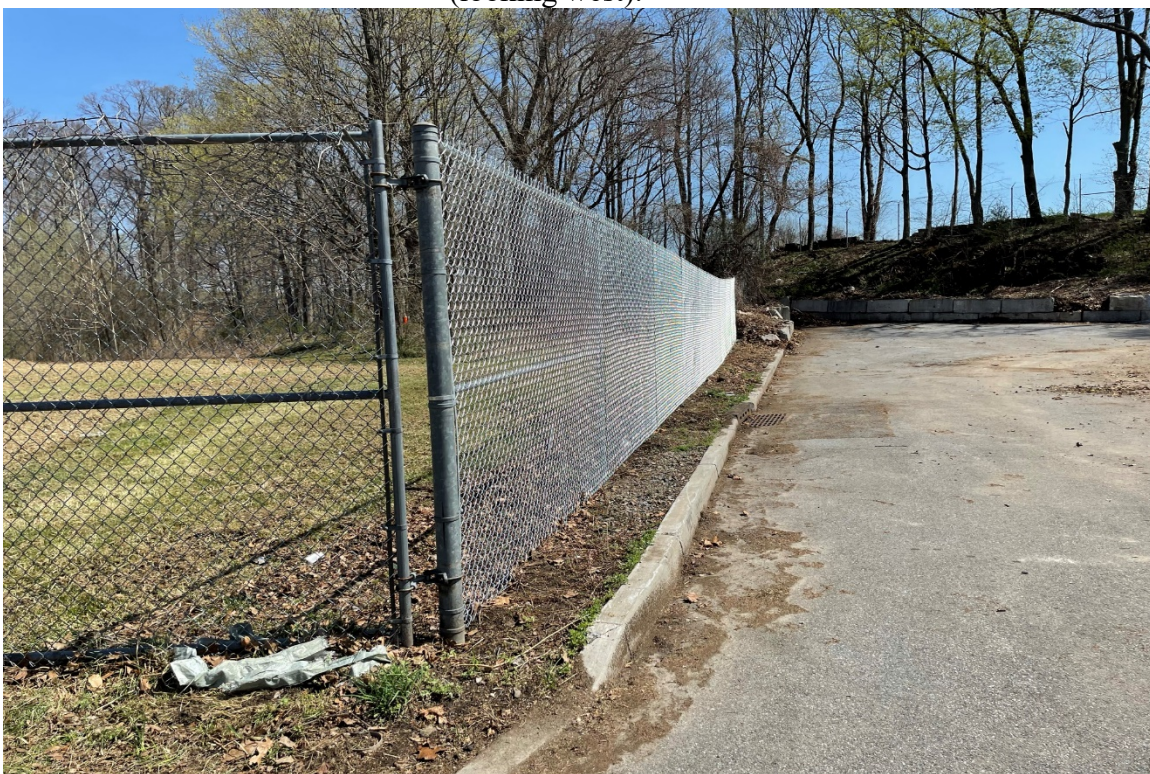
Photo 14: Fence repair east of landfill gate.
