HARRISON SUB-RESIDENCY SEMI-ANNUAL FIELD INSPECTION

Date: 4/27/22

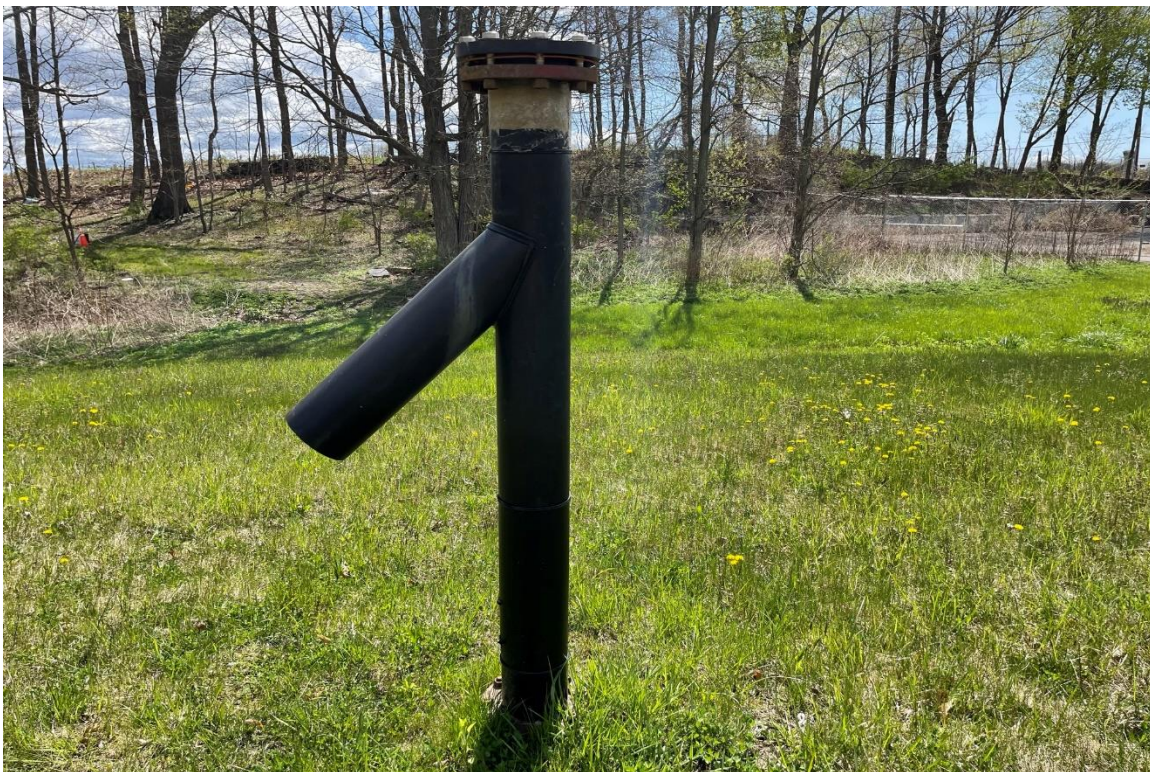
Photo 1: Vent V-1

Four vents (V-1 to V-4) were inspected (Photos 1-4). V-1 and V-2 had their plastic casing holes repaired with fiberglass epoxy in August 2015. A hole presumed to be from a boring insect or woodpecker was made through the previous fiberglass repair in V-2. A patch was applied in December 2021 but appeared to have fallen off due to weather. A different product was purchased and will be applied around June 2022. V-3 and V-4 were in good condition (neither cracks nor movement was observed). V-2 leans slightly to the north.

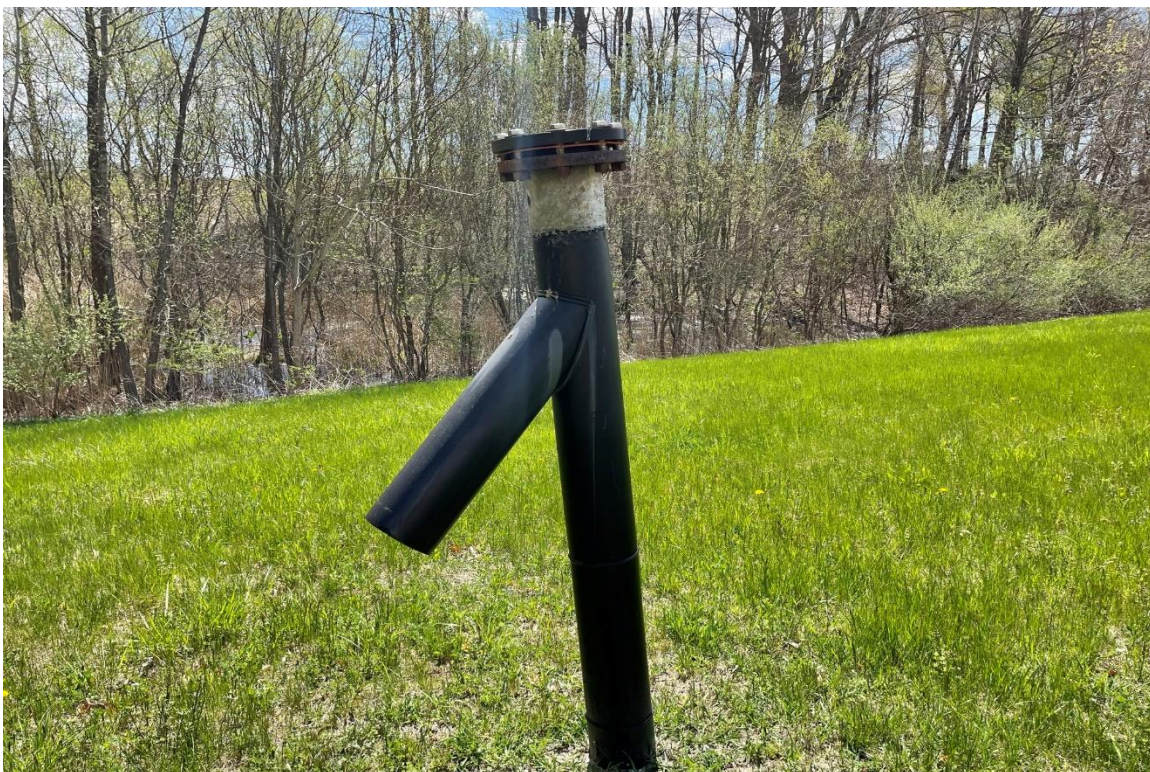
Photo 2: Vent V-2 (hole in repair patch shown)

1. NYSDOT will have its tree removal crew cut down any shrubs and small trees that are above the toe of slope of the west, north and east sides of the landfill. This will be done to ensure that no root systems compromise the clay liner and geotextile that make up the cap. Unpredictable wet weather postponed the removal due to the cap and liner being saturated to support equipment needed for the work. Work is proposed to take place in Summer 2022 during a period of dry weather.
2. The main gate to the facility is locked at the end of the day by the Town of Harrison personnel. The well keys and landfill gate key are in the site office desk.
3. Weed whack the west slope repair area and possibly spray with herbicide to prevent future weed growth through the stone repair. Herbicide will be applied by a NYSDEC licensed applicator.
4. Re-plug hole in vent V-2 with epoxy.

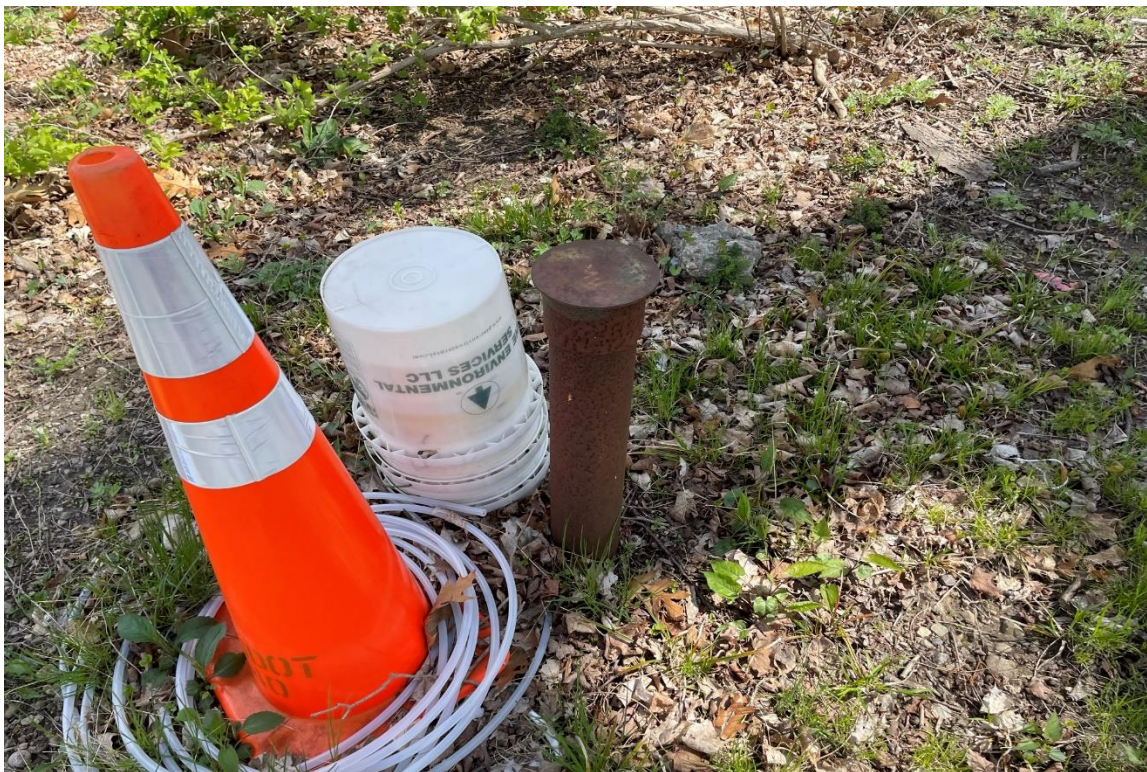
Photo 5: Well LMW-2

All wells were inspected and found to be in good condition. Paths to these wells were still clear of high vegetation.

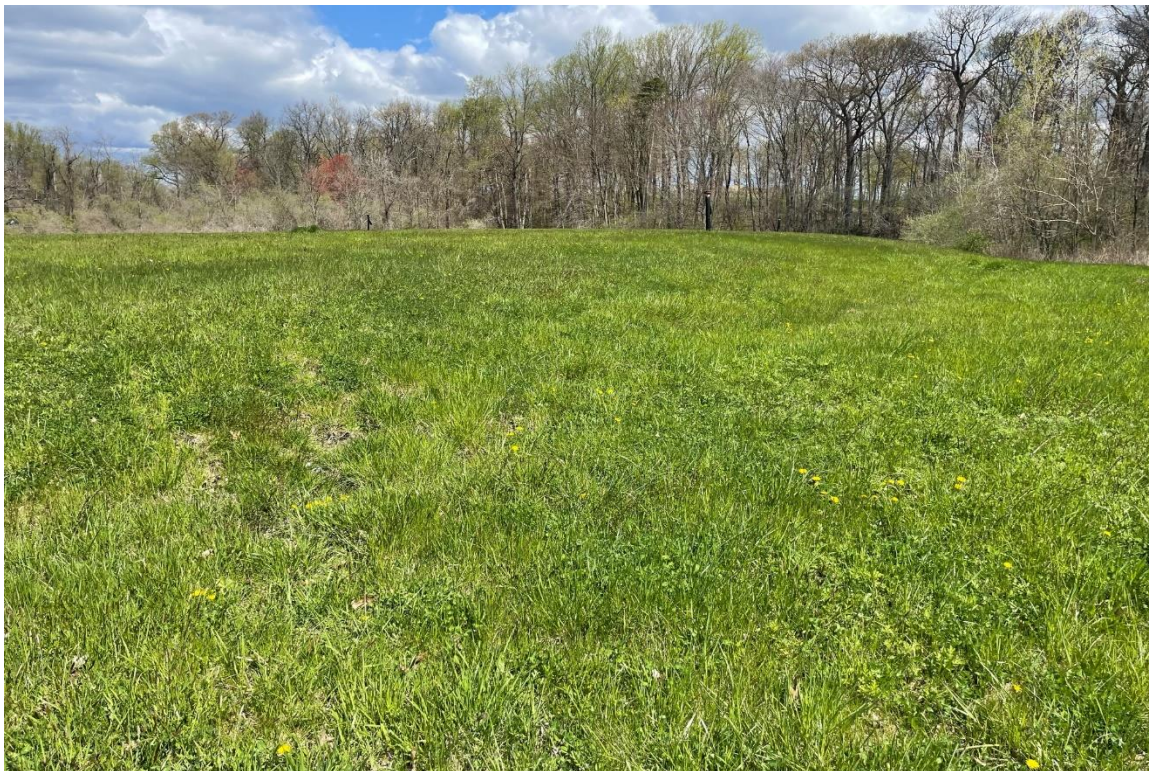
Grass height was satisfactory at the time of inspection (Photo 9). Grass should be cut in June and September. Burrow found under southwest area of the fence (Photo 14). No damage observed on landfill cap.

The landfill grass/vegetation was mowed a week prior to this inspection and was within 6" high. The cap should be mowed every June and September.

Photo 9: Grass on landfill cap cut to correct height (looking northeast).

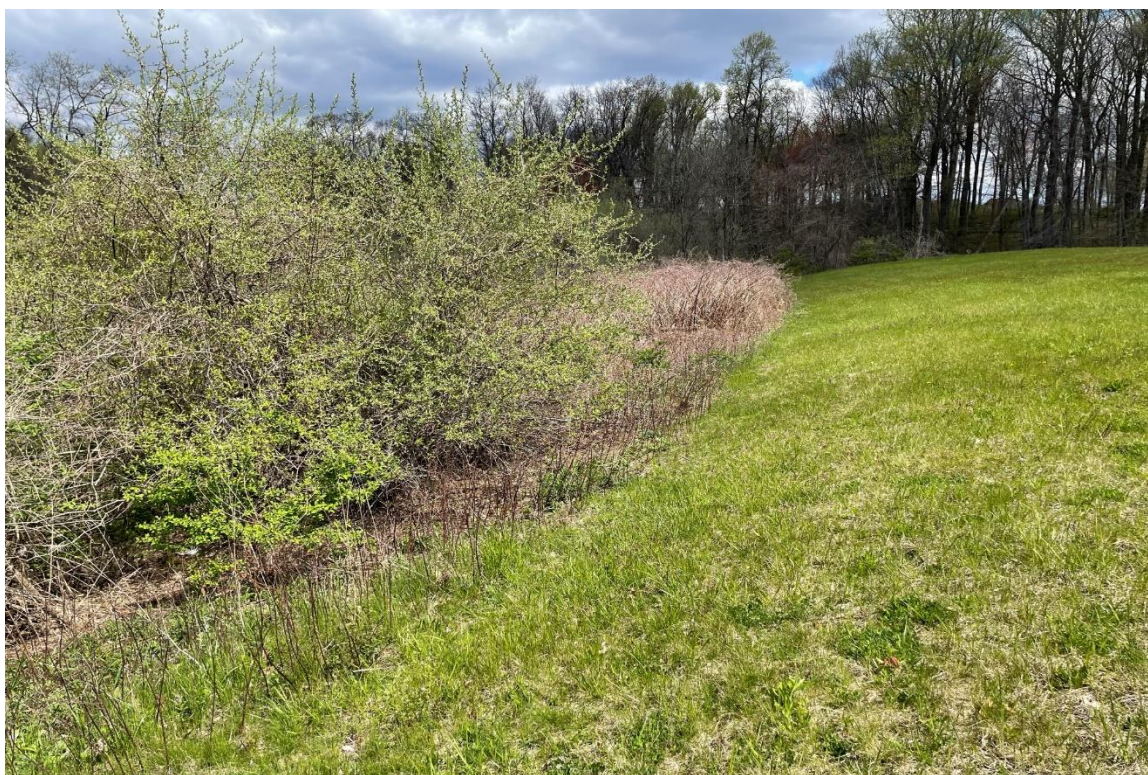
Photo 12: A portion of the west slope erosion area repair that needs clearing (looking north)

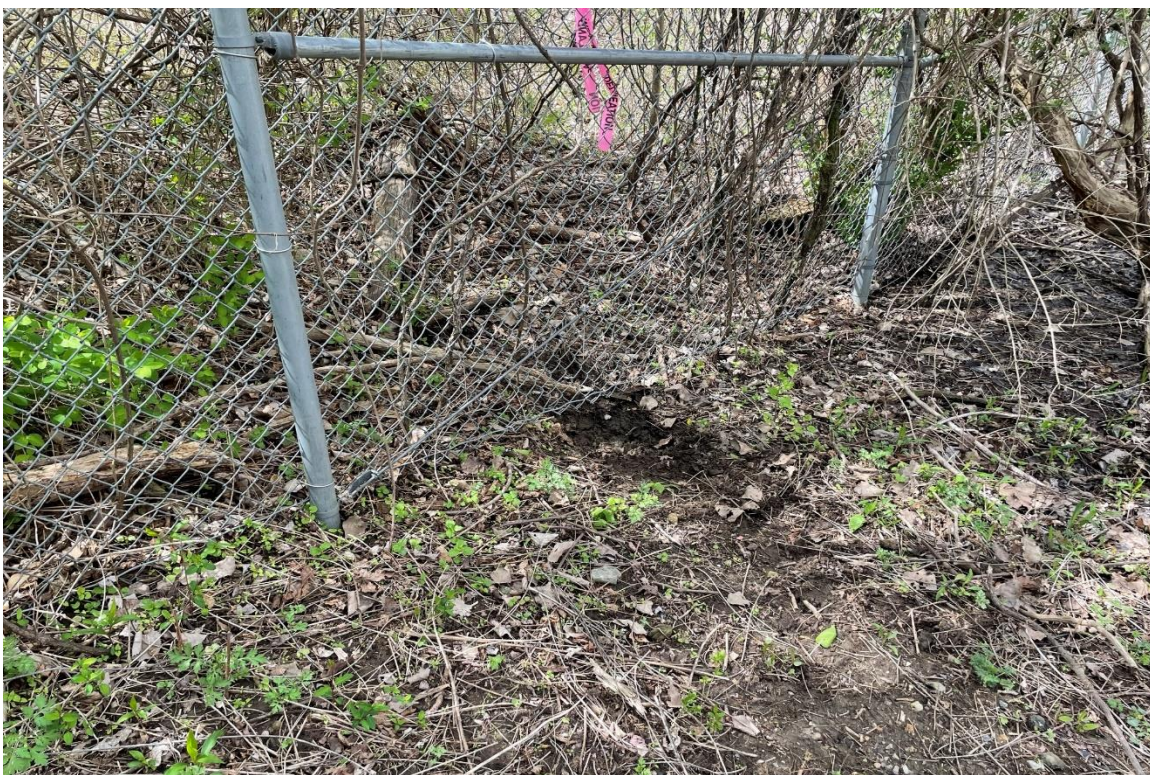
There is an animal burrow found under the southwest area of the fence (Photo 14).

Photo 14: Animal burrow under south fence on landfill cap (looking southwest).
