## **HARRISON SUB-RESIDENCY SEMI-ANNUAL FIELD INSPECTION**

**Name of Inspector(s):** Christopher Kappeller

**Date:** 10/28/22

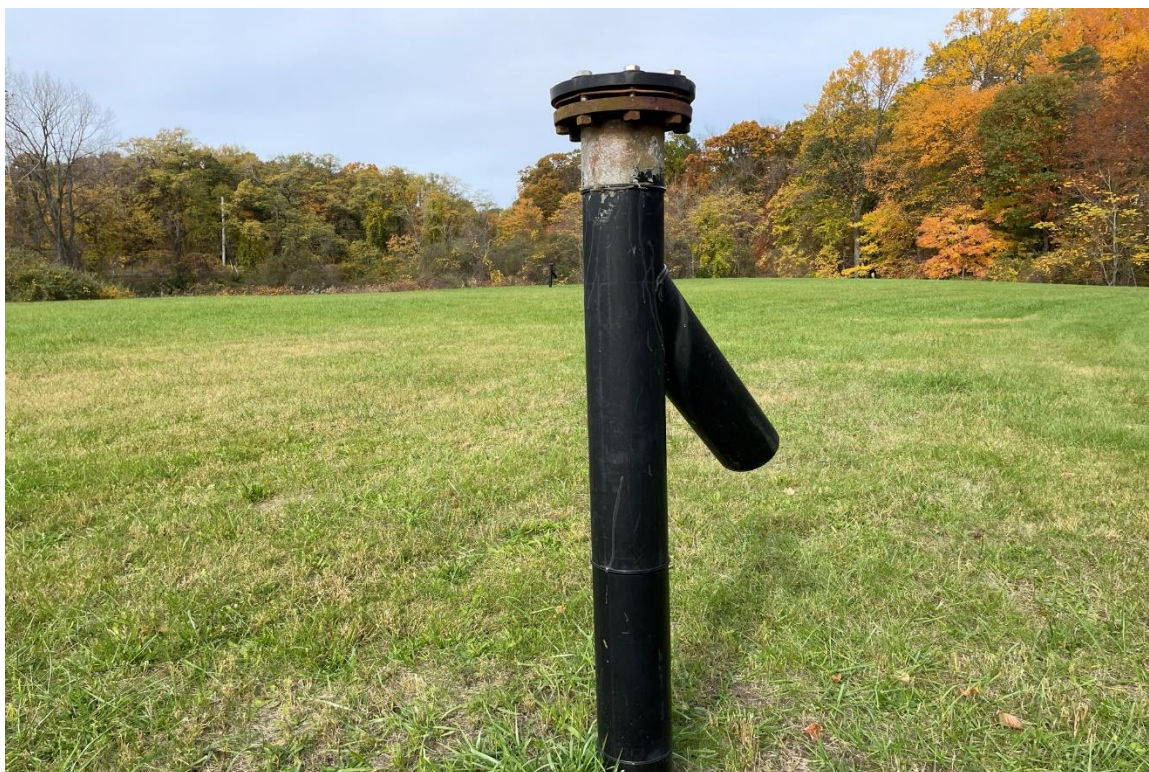
Photo 1: Vent V-1

Four vents (V-1 to V-4) were inspected (Photos 1-4). V-1 and V-2 had their plastic casing holes repaired with fiberglass epoxy in August 2015. A hole formed again in the V-2 repair and was patched with epoxy in June 2022. V-3 and V-4 were in good condition (neither cracks nor movement was observed). V-2 leans slightly to the north.

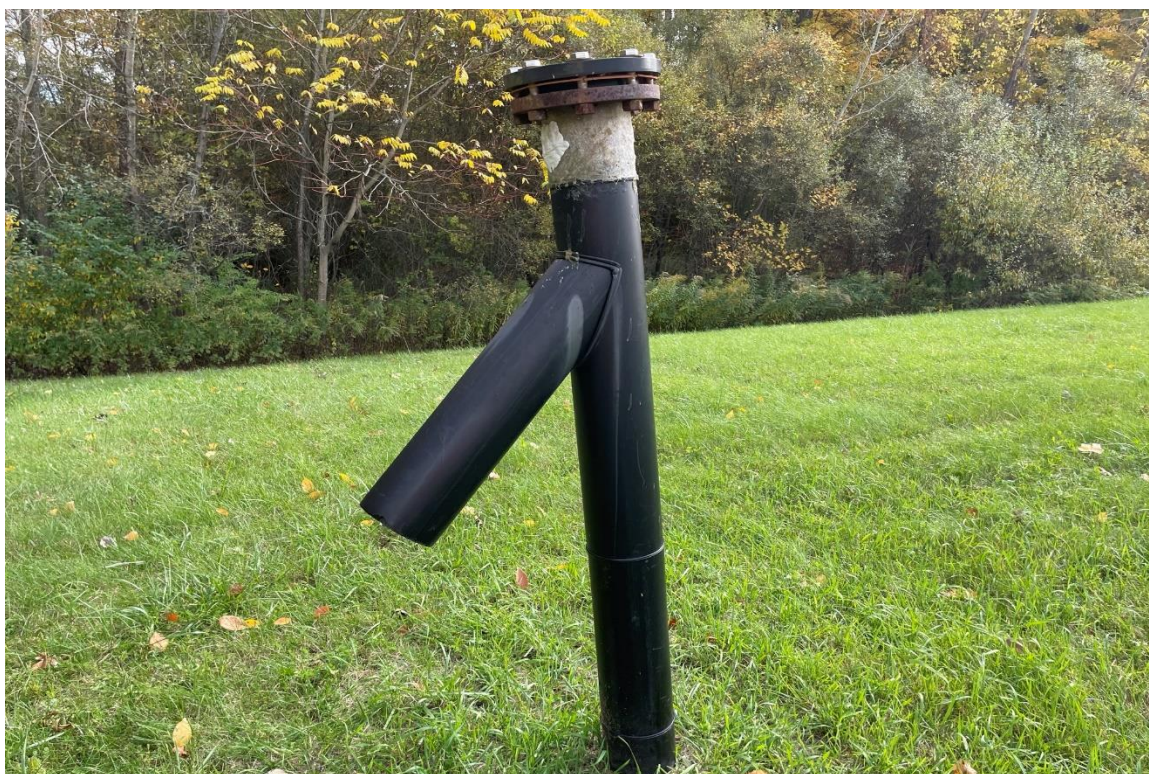
Photo 2: Vent V-2 (new repair patch shown)

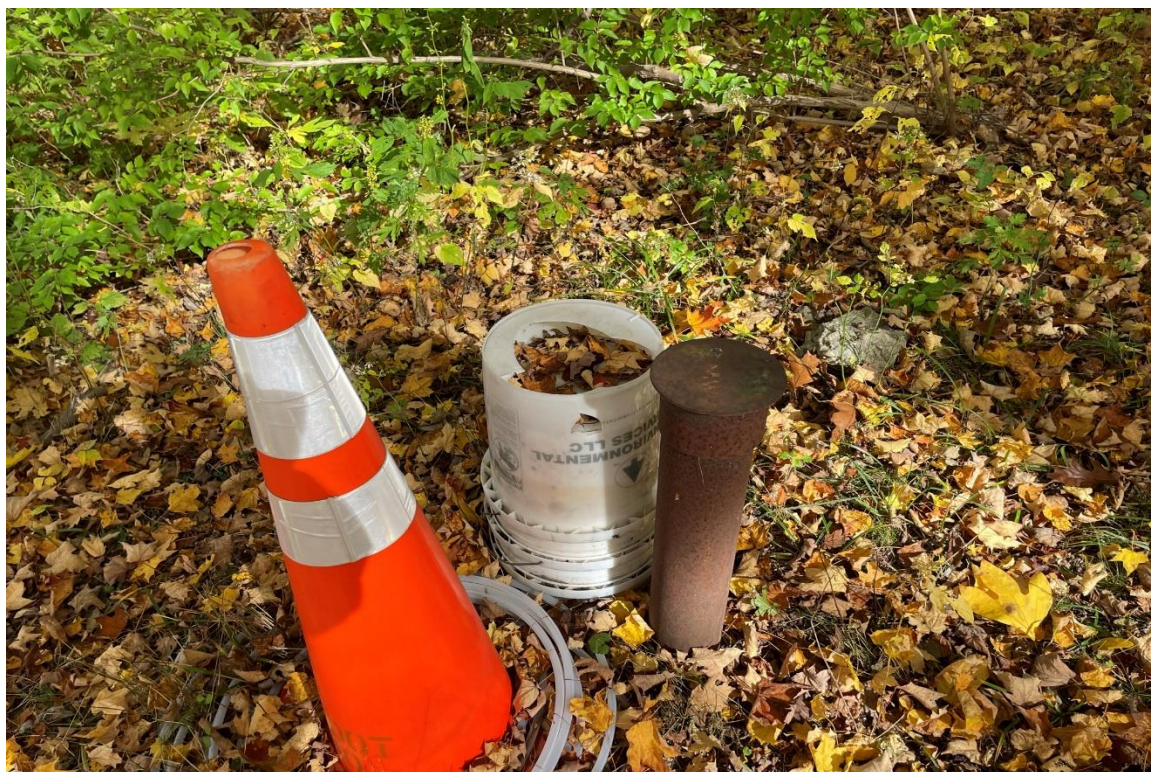
Photo 5: Well LMW-2

All wells were inspected and found to be in good condition. Paths to these wells were still clear of high vegetation.

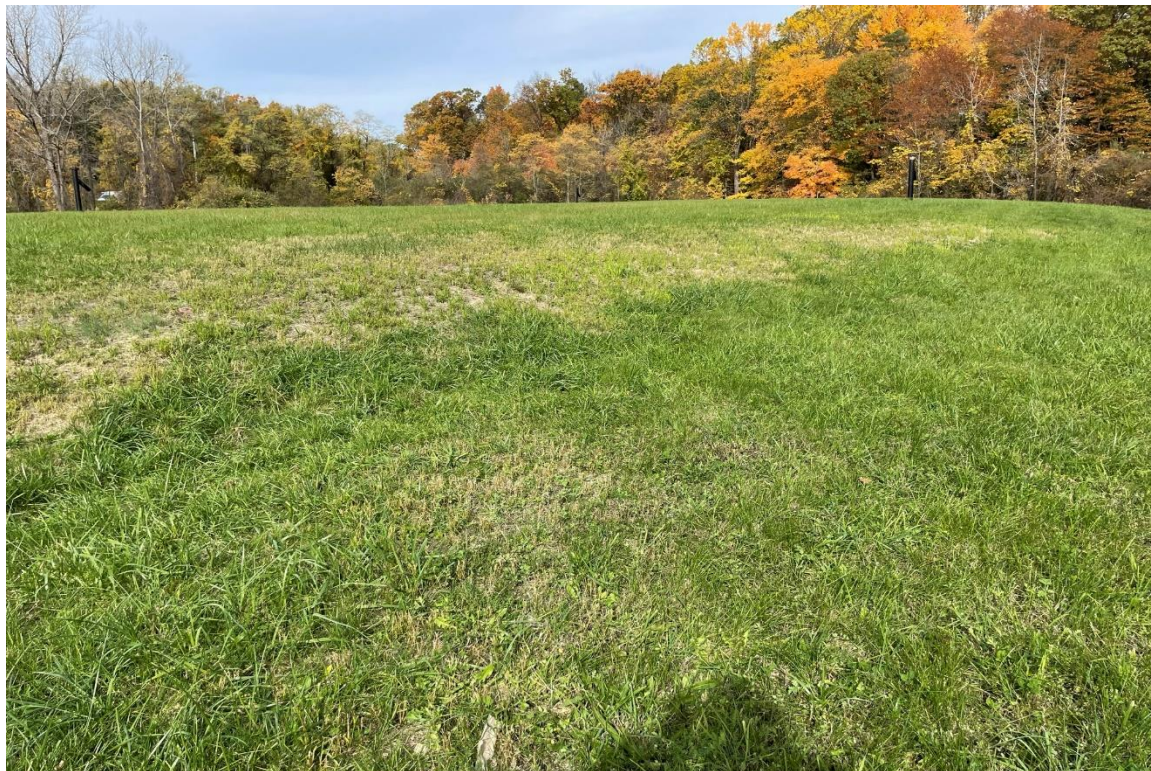
Grass height was satisfactory at the time of inspection (Photo 9). Grass should be cut in June and September. No damage observed on landfill cap.

Photo 9: Grass on landfill cap cut to correct height (looking northeast).

The landfill grass/vegetation was at an acceptable height. The cap should be mowed every June and September.

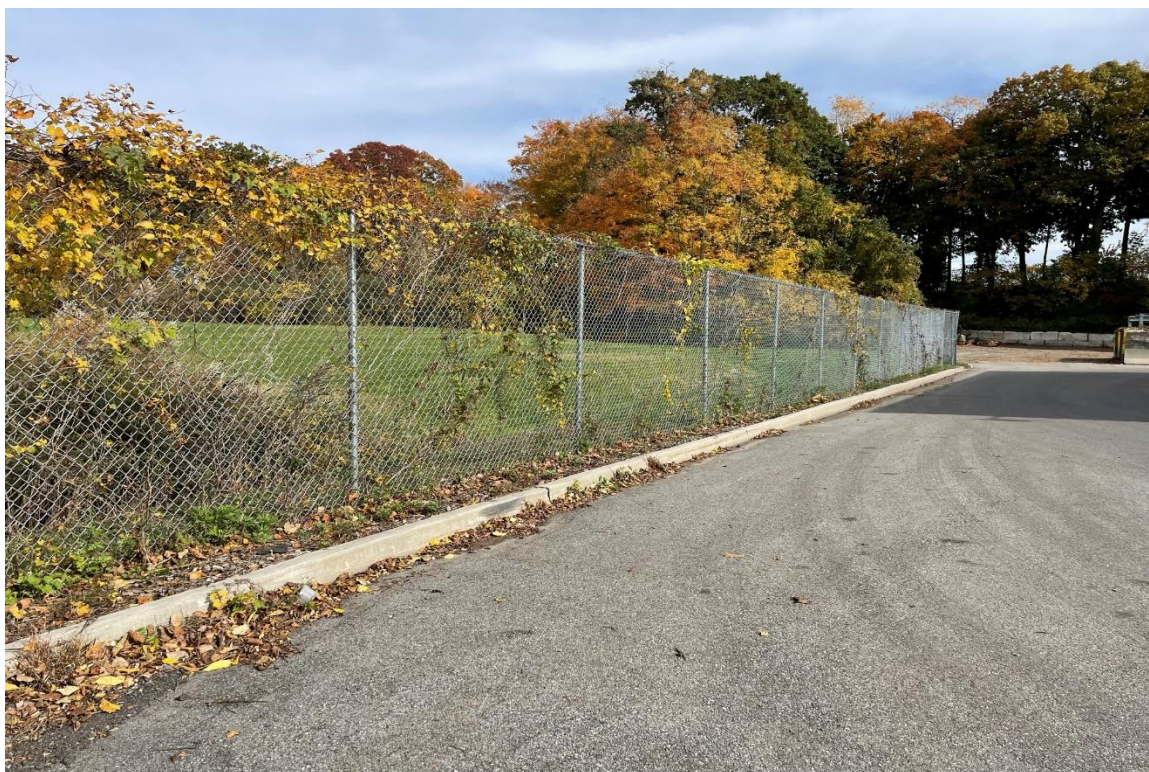
Currently there is no observable damage to the landfill perimeter fence and cap.

Photo 11: South fence (looking east).

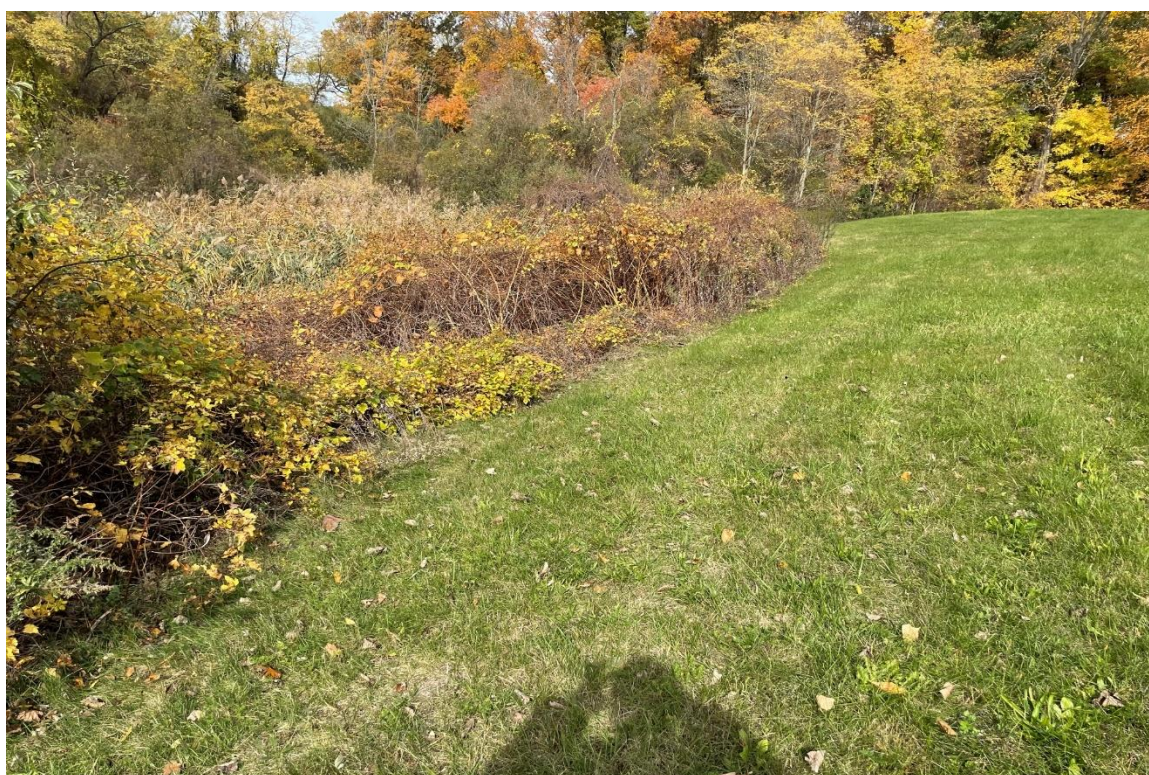
Photo 12: A portion of the west slope erosion area repair that needs clearing (looking north)

1. NYSDOT will have its tree removal crew cut down any shrubs and small trees that are above the toe of slope of the west, north and east sides of the landfill. This will be done to ensure that no root systems compromise the clay liner and geotextile that make up the cap. Unpredictable wet weather postponed the removal due to the cap and liner being saturated to support equipment needed for the work. Work is proposed to take place in Summer 2023 during a period of dry weather.
2. The main gate to the facility is locked at the end of the day by the Town of Harrison personnel. The well keys and landfill gate key are in the site office desk.
3. Weed whack the west slope repair area and possibly spray with herbicide to prevent future weed growth through the stone repair. Herbicide would be applied by a NYSDEC licensed applicator.
