HARRISON SUB-RESIDENCY SEMI-ANNUAL FIELD INSPECTION

Date: 4/28/23

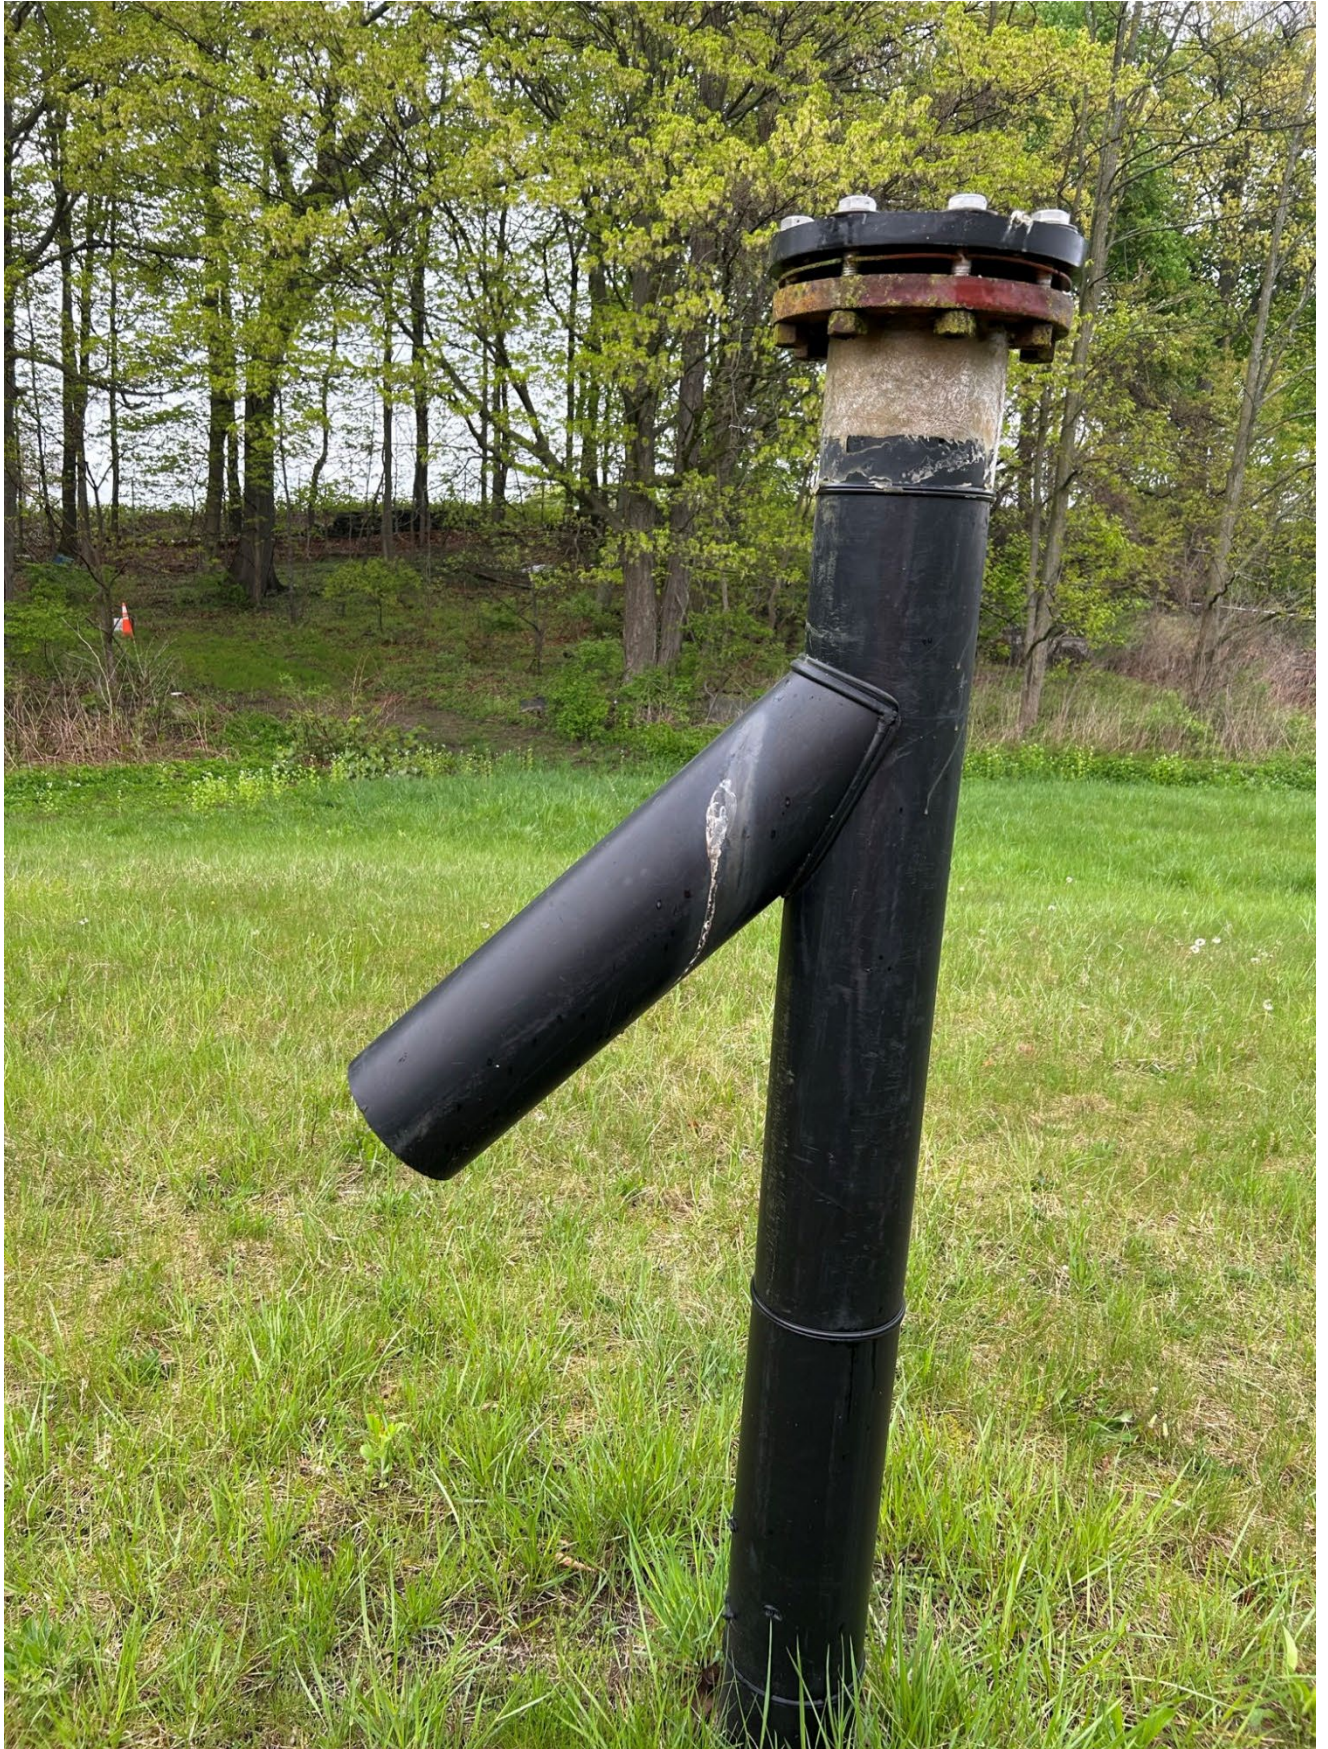
Photo 1: Vent V-1

Four vents (V-1 to V-4) were inspected (Photos 1-4). V-1 and V-2 had their plastic casing holes repaired with fiberglass epoxy in August 2015. A hole formed again in the V-2 repair and was patched with epoxy in June 2022. V-3 and V-4 were in good condition (neither cracks nor movement was observed). V-2 leans slightly to the north.

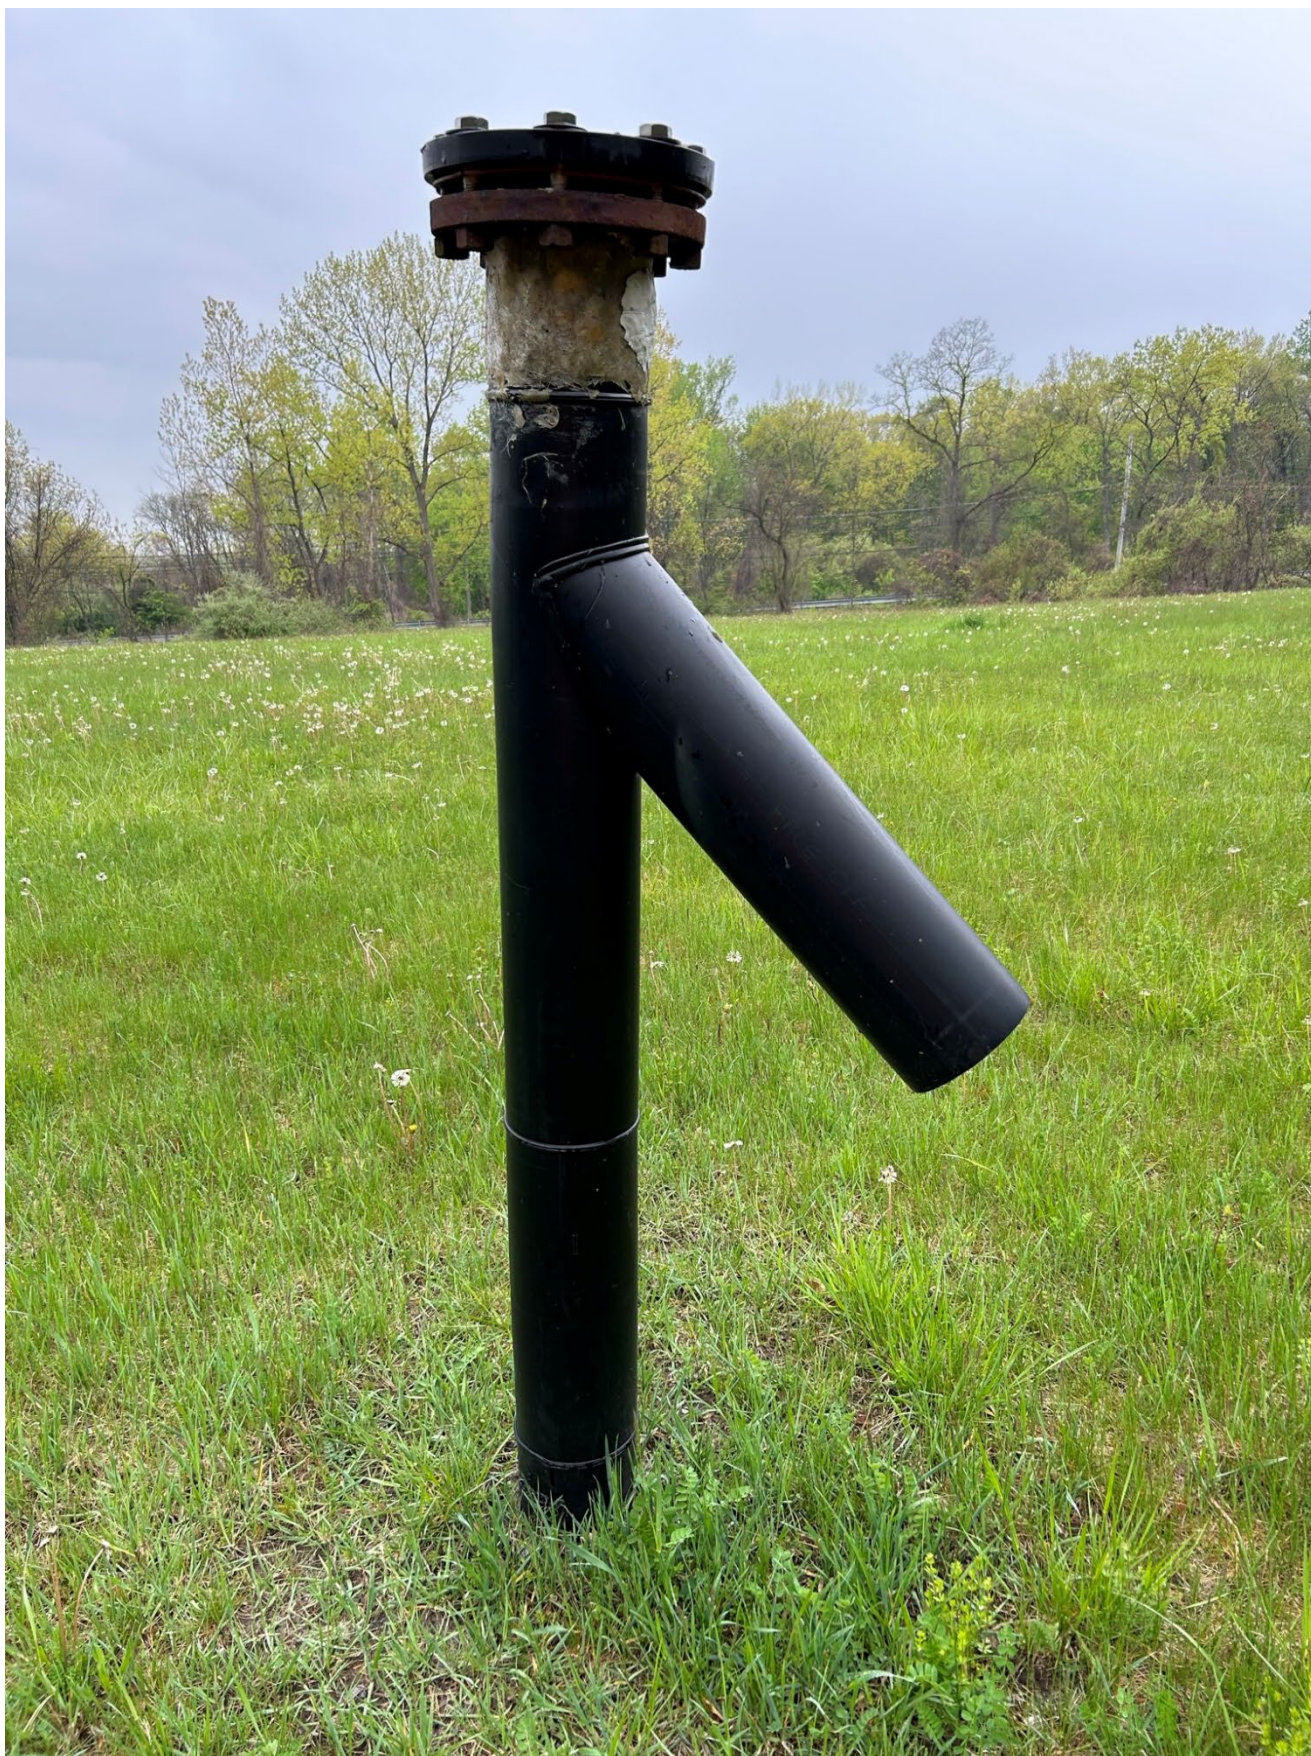
Photo 2: Vent V-2 (new repair patch shown)

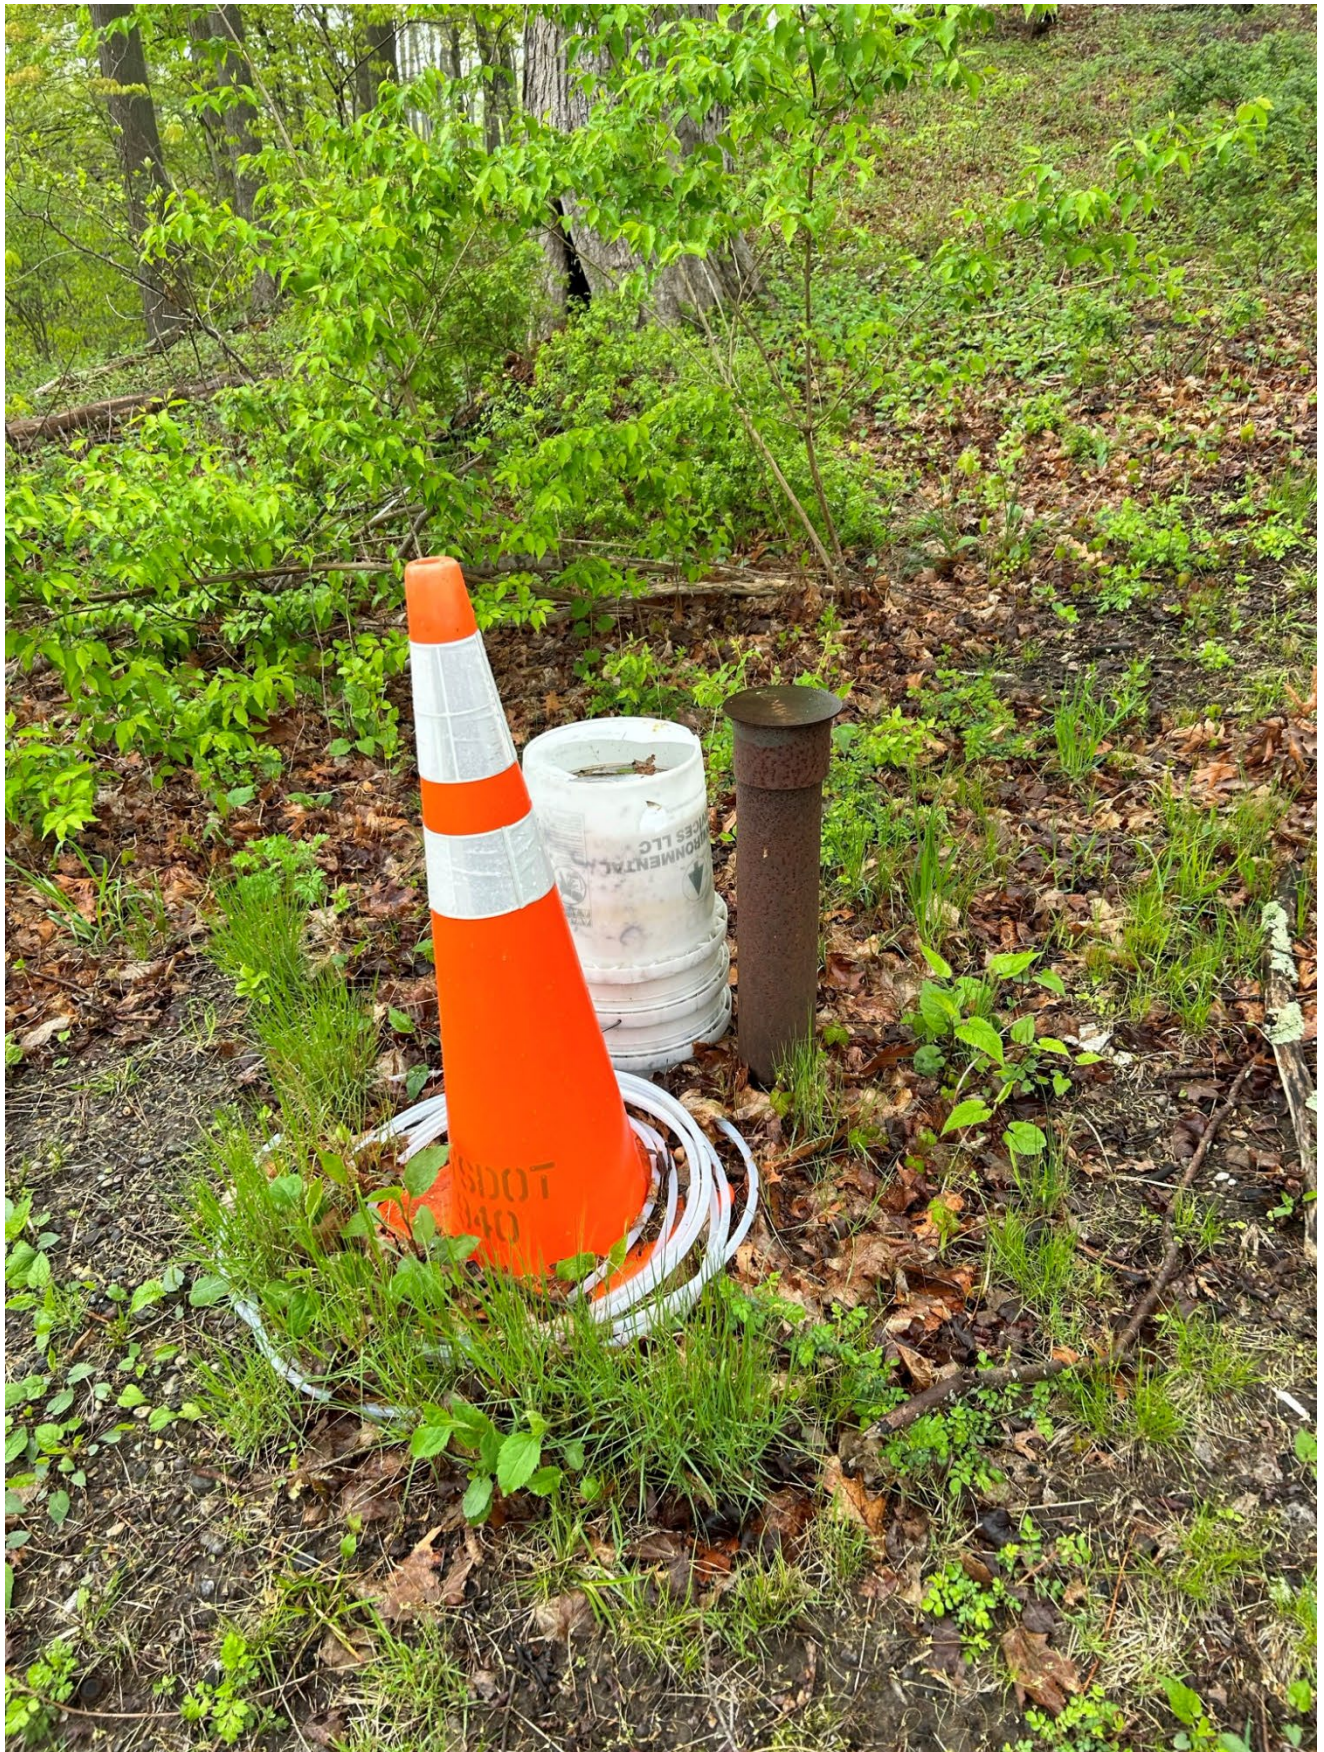
Photo 5: Well LMW-2

All wells were inspected and found to be in good condition. Paths to these wells were still clear of high vegetation.

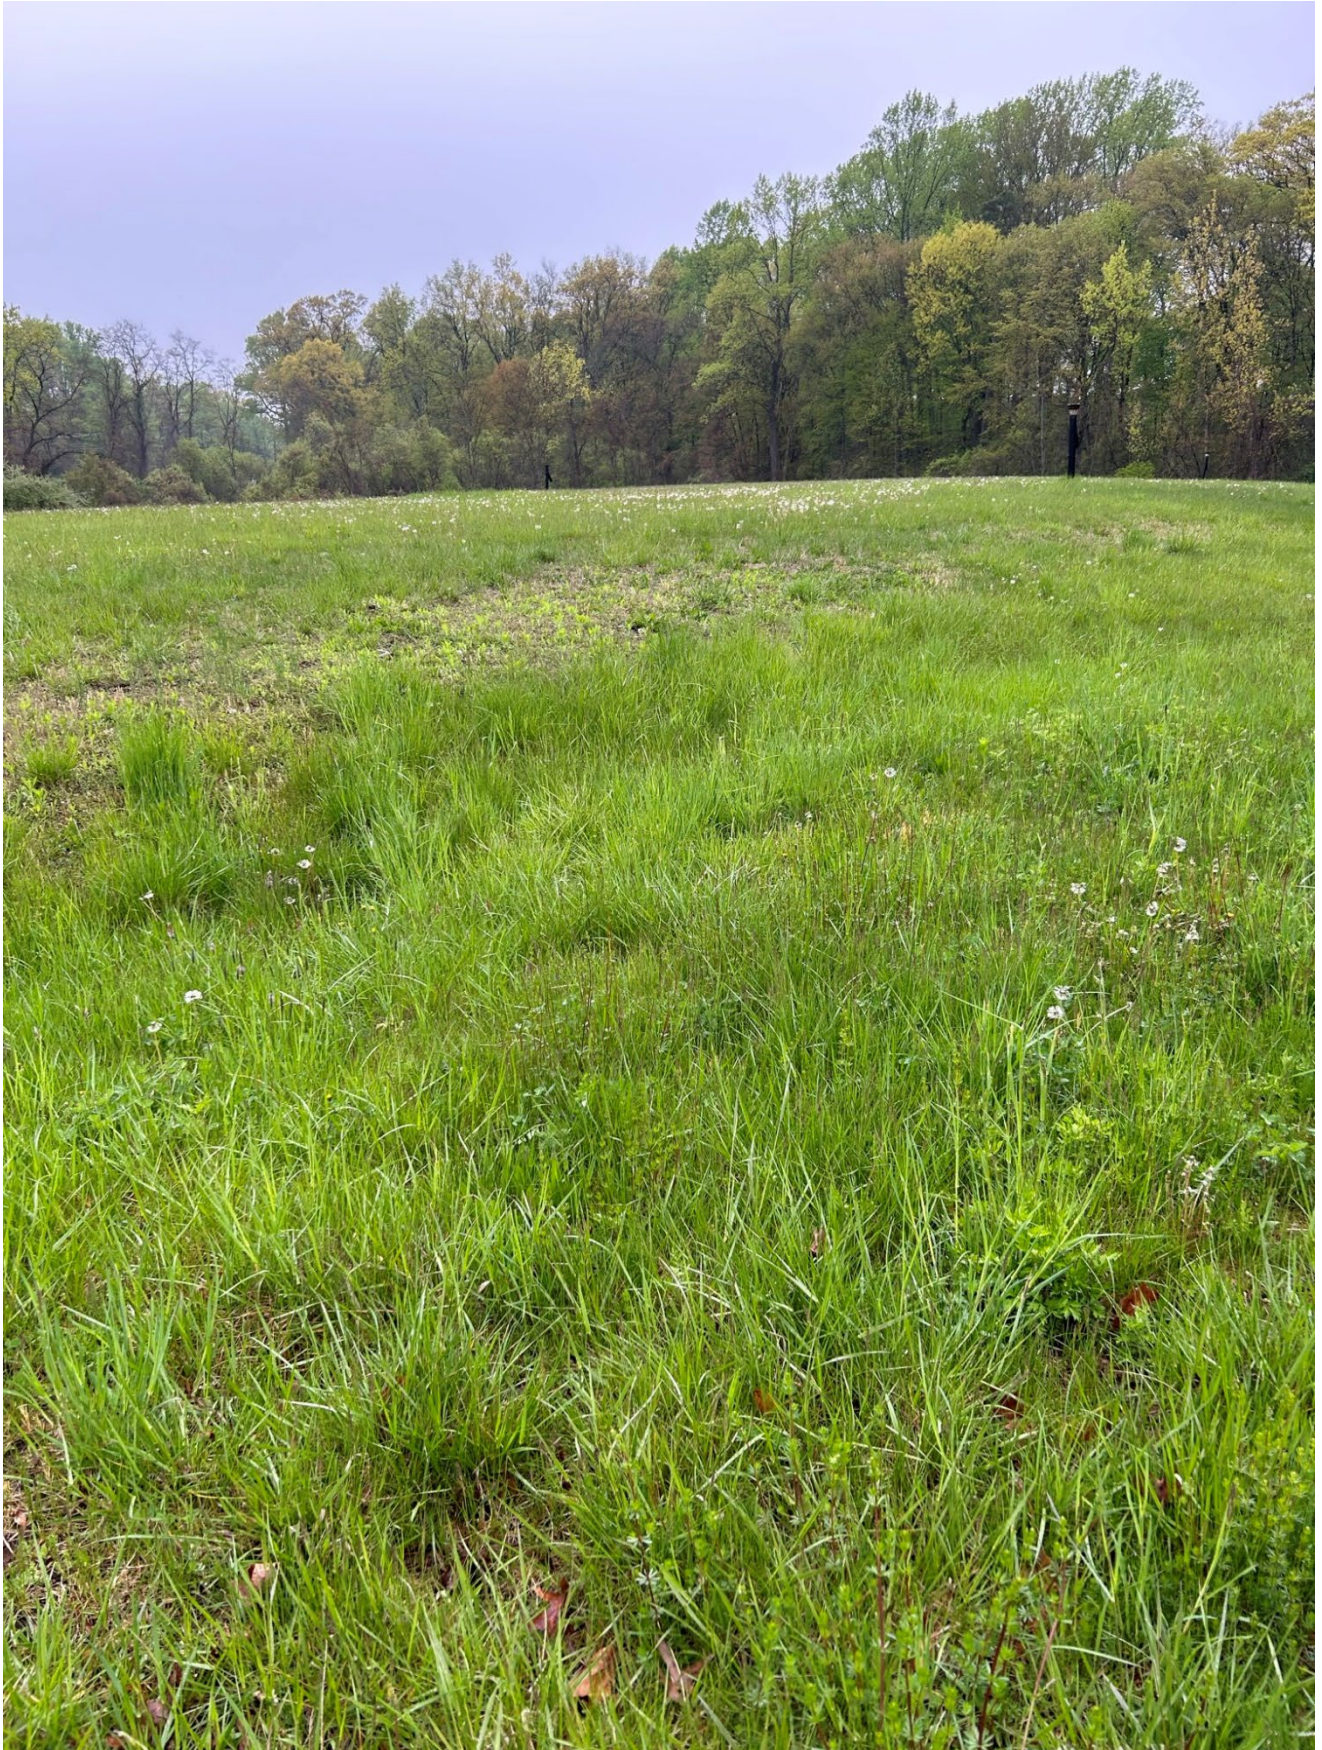
Grass height was satisfactory at the time of inspection (Photo 9). Grass should be cut in June and September. No damage observed on landfill cap.

Photo 9: Grass on landfill cap cut to correct height (looking northeast).

The landfill grass/vegetation was at an acceptable height. The cap should be mowed every June and September.

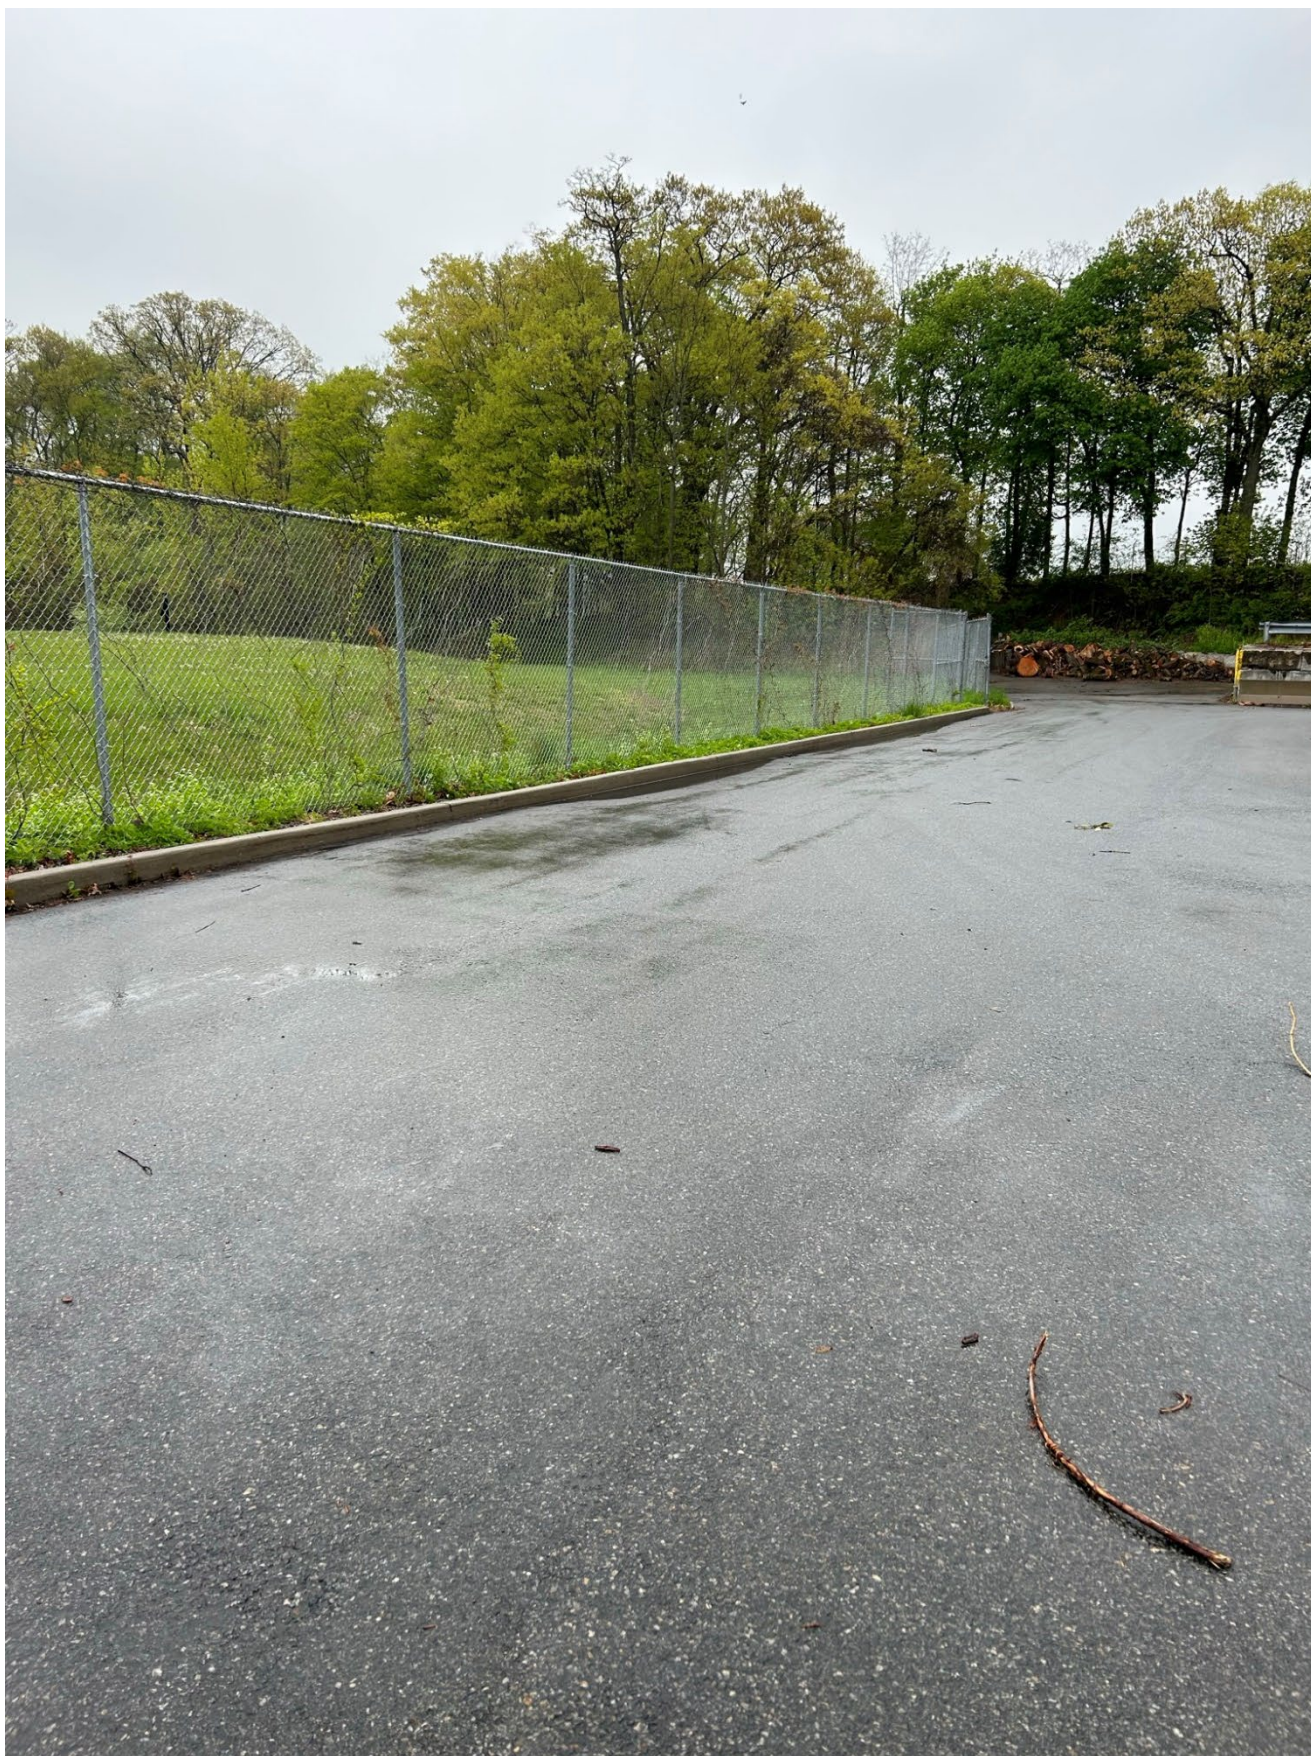
Currently there is no observable damage to the landfill perimeter fence and cap.

Photo 11: South fence (looking east).

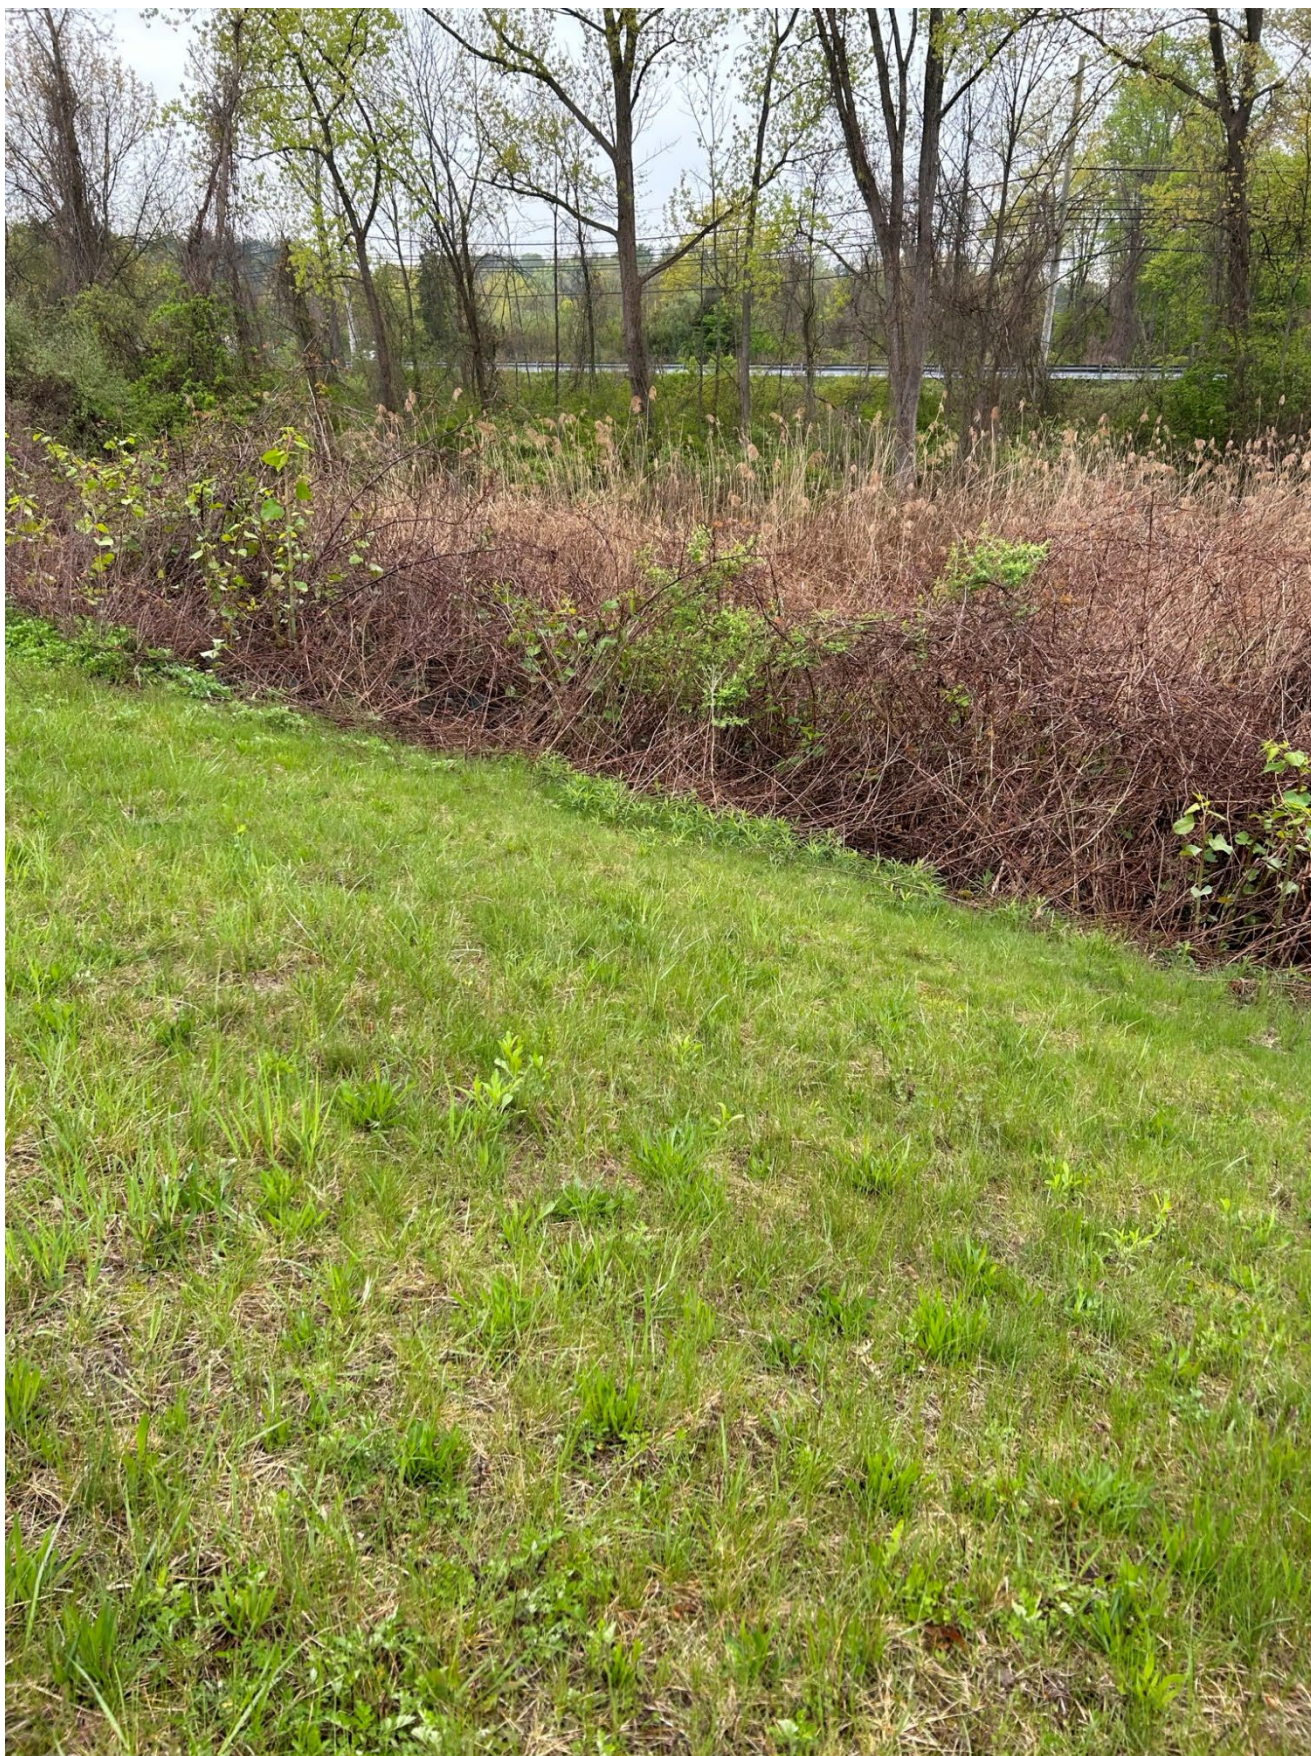
Photo 12: A portion of the west slope erosion area repair that needs clearing (looking north)

1. NYSDOT will have its tree removal crew cut down any shrubs and small trees that are above the toe of slope of the west, north and east sides of the landfill. This will be done to ensure that no root systems compromise the clay liner and geotextile that make up the cap. Unpredictable wet weather postponed the removal due to the cap and liner being saturated to support equipment needed for the work. Work is proposed to take place in Summer 2023 during a period of dry weather.
2. The main gate to the facility is locked at the end of the day by the Town of Harrison personnel. The well keys and landfill gate key are in the site office desk.
3. Weed whack the west slope repair area and possibly spray with herbicide to prevent future weed growth through the stone repair. Herbicide would be applied by a NYSDEC licensed applicator.
