HARRISON SUB-RESIDENCY SEMI-ANNUAL FIELD INSPECTION

Name of Inspector(s): Christopher Kappeller

Date: 10/13/23

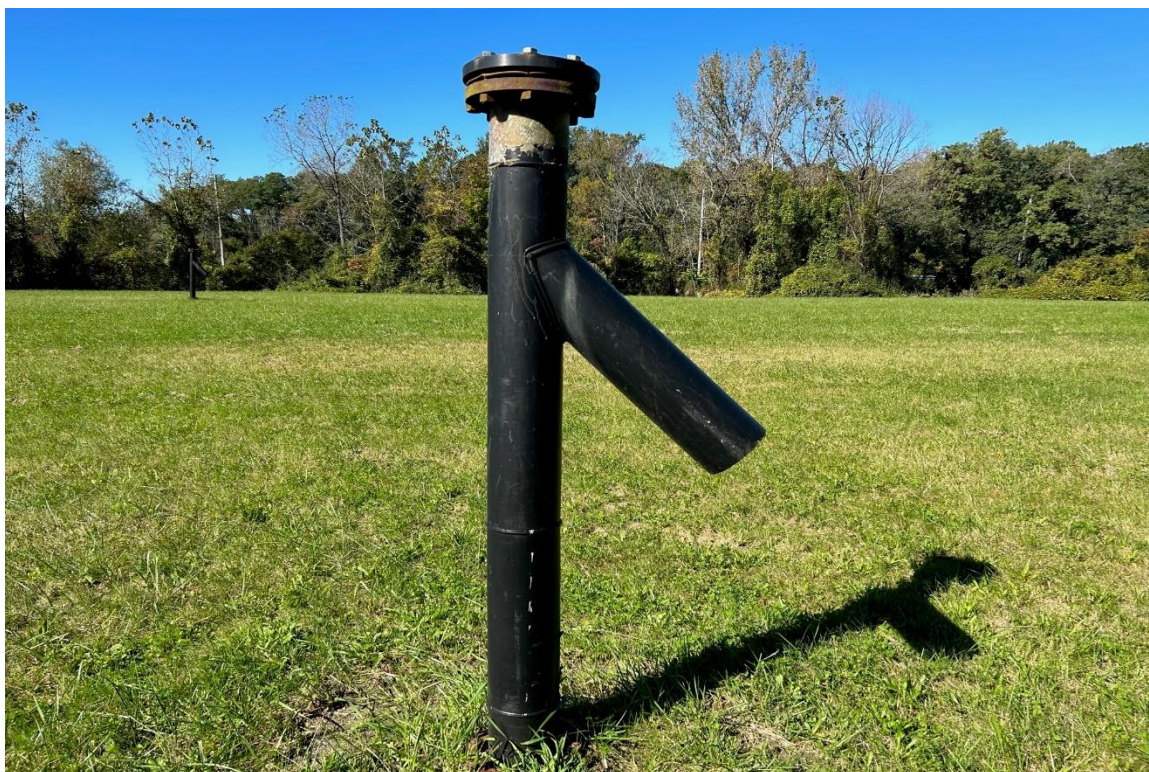
Photo 1: Vent V-1

Four vents (V-1 to V-4) were inspected (Photos 1-4). V-1 and V-2 had their plastic casing holes repaired with fiberglass epoxy in August 2015. A hole formed again in the V-2 repair and was patched with epoxy in June 2022. V-3 and V-4 were in good condition (neither cracks nor movement was observed). V-2 leans slightly to the north.

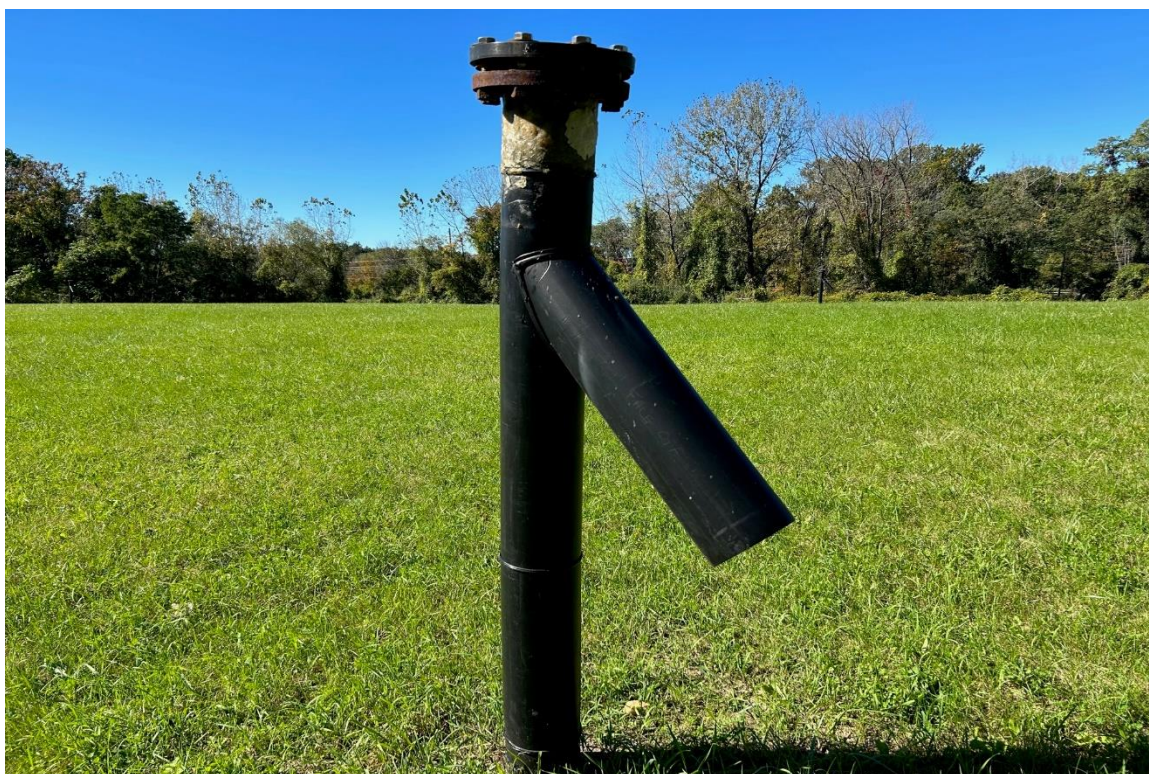
Photo 2: Vent V-2 (new repair patch shown)

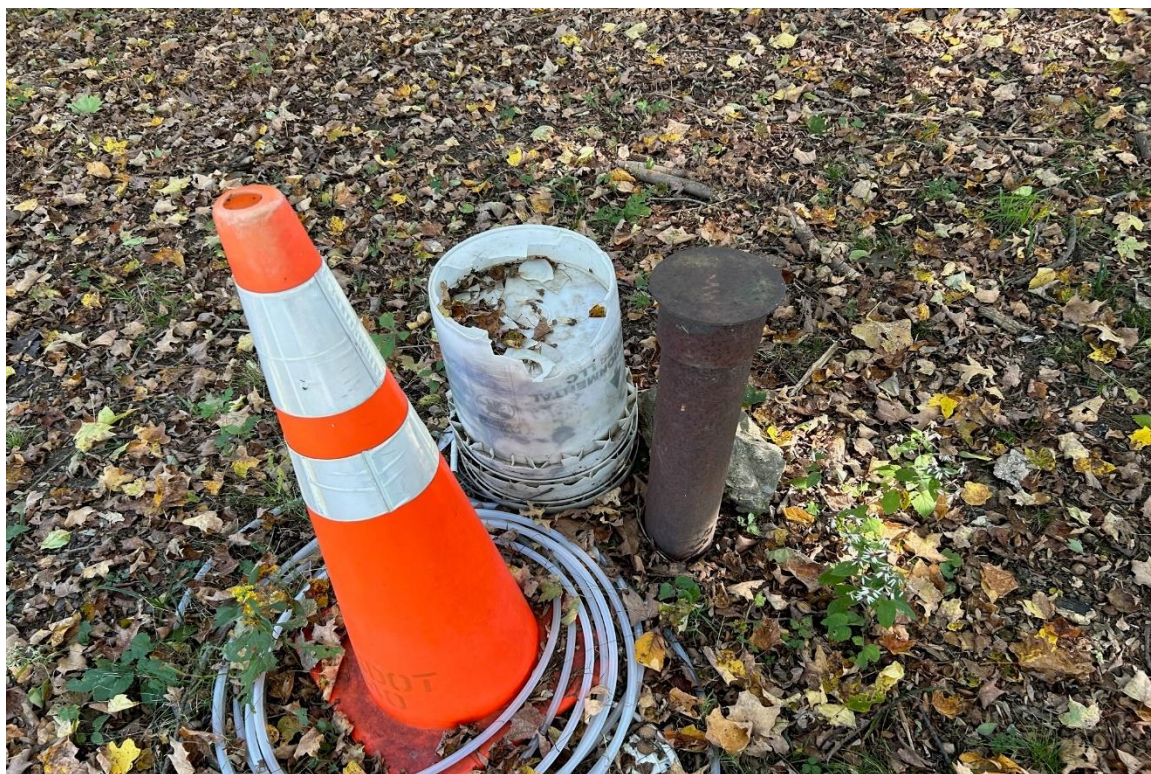
Photo 5: Well LMW-2

All wells were inspected and found to be in good condition. Paths to these wells were still clear of high vegetation.

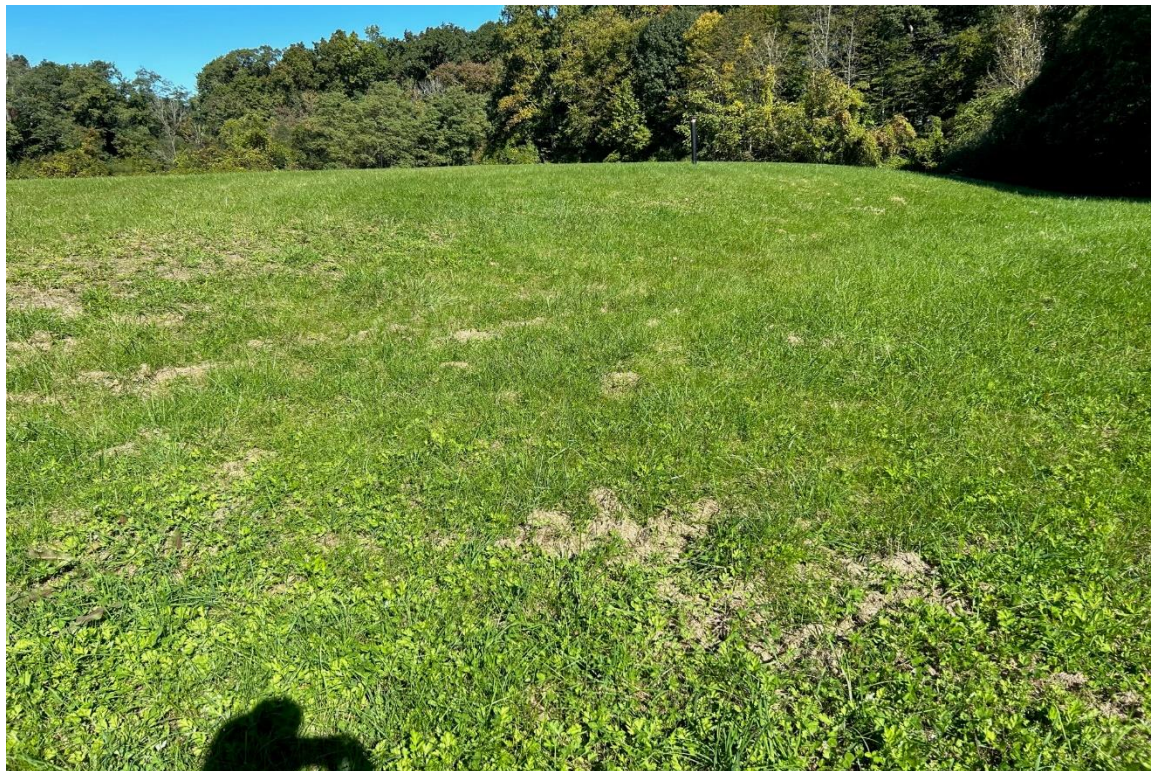
Grass height was satisfactory at the time of inspection (Photo 9). Grass should be cut in June and September. No damage observed on landfill cap.

Photo 9: Grass on landfill cap cut to correct height (looking northeast).

The landfill grass/vegetation was at an acceptable height. The cap should be mowed every June and September.

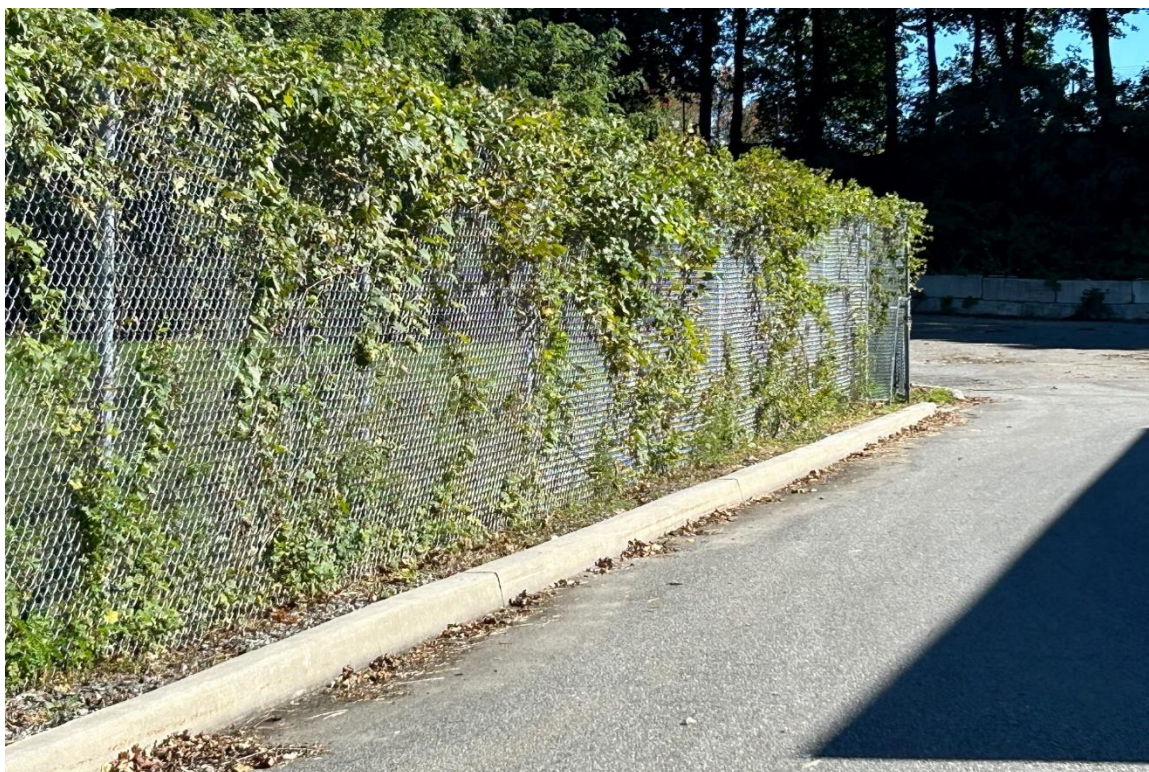
Currently there is no observable damage to the landfill perimeter fence and cap.

Photo 11: South fence (looking east).

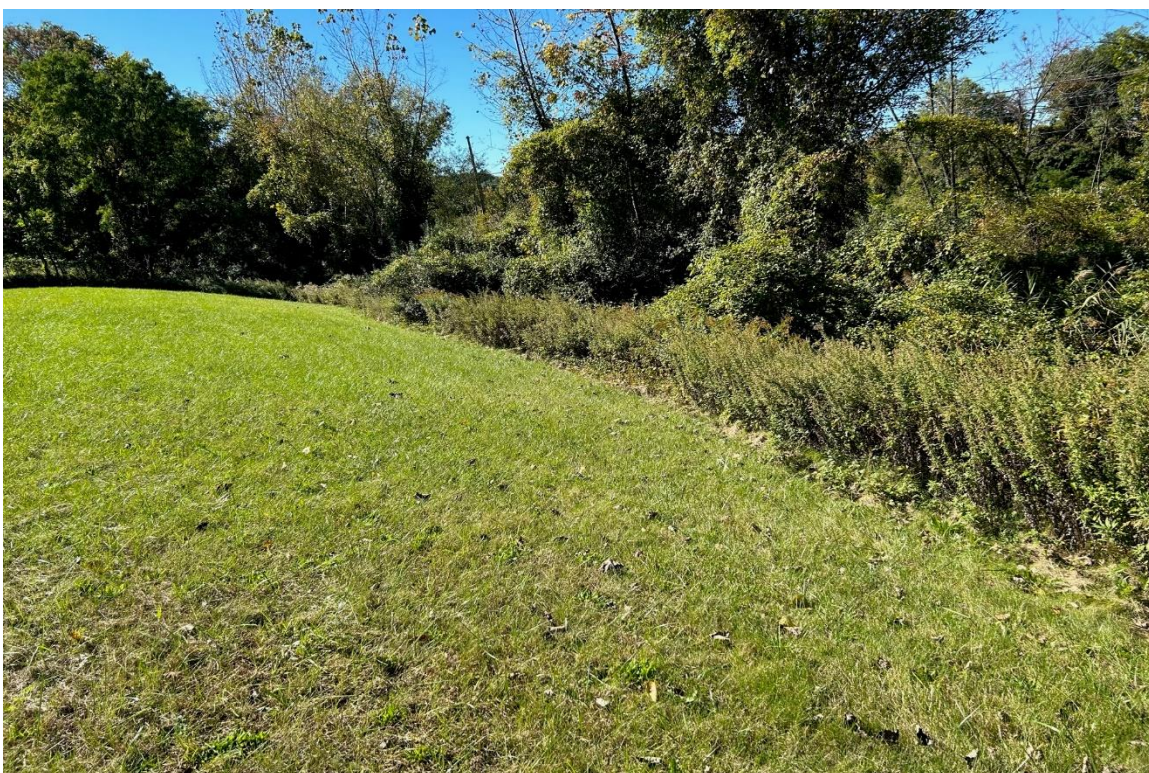
Photo 12: A portion of the west slope erosion area repair that needs clearing (looking north)

1. NYSDOT will have its tree removal crew cut down any shrubs and small trees that are above the toe of slope of the west, north and east sides of the landfill. This will be done to ensure that no root systems compromise the clay liner and geotextile that make up the cap. Unpredictable wet weather postponed the removal due to the cap and liner being saturated to support equipment needed for the work. Work is proposed to take place in Summer 2024 during a period of dry weather.
2. The main gate to the facility is locked at the end of the day by the Town of Harrison personnel. The well keys and landfill gate key are in the site office desk.
3. Weed whack the west slope repair area and possibly spray with herbicide to prevent future weed growth through the stone repair. Herbicide would be applied by a NYSDEC licensed applicator at the beginning of growing season.
