HARRISON SUB-RESIDENCY SEMI-ANNUAL FIELD INSPECTION

Date: 4/15/24

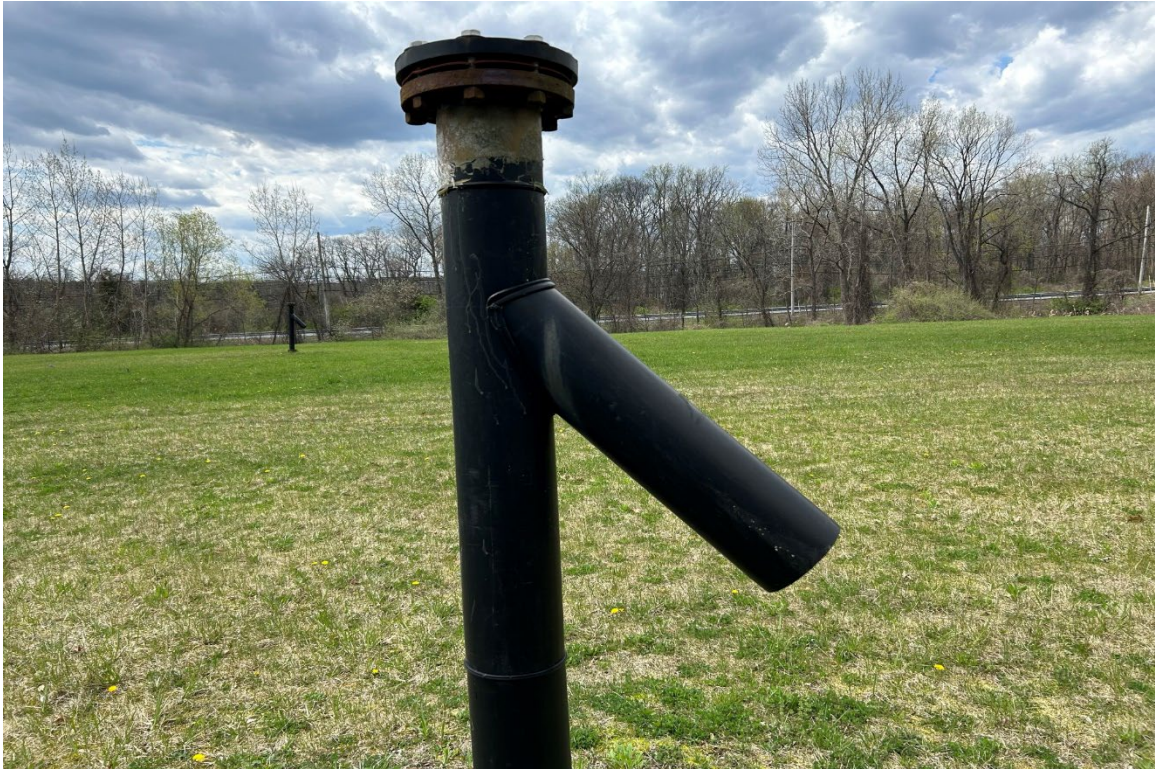
Photo 1: Vent V-1

Four vents (V-1 to V-4) were inspected (Photos 1-4). V-1 and V-2 had their plastic casing holes repaired with fiberglass epoxy in August 2015. A hole formed again in the V-2 repair and was patched with epoxy in June 2022. V-3 and V-4 were in good condition (neither cracks nor movement was observed). V-2 leans slightly to the north.

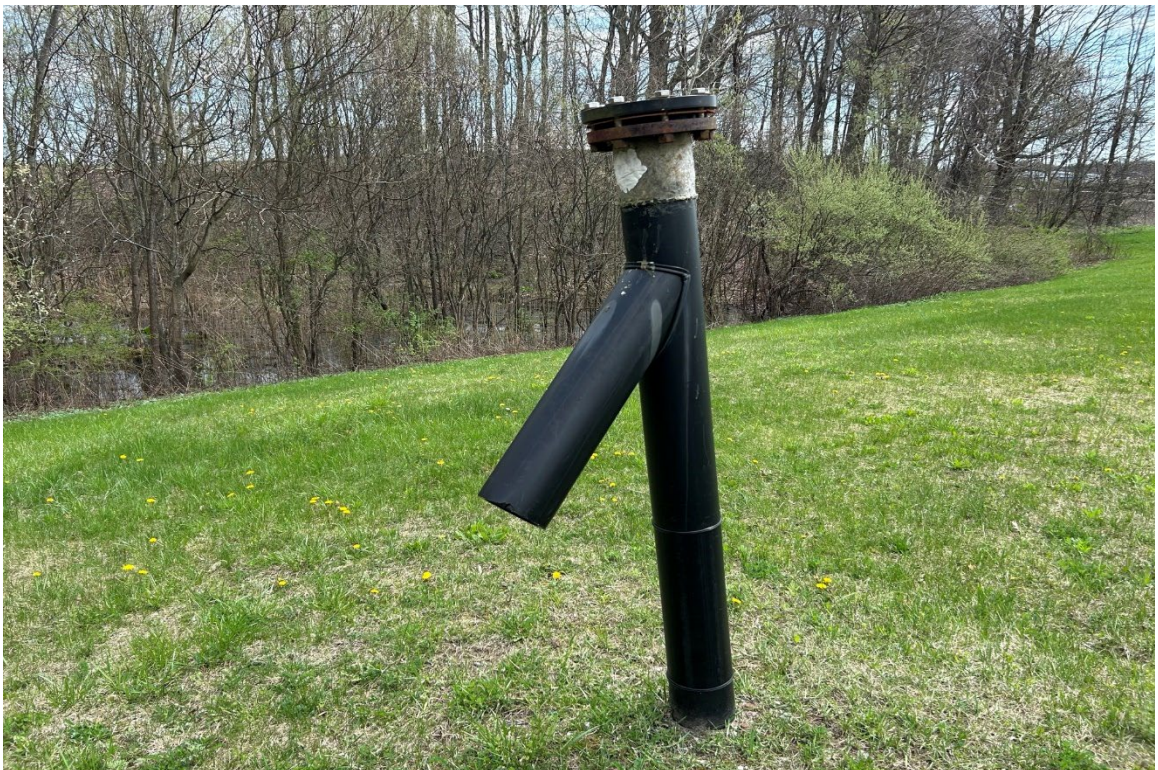
Photo 2: Vent V-2 (new repair patch shown)

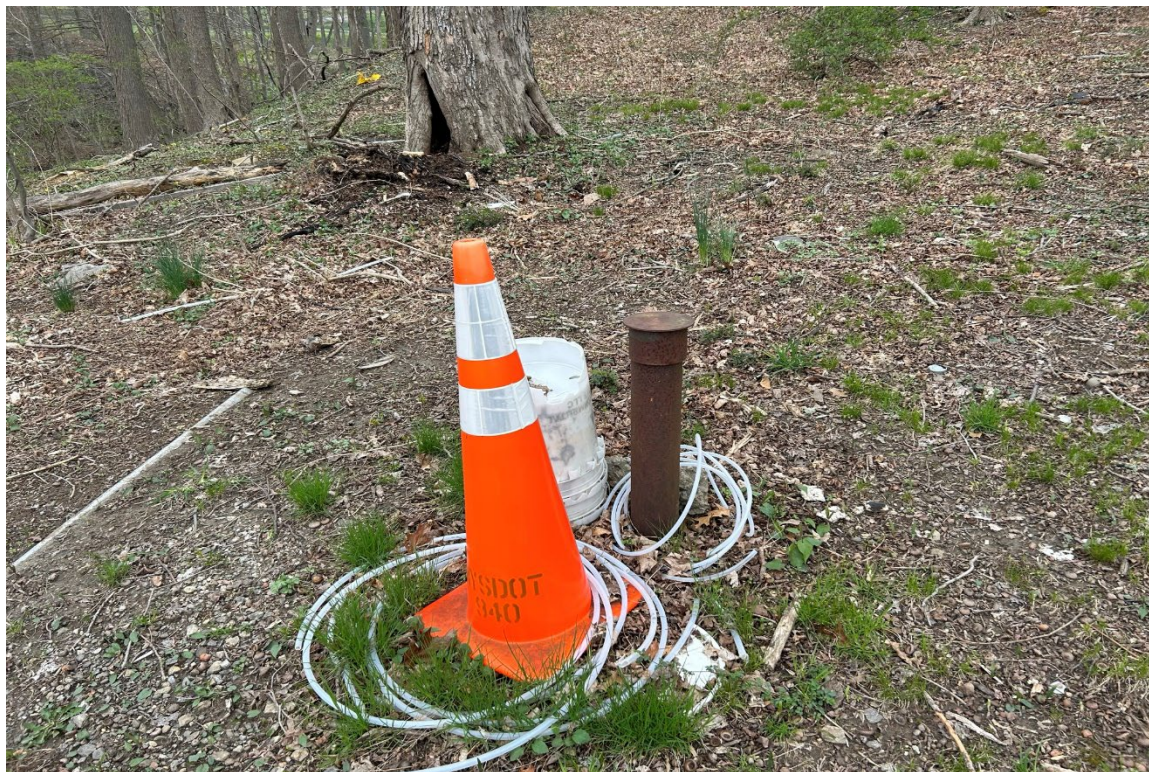
Photo 5: Well LMW-2

All wells were inspected and found to be in good condition. Paths to these wells were still clear of high vegetation.

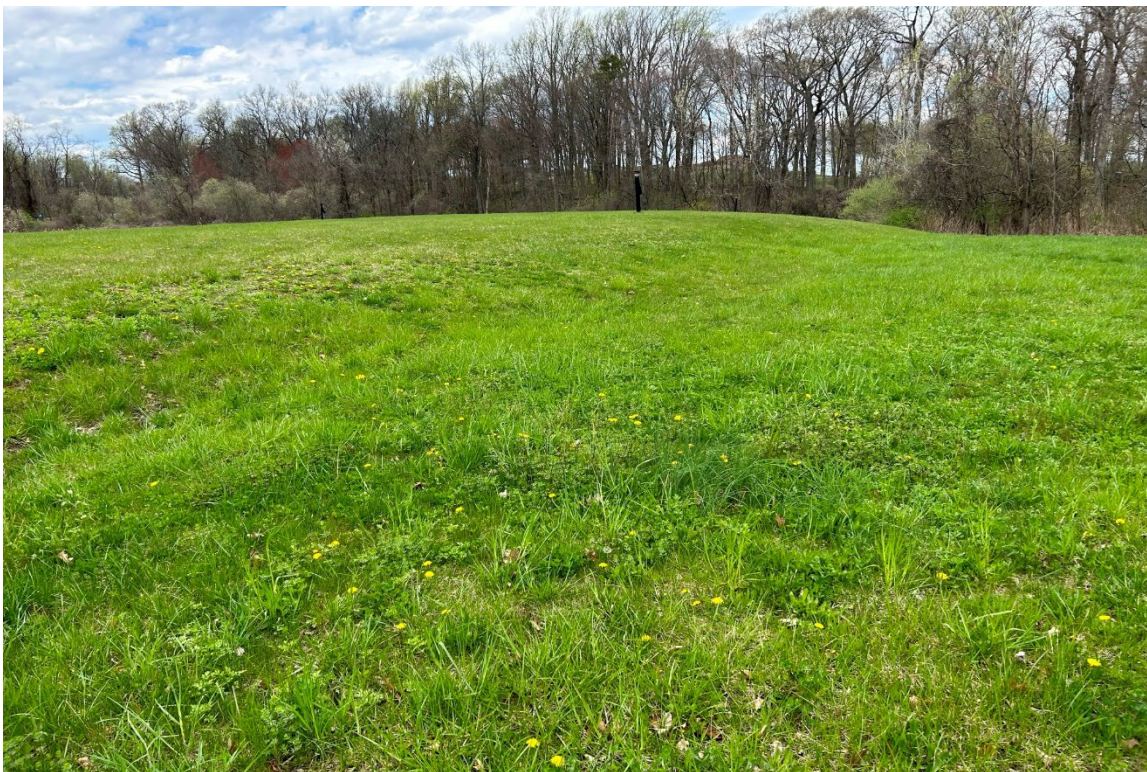
Grass height was satisfactory at the time of inspection (Photo 9). Grass should be cut in June and September. No damage observed on landfill cap.

Photo 9: Grass on landfill cap cut to correct height (looking northeast).

The landfill grass/vegetation was at an acceptable height. The cap should be mowed every June and September.

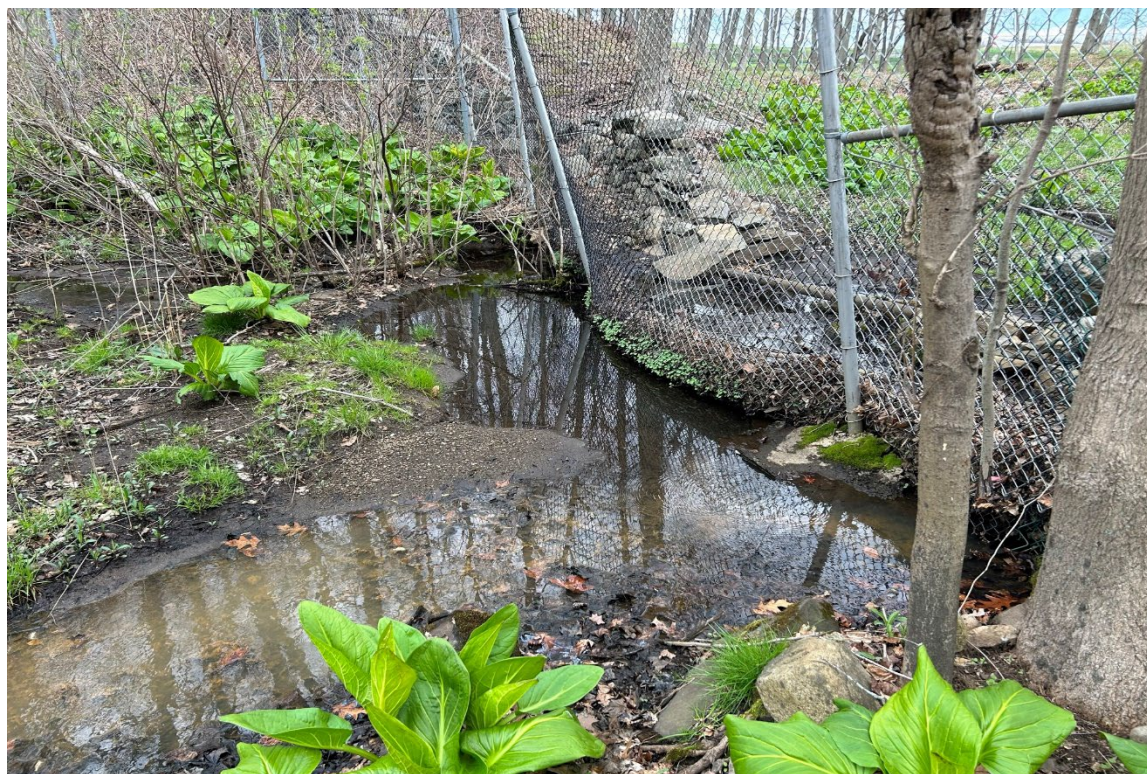
Photo 10: Stream near the northeast corner of the property.

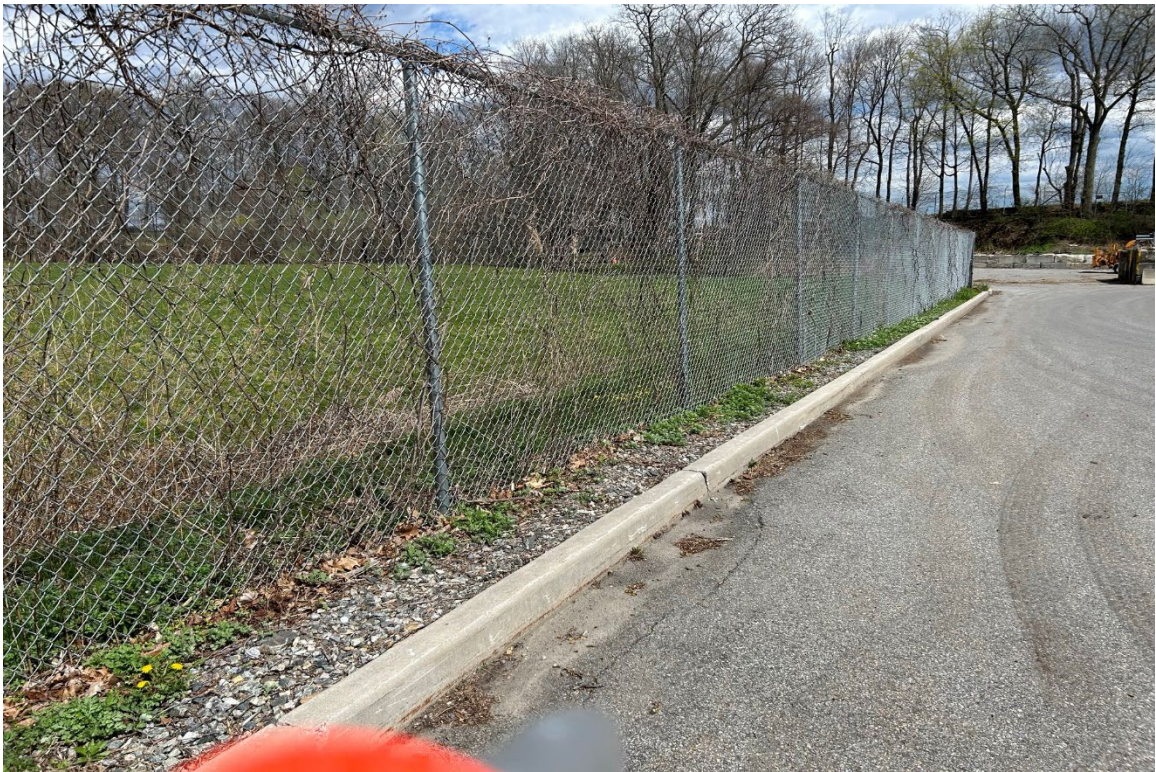
Currently there is no observable damage to the landfill perimeter fence and cap.

Photo 11: South fence (looking east).

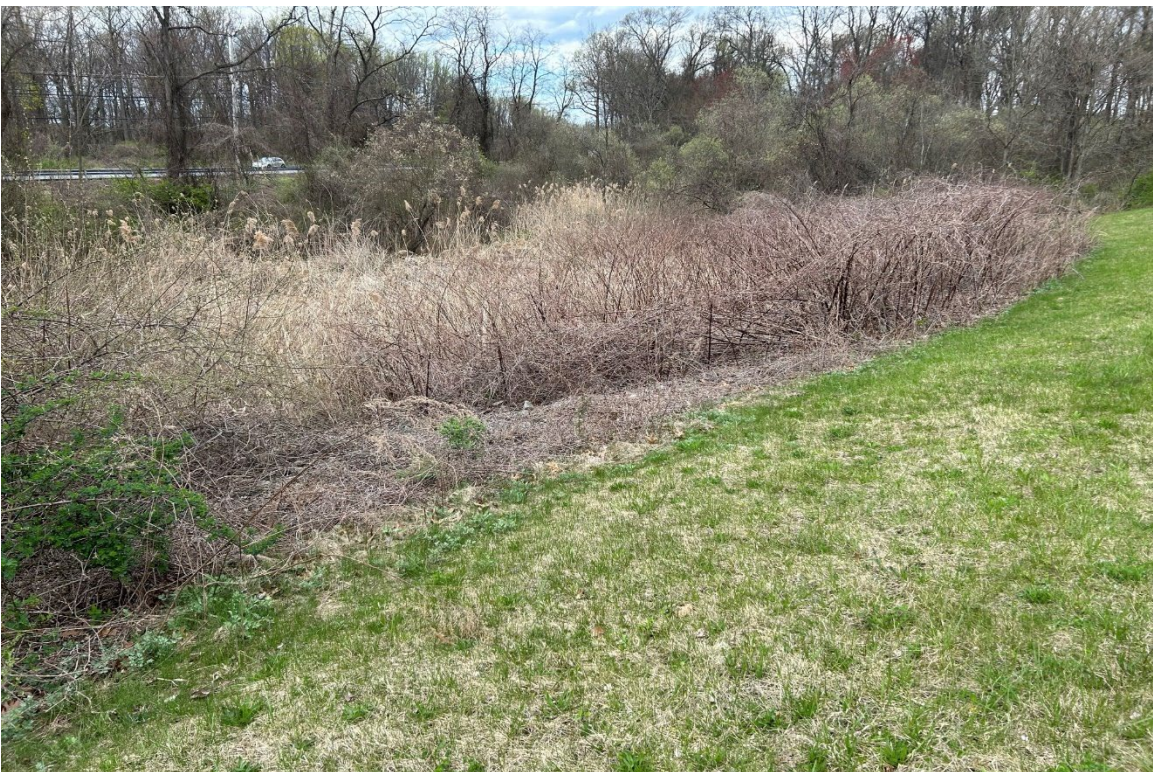
Photo 12: A portion of the west slope erosion area repair that needs clearing (looking north)

3. Weed whack the west slope repair area and possibly spray with herbicide to prevent future weed growth through the stone repair. Herbicide would be applied by a NYSDEC licensed applicator at the beginning of growing season.
