May 22, 2025

Subject:       **2025 Annual Inspection Report**  
                  **AL Tech Specialty Steel (Site No. 401003)**  
                  **Earth Environment Engineering and Geology P.C., Project No. 3616206100**

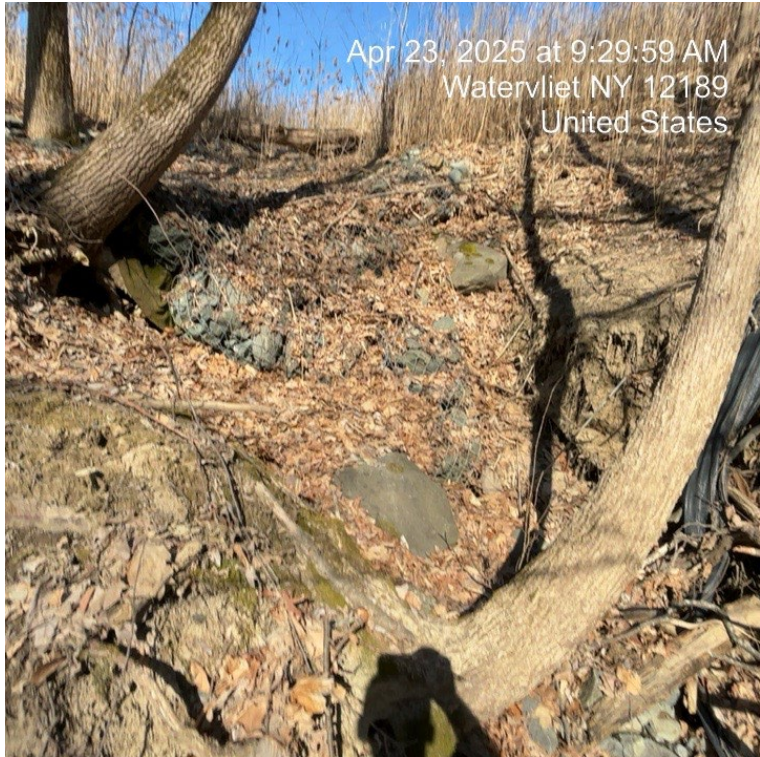
- Extent of exposed gabion mats and potential minor erosion east of WW-17 at the head of the unnamed tributary appears to be unchanged since the last inspection. There appears to be a very slow rate of erosion and settlement of the head of the swale beneath the gabion mats. (**Attachment 1; Photograph 1**).

Gabion mats at head of unnamed tributary west of WW-17.

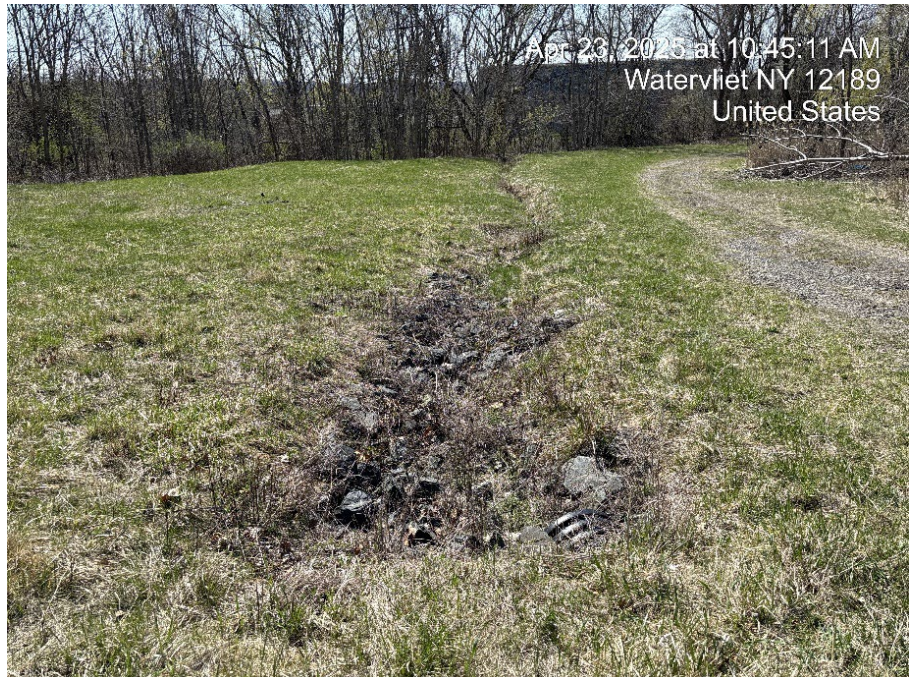
- Some leaning fencing remains on the north side of the landfill (**Attachment 1; Photograph 5**).
- Vegetation growth is noted in drainage swale along lower access road north of Leachate building and eastern portion of landfill (**Attachment 1; Photographs 2 and 22**).

Growth in drainage swale east of cap and lower access road north of Leachate Building and unnamed tributary to Kromma Kill.

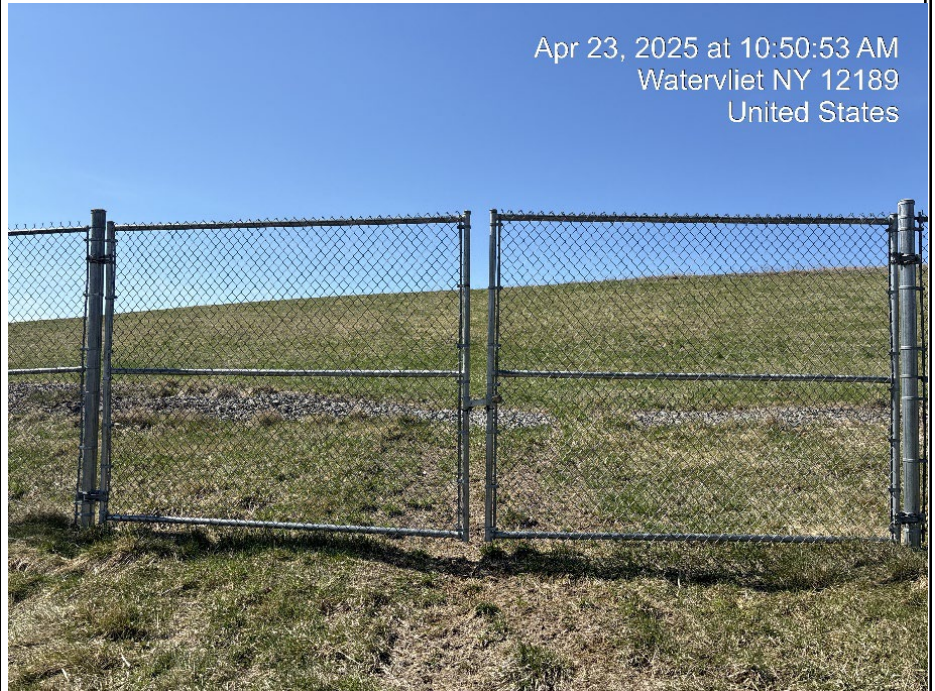
- Minor ruts in the access roads at the northern, southern, and western sides of the landfill were observed; however, access is not impeded (**Attachment 1; Photographs 3, 4 and 16**).

Minor ruts in wet soils at northern Cap access gate. Lock at this gate will not open with site access code.

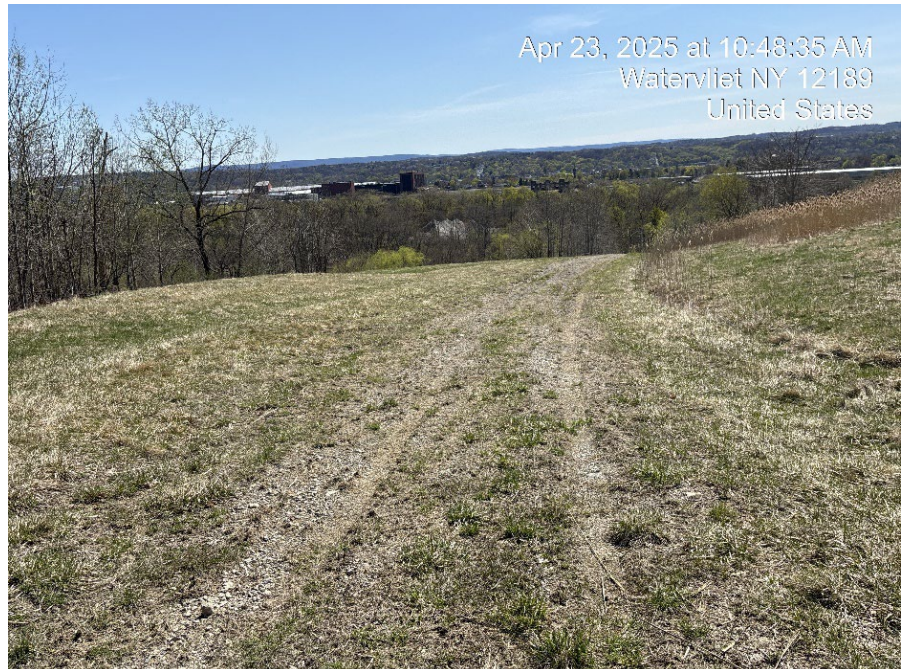
Minor wear and erosion in soil at top of lower access road near the northeast gate to the landfill cap of the WMA.

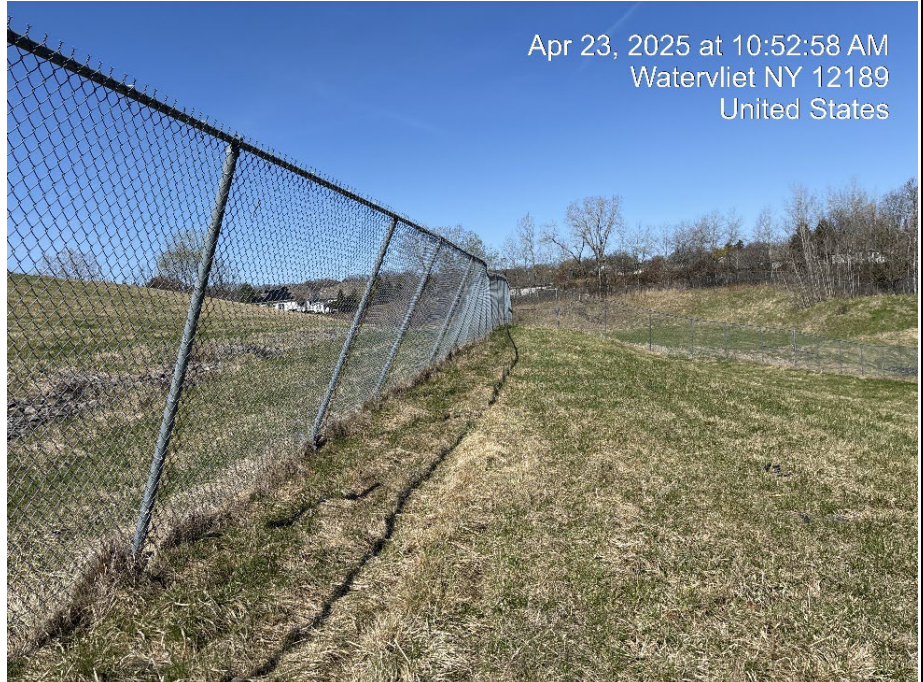
Fence at north side of landfill, west of gate, slightly leaning in some areas.

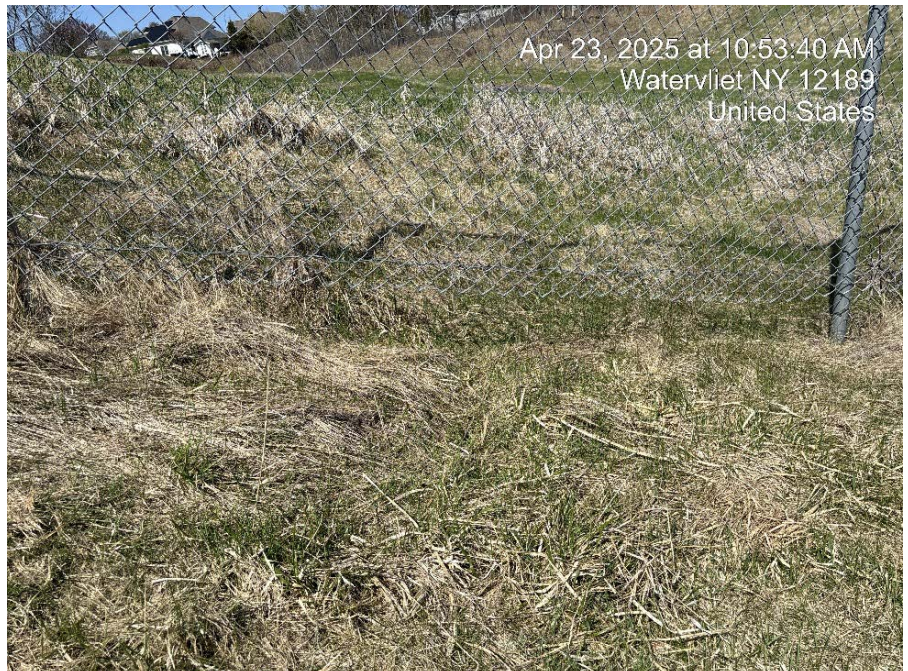
Opening at the bottom of the fence at northern end of the Landfill.

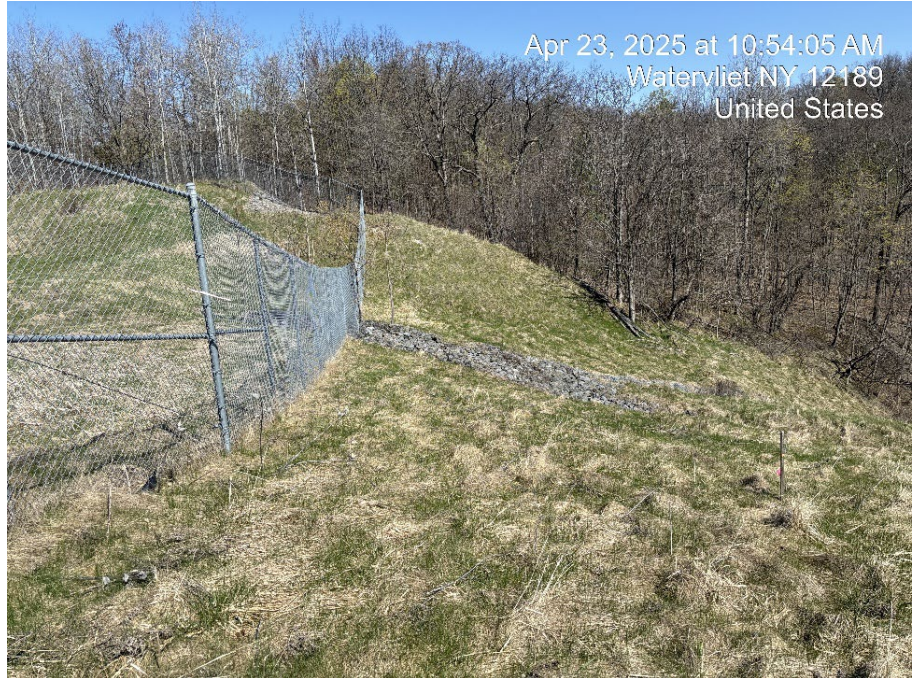
- Extent of exposed geotextile around the north drainage basin discharge appears to be unchanged from the previous inspection (**Attachment 1; Photographs 7, 8 and 10**).

View of fence line and discharge from north basin.

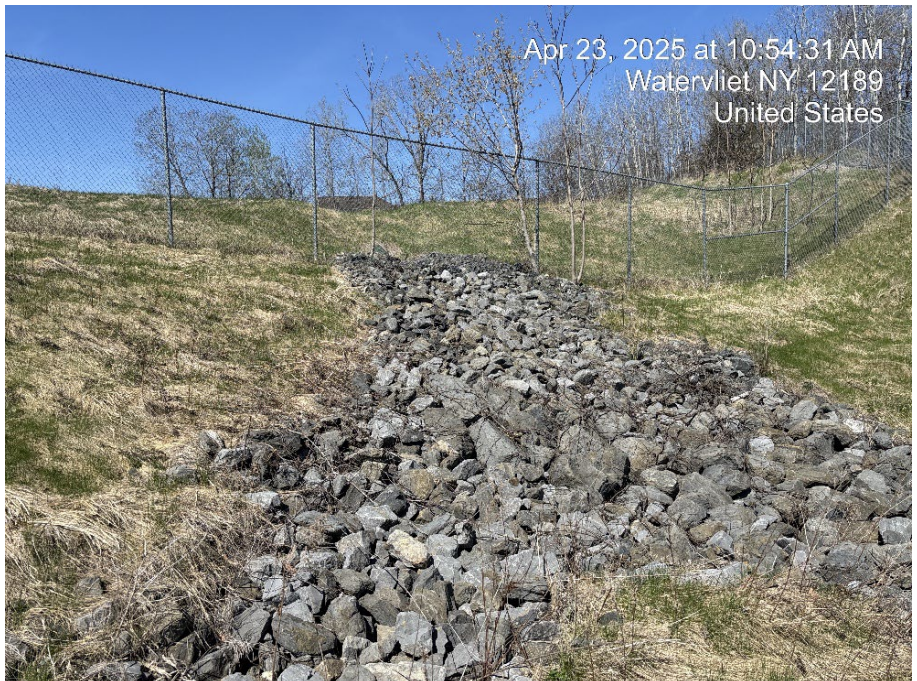
View of fence line and discharge from north basin.

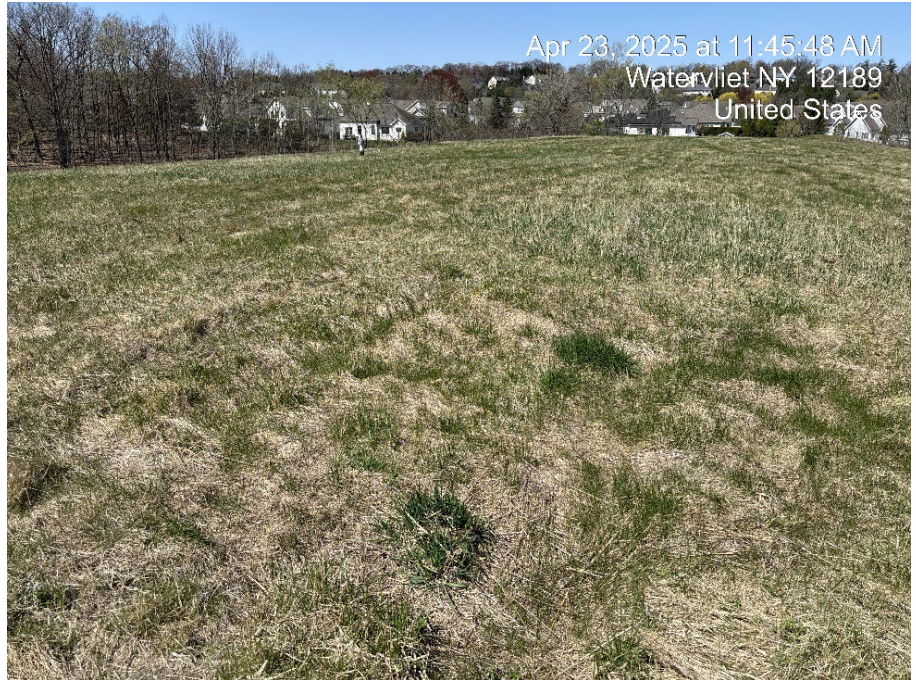
- Results of repairs to the landfill cap due to unauthorized excavation by a trespasser appear to be unchanged from the previous inspection, with a well-established grass cover (**Attachment 1; Photograph 9**).

Repaired hole in cap from unauthorized treasure hunter. Area overgrown with grass.

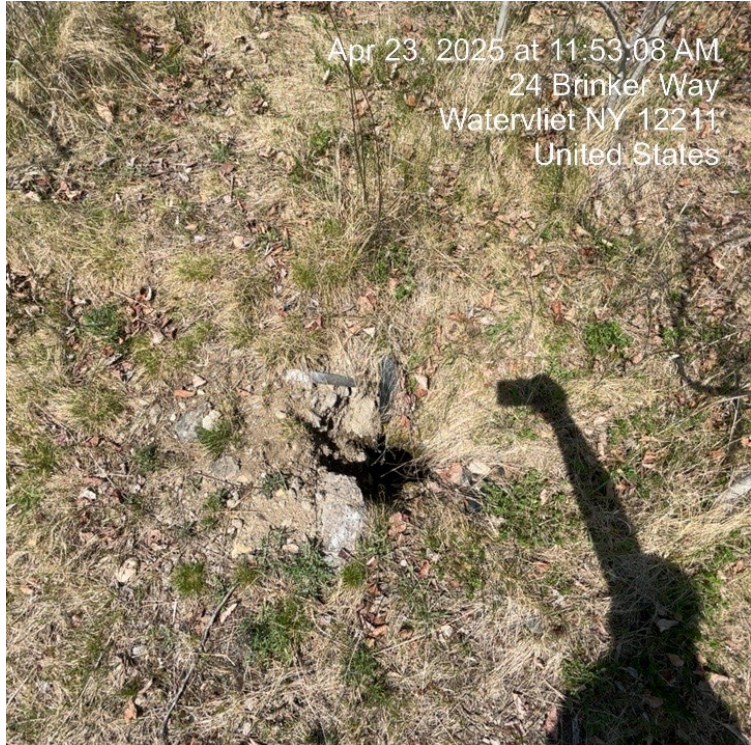
- Rodent holes/burrows along north side of landfill in bank near WW-26I/WW-26B well cluster. No apparent change from previous inspection. (**Attachment 1; Photograph 11**).

Hole in bank near the WW-26I/WW-26B well cluster. No apparent change from previous inspection.

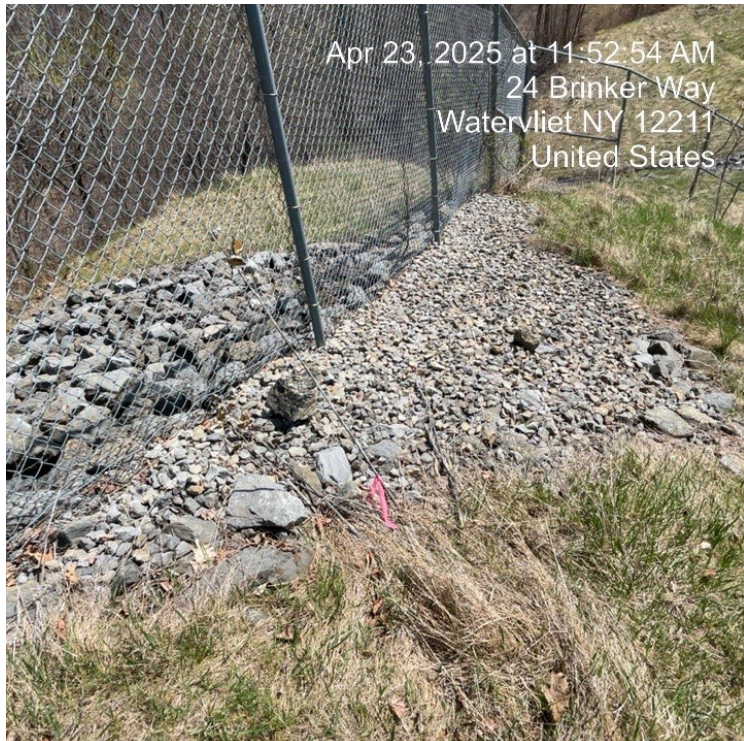
Relatively newly laid gravel/rip rap south of WW-26I and WW-26B.

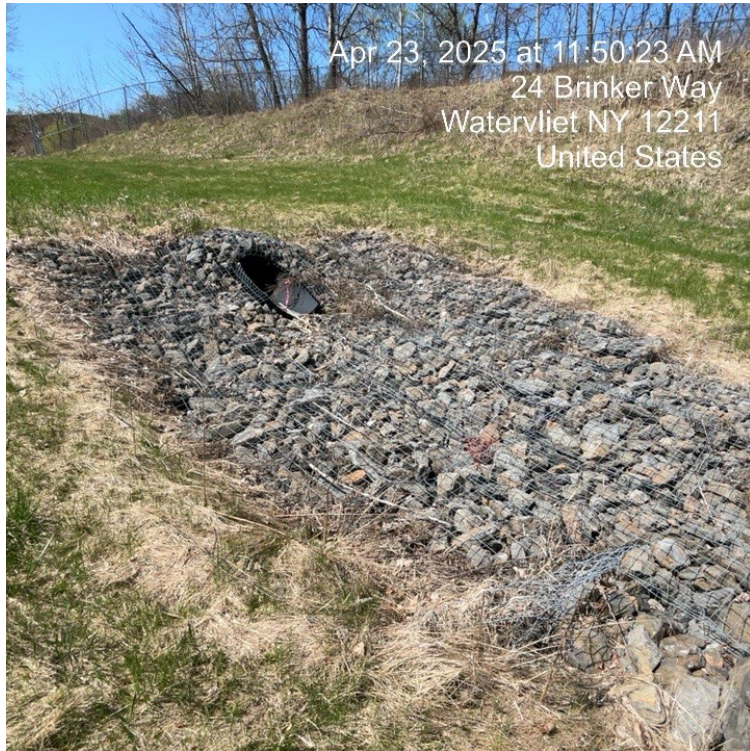
View of inlet to northern drainage basin.

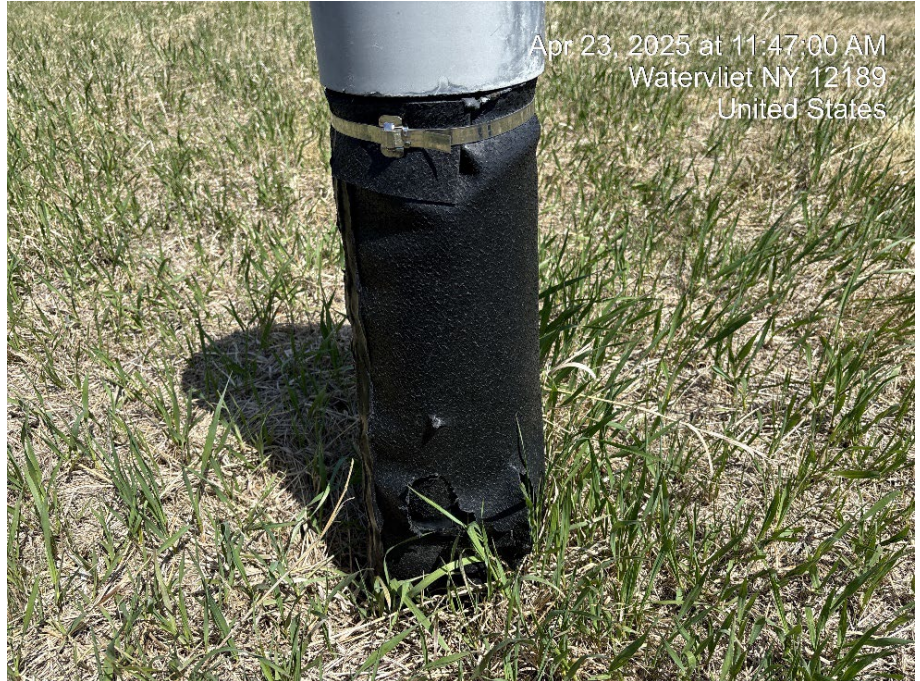
- Extent of minor tears in the black protective wrap on the southeastern gas vent appears to be unchanged from the previous inspection (**Attachment 1; Photograph 15**).

Southeastern gas vent with minor tears in black geotextile.

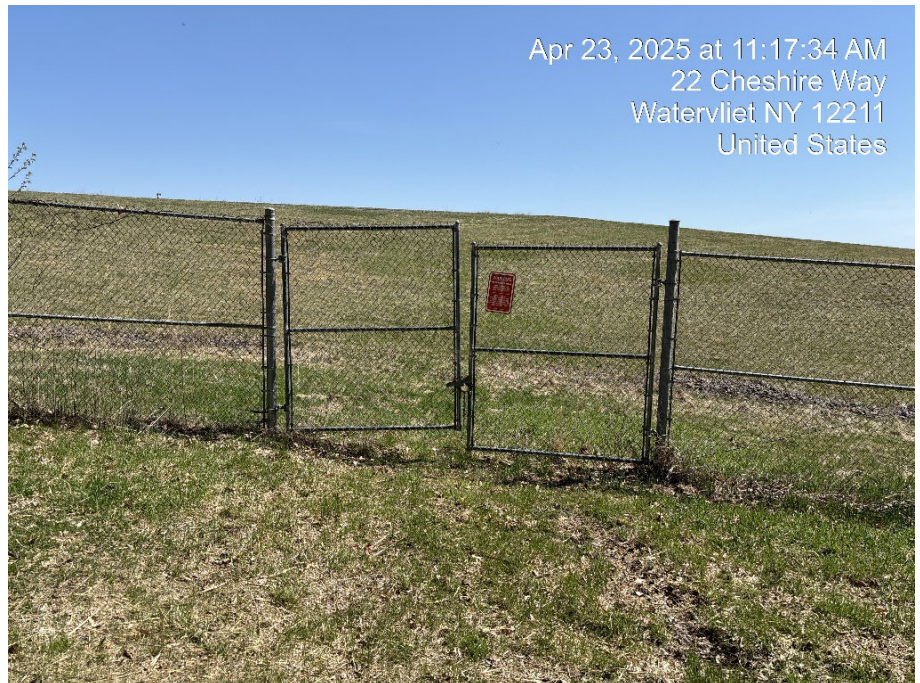
View of fence entrance at the southwest side of the landfill.

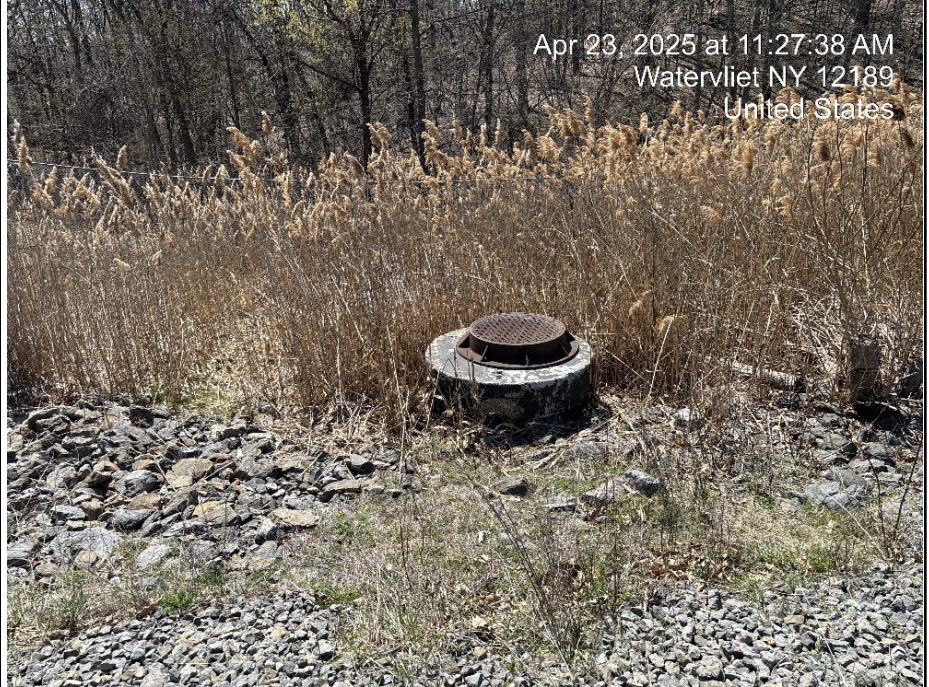
Woody growth in riprap at eastern area of landfill by MH-16 manhole.

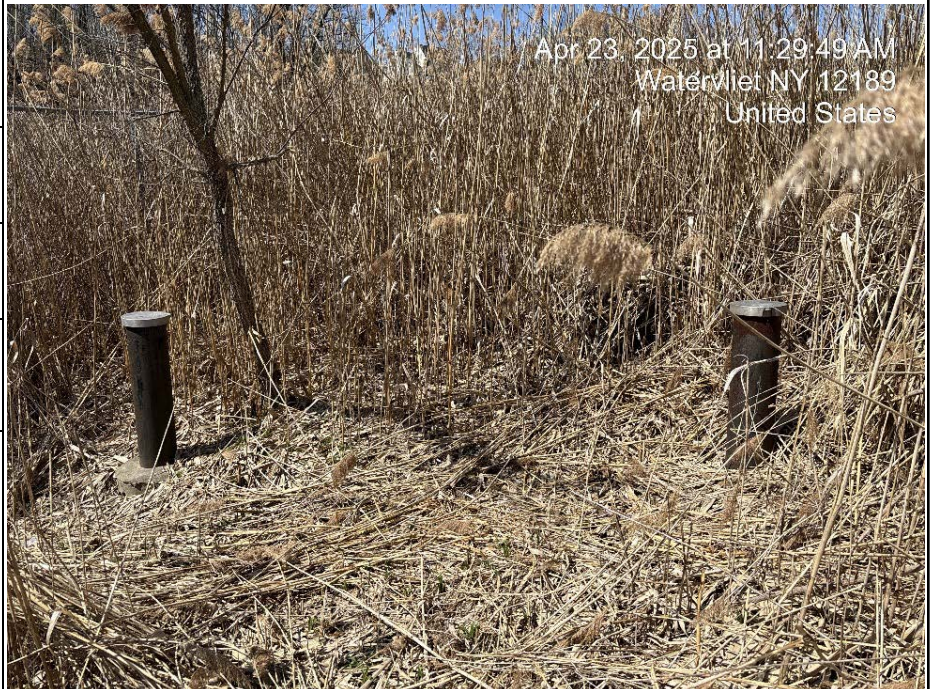
Overgrowth area near WW-16/16B below MH-16.

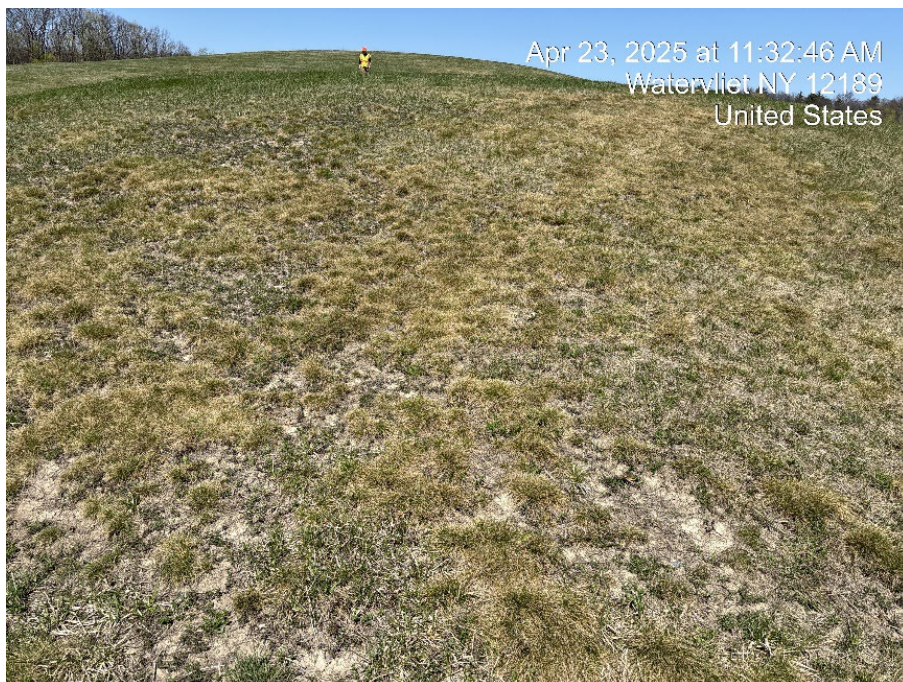
Patchy vegetation growth on East side of landfill.

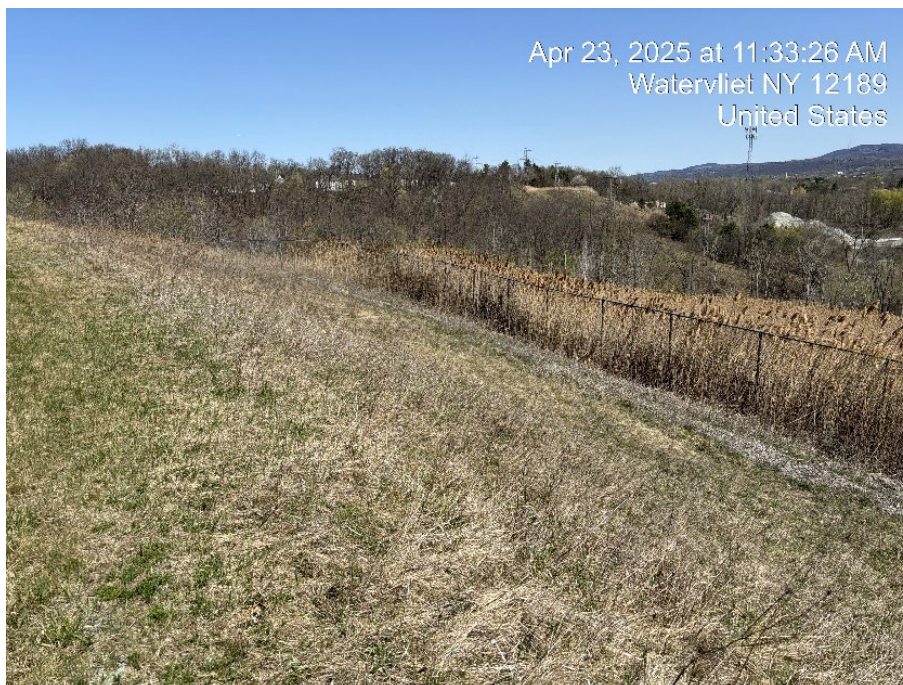
Some woody growth and phragmites along eastern cap fence line.

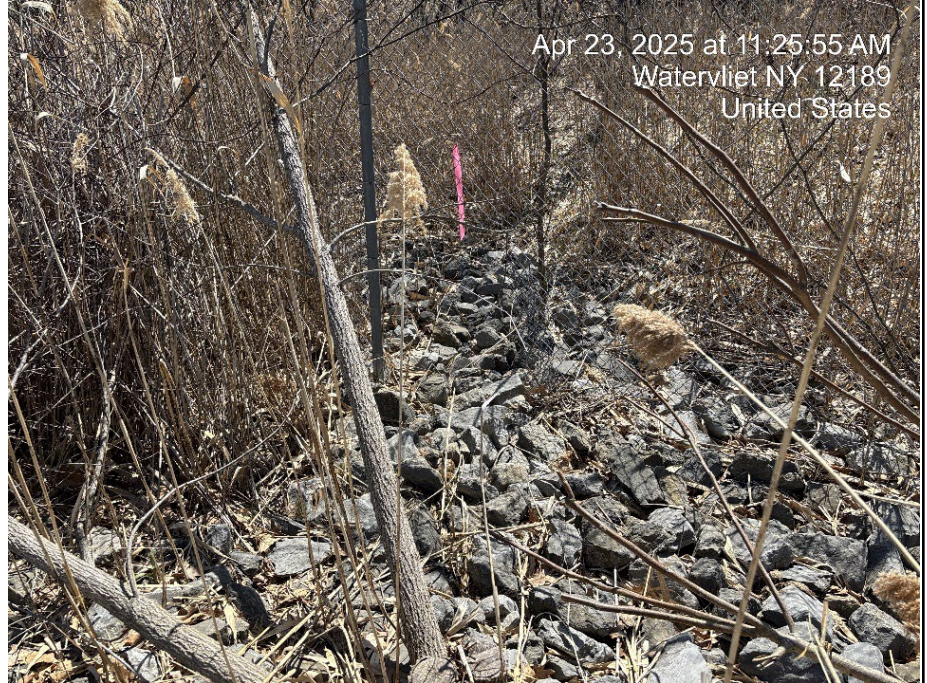
Opening in the fence at the south side drainage basin.

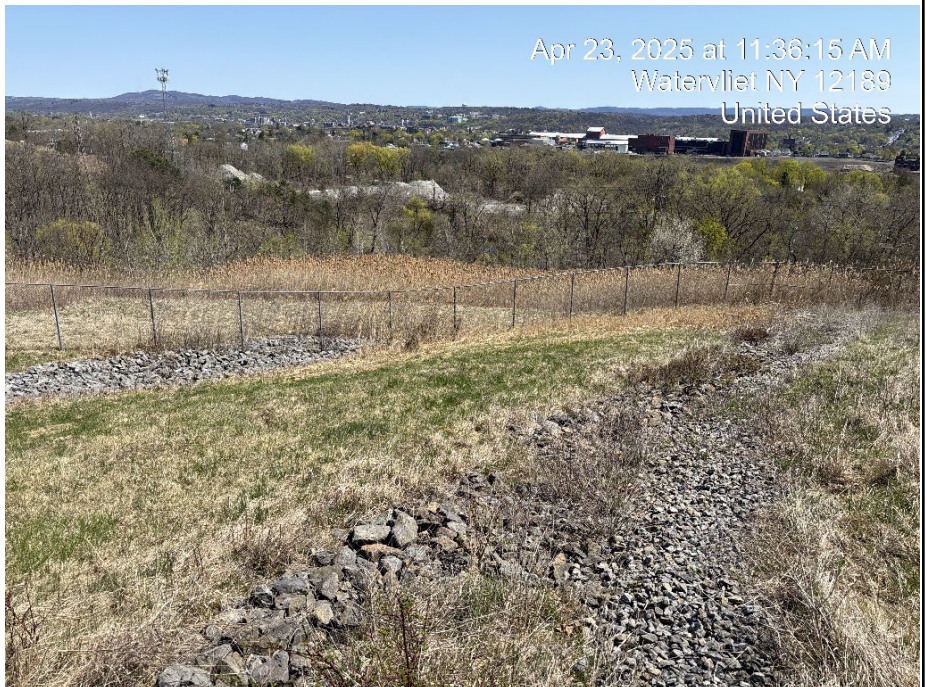
View of Northeastern fencing of landfill. Note vegetation growth in swale.

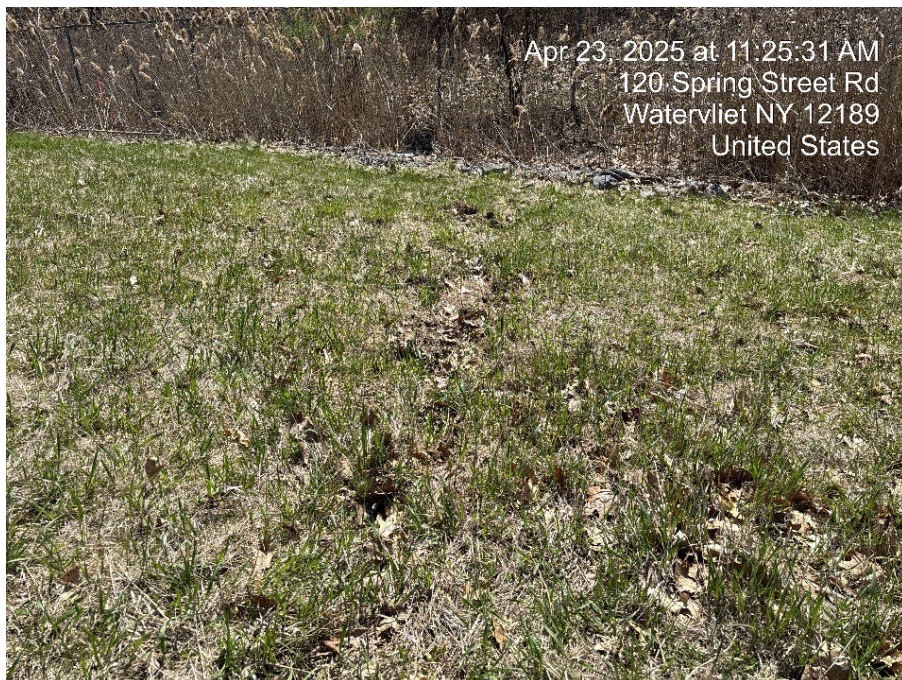
Minor erosion and signs of streaming on Southeast side of the landfill.

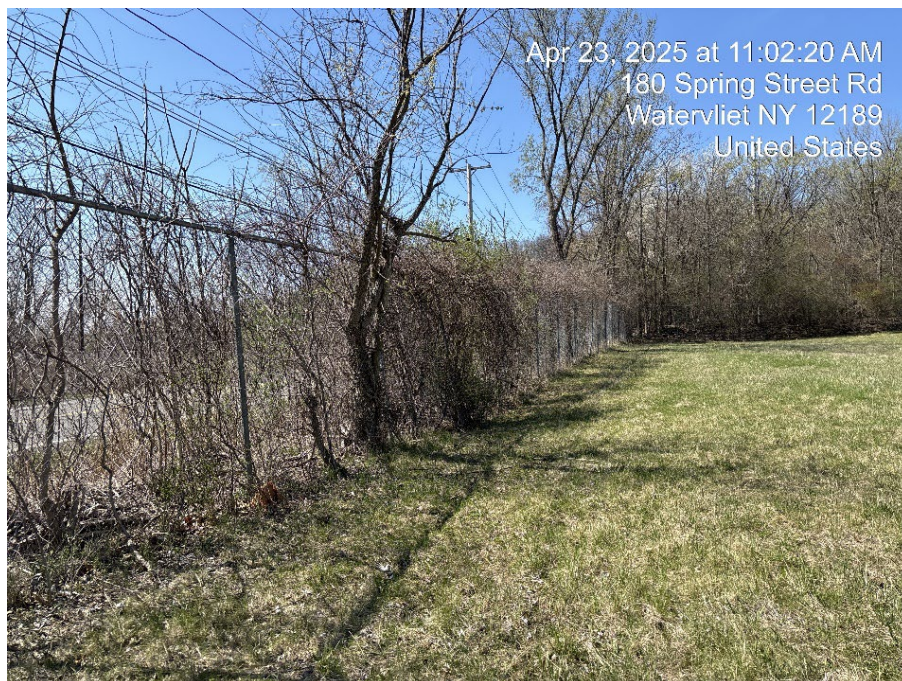
Growth along fence near Spring Street Road.

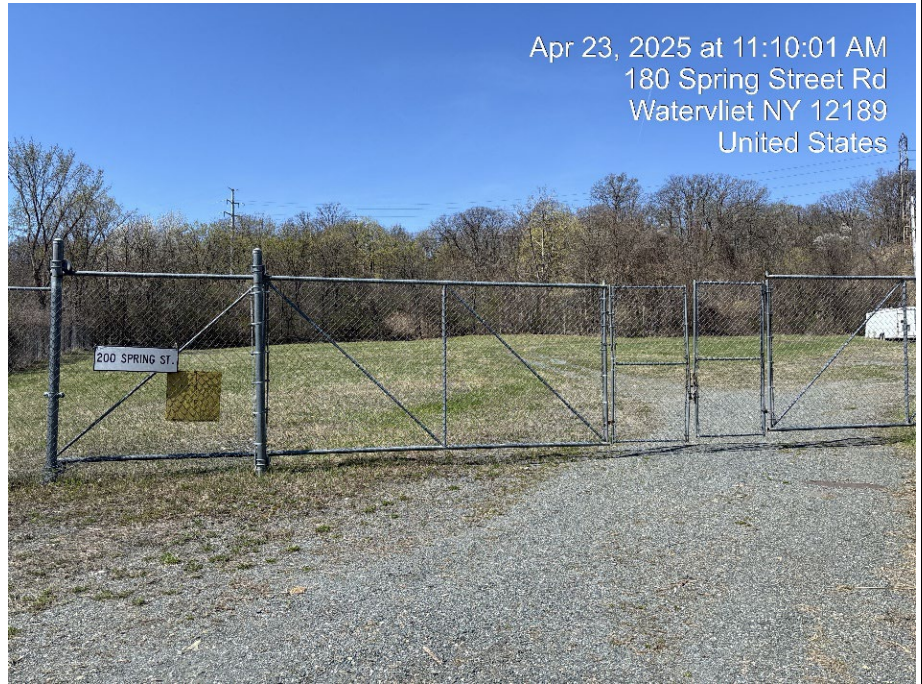
Current condition of site entrance gate off Spring Street Road.

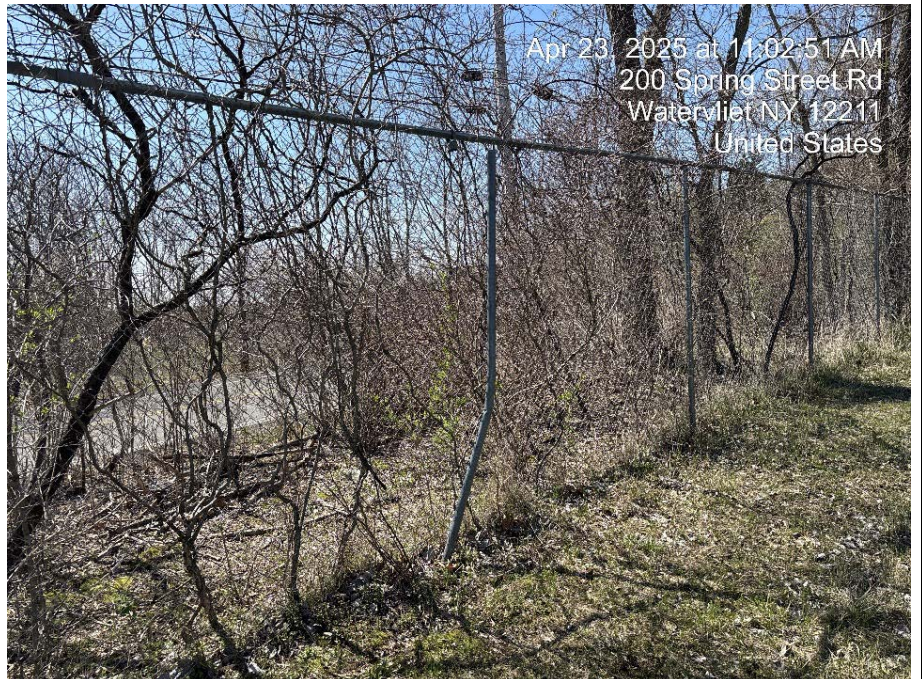
Damaged fence post on Southern fence at Leachate Building area.

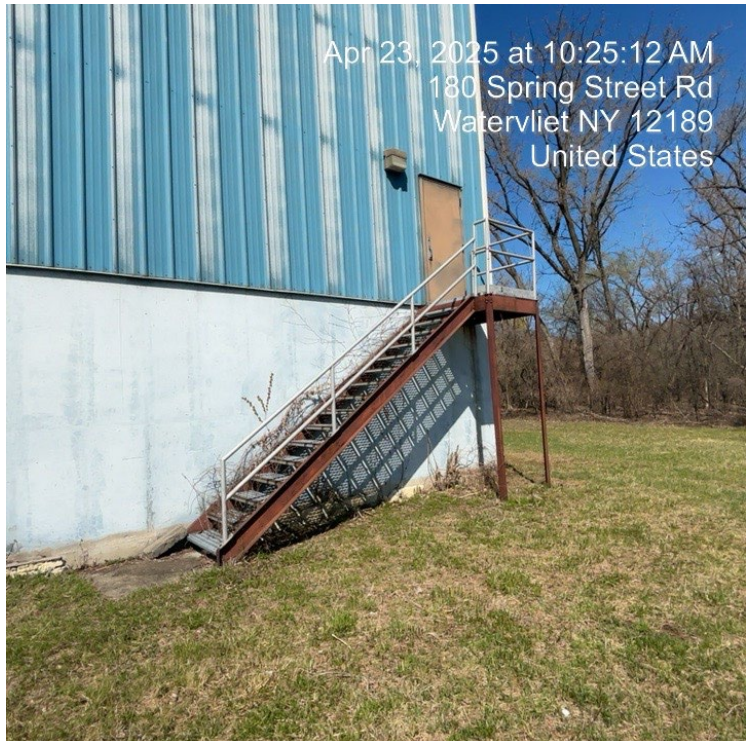
East side of leachate collection building. Vegetation growing on stairs cleared since previous inspection.

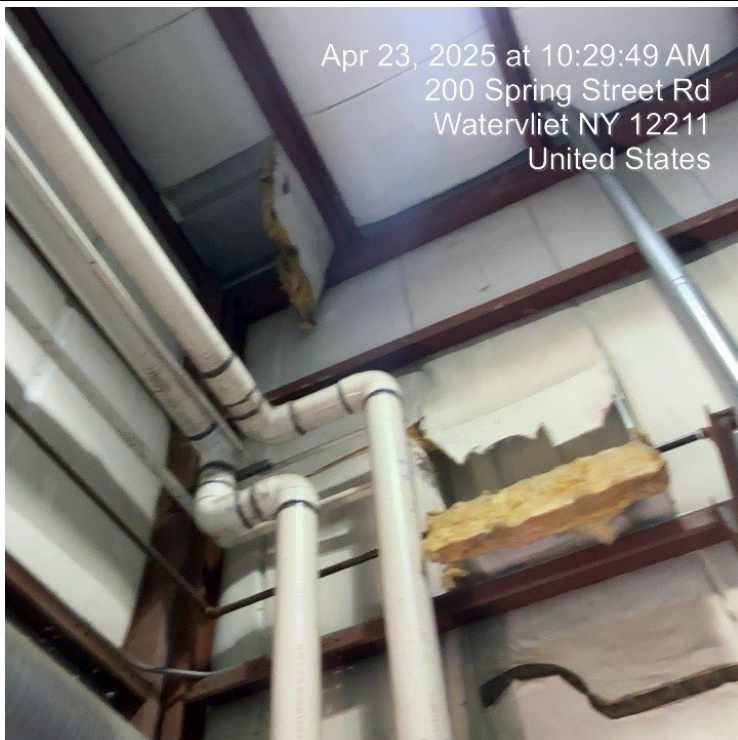
Damaged insulation on west wall near entrance. Appears unchanged since May 1<sup>st</sup>, 2025, inspection.

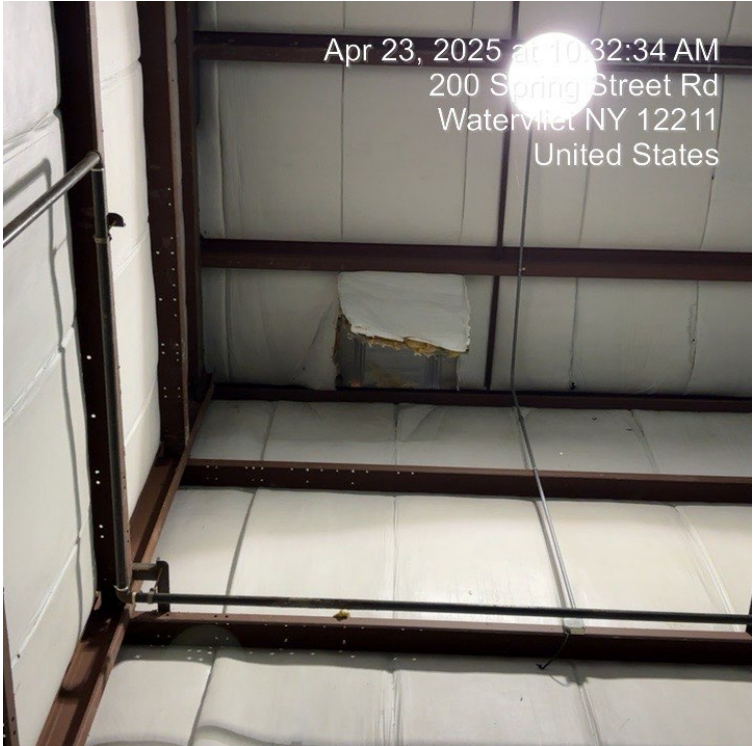
<b><i>Date:</i></b>  April 23, 2025			
<b><i>Photograph:</i></b> 6			
<b><i>Direction:</i></b>  Northwest			
<b><i>Description:</i></b> Damaged ceiling insulation between Tank 2 (eastern most tank) and south wall. Southeast corner.

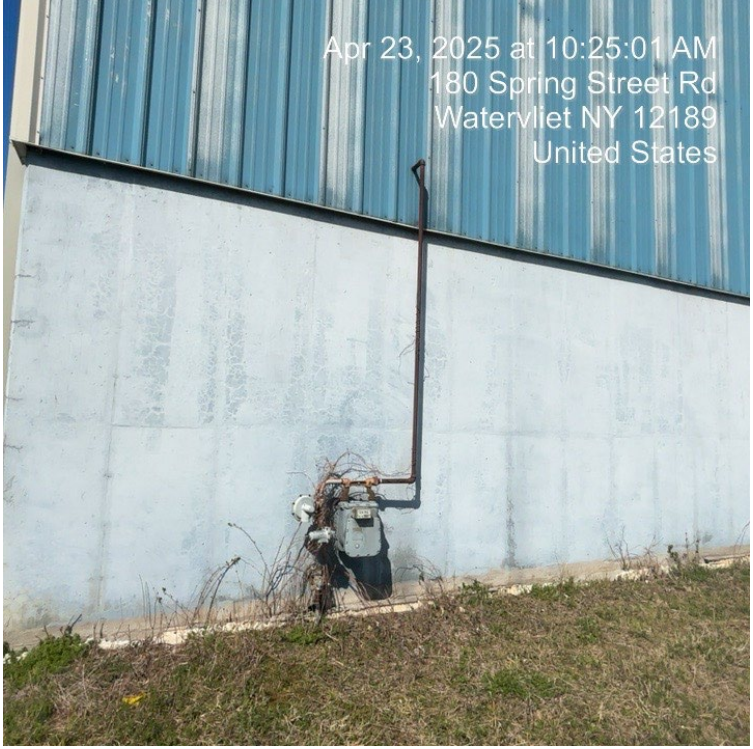
<p>Apr 23, 2025 at 10:25:01 AM 180 Spring Street Rd Watervliet NY 12189 United States</p>		
<b>Date:</b> April 23, 2025			
<b>Photograph:</b> 7			
<b>Direction:</b> West			
<b>Description:</b> Gas line entering building in southeast corner.			
<b>Photographer:</b> John Walsh

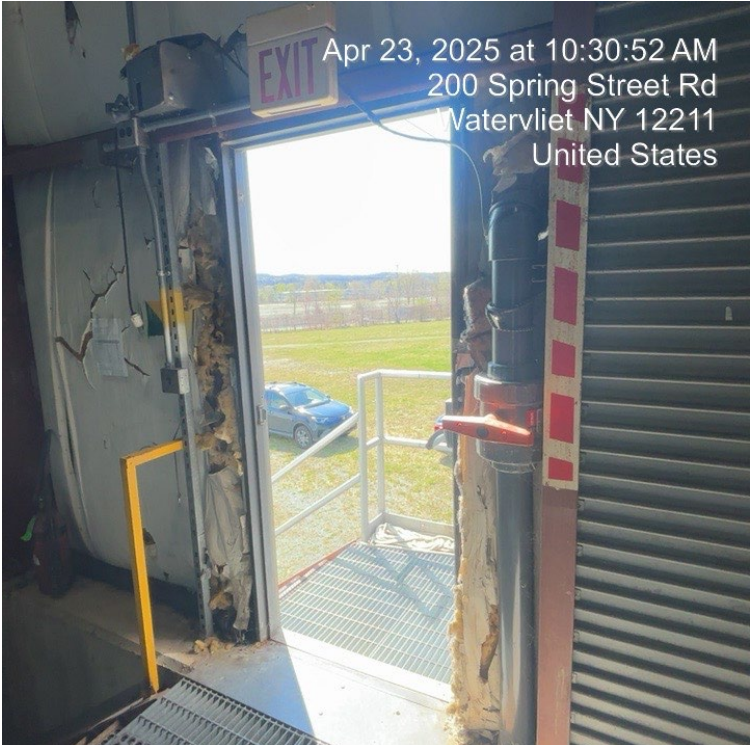
<p>Apr 23, 2025 at 10:30:52 AM 200 Spring Street Rd Watervliet NY 12211 United States</p>		
<b>Date:</b> April 23, 2025			
<b>Photograph:</b> 8			
<b>Direction:</b> Southeast			
<b>Description:</b> Damaged insulation near building's southwest entry door.

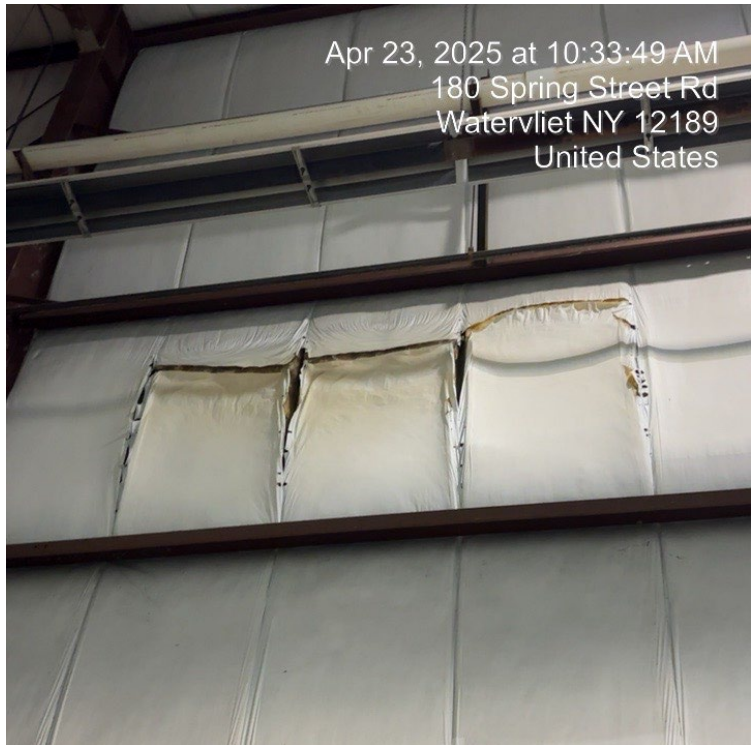
- Damaged insulation on the southern wall between both tanks (**Attachment 2; Photograph 9**).
- An area of standing water had been observed in previous inspections at the base of the northern portion of Tank #1 and the building floor. The source of the water is likely related to seepage from potential minor roof leaks previously observed over Tank #1. No water was present at the time of the April 2025 inspection.

Insulation damage on the South wall between both tanks.

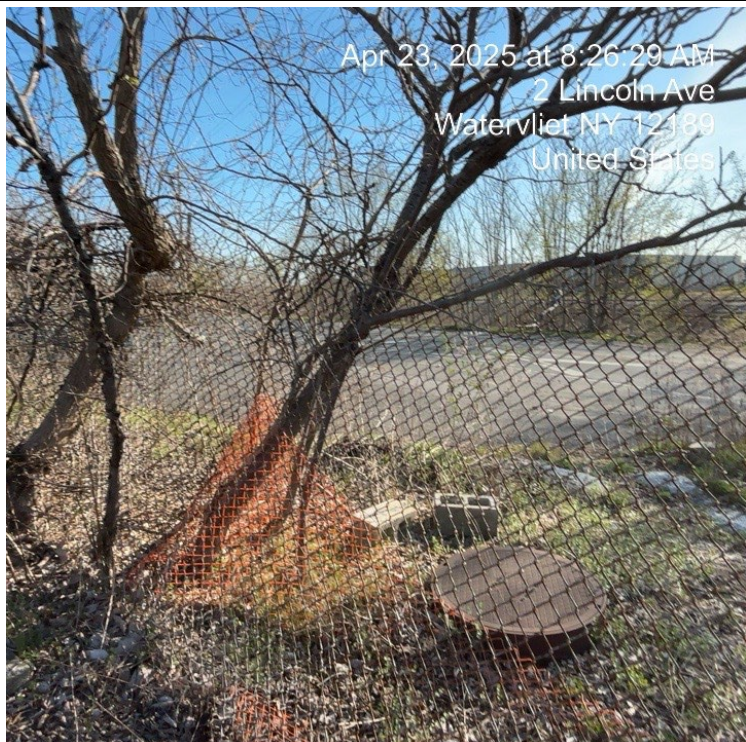
Damaged/leaning fence on Southeast side of site near parking area off Lincoln Ave.

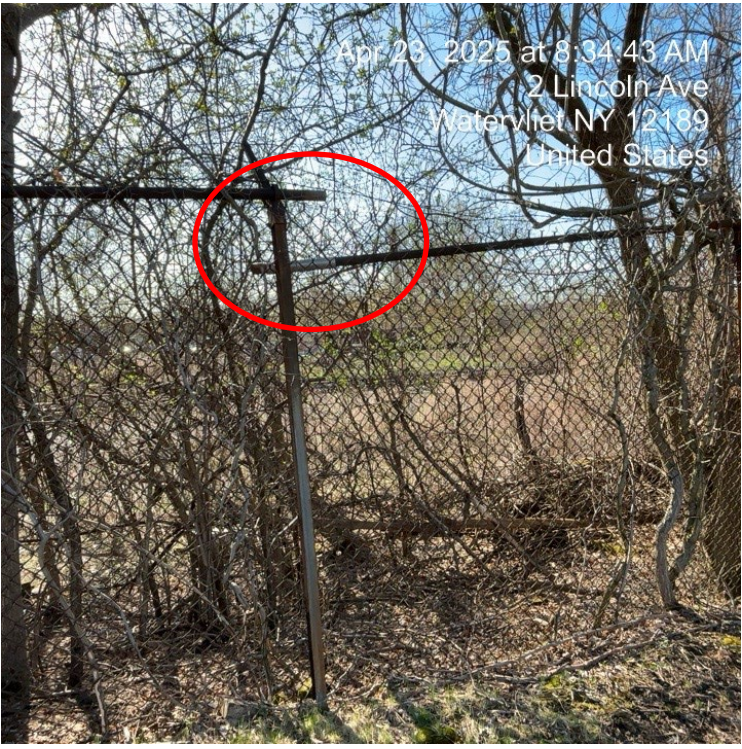
<p style="position: absolute; top: 10%; right: 10%; color: white; font-size: 0.8em;">                         Apr 23, 2025 at 8:34:43 AM                          2 Lincoln Ave                          Watervliet NY 12189                          United States                     </p>		
<b>Date:</b> April 23, 2025			
<b>Photograph:</b> 5			
<b>Direction:</b> Southwest			
<b>Description:</b>  Damaged fence along the Southeast side of the site near Lincoln Ave.			
<b>Photographer:</b> John Walsh

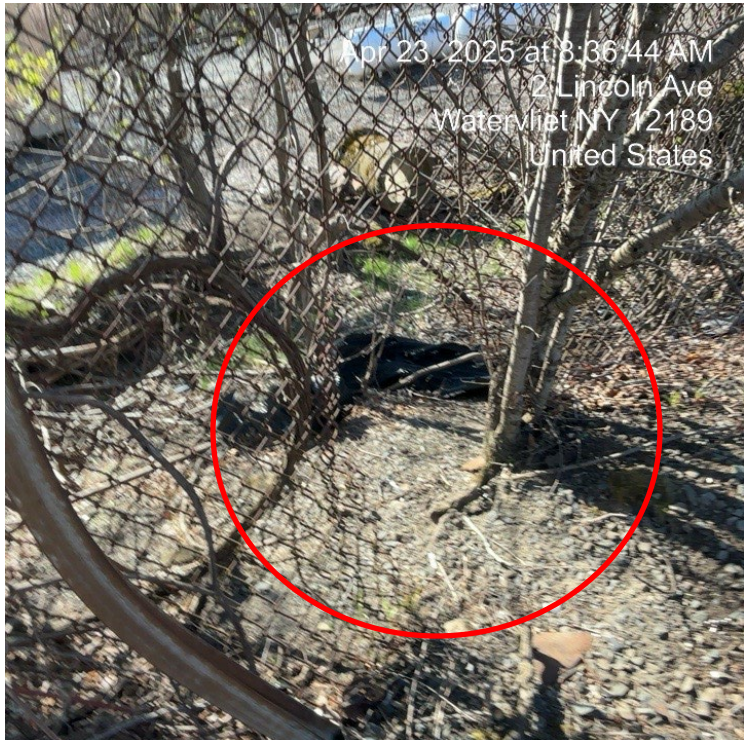
<p>Apr 23, 2025 at 8:36:44 AM 2 Lincoln Ave Watervliet NY 12189 United States</p>	
<b>Date:</b> April 23, 2025			
<b>Photograph:</b> 7			
<b>Direction:</b> Southeast			
<b>Description:</b> Hole in southeast side fence near Lincoln Ave.			
<b>Photographer:</b> John Walsh

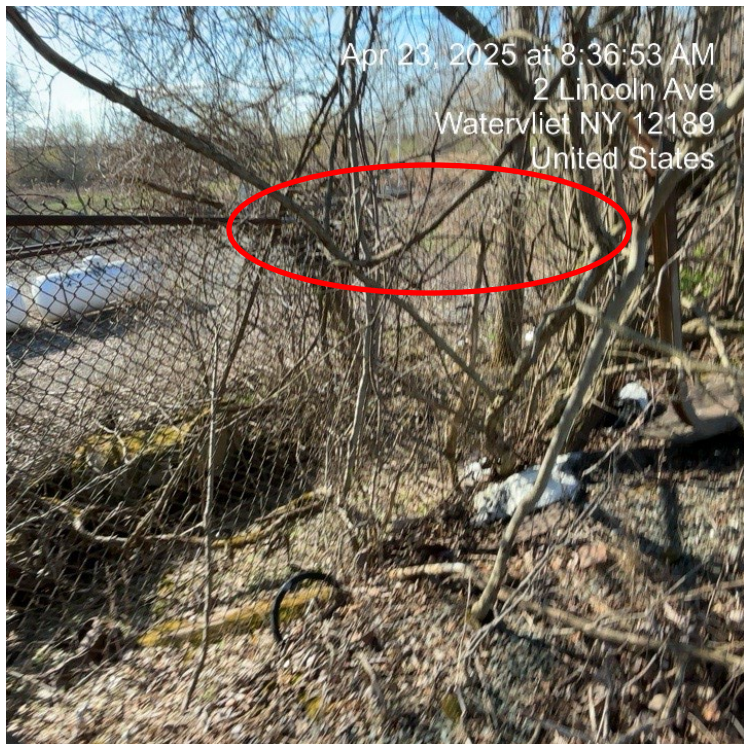
<p>Apr 23, 2025 at 8:36:53 AM 2 Lincoln Ave Watervliet NY 12189 United States</p>	
<b>Date:</b> April 23, 2025			
<b>Photograph:</b> 8			
<b>Direction:</b> South			
<b>Description:</b> Damaged fence along the Southeast side of the site near Lincoln Ave.

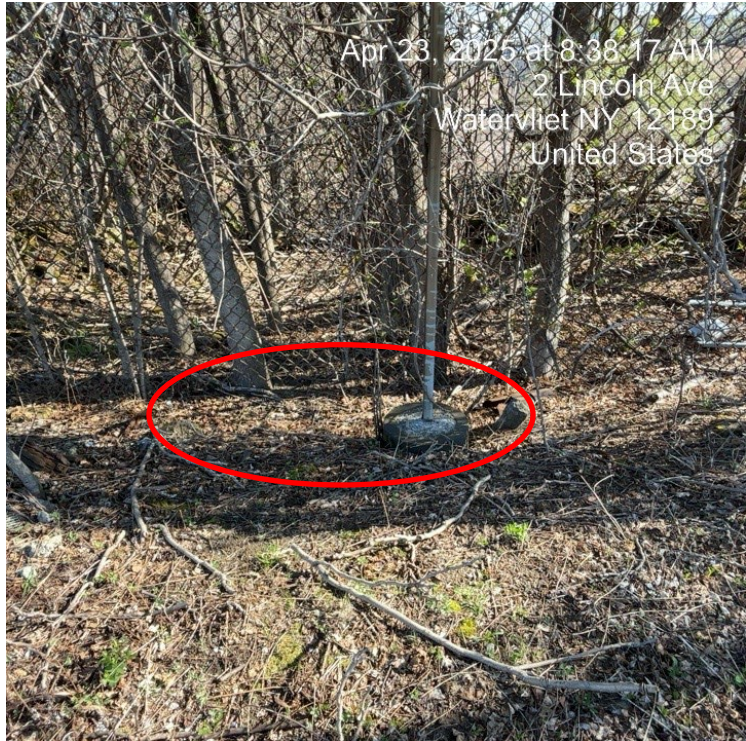
<p>Apr 23, 2025 at 8:38:17 AM 2 Lincoln Ave Watervliet NY 12189 United States</p>		
<b>Date:</b> April 23, 2025			
<b>Photograph:</b> 9			
<b>Direction:</b> Southeast			
<b>Description:</b> Opening in fence near railroad tracks along Lincoln Ave.			
<b>Photographer:</b> John Walsh

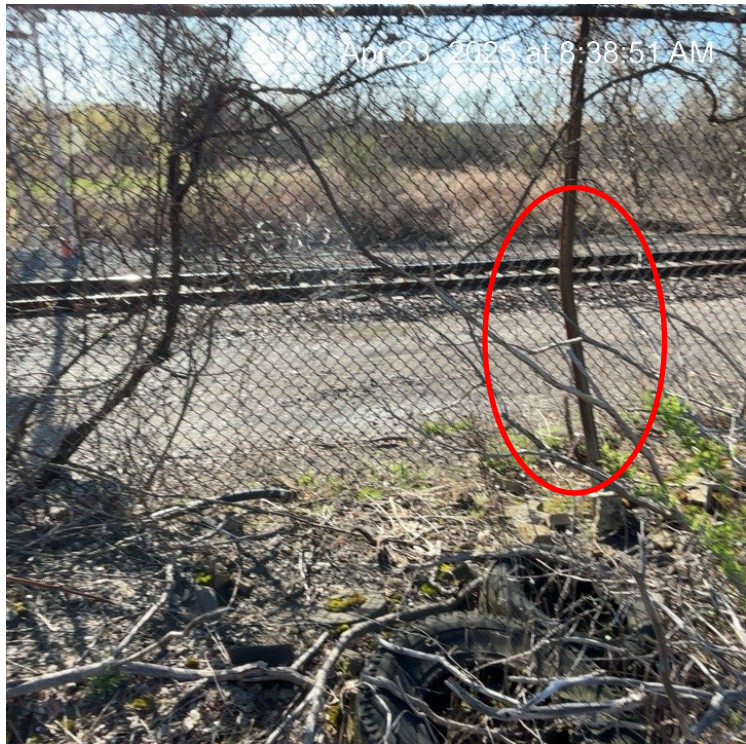
<p>Apr 23, 2025 at 8:38:51 AM</p>		
<b>Date:</b> April 23, 2025			
<b>Photograph:</b> 10			
<b>Direction:</b> Southeast			
<b>Description:</b> Damaged fence near railroad tracks on Southeast side of site.
