May 22, 2025

Subject:       **2025 Annual Inspection Report**  
                  **AL Tech Specialty Steel (Site No. 401003)**  
                  **Earth Environment Engineering and Geology P.C., Project No. 3616206100**

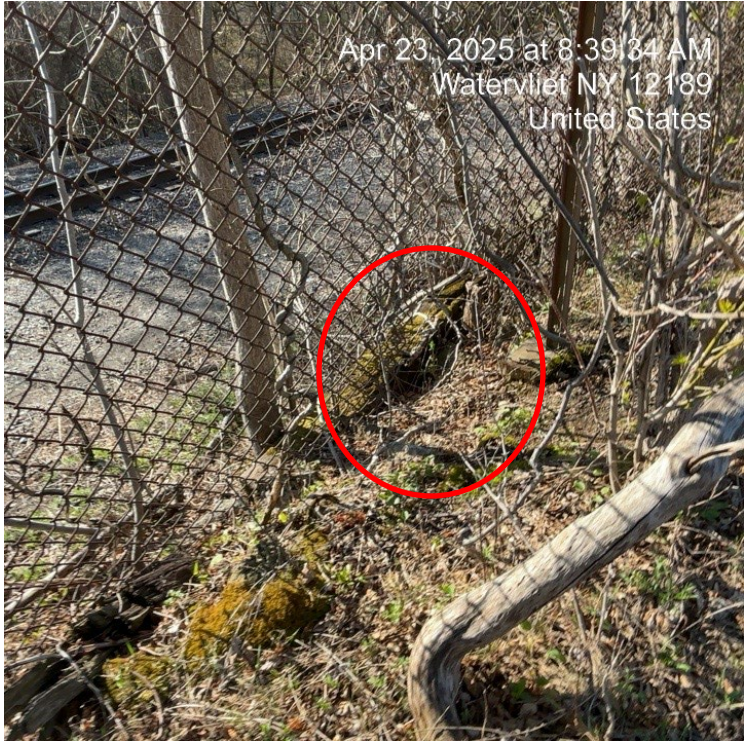
<b>Date:</b> April 23, 2025			
<b>Photograph:</b> 11			
<b>Direction:</b> South			
<b>Description:</b> Hole in Southeast side fence near railroad.			
<b>Photographer:</b> John Walsh

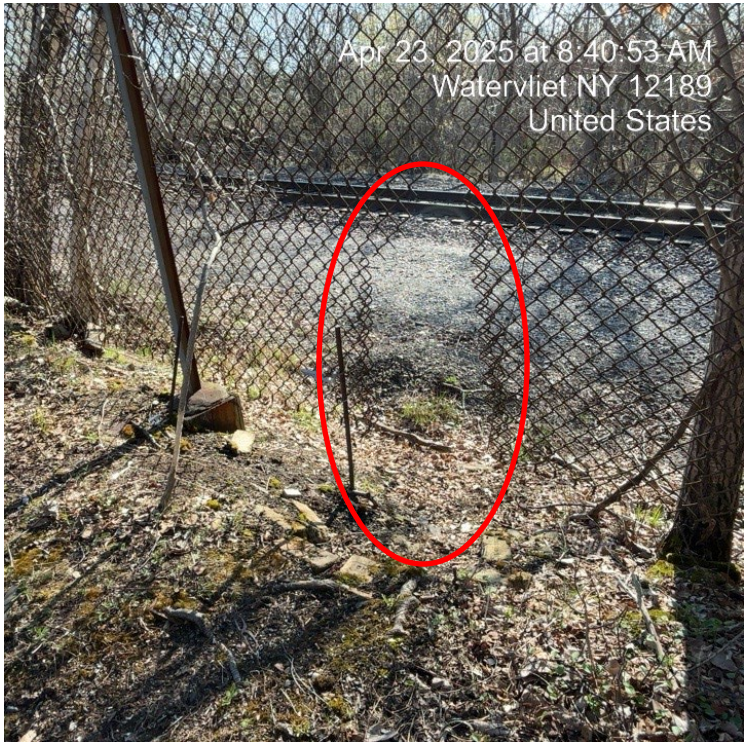
<b>Date:</b> April 23, 2025			
<b>Photograph:</b> 12			
<b>Direction:</b> Southeast			
<b>Description:</b> Opening/cut in fence on Southeast side of site, near railroad.

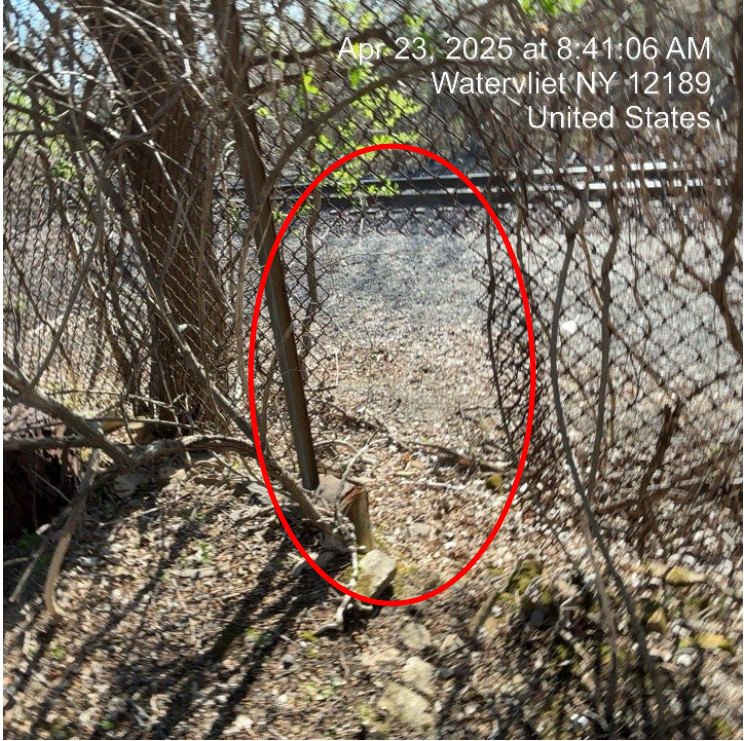
Apr 23, 2025 at 8:41:06 AM Watervliet NY 12189 United States	
<b>Date:</b> April 21, 2022			
<b>Photograph:</b> 13			
<b>Direction:</b> Southeast			
<b>Description:</b> Opening/cut in fence on Southeast side of site, near railroad.			
<b>Photographer:</b> John Walsh

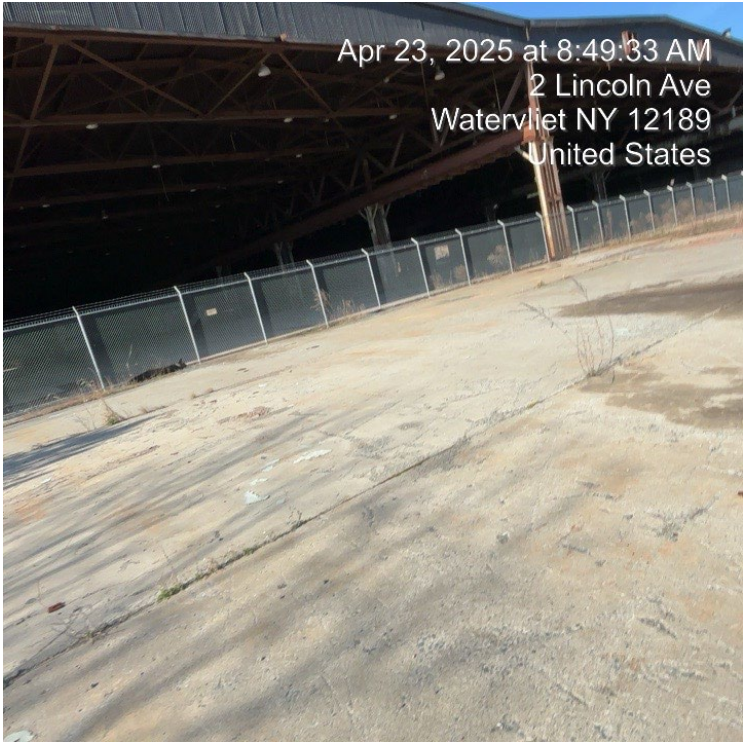
Apr 23, 2025 at 8:49:33 AM 2 Lincoln Ave Watervliet NY 12189 United States	
<b>Date:</b> April 23, 2025			
<b>Photograph:</b> 14			
<b>Direction:</b> Southwest			
<b>Description:</b> New fencing restricting access to last remaining building on site.

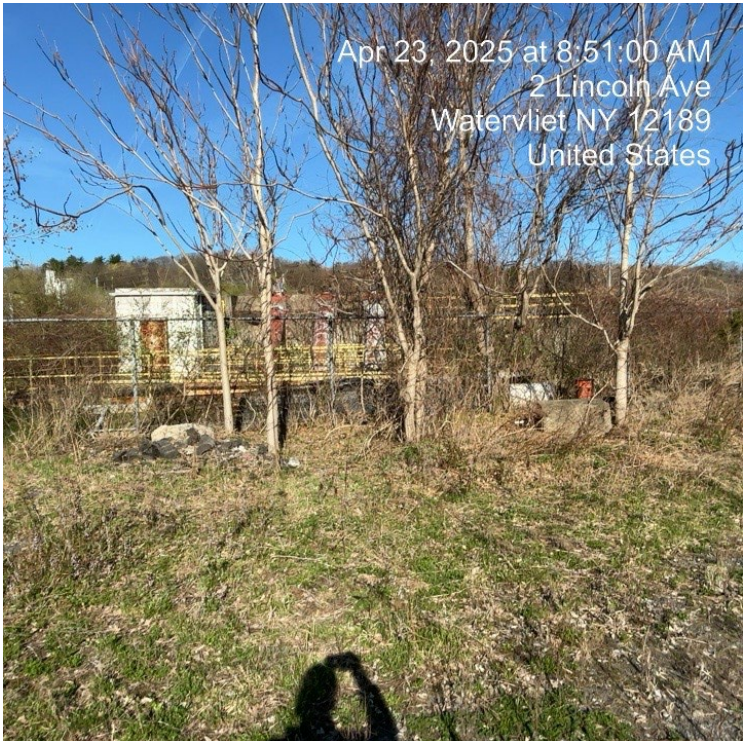
<b><i>Date:</i></b> April 23, 2025	
<b><i>Photograph:</i></b> 15	
<b><i>Direction:</i></b> Northwest	
<b><i>Description:</i></b> Fencing inside the site around old weighing station.	
<b><i>Photographer:</i></b> John Walsh

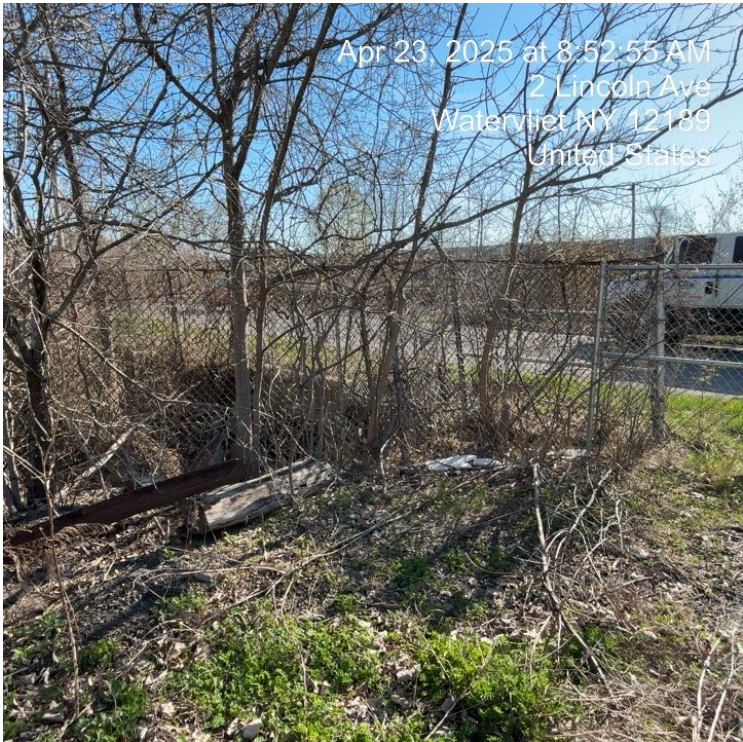
<b><i>Date:</i></b> April 23, 2025	
<b><i>Photograph:</i></b> 16	
<b><i>Direction:</i></b> Northeast	
<b><i>Description:</i></b> Overgrowth around fencing just north of Lincoln Ave site entrance, near Kromma Kill road crossing.

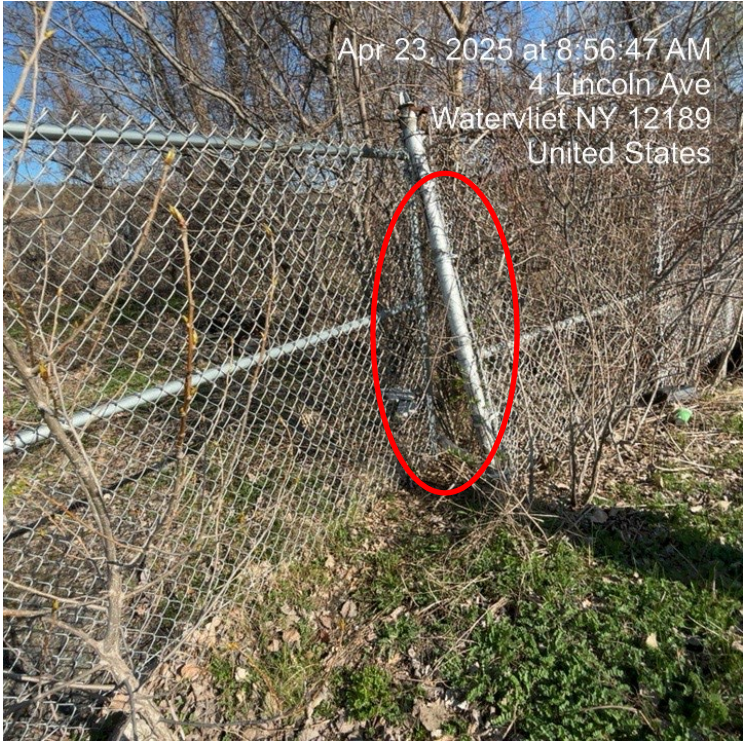
Apr 23, 2025 at 8:56:47 AM 4 Lincoln Ave Watervliet NY 12189 United States	
<b>Date:</b> April 23, 2025			
<b>Photograph:</b> 17			
<b>Direction:</b> North			
<b>Description:</b> Opening/damaged fence along east side of site along Lincoln Ave.			
<b>Photographer:</b> John Walsh

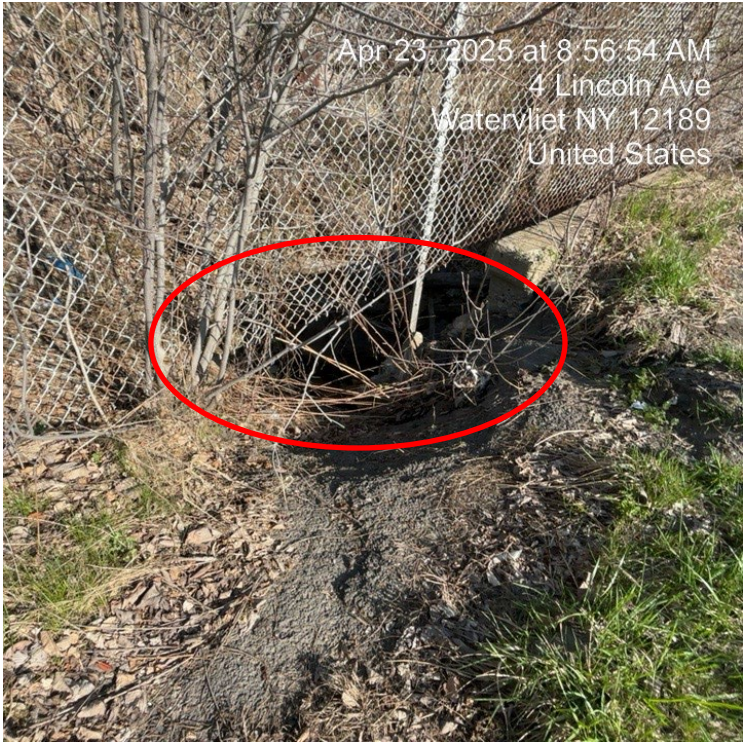
Apr 23, 2025 at 8:56:54 AM 4 Lincoln Ave Watervliet NY 12189 United States	
<b>Date:</b> April 23, 2025			
<b>Photograph:</b> 18			
<b>Direction:</b> North			
<b>Description:</b> Opening at the bottom of fence along East side of site.

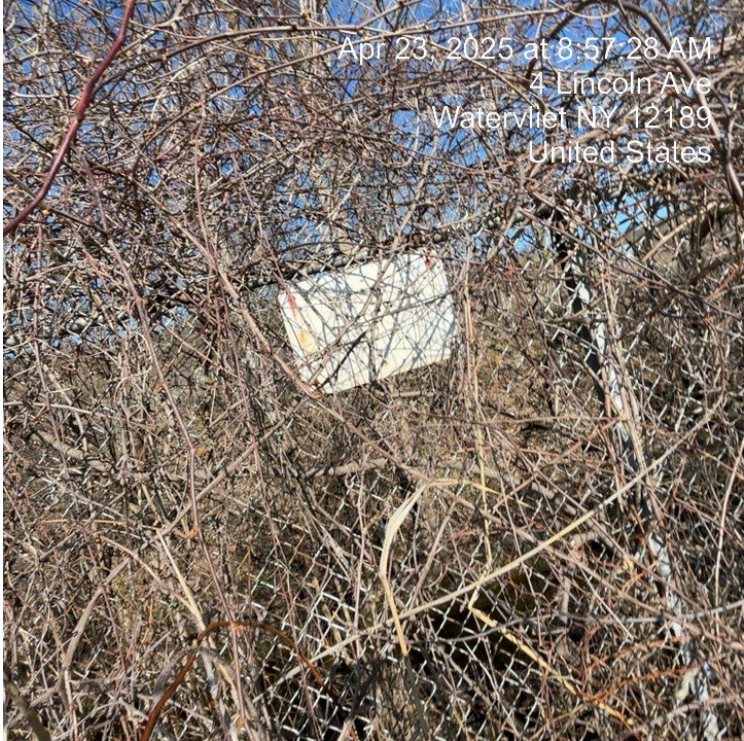
Apr 23, 2025 at 8:57:28 AM 4 Lincoln Ave Watervliet NY 12189 United States	
<b>Date:</b> April 23, 2025			
<b>Photograph:</b> 19			
<b>Direction:</b> Northwest			
<b>Description:</b> Faded signage along East side of site.			
<b>Photographer:</b> John Walsh

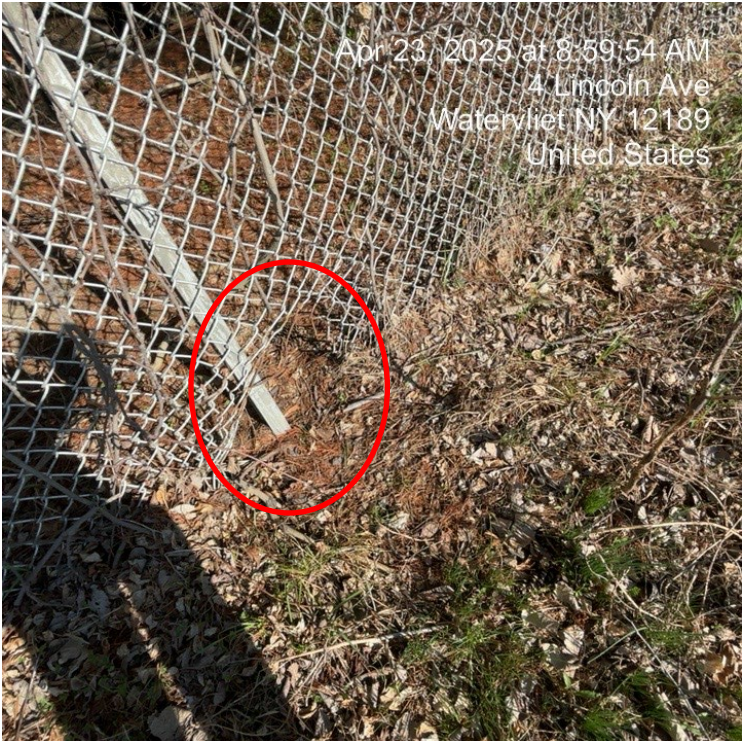
Apr 23, 2025 at 8:59:54 AM 4 Lincoln Ave Watervliet NY 12189 United States	
<b>Date:</b> April 23, 2025			
<b>Photograph:</b> 20			
<b>Direction:</b> North			
<b>Description:</b> Opening/cut in fence along east side of site.

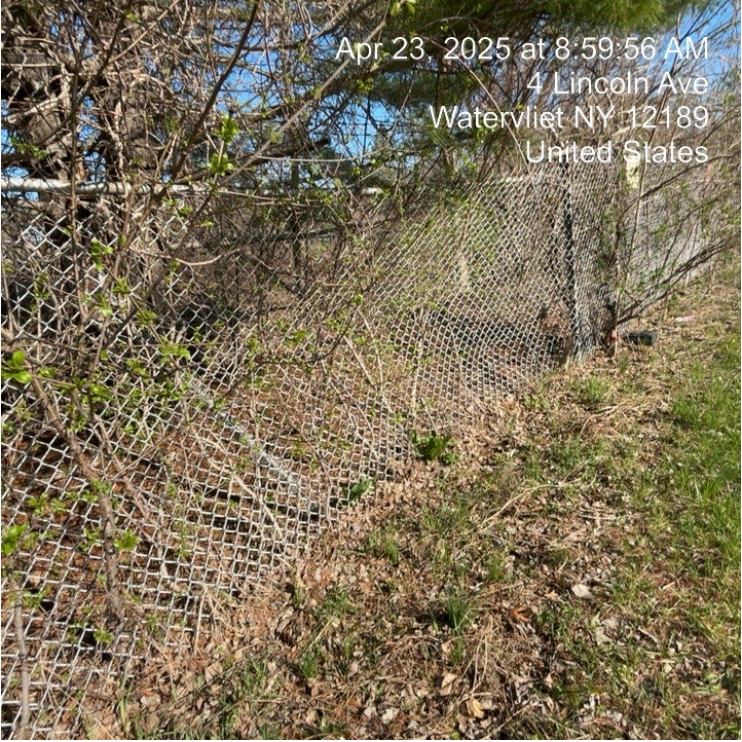
Apr 23, 2025 at 8:59:56 AM 4 Lincoln Ave Watervliet NY 12189 United States	
<b>Date:</b> April 23, 2022			
<b>Photograph:</b> 21			
<b>Direction:</b> North			
<b>Description:</b> Damaged/leaning fence along East side of the site.			
<b>Photographer:</b> John Walsh

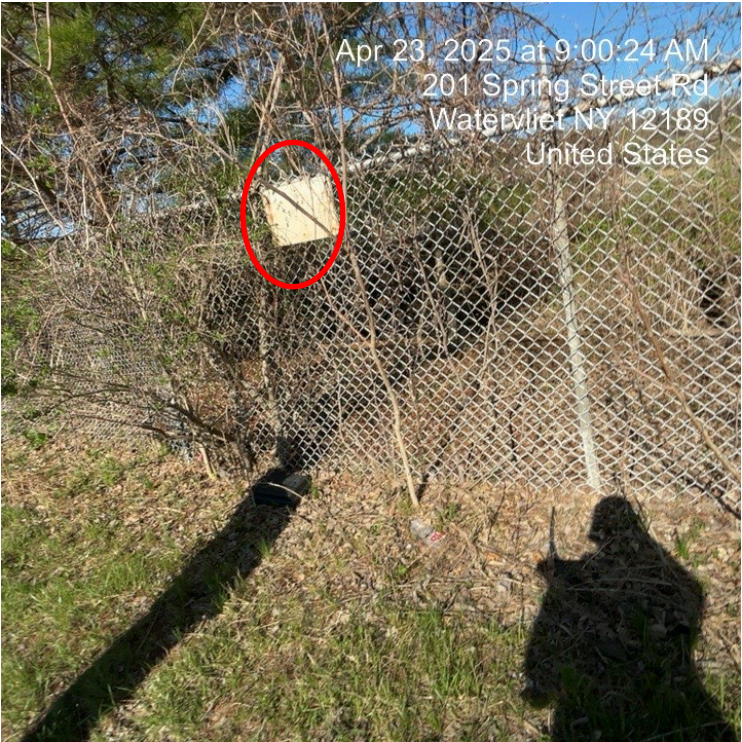
Apr 23, 2025 at 9:00:24 AM 201 Spring Street Rd Watervliet NY 12189 United States	
<b>Date:</b> April 23, 2025			
<b>Photograph:</b> 22			
<b>Direction:</b> West			
<b>Description:</b> Faded signage along the East side of the site fencing.

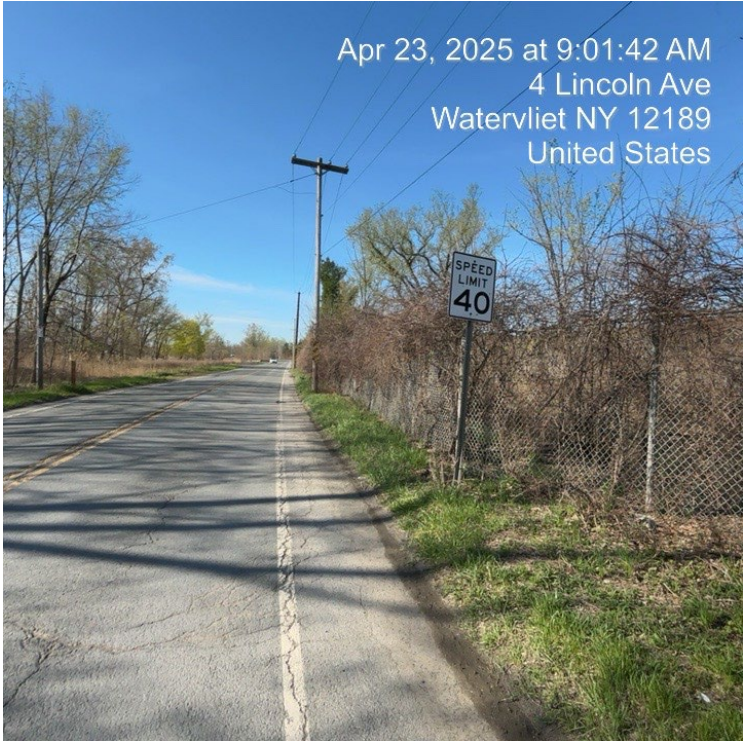
Apr 23, 2025 at 9:01:42 AM 4 Lincoln Ave Watervliet NY 12189 United States	
<b>Date:</b> April 23, 2025			
<b>Photograph:</b> 23			
<b>Direction:</b> South			
<b>Description:</b> Overgrowth along Lincoln Ave fence.			
<b>Photographer:</b> John Walsh

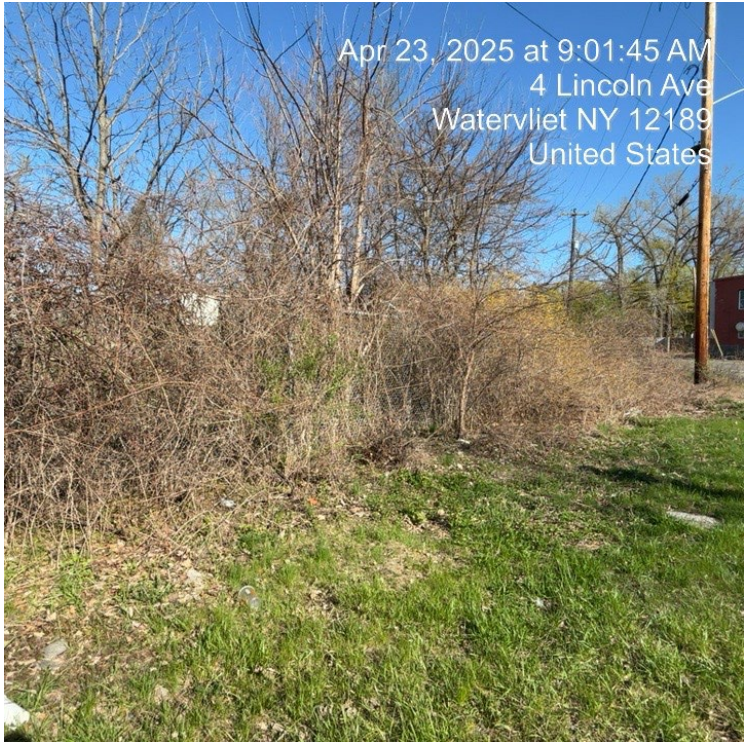
Apr 23, 2025 at 9:01:45 AM 4 Lincoln Ave Watervliet NY 12189 United States	
<b>Date:</b> April 23, 2025			
<b>Photograph:</b> 24			
<b>Direction:</b> Southwest			
<b>Description:</b> Overgrowth along fence at the corner of Lincoln Ave and Spring Street Rd.

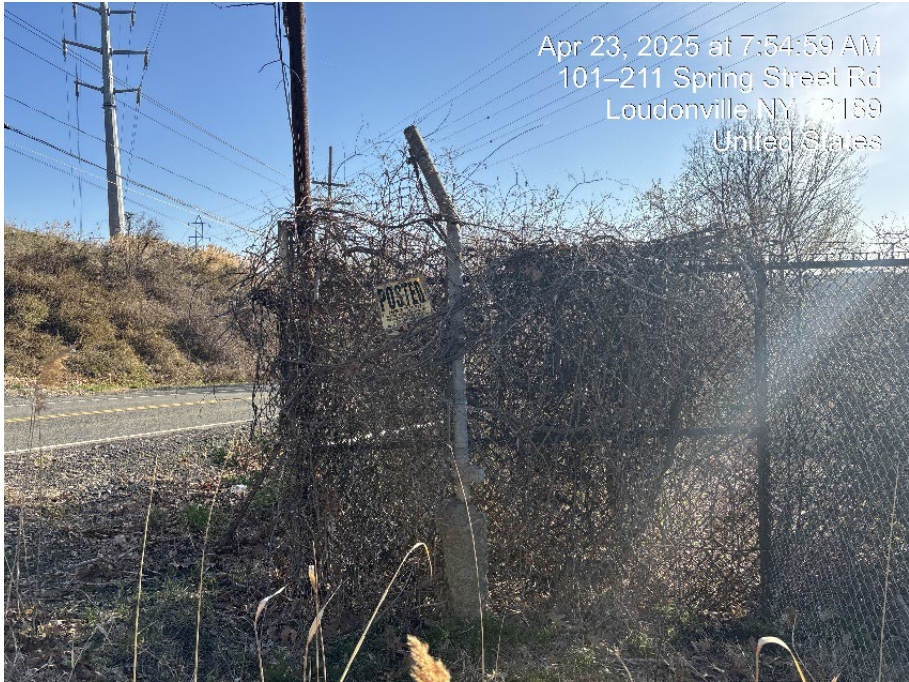
<p>Apr 23, 2025 at 7:54:59 AM 101-211 Spring Street Rd Loudonville NY 12189 United States</p>		
<b>Date:</b> April 23, 2025			
<b>Photograph:</b>			
<b>Direction:</b> East			
<b>Description:</b> Overgrowth and signage along Northwest end of site.			
<b>Photographer:</b> John Walsh

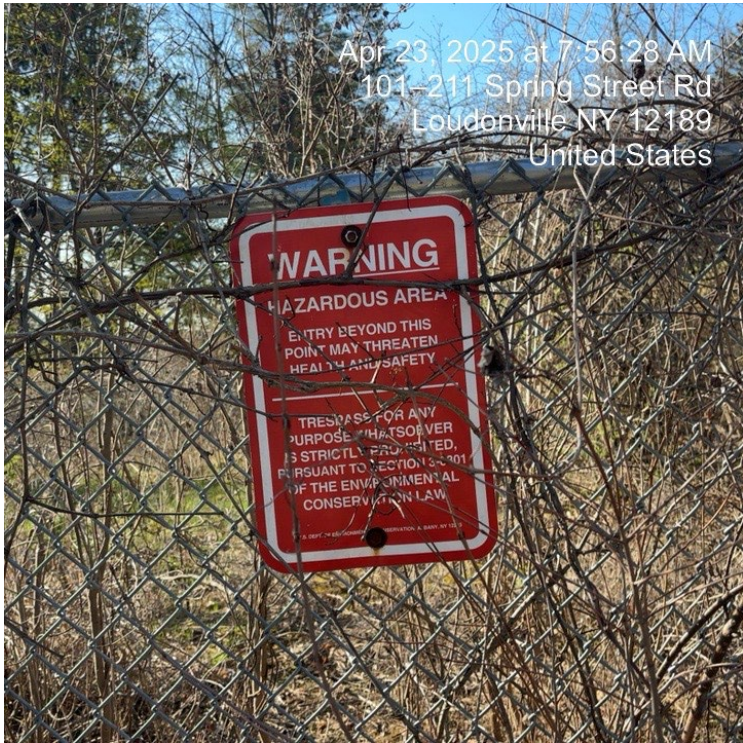
<p>Apr 23, 2025 at 7:56:28 AM 101-211 Spring Street Rd Loudonville NY 12189 United States</p>		
<b>Date:</b> April 23, 2025			
<b>Photograph:</b>			
<b>Direction:</b> South			
<b>Description:</b> Newer signage along Spring Street Rd fence.

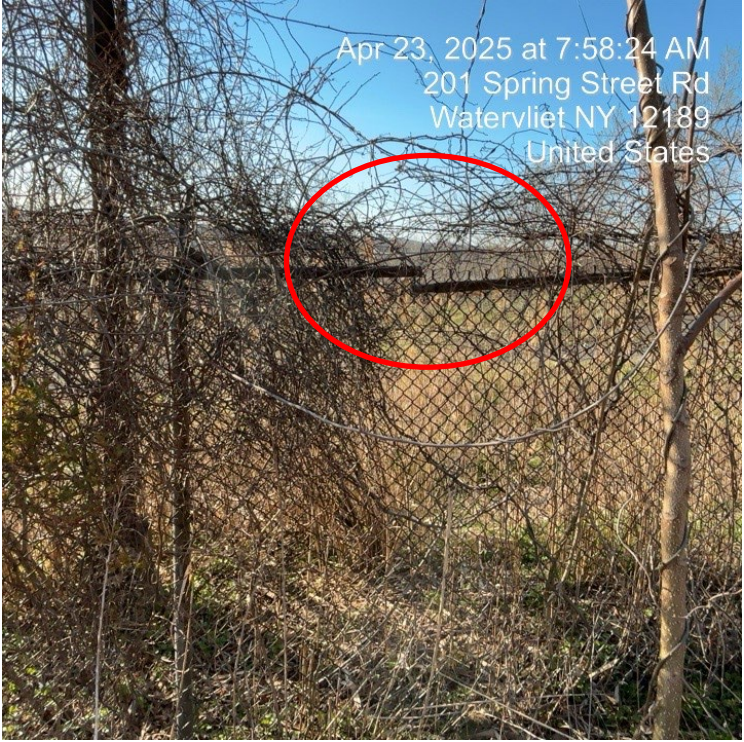
Apr 23, 2025 at 7:58:24 AM 201 Spring Street Rd Watervliet NY 12189 United States	
<b>Date:</b> April 23, 2025			
<b>Photograph:</b> 27			
<b>Direction:</b> Southeast			
<b>Description:</b> Damaged fence along Spring Street Rd Fence.			
<b>Photographer:</b> John Walsh

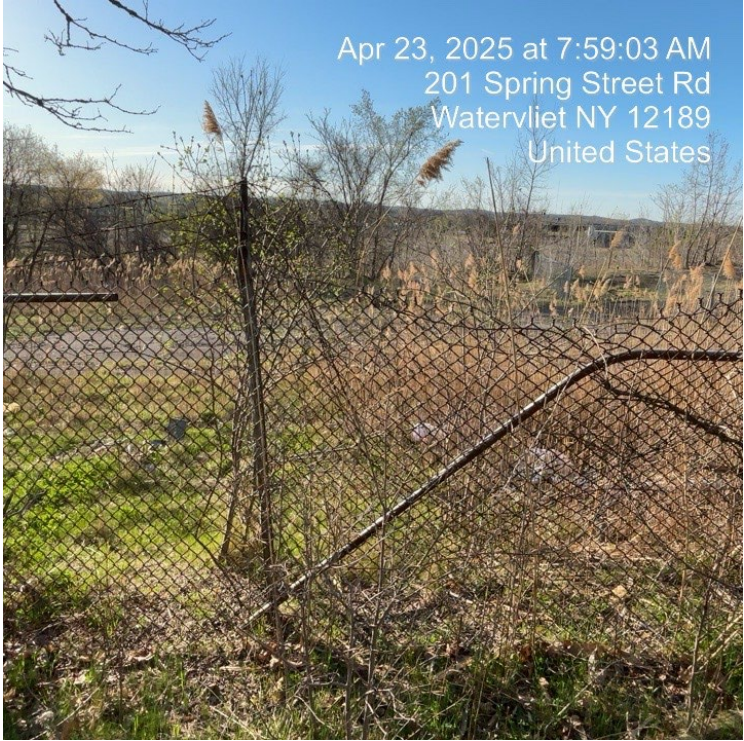
Apr 23, 2025 at 7:59:03 AM 201 Spring Street Rd Watervliet NY 12189 United States	
<b>Date:</b> April 23, 2025			
<b>Photograph:</b> 28			
<b>Direction:</b> South			
<b>Description:</b> Damaged fence along Spring Street Rd.

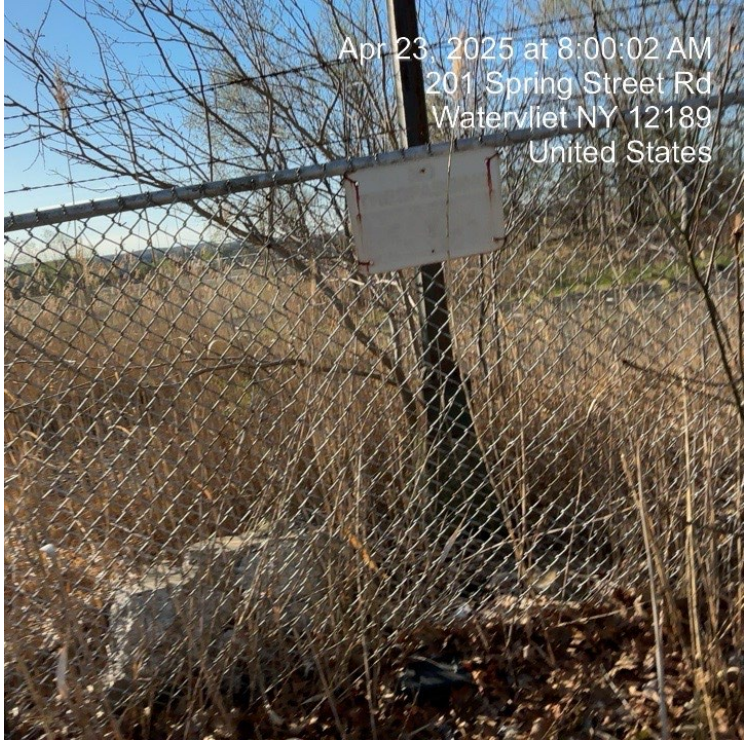
Apr 23, 2025 at 8:00:02 AM 201 Spring Street Rd Watervliet NY 12189 United States	
<b>Date:</b> April 23, 2025			
<b>Photograph:</b> 29			
<b>Direction:</b> South			
<b>Description:</b> Faded signage along Spring Street Rd fence.			
<b>Photographer:</b> John Walsh

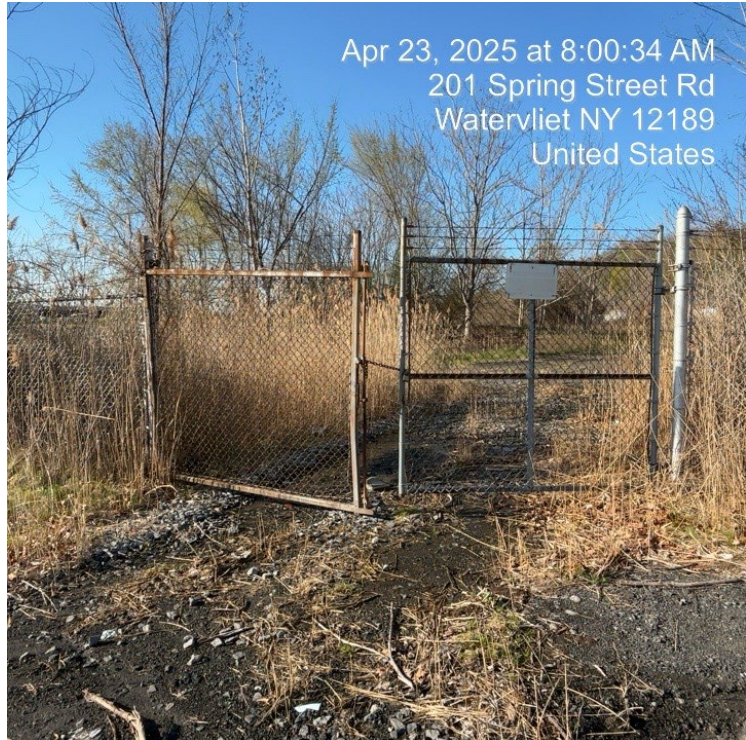
- The perimeter fence around the eastern and northern portions of the MPA is largely intact; however, several cut openings were observed south of Lincoln Ave along the railroad tracks and along Spring Street Road (**Attachment 3; Photographs 3, 4, 7, 11, 12, 13, 17, 20 and 36**). These openings allow access to Site trespassers and should be secured in anticipation of future activities for OU-1 and OU-4.
- The access gate and fencing near the guard shack on Spring Street Ave was observed to be in poor shape, with gaps and dumped material in the area (**Attachment 3; Photographs 30, 31 and 32**). The access gate for the northern portion of the site was observed to be missing a lock (**Attachment**

Apr 23, 2025 at 8:00:34 AM 201 Spring Street Rd Watervliet NY 12189 United States	
<b>Date:</b> April 23, 2025			
<b>Photograph:</b> 30			
<b>Direction:</b> West			
<b>Description:</b> Site entrance near Spring Street Rd. (dumping was noted at this area)

**3; Photograph 30).** Vehicle traffic through the northern gate is blocked by dumped debris and the gate is in poor repair, limiting its opening capabilities. It is recommended that this gate be secured with a new chain and combination lock.

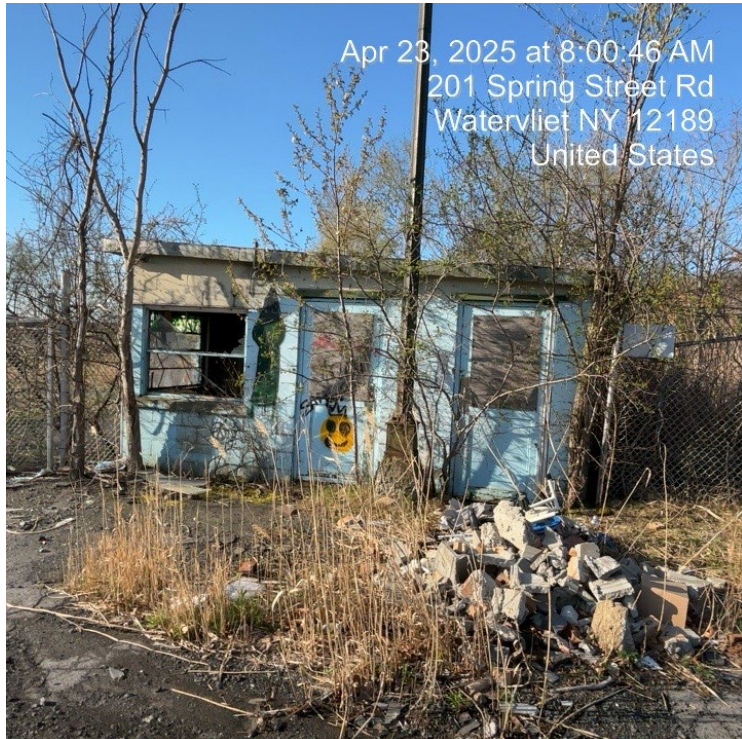
Abandoned building along fence line at Spring Street Rd site entrance. (dumping was noted at this area)

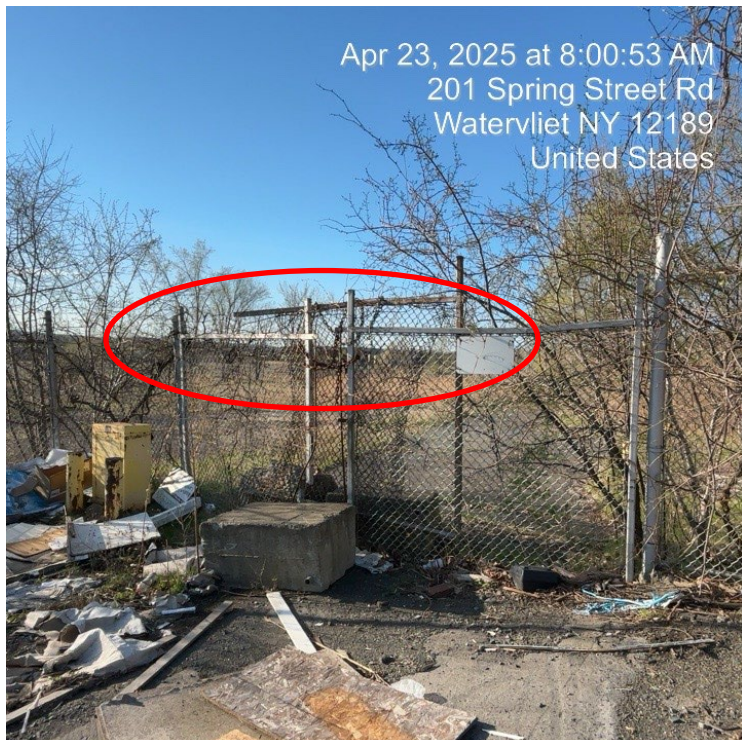
Fence damaged near Spring Street Rd site entrance. (dumping was noted at this area)

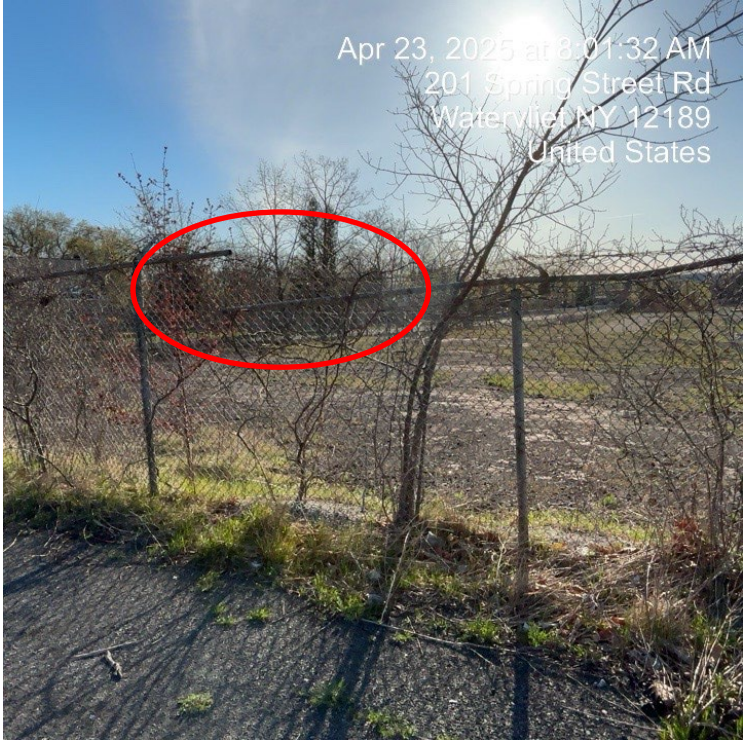
<b>Date:</b> April 23, 2025			
<b>Photograph:</b> 33			
<b>Direction:</b> East			
<b>Description:</b> Damaged fence near Spring Street Rd site entrance.			
<b>Photographer:</b> John Walsh

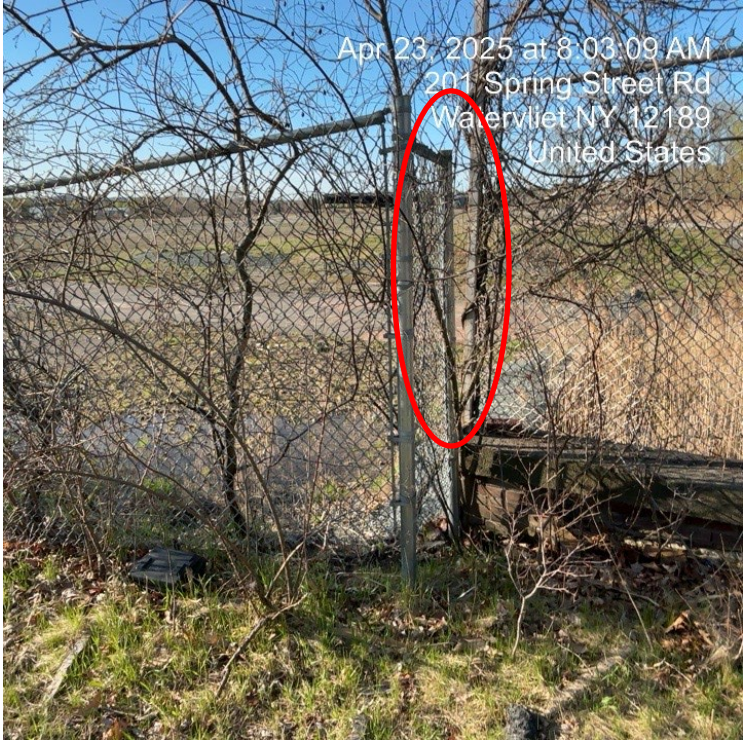
<b>Date:</b> April 23, 2025			
<b>Photograph:</b> 34			
<b>Direction:</b> South			
<b>Description:</b> Opening between fence connection along Spring Street Rd.
