**Groundwater Monitoring Operation and Maintenance
Inspection Report**
Al Tech Specialty Steel, Site No. 401003
OU2 – Waste Management Area

Groundwater Operation and Maintenance Inspection Report

Facility: Al Tech Specialty Steel, Site No. 401003, Waste Management Area, Operable Unit 2

Inspection Date: February 3, 4, and June 9 2025

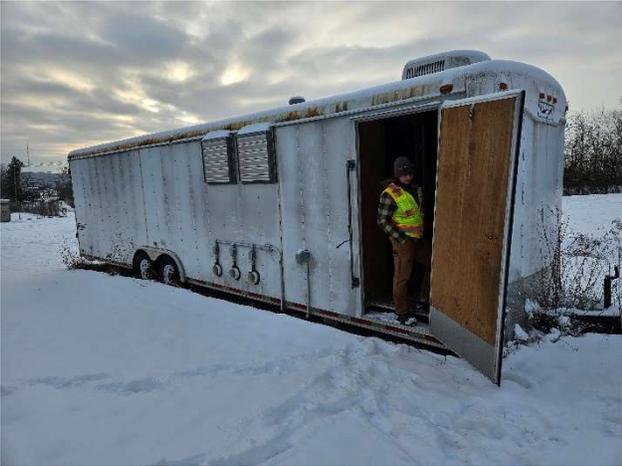
Trailer in front of leachate building	Vandalized / damaged door on trailer being evaluated.

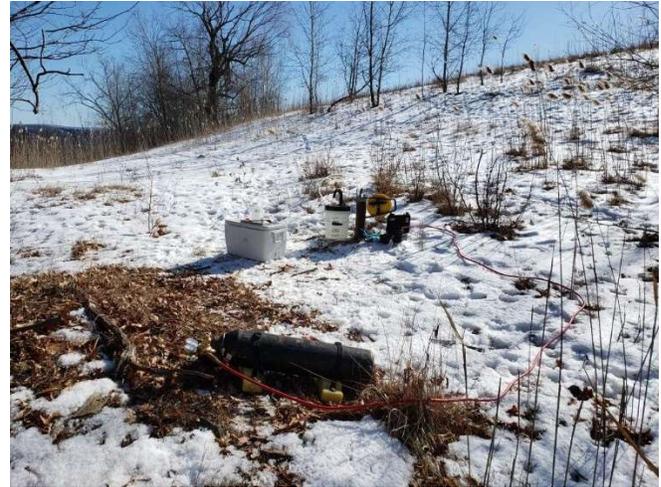
The monitoring wells were also inspected and appear to be in good condition. WW-27B has a damaged concrete collar, but NYSDEC and their contractor will continue to inspect this well on an annual basis and repair the collar if needed.

The landfill and its monitoring wells appear to be well maintained and in generally good condition. The concrete collar around WW-27B will continue to be inspected on a yearly basis and repaired if deemed necessary.

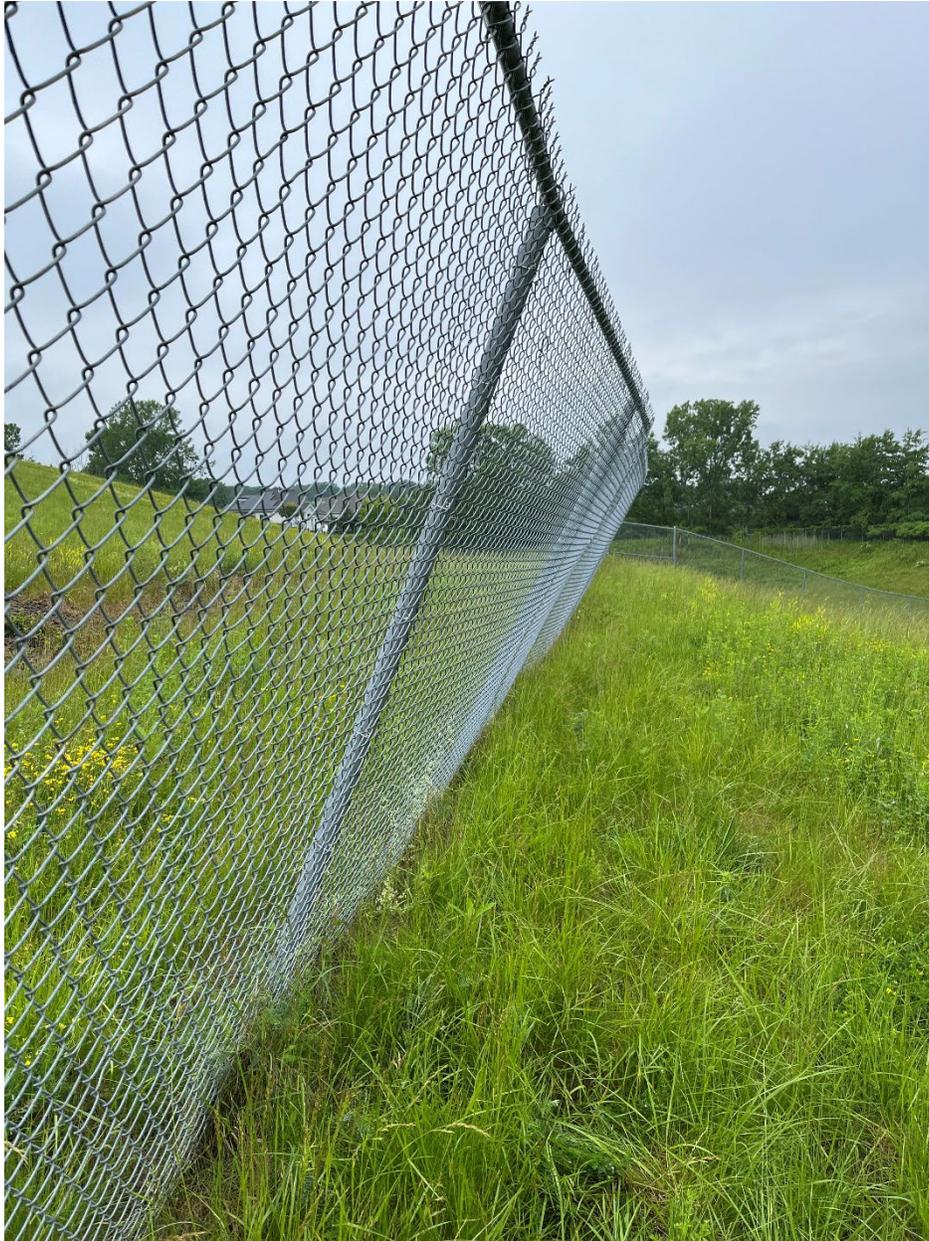
Leaning Fence along Eastern WMA Edge

Issues in need of action is the repair of the fence along the northern portion of the landfill, fissures along the ravine, and installation of locking covers. WSP will hire sub contractors to address these issues.

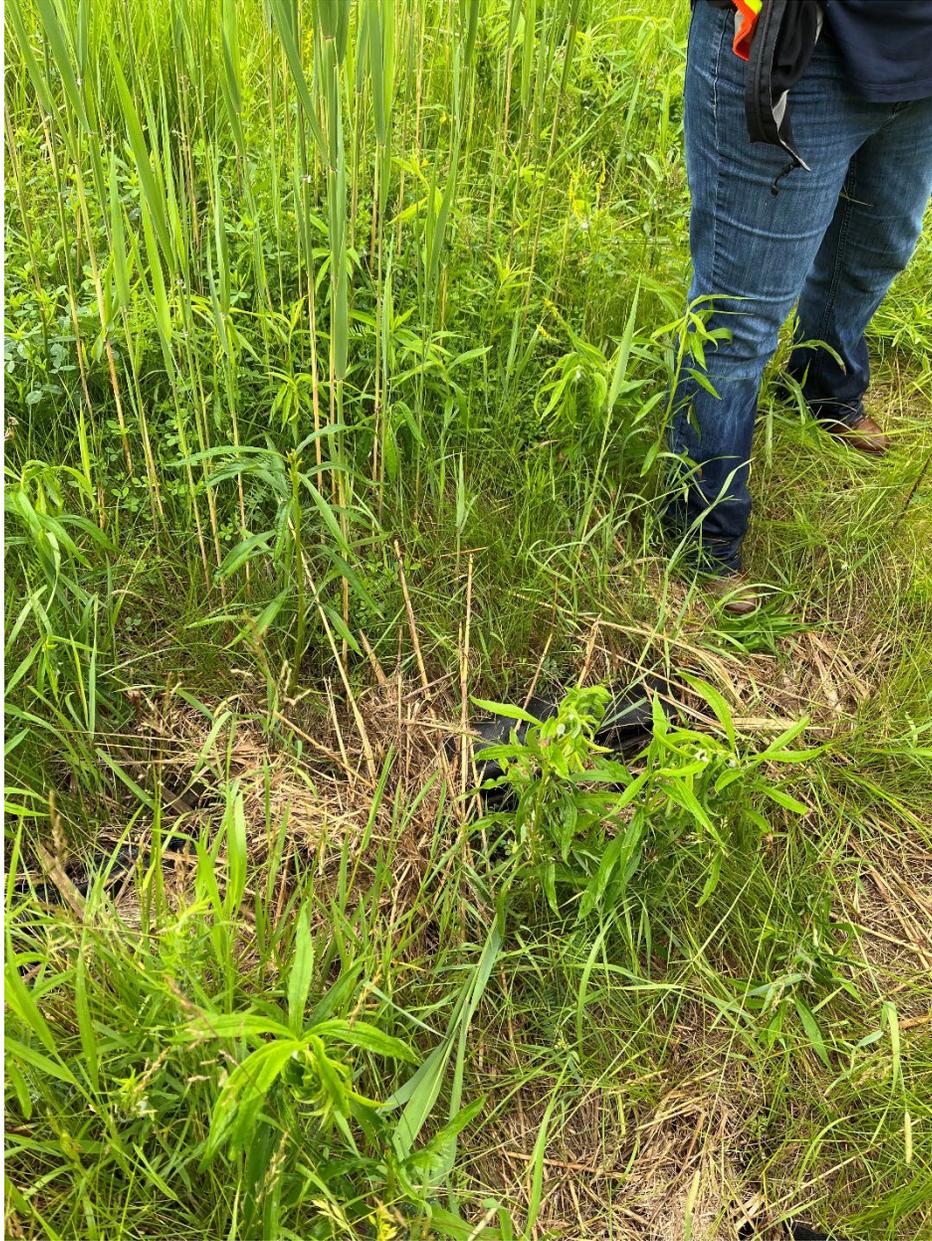
Exposed Silt Fence

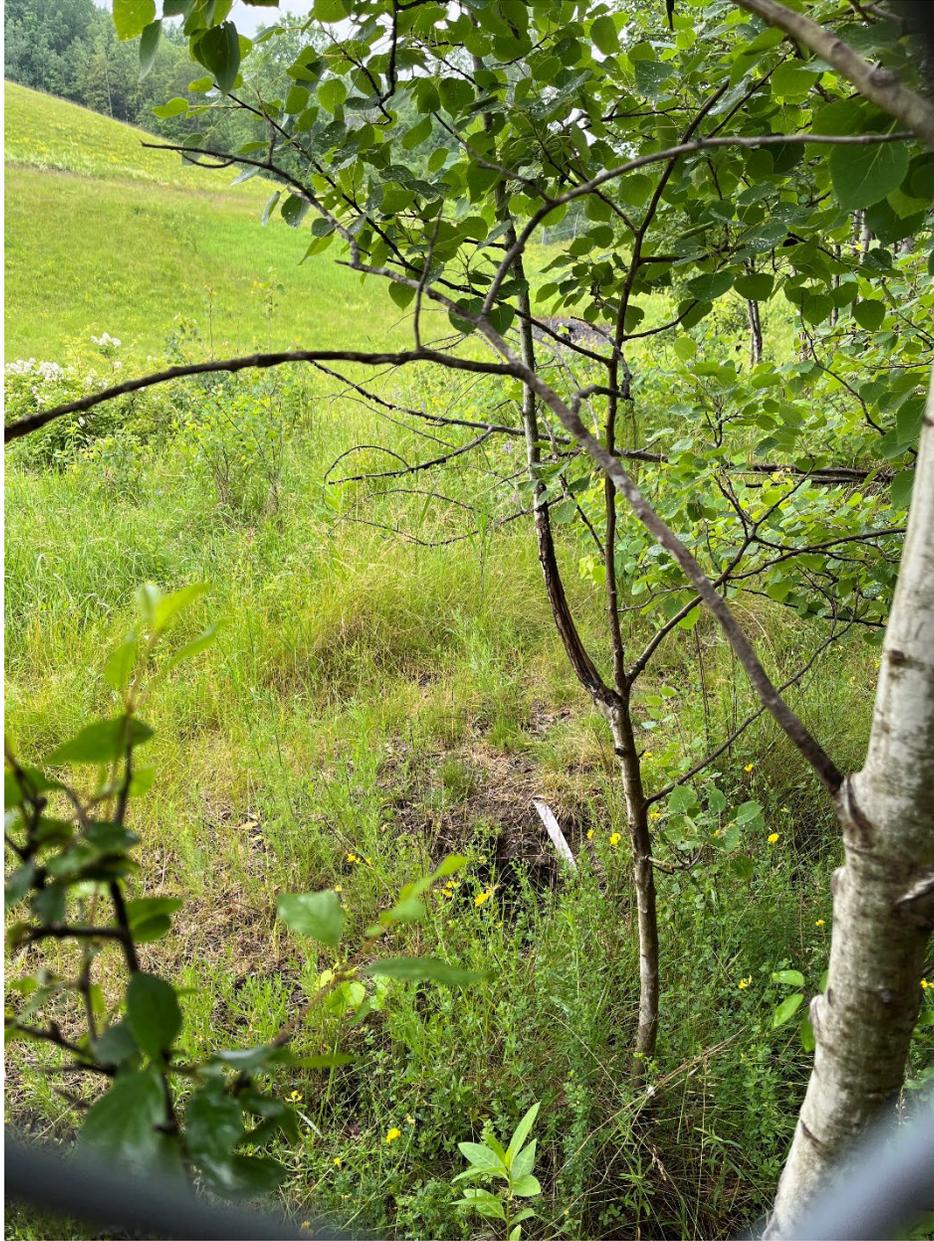
Fissures forming on WMA

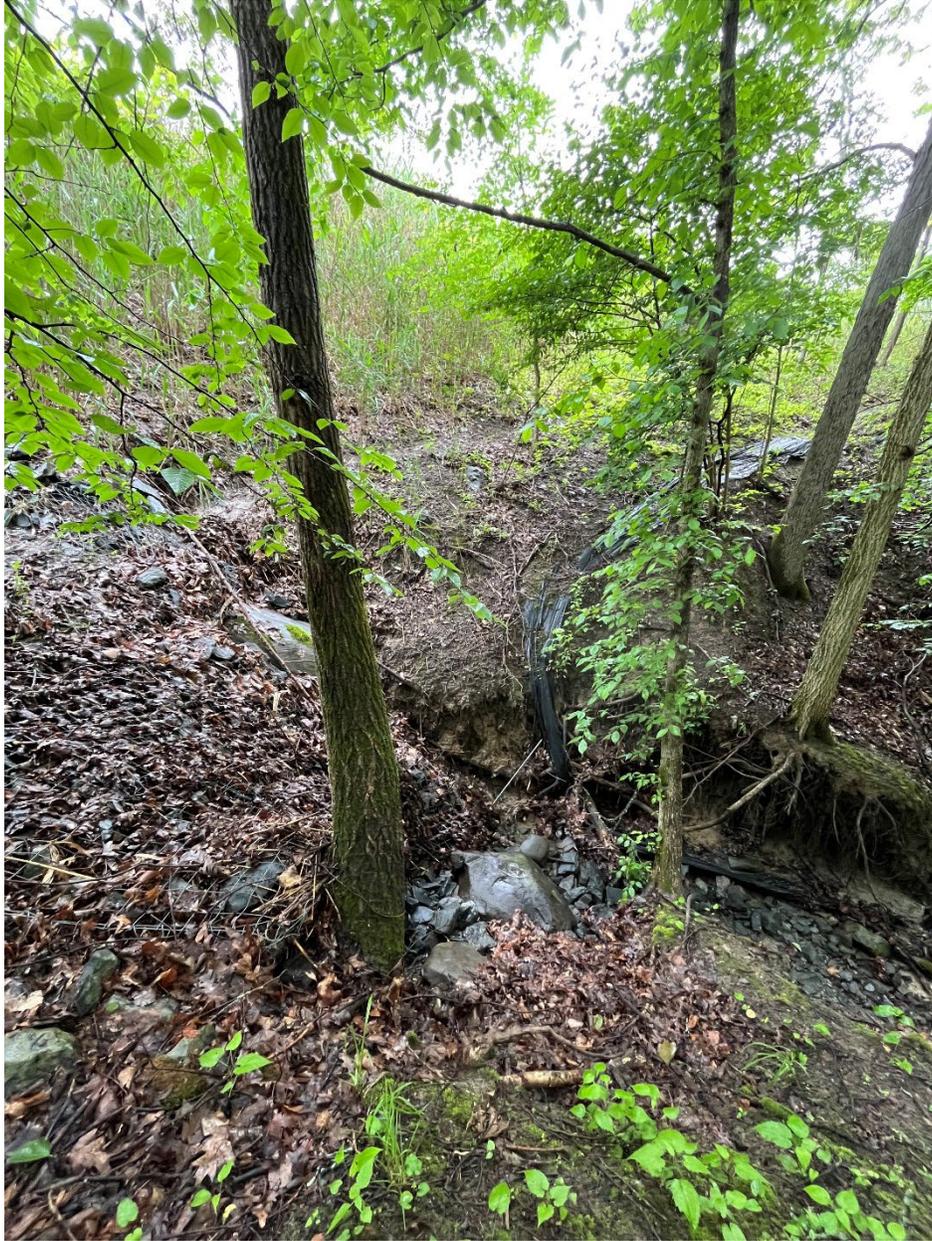
Failing Erosion Control along Bearoff Boundary

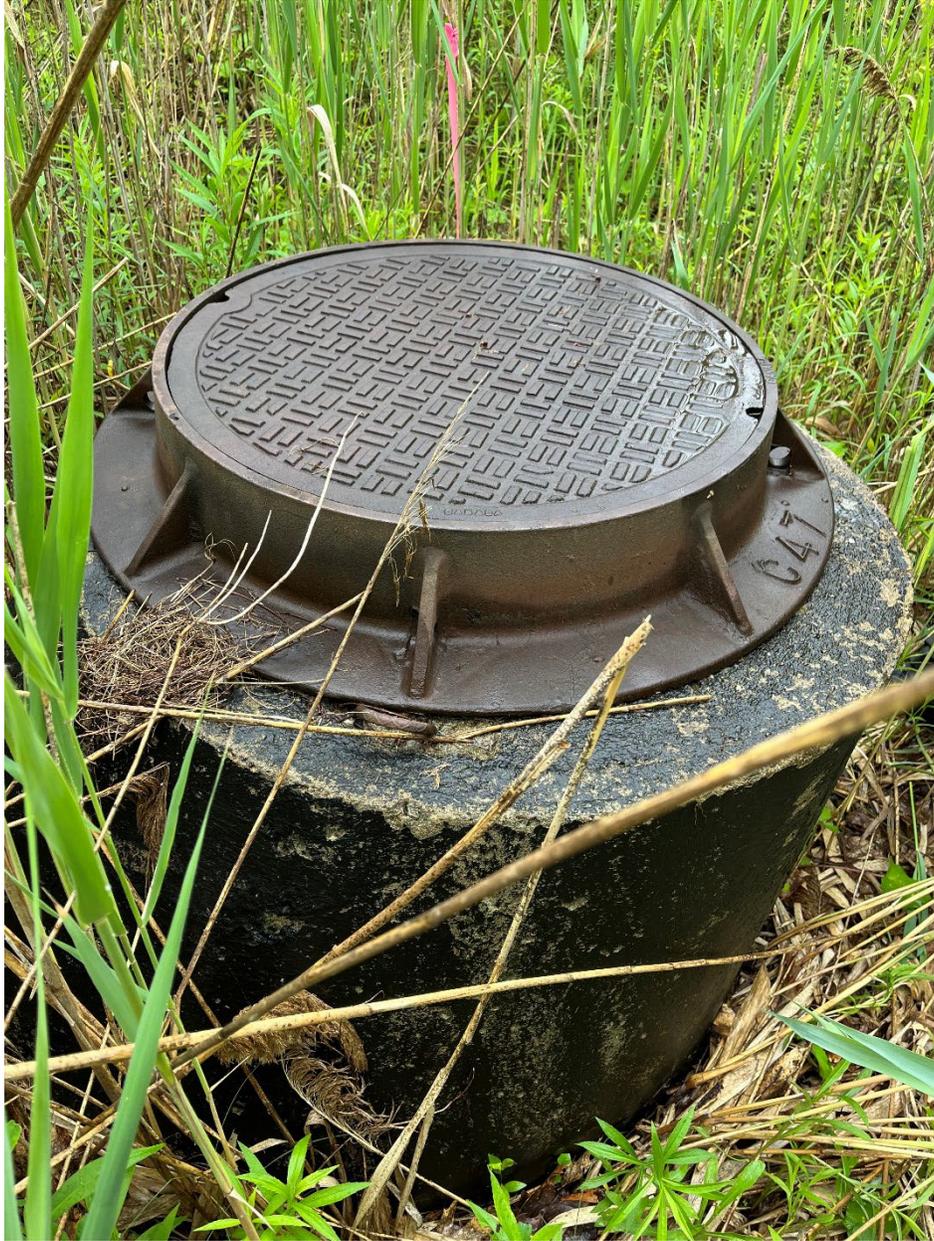
Manhole Cover to be Replaced
