| FACILITY: <b>Former Bendix Landfill)</b> | NYSDEC SITE NO. 401005 |

### LANDFILL INSPECTION CHECKLIST

# Honeywell (Bendix) Inactive Closed Landfill. Follow-up Inspection 10/28/14 and 10/30/14

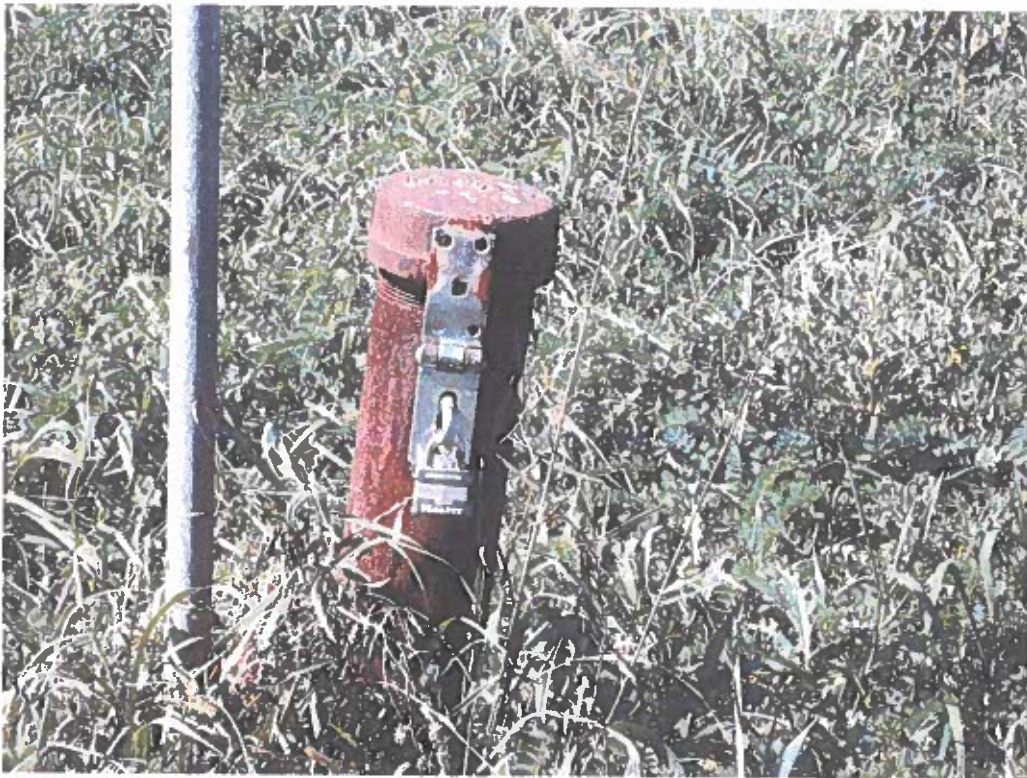
**Figure 1: Well Lock**

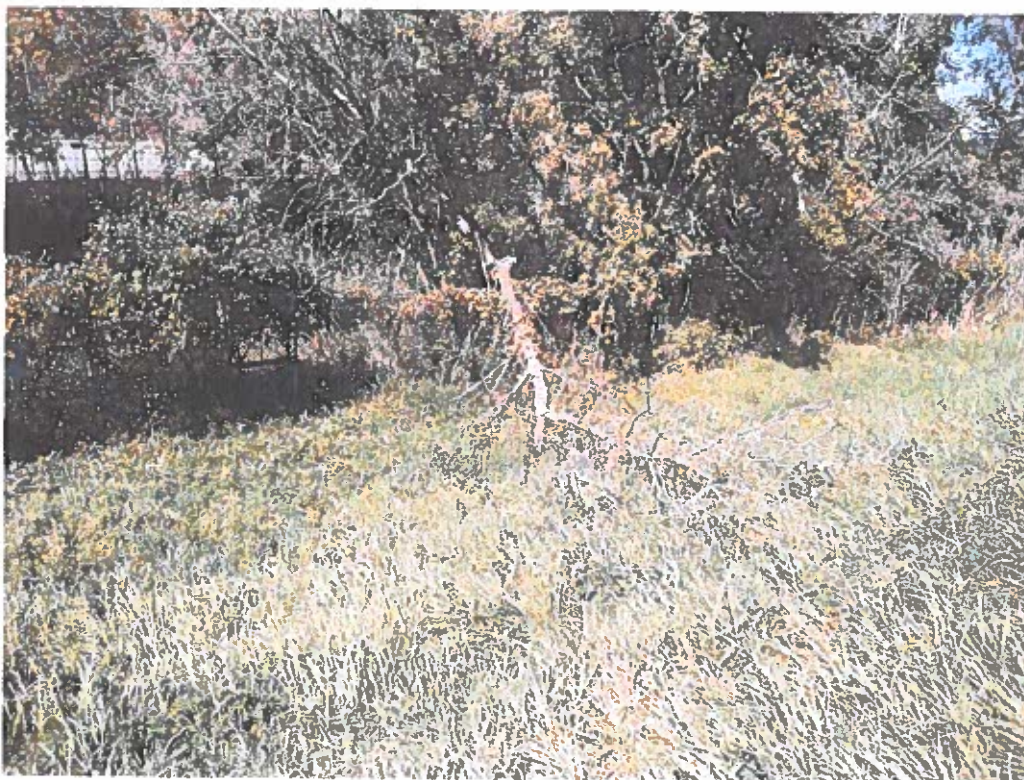
| Item No. | Item Description | Condition | | | Maintenance Required? | | | Comments |
|---|---|---|---|---|---|---|---|---|
| 12 | Are trees or shrubs (woody growth) present within the landfill cover? | ✓ | | | | ✓ | | Along fence line (tree), Remove tree |

**Figure 2: Fallen Tree**

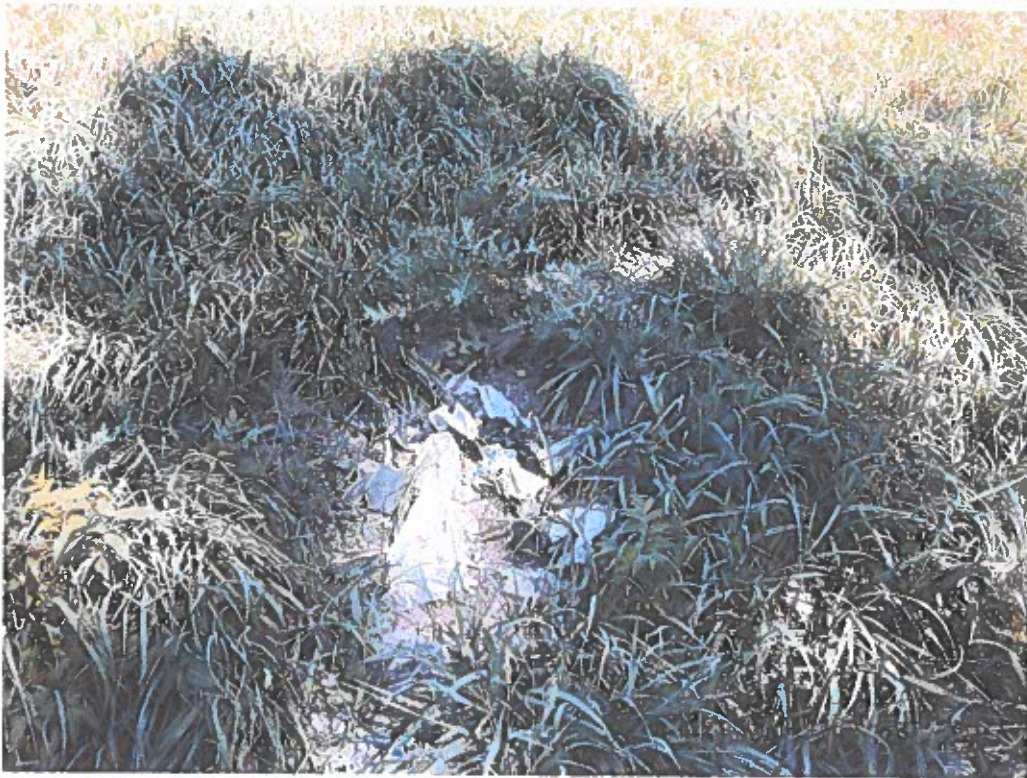
| Item No. | Item Description | Condition | | | Maintenance Required? | | | Comments |
|---|---|---|---|---|---|---|---|---|
| 15 | Is there evidence of damage due to burrowing animals? | ✓ | | | | ✓ | | 7 woodchuck holes |

**Figure 3: Woodchuck Hole**

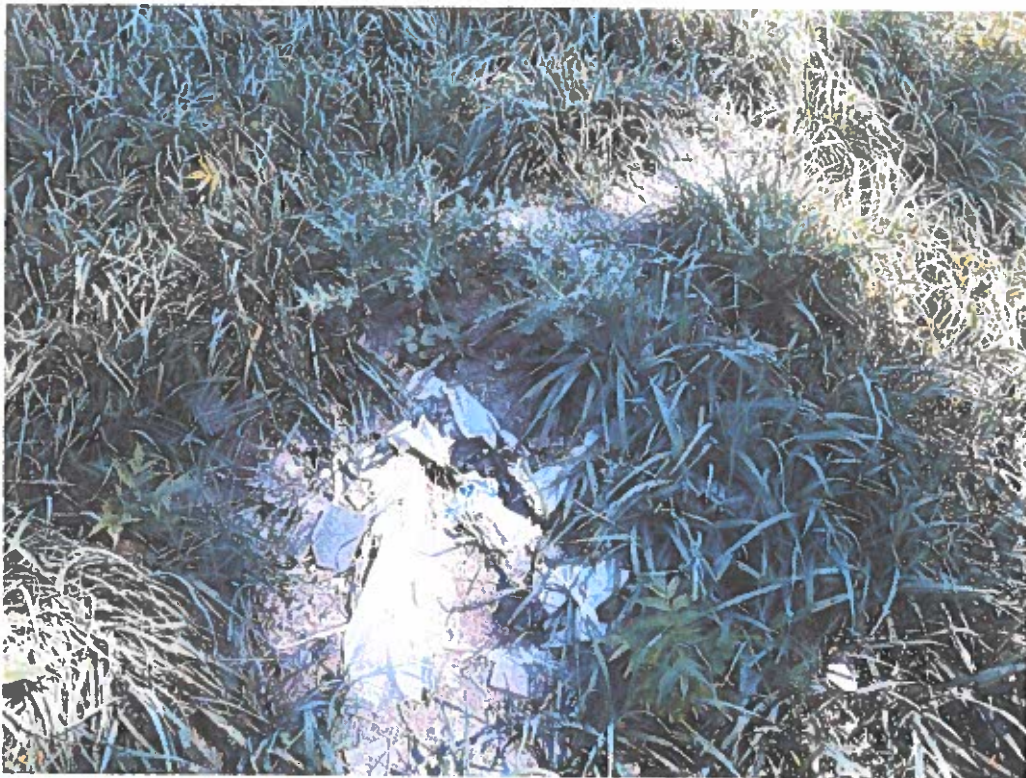
**Figure 4: Woodchuck Hole**

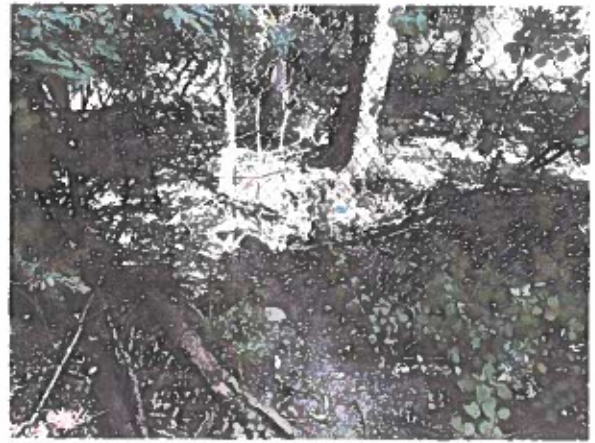
14 (Hole In Fence)

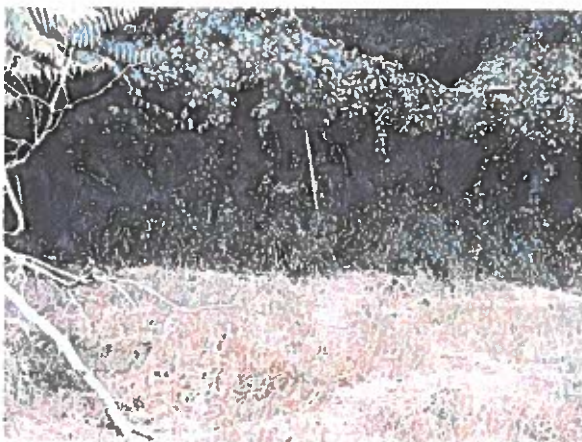
17 (Hole In Fence)

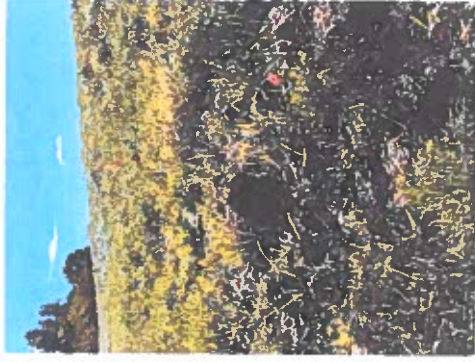
Chuck Hole #1

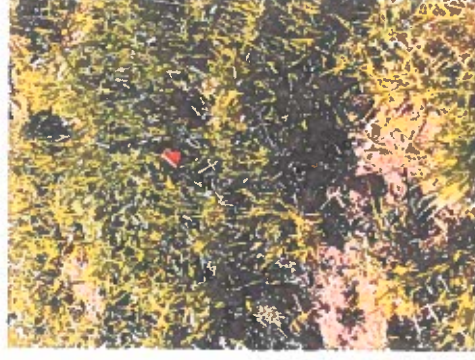
Chuck Hole #2

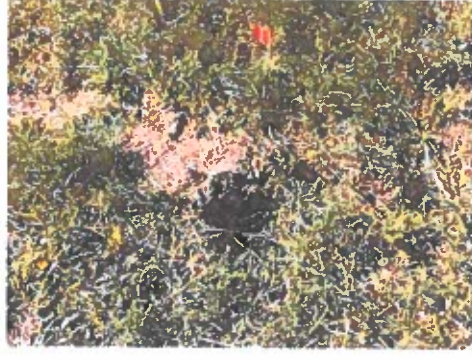
Chuck Hole #3

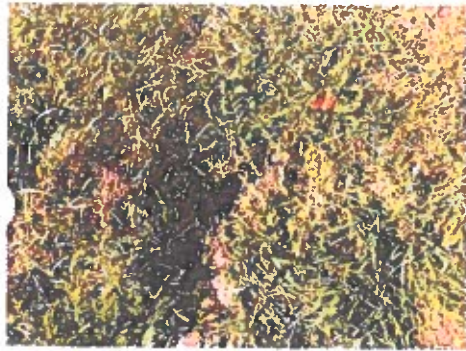
Chuck Hole #4

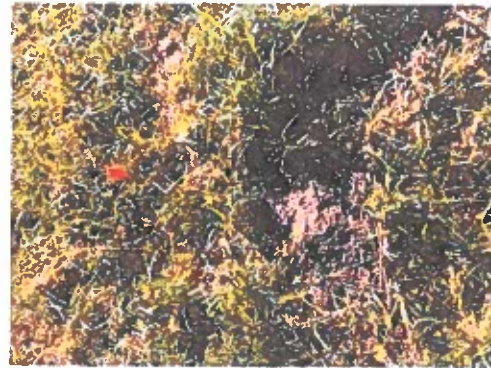
Chuck Hole #6

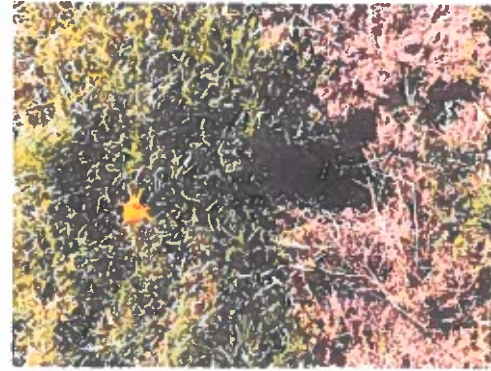
Chuck Hole #7

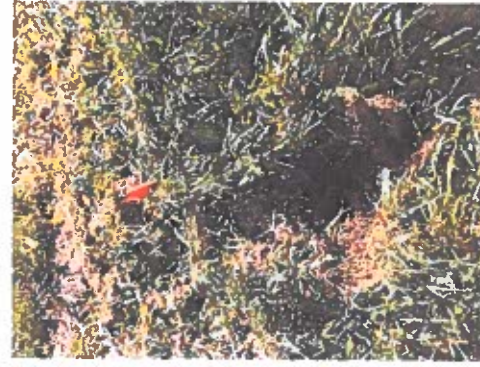
Chuck Hole #8

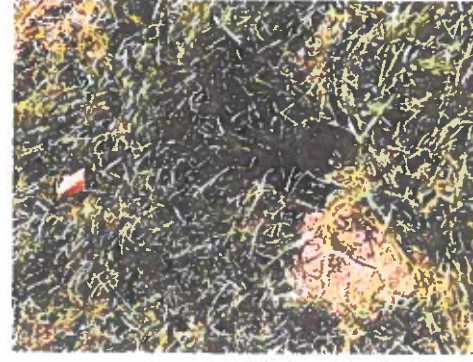
Chuck Hole #9

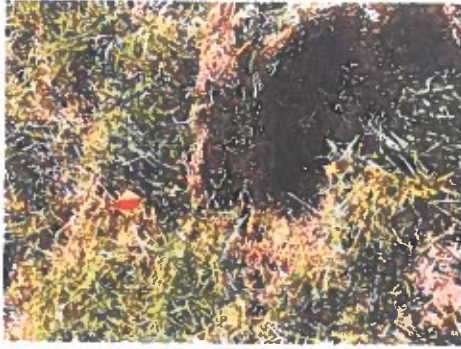
Chuck Hole #10

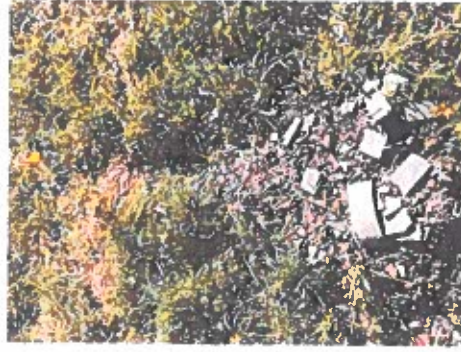
Chuck Hole #11

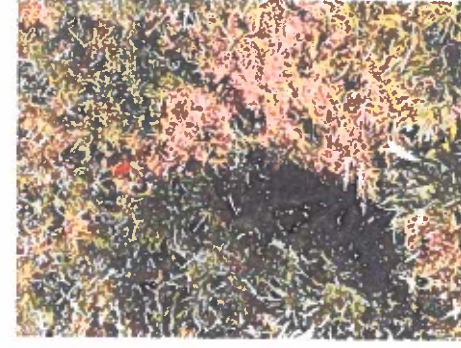
Chuck Hole #12

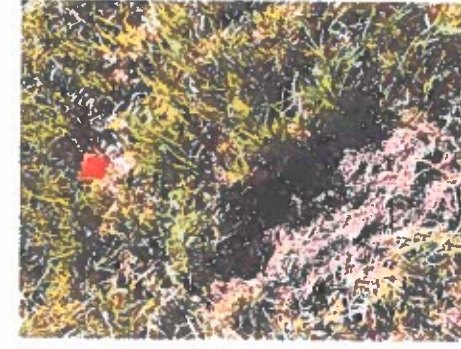
Chuck Hole #13

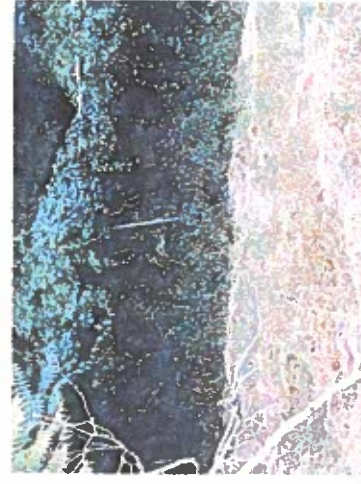
South Fence- 2

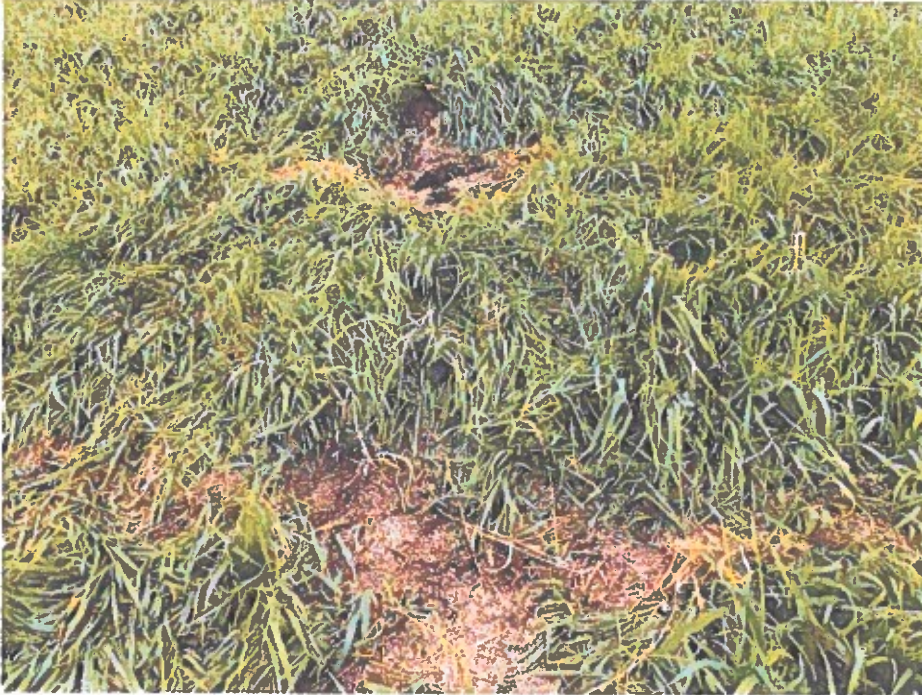
**Photograph: 1**

**Description:**  
Groundhog holes  
repaired and topped  
with contractors' seed

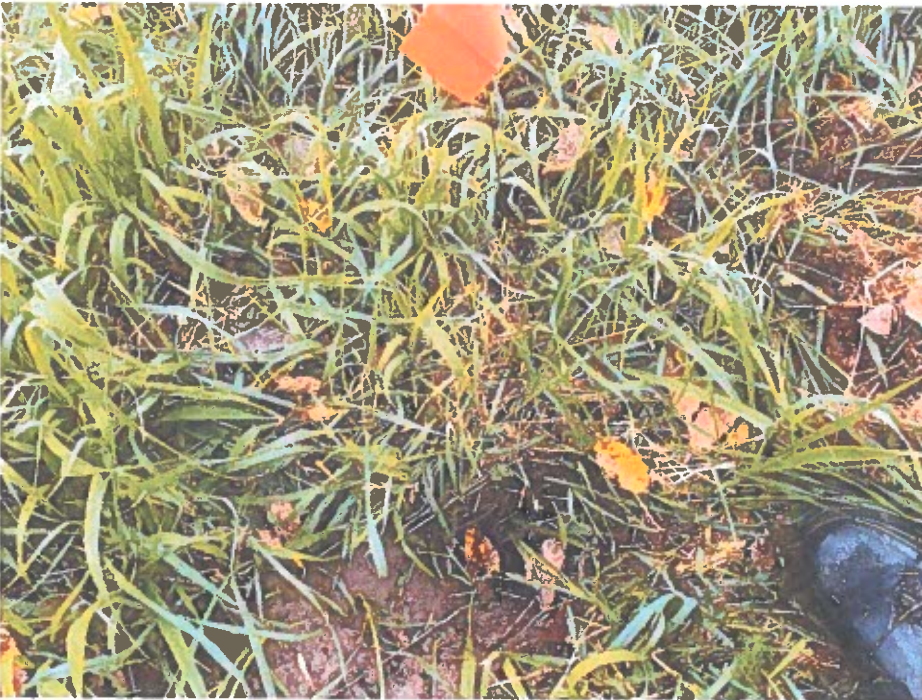
**Photograph: 2**

**Description:**  
Groundhog holes  
before repairing

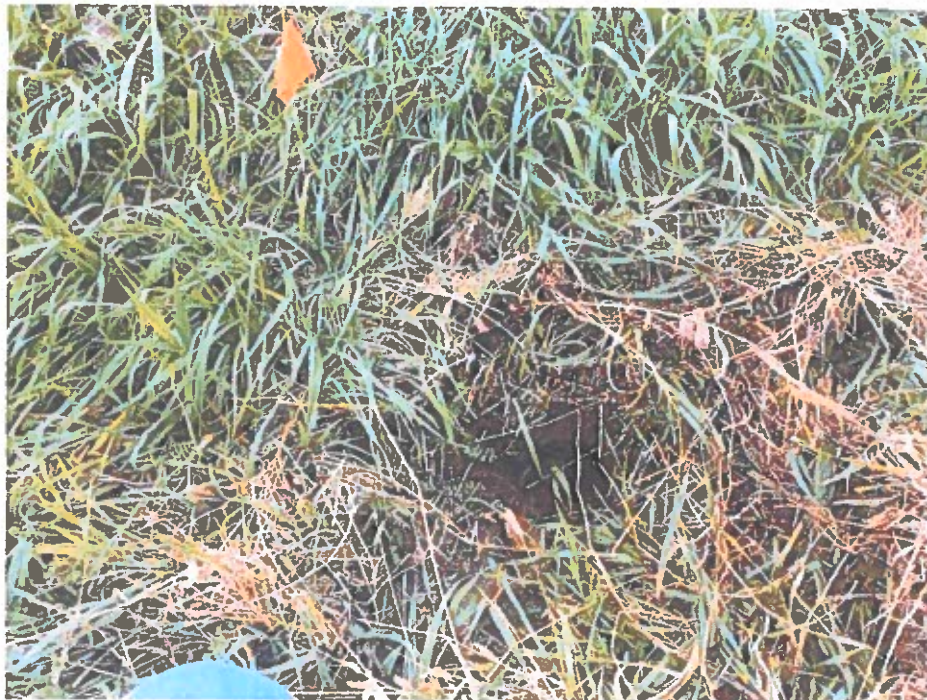
**Photograph: 3**

**Description:**  
Groundhog holes  
before repairing

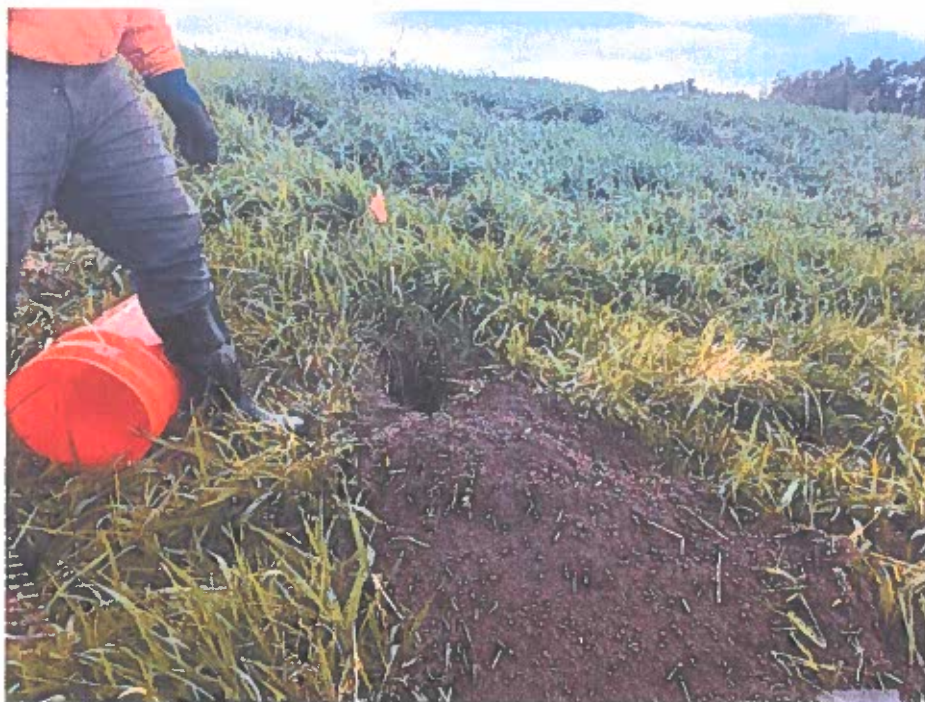
**Photograph: 4**

**Description:**  
Fresh groundhog holes  
before repairing

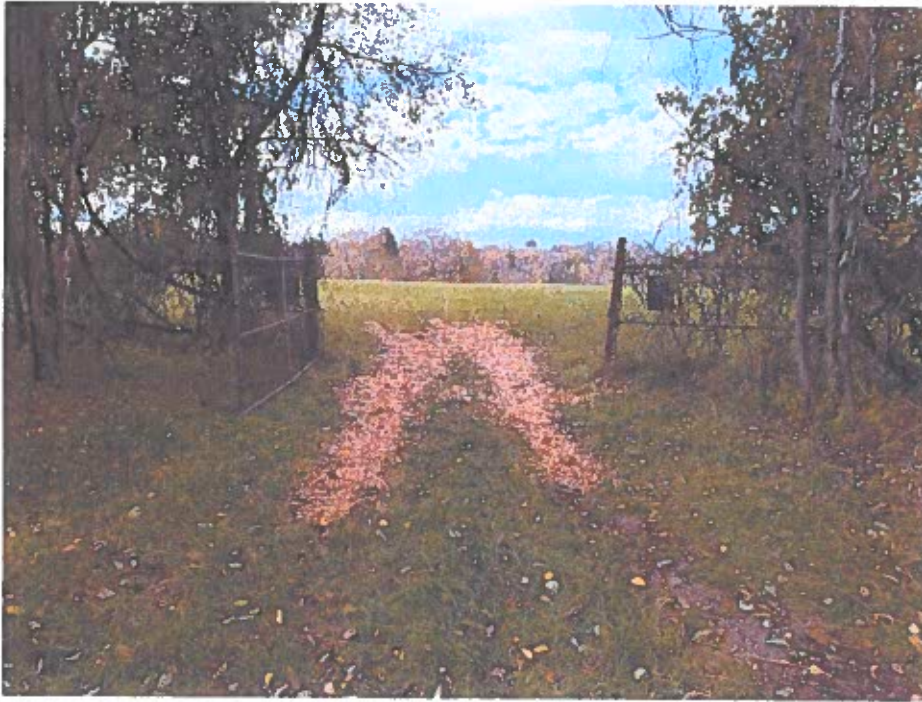
### **Photograph: 5**

**Description:**  
Landfill entrance  
maintenance with seed  
and hay

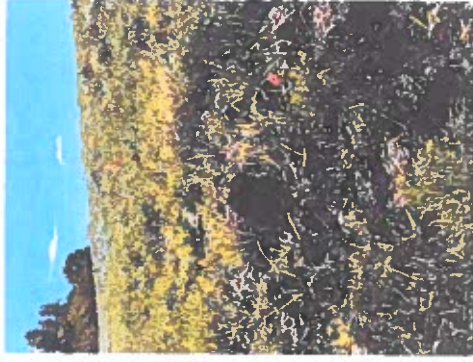
Chuck Hole #1

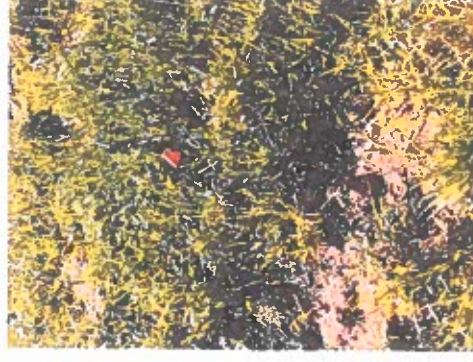
Chuck Hole #2

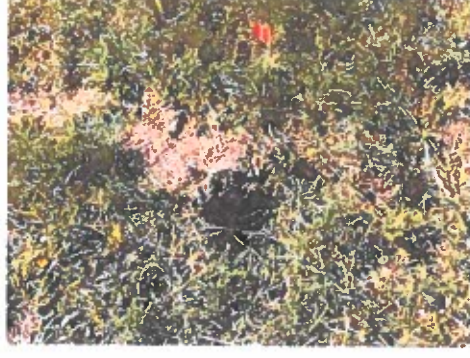
Chuck Hole #3

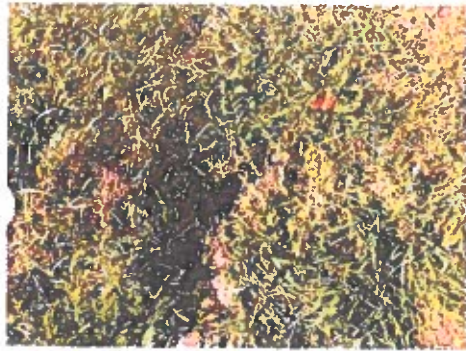
Chuck Hole #4

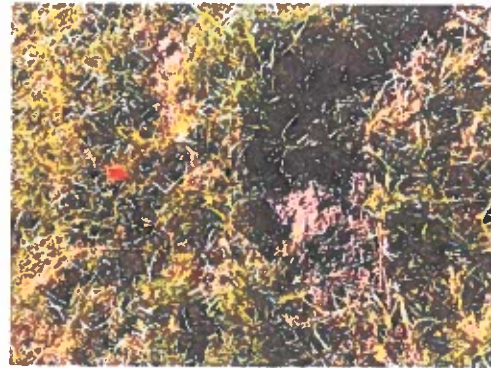
Chuck Hole #6

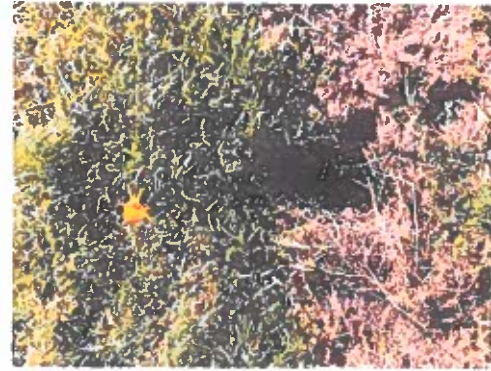
Chuck Hole #7

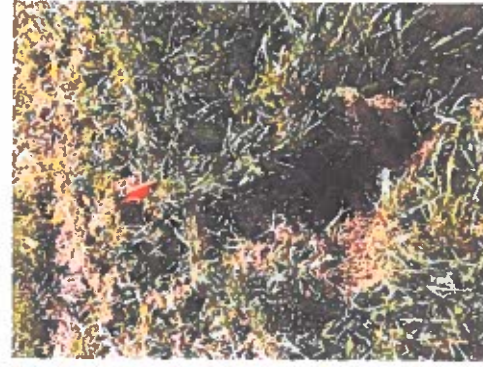
Chuck Hole #8

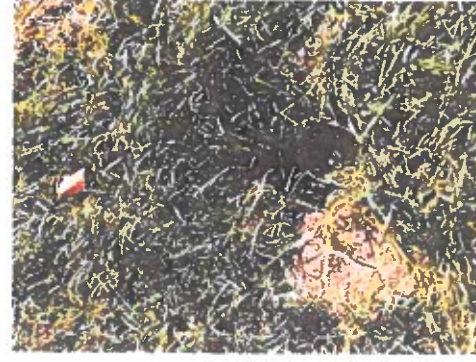
Chuck Hole #9

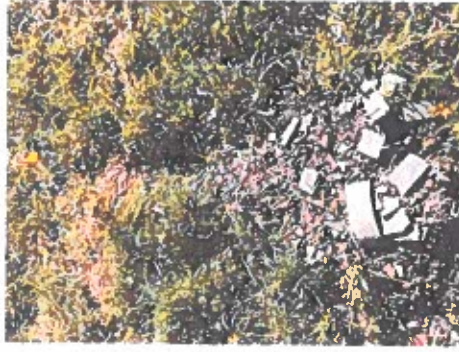
Chuck Hole #11

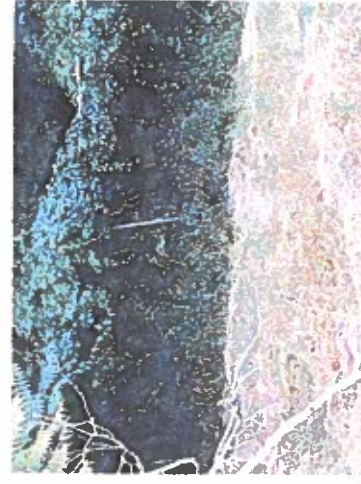
South Fence- 2

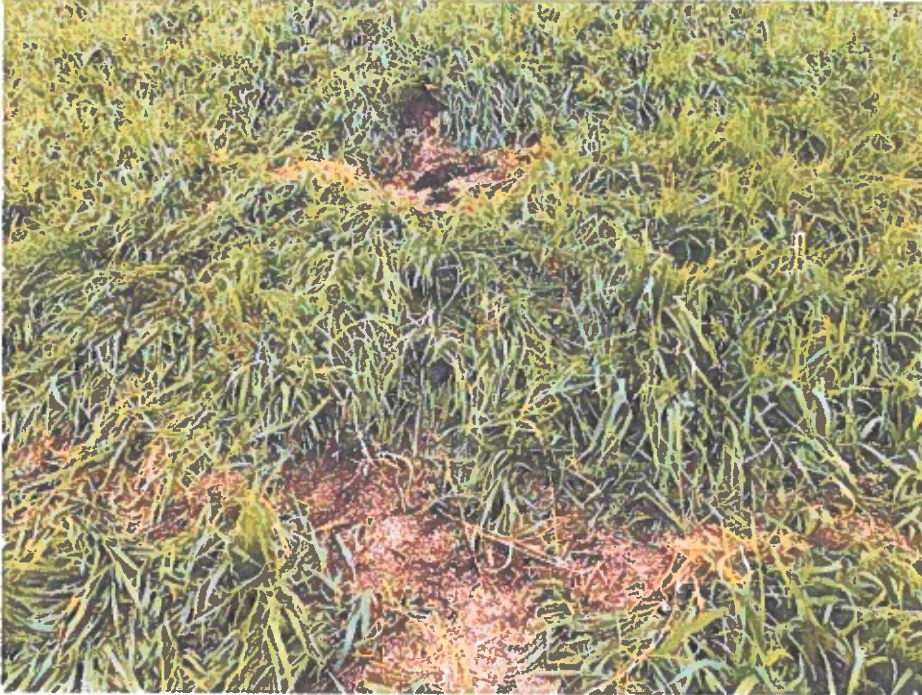
**Photograph: 1**

**Description:**  
Groundhog holes  
repaired and topped  
with contractors' seed

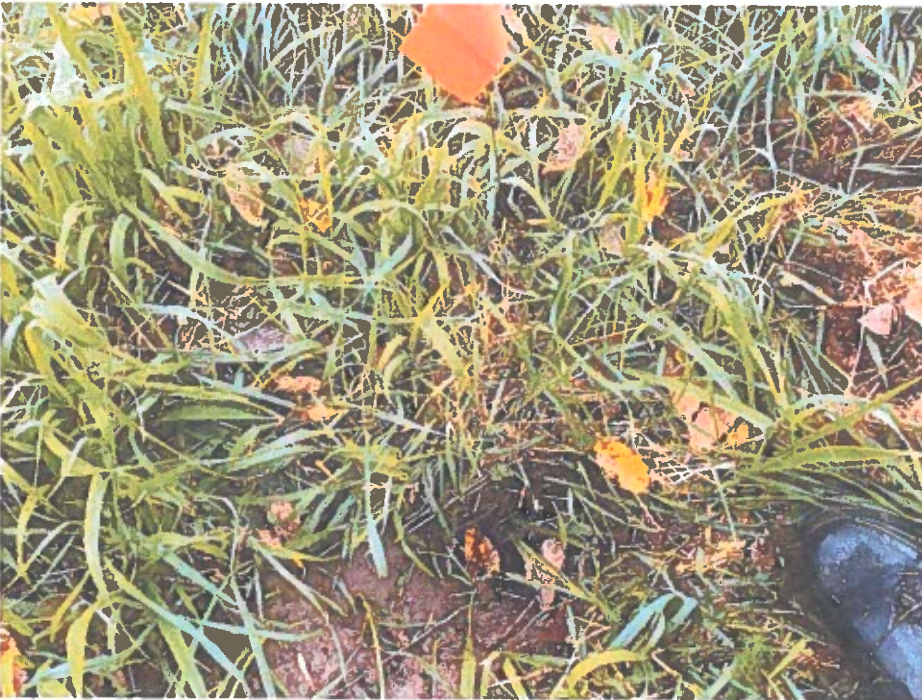
**Photograph: 2**

**Description:**  
Groundhog holes  
before repairing

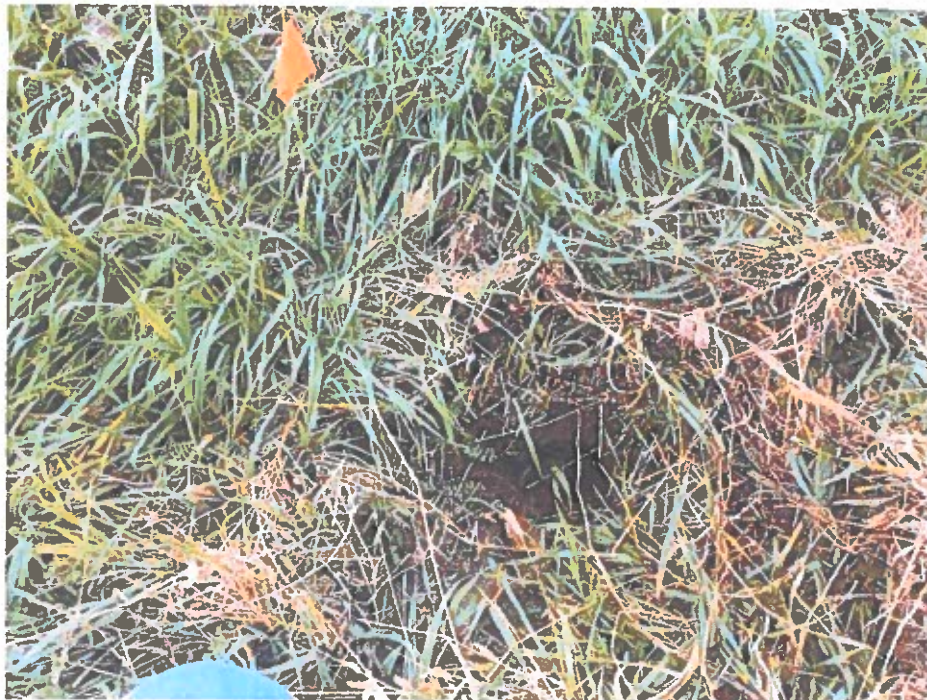
**Photograph: 3**

**Description:**  
Groundhog holes  
before repairing

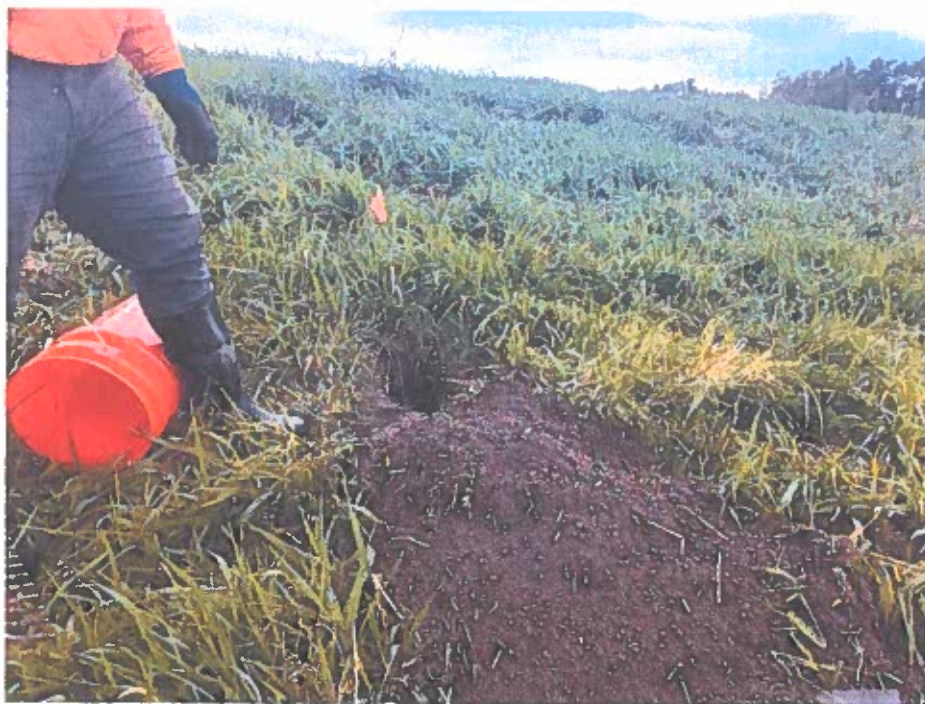
**Photograph: 4**

**Description:**  
Fresh groundhog holes  
before repairing

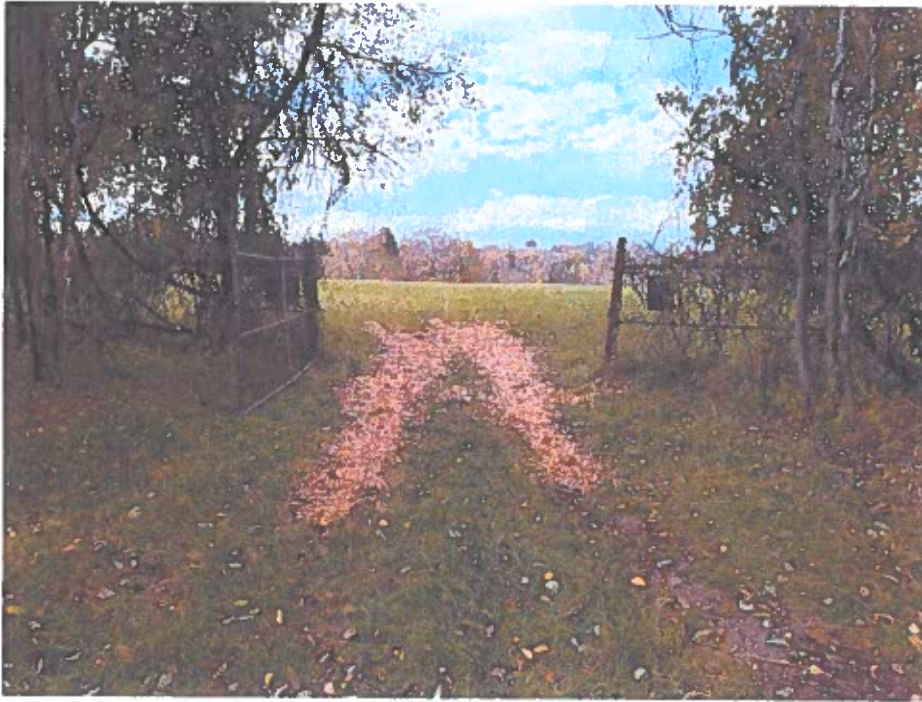
### **Photograph: 5**

**Description:**  
Landfill entrance  
maintenance with seed  
and hay
