New Scotland Ave. (Wadsworth Laboratory), 401031

DER Site Management, 09/14/2012

Photos with Notes

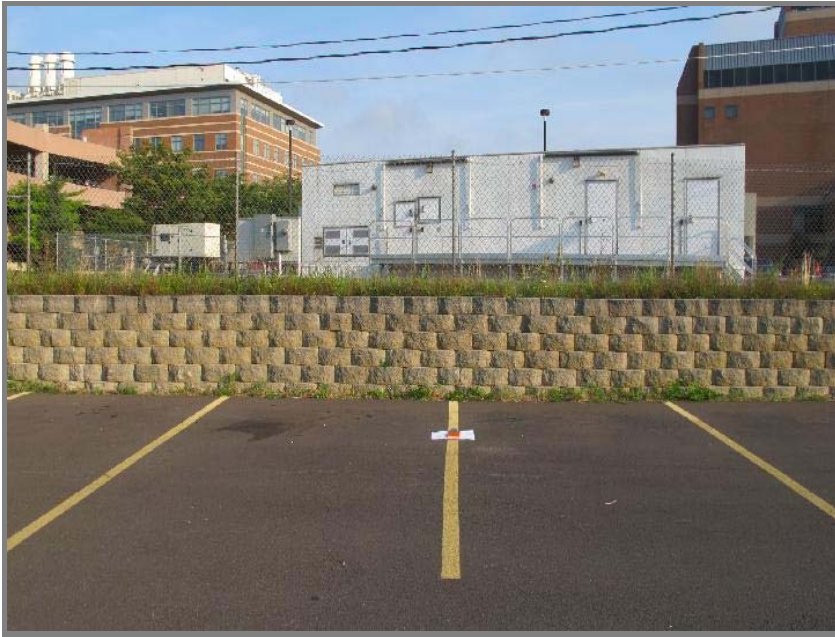
Penny, post and brick mark the point along the wall where MW-8 will be installed. There is a crack in a lower brick beneath this location.

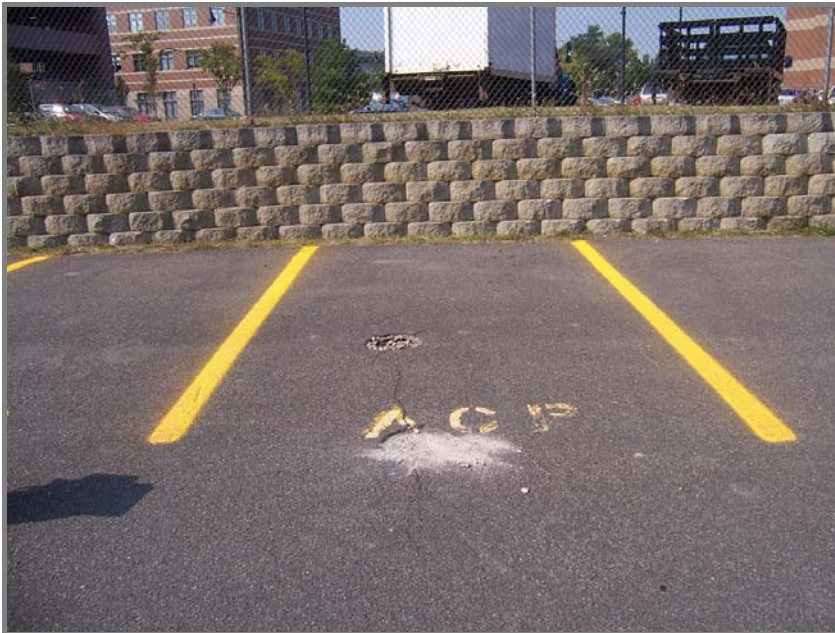
Standing in the college parking area to the rear of the Wadsworth site looking up the parking line to the location of the new well - by my field book and clipboard.

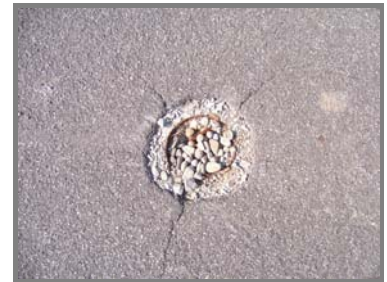
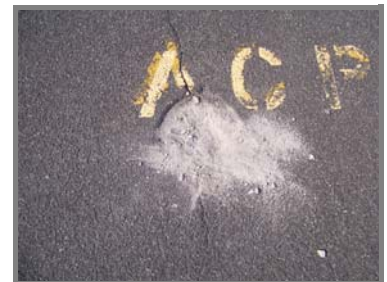
In 2005 I photographed the remains of MW-8 and an old plugged hole. Since that time the parking lot was paved and these locations were lost.

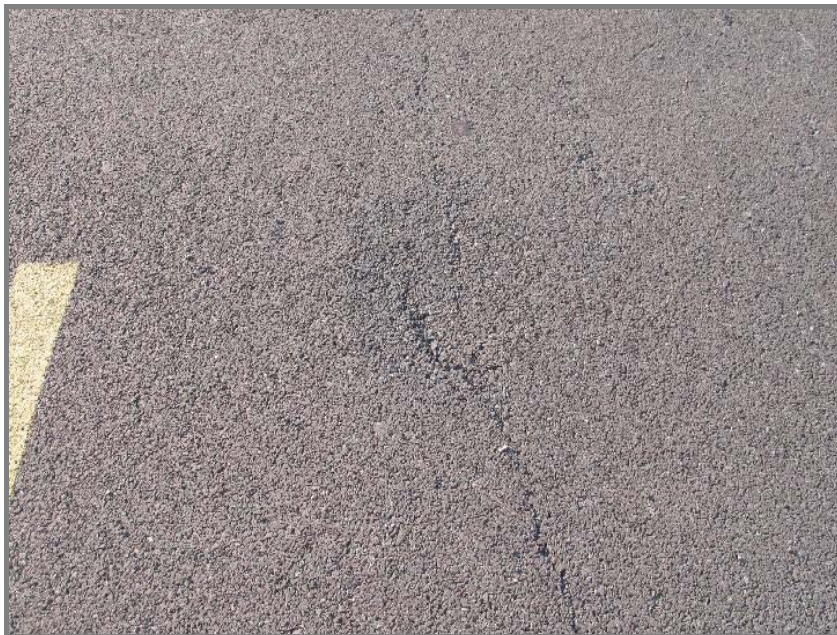
In 2012, near the end of the parking stripe is a circular crack in the blacktop. This was checked with a metal detector prior to our visit. There was too much metal in the area to get a good "hit." So Laurie made the decision to leave the new paving alone and install a new well nearer the wall.

Looking away from the wall at the circular crack and slight depression.

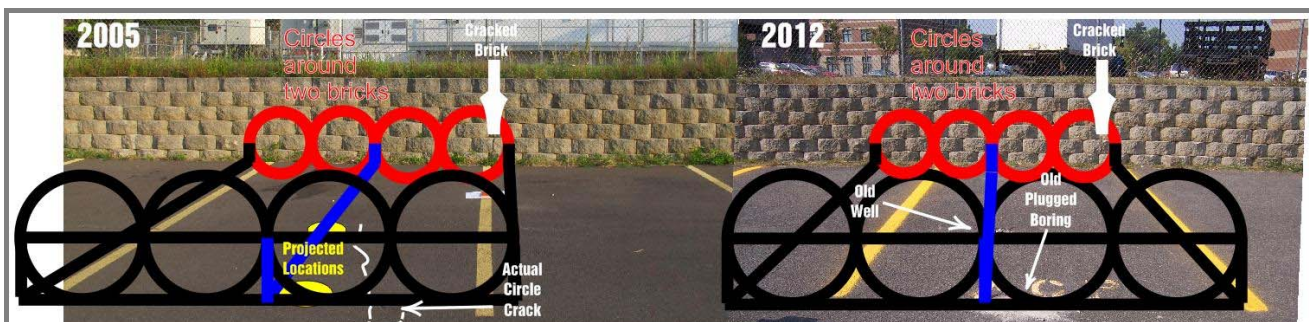
Projection Estimates to Locate former MW-8

Cracks in pavement in 2012 do not align with projected positions based upon position relative to a cracked brick in the retaining wall

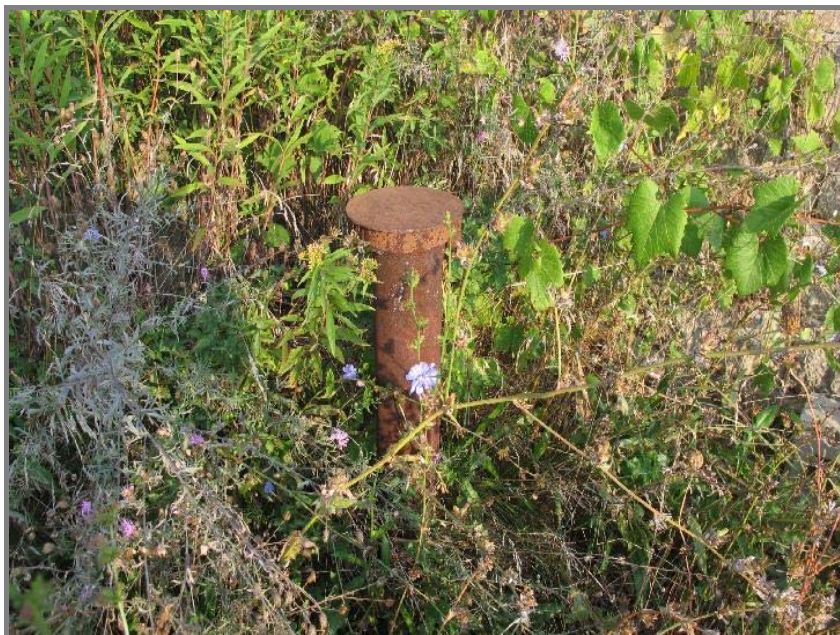
Walking to the corner of the parking lot, edge of the wall, I photographed MW-11S in the vegetation. I recommended painting and labeling the well.

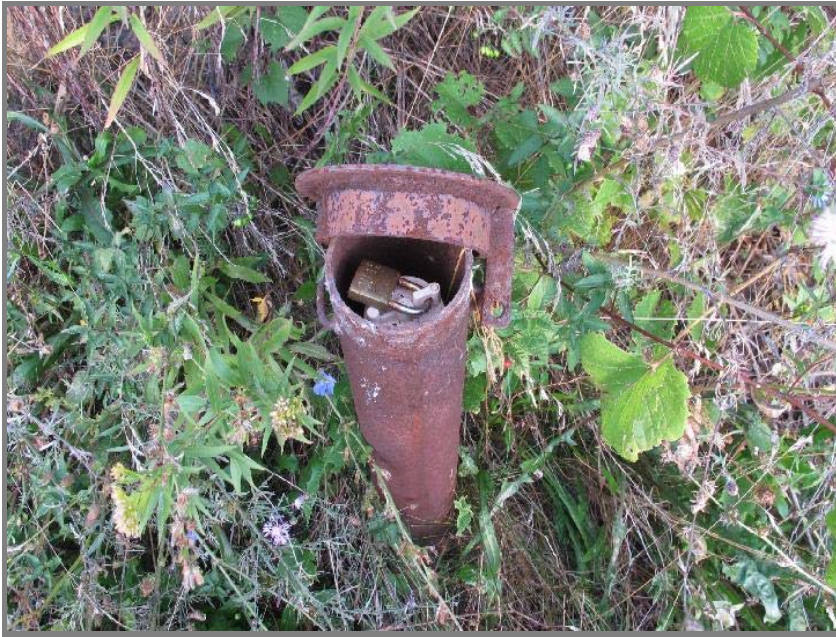
MW-11S

Outer cover is loose, but the well has a locking gripper cap inside.

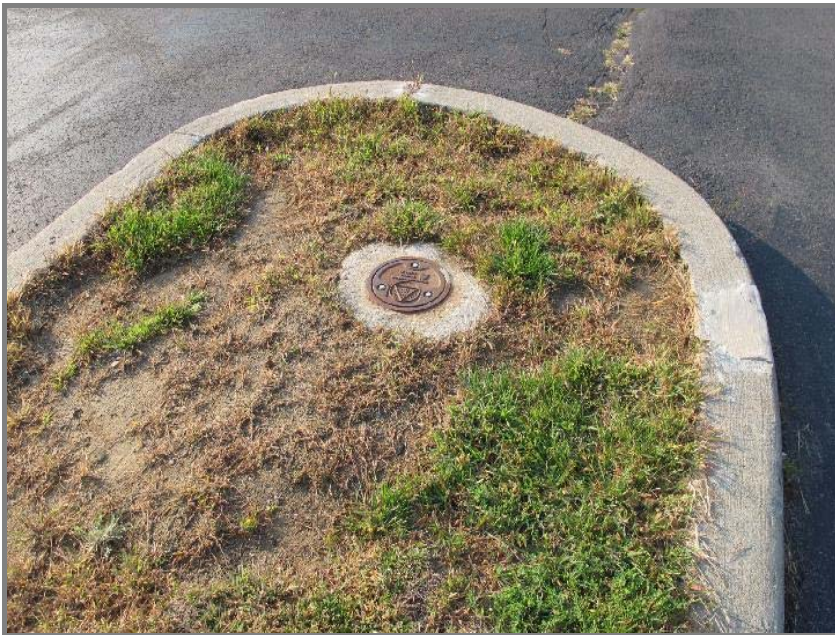
Pivot to the right, in the grassy median is MW-9S.

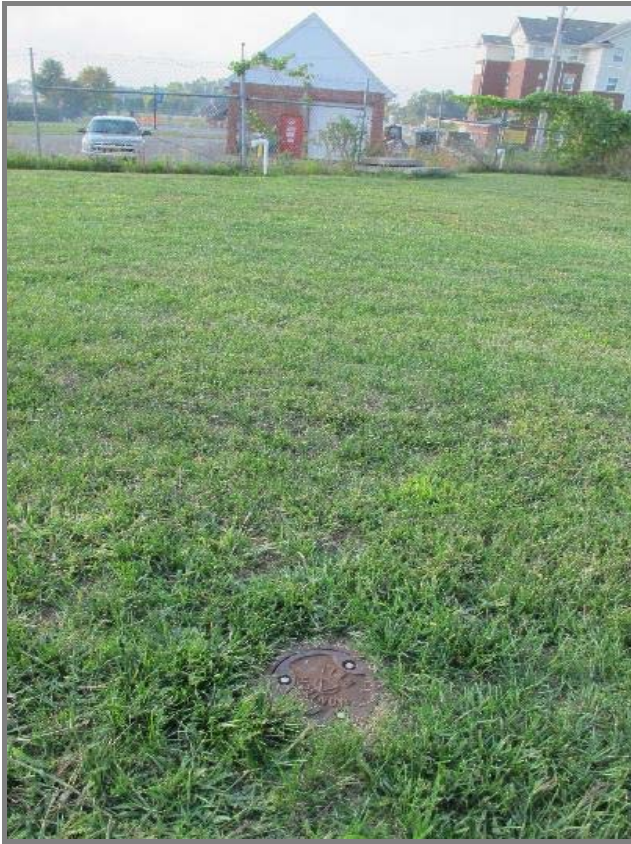
Unknown, on-site well behind the generator.
