**REMEDIATION ENGINEERING CERTIFICATION REPORT**

**The Vatrano Road Site  
Albany, New York**

**(New York State Department of Environmental Conservation  
Inactive Hazardous Waste Site Number – 401036)**

**CLOUGH, HARBOUR & ASSOCIATES LLP  
Albany, NY 12205**

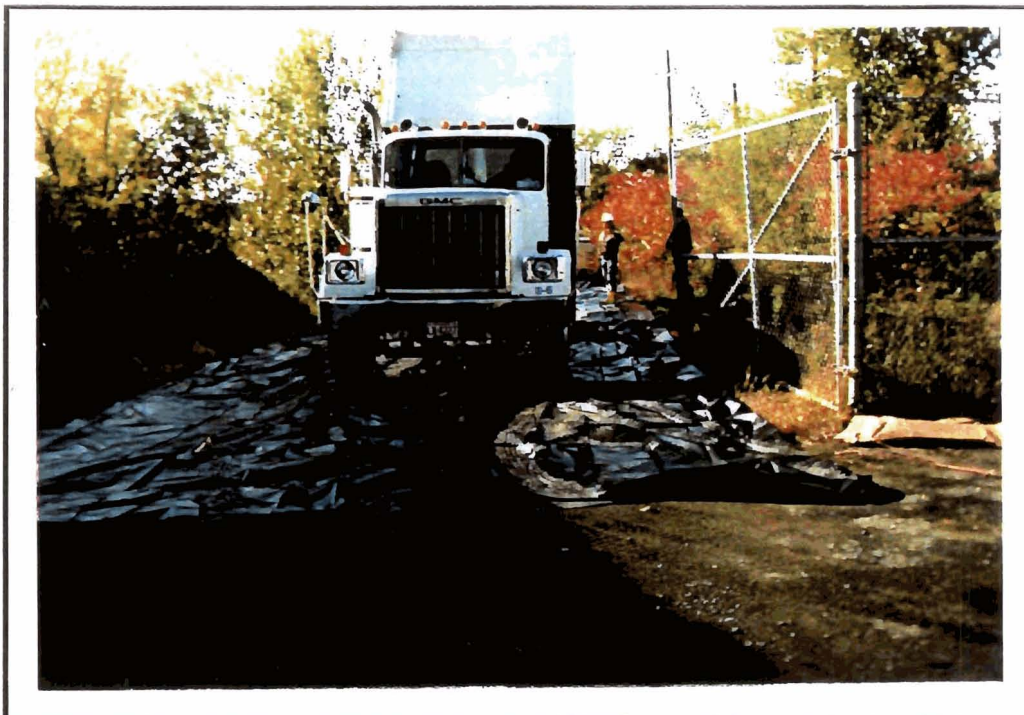
PHOTO #1

FRONT OF SITE  
EXISTING CONDITIONS

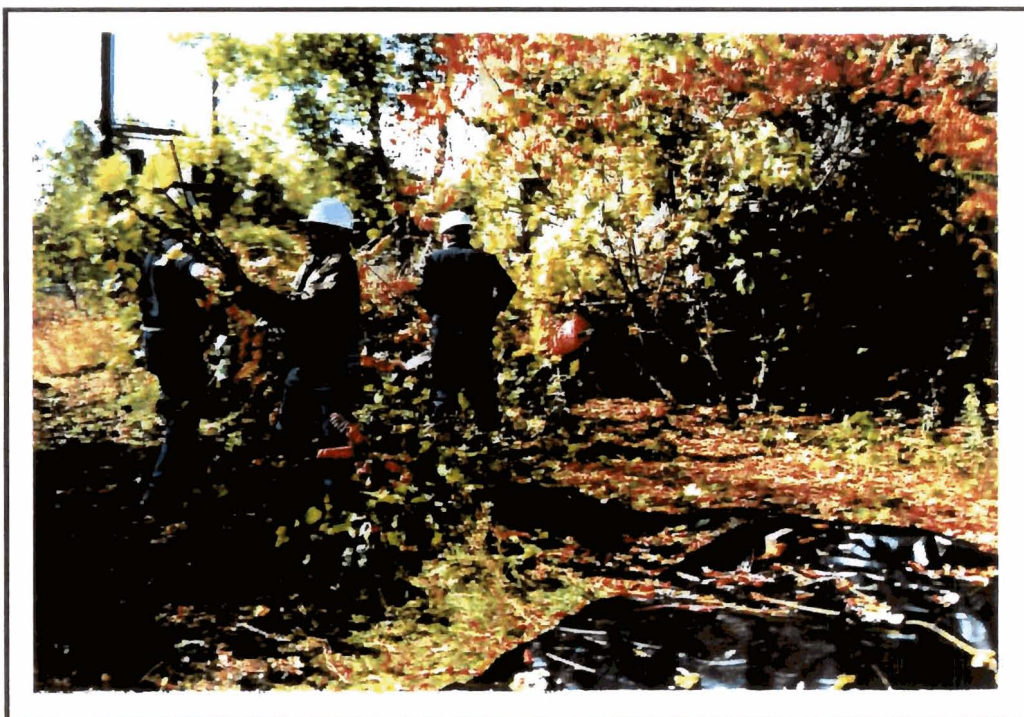
PHOTO #2

REAR OF SITE  
THICK BRUSH

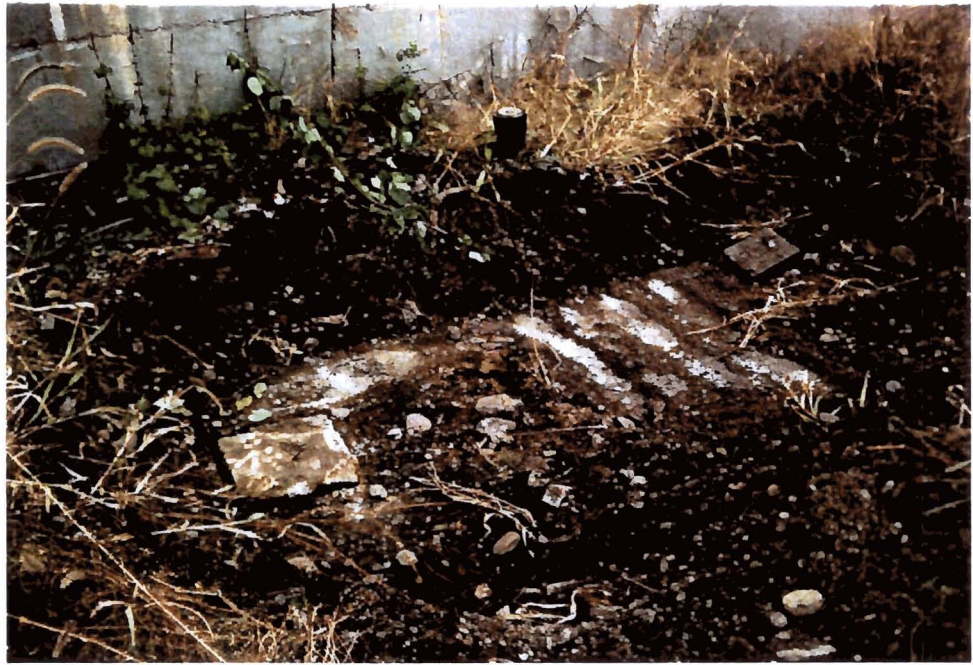
PHOTO #3

A total of 1750 gallons of liquids were pumped from the three on site UST's or concrete vaults. Figure 2 shows the locations of the three tanks labeled vault 1 (Photo 3), vault 2 and oil water separator. Vault 1 and vault 2 were analyzed for volatiles via EPA method 8260 and semivolatiles via method 8270. In addition, both were tested for PCB's by method 8081. Vault 2 showed no evidence of volatiles, semivolatiles or PCB's above detection limits. The only compound found above detection limits in vault 1 was Aroclor 1260 at 320 ug/l (ppb). The results of the laboratory analysis are found in Appendix I. A summary of selected components of all site tank results is found in Table 1. The oil water separator was tested during a previous investigation in the summer of 1997.

CONCRETE TANK AT NORTHEAST  
CORNER OF BUILDING 14

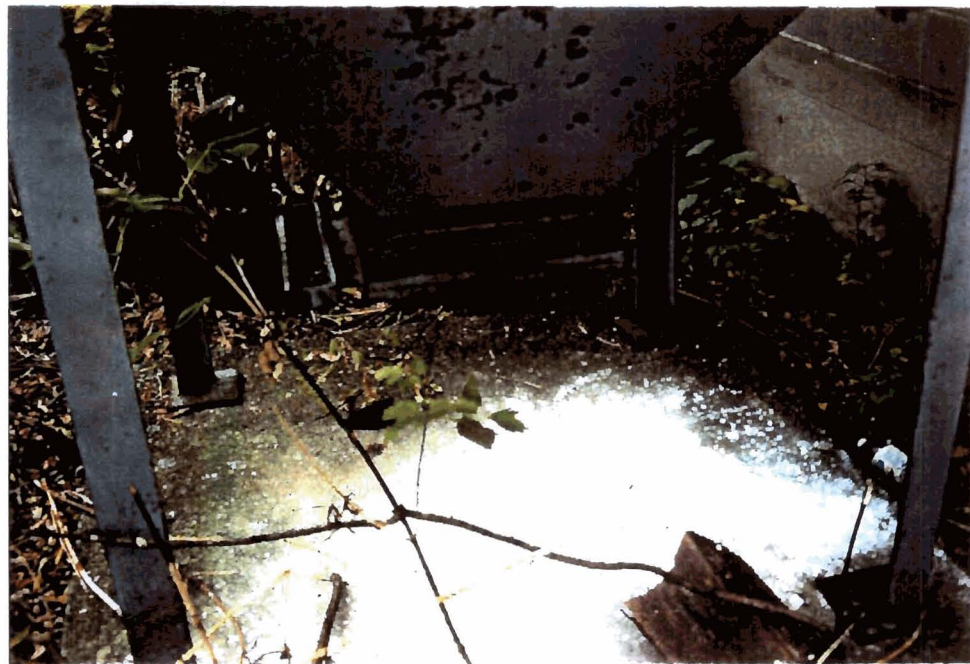
PHOTO #4

HOPPER CONTAINING WHITE  
NON-HAZARDOUS POWDER AT  
SOUTHWEST CORNER OF BUILDING 16

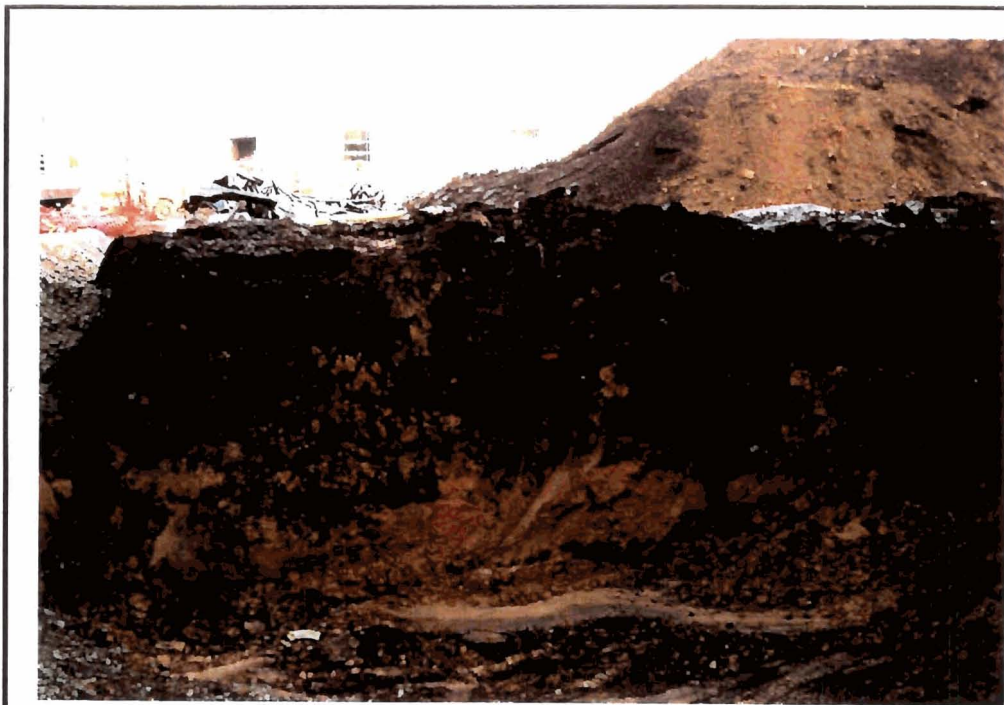
PHOTO #7

Photo 7 shows a typical soil section from the site. As seen in the photo, the first one to three feet of soil consists of a black coarse sand to fine gravel fill material with cinders and miscellaneous construction debris including bricks. This fill material is underlain by an orange brown, fine to medium sand with silt unit approximately five (west) to 11(east) feet thick. This unit is underlain by a grayish clayey silt layer approximately thirty feet thick. A simplified site soil profile is shown below.

TYPICAL ON SITE  
SOIL SECTION

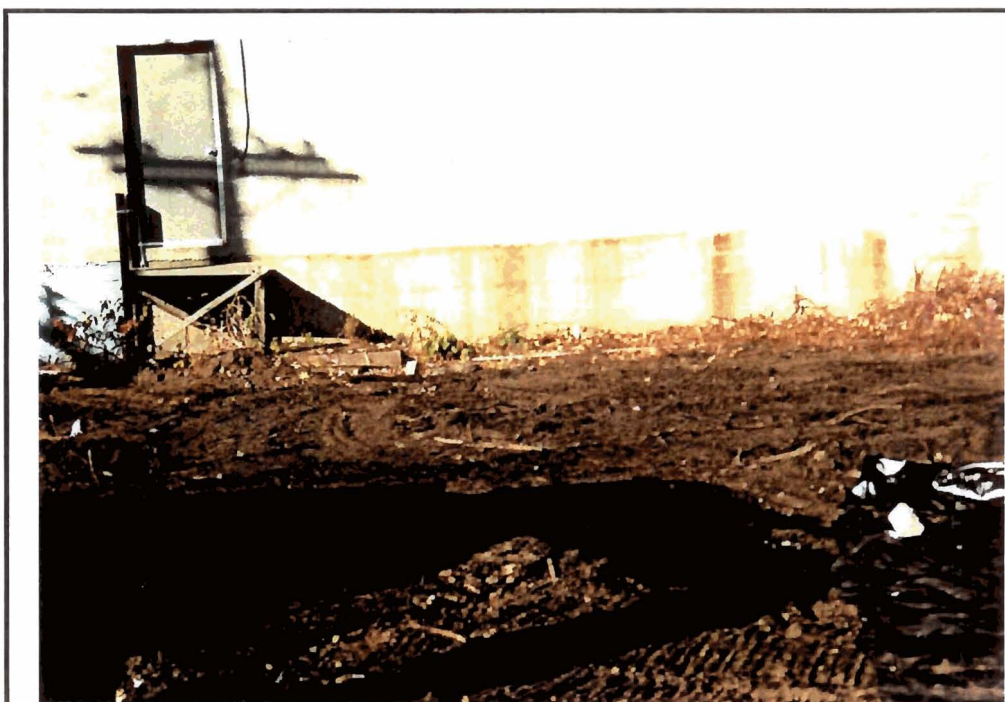
PHOTO #8

WOODEN PLATFORM ATTACHED TO THE  
SOUTHEAST CORNER OF  
BUILDING 14

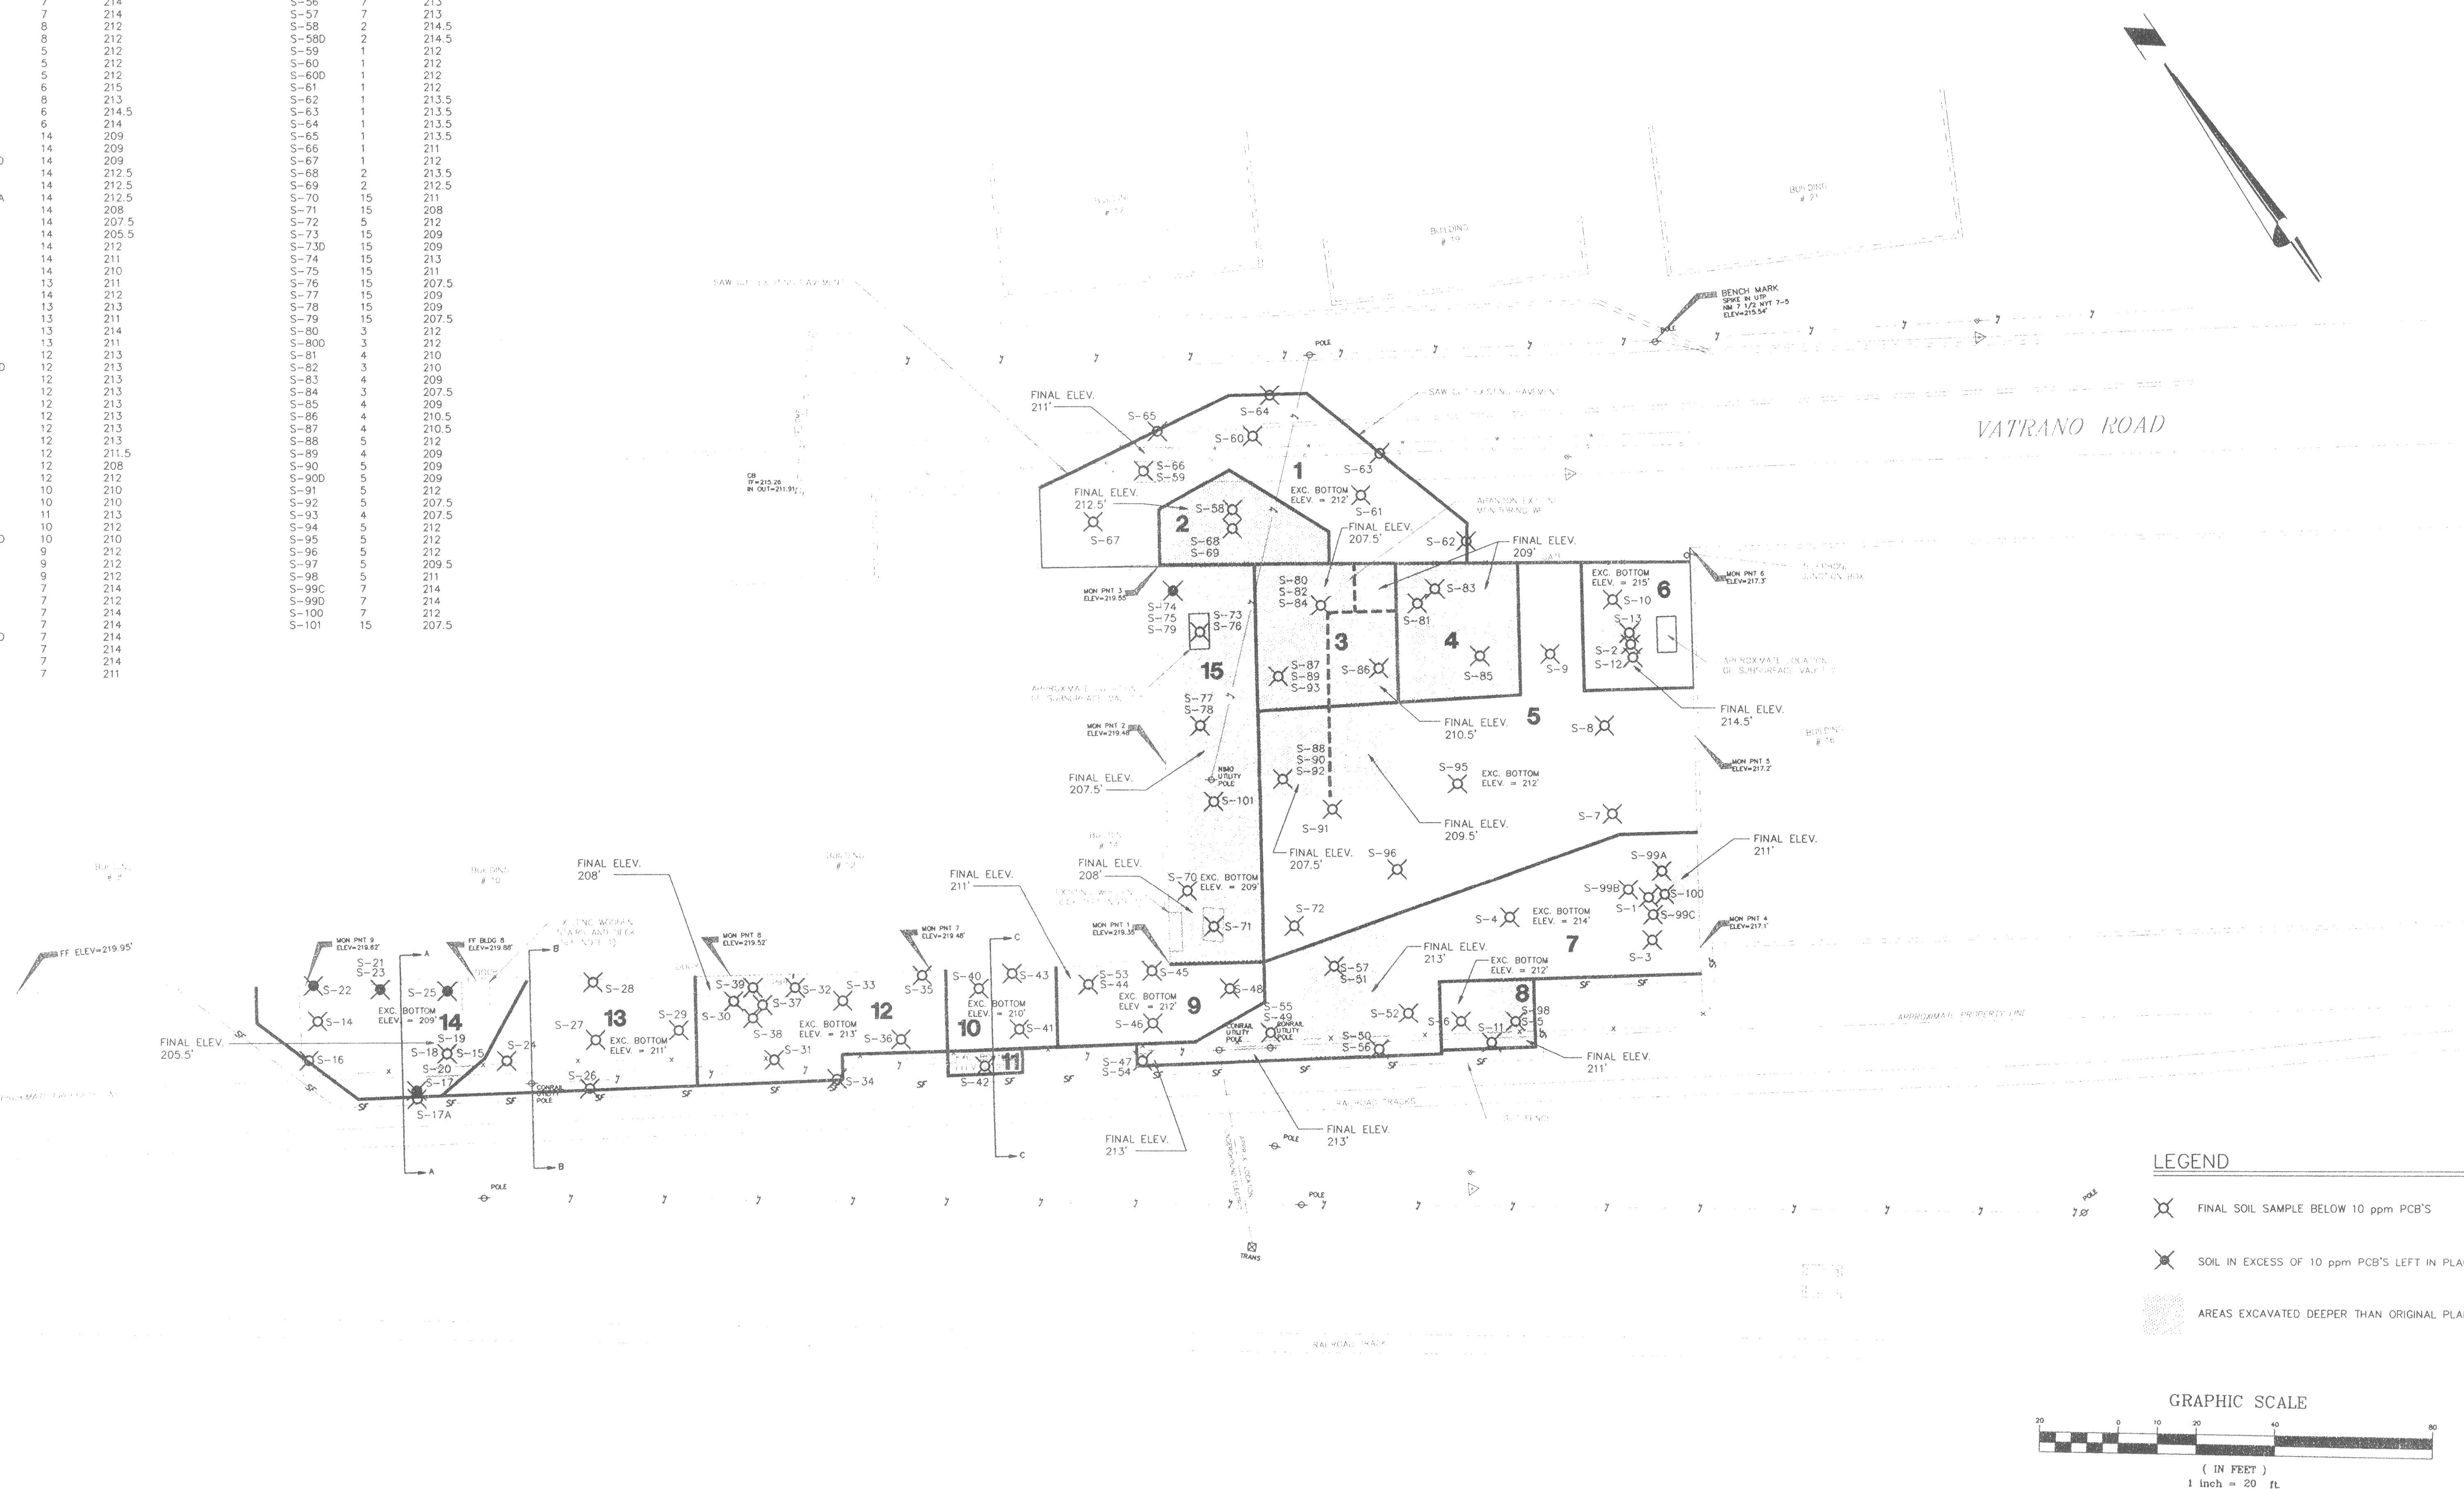
The goal of this remediation project was to remove as much PCB contamination as possible including the oil water separator system. This goal was achieved. PCB contaminated soil was left in only three limited areas of the site (see Figure 3) due to structural limitations associated with existing buildings, railroad tracks, and site utilities. New monitoring wells that meet the NYSDEC's 6 NYCRR Part 360 Solid Waste Management Facilities (Jan. 1997) regulations were constructed and developed. In addition, the site has become less hazardous due to the removal of construction debris found across the site, including roofing materials containing asbestos. The replacement of older, unsafe deck structures with new decks was an added benefit to the tenants of the site.

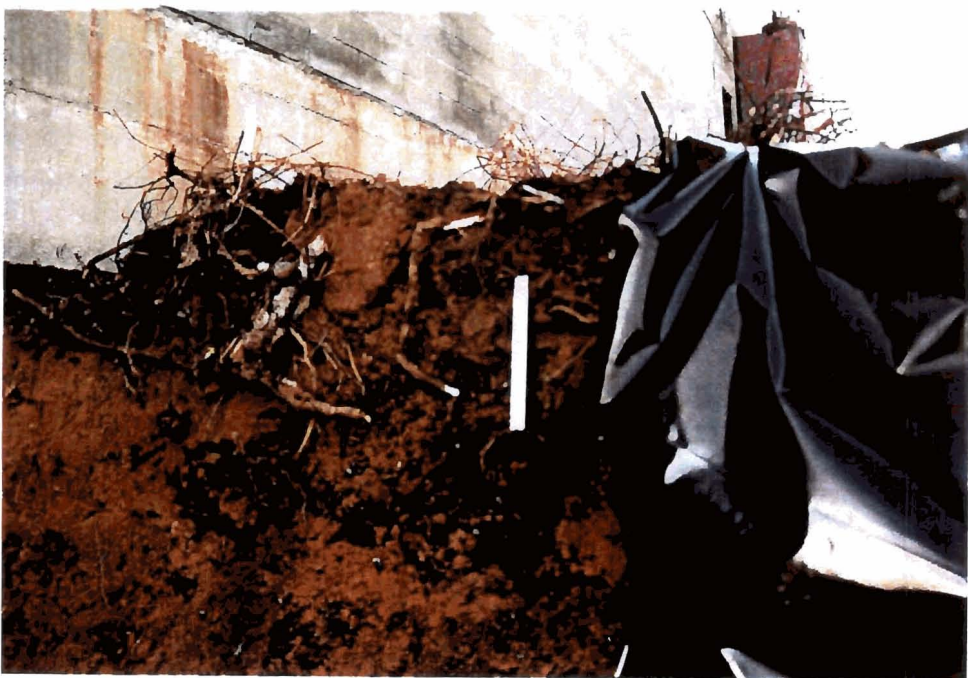
PHOTO #10

Area 9 required a 10 X 10 foot area to be excavated an extra foot as sample S-44's immunoassay result indicated a PCB concentration higher than 10 ppm. Sample S-53's immunoassay indicated a value less than 10 ppm and no further excavation was necessary. It was noted that the gravity fed pipe that started from behind building 10 continued into area 9 and made a right angle turn northwards toward the oil water separator found in area 15. (See photo 10).

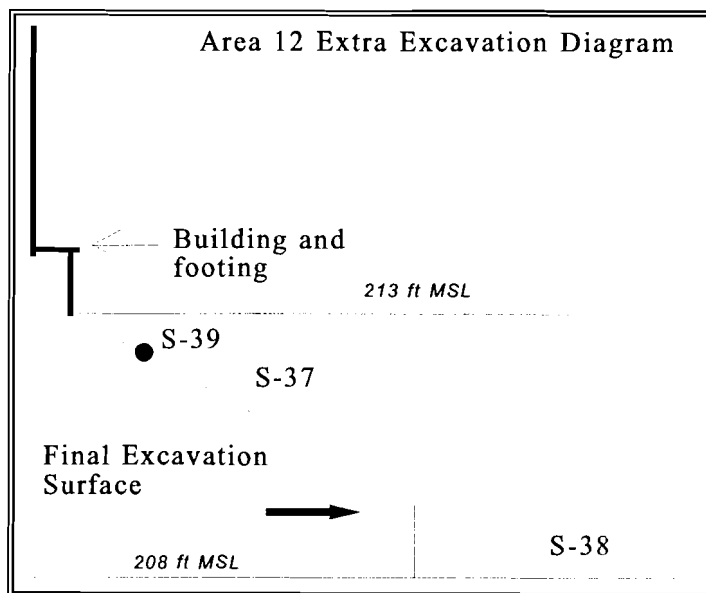
Due to higher than expected PCB concentrations found in the Northwest corner of area 12, an extra wedge of material had to be removed. Samples S-37 and S-39 were located on the slope of this extra excavation and showed PCB concentrations less than 10 ppm. Sample S-38 was located at an elevation of 208 ft (five feet lower than planned) and was below the 10 ppm PCB target concentration. This area of extra excavation is shown as the shaded area on Figure 3 and a cross section sketch is shown at right.

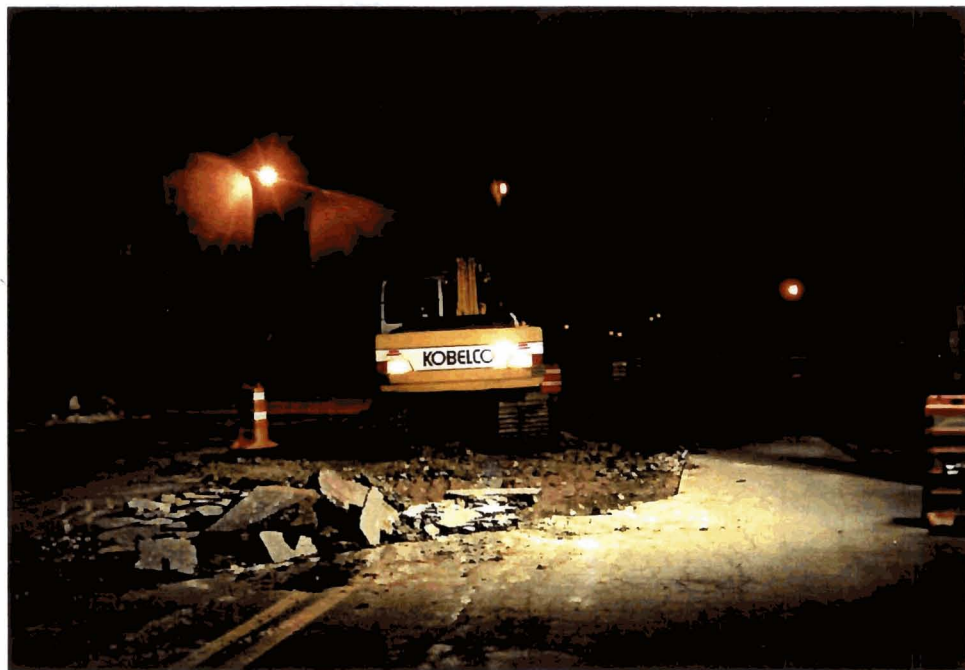
PHOTO #11

NIGHT TIME EXCAVATION  
OF VATRANO ROAD

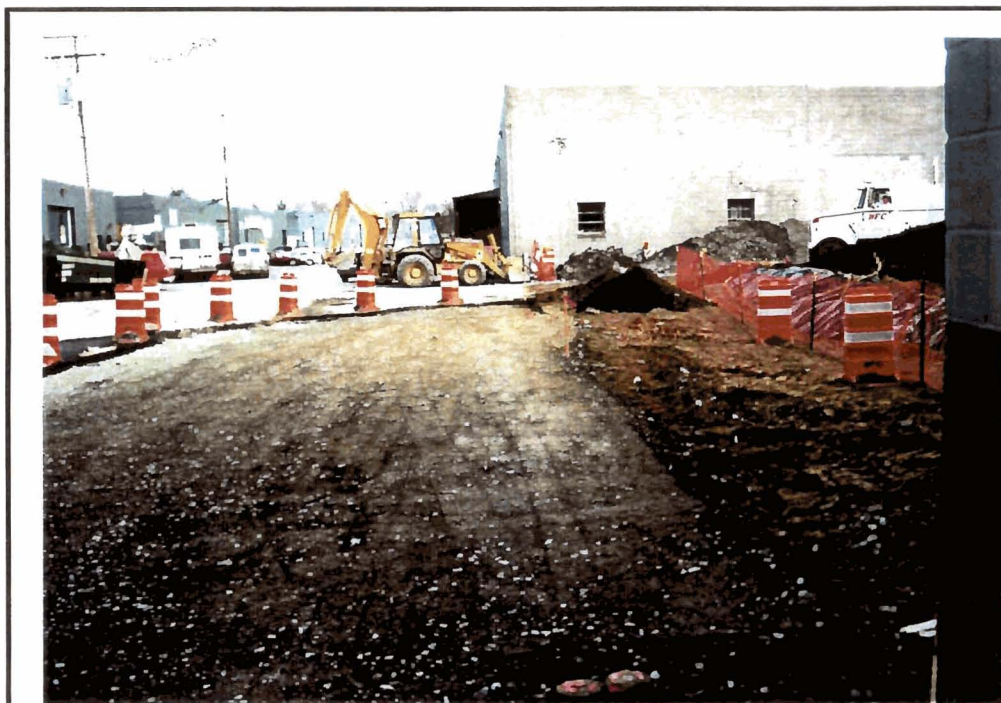
PHOTO #12

VATRANO ROAD  
COMPACTED SUBBASE

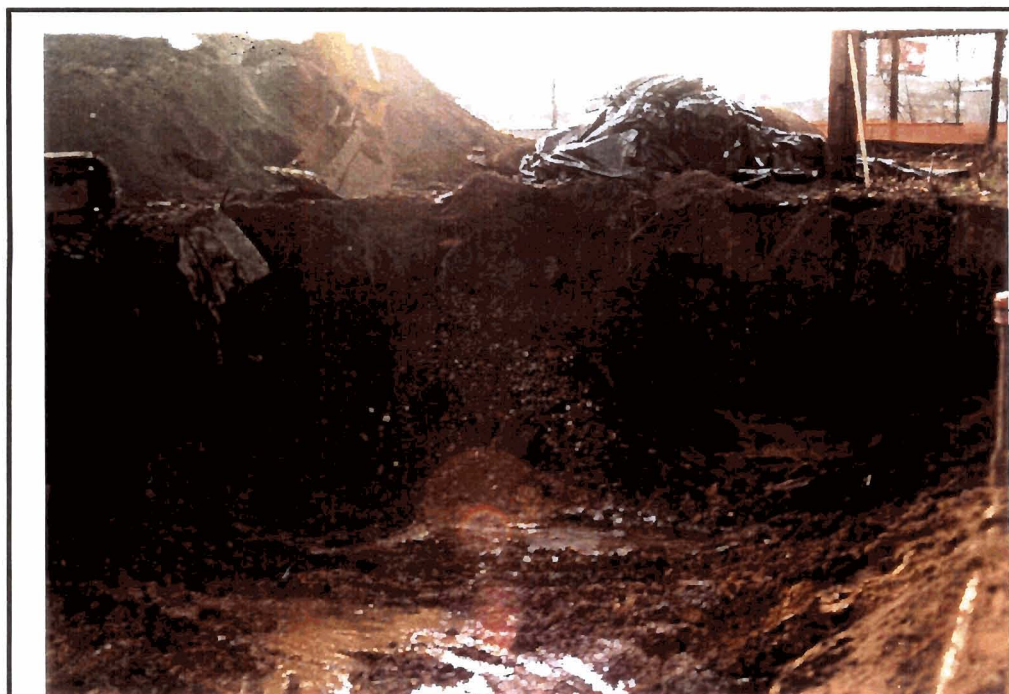
Area 15 contained two connected vaults, associated pipes and a stone dry well system (photos' 13, 14, 15 & 16). The approximate locations of these structures is shown on Figure 2. All these structures were removed and disposed of with the contaminated soils. Almost all of Area 15 had to be excavated to 207.5 or approximately 1.5 feet into the water table before sampling indicated PCB's below 10 ppm.

EXCAVATED AREA NORTH OF OIL WATER SEPARATOR SHOWING  
ROUNDED STONE DRYWELL  
PHOTO #16

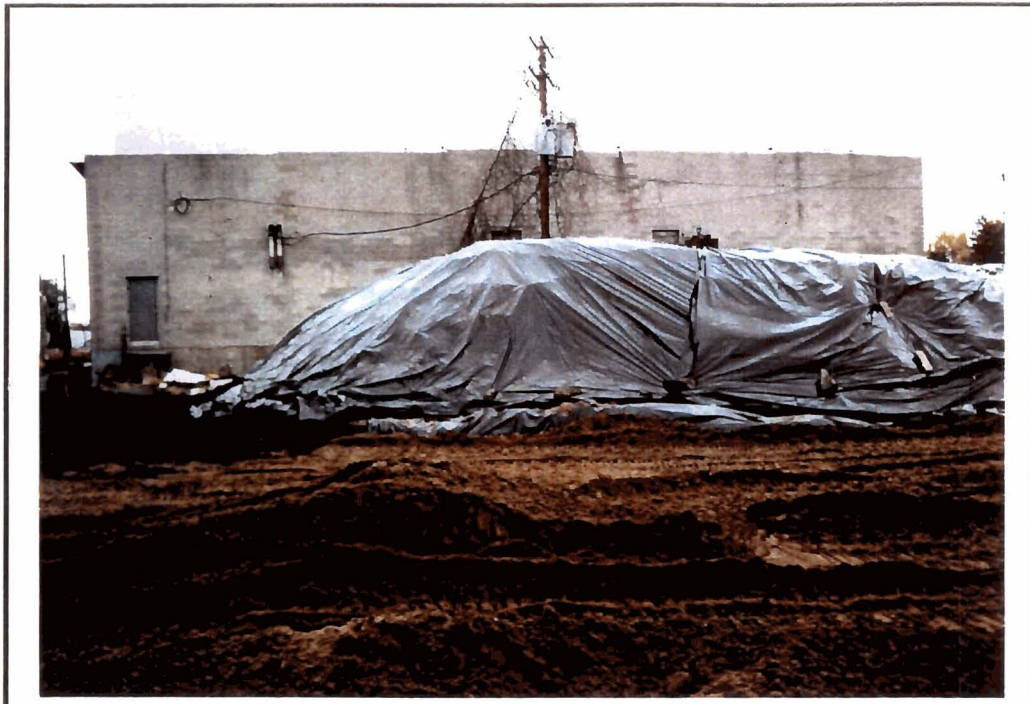
PHOTO #17

COVERED CONTAMINATED  
SOIL PILE

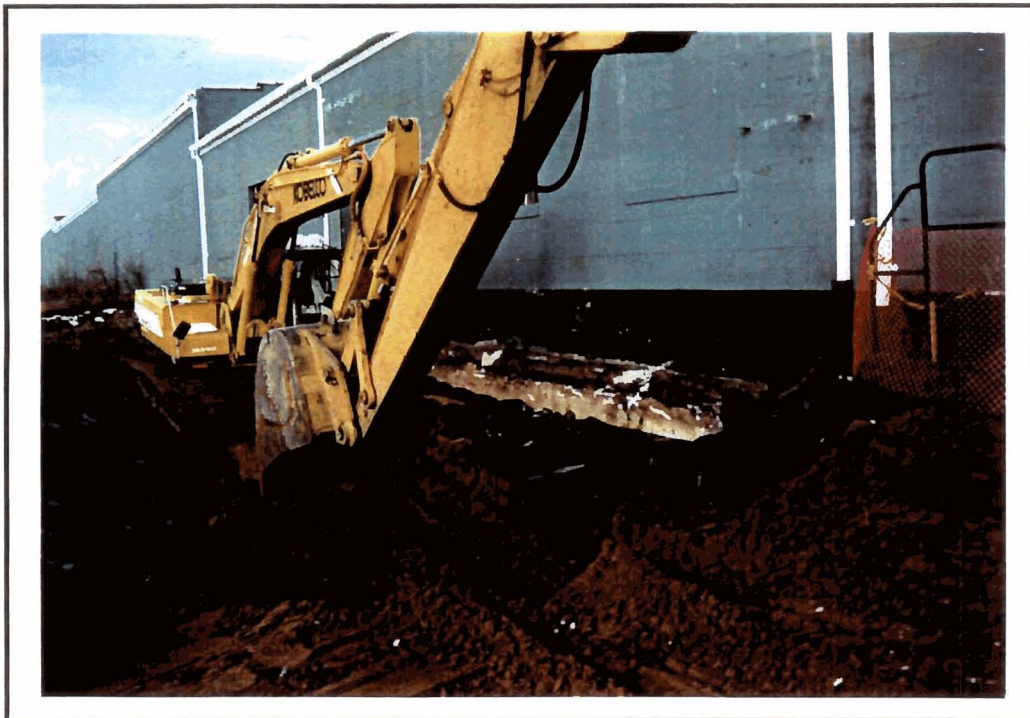
PHOTO #18

BACKFILLING OPERATIONS  
BEHIND BUILDING 14

All excavations were backfilled using clean sand except for the gravel subbase used under the road. Laboratory analysis of these materials can be found in Appendix L. Once an area was deemed clean by the field scientist, polyethylene plastic was placed over any side slopes and then backfill was placed either by direct dumping or from an uncontaminated track hoe (photo 18). The track hoe bucket and tracks were used to compact the backfill. The backfill was placed in lifts not to exceed 2 ft. A walk behind plate compactor was used to compact backfill in areas adjacent to buildings and other structures.

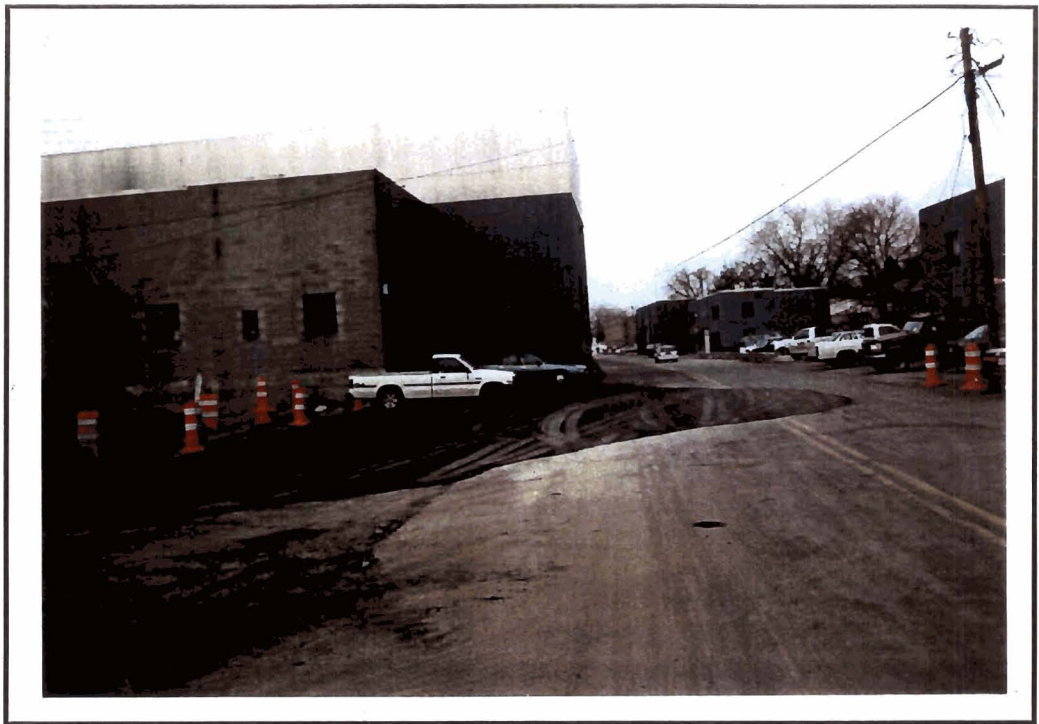
PHOTO #19

NEWLY PAVED AREA

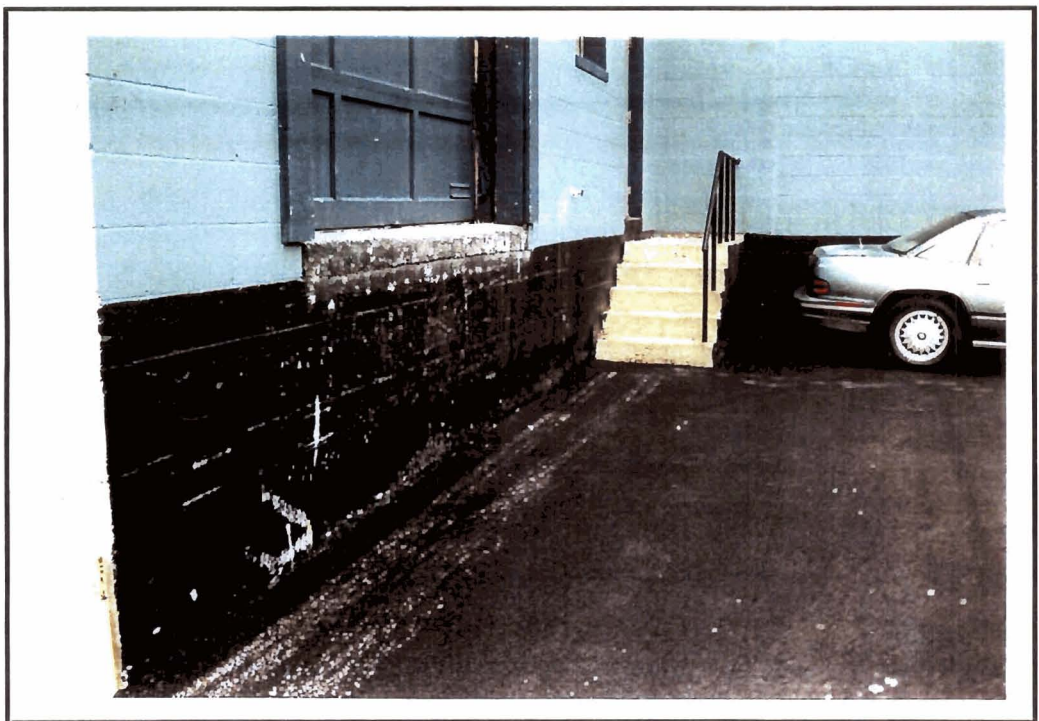
PHOTO #20

NEW PAVEMENT ADJACENT  
TO BUILDING 14

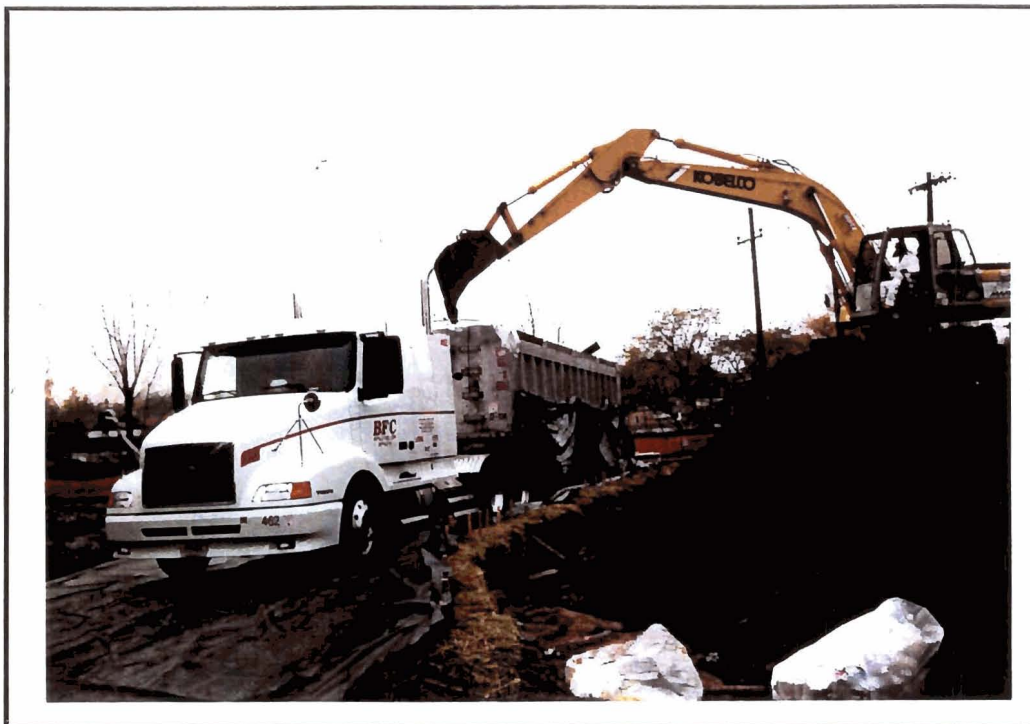
PHOTO #21

LOADING CONTAMINATED SOIL  
INTO TRUCKS

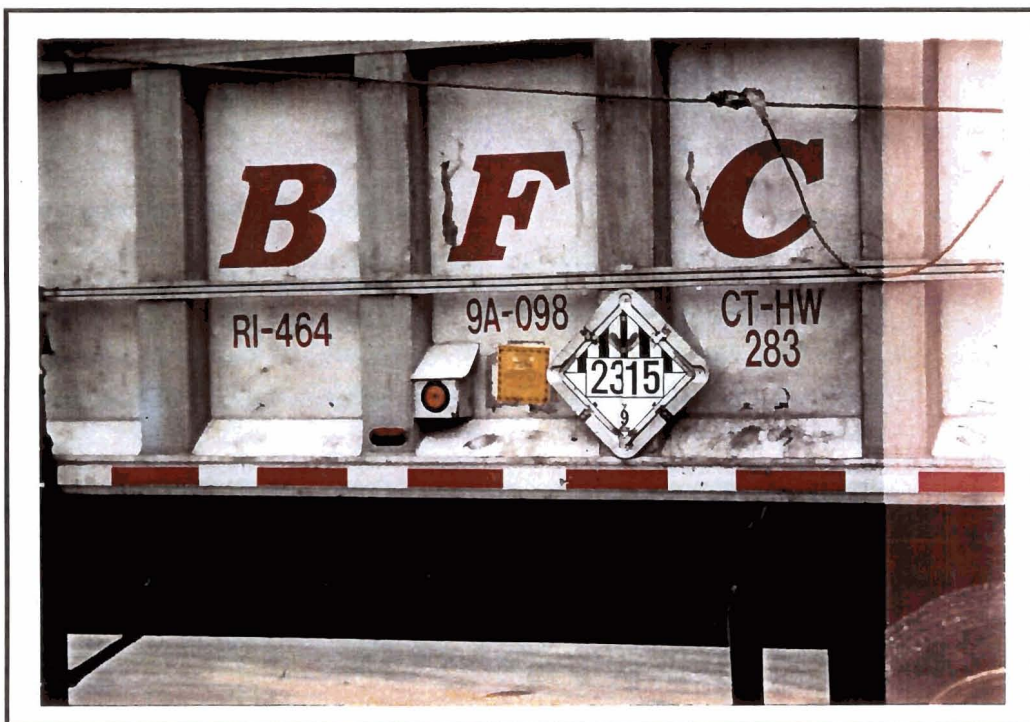
PHOTO #22

PROPERLY PLACARDED  
TRUCK

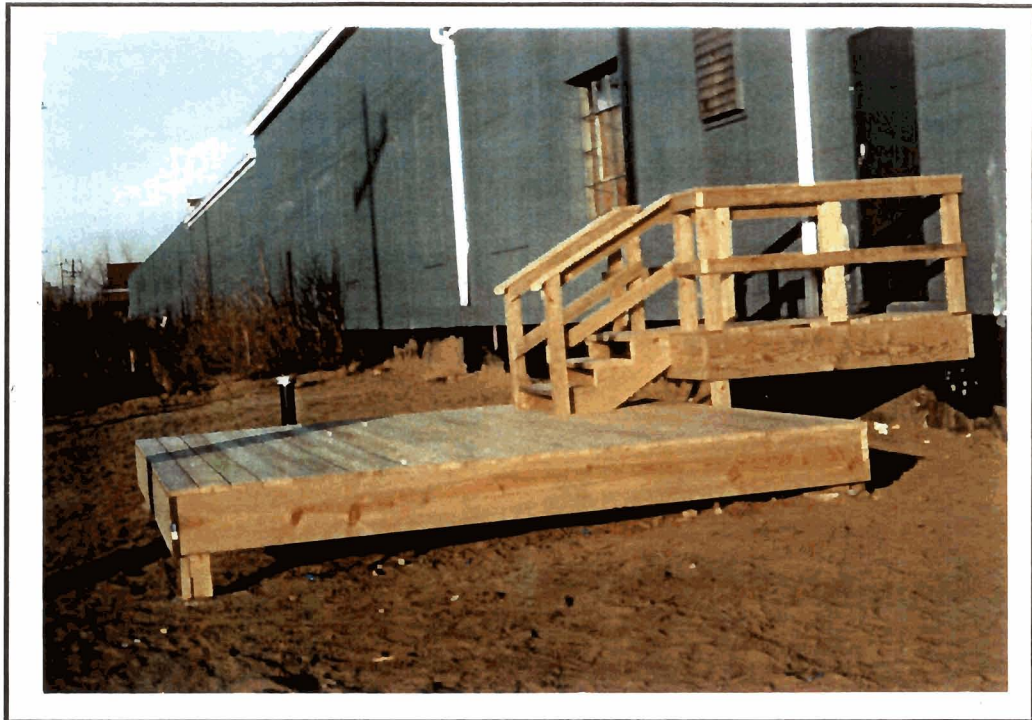
PHOTO #23

NEW DECK ATTACHED TO BUILDING 10.  
MW-2 IN BACKGROUND

As seen from photos 23 and 24 new decks were constructed behind building 10 and on the side of building 14. These were built to replace the structures that had to be removed in order to facilitate remedial activities. These new structures are built to local building codes. A copy of the specifications can be found in Appendix H. Once all excavation and backfilling was accomplished, a six-inch layer of gravel was placed and compacted between buildings 14 and 16. This is to serve as a new parking area. The area behind buildings 10-14 requires final grading, top soil, and seeding. This was completed during August, September and October of 1998 by Four Seasons Environmental. Photos 25 and 26 shows the final condition of the site. A final survey of the site was conducted by Boswell Engineering of Albany, New York and is shown in Figure 4.

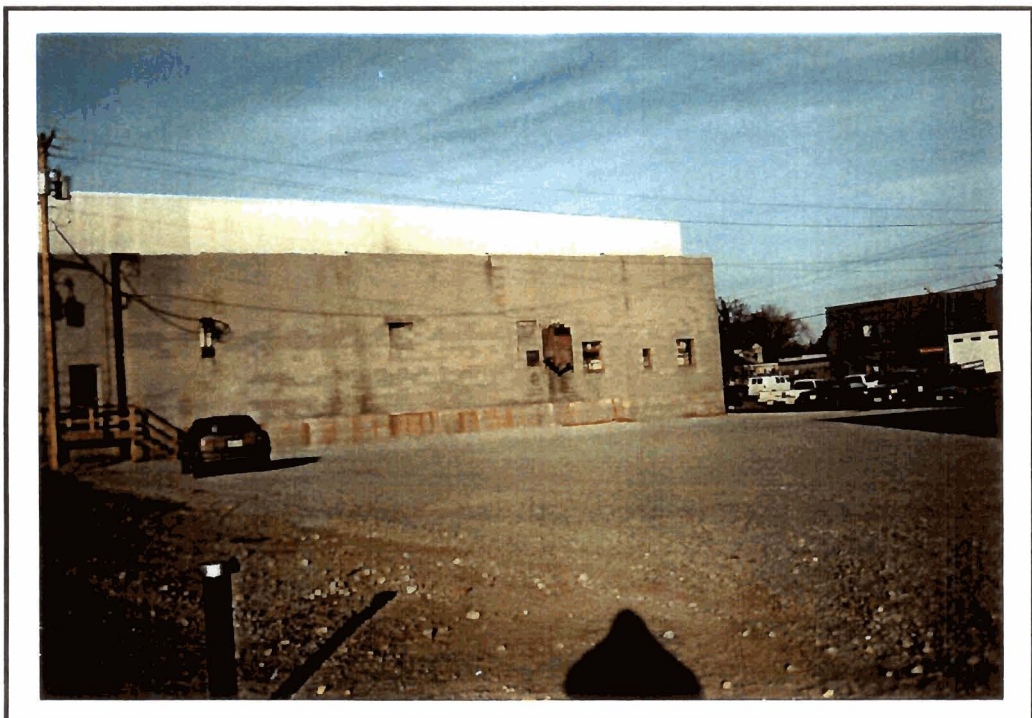
PHOTO #24

COMPLETED GRAVEL PARKING AREA  
LOOKING NORTH. MW-5 IN FOREGROUND

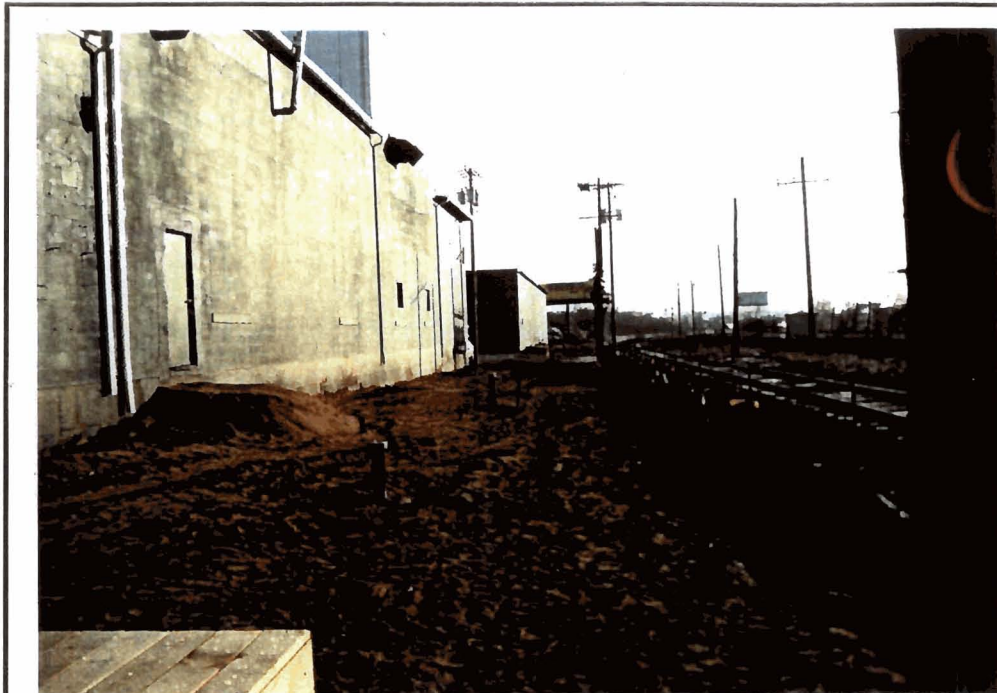
PHOTO #25

LOOKING SOUTHEAST BEHIND BUILDING  
10-14. NOTE NEW MONITORING WELLS

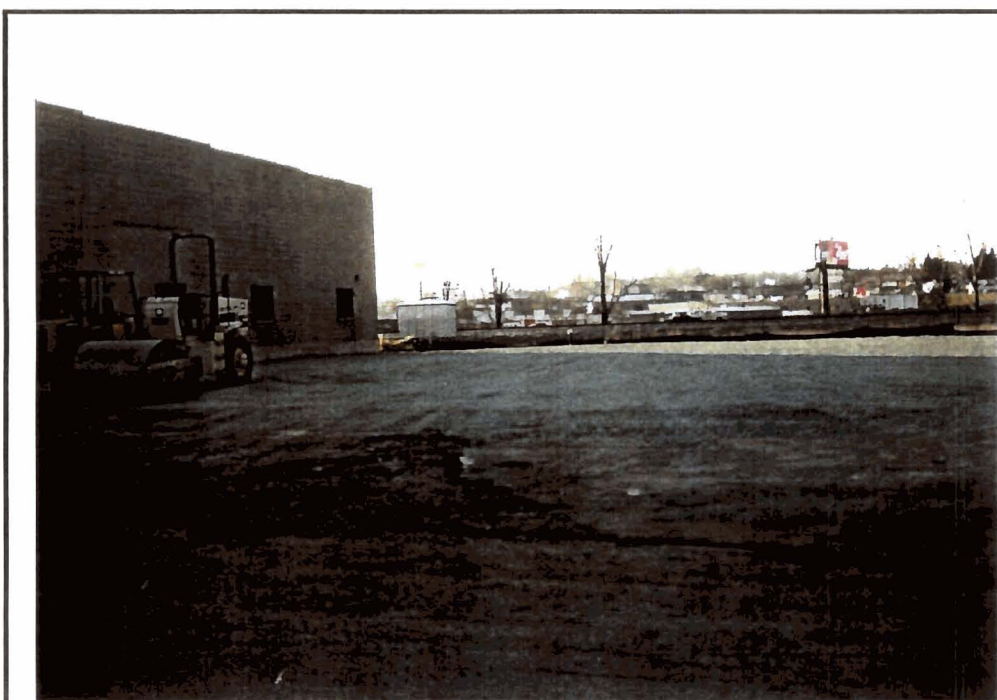
PHOTO #26

COMPLETED PARKING AREA  
LOOKING SOUTH

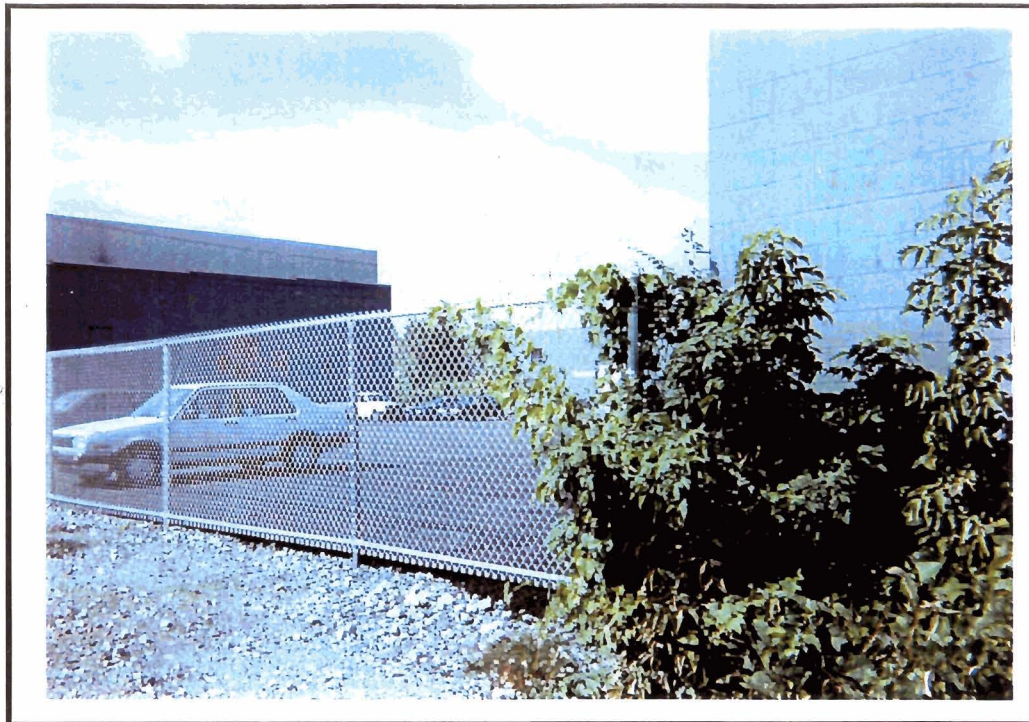
PHOTO #27

It should be noted that Vatrano Realty, the owners of the site, elected to pave the area between buildings 14 and 16. While this activity was conducted without the knowledge of CHA, it is our opinion that this activity will not compromise the integrity of the remedial activities conducted to date.

PAVED PARKING AREA BETWEEN  
BUILDING 14 and BUILDING 16

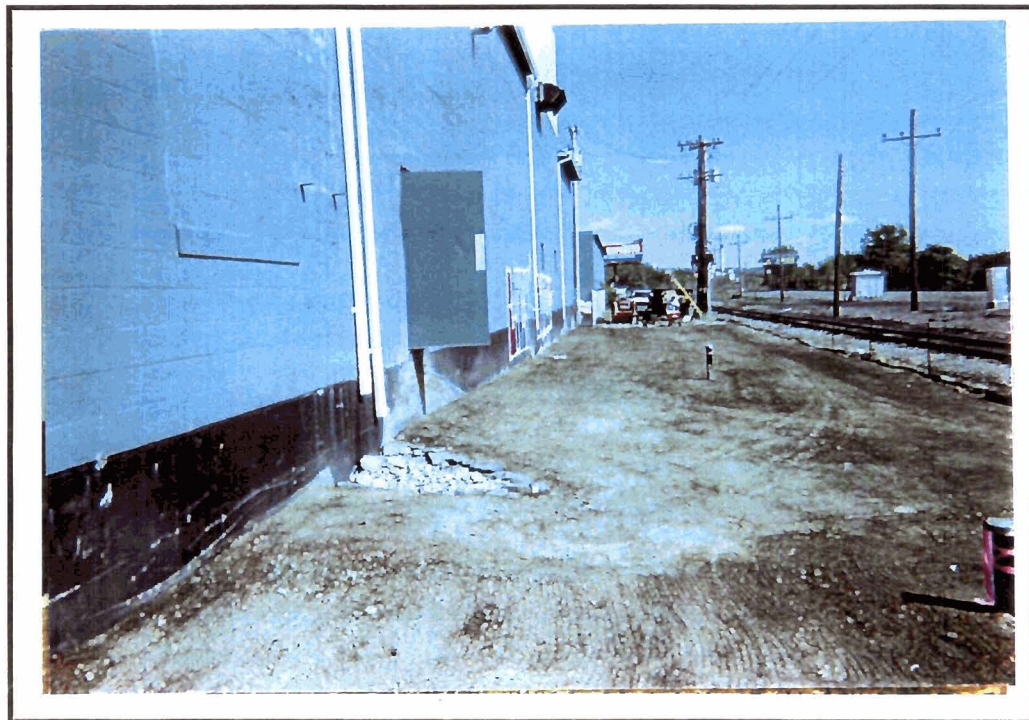
PHOTO #28

SOUTHEAST LIMIT OF  
TOP SOIL/SEEDING
