**2024 Annual Wetland and Waterway  
Monitoring Report  
Former Adirondack Steel Site  
Operable Units 02 and 03  
NYSDEC Site No. 401039  
Colonie, New York**

June 2025  
Version: FINAL  
EA Project No. 16025-27-00-CP

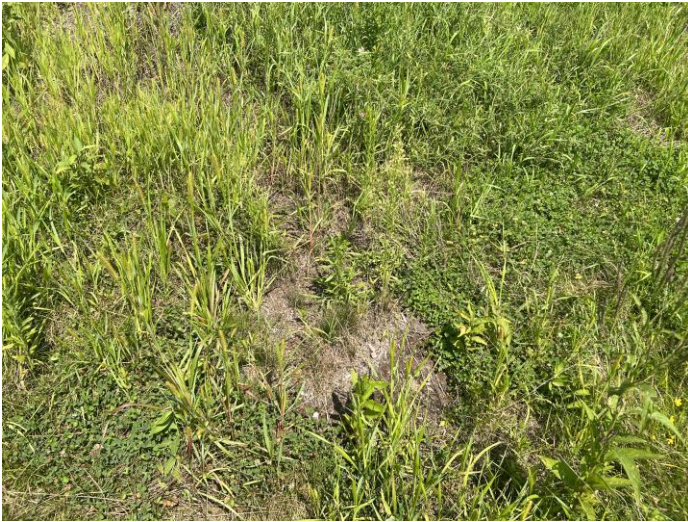
| Plot | Monitoring Area | Percent Native Cover | Dominant Species |
|---|---|---|---|
| V1 | Riparian | 95% | Boneset, Green Foxtail, Blue vervain, and Soft rush |

**Photograph 1:** Overview of vegetation sample plot #1.

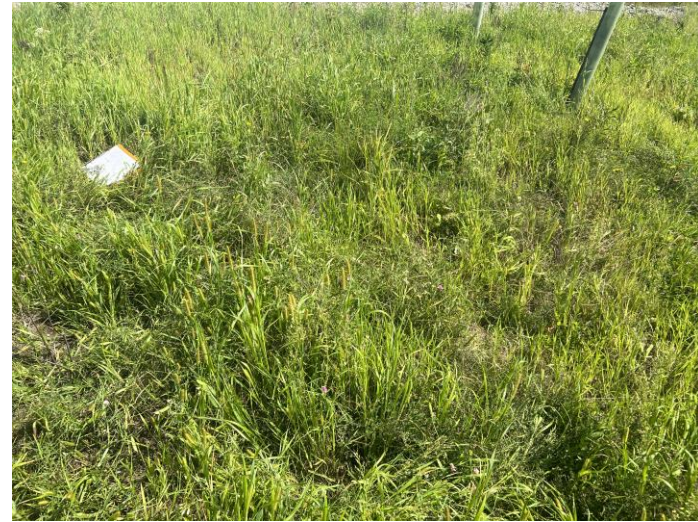
| Plot | Monitoring Area | Percent Native Cover | Dominant Species |
|---|---|---|---|
| V2 | Riparian | 85% | Green foxtail and Blue vervain |

**Photograph 2:** Overview of vegetation sample plot #2.

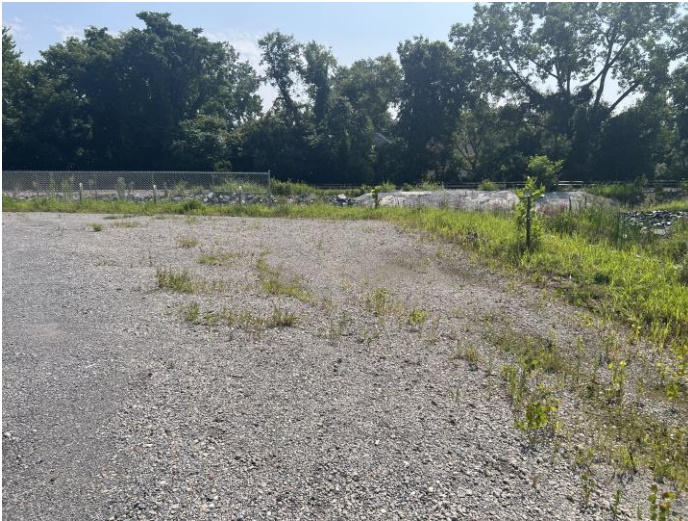
| Plot | Monitoring Area | Percent Native Cover | Dominant Species |
|---|---|---|---|
| V3 | Restored with RCM only | | |

**Photograph 3:** Overview of vegetation sample plot #3.

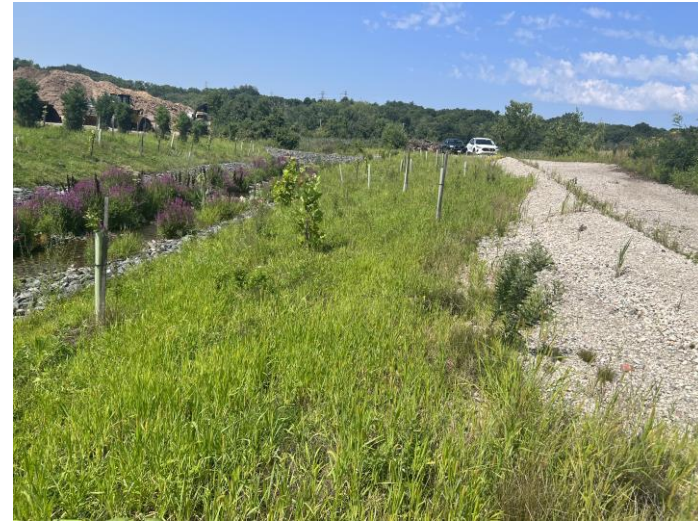
**Photograph 4:** View facing upstream of the riparian planting zone along the north side of the stream channel.

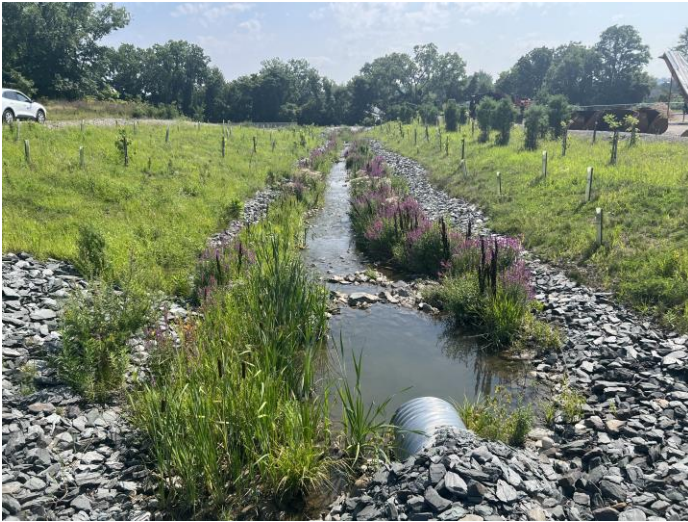
During the monitoring effort, EA personnel did not observe areas of stream bank erosion or signs of stream instability along the channel. The stream channel appears to be well stabilized with rip-rap and photographic documentation of the current channel conditions are provided in **Appendix C**.

**Photograph 5:** View facing downstream from the upper stream crossing.

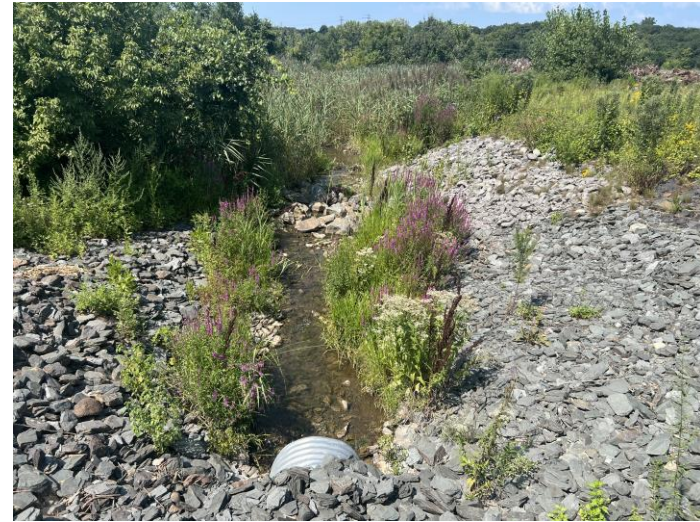
**Photograph 6:** View facing upstream at the upper portion of the site.

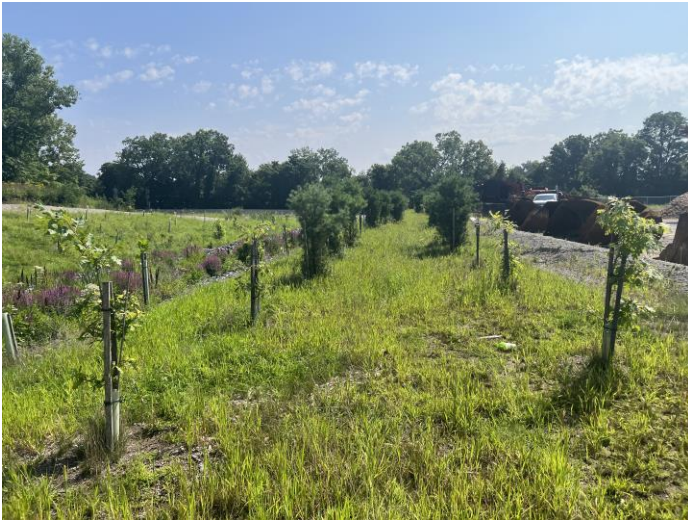
**Photograph 7:** View facing downstream along the upland planting zone on the south side of the stream channel.

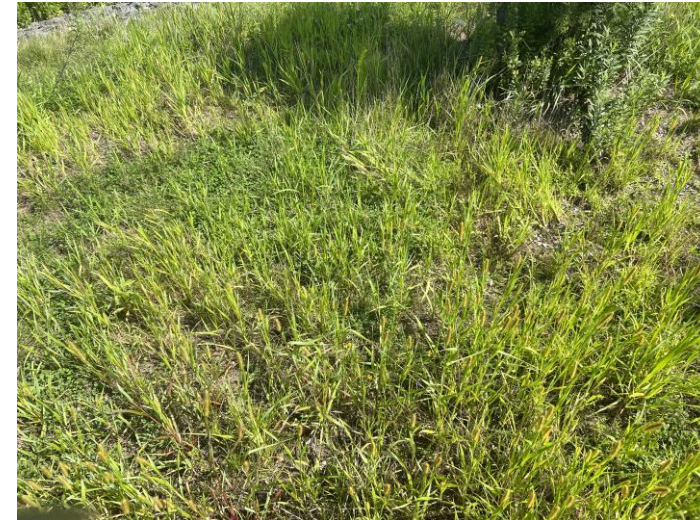
| Plot | Monitoring Area | Percent Native Cover | Dominant Species |
|---|---|---|---|
| V4 | Upland | 95% | Red clover, White clover, Green foxtail |

**Photograph 8:** Overview of vegetation sampling plot #4.

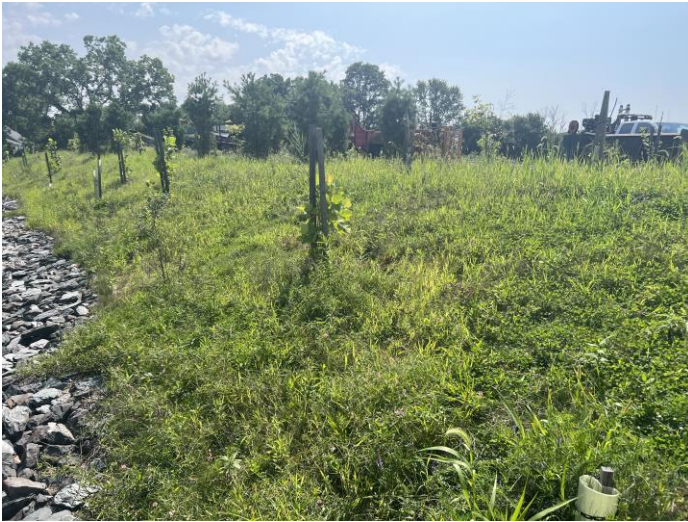
| Plot | Monitoring Area | Percent Native Cover | Dominant Species |
|---|---|---|---|
| V5 | Riparian | 95% | Red clover, Green foxtail, and Bonset |

**Photograph 9:** Overview of vegetation sampling plot #5.

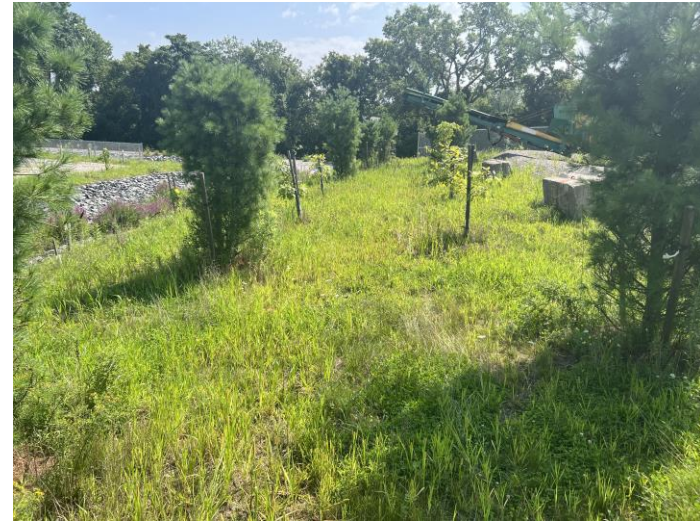
| Plot | Monitoring Area | Percent Native Cover | Dominant Species |
|---|---|---|---|
| V6 | Upland | 95% | Tall goldenrod, Red clover and White clover |

**Photograph 10:** Overview of vegetation sampling plot #6.

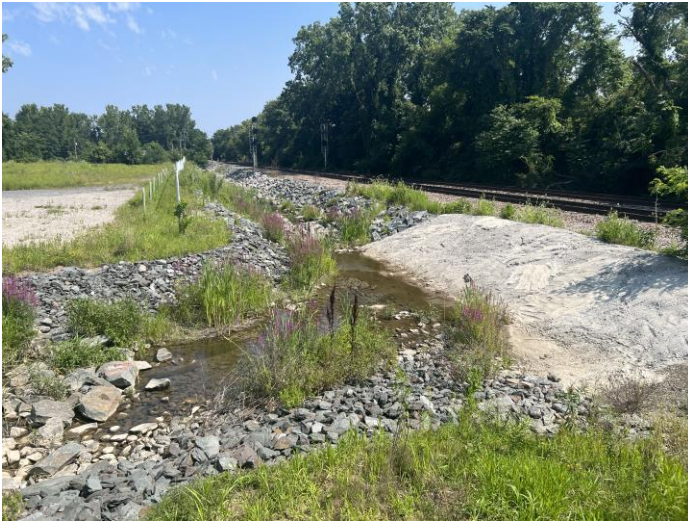
**Photograph 11:** confluence of stream channel and wetland swale along the existing railroad embankment.

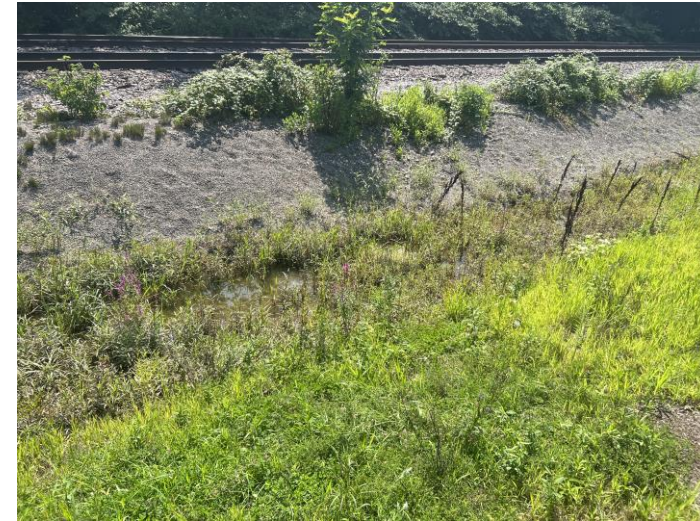
**Photograph 12:** overview of emergent wetland restoration area at the confluence with the existing stream channel.

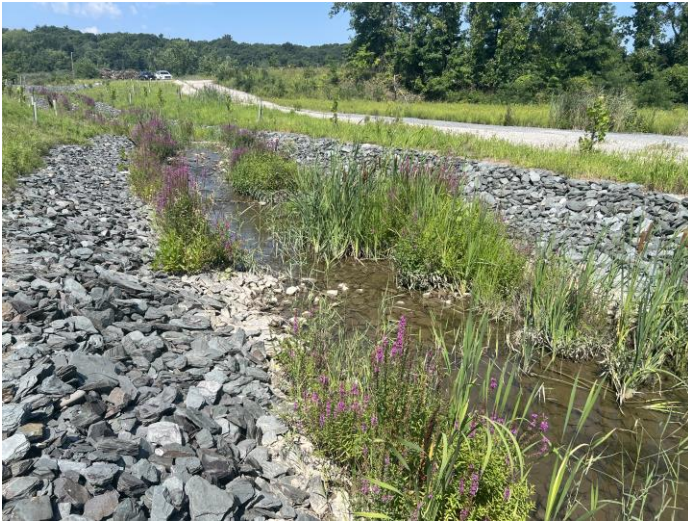
Purple loosestrife was identified at a total of 45 locations with 40 of those locations in small populations less than 100 ft<sup>2</sup> per location and 5 locations covering between 100 ft<sup>2</sup> and 581 ft<sup>2</sup>. A total of 2,238 ft<sup>2</sup> of purple loosestrife was delineated across the 54,317 ft<sup>2</sup> of revegetated areas and stream channel for a total aerial coverage of 4.01%. Many of the populations of purple loosestrife were identified along the stream banks along the existing rip-rap edge.

Common reed was identified at a total of 15 locations with 12 of those locations in small populations less than 100 ft<sup>2</sup> per location and 3 locations covering between 177 ft<sup>2</sup> and 524 ft<sup>2</sup>. A total of 1,177 ft<sup>2</sup> of common reed was delineated across the 54,317 ft<sup>2</sup> of revegetated areas and stream channel for a total aerial coverage of 2.17%.

**Photograph 13:** Phragmites and Purple loosestrife along the lower portion of the stream channel.

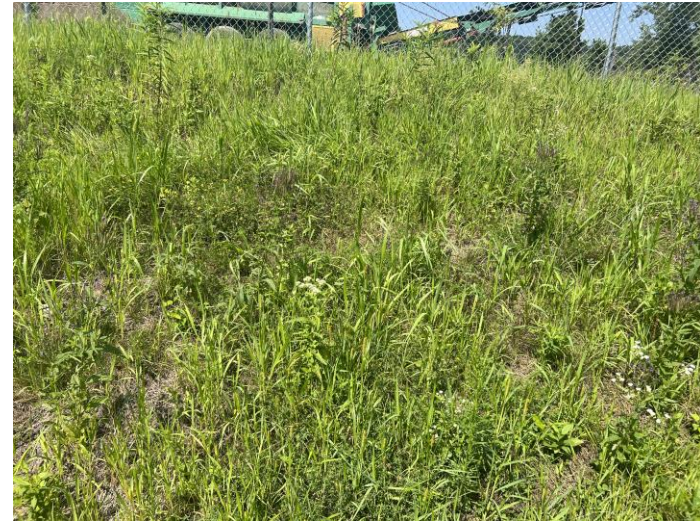
| Plot | Monitoring Area | Percent Native Cover | Dominant Species |
|---|---|---|---|
| V7 | Riparian | 90% | Green foxtail, Blue vervain |

**Photograph 14:** Overview of vegetation sampling plot #7.

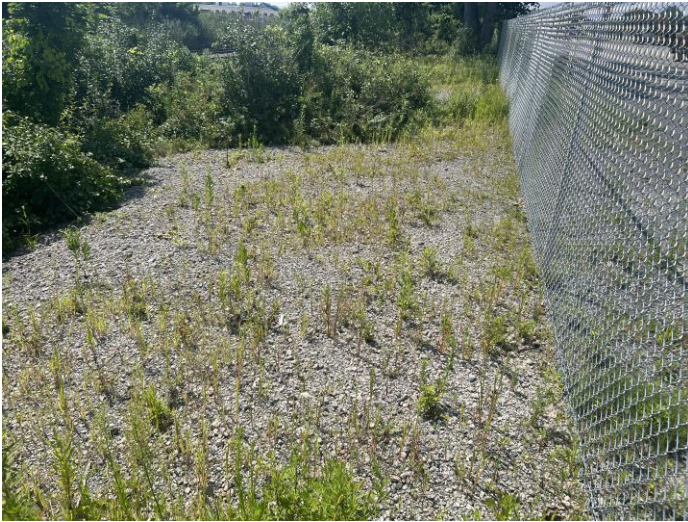
**Photograph 17:** Overview of the upland restored area along the wetland swale.

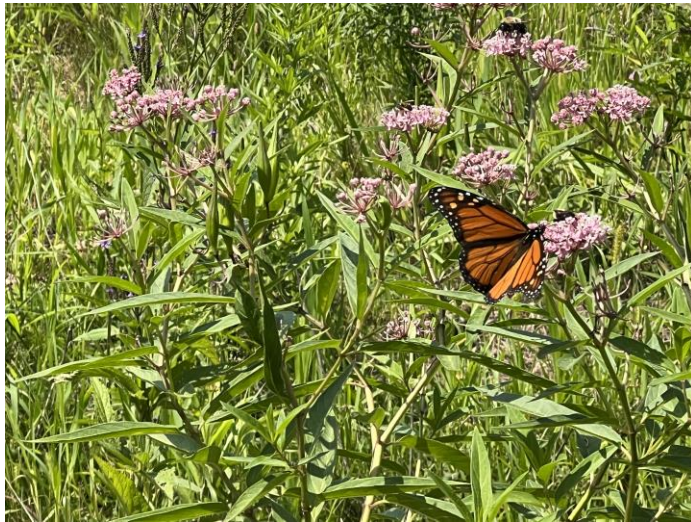
**Photograph 21:** Monarch butterfly observed on milkweed within the riparian planting zone.

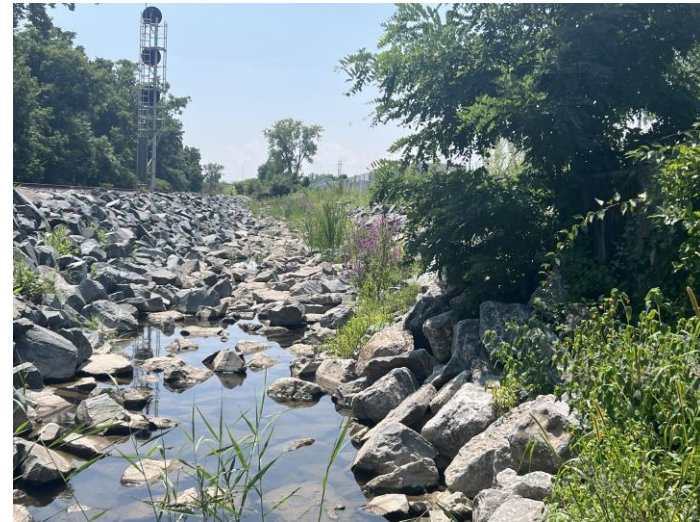
**Photograph 22:** View facing upstream from the lower portion of the stream channel.

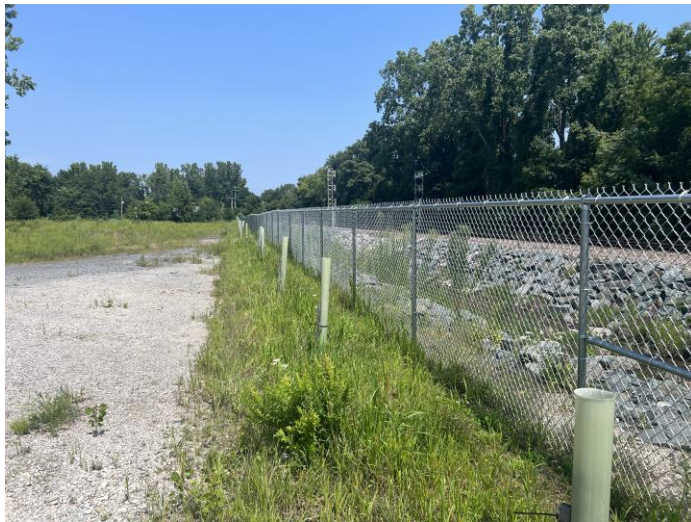
**Photograph 23:** Riparian planting zone along the newly installed chain-link fence.
