Subject: Erie Boulevard Hydropower, L.P.  
(former Niagara Mohawk Power Corporation)  
School Street Hydroelectric Station  
Former Fire Training Area  
NYSDEC Site #401044  
*2022 Periodic Review Report & IC/EC Form*

ERIE BOULEVARD HYDROPOWER, L.P.  
 SCHOOL ST. HYDROELECTRIC STATION - COHOES, NY  
**2022 PERIODIC REVIEW REPORT**

2019 Annual Site Inspection  
Erie Boulevard Hydropower, L.P.  
School Street Hydroelectric Station, Cohoes, New York

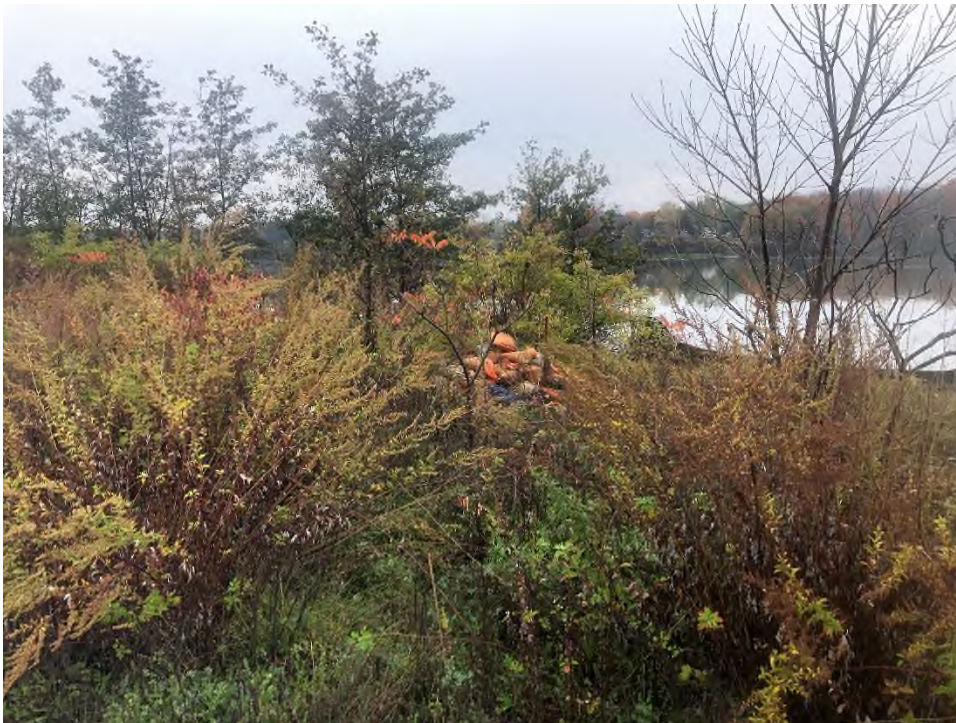
**Photograph: 7**

**Description:**  
Sand Bags in Former Fire Training Area

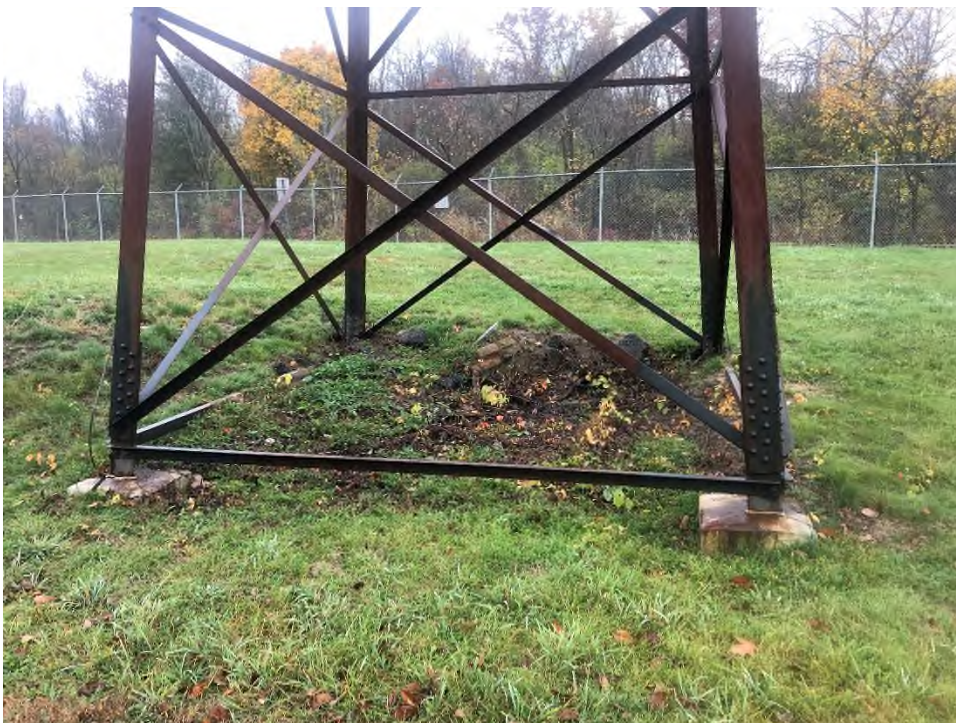
**Photograph: 8**

**Description:**  
Looking at 34.5 kV  
Electrical Transmission  
Tower Near Northern Part  
of Institutional Control  
Area
