**POST-CONSTRUCTION SITE VISIT REPORT**

<b>Site Code #:</b> 401058	<b>Contract No.</b> 009709	<b>Date:</b> 11/10/16	<b>Report #:</b> hw401058.2016_NOV_10
----------------------------	----------------------------	-----------------------	---------------------------------------

**Site Name:** Former Roxy Cleaners

**Location:** 156 Delaware Ave. Town of Bethlehem, Albany County, New York

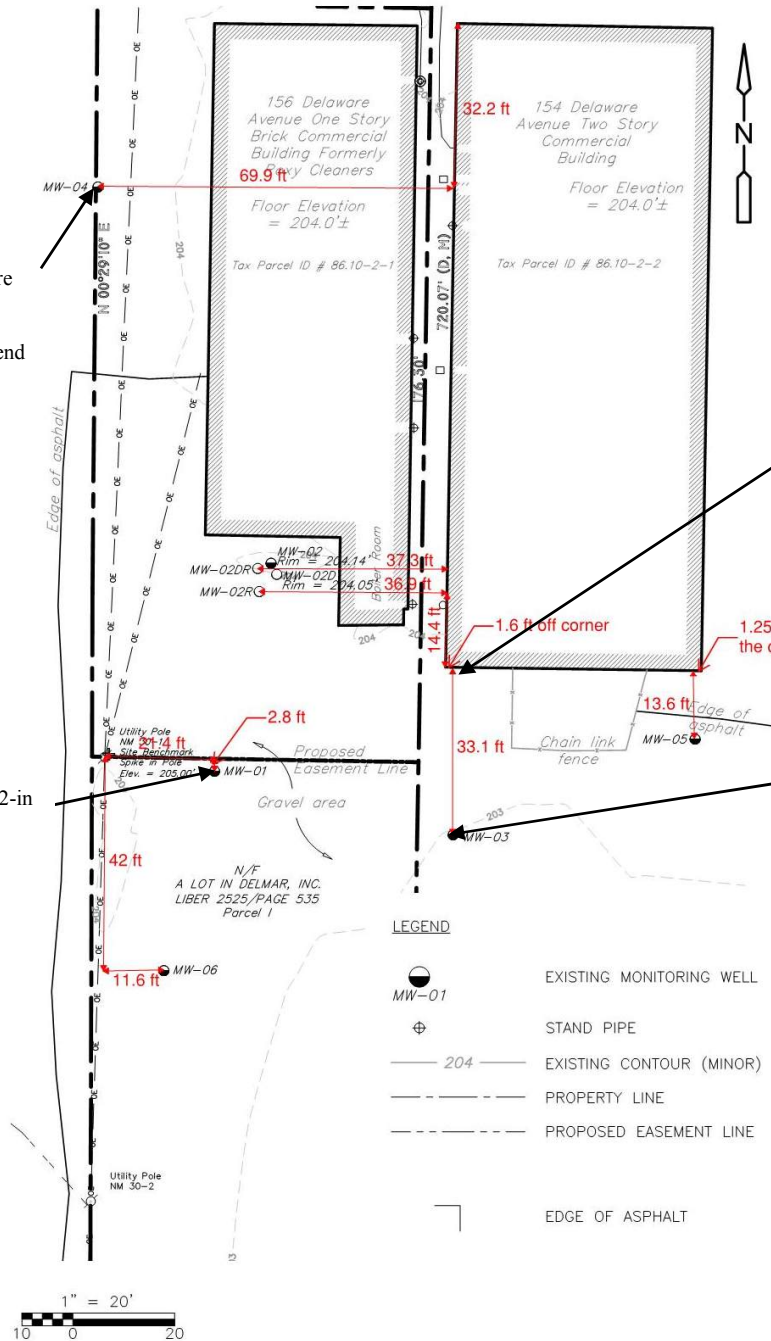
# Site Map

Road box and protective cap are missing. Riser is full of gravel, recommend a redrill.

Buried under ~12-in of crushed stone

Non-Haz 55-gal Drum

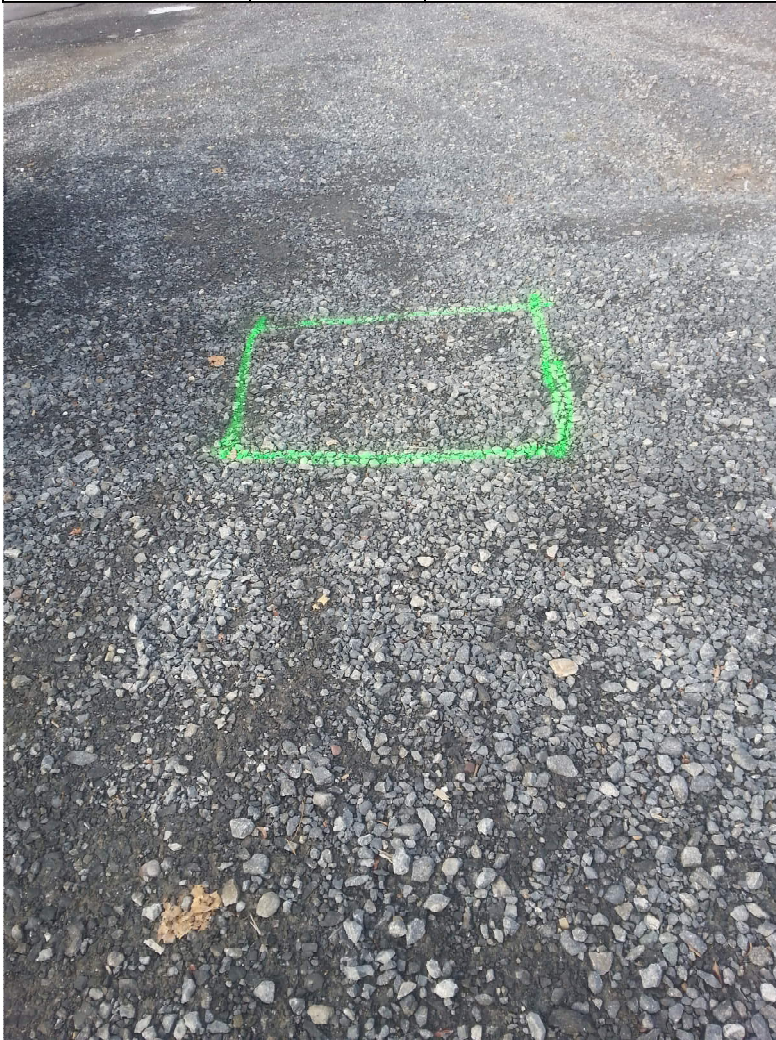
Major Issues	Description & Reason
MW-01	<p>Approximately 12-inches of crushed stone is covering this well. CDM Smith recommends removal of crushed stone, and installation of a 12-in riser and road box to access the well.</p> <p>It is unclear which party (NYSDEC, current owner, potential buyer) is responsible for funding this. A rough estimate to complete repairs has been provided as an attachment to this document.</p>
MW-03	<p>Approximately 12-inches of crushed stone is covering this well. CDM Smith recommends removal of crushed stone, and installation of a 12-in riser and road box to access the well.</p> <p>It is unclear which party (NYSDEC, current owner, potential buyer) is responsible for funding this. A rough estimate to complete repairs has been provided as an attachment to this document.</p>
MW-04	<p>The road box and cap are missing. Gravel and stone were observed fully blocking the well riser. Well will need to jet cleaned or redrilled. CDM Smith recommends abandonment of the existing well and installation of a replacement well.</p> <p>It is unclear which party (NYSDEC, current owner, potential buyer) is responsible for funding this. A rough estimate to complete repairs has been provided as an attachment to this document.</p>

**Photo 1: MW-01, looking north towards Delaware Avenue. Rough location was determined using measurements (shown in Site Map) and then pinpointed using metal detector. CDM Smith recommends removal of crushed stone and installation of a 12-inch riser and new road box to properly access MW-01.**

Item	Unit Cost (Average 2016 Unite Rates)		Total No. Units	Total Cost	Assumptions
Digging out wells and installing riser/road box - LABOR	\$ 160.00	/hr/person	8	\$ 1,280.00	2 Laborers, 4 hrs to complete
PVC Well Riser, 2-in I.D., Sched 40	\$ 7.50	/ft	2	\$ 15.00	
4-in O.D. Flushmount Road Box	\$ 155.00	each	2	\$ 310.00	
<b>Subtotal</b>			<b>\$ 1,605.00</b>

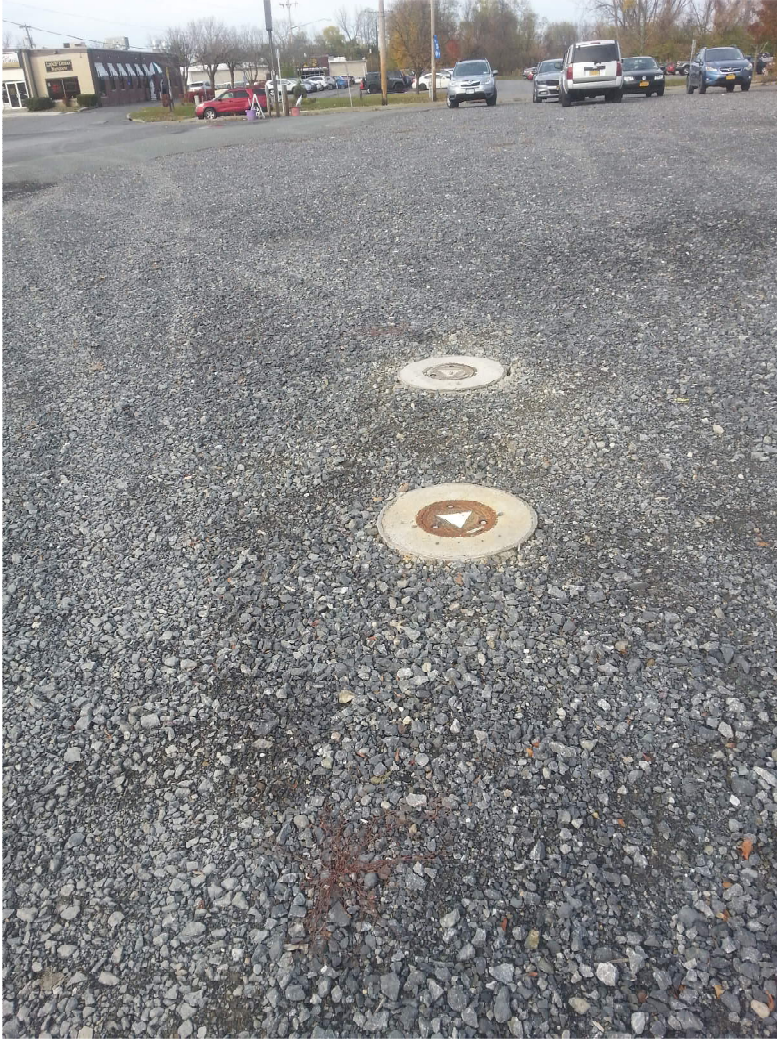
**Photo 2: MW-2R and MW-2DR, looking north. Wells and road boxes do not require repairs.**

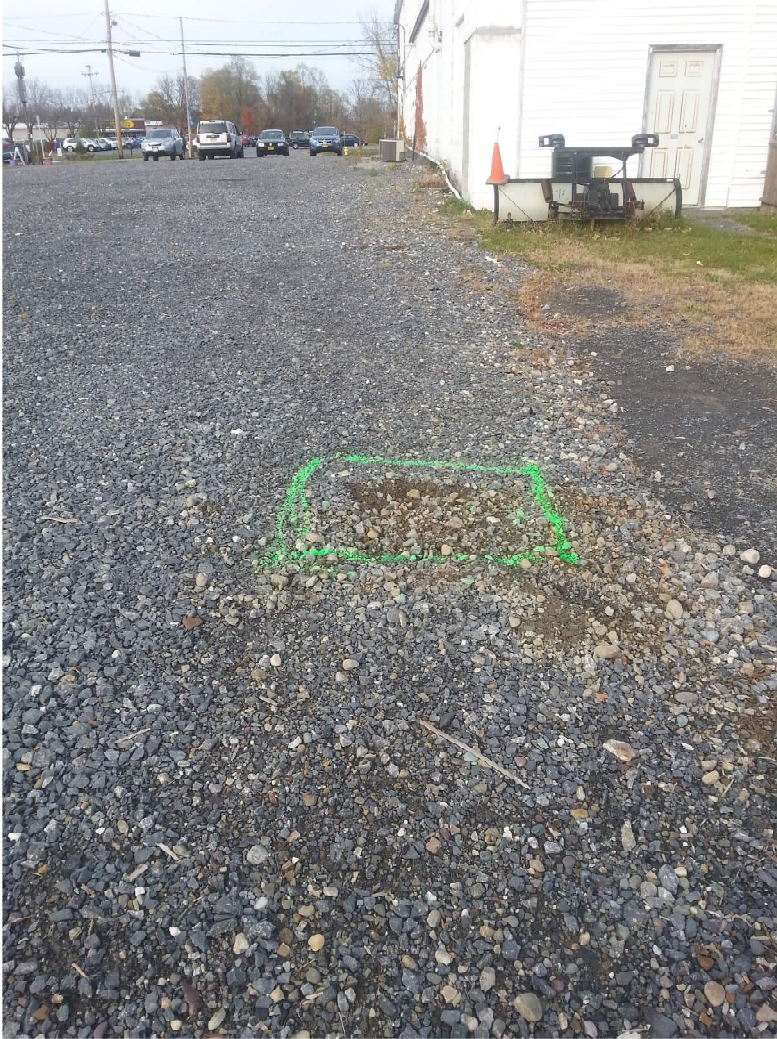
**Photo 3: MW-03, looking north. Rough location was determined using measurements (shown in Site Map) and then pinpointed using metal detector. CDM Smith recommends removal of crushed stone and installation of a 12-inch riser and new road box to properly access MW-03.**

**MW-01 and MW-03, remove excess crushed stone and install new riser/road box**

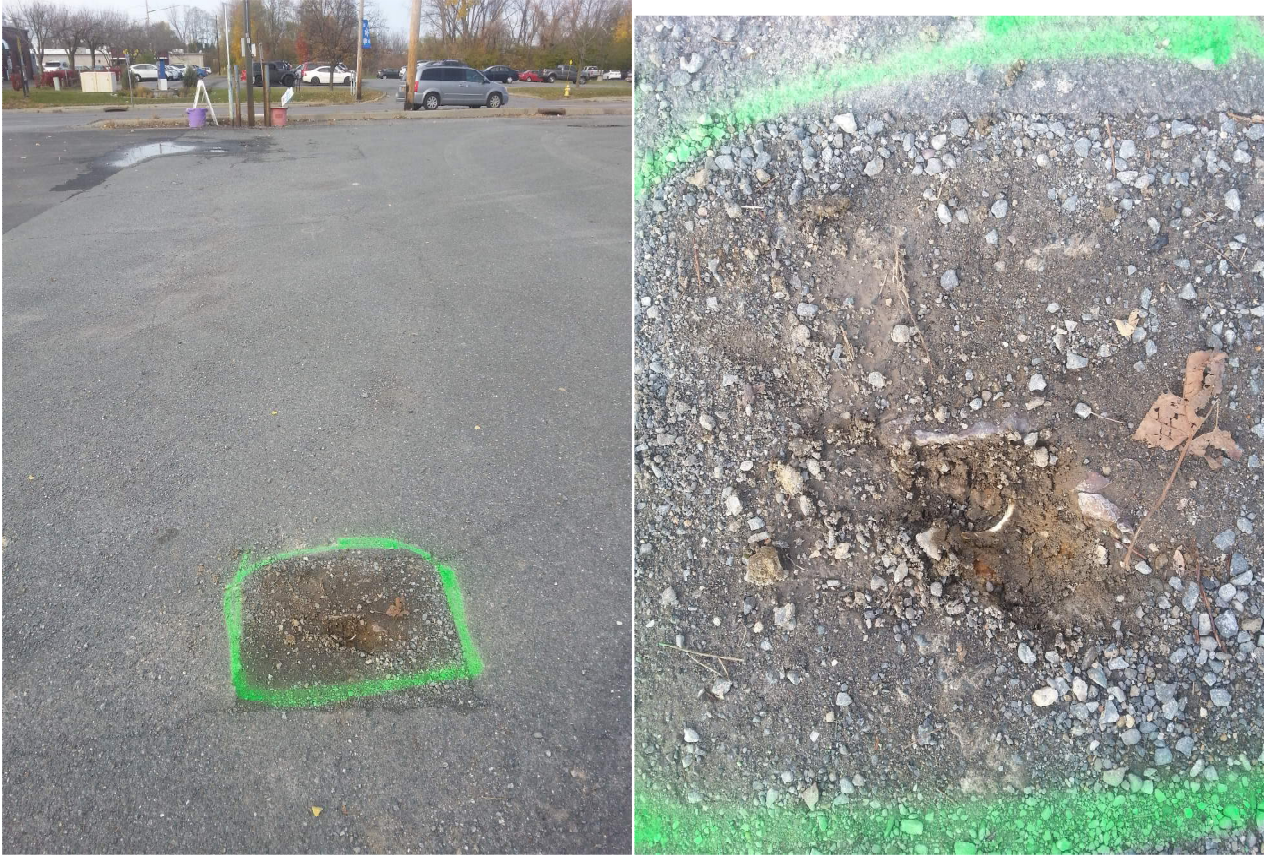
**Photo 4: MW-04, looking north (left photo) and east (right photo). Road box and protective cap is missing. Close-up photo shows riser fully blocked with gravel and soil. CDM Smith recommends abandoning the existing well and installation of a replacement MW-04.**

**MW-04, abandon existing well and installation of new well**

Item	Unit Cost		Total No.	Total Cost	Assumptions
	(Average 2016 Unite Rates)		Units		
Dig out and cut off existing MW-04 - LABOR	\$	160.00 /hr/person	4	\$ 640.00	2 Laborers, 2 hrs to complete Info from Table 2-2 in the Remedial Investigation Report, E&E (July 2012)
Grout existing MW-04	\$	7.75 /LF	25	\$ 193.75	
Hollow Stem Auger, 4.25-in PVC Well Riser, 2-in I.D., Sched 40	\$	14.40 /LF	25	\$ 360.00	
PVC Well Screen, 2.0 inch ID, #10 slot, schedule 40	\$	7.50 /ft	15	\$ 112.50	
Well screen sand pack for 2.0 inch monitoring - well set in 4.25 inch hollow stem augers	\$	7.00 /ft	10	\$ 70.00	
Seal for 2.0 inch monitoring well set in 4.25 inch hollow stem augers	\$	7.20 /ft	10	\$ 72.00	
Riser Backfill for 2.0 inch well set in 4.25 inch hollow stem augers	\$	19.00 /ft	2	\$ 38.00	
4-in O.D. Flushmount Road Box	\$	9.50 /ft	13	\$ 123.50	
Well Development, Pump and surge method (w/surge block)	\$	155.00 each	1	\$ 155.00

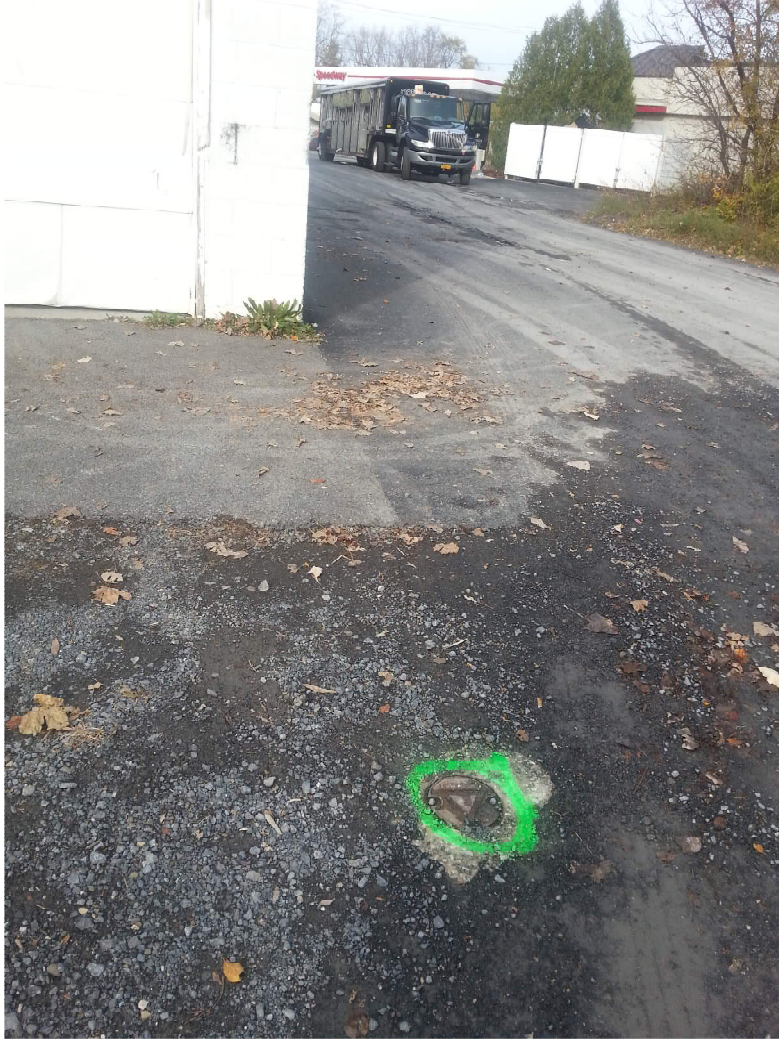
**Photo 5: MW-05, looking north. No repairs are needed.**

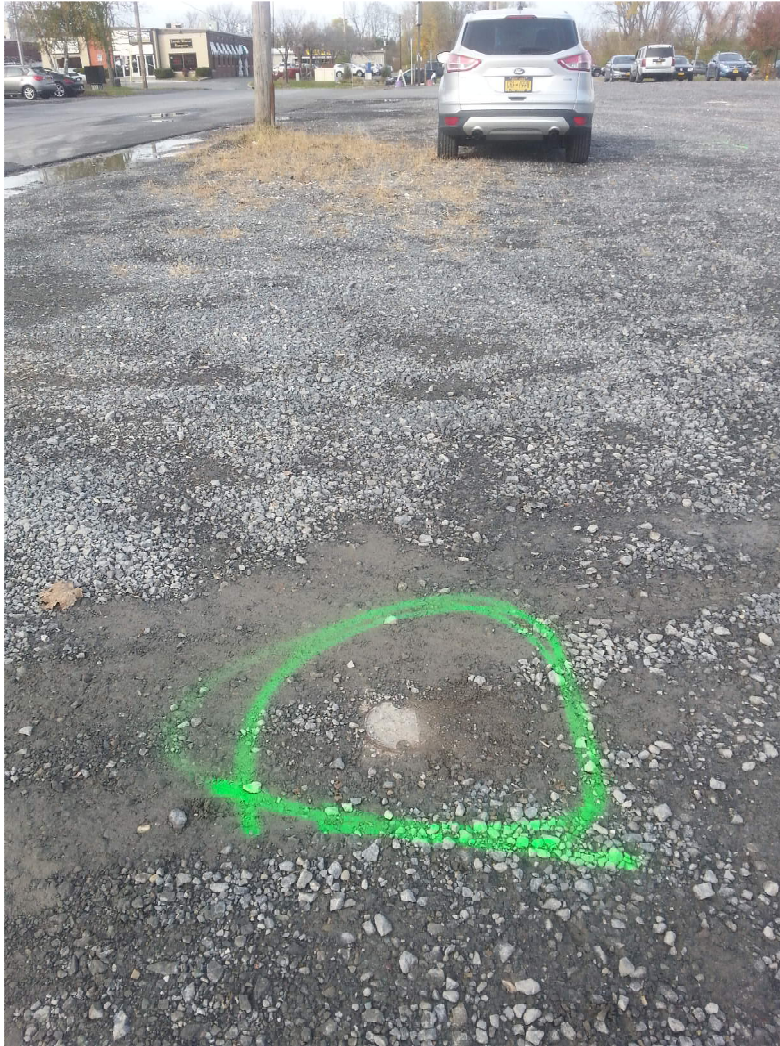
**Photo 6: MW-06, looking north. No repairs are needed.**

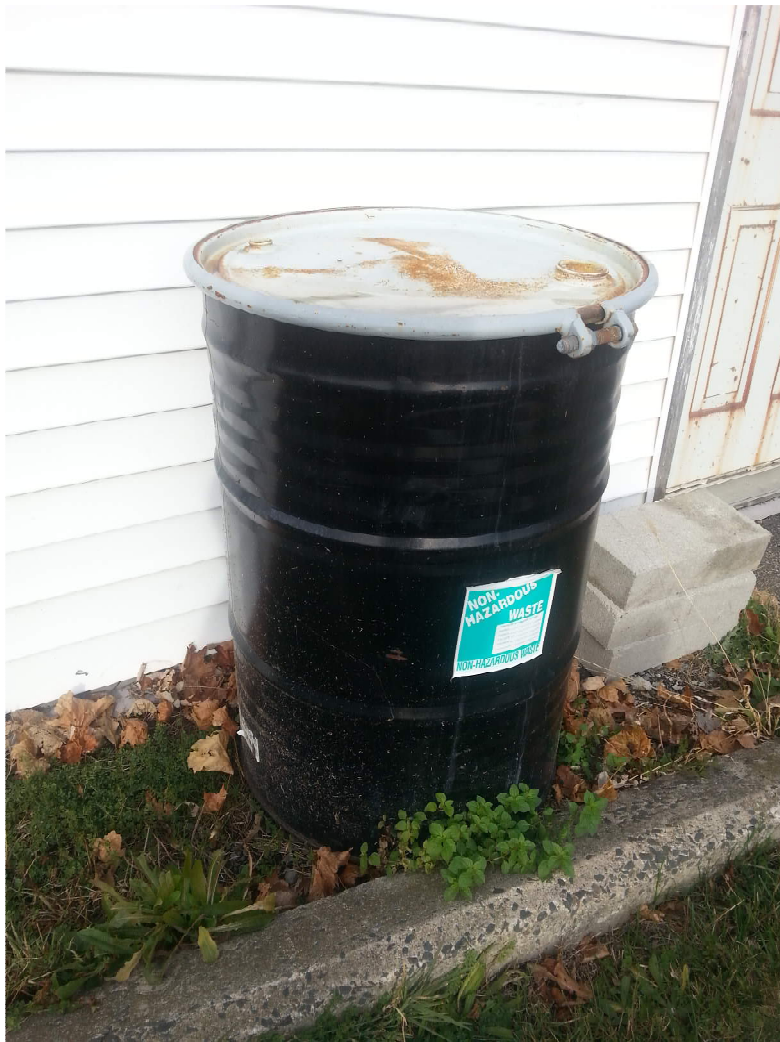
Drum	<p>A 55-gallon drum with a Non-Hazardous Waste label was observed on the southwest corner of the Healthy Pet Center. The drum needs to be transported offsite for proper disposal.</p> <p>There is no funding mechanism under CDM Smith's current Work Assignment to fund the transportation and disposal of this drum. CDM Smith recommends that NYSDEC reach out to a call-out contractor to perform this work. A rough estimate to complete transport and disposal has been provided as an attachment to this document.</p>

**Photo 7: Non-Haz drum, located on southwest corner of Healthy Pet Center. Drum appears sound, no obvious leakage or buckling observed. CDM Smith recommends transport & disposal of drum.**

**IDW - Pickup & Disposal of Three (3) Drums - existing drum + well install soil cuttings drum + well development purge water drum**

Item	Unit Cost		Total No.	Total Cost	Assumptions
	(Average 2016 Unite Rates)		Units		
Transportation	\$	250.00	/trip	1	\$250.00
Drum Disposal					
Water - Non-Haz Waste	\$	105.00	/drum	1	\$105.00
Drum Disposal					
Soil - Non-Haz Waste	\$	105.00	/drum	2	\$210.00
