# 2017 PERIODIC REVIEW REPORT

**Former Albany Laboratories Site  
67 Howard Street/140 State Street  
City of Albany, New York**

**New York State  
Department of Environmental Conservation  
Site Number: 401061**

**February 6, 2018**

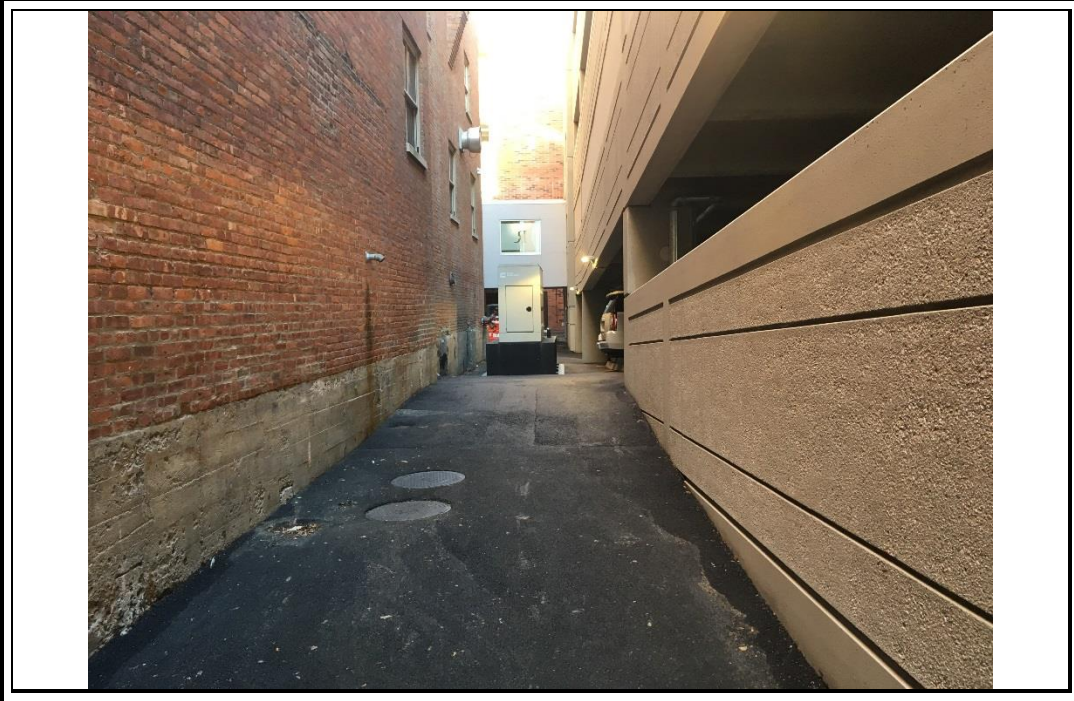
**Photo 1: Looking northeast; asphalt cover between 144 State Street and parking garage.**

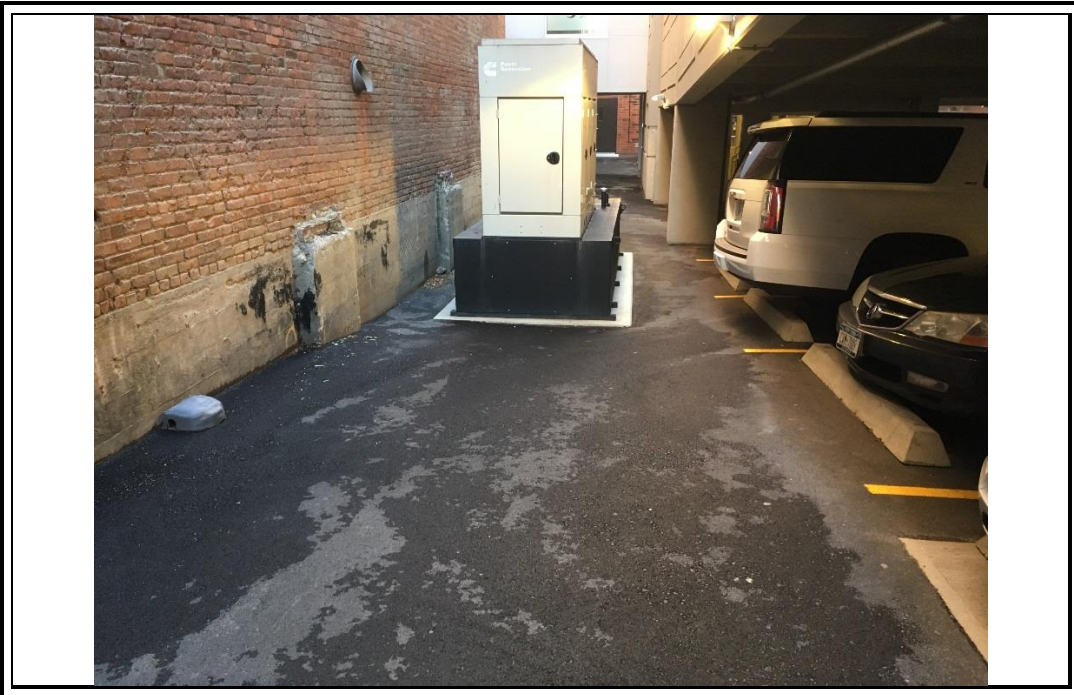
**Photo 2: Looking northeast; asphalt cover between 144 State Street and parking garage; emergency generator unit on concrete pad.**

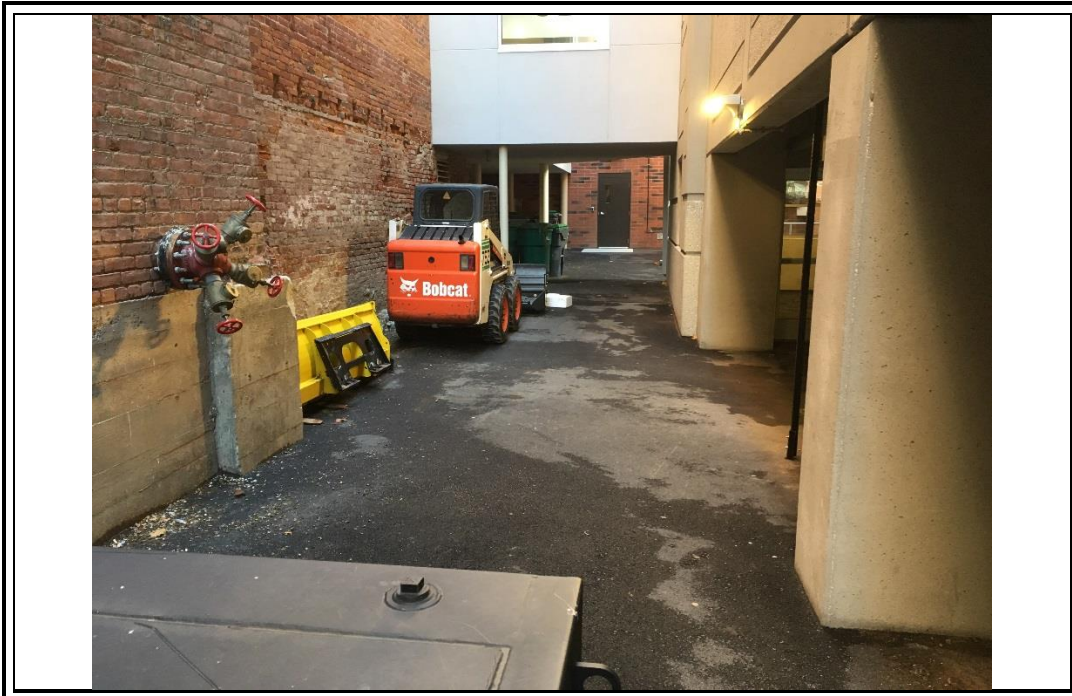
**Photo 3: Looking northeast; asphalt cover between 144 State Street and parking garage; portion of emergency generator unit in foreground.**

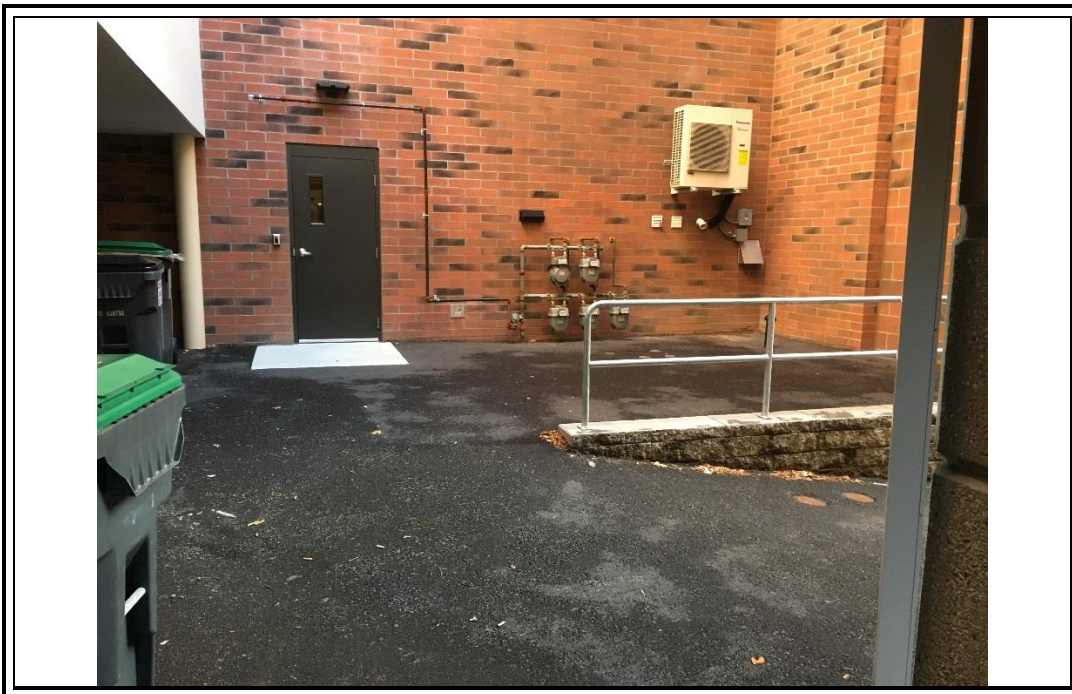
**Photo 4: Looking east-northeast; asphalt cover adjacent to rear (southwest) side of 140 State Street.**

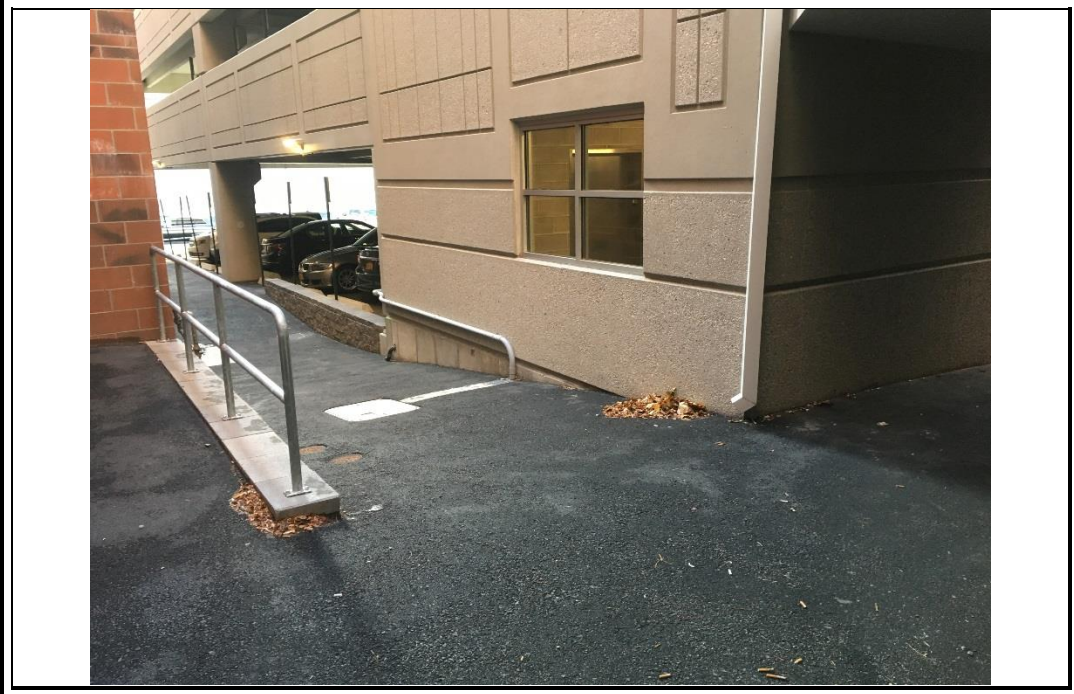
**Photo 5: Looking southeast; asphalt cover between 140 State Street and parking garage.**

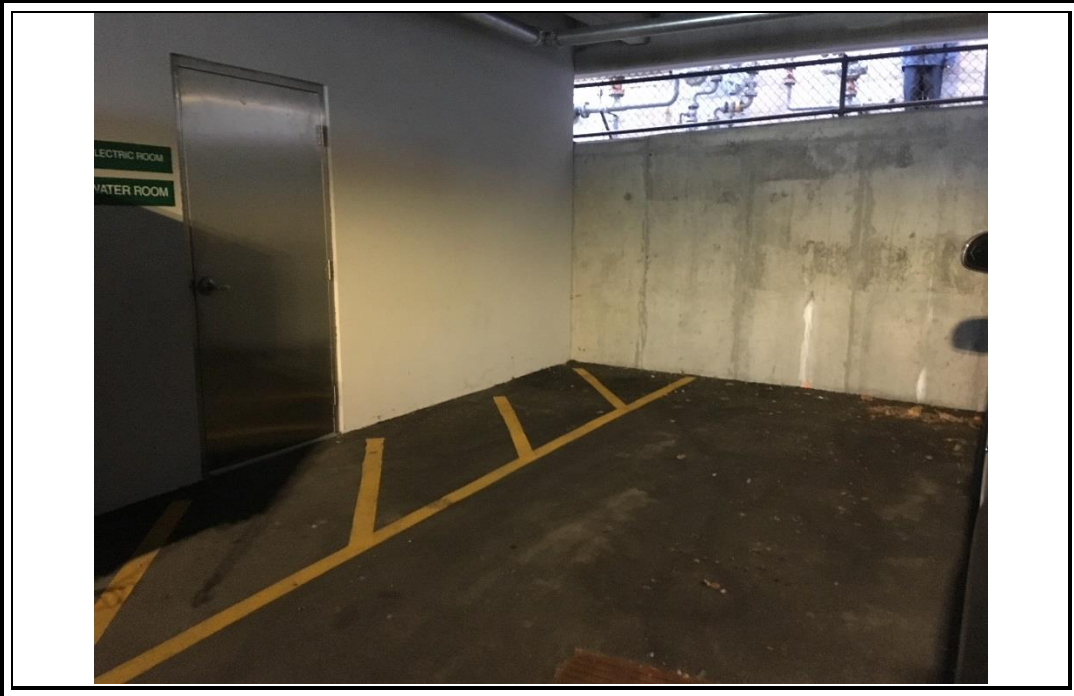
**Photo 6: Looking west; asphalt cover in southwest corner of parking garage.**

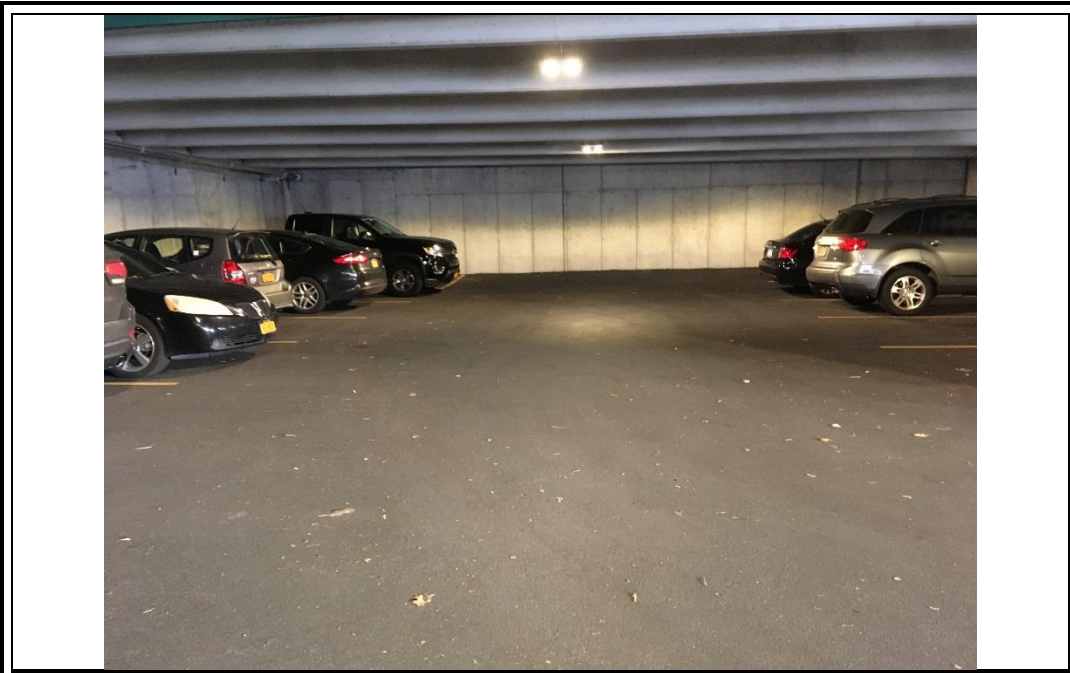
**Photo 7: Looking north-northeast; asphalt cover in northwest portion of parking garage.**

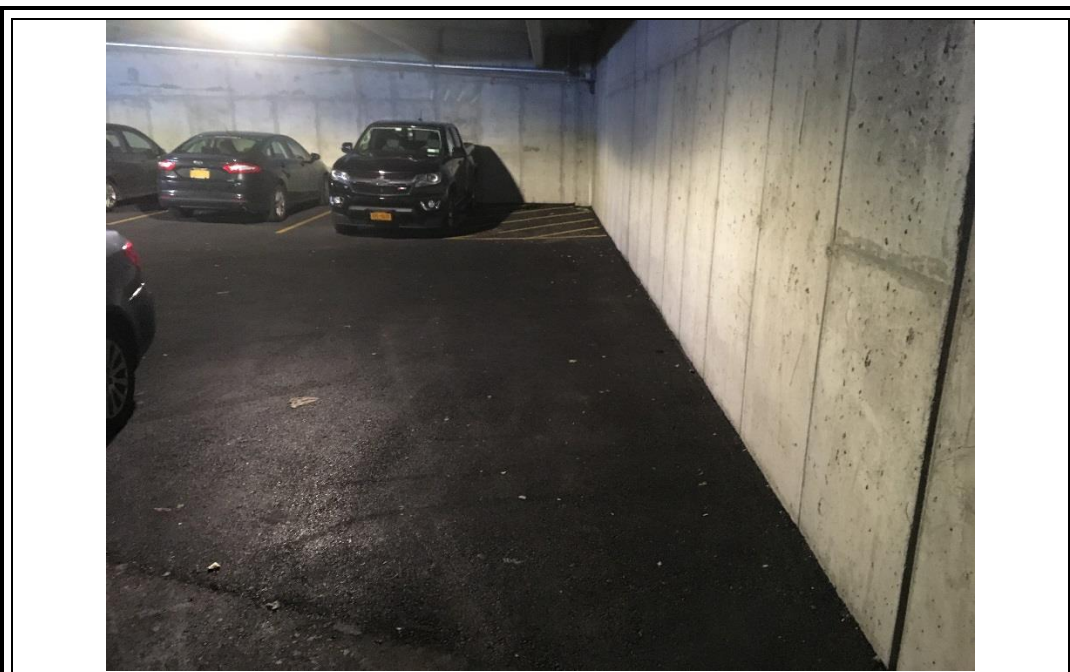
**Photo 8: Looking northwest; asphalt cover in northwest portion of parking garage.**

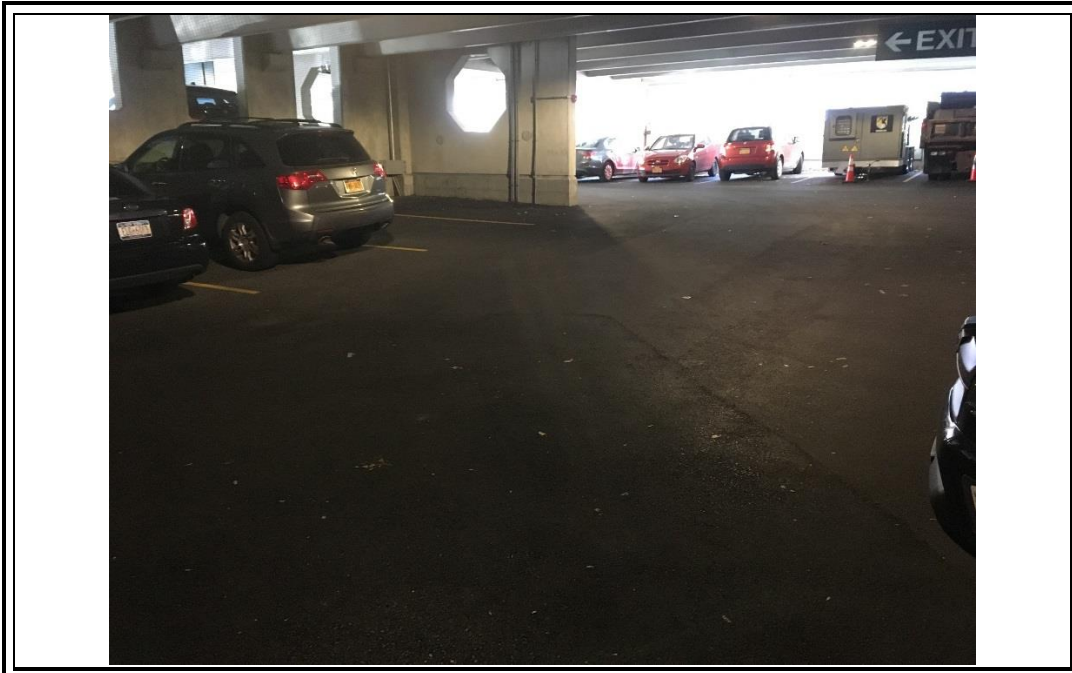
**Photo 9: Looking south; asphalt cover in southwest portion of parking garage.**

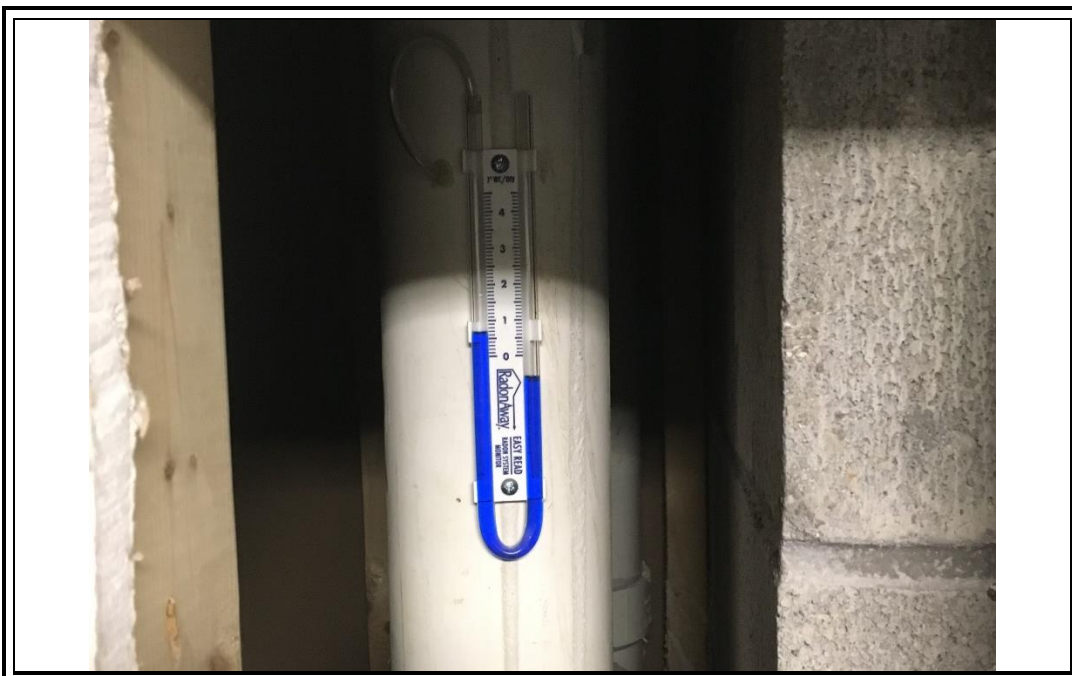
At the time of the December 6, 2017 inspection, the sub-slab depressurization system in the 140 State Street building was observed to be operating and functioning properly, as indicated by the pressure gauge in the vertical riser pipe (accessed via a wall-mounted hatch in the basement). Operation was then confirmed during inspection of the in-line fan and discharge piping on the roof of the building.

**Photo 10: Vacuum gauge on vertical riser pipe for vapor mitigation system at 140 State Street (gauge accessed via a wall hatch in the basement).**

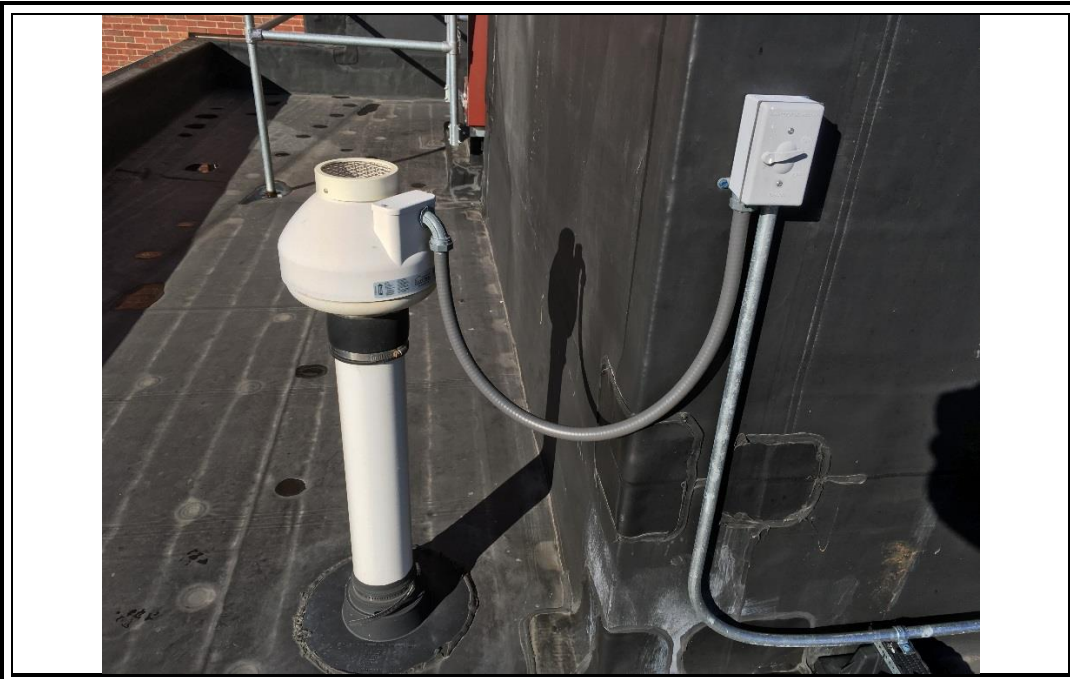
**Photo 11: Fan and vapor mitigation system exhaust point on the roof of 140 State Street.**

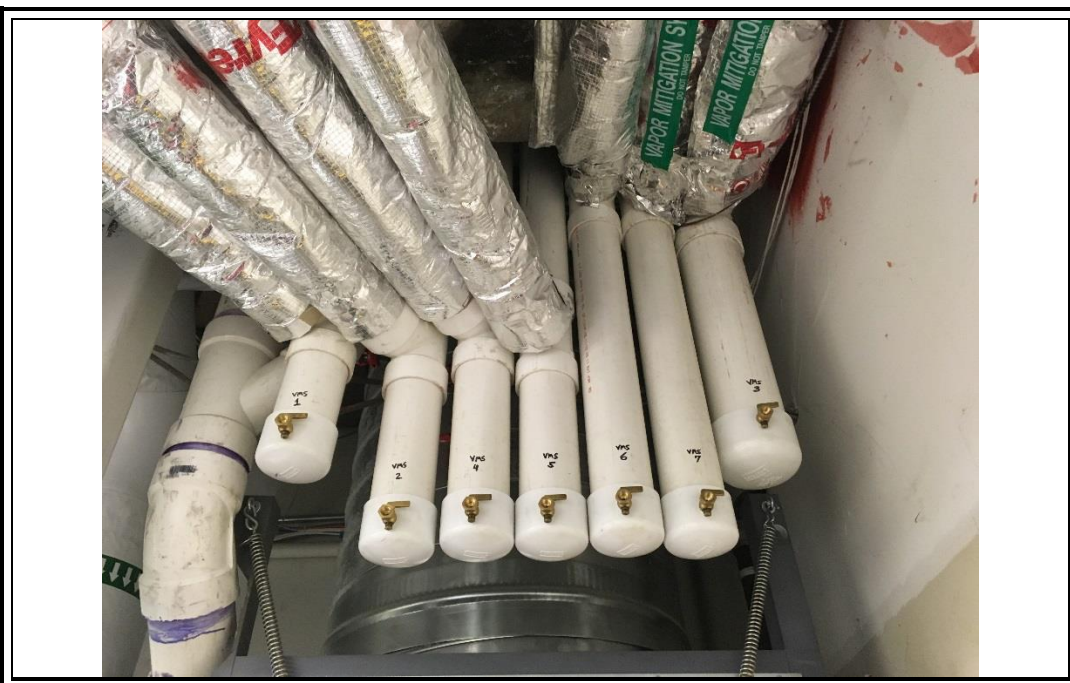
**Photo 12: Bottoms of vertical riser pipes for the vapor mitigation system at 144 State Street (pipes are accessed via a closet in the basement of the building).**

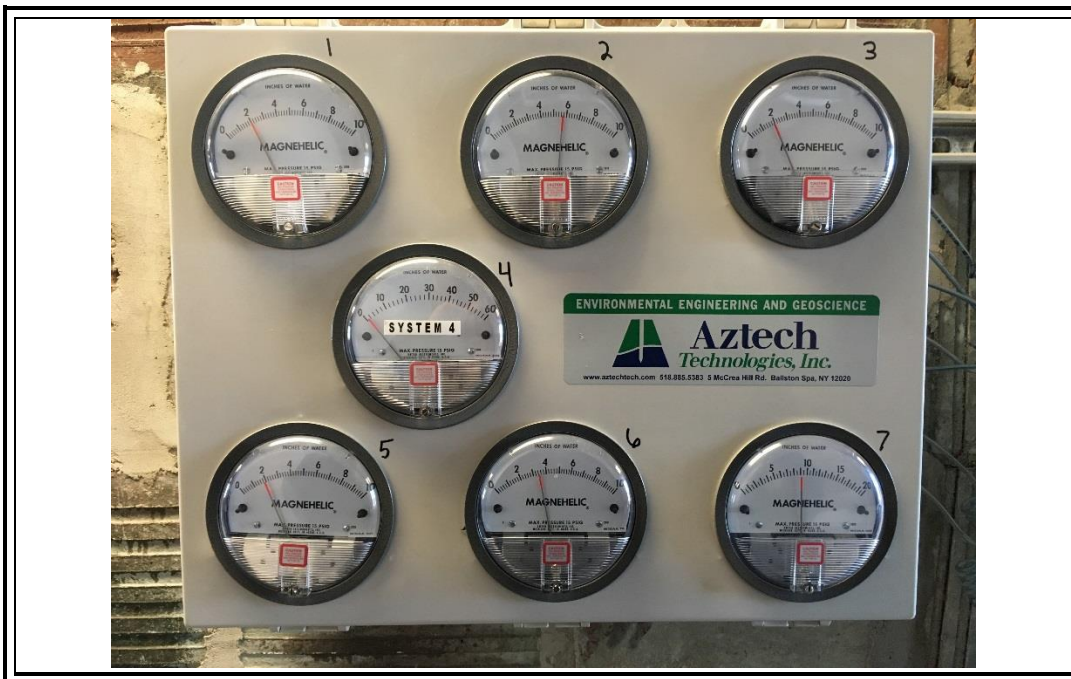
At the time of the December 6, 2017 inspection, the sub-slab depressurization system in the 144 State Street building (Renaissance Hotel) was observed to be operating and functioning properly, as indicated by the magnehelic monometer for each sub-system (#1 through #7). The manometer readings were consistent with the readings observed in September 2015 (soon after the system was activated) and also during site visits by CHA in April and December 2016. Based on post-installation communication testing conducted by Aztech Technologies, Inc. during the fall of 2015, these readings are indicative of sufficient vacuum to produce the required negative sub-slab pressure at monitoring points throughout the basement.

**Photo 13: Vacuum gauge panel for vapor mitigation system at 144 State Street.**

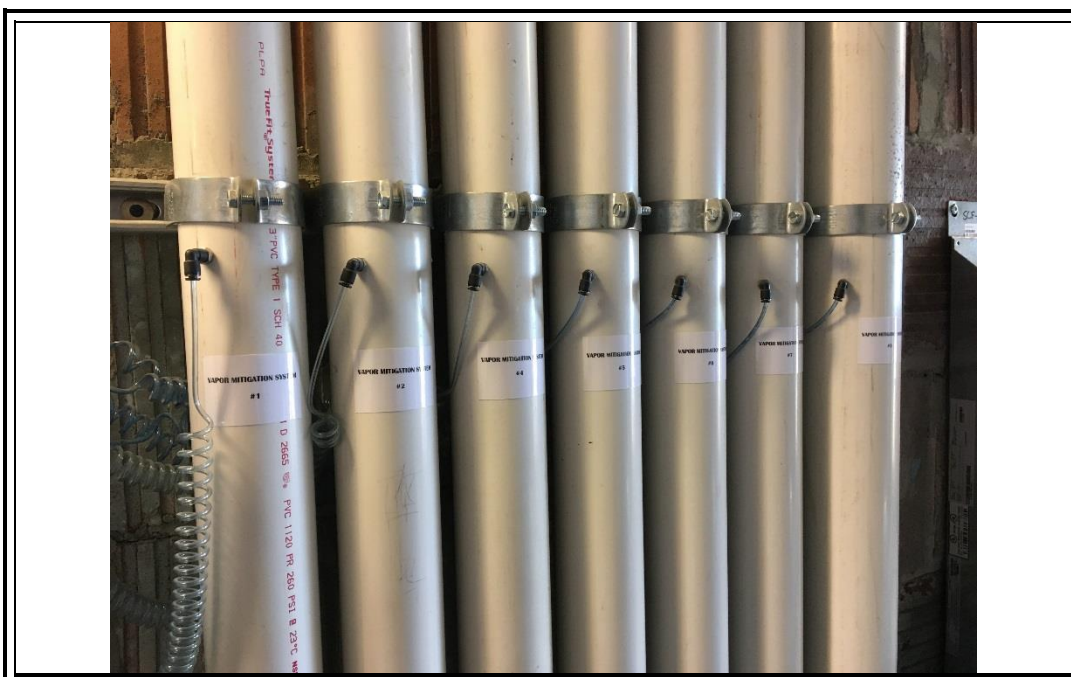
**Photo 14: Vertical riser pipes for the seven sub-systems comprising the vapor mitigation system at 144 State Street.**

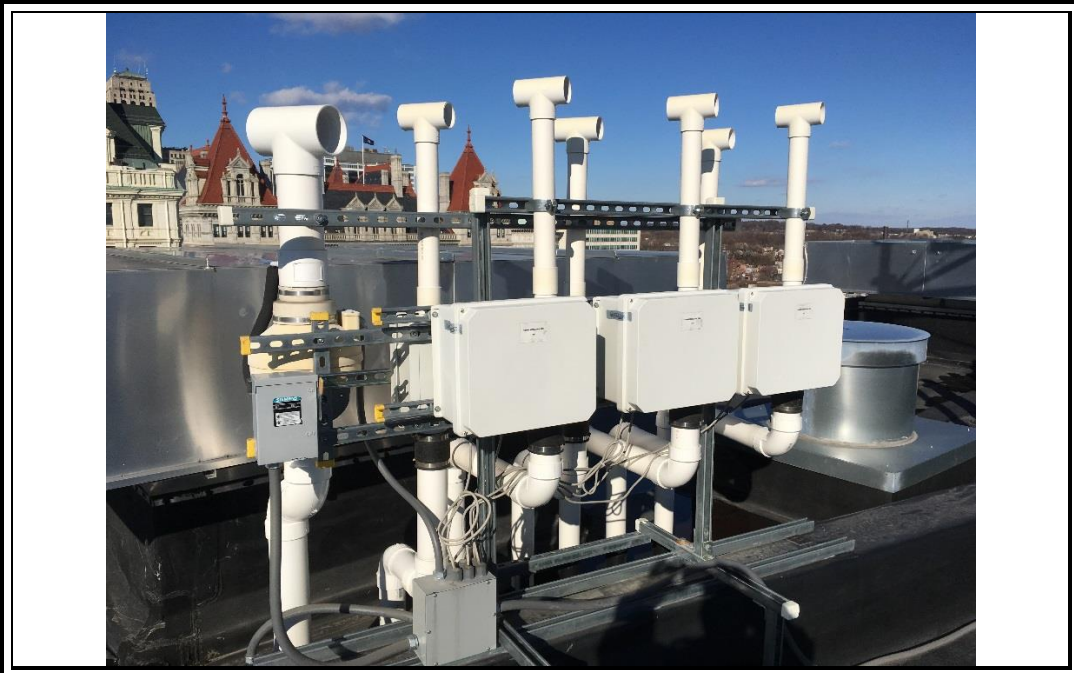
System operation was confirmed via inspection of the seven in-line fans mounted on the roof of the building. Each fan was observed to be operating and air flow was noted from each of the discharge pipes. No cracks or other evidence of damage to the piping or fans was observed. As part of the inspection, the main system switch for the fans was tested and the system was temporarily switched off. The switch functioned properly, as all seven fans shut down.

**Photo 15: Vapor mitigation system fans and exhaust piping on the roof of 144 State Street.**

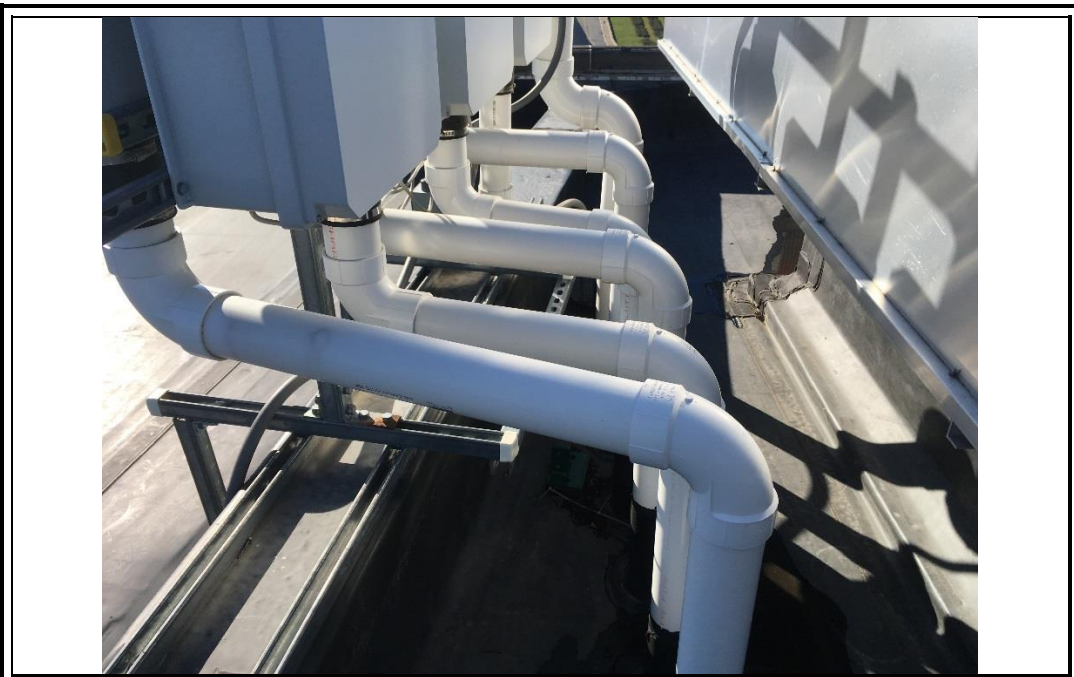
**Photo 16: Vapor mitigation system piping connecting the vertical riser pipes with the fans at 144 State Street.**

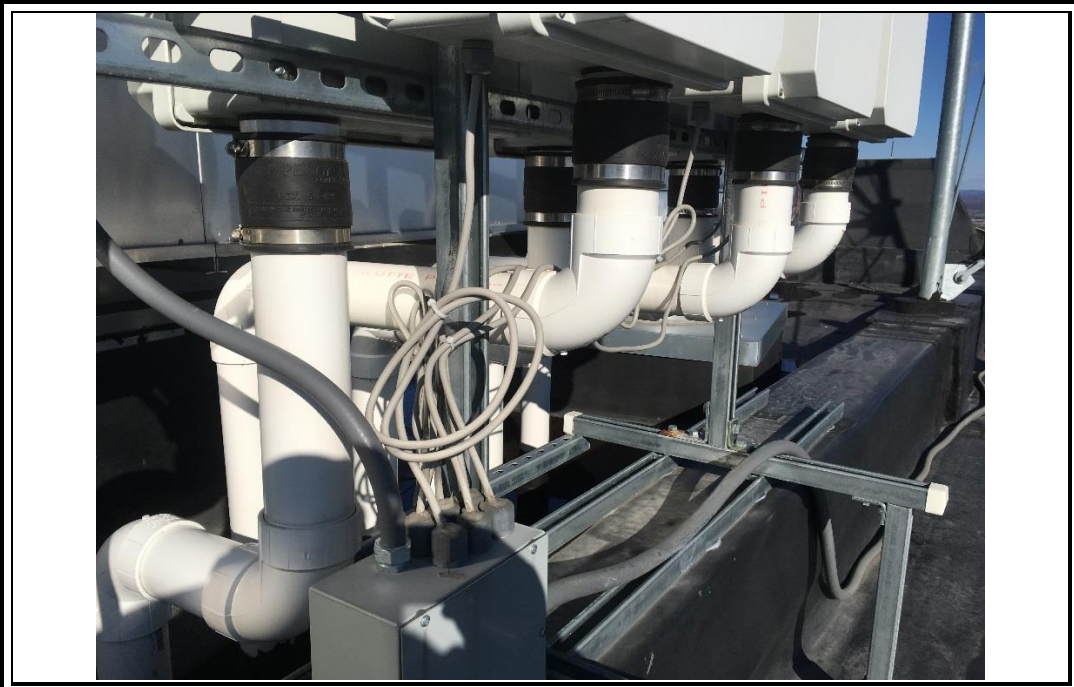
**Photo 17: Vapor mitigation system piping connecting the vertical riser pipes with the fans at 144 State Street.**
