2018 PERIODIC REVIEW REPORT

**Former Albany Laboratories Site
67 Howard Street/140 State Street
City of Albany, New York**

**New York State
Department of Environmental Conservation
Site Number: 401061**

April 4, 2019

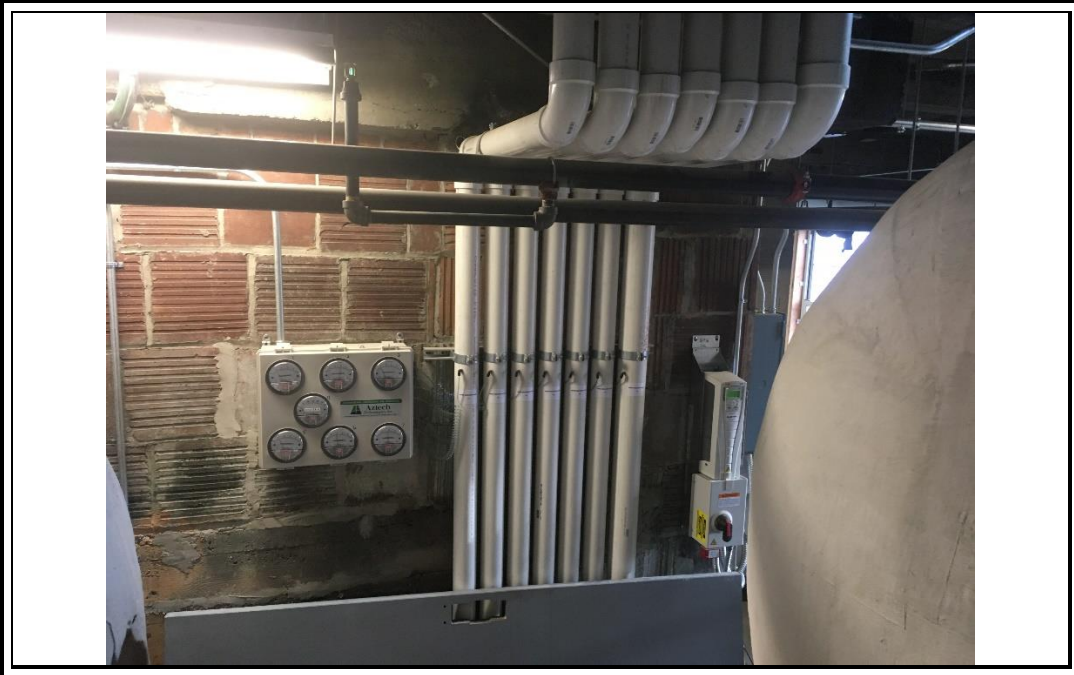
Photo 1: Magnehelic manometer panel and riser pipes for the seven individual subsystems comprising the sub-slab depressurization system at 144 State Street (12/05/18).

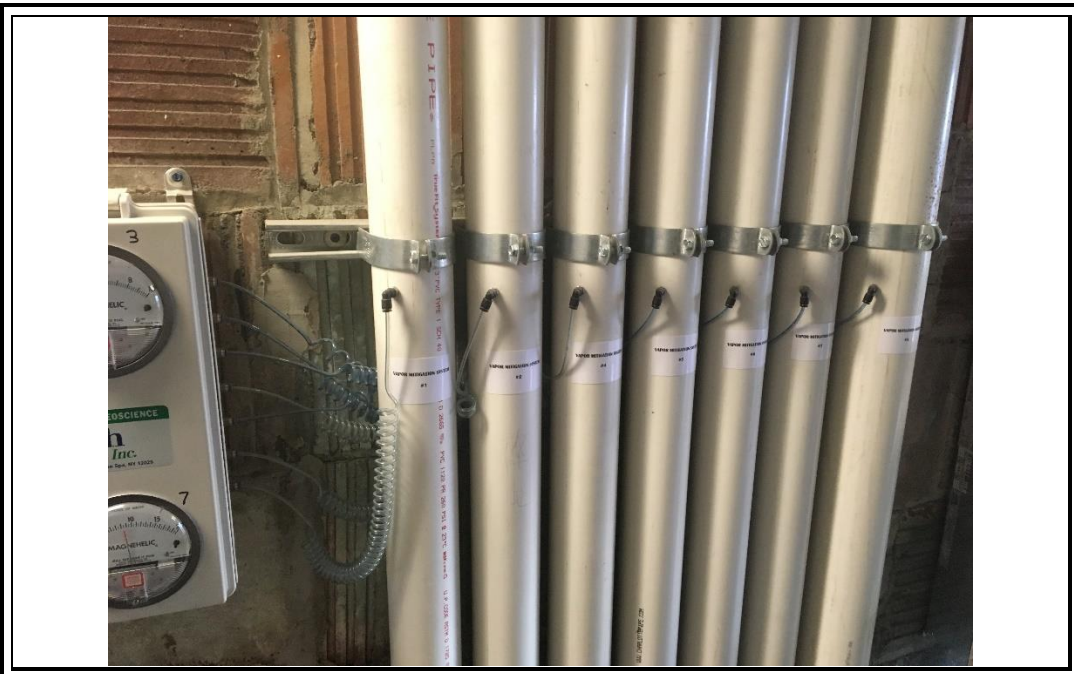
Photo 2: Close-up view of riser pipes for individual subsystems and tubing associated with the magnehelic manometers (12/05/18).

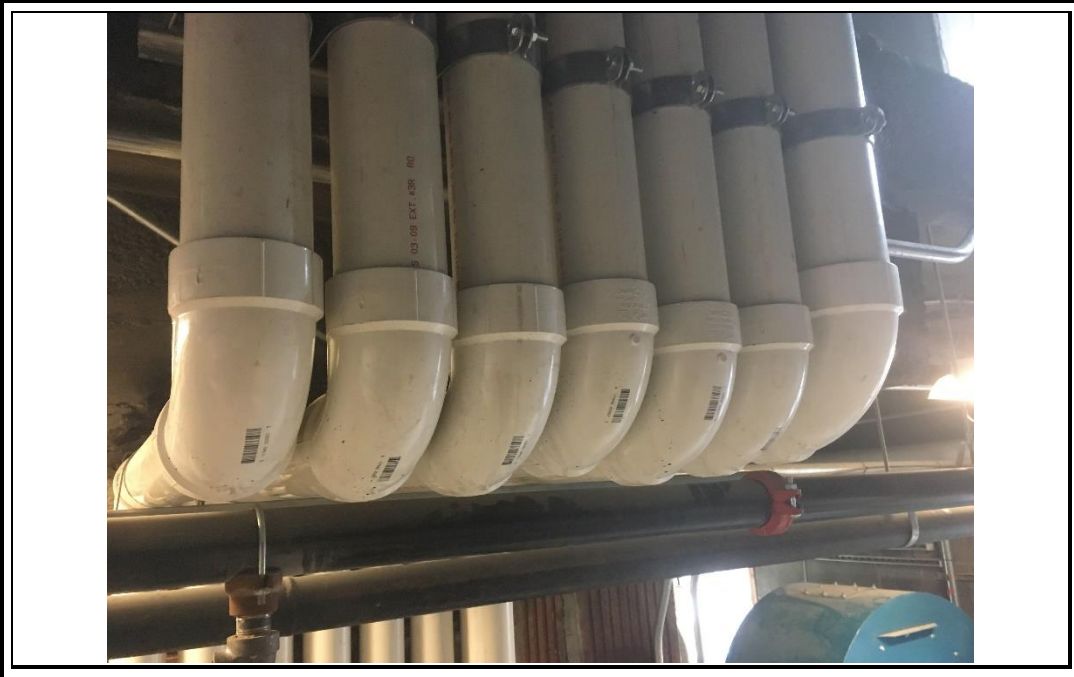
Photo 3: Riser pipes for individual subsystems (12/05/18).

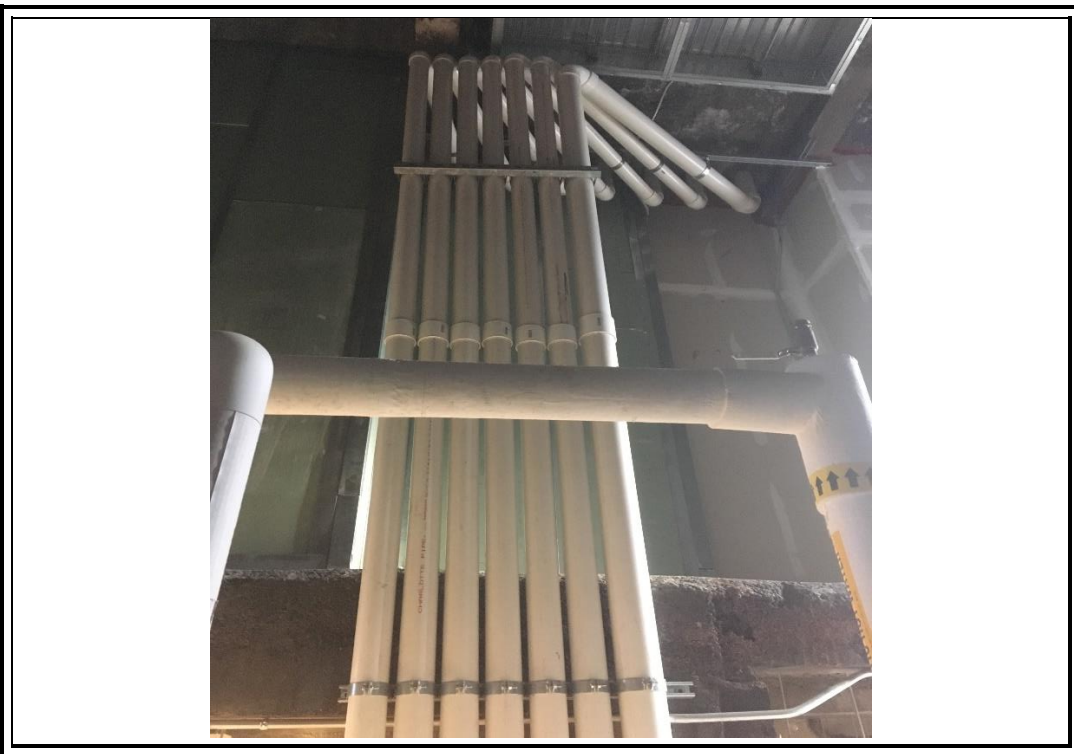
Photo 4: Riser pipes for individual subsystems extending to/through the building roof (12/05/18).

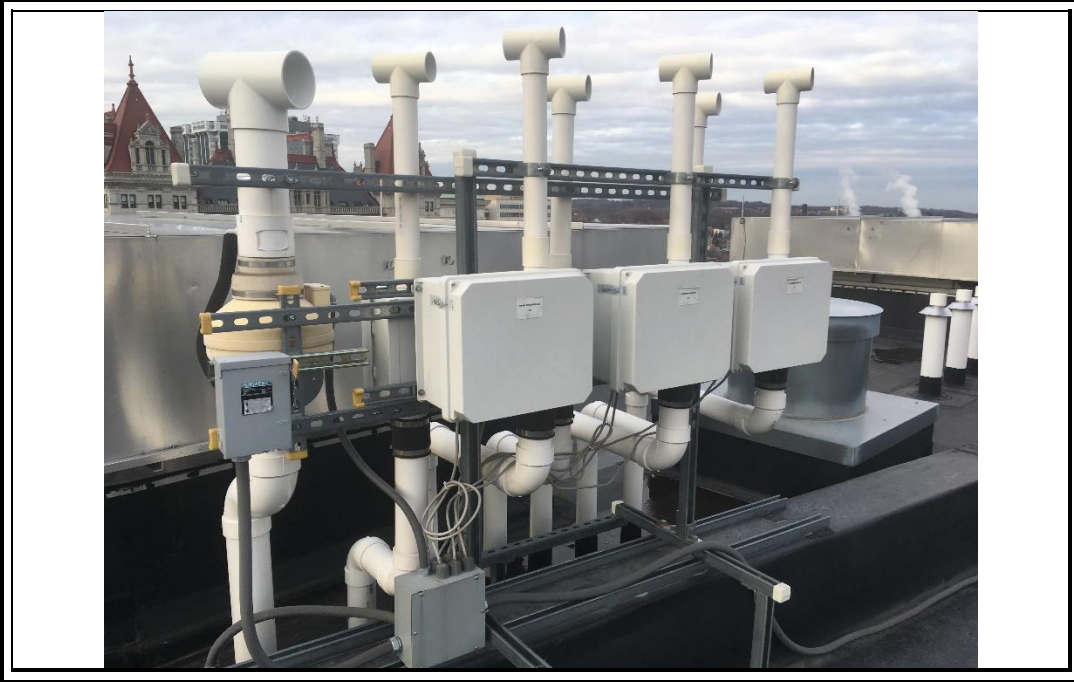
System operation was confirmed via inspection of the seven in-line fans mounted on the roof of the building. Each fan was observed to be operating and air flow was noted from each of the discharge pipes. No cracks or other evidence of damage to the piping or fans was observed. As part of the inspection, the main system switch for the fans was tested and the system was temporarily switched off. The switch functioned properly, as all seven fans shut down.

**Photo 5: Roof-mounted fan units and exhaust points for individual subsystems at 144 State Street
(12/05/18)**

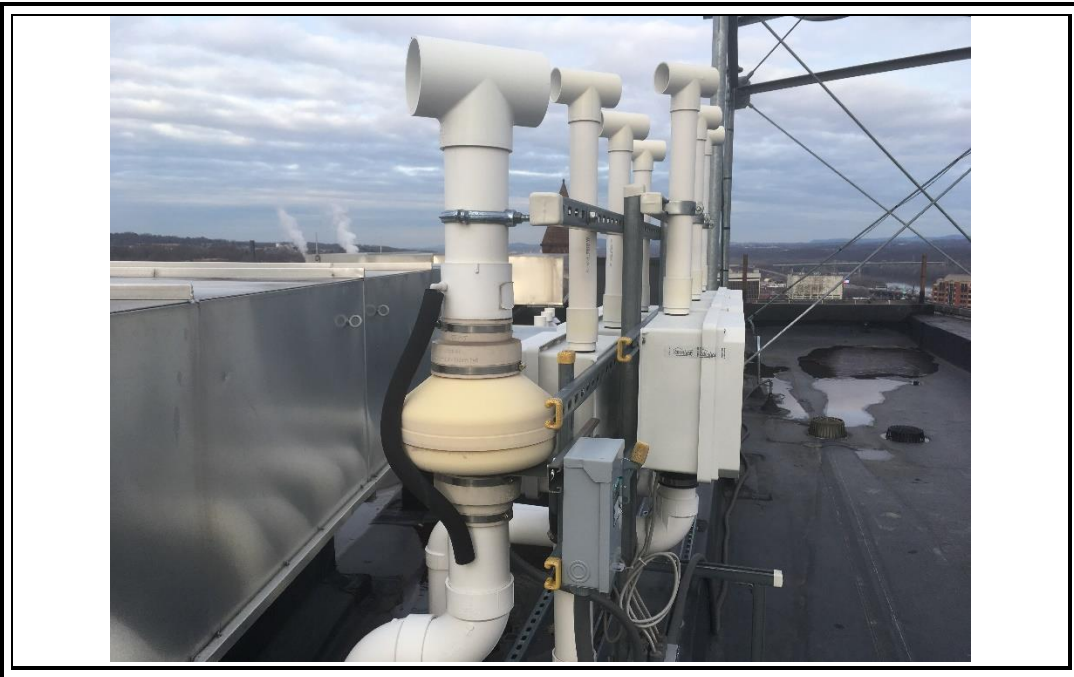
**Photo 6: Roof-mounted fan units and exhaust points for individual subsystems at 144 State Street
(12/05/18)**

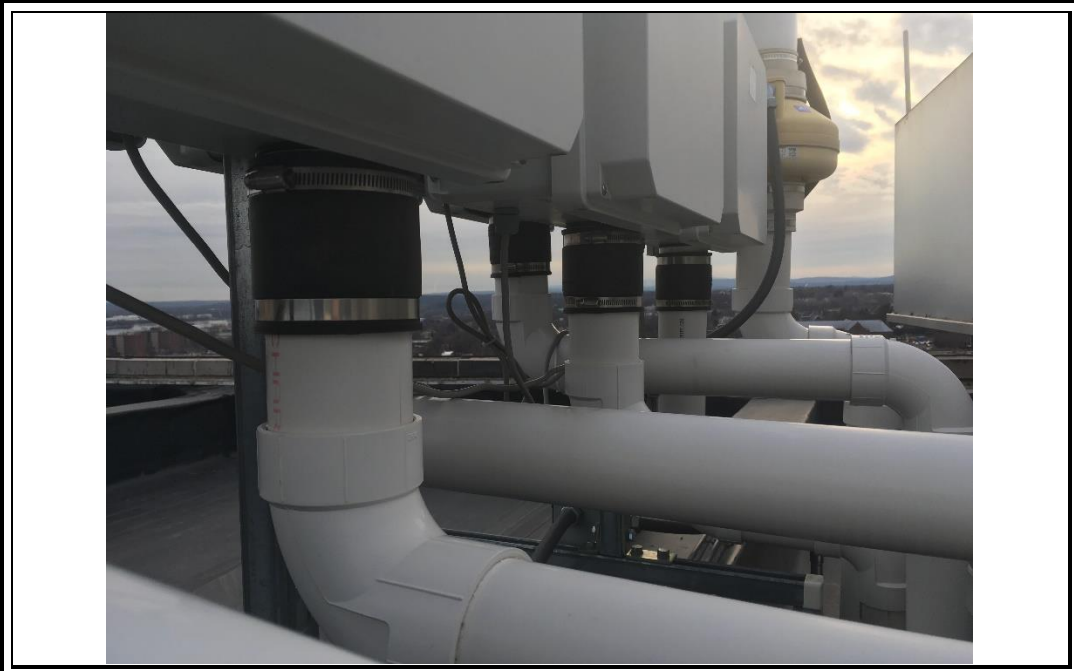
Photo 7: Piping connections to fans for individual subsystems at 144 State Street (12/05/18).

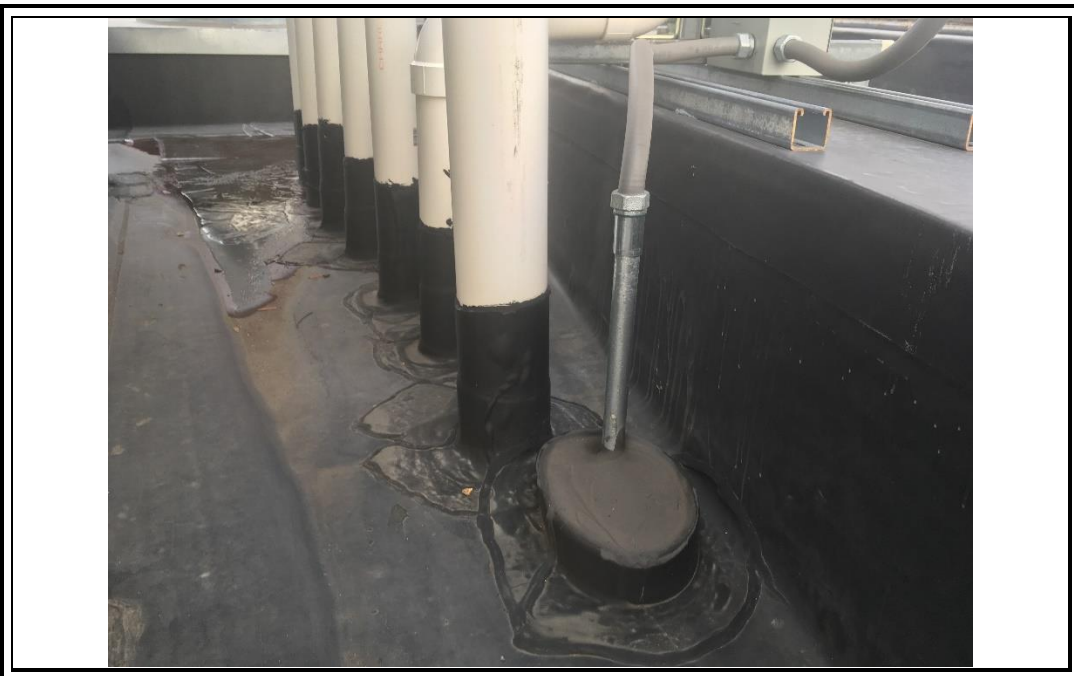
Photo 8: Riser pipes for individual subsystems extending through the roof at 144 State Street (12/05/18)

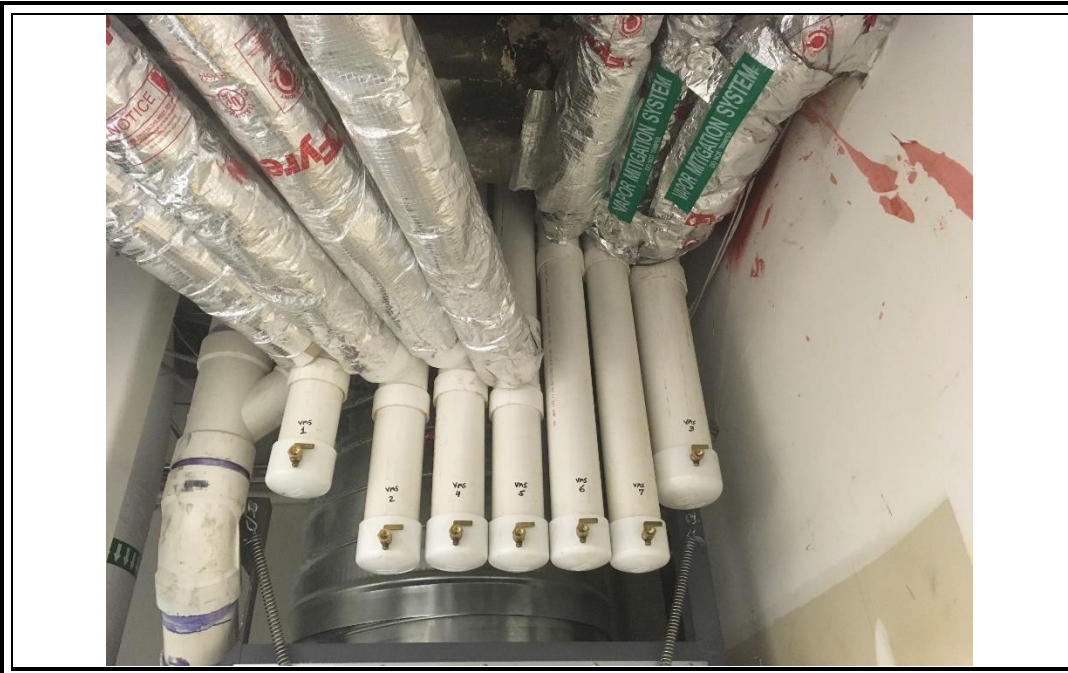
Photo 9: Inside laundry chute room in basement of 144 State Street; horizontal piping for individual subsystems connected to vertical riser pipes; condensation collection sumps comprise bottom portion of each vertical riser pipe (12/05/18) .

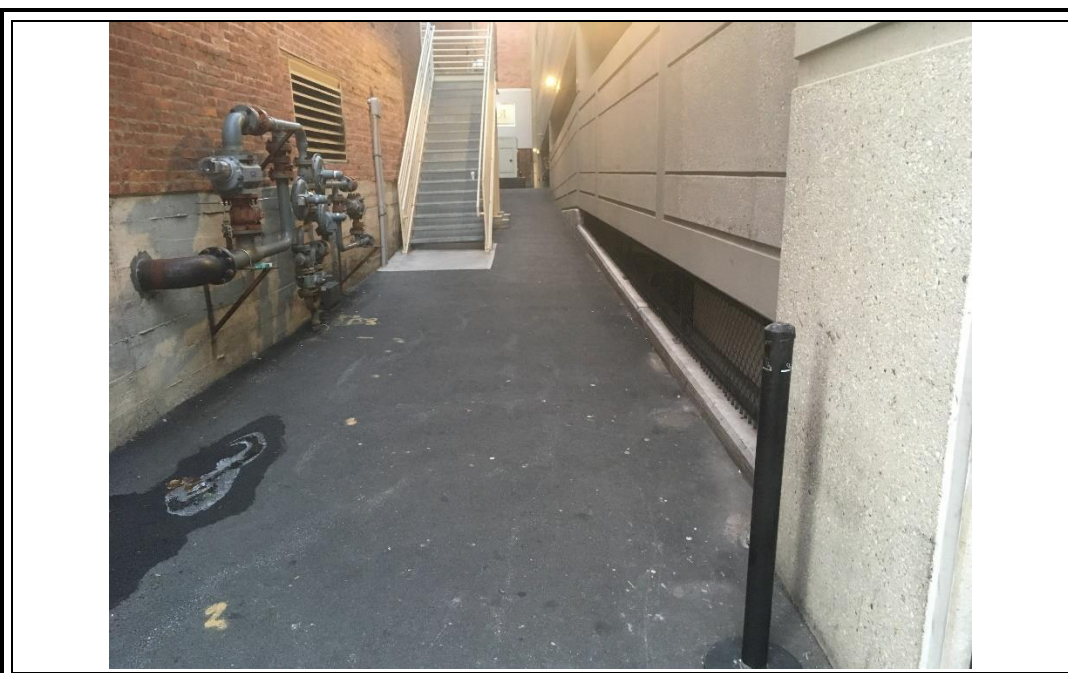
Photo 10: Looking northeast; paved surface cover in alley between 144 State Street (to the left) and the parking garage (to the right) (12/10/18).

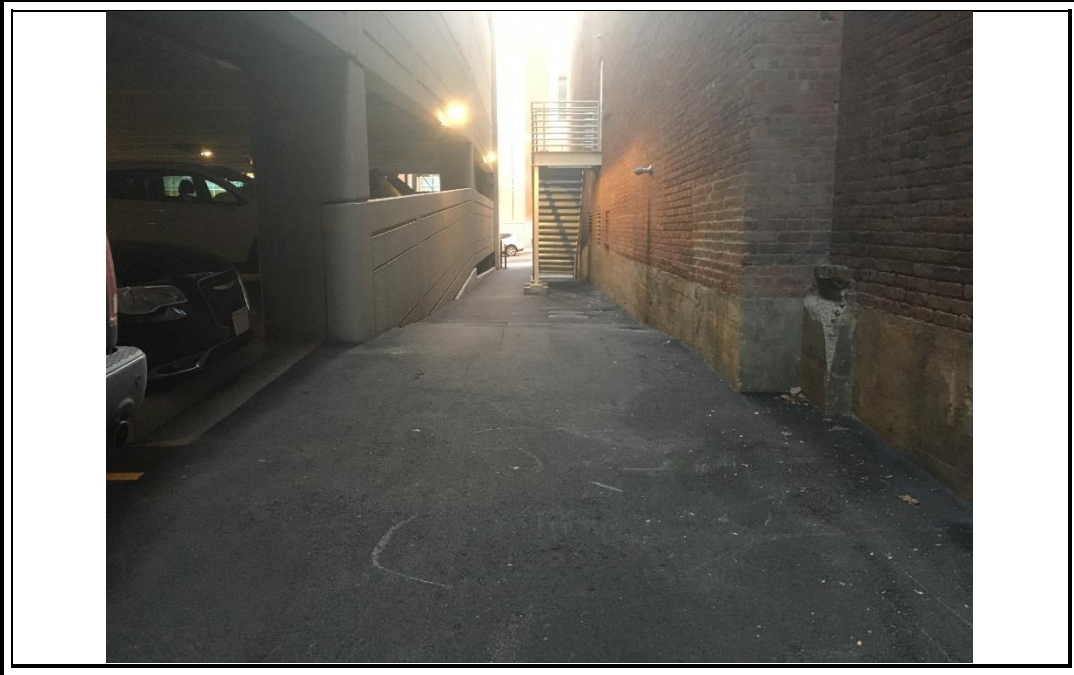
Photo 11: Looking southwest, toward Howard Street; paved surface cover in alley between 144 State Street (to the right) and the parking garage (to the left) (12/10/18).

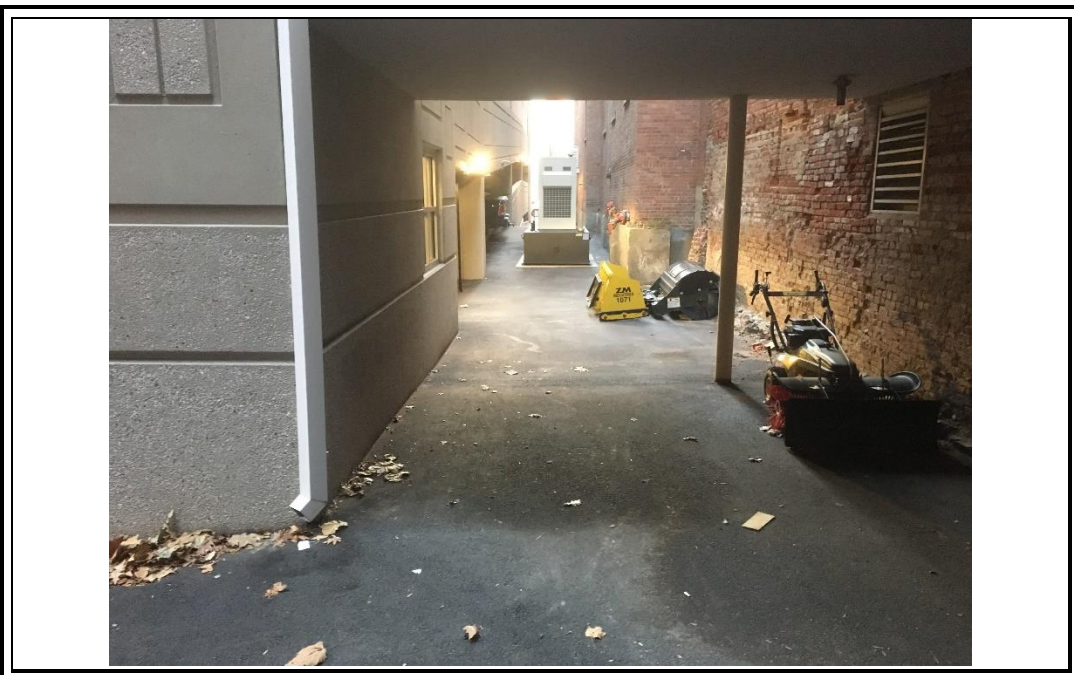
Photo 12: Looking southwest; paved surface cover in alley between 144 State Street (to the right) and the parking garage (to the left); emergency generator visible in upper center of photo (12/10/18).

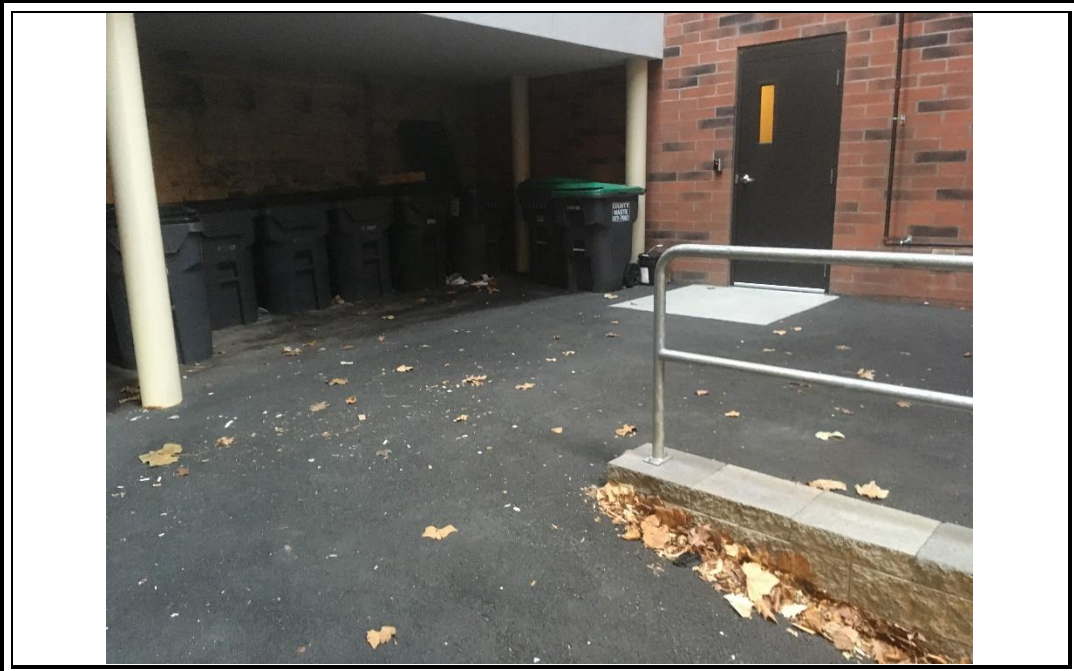
Photo 13: Looking north; Paved surface cover adjacent to rear side of 140 State Street building (upper right) and 144 State Street building (upper left) (12/10/18).

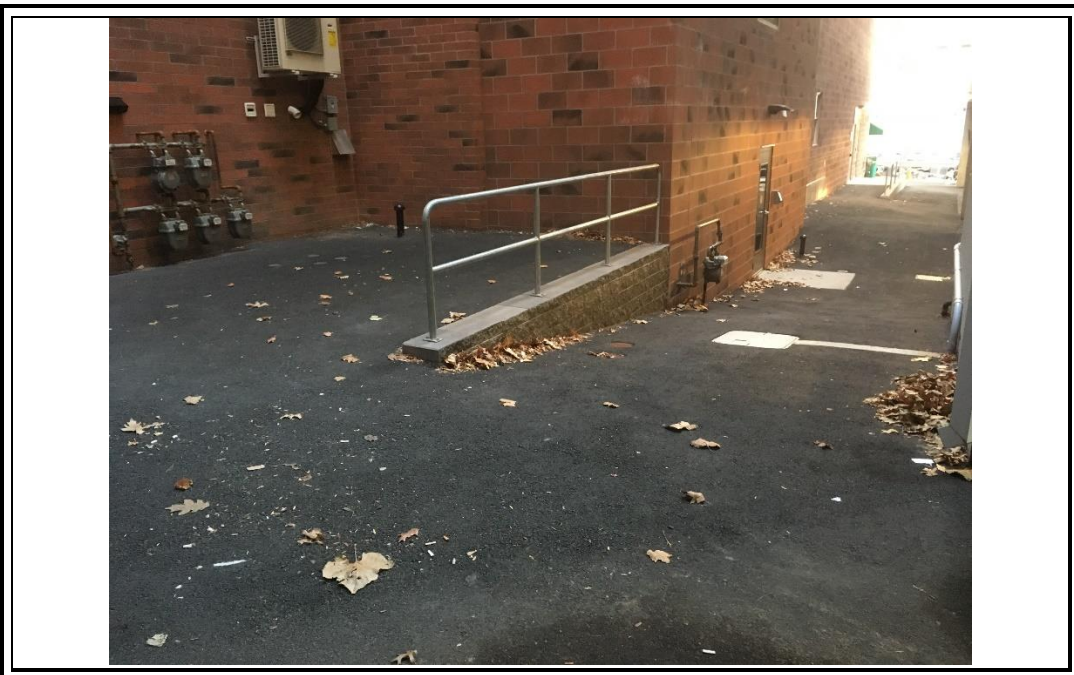
Photo 14: Looking south-southwest; paved surface cover in area adjacent to rear side of 140 State Street building; south side of parking garage visible at far right in photo (12/10/18).

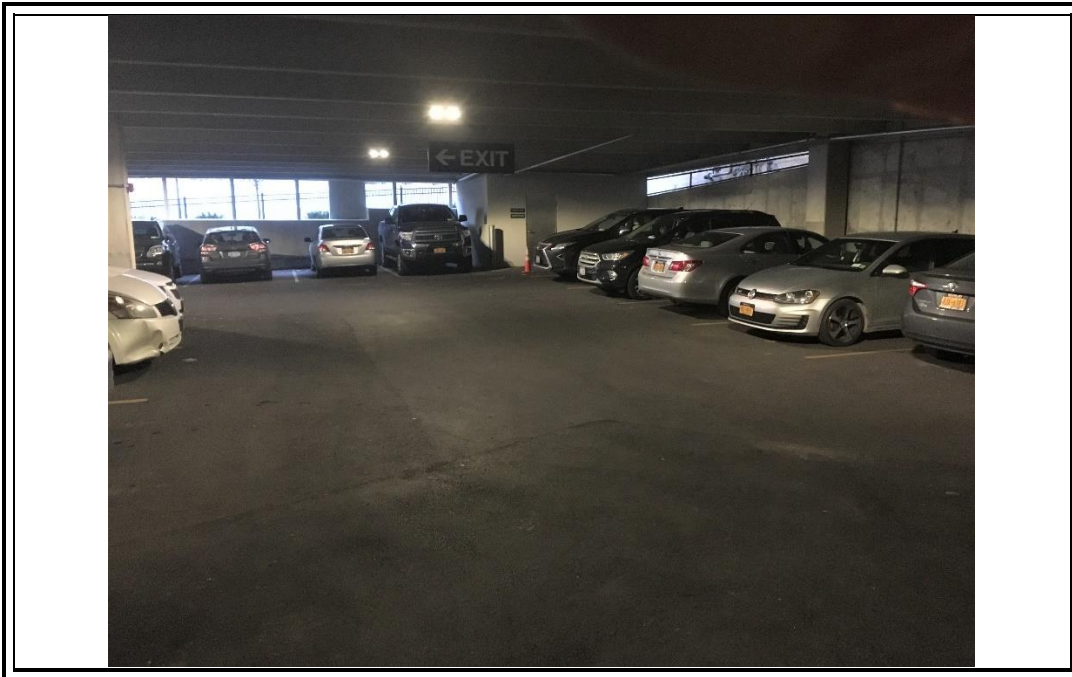
Photo 15: Looking west (toward Howard Street); paved surface cover within lowest level of parking garage; utility room visible in upper center of photo (12/10/18).

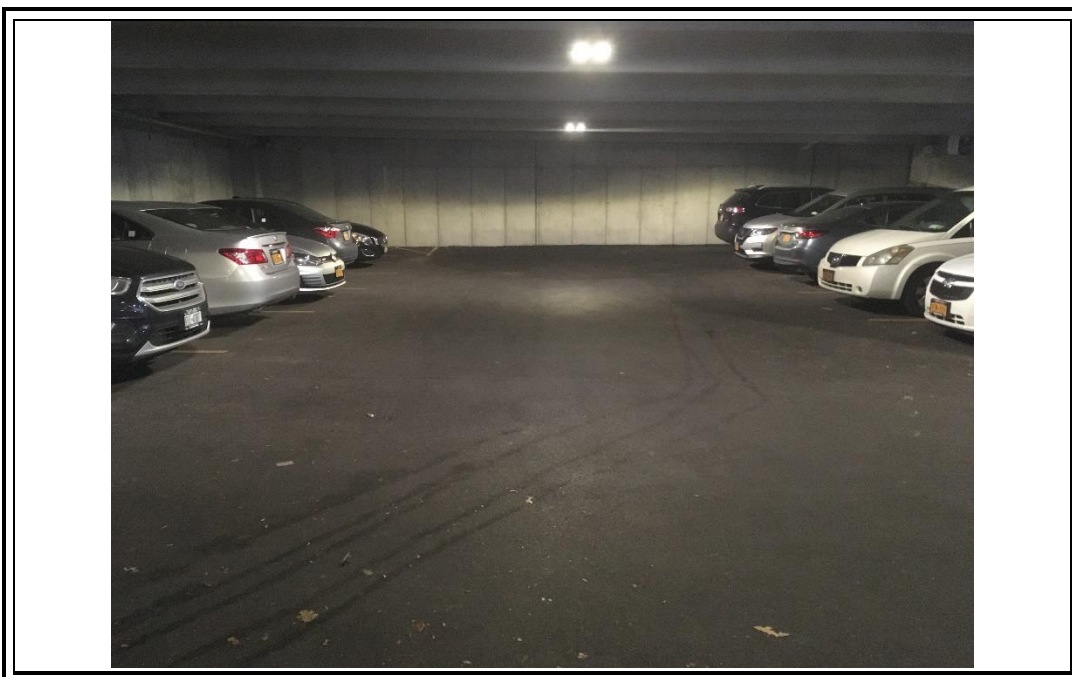
Photo 16: Looking northeast; paved surface cover within lowest level of parking garage (12/10/18).

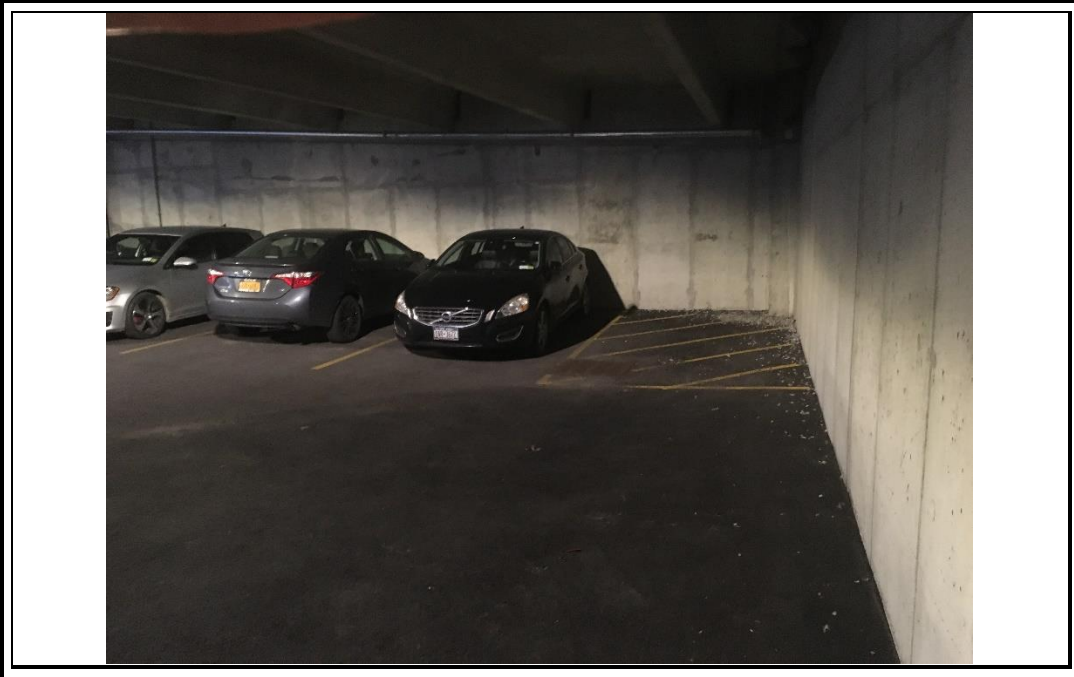
Photo 17: Looking northwest; paved surface cover and storm drain (center of photo) within the northwest corner of the lowest level of the parking garage (12/10/18).

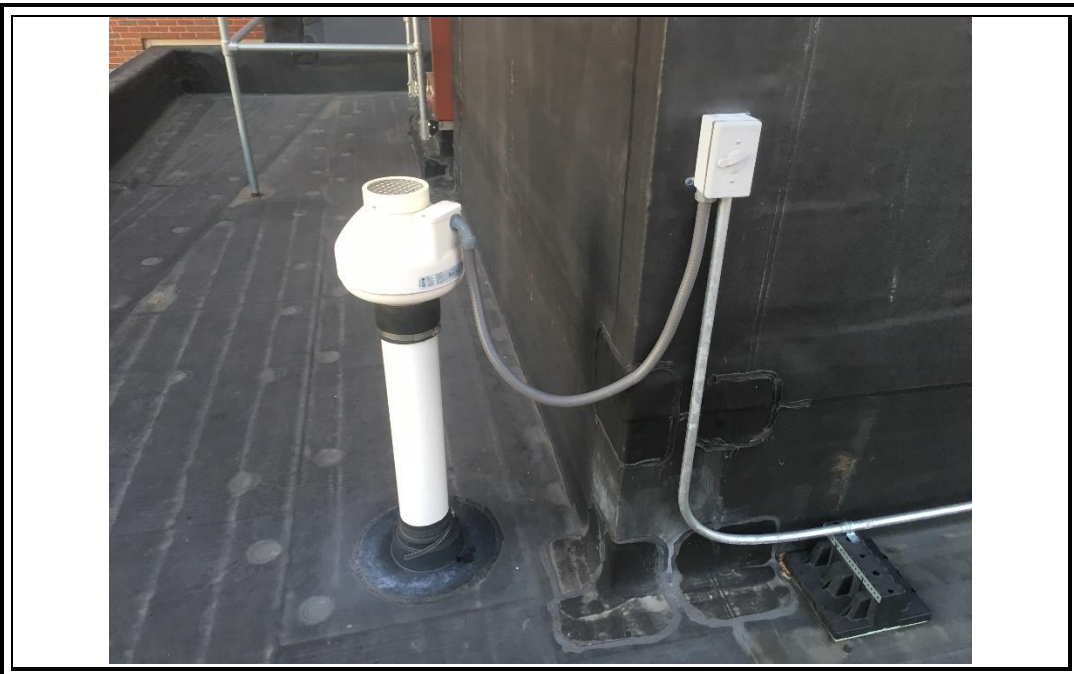
At the time of the December 10, 2018 inspection, the SSDS at the 140 State Street building was observed to be non-operational, as indicated by the manometer in the vertical riser pipe (accessed via a wall-mounted hatch in the basement) and then confirmed upon inspection of the fan and discharge piping on the roof of the building. The cause of the malfunction was not readily apparent at the time of the inspection; however, it was suspected to be a faulty fan.

Photo 18: Roof of 140 State Street building; exhaust stack, fan and switch for the sub-slab depressurization system (12/10/18).

Consequently, CHA contacted Alpine Environmental Services (Alpine), the contractor that installed the fan. It was Alpine's opinion that based on the limited number of years the fan has been in service, the problem was unlikely to be a faulty fan. Alpine recommended that the building management company, BBL Management Group (BBL), first conduct an assessment of the electrical service to the fan and associated electrical components (e.g. junction box, switch). Following investigation by BBL and its electrical contractor into possible electrical-related issues, it was ultimately determined that the problem was associated with the wiring to the switch for the fan. On March 11, 2019, the electrician replaced the wiring to the switch and from the switch to the fan, and the system was reactivated. No further issues were noted.

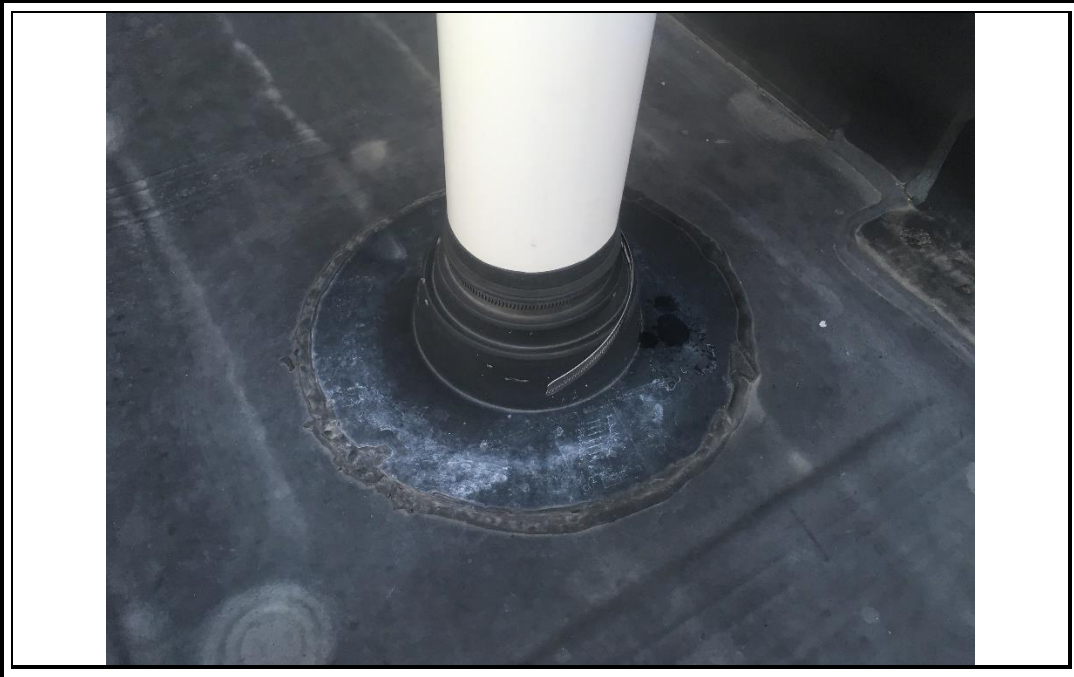
Photo 19: Close-up view of roof penetration point for SSDS exhaust stack at 140 State Street (12/10/18).

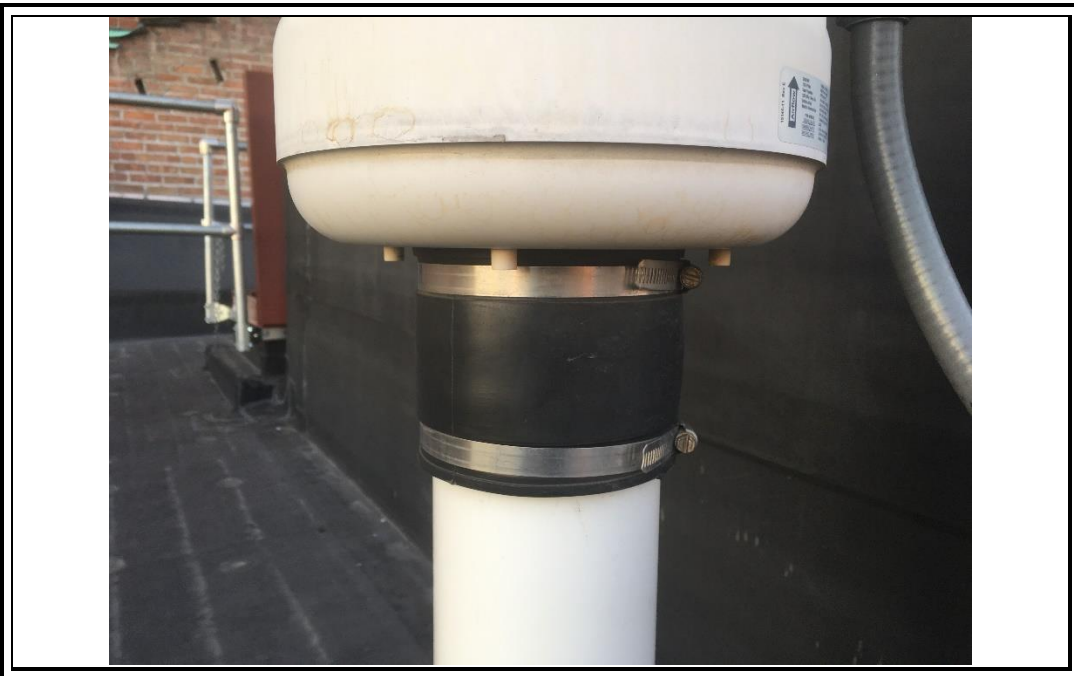
Photo 20: Close-up view of connection between SSDS exhaust stack and fan at 140 State Street (12/10/18).
