# 2020 PERIODIC REVIEW REPORT

**Former Albany Laboratories Site  
67 Howard Street/140 State Street  
City of Albany, New York**

**New York State  
Department of Environmental Conservation  
Site Number: 401061**

**February 3, 2021**

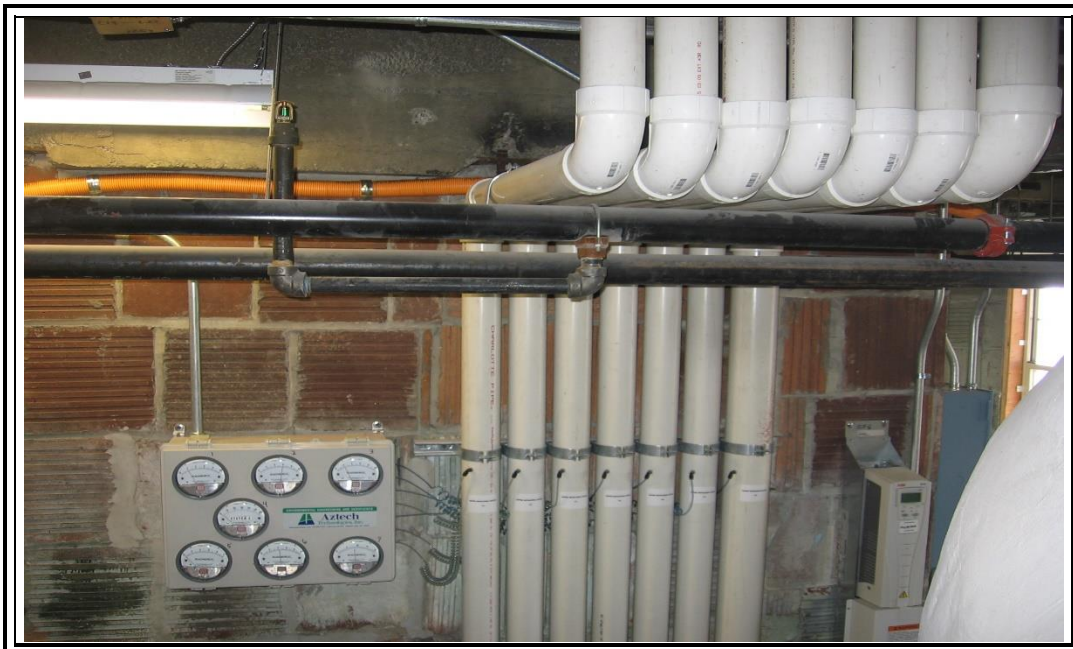
**Photo 1: Mannehelic manometer panel and riser piping for the seven individual subsystems comprising the sub-slab depressurization system at 144 State Street (12/3/20).**

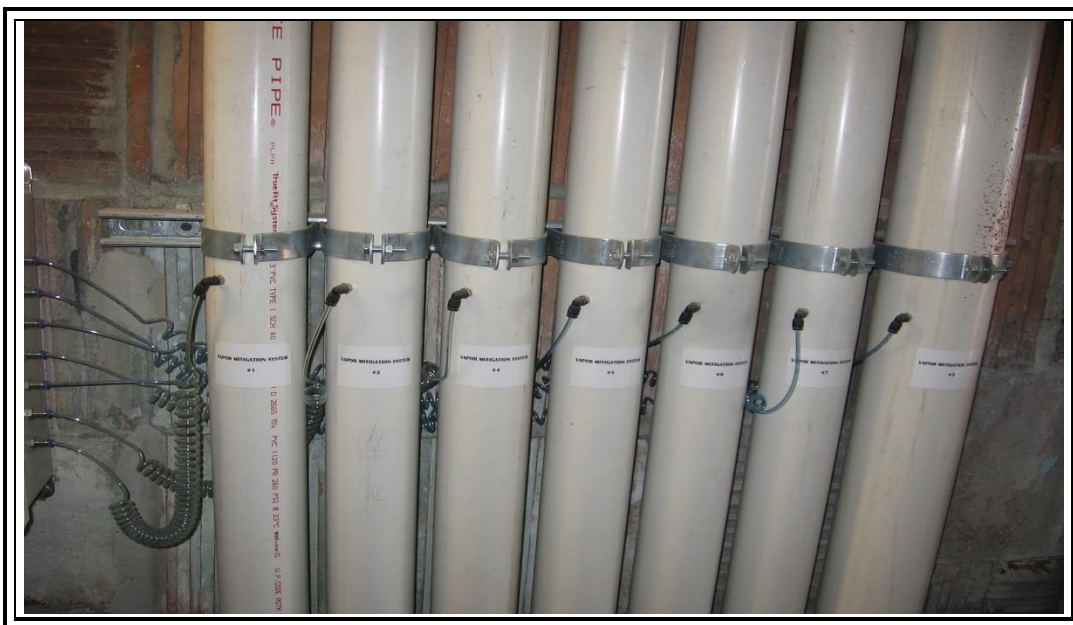
**Photo 2: Close-up view of riser piping for individual subsystems and tubing associated with the mannehelic manometers (12/3/20).**

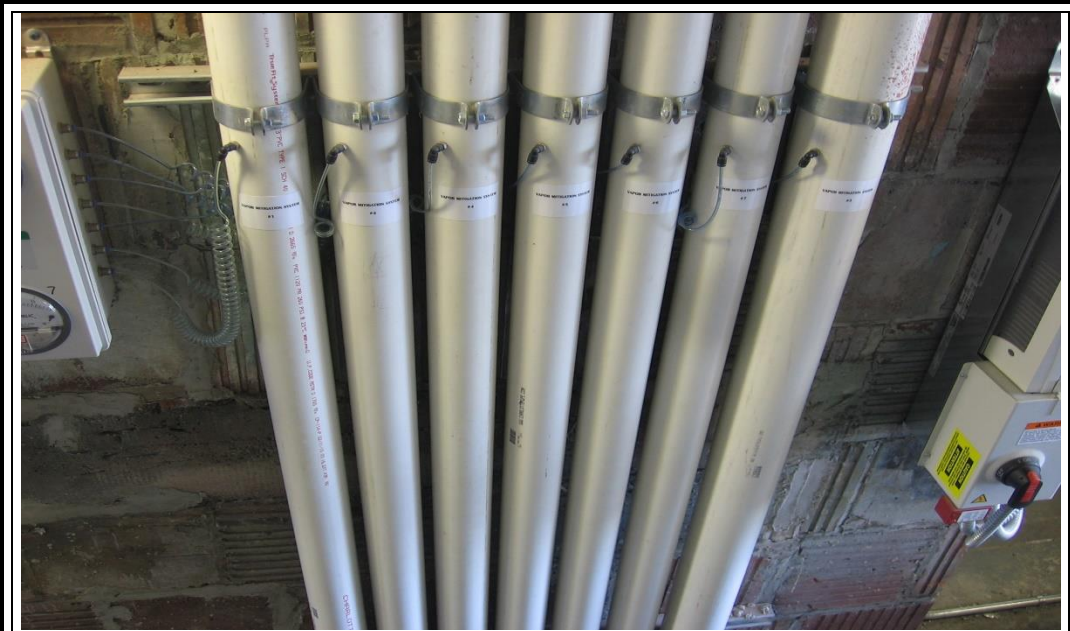
**Photo 3: Riser piping for individual subsystems (12/3/20).**

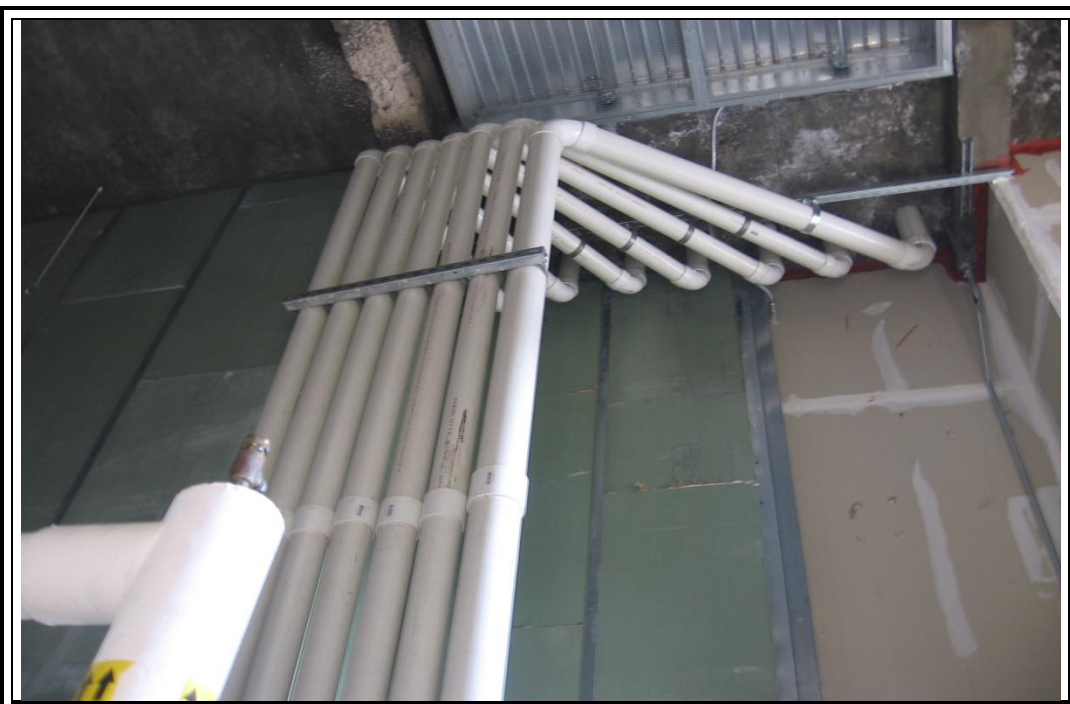
**Photo 4: Riser piping for individual subsystems extending to/through the building roof (12/3/20).**

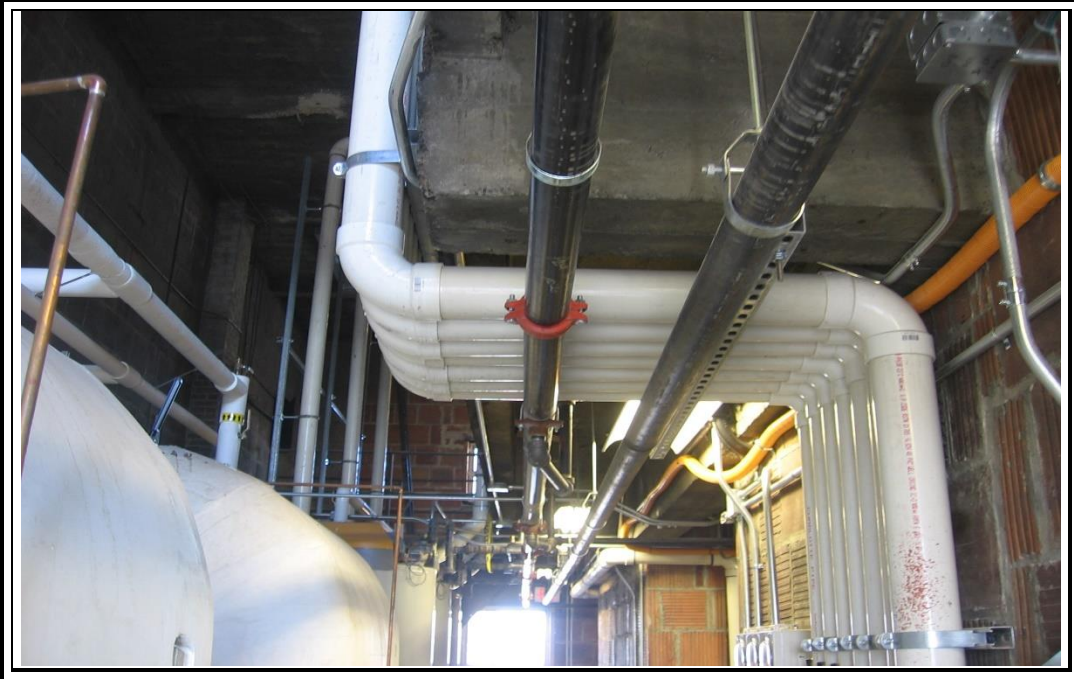
**Photo 5: Riser piping for individual subsystems (12/3/20).**

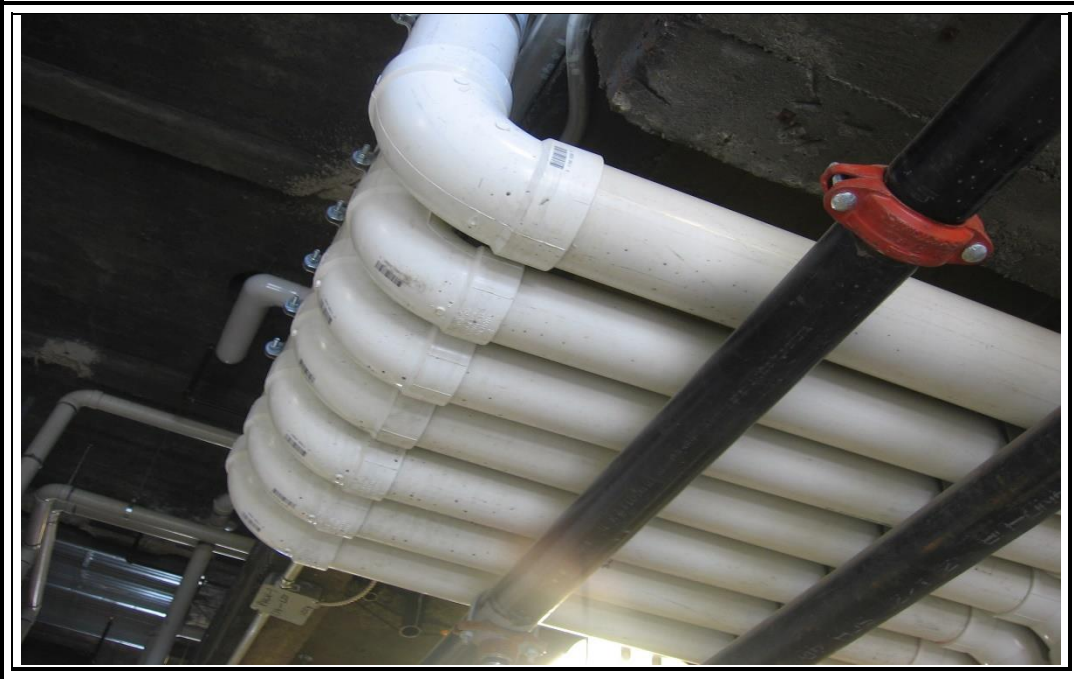
**Photo 6: Riser piping for individual subsystems (12/3/20).**

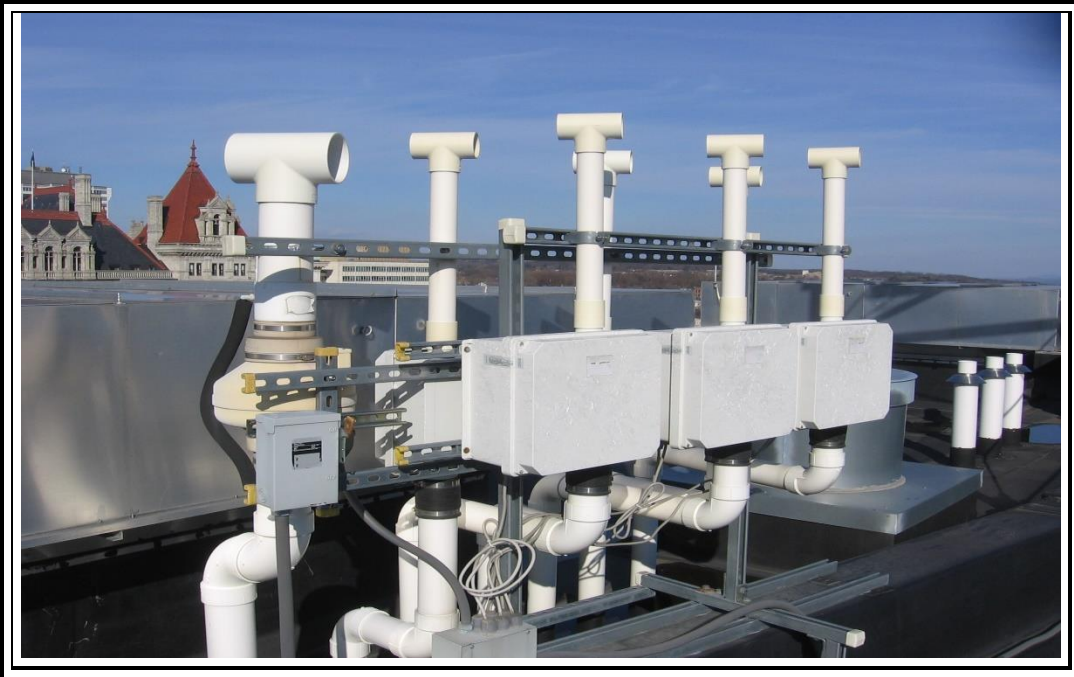
System operation was confirmed via inspection of the seven in-line fans mounted on the roof of the building. Each fan was observed to be operating and air flow was noted from each of the discharge pipes. No cracks or other evidence of damage to the piping or fans was observed. As part of the inspection, the main system switch for the fans was tested and the system was temporarily switched off. The switch functioned properly, as all seven fans shut down.

**Photo 7: Roof-mounted fan units for individual subsystems at 144 State Street (12/3/20).**

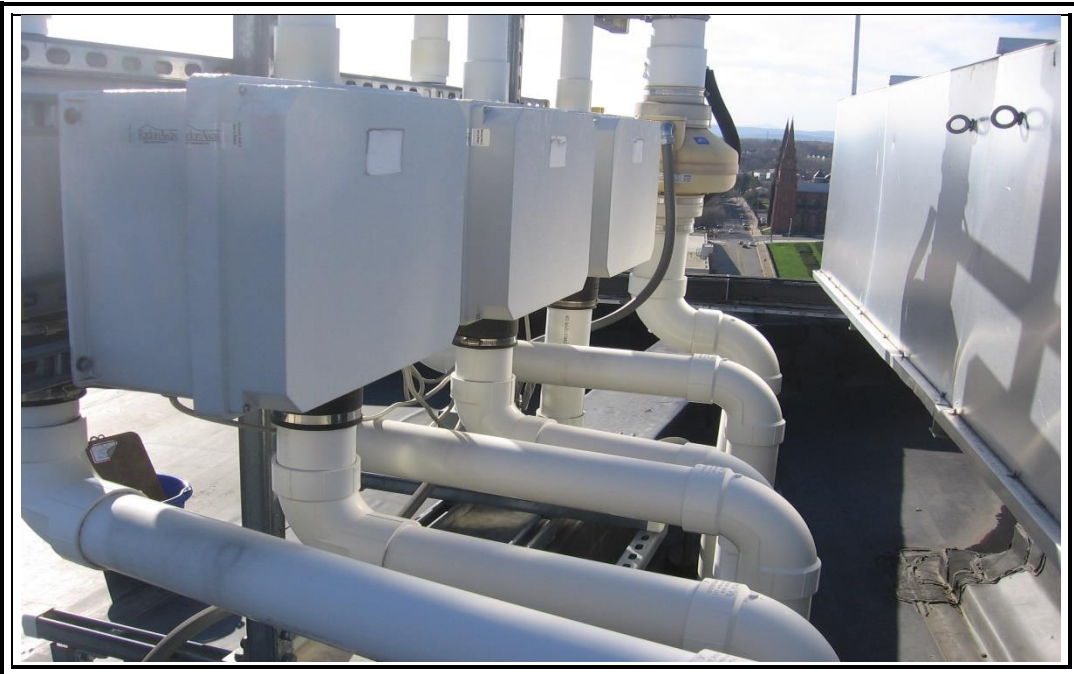
ITEM/CONDITION	TRUE	FALSE	N/A	COMMENTS
All above-grade piping in good condition and free of cracks or other damage.	<input checked="" type="checkbox"/>	<input type="checkbox"/>	<input type="checkbox"/>	
All pipe supports undamaged and functional.	<input checked="" type="checkbox"/>	<input type="checkbox"/>	<input type="checkbox"/>	
In-line mufflers/silencers installed and functioning properly.	<input type="checkbox"/>	<input type="checkbox"/>	<input checked="" type="checkbox"/>	
Discharge piping above roof undamaged and free of obstructions.	<input checked="" type="checkbox"/>	<input type="checkbox"/>	<input type="checkbox"/>	
All labels are present and legible.	<input checked="" type="checkbox"/>	<input type="checkbox"/>	<input type="checkbox"/>	Fan Labels are worn

**Photo 8: Fan units for subsystems 2, 5, 7 and 3 (left to right); labels worn, require replacement (12/3/20).**

Need to be  
Replaced.

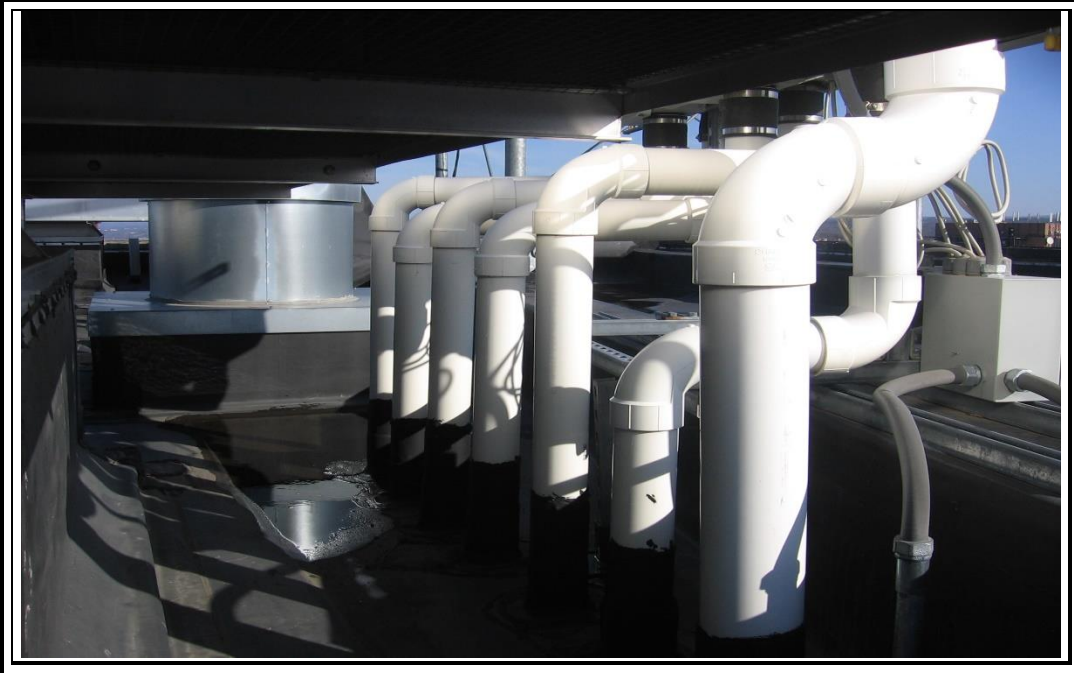
**Photo 9: Riser pipes extending through roof and into fan units (12/3/20).**

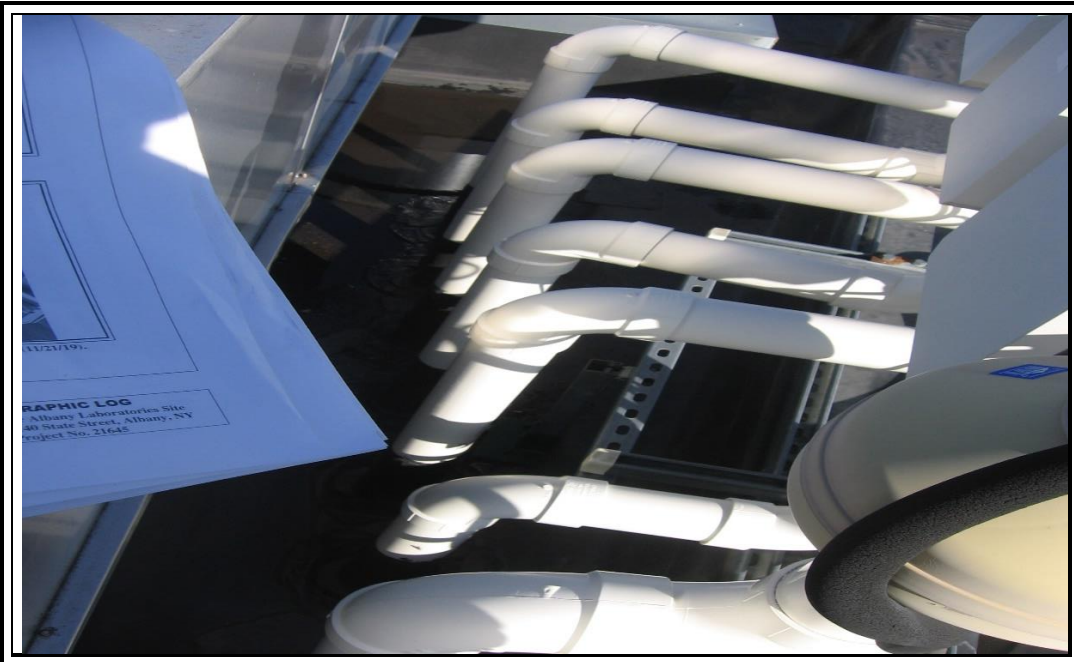
**Photo 10: Riser pipes extending through roof and into fan units 12/3/20).**

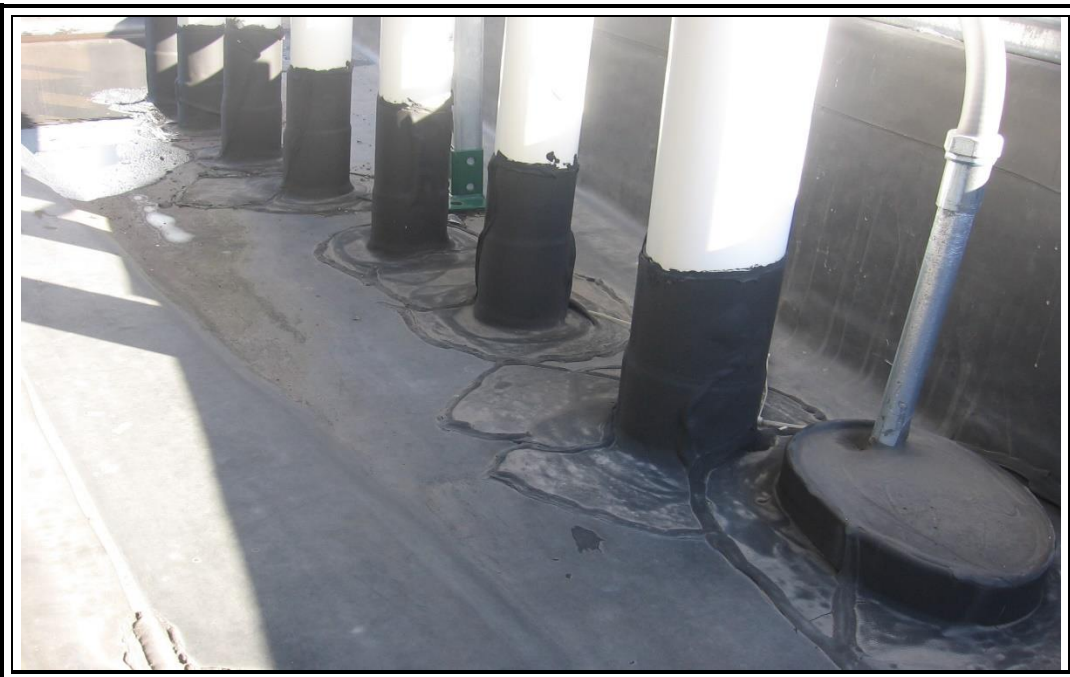
**Photo 11: Seals around riser pipes at roof penetrations (12/3/20).**

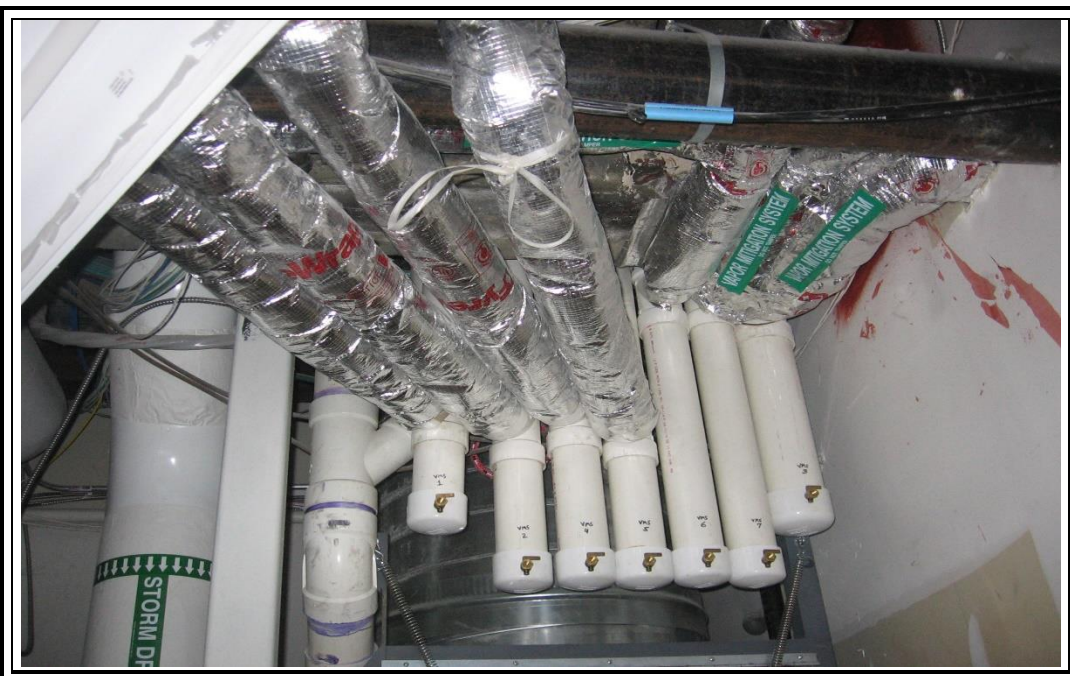
**Photo 12: Inside laundry chute room in basement of 144 State Street; horizontal piping for individual subsystems connected to vertical riser pipes (12/3/20).**

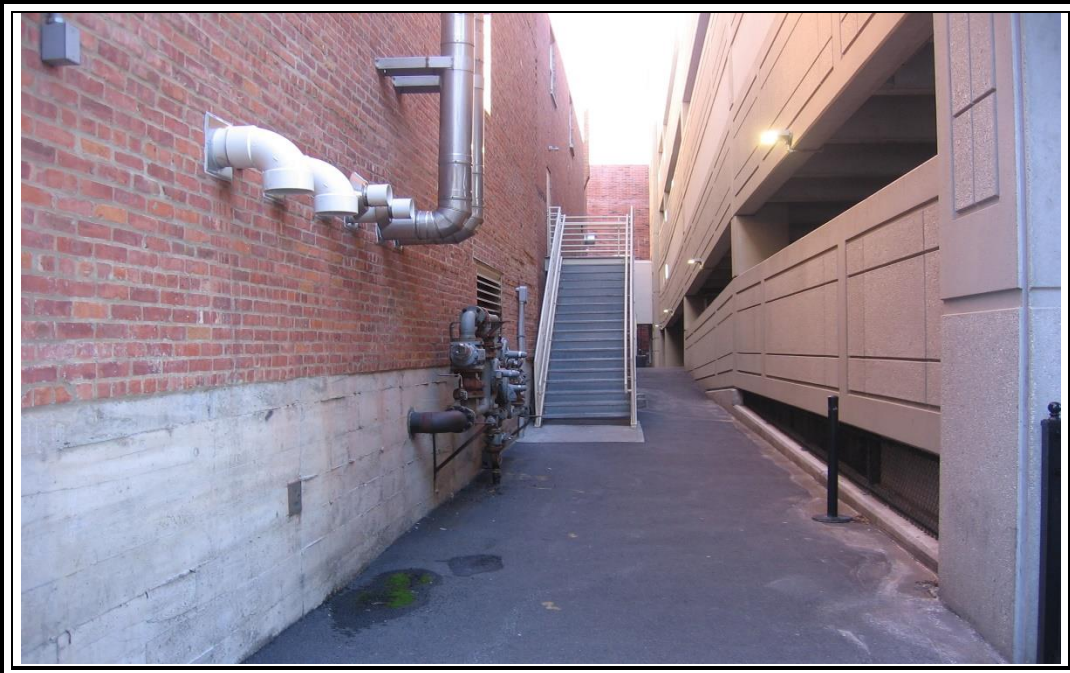
**Photo 13: Looking northeast (from Howard Street); paved surface cover in alley between 144 State Street (to the left) and parking garage (to the right) (12/3/20).**

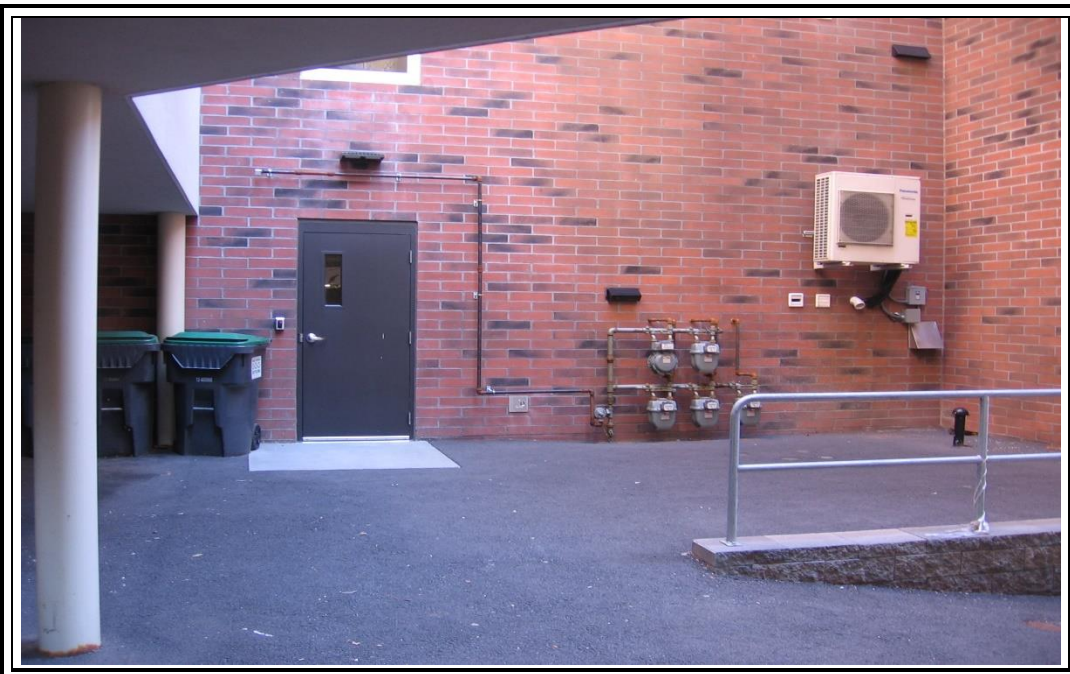
**Photo 14: Looking northeast; paved surface cover adjacent to rear side of 140 State Street building (12/3/20).**

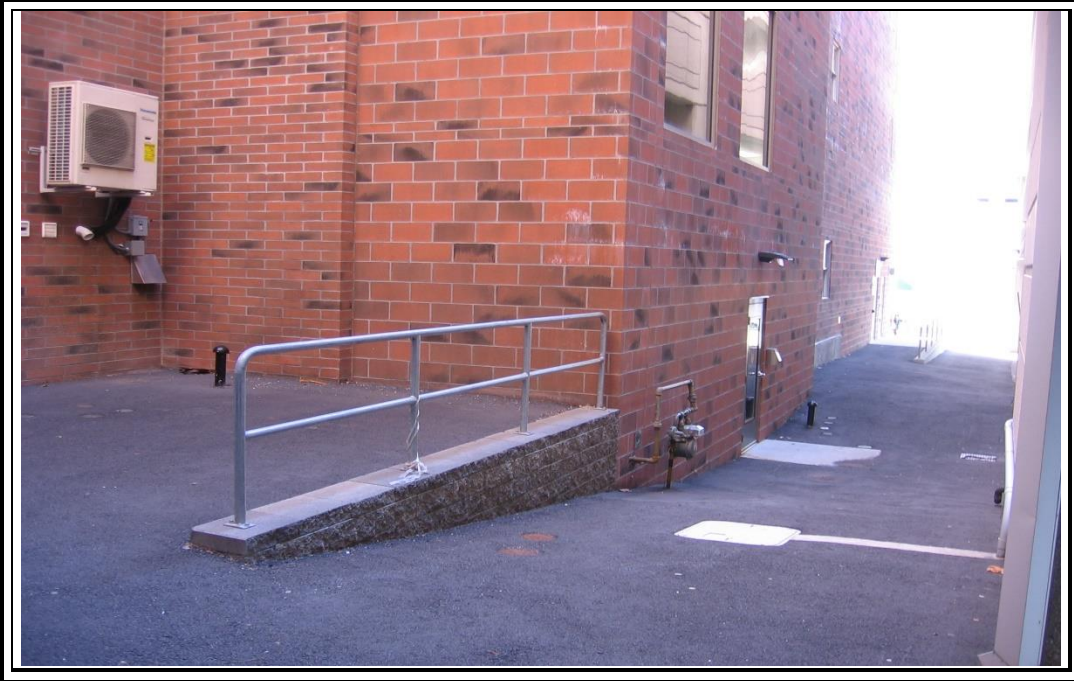
**Photo 15: Looking southeast; paved surface cover in area adjacent to rear side of 140 State Street building; north side of parking garage visible at right in photo (12/3/20).**

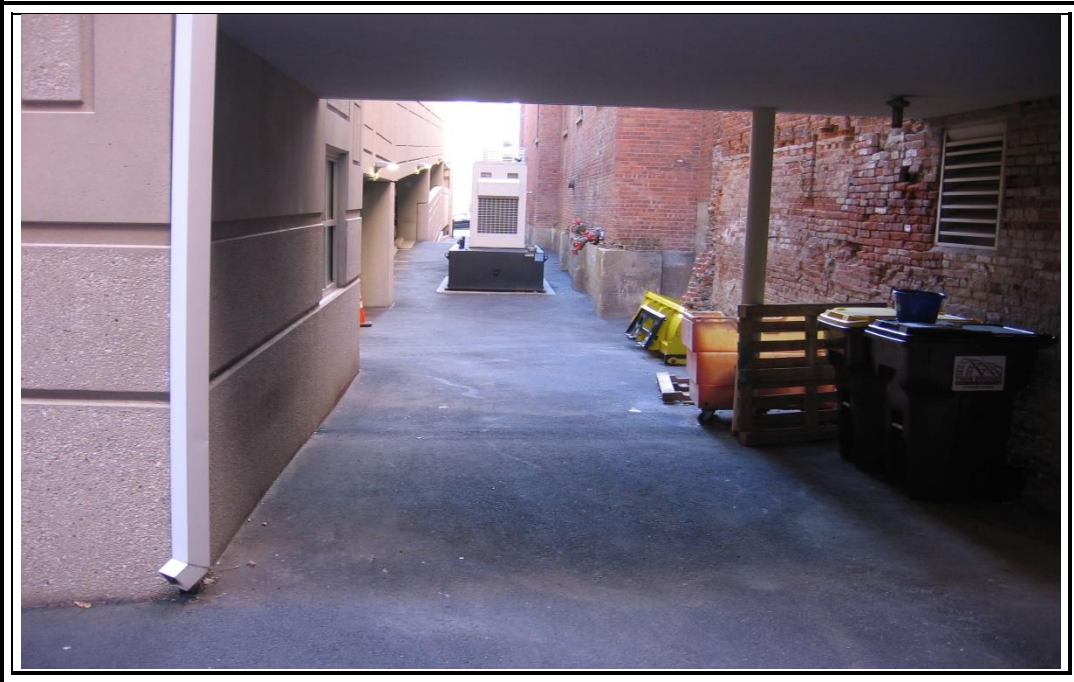
**Photo 16: Looking southwest; paved surface cover in alley between 144 State Street (to the right) and the parking garage (to the left); emergency generator visible in upper center of photo (12/3/20).**

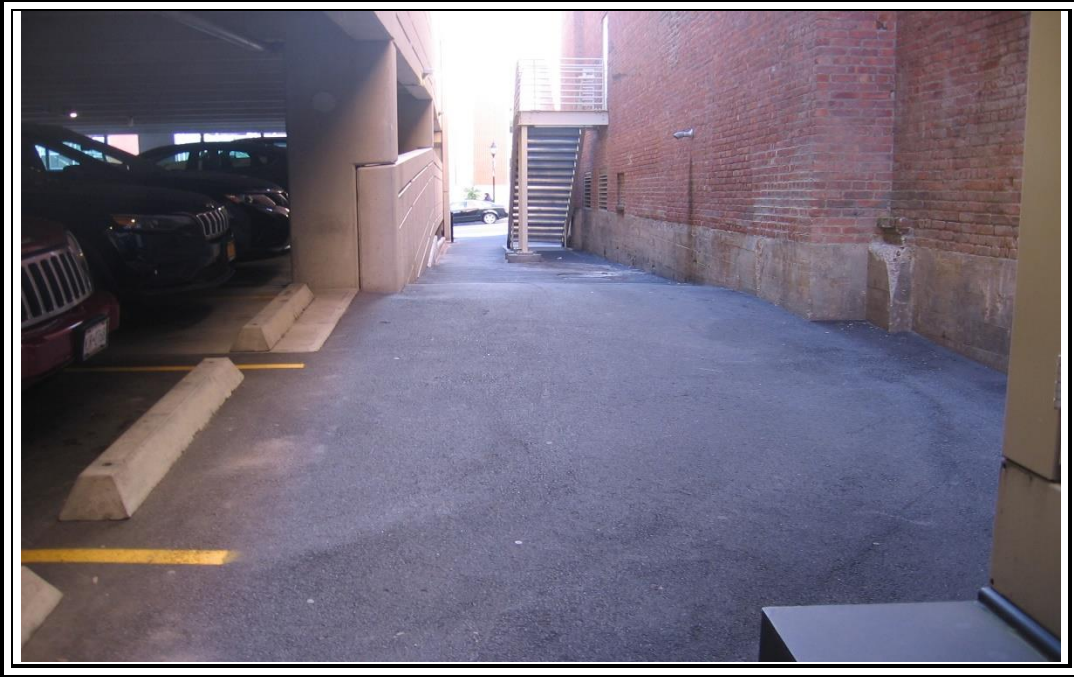
**Photo 17: Looking southwest; paved surface cover in alley between 144 State Street and the parking garage (12/3/20).**

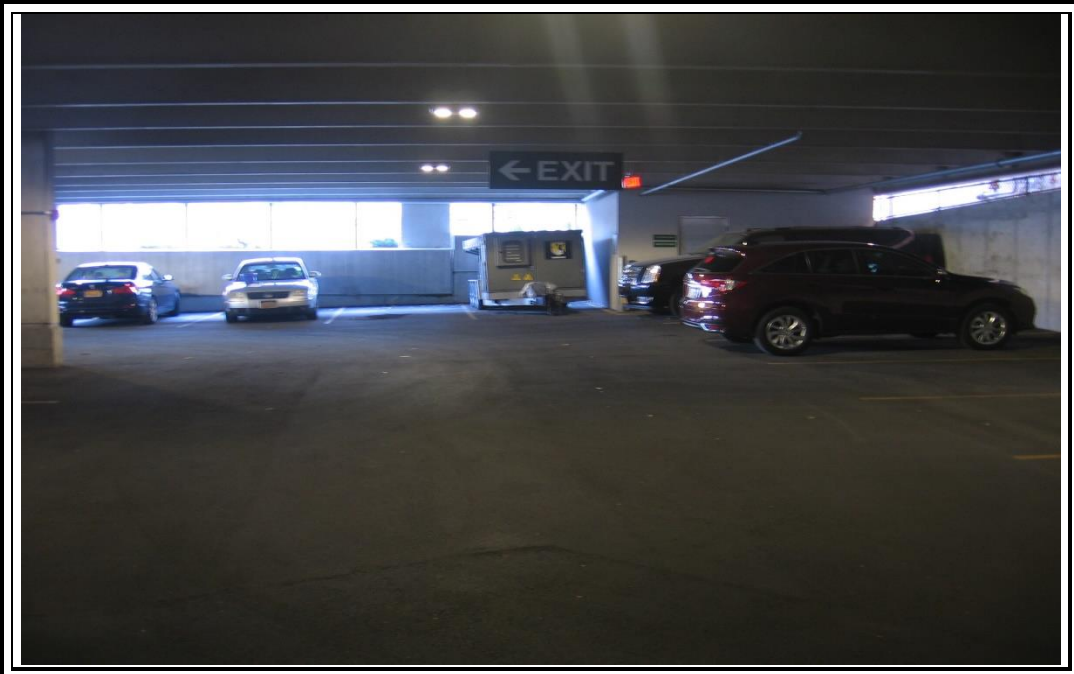
**Photo 18: Looking west toward Howard Street; paved surface cover within lowest level of parking garage (12/3/20).**

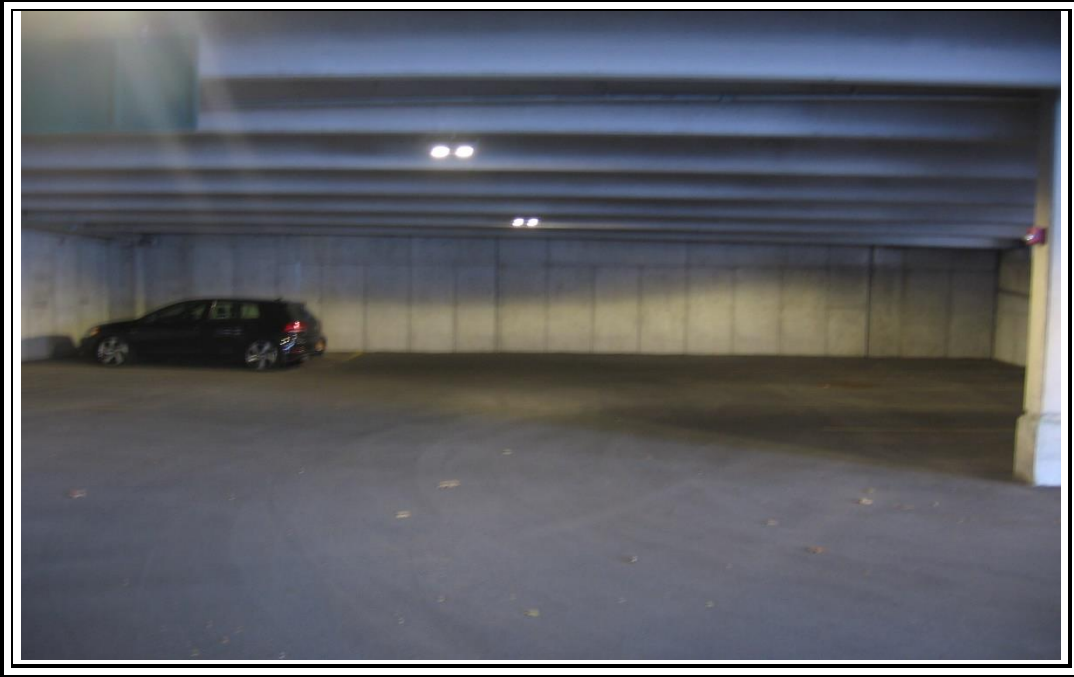
**Photo 19: Looking northeast; paved surface cover within lowest level of parking garage (12/3/20).**

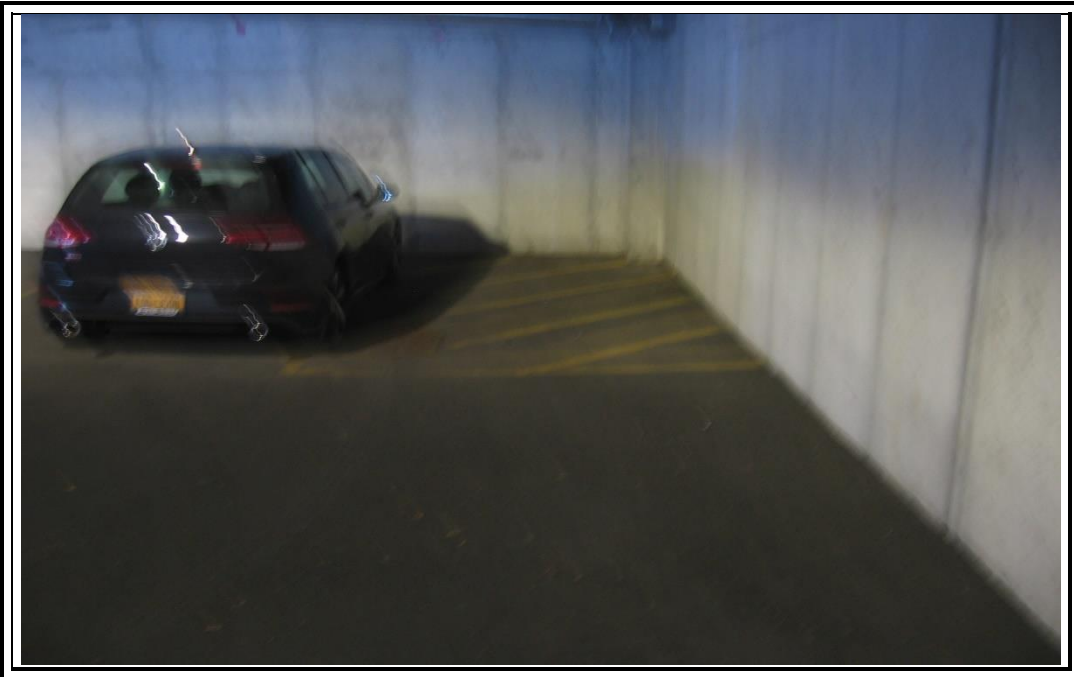
**Photo 20: Looking northwest; paved surface cover and storm drain within the northwest corner of the lowest level of the parking garage (12/3/20).**

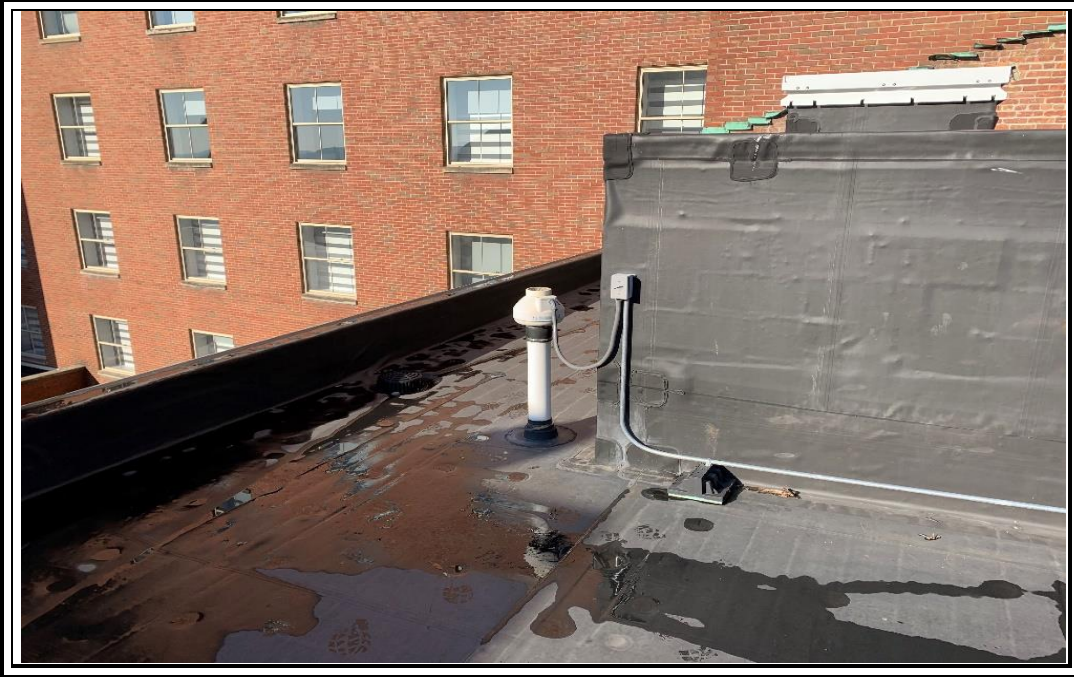
**Photo 21: Roof of 140 State Street building; exhaust stack, fan and switch for SSDS (12/3/20).**

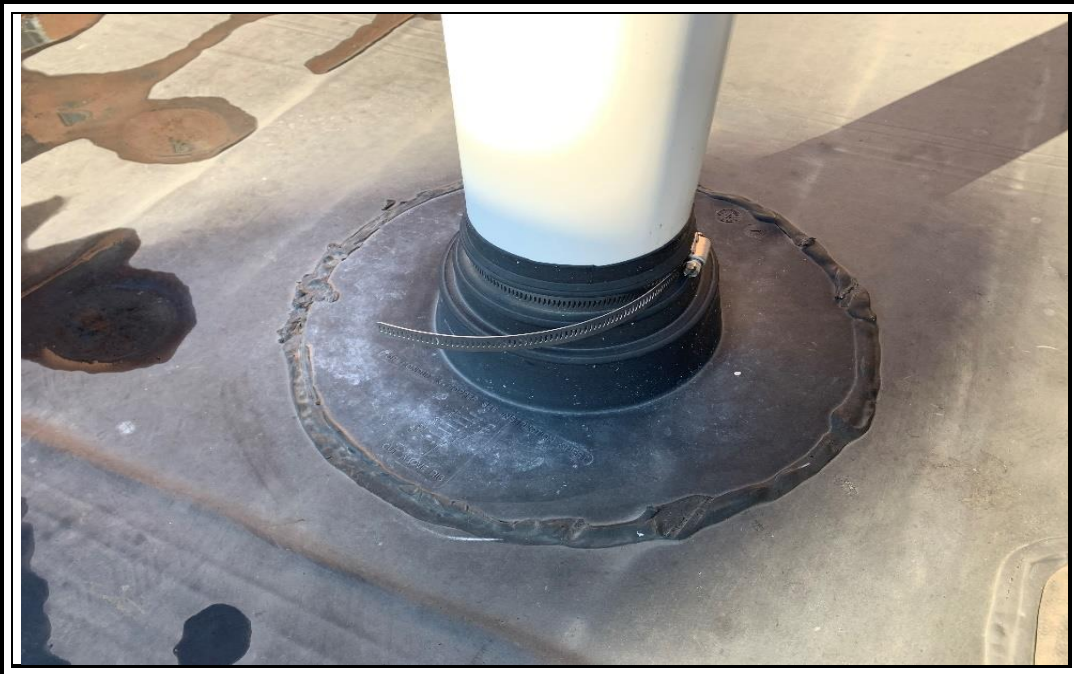
**Photo 22: Close-up view of roof penetration/seal for SSDS exhaust stack at 140 State Street (12/3/20).**

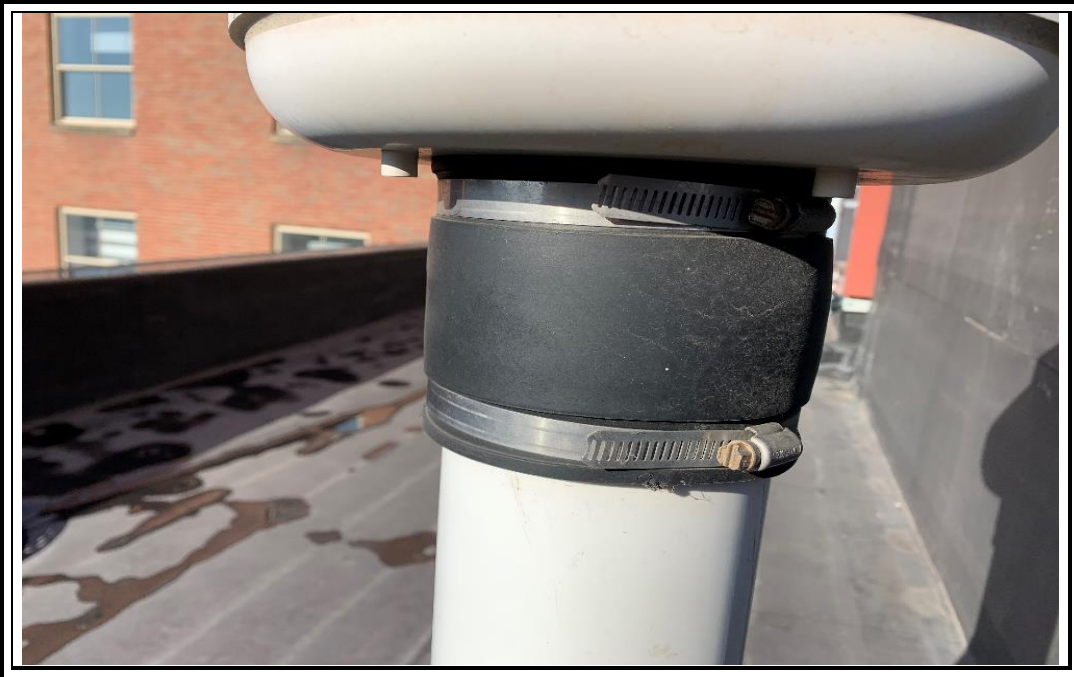
**Photo 23: Close-up view of connection between SSDS exhaust stack and fan at 140 State Street (12/3/20).**

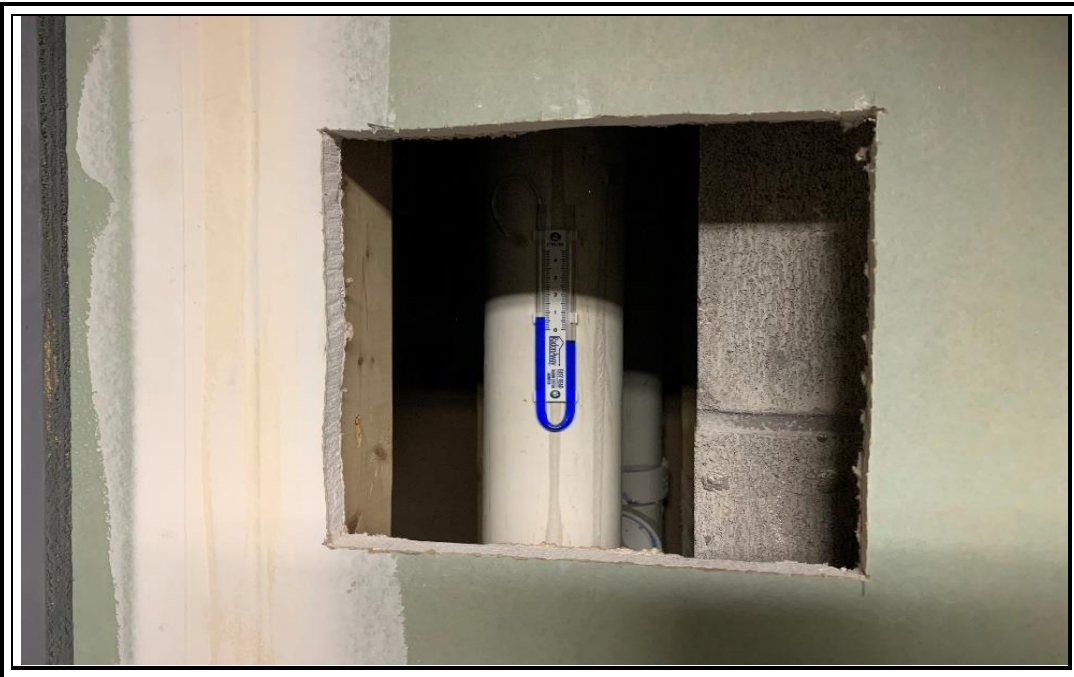
At the time of the December 3, 2020 inspection, the SSDS at the 140 State Street building was observed to be operating properly, as indicated by the manometer in the vertical riser pipe (accessed via a wall-mounted hatch in the basement) and then confirmed upon inspection of the fan and discharge piping on the roof of the building.

**Photo 24: View of manometer and vertical riser pipe for SSDS at 140 State Street (access via basement level) (12/3/20).**
