2023 PERIODIC REVIEW REPORT

**Former Albany Laboratories Site
67 Howard Street/140 State Street
City of Albany, New York**

NYSDEC Site Number: 401061

March 2024

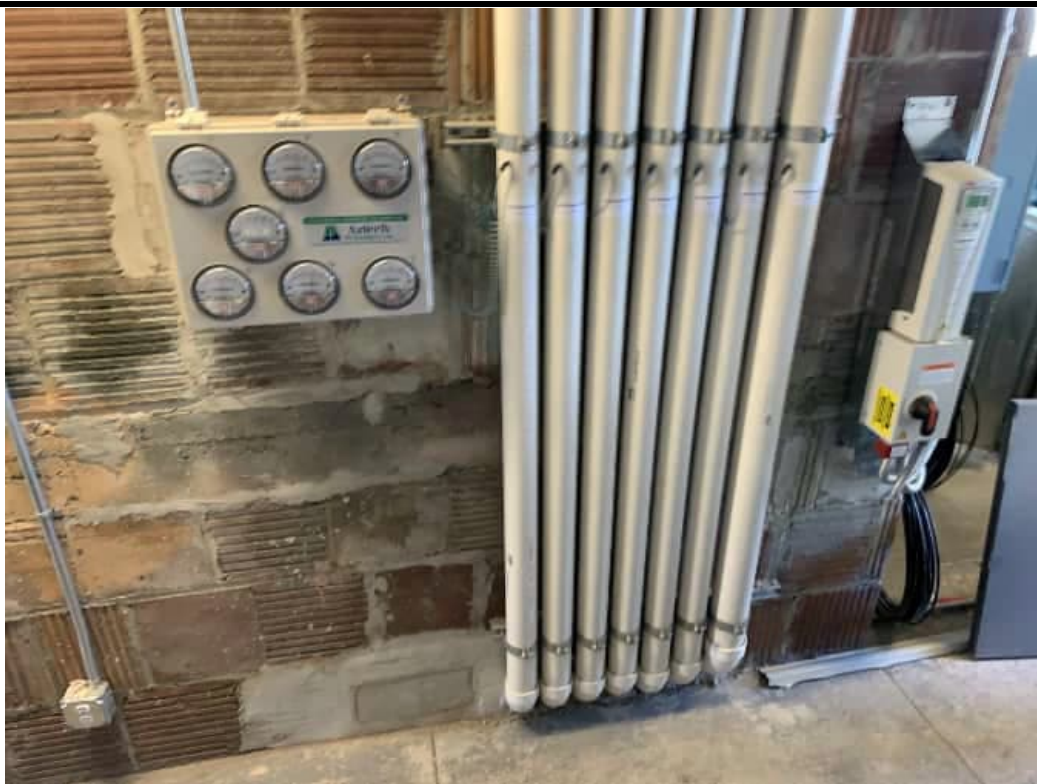
During the 2023 reporting period, the annual inspection of the SSDS at the 144 State Street building (Renaissance Hotel) was completed by CHA on December 15, 2023. At the time of the inspection, the SSDS was observed to be operating and functioning properly, as indicated by the Magnehelic manometer for each sub-system (#1 through #7), and confirmed upon inspection of each roof-mounted sub-system fan. Airflow was noted at the discharge points for each of these sub-systems. The manometer readings for the seven operating fans were consistent with the readings observed in September 2015 (soon after the system was activated) and during the subsequent Site inspection visits that have been completed since that time. Based on post-installation communication testing conducted by Aztech Technologies, Inc. during the fall of 2015, the December 2023 manometer readings are indicative of sufficient vacuum to produce the

Photograph 1. Magnehelic manometer panel and riser piping for the seven individual subsystems comprising the sub-slab depressurization system at 144 State Street (12/15/23).

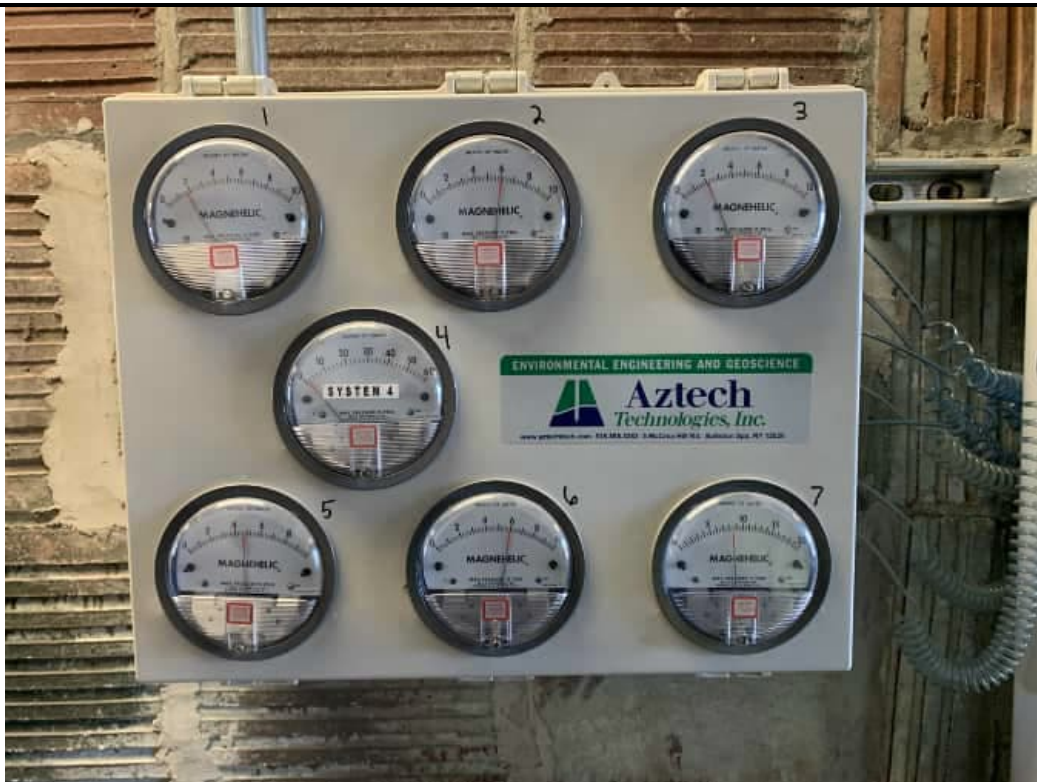
Photograph 2. Close-up view of manometer panel for individual subsystems and tubing associated with the magnehelic manometers (12/15/23).

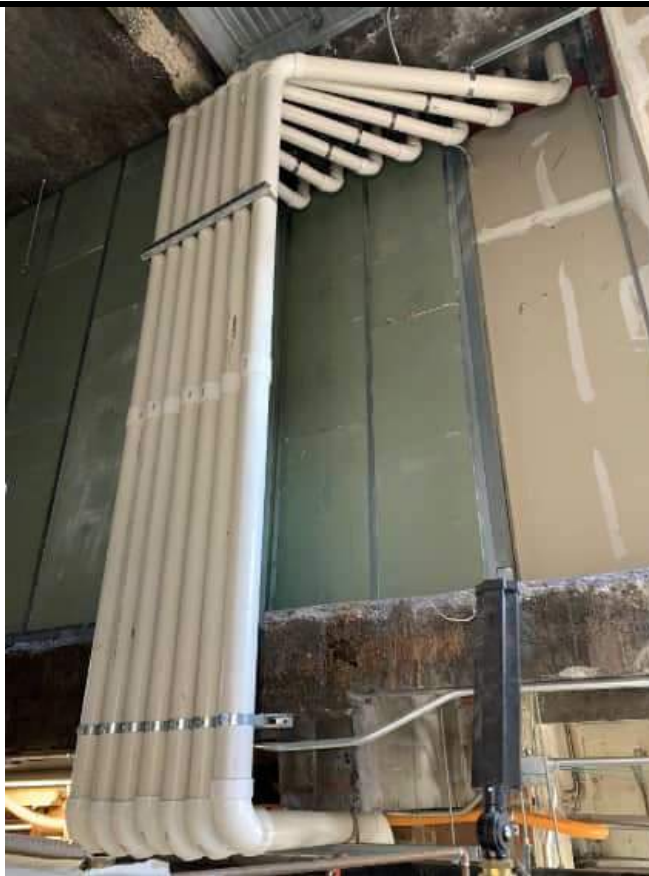
Photograph 3. Riser piping for individual subsystems at 144 State Street (12/15/23).

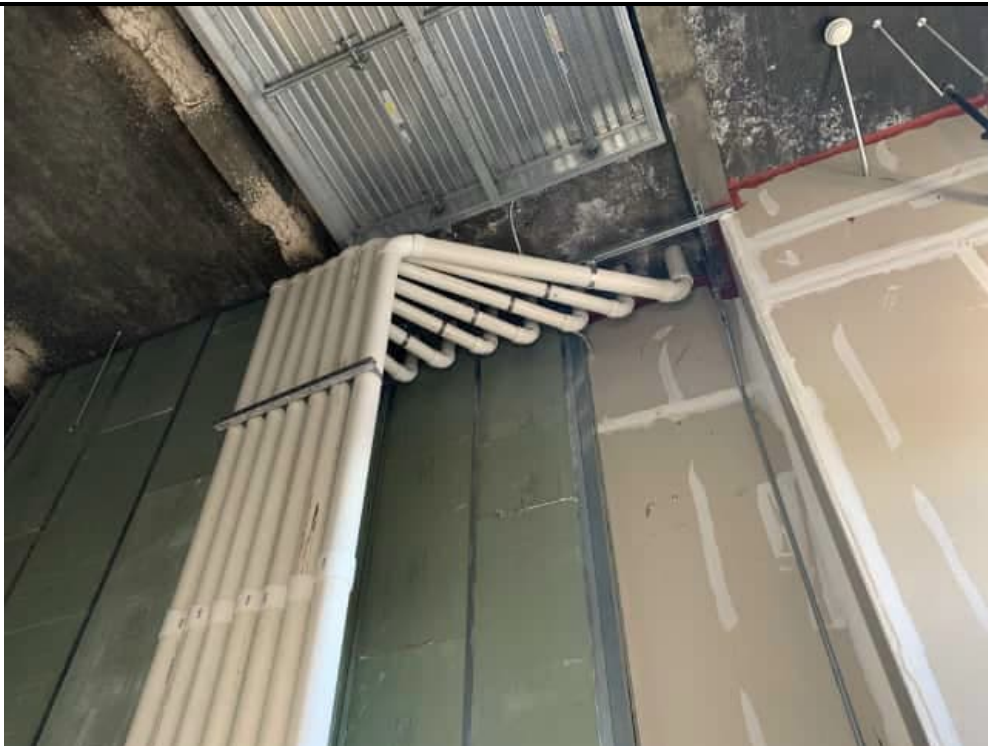
Photograph 4. Riser piping for individual subsystems extending through the building roof at 144 State Street (12/15/23).

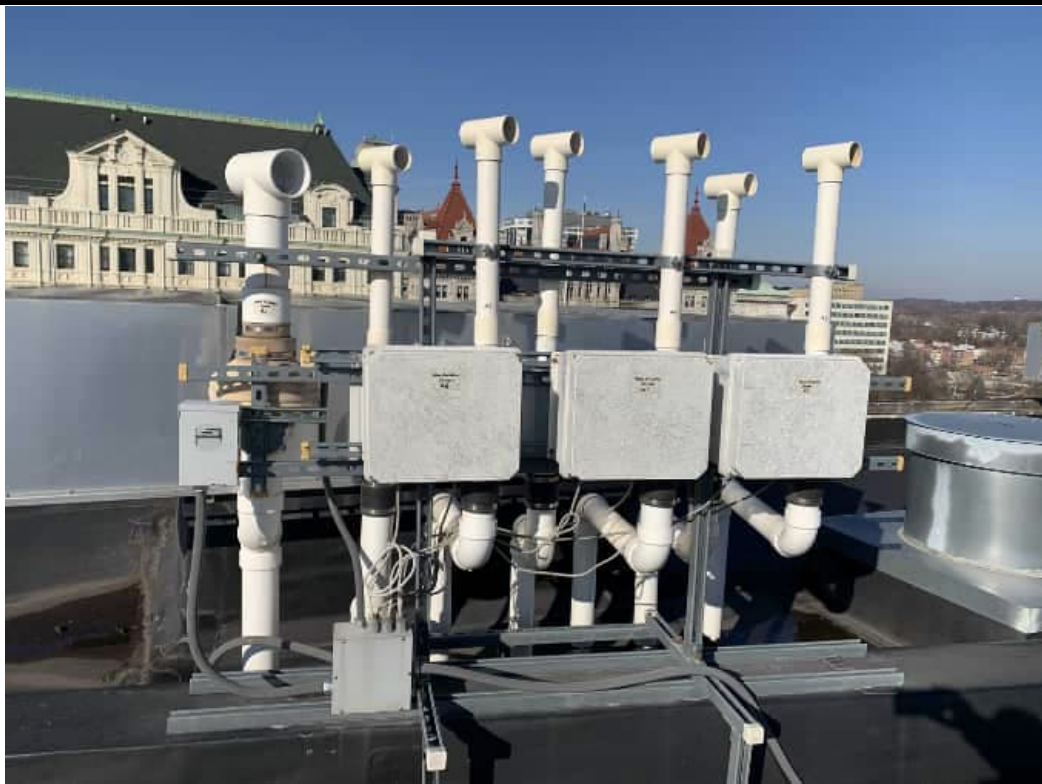
Photograph 5. Roof-mounted fan units for individual sub-systems at 144 State Street (12/15/23).

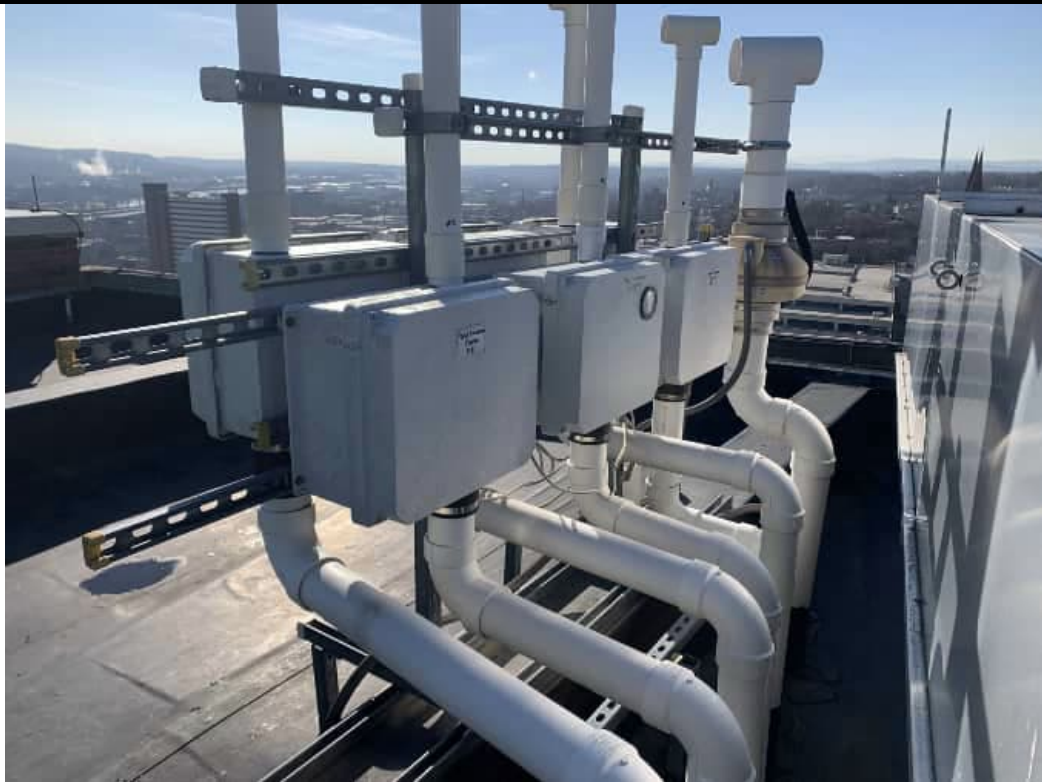
**Reading was 0 inches of water column on December 14, 2022. Following the replacement of the fan for sub-system #5, the vacuum was recorded as 5.0 inches of water column on January 27, 2023.*

Photograph 6. Fan units for subsystems 2, 5, 7 and 3 (left to right) at 144 State Street (12/15/23).

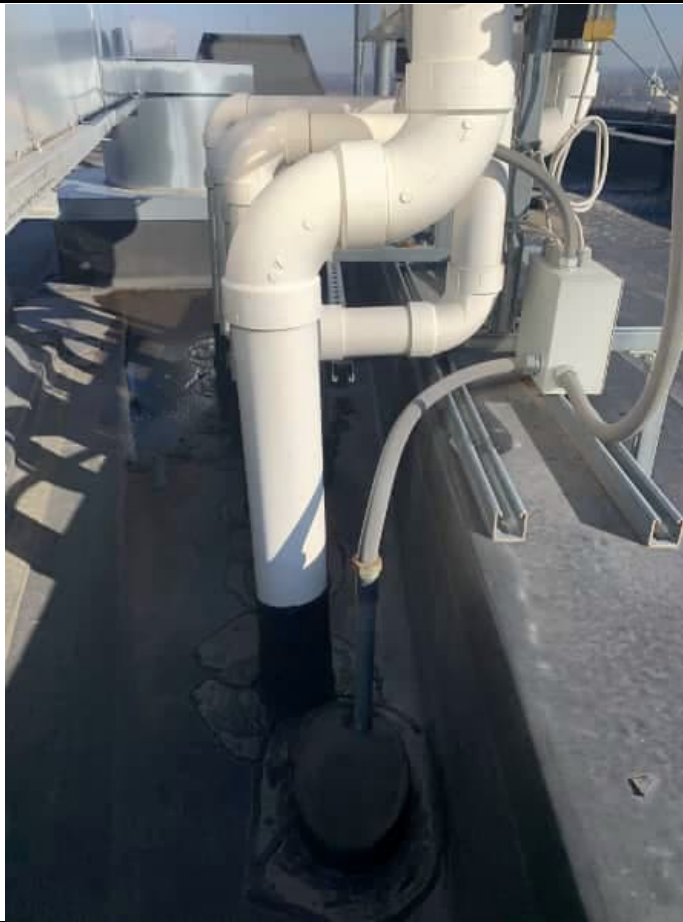
Photograph 7. Riser pipes extending through roof and into fan units at 144 State Street (12/15/23).

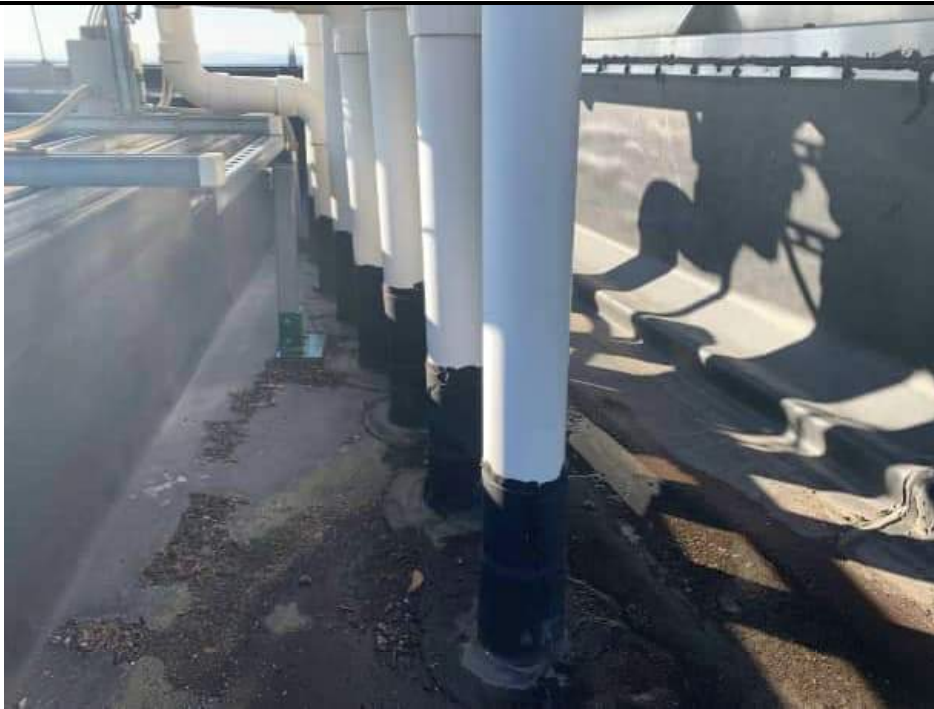
Photograph 8. Seals around riser pipes at roof penetrations (12/15/23).

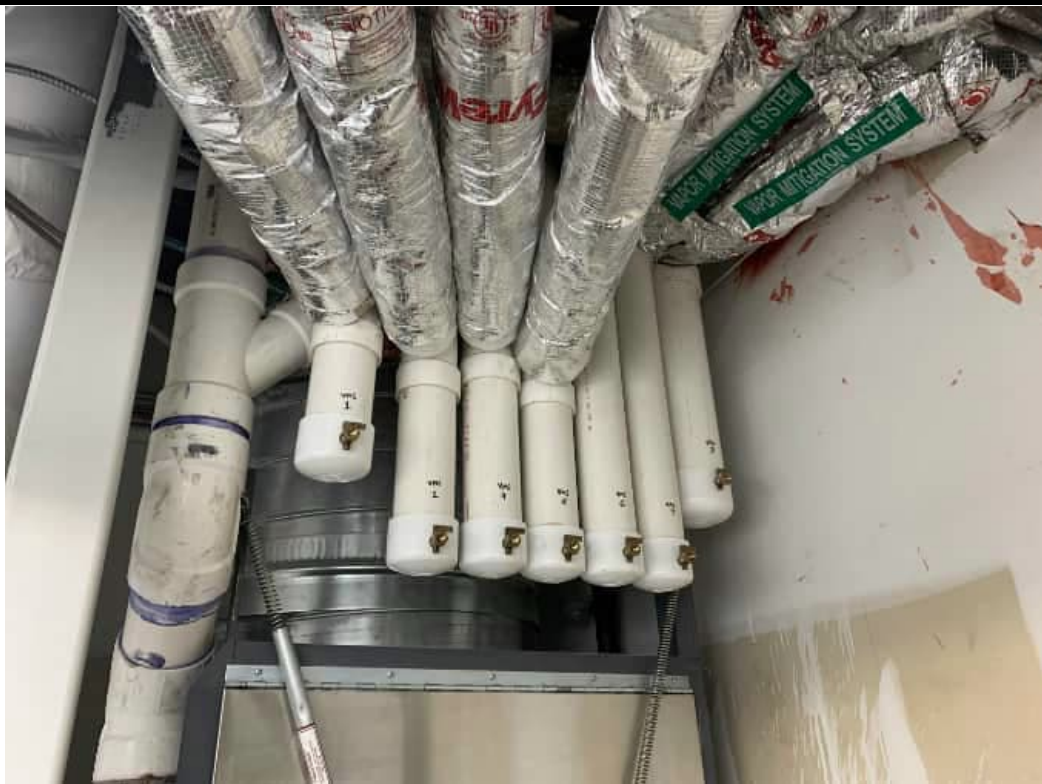
Photograph 9. Inside laundry chute room in basement of 144 State Street; horizontal piping for individual sub-systems connected to vertical riser pipes (12/15/23).

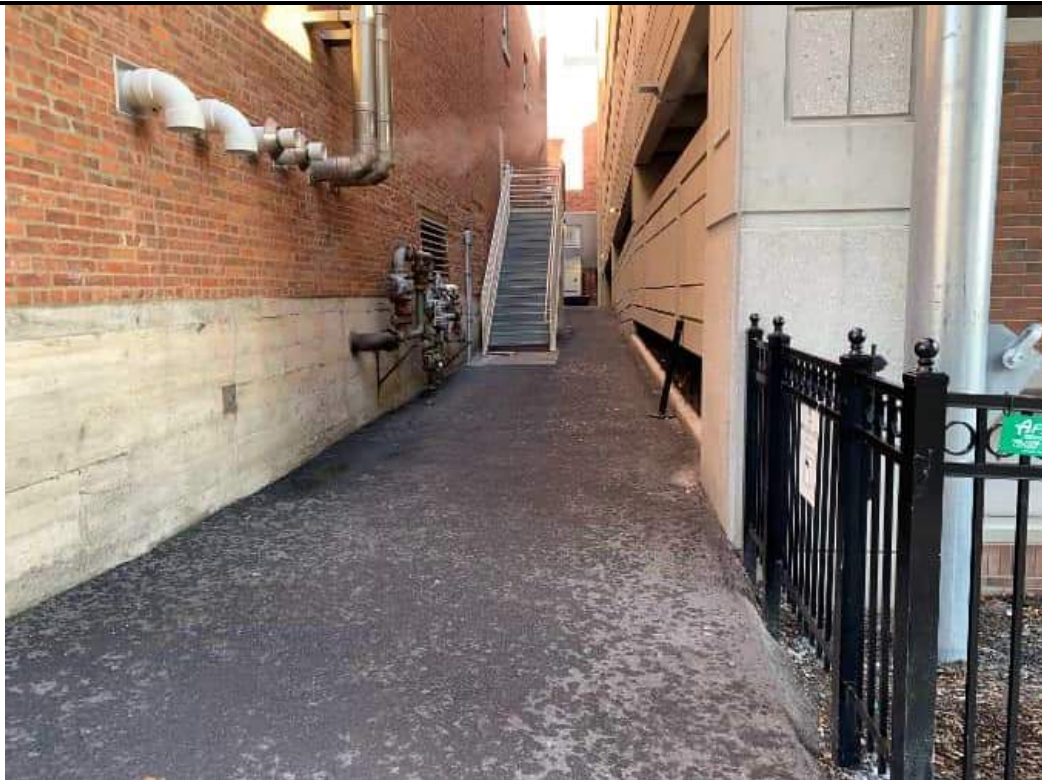
Photograph 10. Looking northeast (from Howard Street); paved surface cover in alley between 144 State Street (to the left) and parking garage (to the right) (12/15/23).

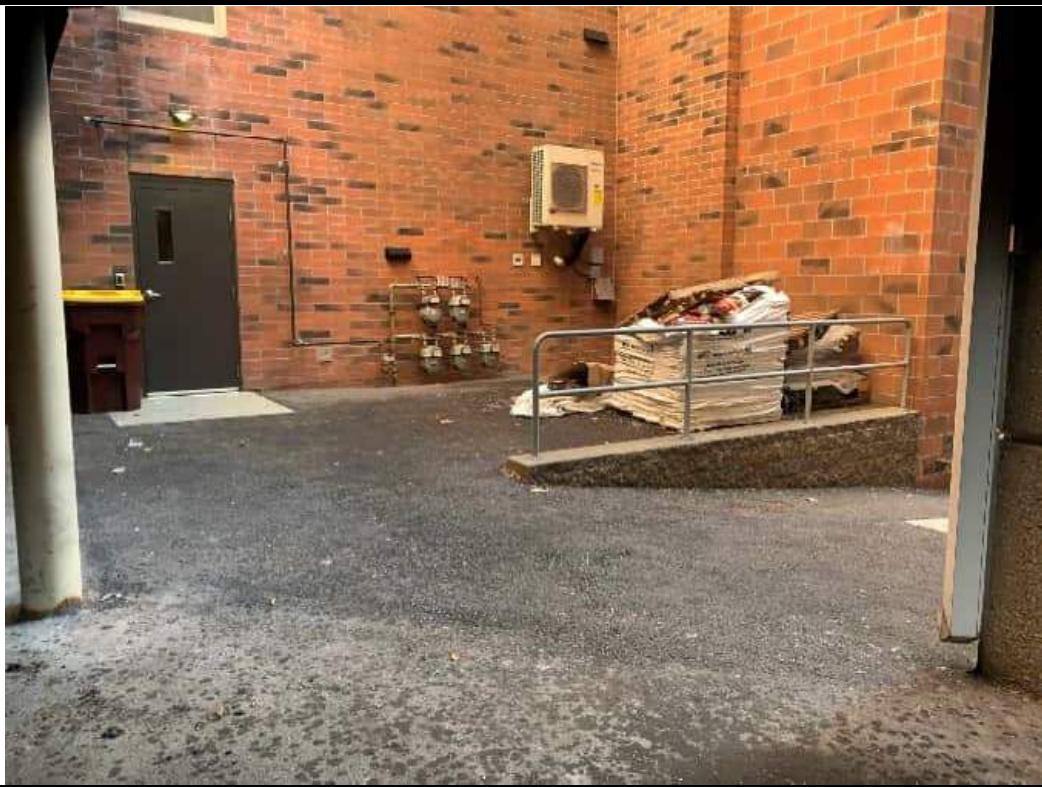
Photograph 11. Looking east; paved surface cover in area adjacent to rear side of 140 State Street building (12/15/23).

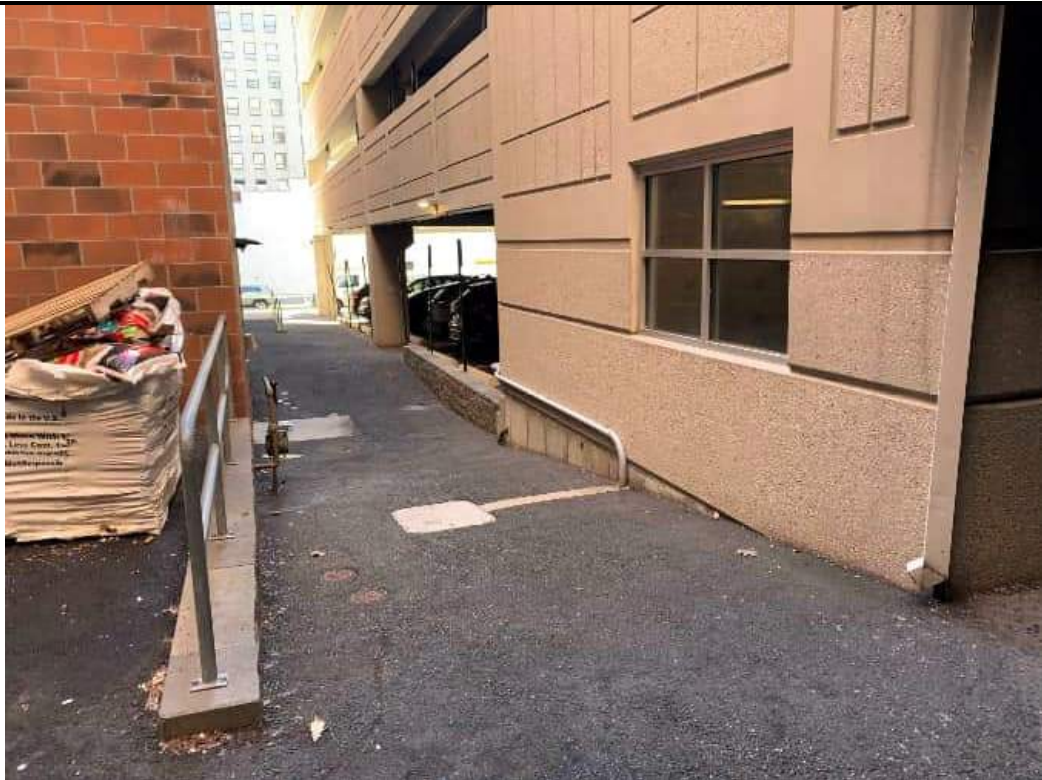
Photograph 12. Looking southeast; paved surface cover between 140 State Street (to the left) and the parking garage (to the right) (12/15/23).

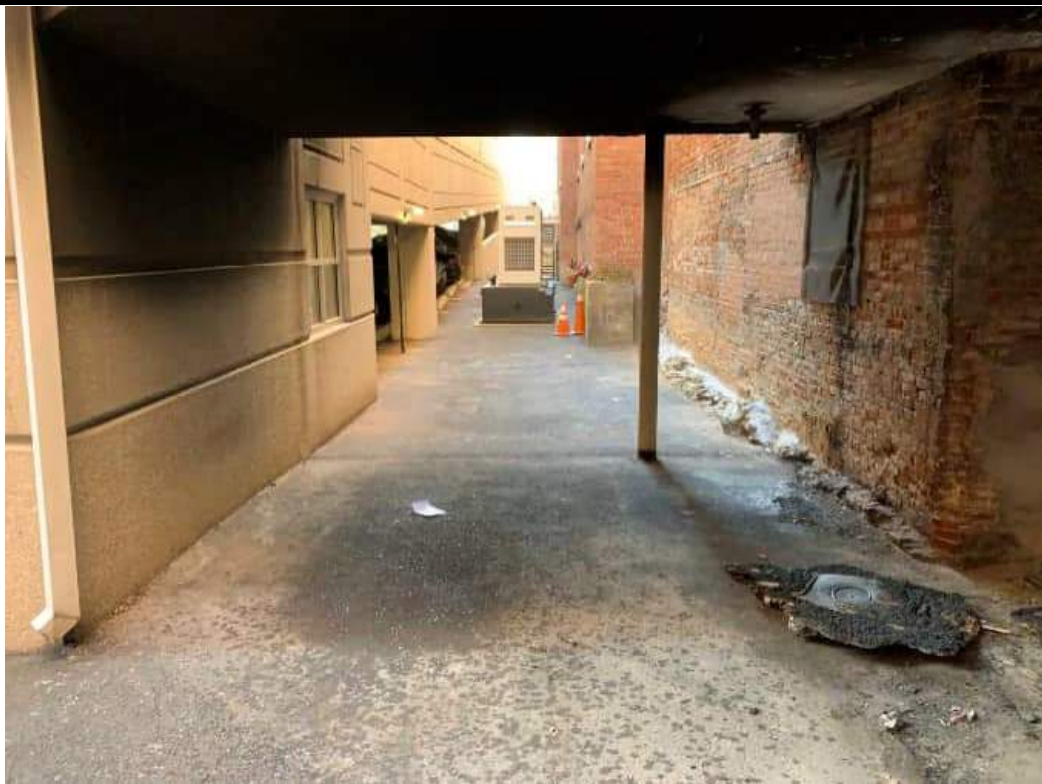
Photograph 13. Looking southwest toward Howard Street; paved surface cover in alley between 144 State Street and the parking garage (12/15/23). Staining was observed on the exterior walls due to a manmade fire. No other damage to the building or pavement was noted.

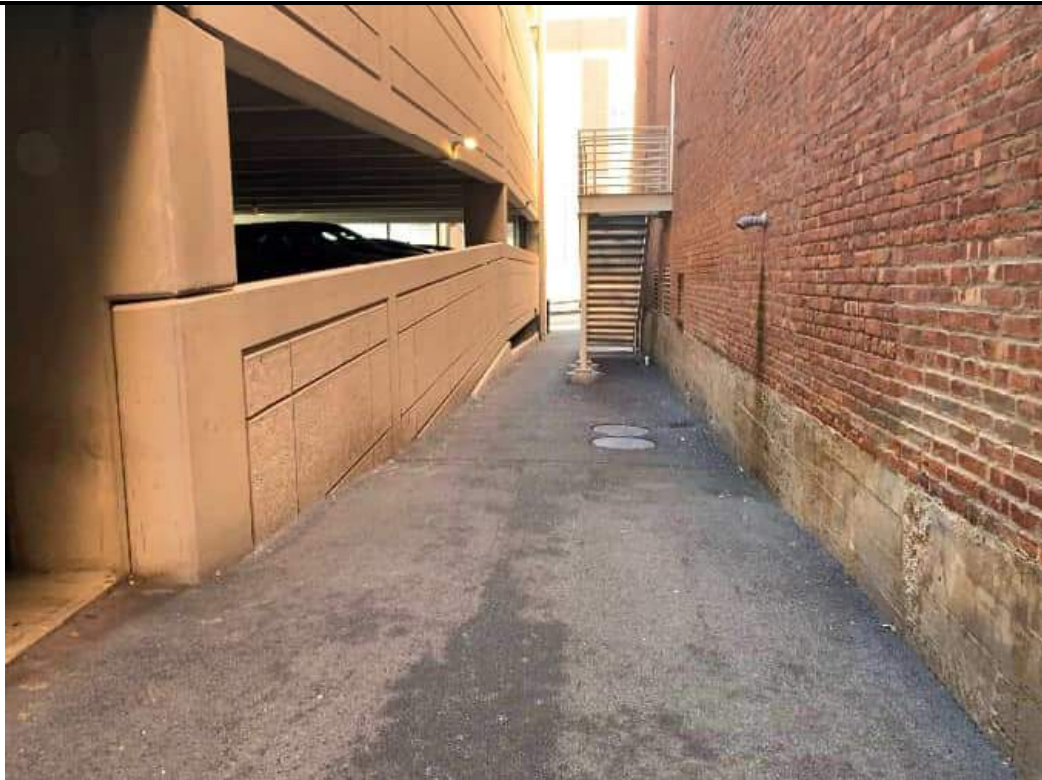
Photograph 14. Looking southwest toward Howard Street; paved surface cover in alley between 144 State Street and the parking garage (12/15/23).

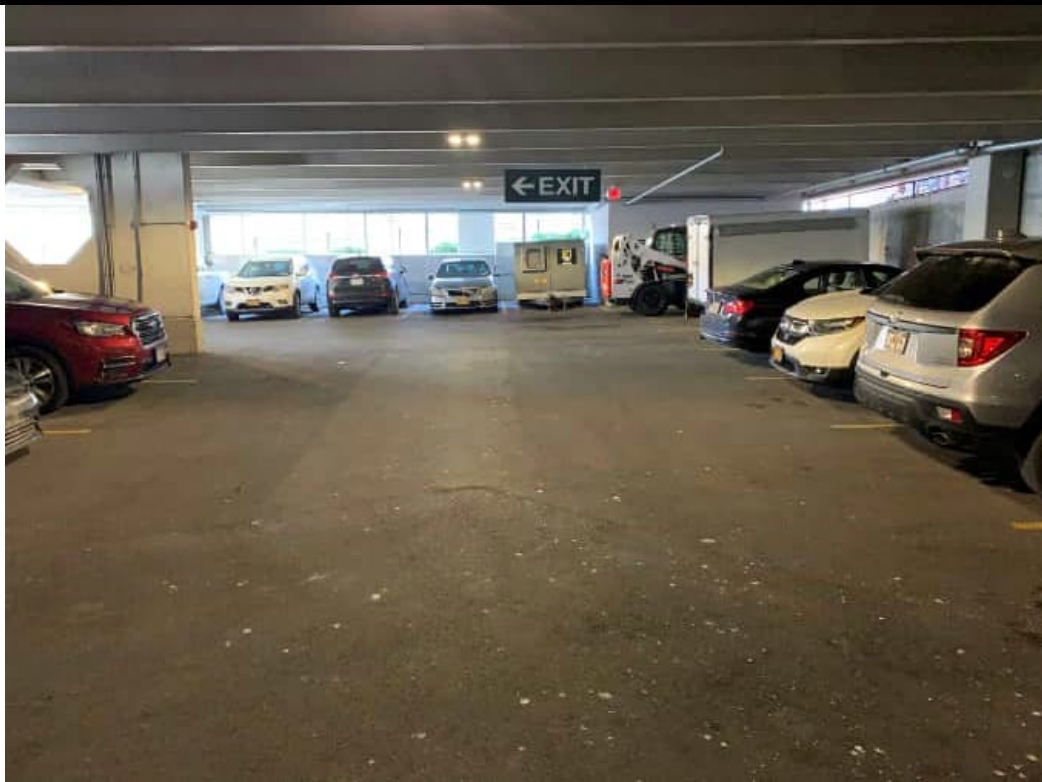
Photograph 15. Looking southwest toward Howard Street; paved surface cover within lowest level of parking garage (12/15/23).

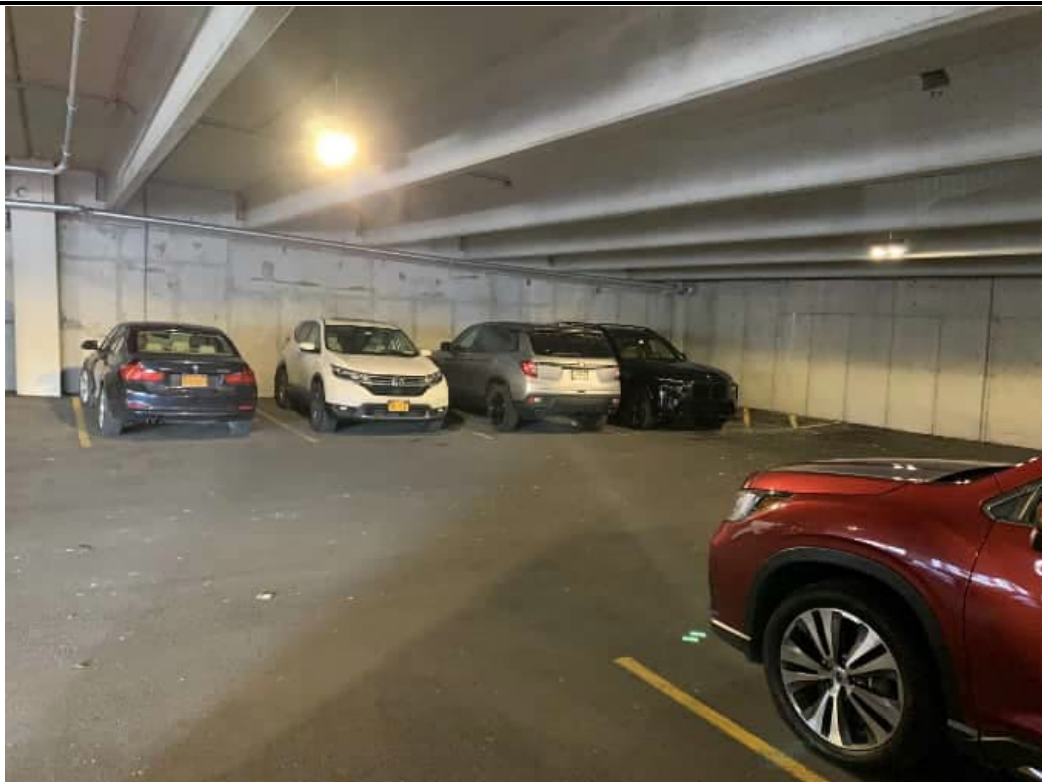
Photograph 16. Looking north; paved surface cover within lowest level of the parking garage (12/15/23).

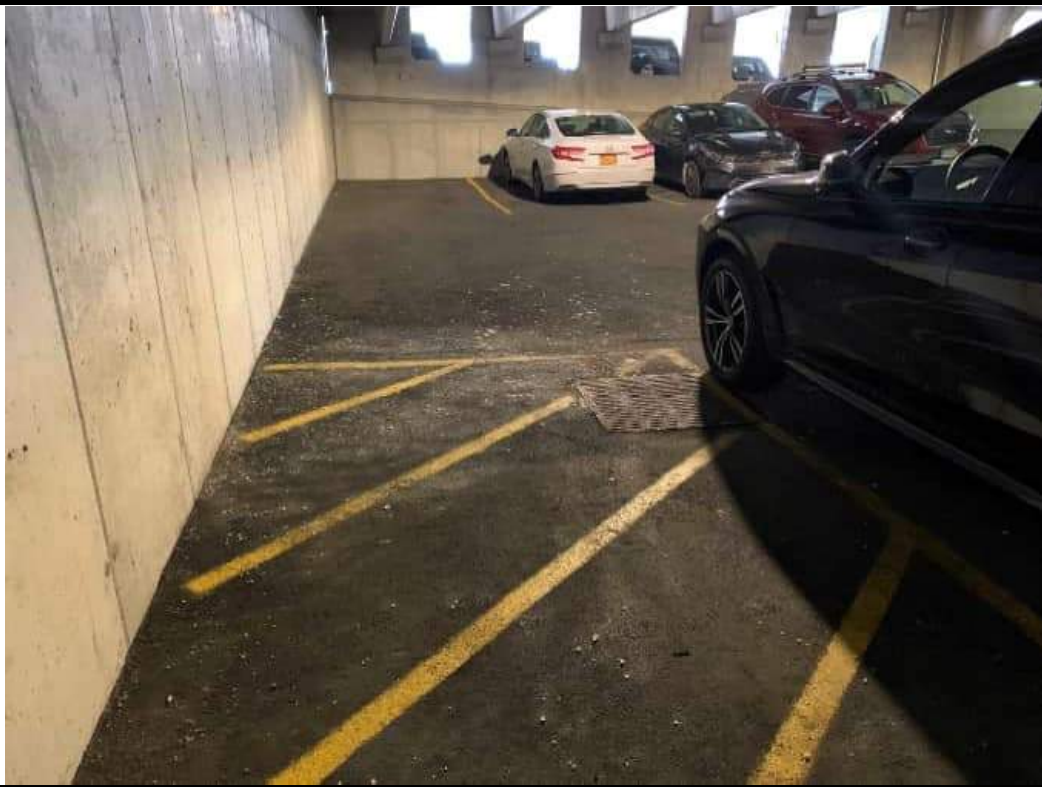
Photograph 17. Looking southeast; paved surface cover and storm drain within lowest level of parking garage (12/15/23).

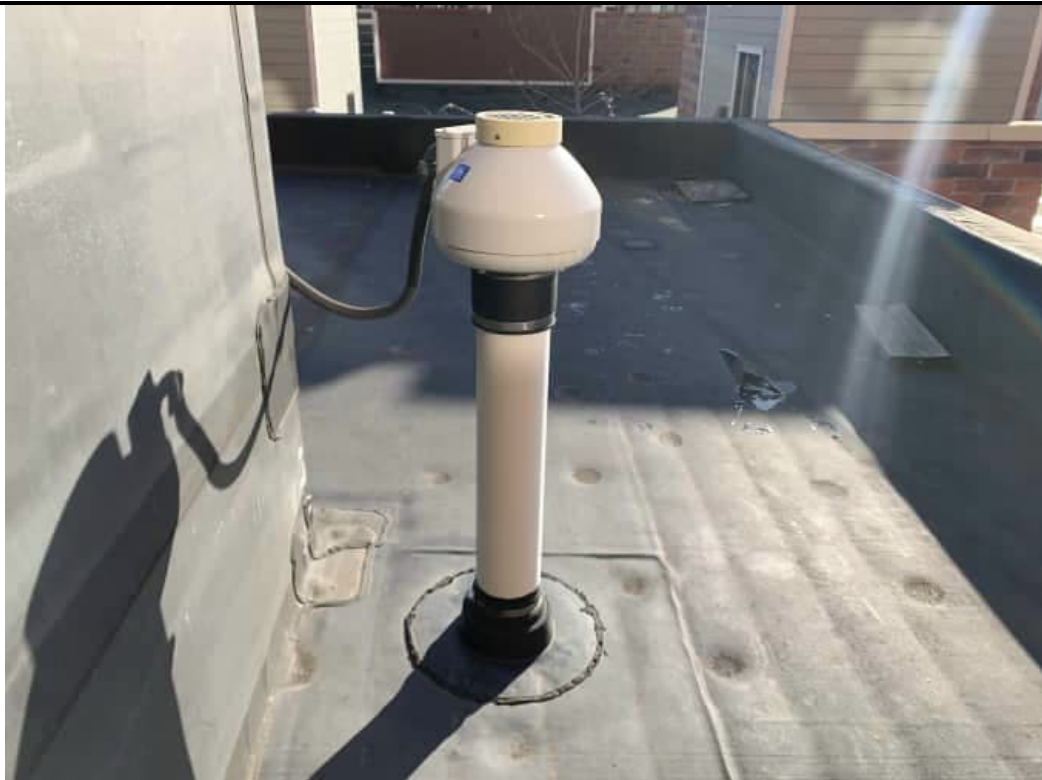
Photograph 18. Roof of 140 State Street building; exhaust stack, fan and switch for SSDS (12/15/23).

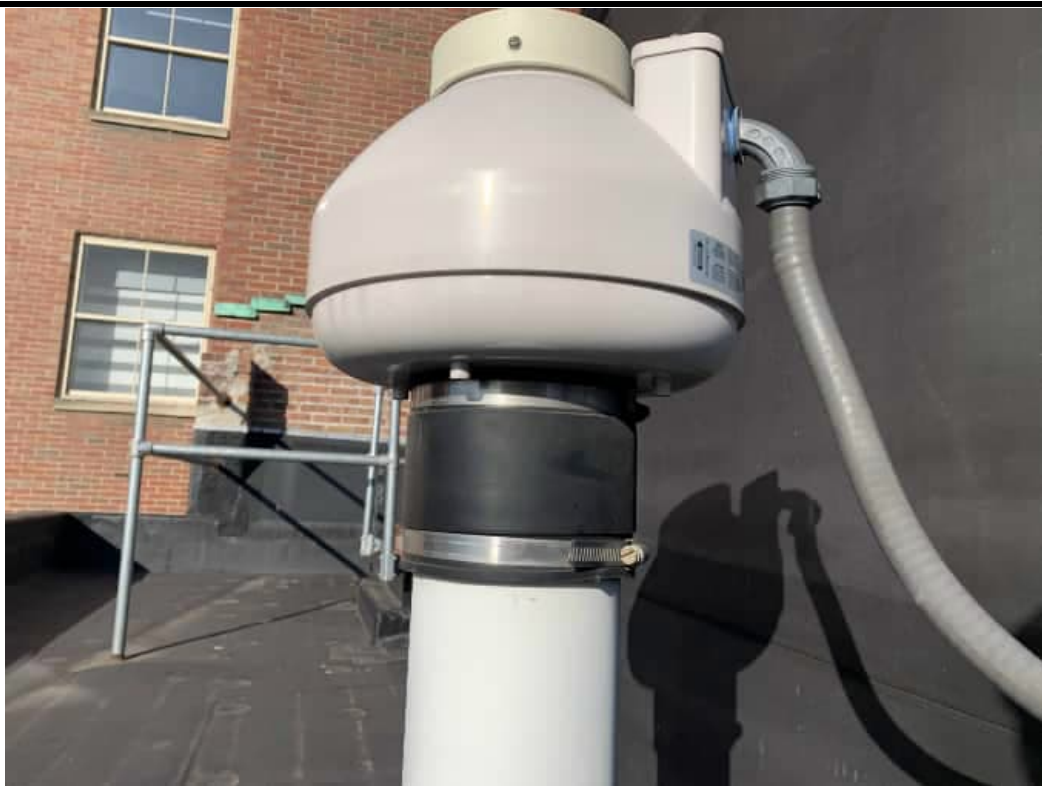
Photograph 19. Close-up view of connection between SSDS exhaust stack and fan at 140 State Street (12/15/23).

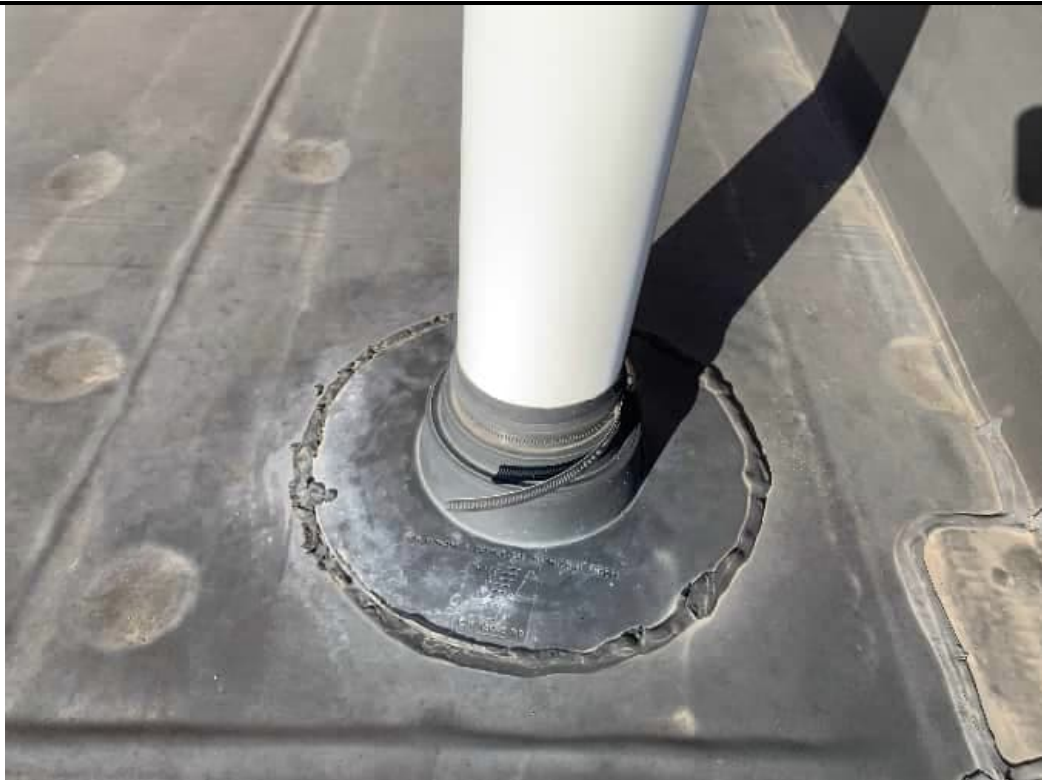
Photograph 20. Close-up view of roof penetration/seal for SSDS exhaust stack at 140 State Street (12/15/23).

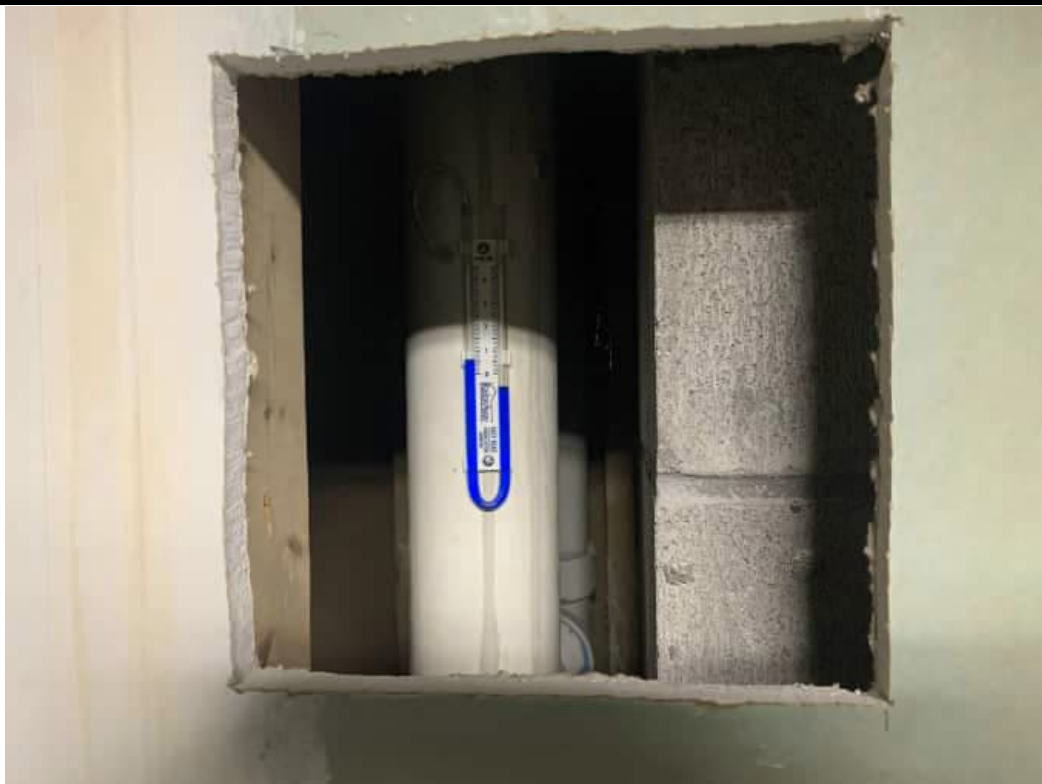
At the time of the December 15, 2023 inspection, the SSDS at the 140 State Street building was observed to be operating properly, as indicated by the manometer in the vertical riser pipe (accessed via a wall-mounted hatch in the basement) and then confirmed upon inspection of the fan and discharge piping on the roof of the building. No cracks or other evidence of damage to the visible piping or fan was observed.

Photograph 21. View of manometer and vertical riser pipe for SSDS at 140 State Street (access via basement level) (12/15/23).
