# 2024 PERIODIC REVIEW REPORT

**Former Albany Laboratories Site  
67 Howard Street/140 State Street  
City of Albany, New York**

**NYSDEC Site Number: 401061**

**March 2025**

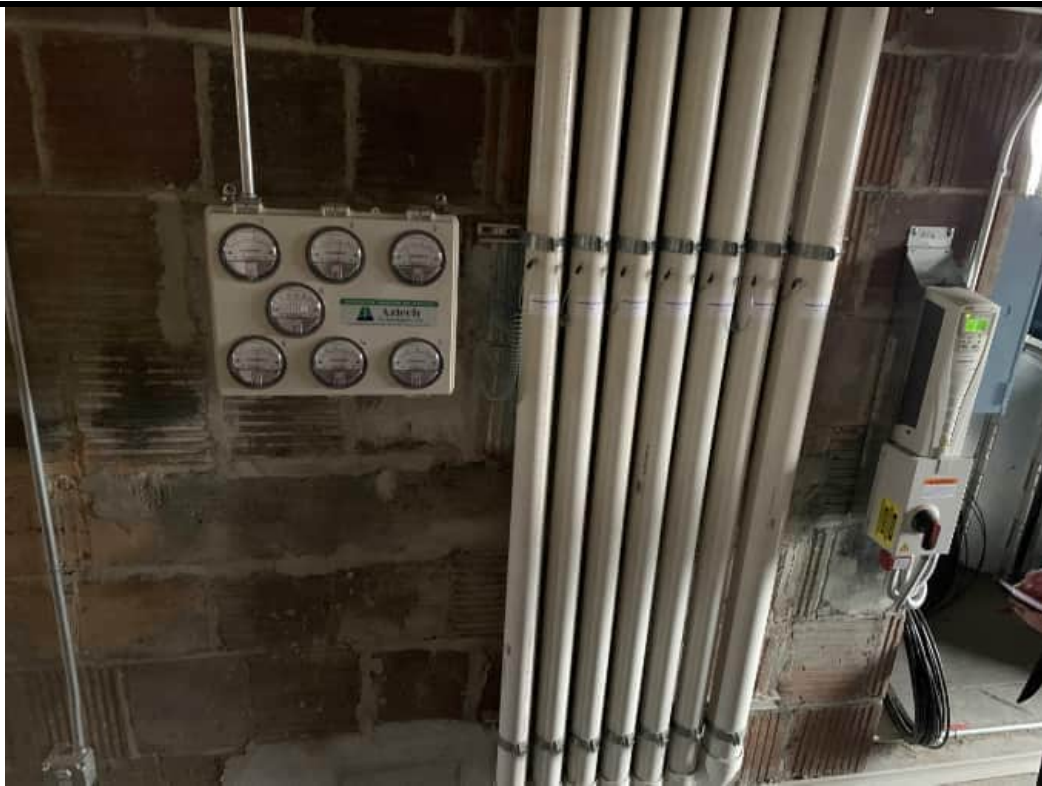
**Photograph 1.** Magnehelic manometer panel and riser piping for the seven individual subsystems comprising the sub-slab depressurization system at 144 State Street (12/20/24).

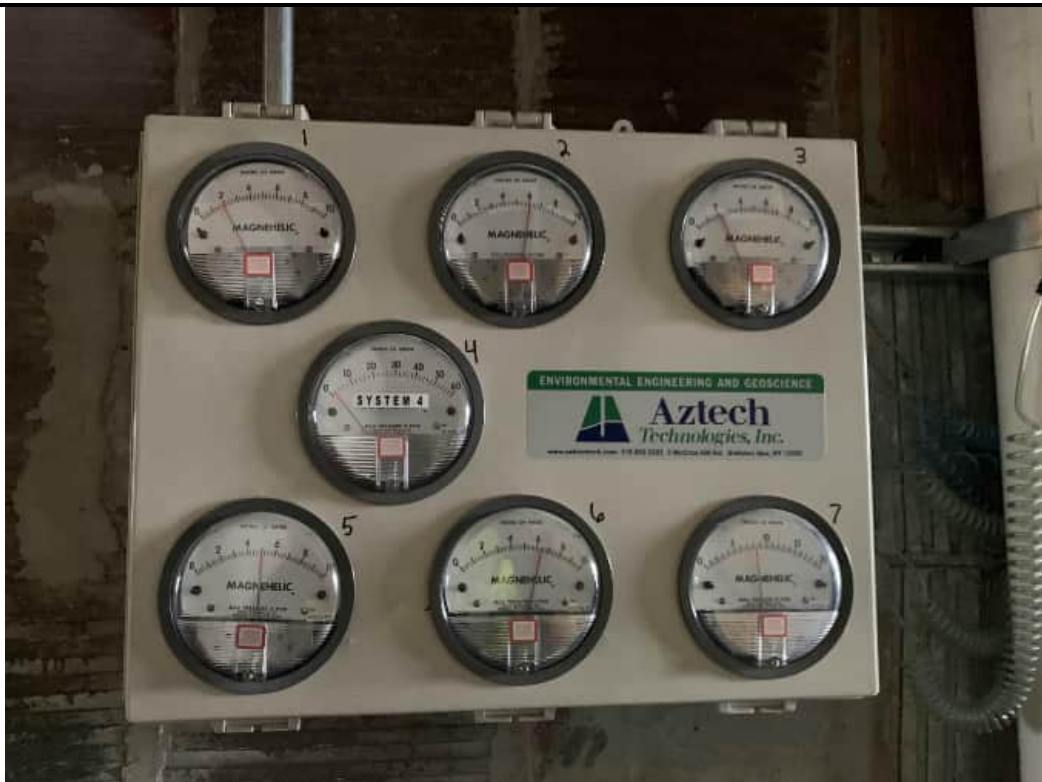
**Photograph 2.** Close-up view of manometer panel for individual subsystems and tubing associated with the magnehelic manometers (12/20/24).

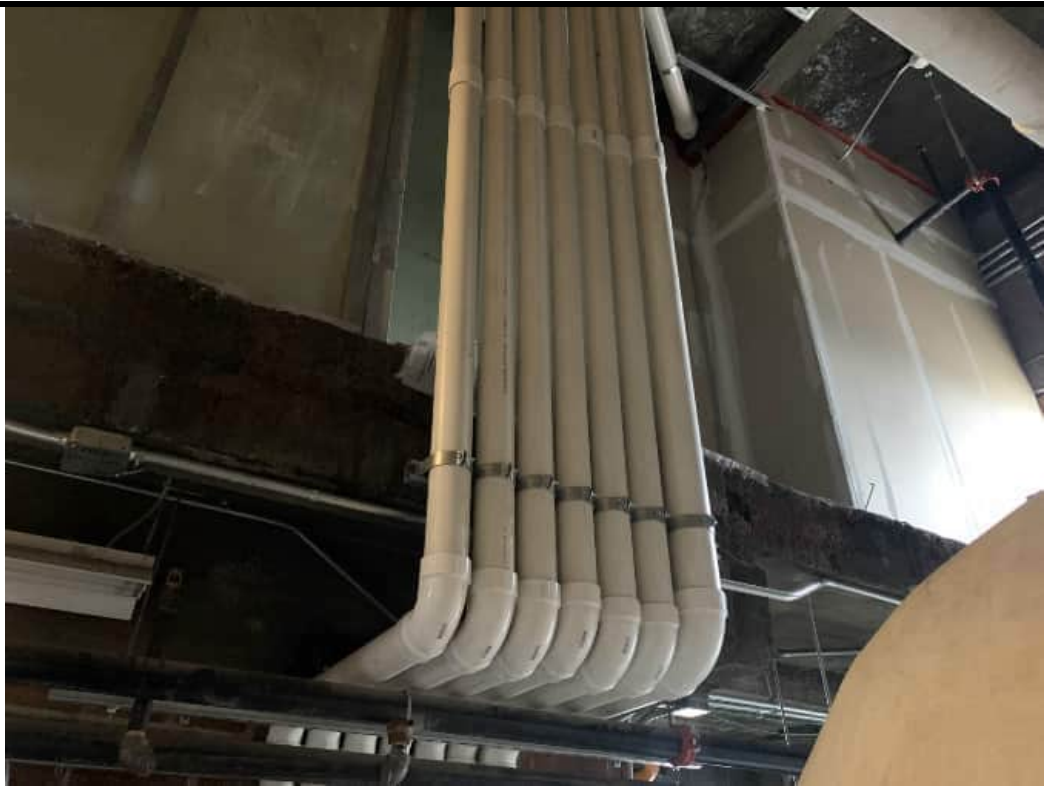
**Photograph 3.** Riser piping for individual subsystems at 144 State Street (12/20/24).

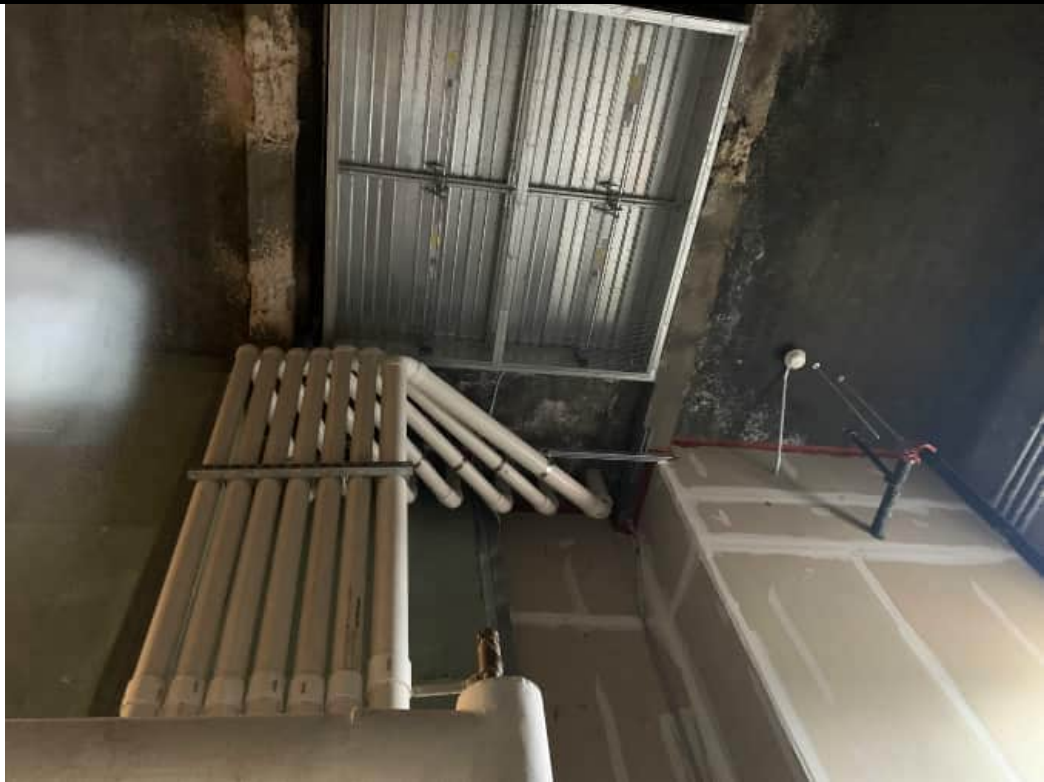
**Photograph 4.** Riser piping for individual subsystems extending through the building roof at 144 State Street (12/20/24).

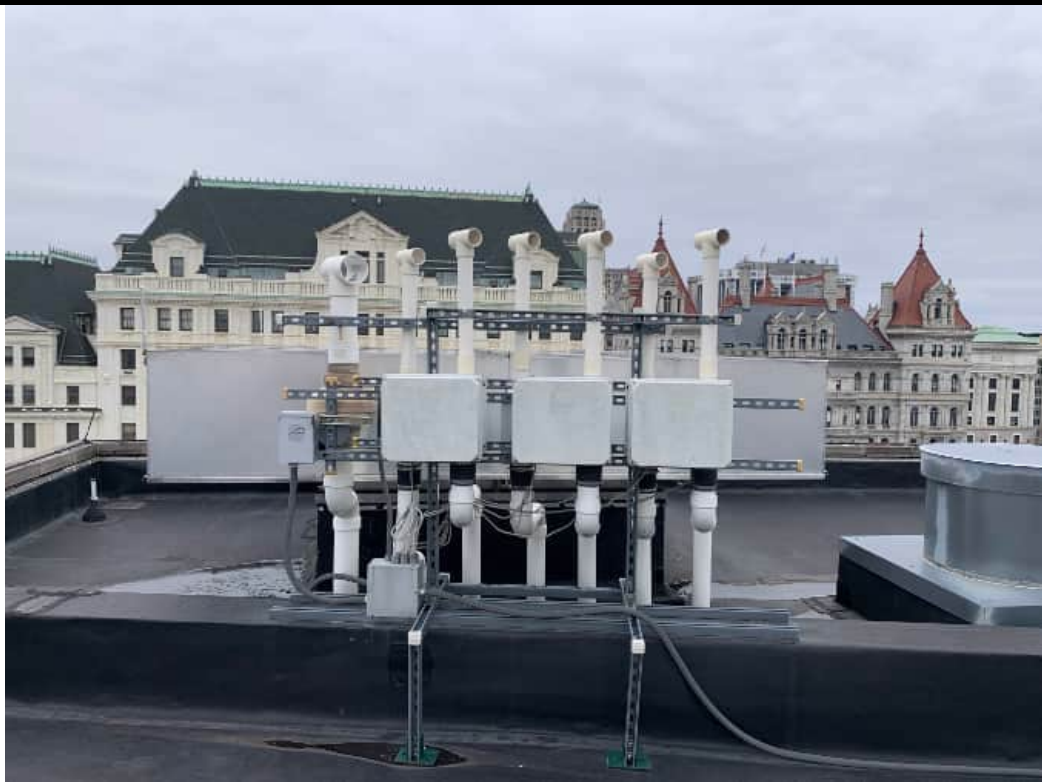
**Photograph 5.** Roof-mounted fan units for individual sub-systems at 144 State Street (12/20/24).

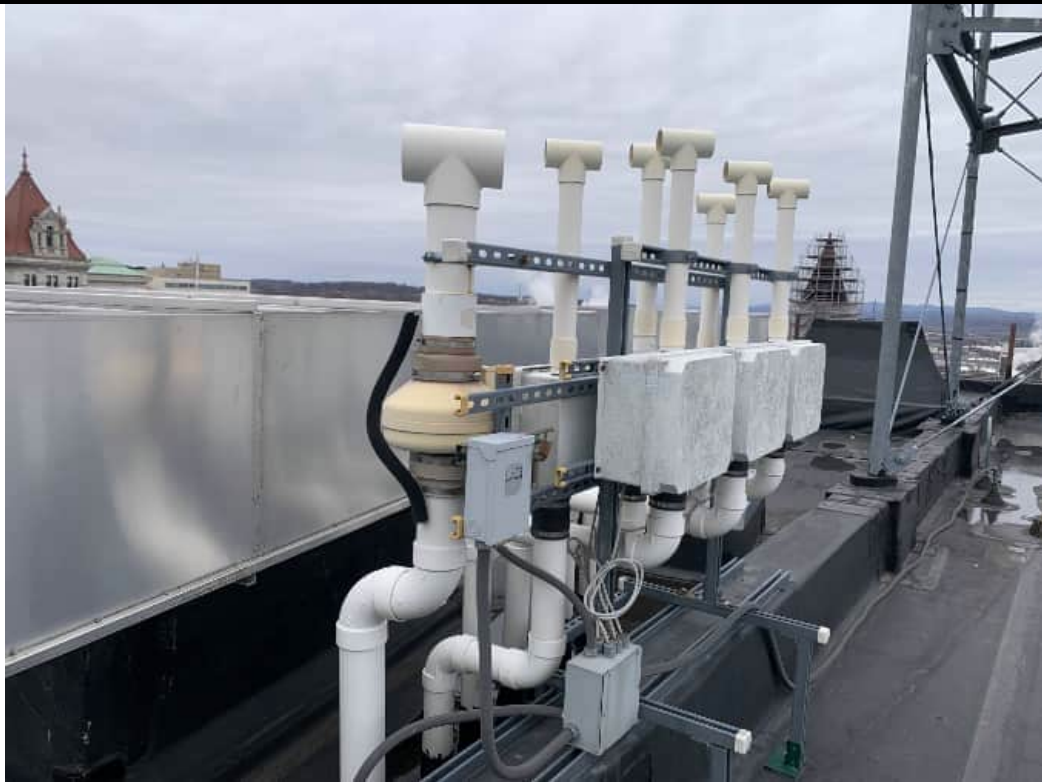
**Photograph 6.** Fan units for subsystems at 144 State Street (12/20/24).

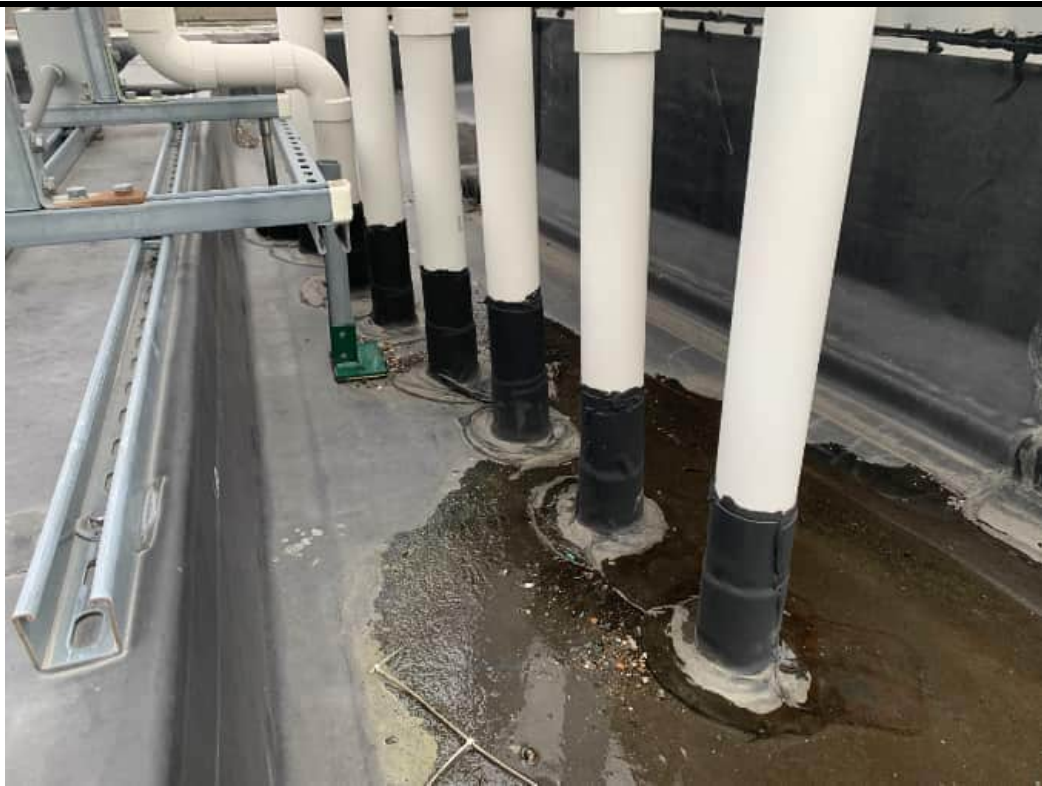
**Photograph 7.** Seals around riser pipes at roof penetrations (12/20/24).

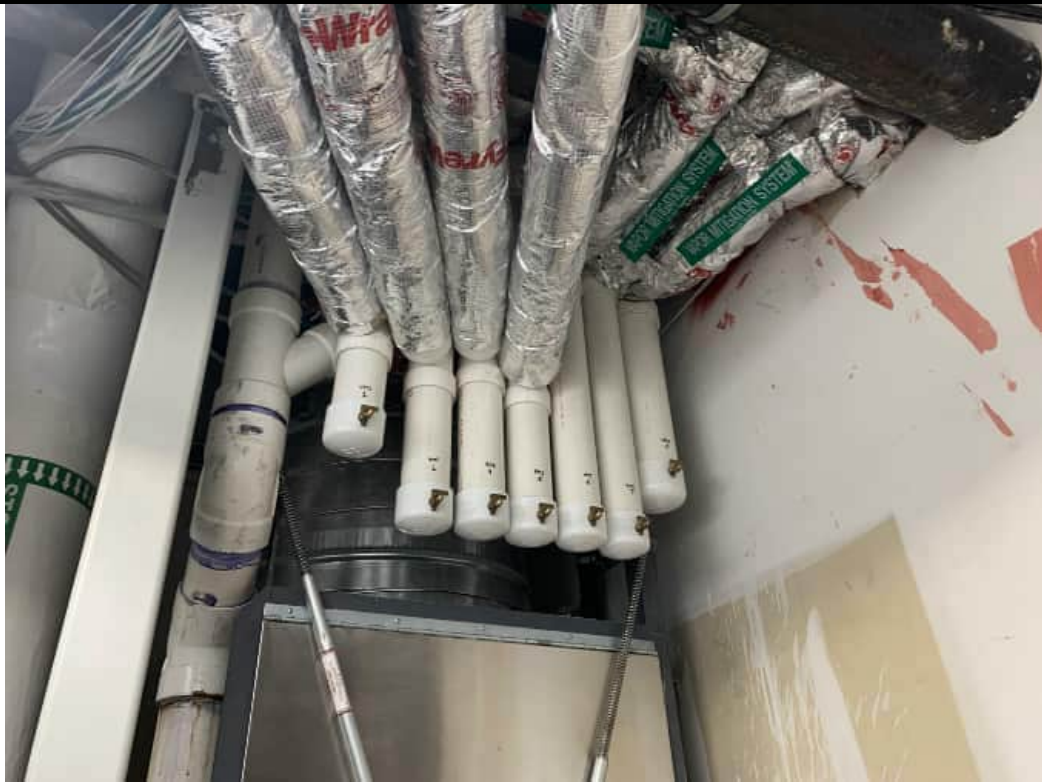
**Photograph 8.** Inside laundry chute room in basement of 144 State Street; horizontal piping for individual sub-systems connected to vertical riser pipes (12/20/24).

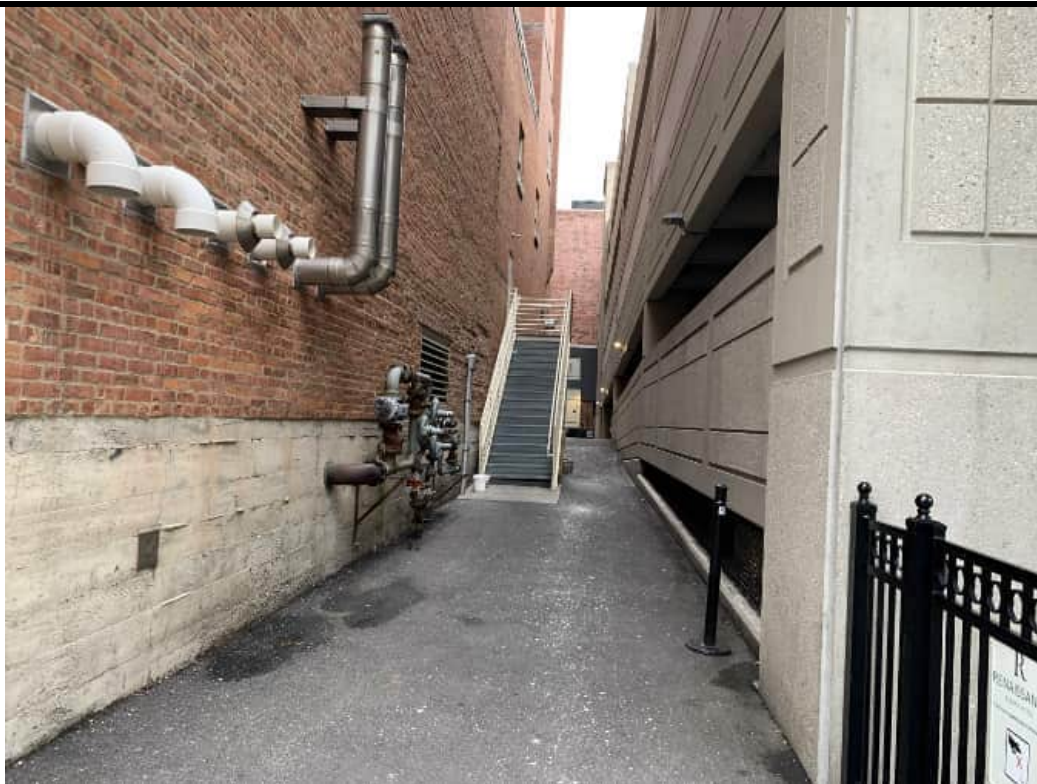
**Photograph 9.** Looking northeast (from Howard Street); paved surface cover in alley between 144 State Street (to the left) and parking garage (to the right) (12/20/24).

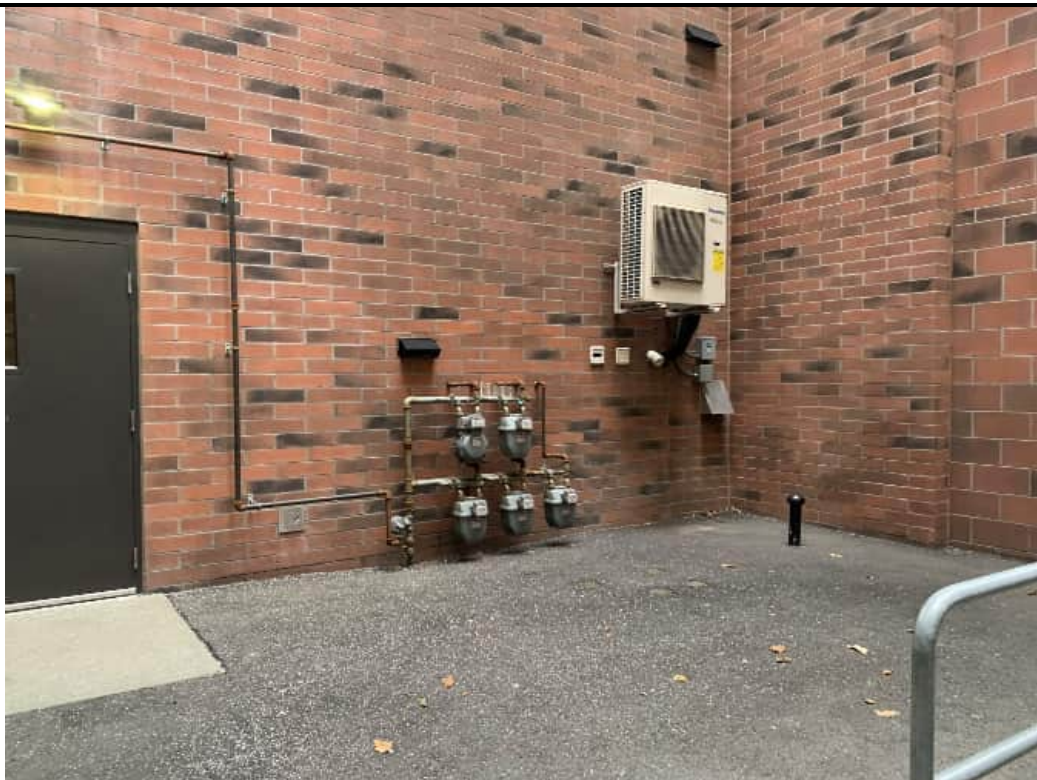
**Photograph 10.** Looking east; paved surface cover in area adjacent to rear side of 140 State Street building (12/20/24).

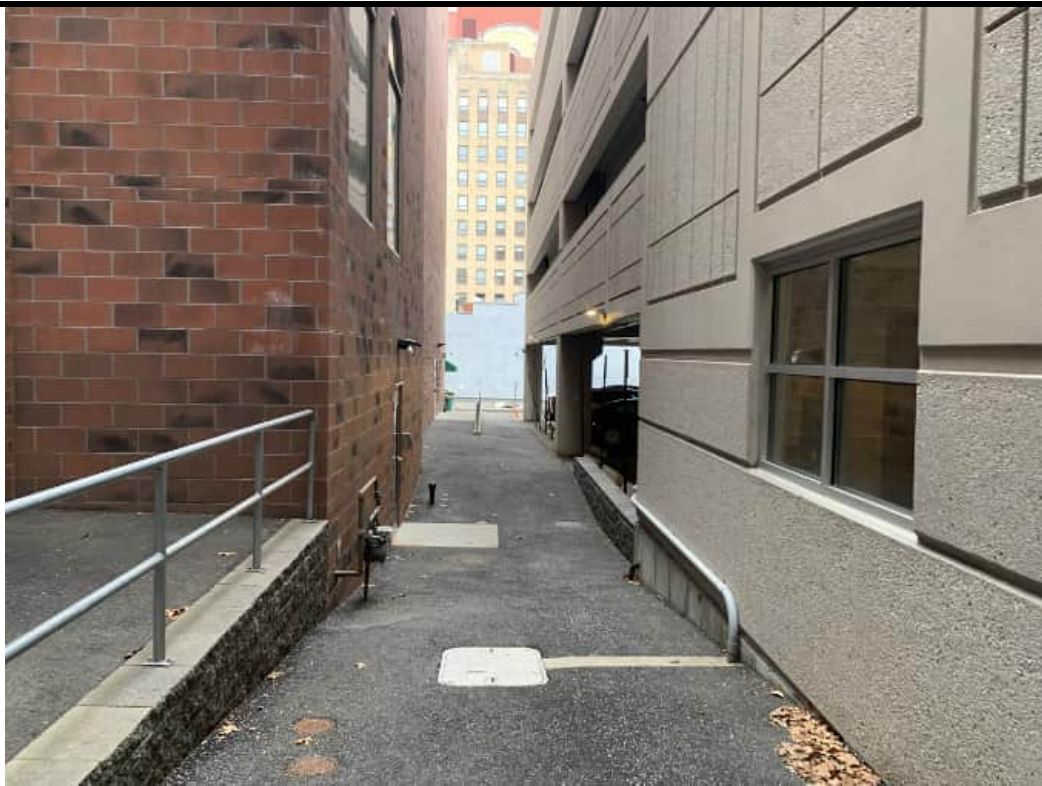
**Photograph 11.** Looking southeast; paved surface cover between 140 State Street (to the left) and the parking garage (to the right) (12/20/24).

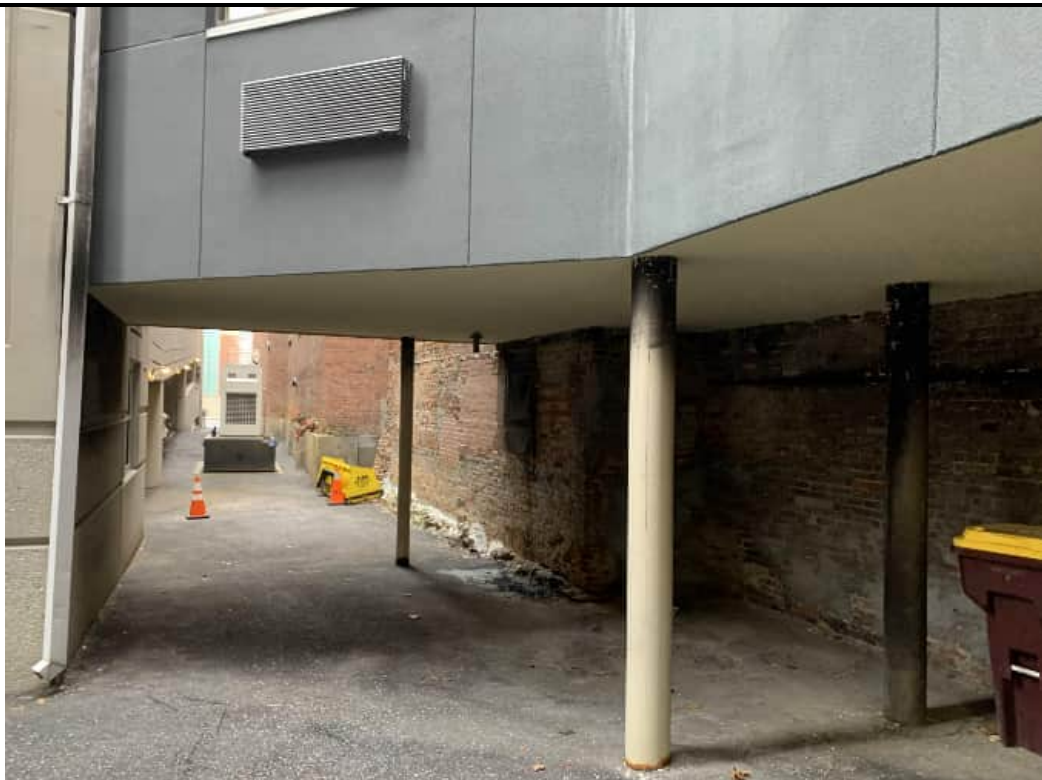
**Photograph 12.** Looking southwest toward Howard Street; paved surface cover in alley between 144 State Street and the parking garage (12/20/24). Staining was observed on the exterior walls due to a manmade fire. No other damage to the building or pavement was noted.

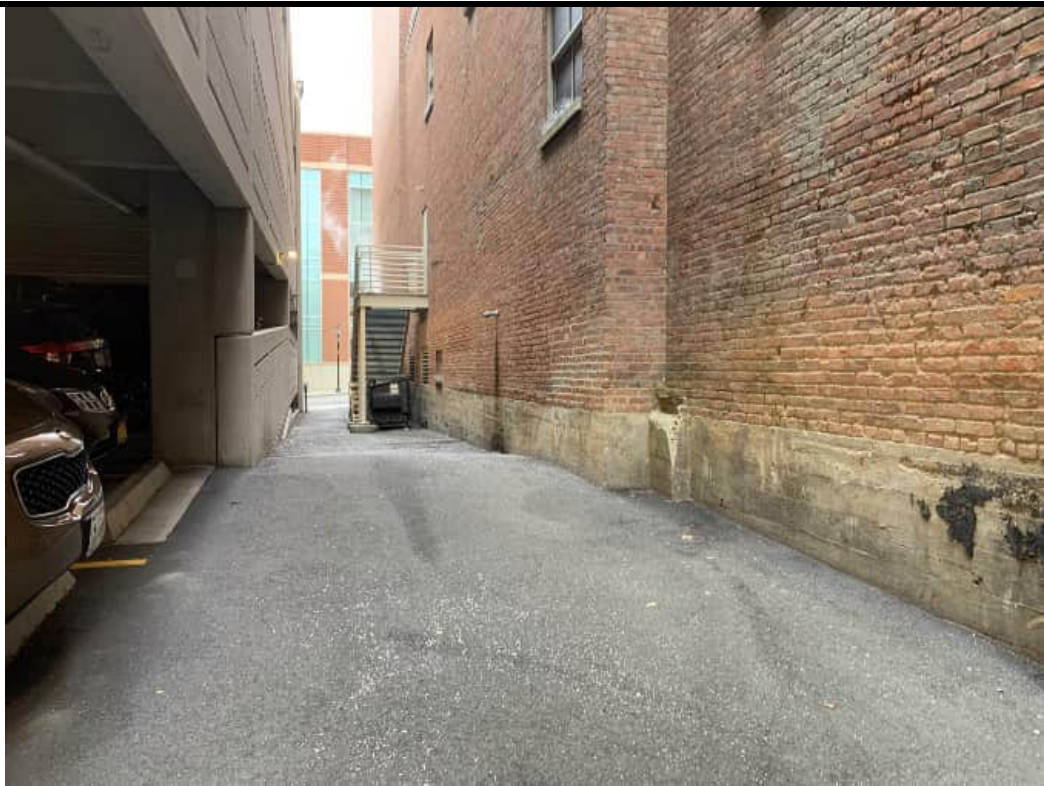
**Photograph 13.** Looking southwest toward Howard Street; paved surface cover in alley between 144 State Street and the parking garage (12/20/24).

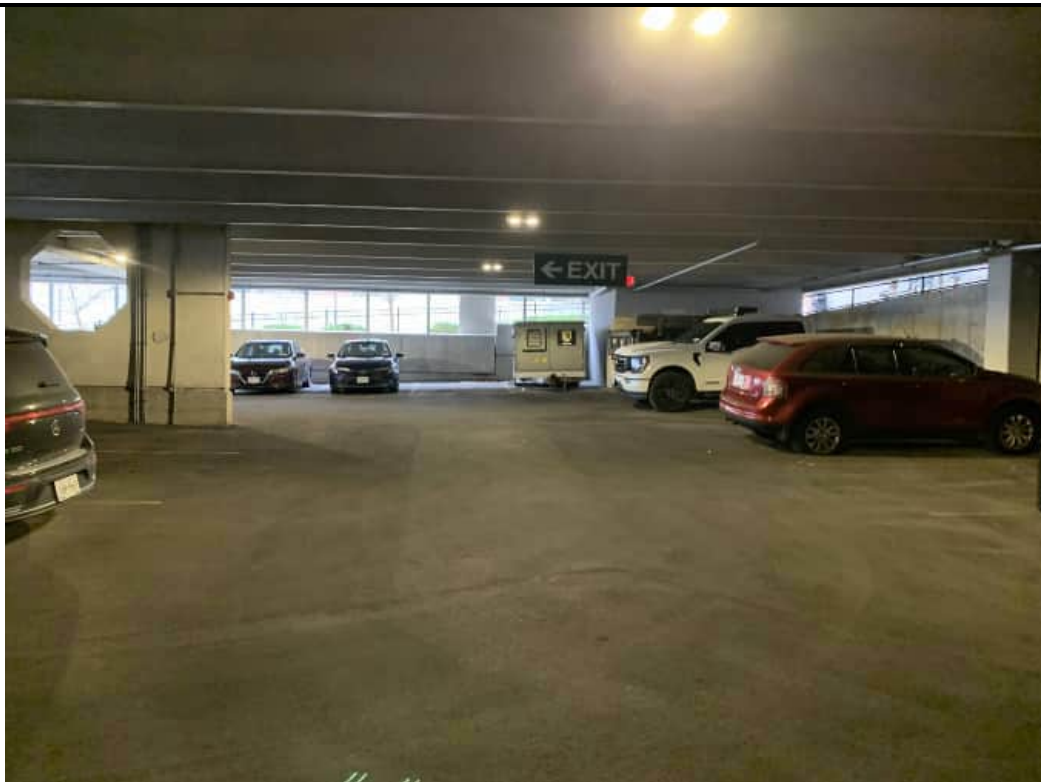
**Photograph 14.** Looking southwest toward Howard Street; paved surface cover within lowest level of parking garage (12/20/24).

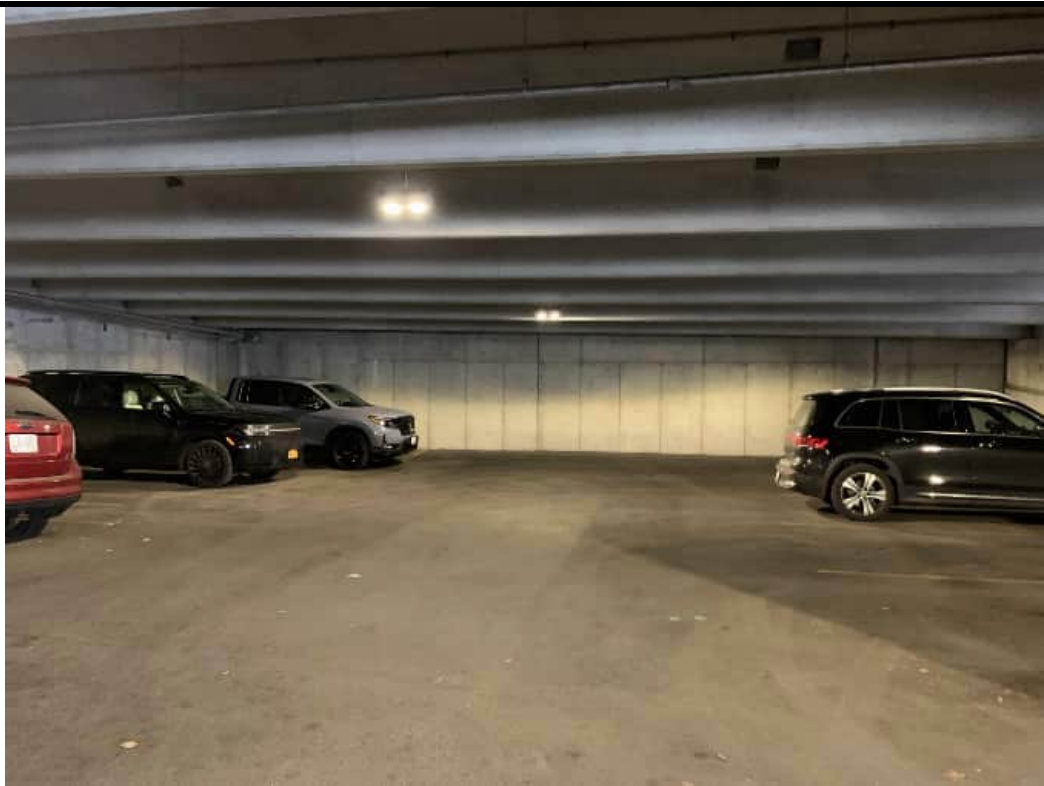
**Photograph 15.** Looking north; paved surface cover within lowest level of the parking garage (12/20/24).

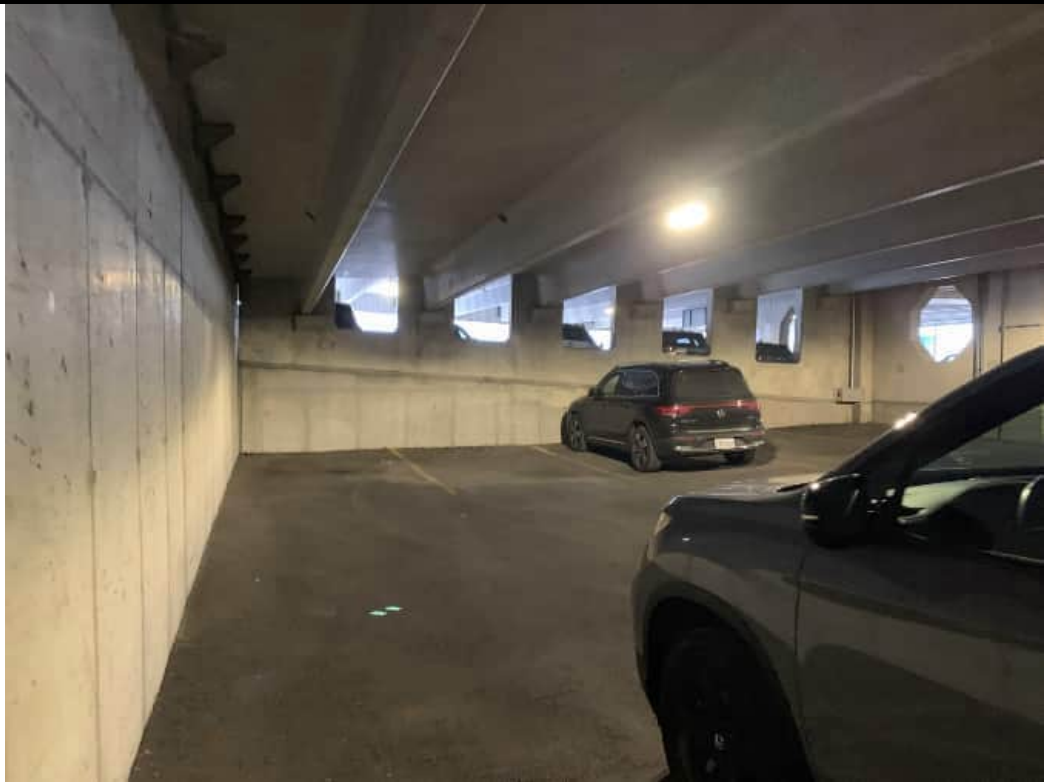
**Photograph 16.** Looking southeast; paved surface cover and storm drain within lowest level of parking garage (12/20/24).

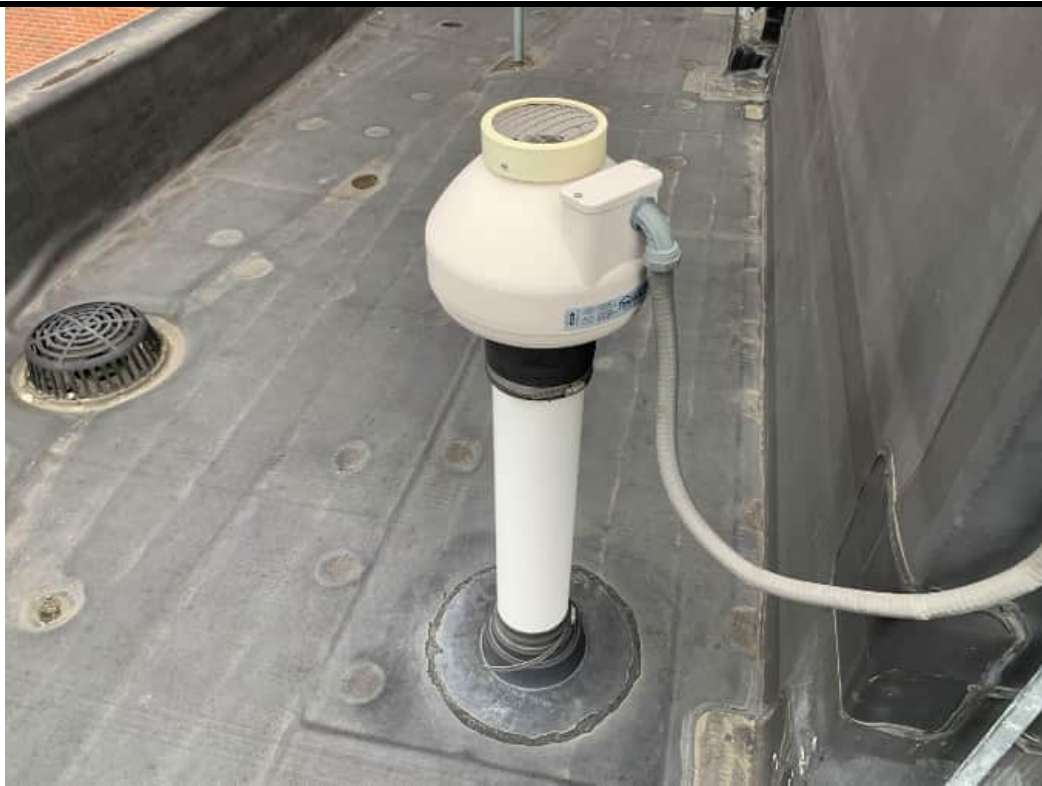
**Photograph 17.** Roof of 140 State Street building; exhaust stack, fan and switch for SSDS (12/20/24).

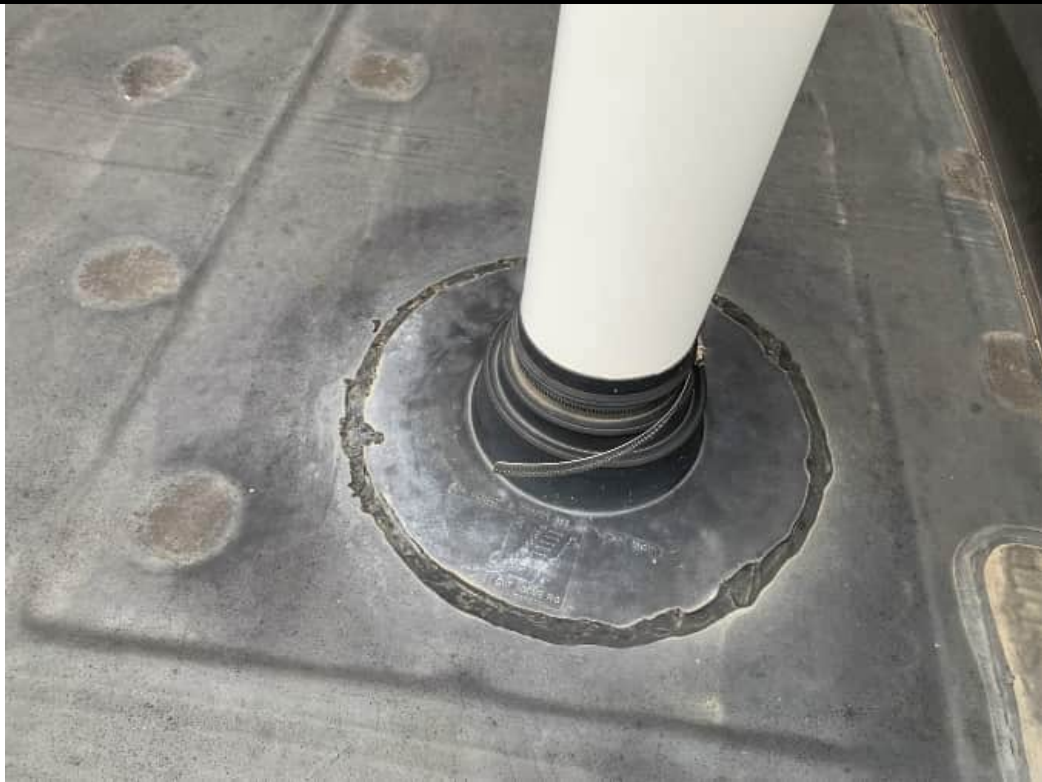
**Photograph 18.** Close-up view of roof penetration/seal for SSDS exhaust stack at 140 State Street (12/20/24).

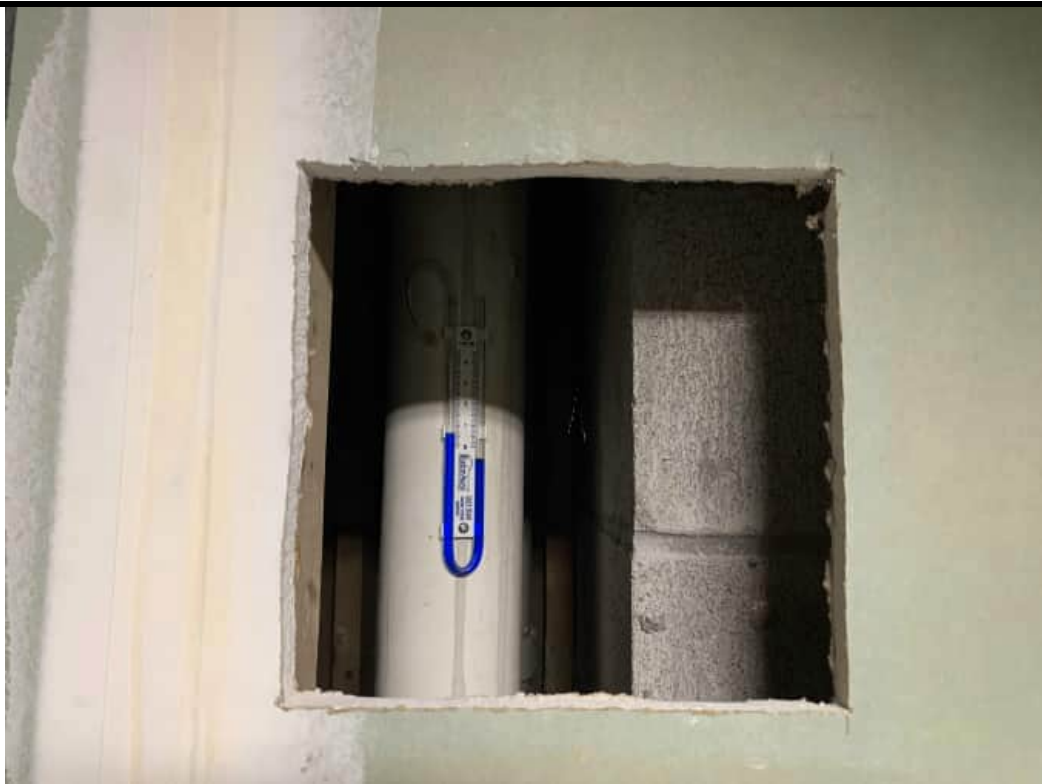
At the time of the December 20, 2024 inspection, the SSDS at the 140 State Street building was observed to be operating properly, as indicated by the manometer in the vertical riser pipe (accessed via a wall-mounted hatch in the basement) and then confirmed upon inspection of the fan and discharge piping on the roof of the building. No cracks or other evidence of damage to the visible piping or fan was observed.

**Photograph 19.** View of manometer and vertical riser pipe for SSDS at 140 State Street (access via basement level) (12/20/24).
