# 2025 PERIODIC REVIEW REPORT

**Former Albany Laboratories Site  
67 Howard Street/140 State Street  
City of Albany, New York**

**NYSDEC Site Number: 401061**

**April 14, 2026**

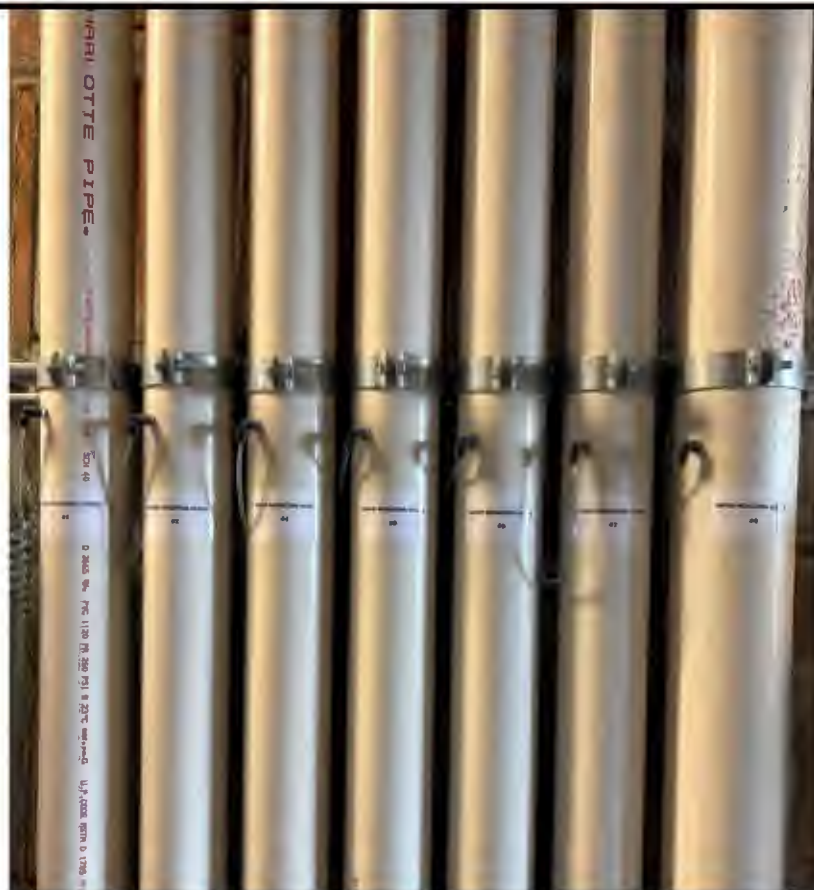
At the time of the inspection conducted by CHA on April 13, 2026, the SSDS at the 144 State Street building (Renaissance Hotel) was observed to be operating and functioning properly. Specifically, the Magnehelic manometer for each sub-system (#1 through #7) and the roof-mountain sub-system fan all appeared to be in good condition and operating correctly. Airflow was noted at the discharge points for each of these sub-systems. The manometer readings for the seven operating fans were consistent with the readings observed in September 2015 (soon after the system was activated) and during the subsequent Site inspection visits that have been completed since that time. Based on post-installation communication testing conducted by Aztech Technologies, Inc. during the fall of 2015, the April 2026 manometer readings are indicative of

**Photograph 1.** Riser piping for the seven individual subsystems comprising the sub-slab depressurization system at 144 State Street (4/13/2026).

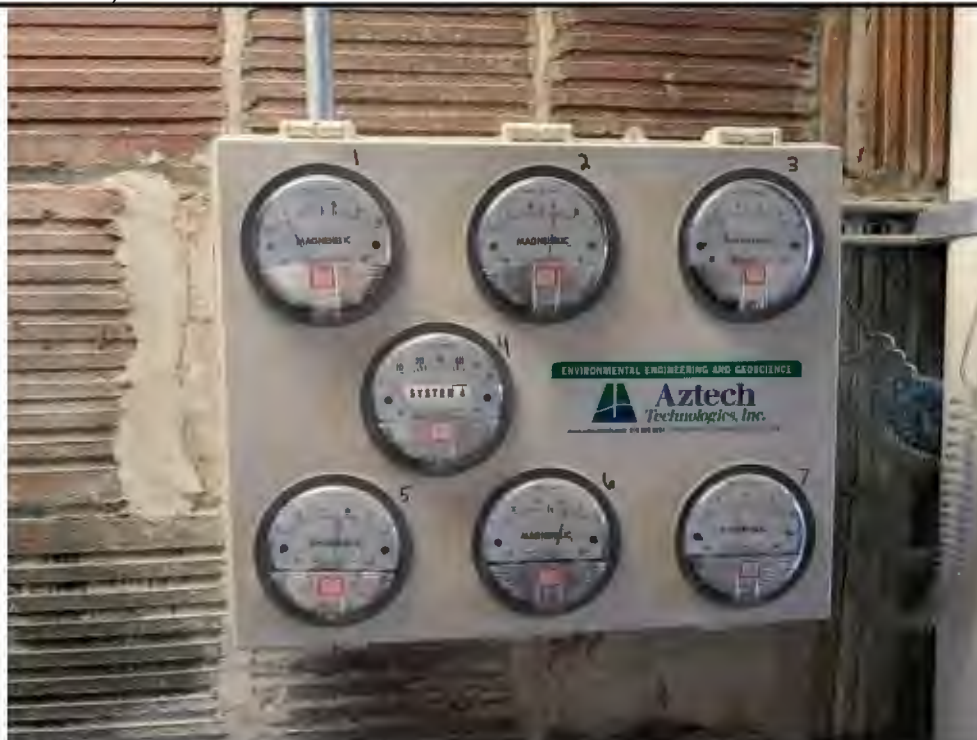
**Photograph 2.** Close-up view of manometer panel for individual subsystems and tubing associated with the magnehelic manometers (4/13/2026).

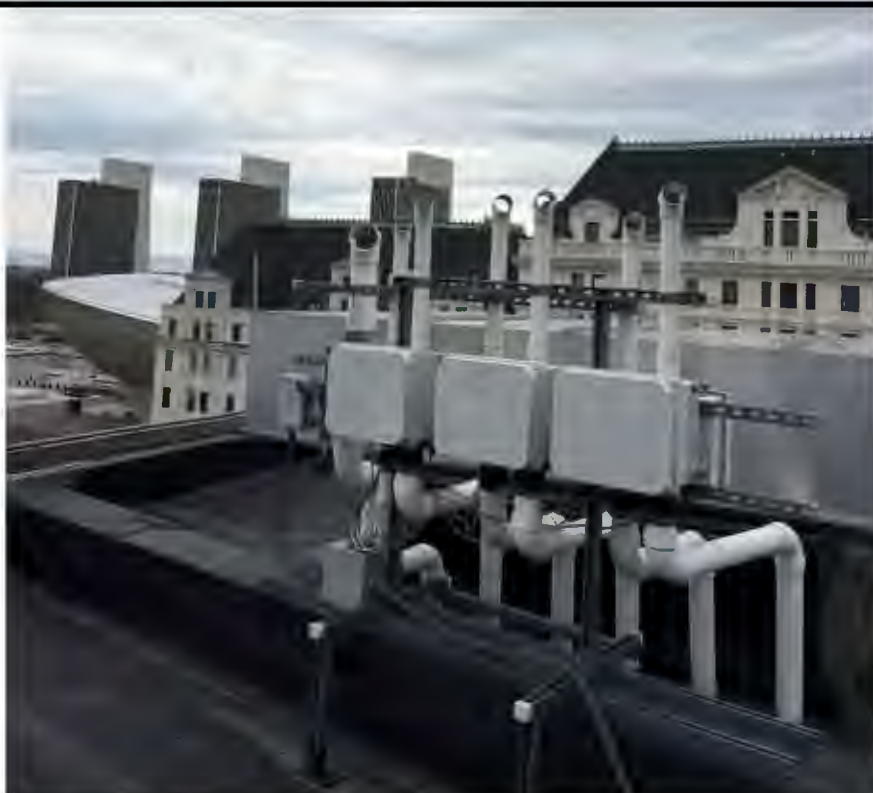
**Photograph 3.** Roof-mounted fan units for individual sub-systems at 144 State Street (4/13/2026).

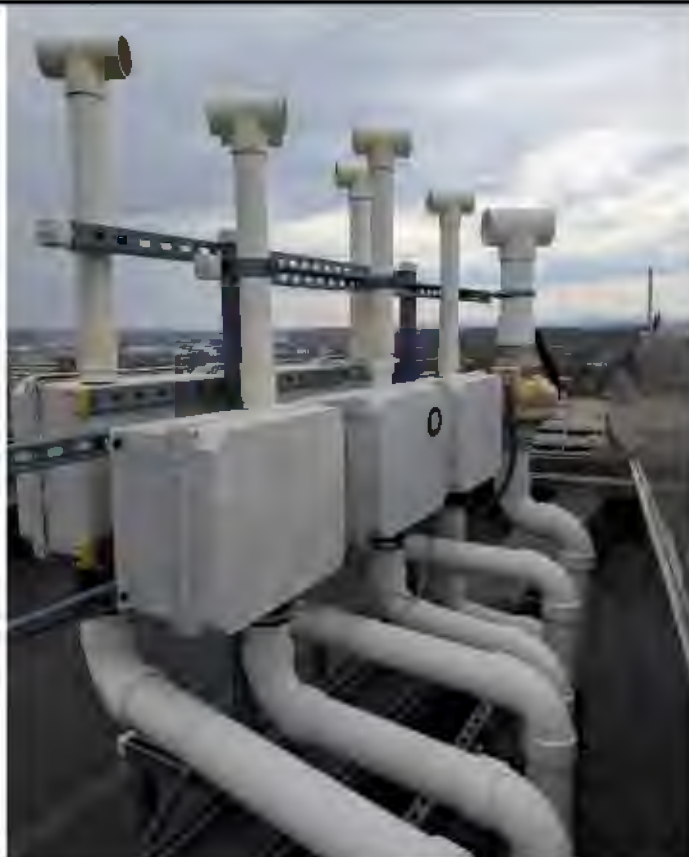
**Photograph 4.** Fan units for subsystems at 144 State Street (4/13/2026).

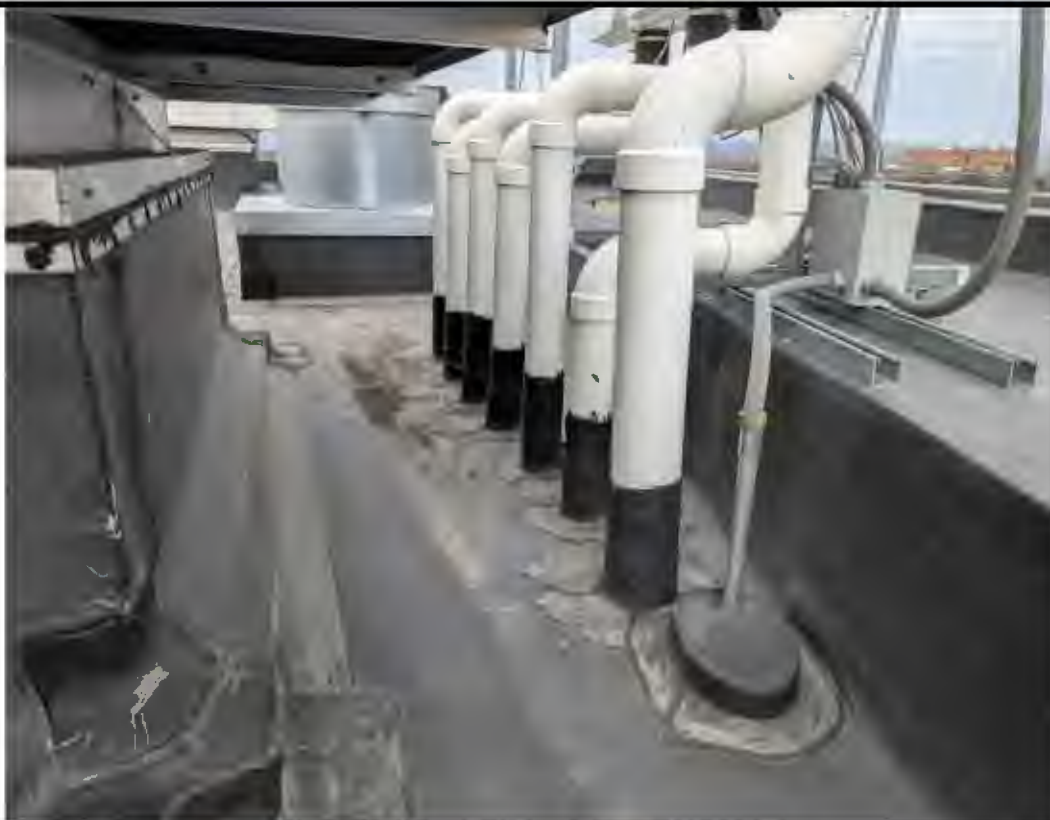
**Photograph 5.** Seals around riser pipes at roof penetrations (4/13/2026).

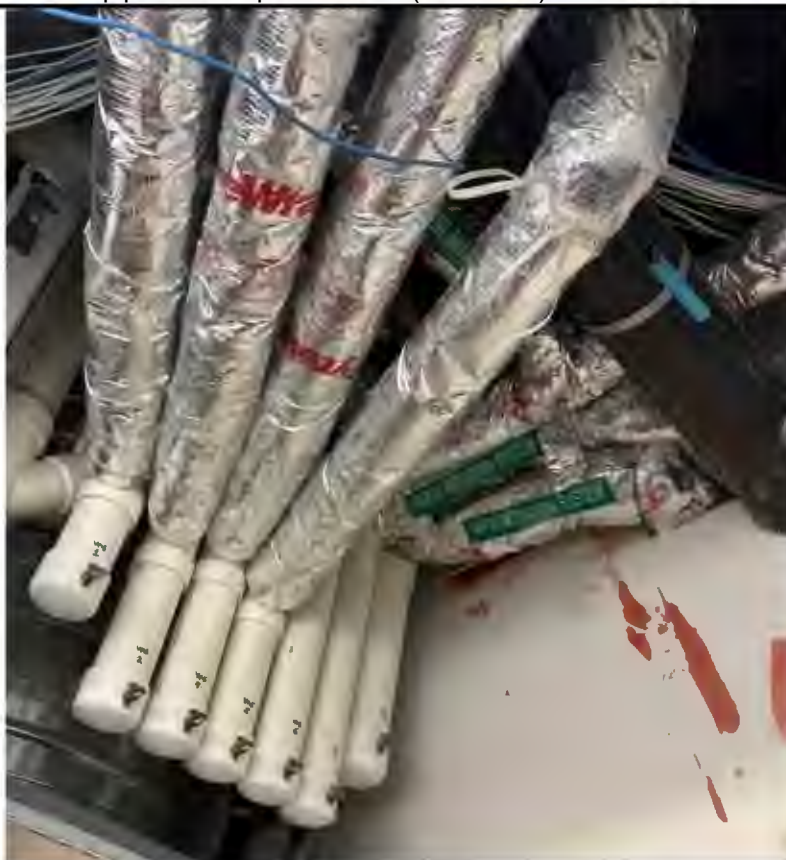
**Photograph 6.** Inside laundry chute room in basement of 144 State Street; horizontal piping for individual sub-systems connected to vertical riser pipes (4/13/2026).

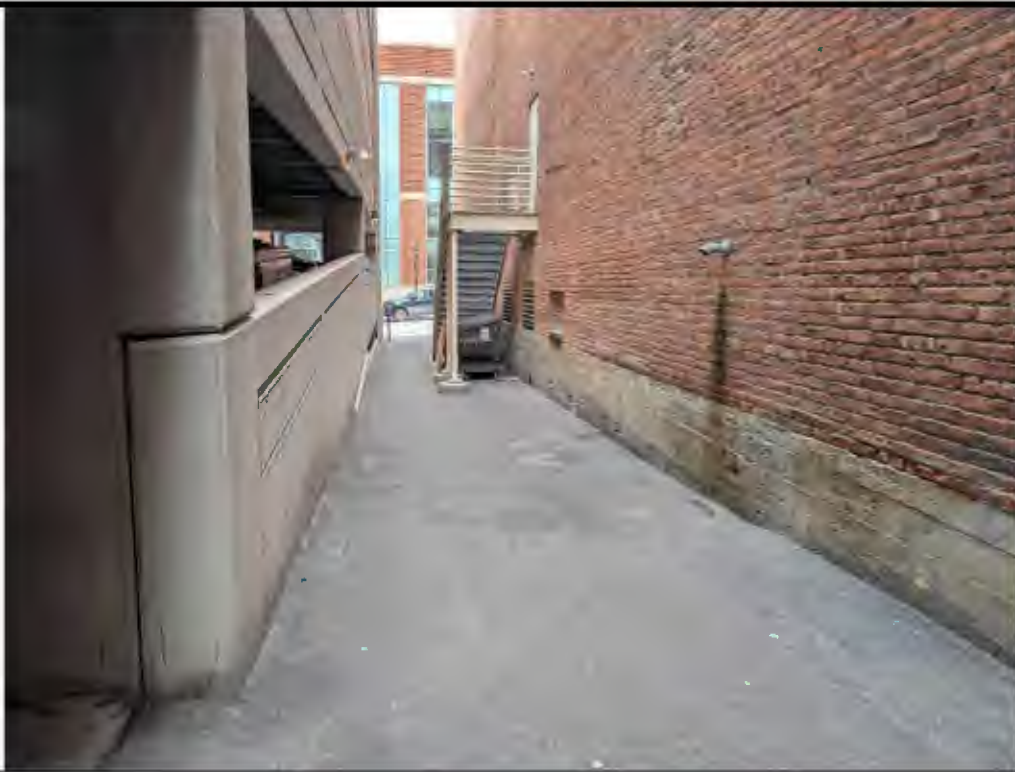
**Photograph 7.** Looking southwest; paved surface cover in alley between 144 State Street (to the right) and parking garage (to the left) (4/13/2026).

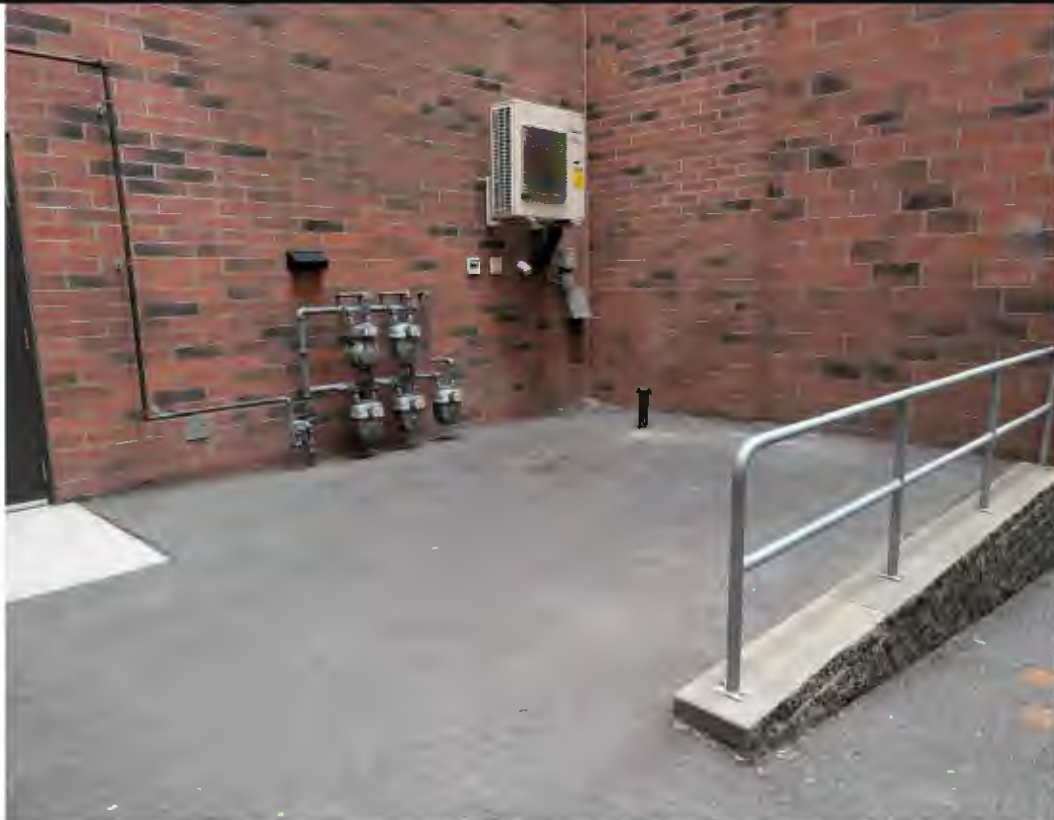
**Photograph 8.** Looking east; paved surface cover in area adjacent to rear side of 140 State Street building (4/13/26).

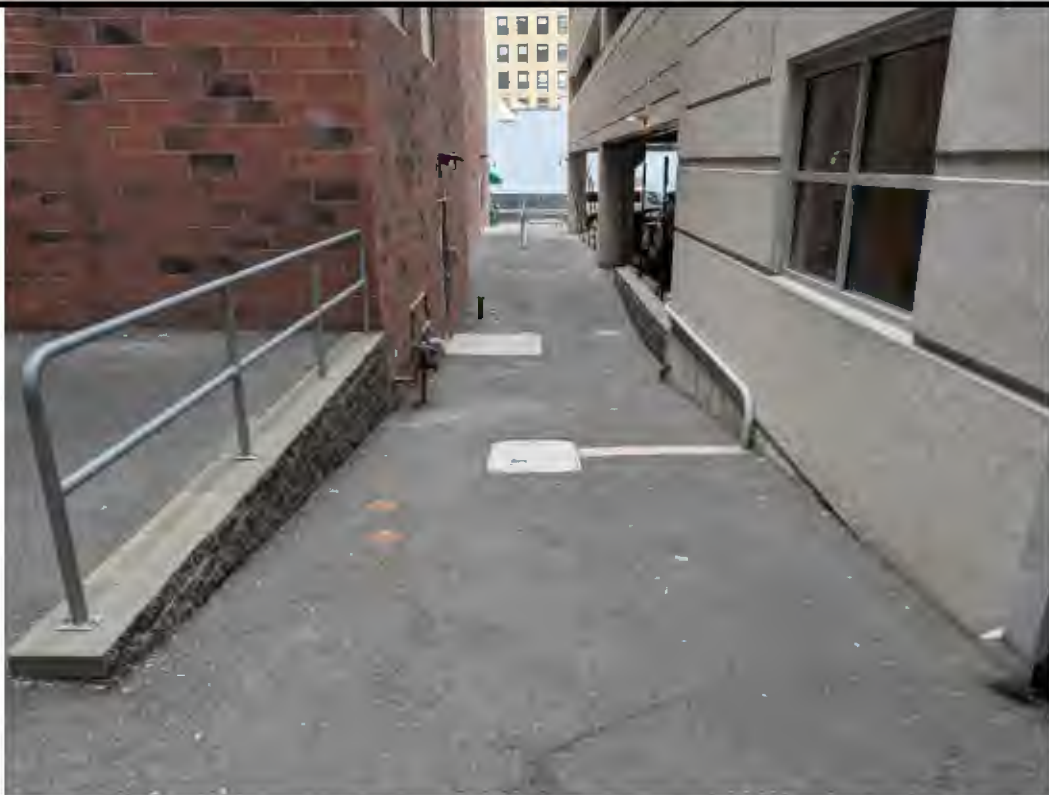
**Photograph 9.** Looking southeast; paved surface cover between 140 State Street (to the left) and the parking garage (to the right) (4/13/26).

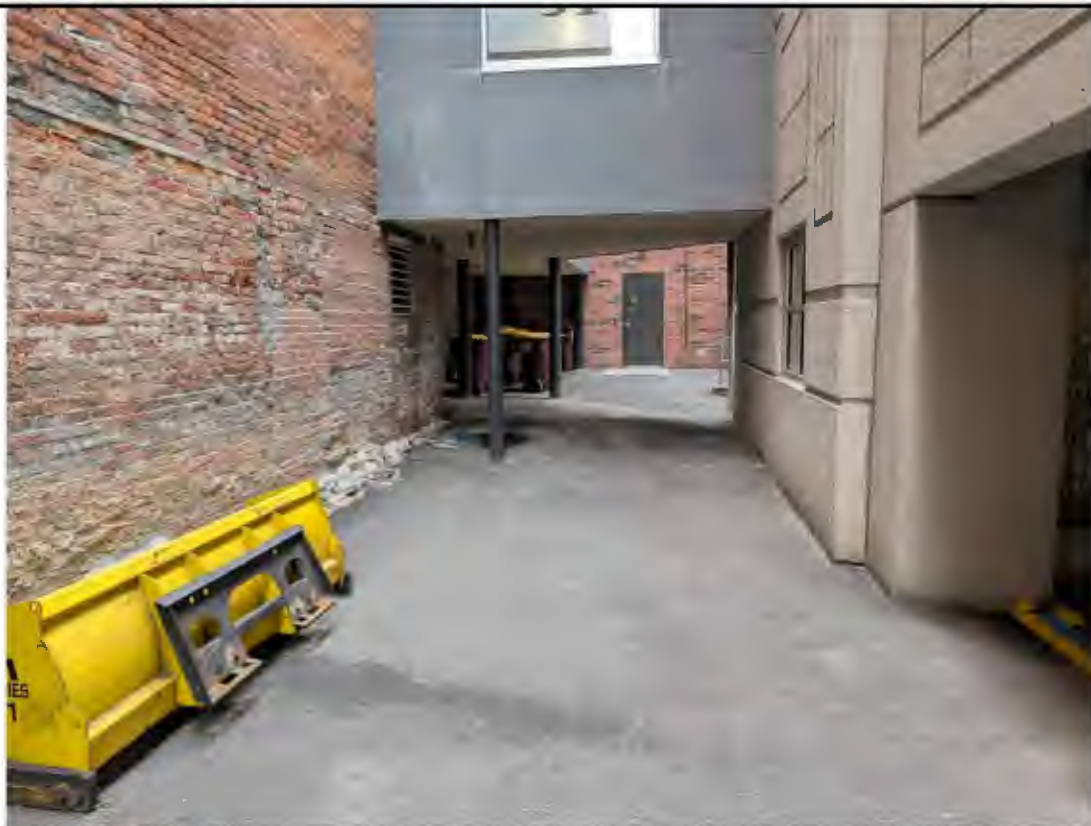
**Photograph 10.** Looking northeast from Howard Street; paved surface cover in alley between 144 State Street and the parking garage (4/13/26).

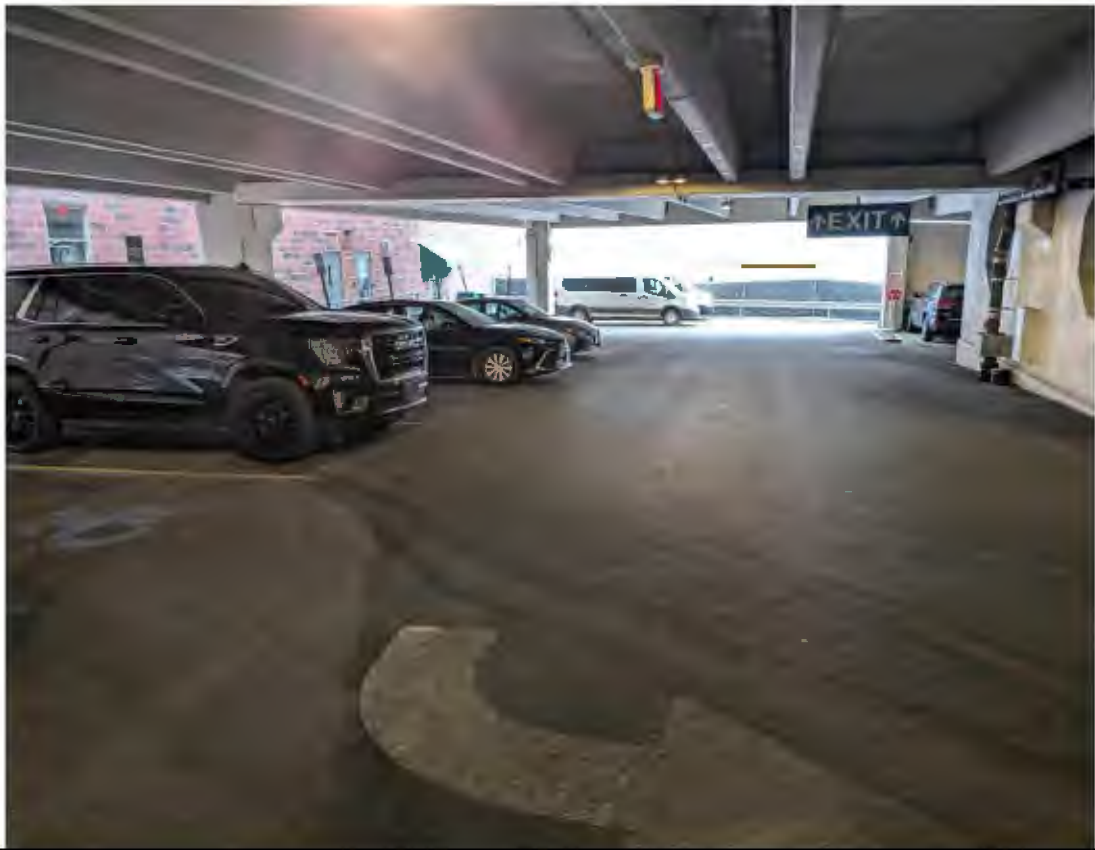
**Photograph 11.** Looking southeast toward Howard Street; paved surface cover within lowest level of parking garage (4/13/26).

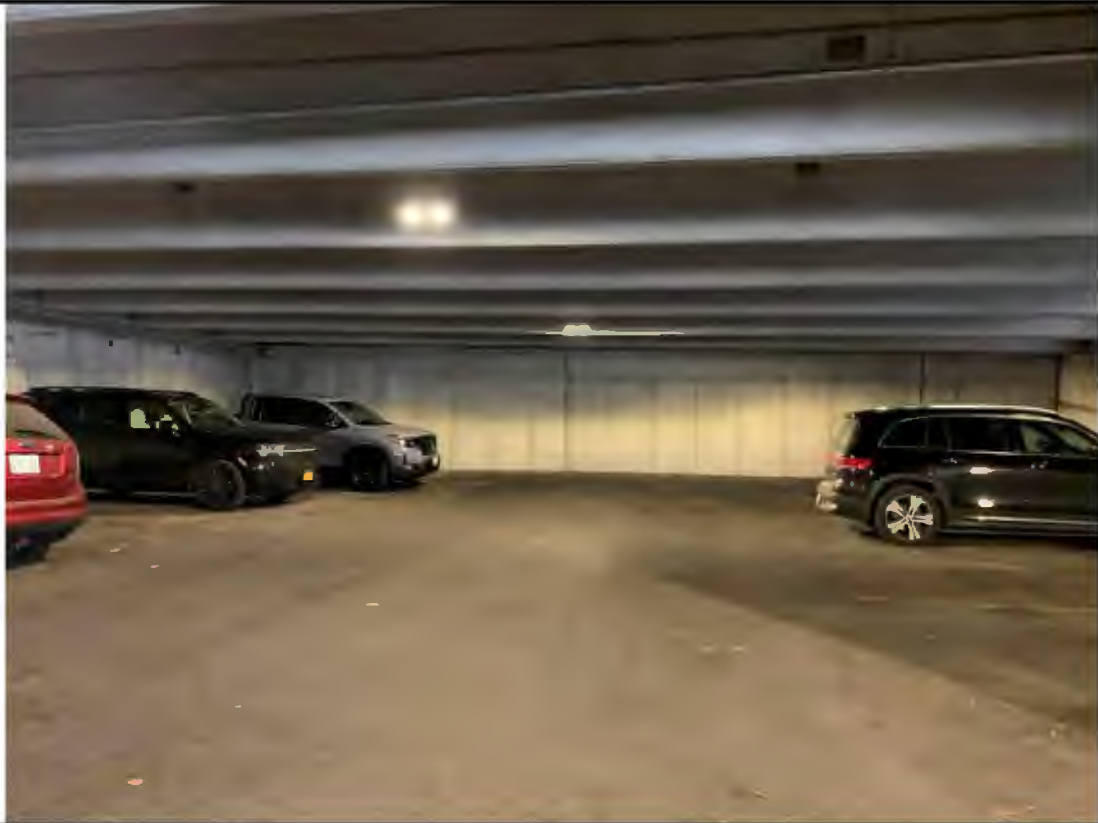
**Photograph 12.** Looking north; paved surface cover within lowest level of the parking garage (4/13/26).

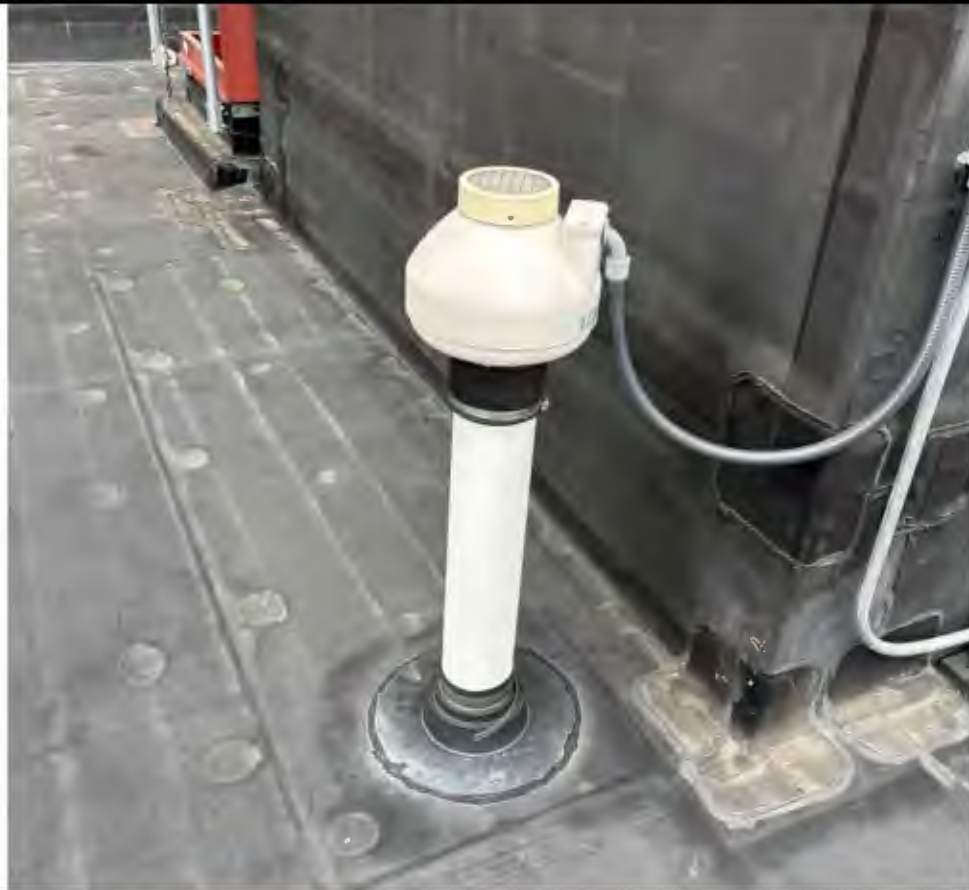
At the time of the April 13, 2026 inspection, the SSDS at the 140 State Street building was observed to be operating properly, as indicated by the manometer in the vertical riser pipe (accessed via a wall-mounted hatch in the basement) and then confirmed upon inspection of the fan and discharge piping on the roof of the building. No cracks or other evidence of damage to the visible piping or fan was observed.

**Photograph 13.** Roof of 140 State Street building; exhaust stack, fan and switch for SSDS (4/13/26).

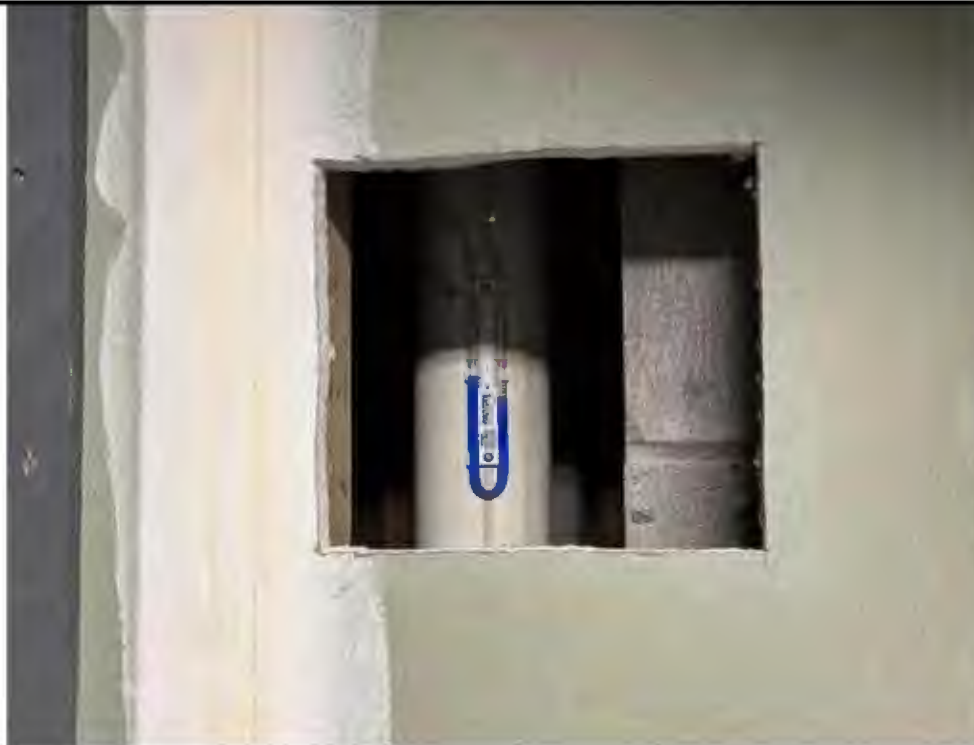
**Photograph 14.** View of manometer and vertical riser pipe for SSDS at 140 State Street (access via basement level) (4/13/26).
