**Construction Completion Report
Admiral Cleaners (401075)
Interim Remedial Measure No. 1 (IRM No.1)
Watervliet, New York**

January 2021
Version: FINAL
EA Project No. 16025.04

Christopher Schroer, Project Manager
EA Science and Technology

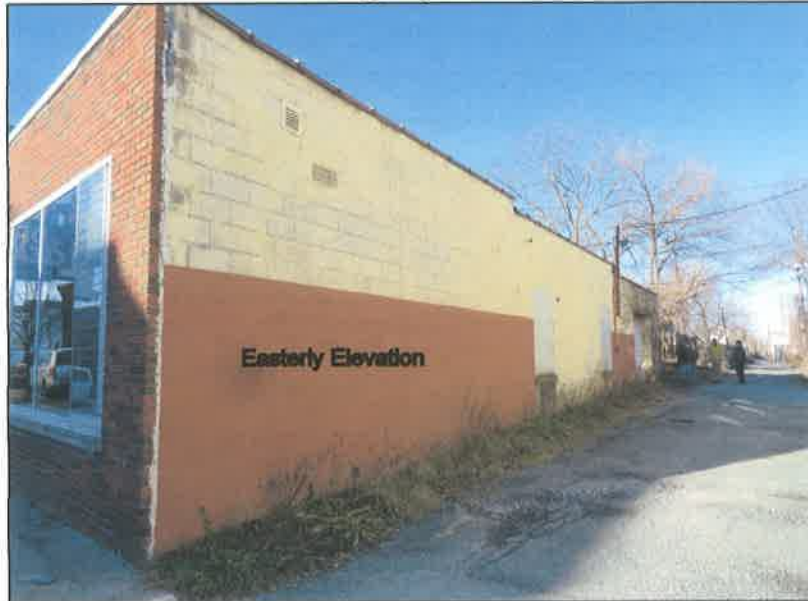
Photograph 2

Photographs 2 and 3 show the Easterly and Northerly elevation views respectively. There are numerous roof penetrations where water damage

is present. The roof underlayment and roof joists exhibit significant deterioration and rotting specifically along the Northeasterly and Northwesterly quadrants of the building. There is a transverse fracture crack that extends nearly the entire length of the Northeasterly wall section of the original building. This is more specifically shown in Photographs 3 and 4. This is the direct result of failing roof joists exerting eccentric loads on the rear CMU bearing wall and causing a rotational mode of failure in this upper wall section. This has produced a condition of instability in the upper rear bearing wall.

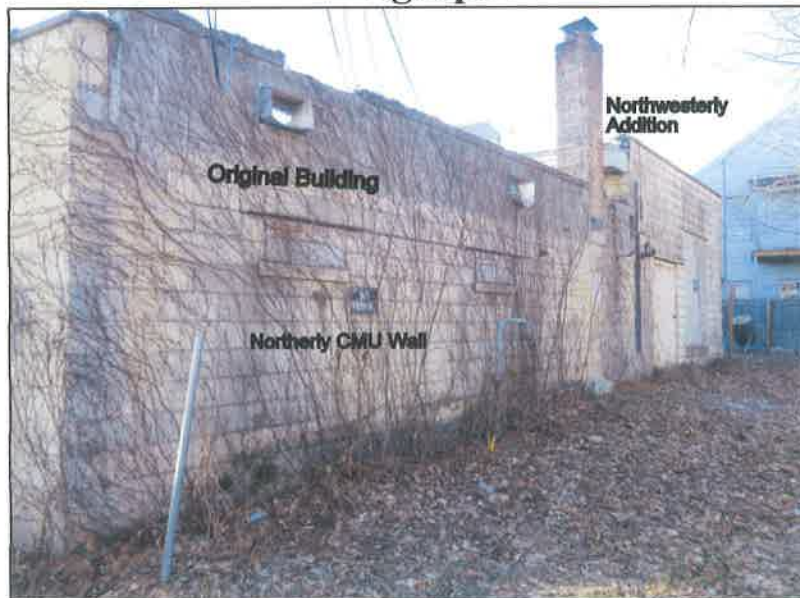
Photograph 3

It shall be noted that various portions of the building have been subjected to extensive water damage and deterioration for a number of years. Unbalanced snow loads result in a mal-distribution of loads which cause unstable eccentric loading to the roof system and main beam support systems in the skeletal framing of the roof. This creates significant structural deficiencies associated with this structure. A localized collapse of the upper portion of the Northeasterly bearing wall as depicted in Photographs 3 and 4 is considered imminent at this time.

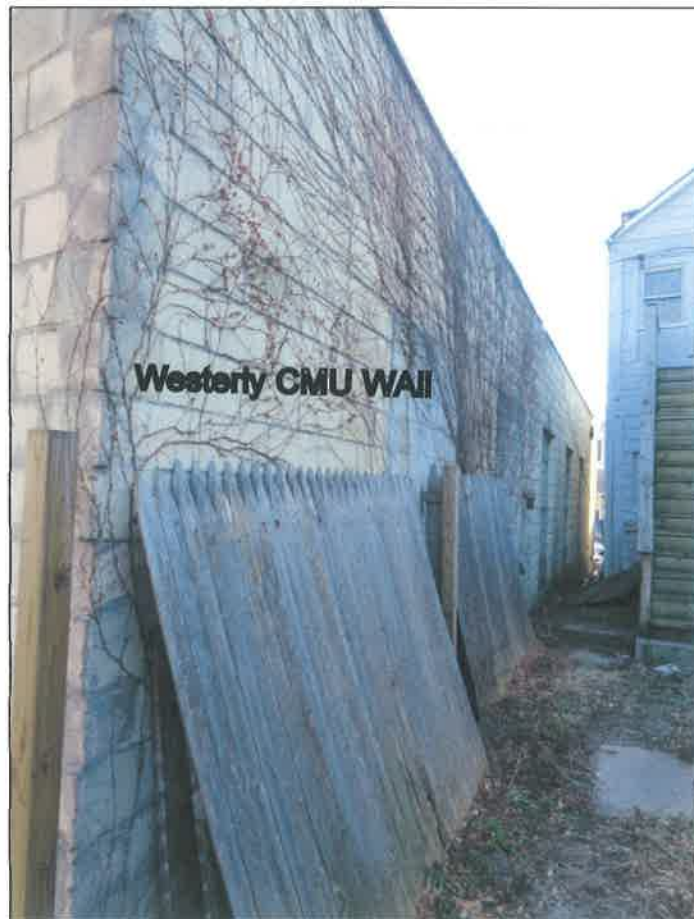
Photograph 5 shows the Westerly elevation view of the exterior concrete block bearing wall. The Westerly addition contains timber roof framing members that span in an East / West direction, 90 degrees to that of the original structure roof framing. There are substantial roof leaks in the addition. Water is saturating portions of the Northwesterly rear CMU block wall and Northwesterly side wall as shown in Photograph 7. Over

the years successive freeze / thaw cycles are deteriorating the masonry block wall assembly.

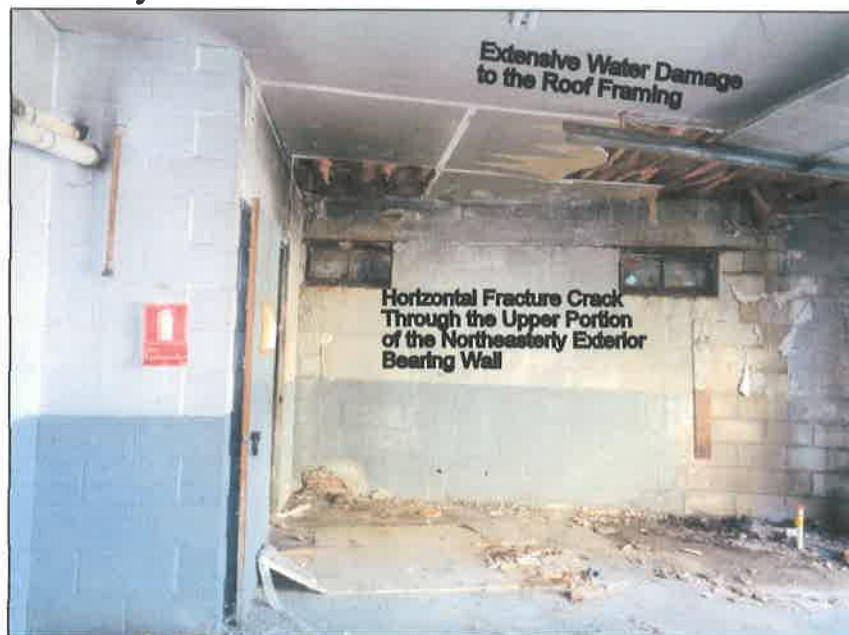
Photograph 6 shows a typical view of the Northeasterly rear bearing wall. The upper portion of this rear wall is in rotational failure as we indicate earlier in this report. There is extensive water damage and deterioration to the roof framing members.

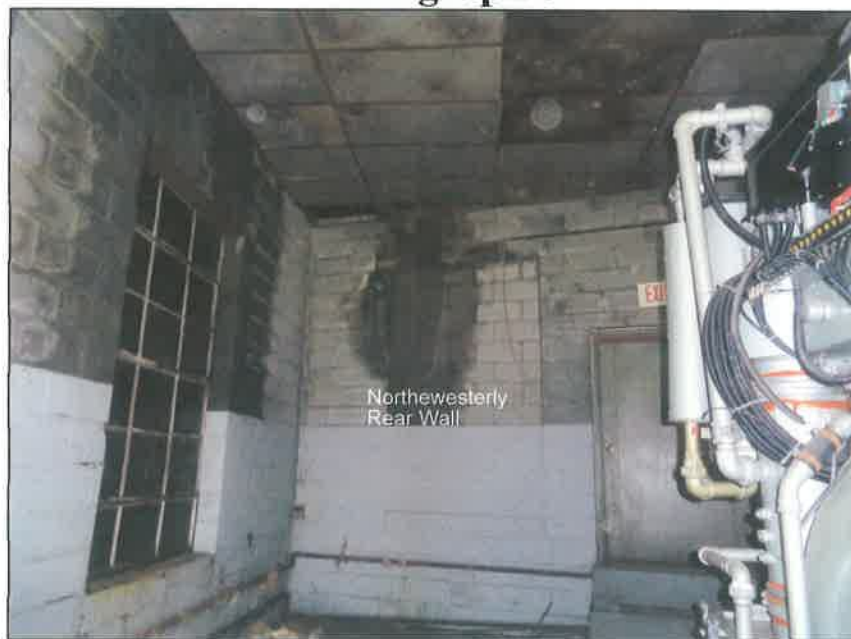
Photograph 7

The entire Northwesterly rear wall is separating from the adjacent bearing wall of the original building. There is no mechanical attachment of the rear Northwesterly CMU wall into the adjacent block bearing wall thus making a highly unstable condition. Daylight can be seen on the

interior portion of the building at this joint interface. The Northwestern rear wall is highly unstable.

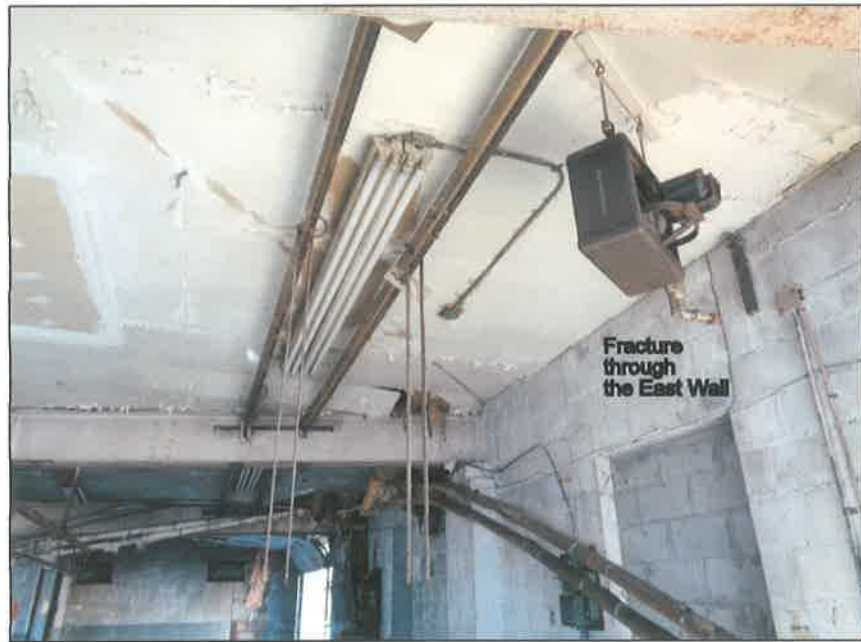
Photograph 9 was taken on the Easterly side of the original building. There is a vertical fracture crack through the East wall as can be seen in the photograph. This was due to improper reinforcing within this wall section and improper reinforcing of a lintel over a former opening which is also depicted in this photo. We are bringing this to your attention because the entire fracture lies over an unsupported edge of this former

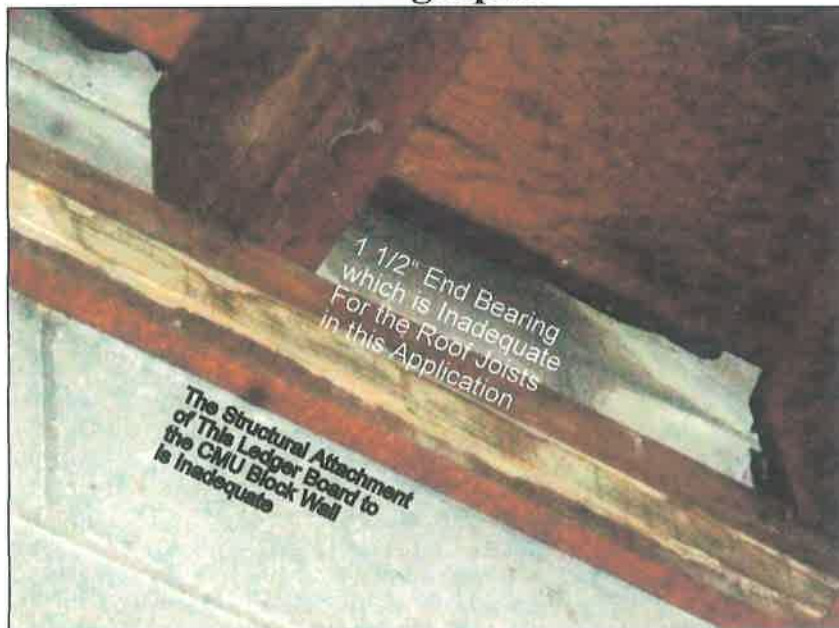
Photograph 10 shows a typical view of the roof framing members along the Westerly side of the building. Roof joists are not framed into and bearing on the exterior Westerly concrete block wall. The roof framing members bear on a 2" x 6" leger with 1 1/2" end bearing only as depicted in Photograph 10. This is inadequate and structurally deficient for this application. All legers used for structural applications of this type require an epoxy bolted threaded rod either 1/2" or 5/8" in diameter or if the masonry is reinforced with concrete placed in the interior cores, where expansive concrete bolt anchors can be used for this application. Instead, we find that powder actuated concrete nails were used in this instance which are not appropriate or sufficient to safely support the live and dead loads associated with this roof structure. With the impending snow, this will be problematic for a localized joist bearing failure which will be compounded by the deteriorated roof joist system.

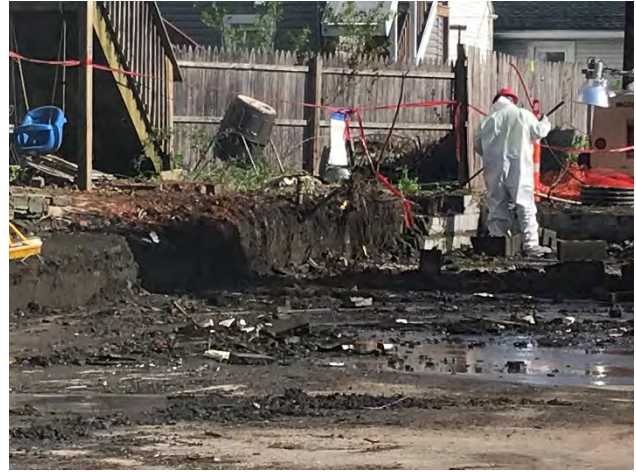
Exposed soil ledge on west end of foundation

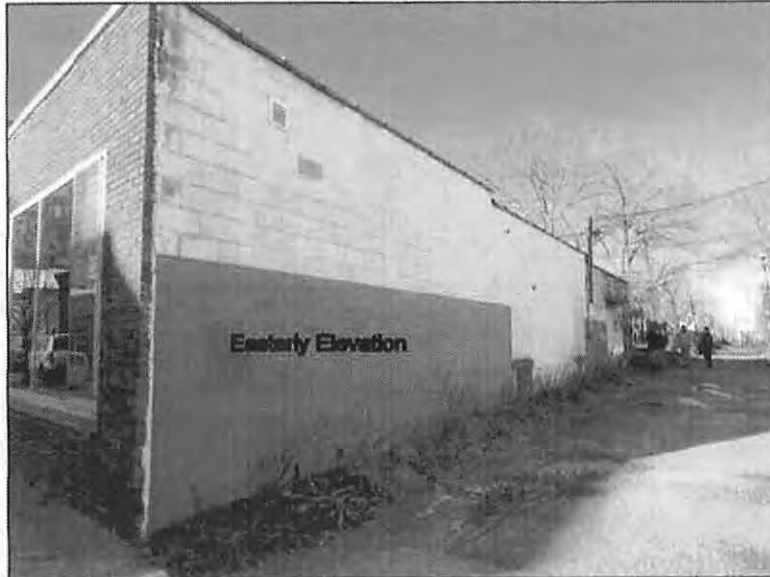
Photograph 2

Photographs 2 and 3 show the Easterly and Northerly elevation views respectively. There are numerous roof penetrations where water damage

is present. The roof underlayment and roof joists exhibit significant deterioration and rotting specifically along the Northeasterly and Northwesterly quadrants of the building. There is a transverse fracture crack that extends nearly the entire length of the Northeasterly wall section of the original building. This is more specifically shown in Photographs 3 and 4. This is the direct result of failing roof joists exerting eccentric loads on the rear CMU bearing wall and causing a rotational mode of failure in this upper wall section. This has produced a condition of instability in the upper rear bearing wall.

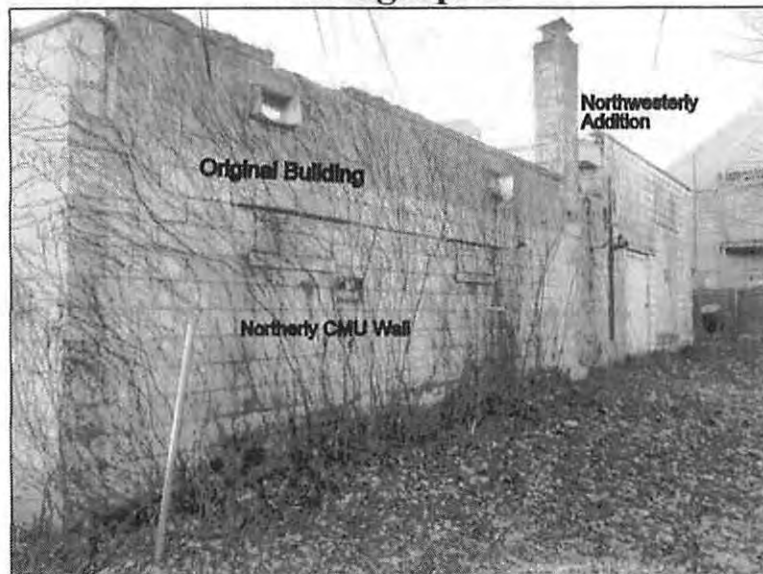
Photograph 3

It shall be noted that various portions of the building have been subjected to extensive water damage and deterioration for a number of years. Unbalanced snow loads result in a mal-distribution of loads which cause unstable eccentric loading to the roof system and main beam support systems in the skeletal framing of the roof. This creates significant structural deficiencies associated with this structure. A localized collapse of the upper portion of the Northeasterly bearing wall as depicted in Photographs 3 and 4 is considered imminent at this time.

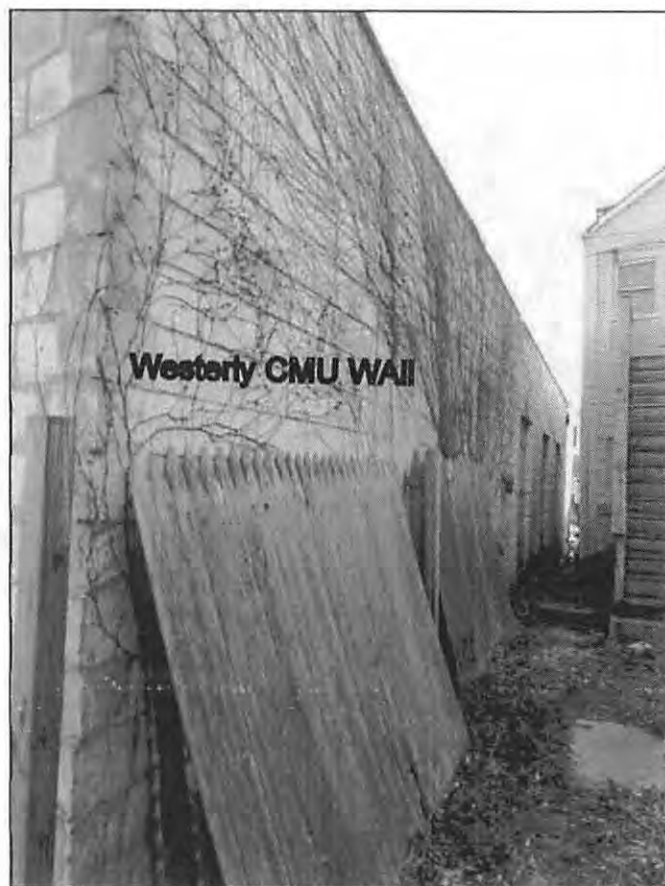
Photograph 5 shows the Westerly elevation view of the exterior concrete block bearing wall. The Westerly addition contains timber roof framing members that span in an East / West direction, 90 degrees to that of the original structure roof framing. There are substantial roof leaks in the addition. Water is saturating portions of the Northwesternly rear CMU block wall and Northwesternly side wall as shown in Photograph 7. Over

the years successive freeze / thaw cycles are deteriorating the masonry block wall assembly.

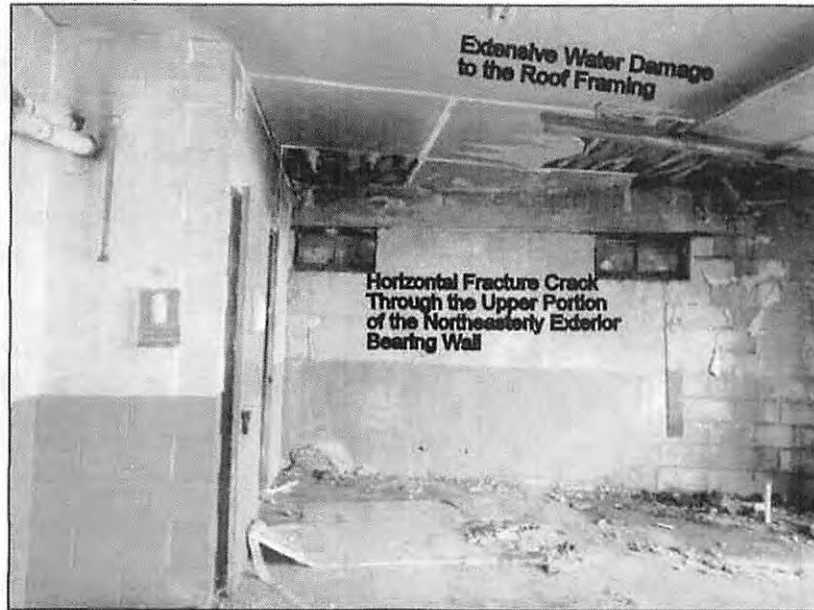
Photograph 6 shows a typical view of the Northeasterly rear bearing wall. The upper portion of this rear wall is in rotational failure as we indicate earlier in this report. There is extensive water damage and deterioration to the roof framing members.

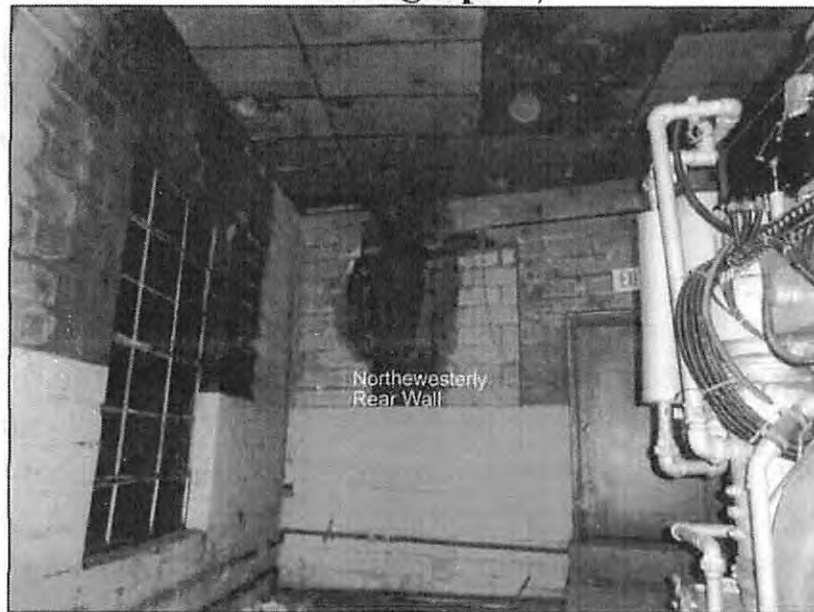
Photograph 7

The entire Northwesterly rear wall is separating from the adjacent bearing wall of the original building. There is no mechanical attachment of the rear Northwesterly CMU wall into the adjacent block bearing wall thus making a highly unstable condition. Daylight can be seen on the

interior portion of the building at this joint interface. The Northwestern rear wall is highly unstable.

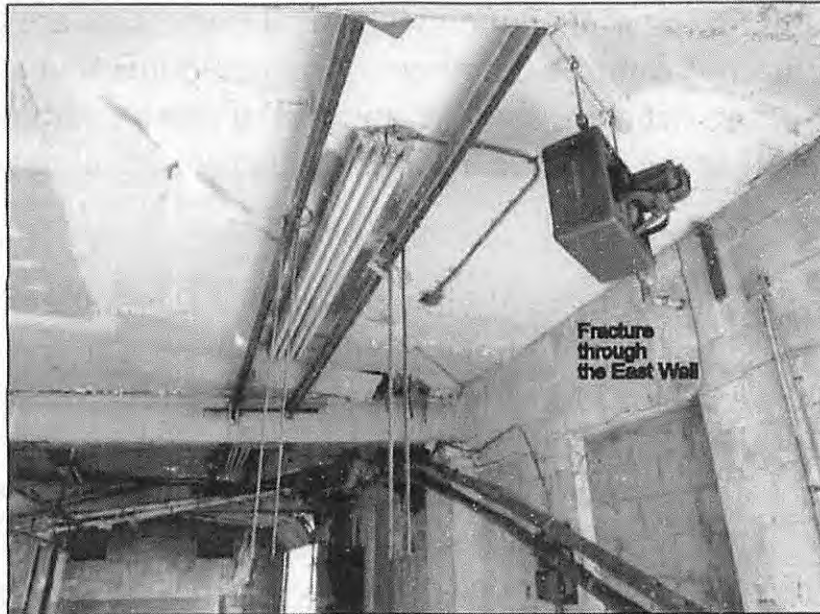
Photograph 9 was taken on the Easterly side of the original building. There is a vertical fracture crack through the East wall as can be seen in the photograph. This was due to improper reinforcing within this wall section and improper reinforcing of a lintel over a former opening which is also depicted in this photo. We are bringing this to your attention because the entire fracture lies over an unsupported edge of this former

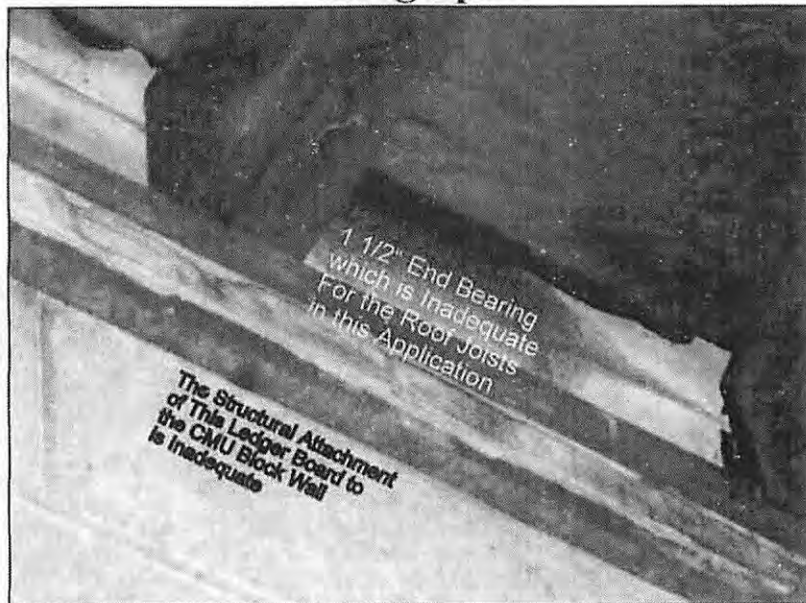
Photograph 10 shows a typical view of the roof framing members along the Westerly side of the building. Roof joists are not framed into and bearing on the exterior Westerly concrete block wall. The roof framing members bear on a 2" x 6" leger with 1 1/2" end bearing only as depicted in Photograph 10. This is inadequate and structurally deficient for this application. All legers used for structural applications of this type require an epoxy bolted threaded rod either 1/2" or 5/8" in diameter or if the masonry is reinforced with concrete placed in the interior cores, where expansive concrete bolt anchors can be used for this application. Instead, we find that powder actuated concrete nails were used in this instance which are not appropriate or sufficient to safely support the live and dead loads associated with this roof structure. With the impending snow, this will be problematic for a localized joist bearing failure which will be compounded by the deteriorated roof joist system.
