**Interim Remedial Measure No. 1
Scope of Work - Building Demolition
Former Admiral Cleaners Site (No. 401075)**

**City of Watervliet
Albany County, New York**

April 2019
Version: FINAL
EA Project No. 14907.38

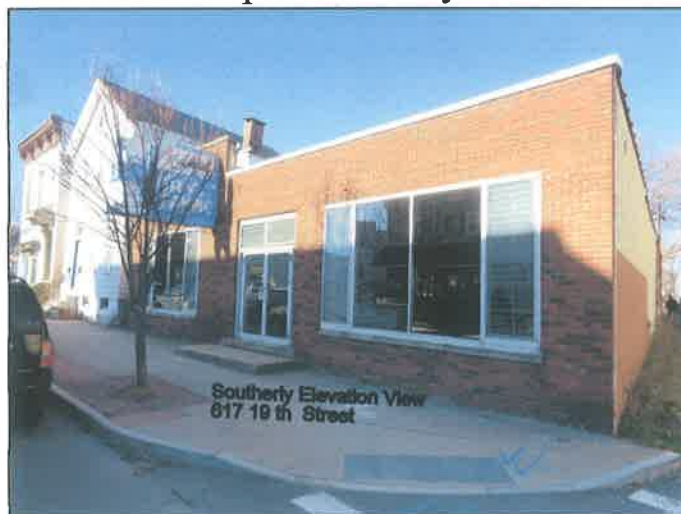
Photograph 1 shows the front Southerly elevation view of the building as seen from 19th Street. The building consists of the original structure which includes the entrance door and large window section as seen in Photograph 1. A later addition was constructed on the West side of the original building so as to provide for additional clear span open space. The addition can be seen in Photograph 1 to the left of the sign.

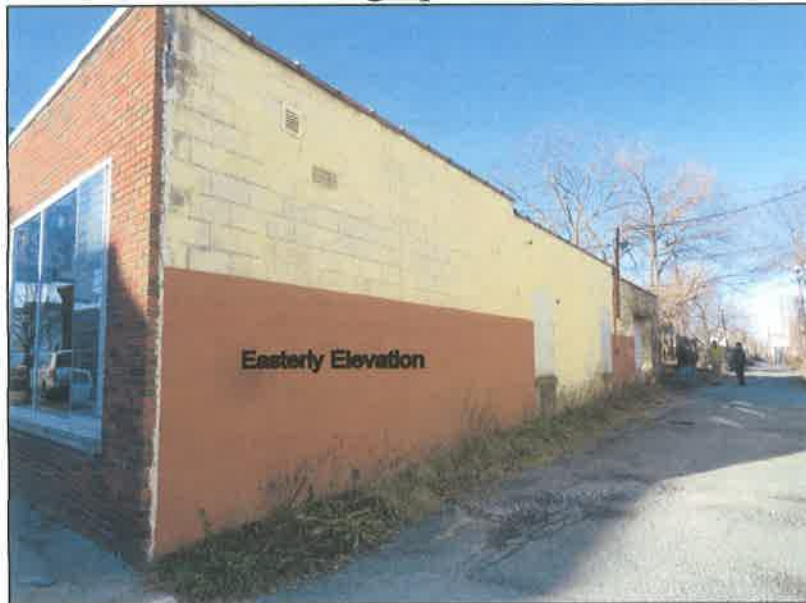
Photograph 2

Photographs 2 and 3 show the Easterly and Northerly elevation views respectively. There are numerous roof penetrations where water damage

is present. The roof underlayment and roof joists exhibit significant deterioration and rotting specifically along the Northeasterly and Northwesterly quadrants of the building. There is a transverse fracture crack that extends nearly the entire length of the Northeasterly wall section of the original building. This is more specifically shown in Photographs 3 and 4. This is the direct result of failing roof joists exerting eccentric loads on the rear CMU bearing wall and causing a rotational mode of failure in this upper wall section. This has produced a condition of instability in the upper rear bearing wall.

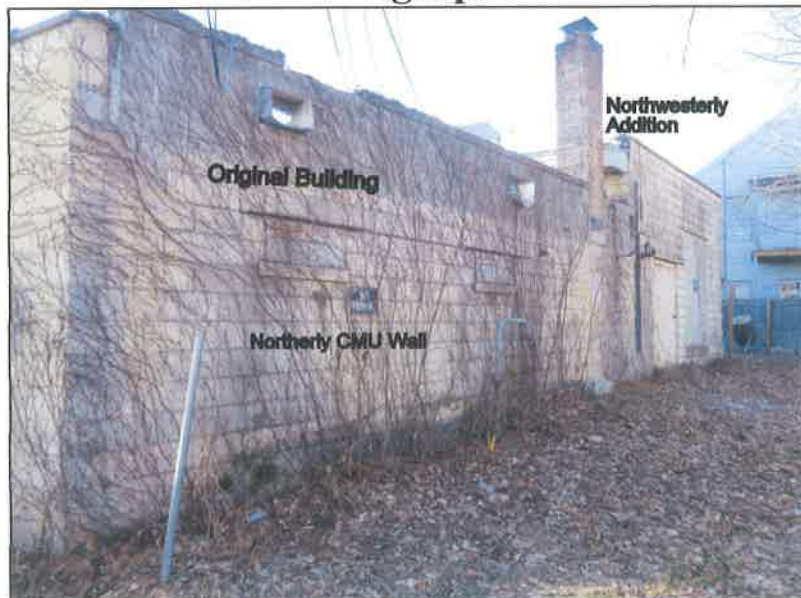
Photograph 3

It shall be noted that various portions of the building have been subjected to extensive water damage and deterioration for a number of years. Unbalanced snow loads result in a mal-distribution of loads which cause unstable eccentric loading to the roof system and main beam support systems in the skeletal framing of the roof. This creates significant structural deficiencies associated with this structure. A localized collapse of the upper portion of the Northeasterly bearing wall as depicted in Photographs 3 and 4 is considered imminent at this time.

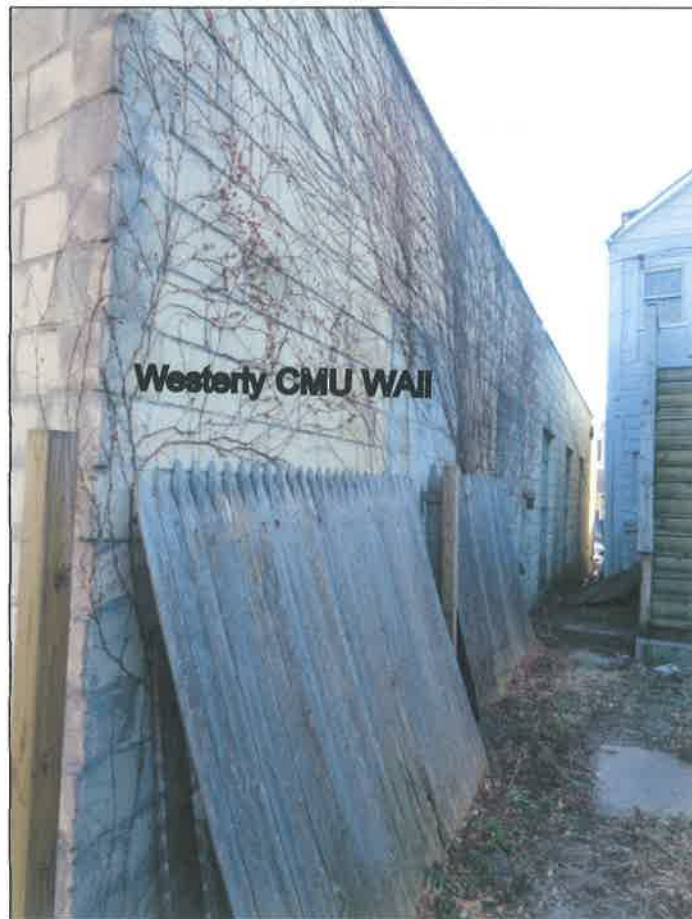
Photograph 5 shows the Westerly elevation view of the exterior concrete block bearing wall. The Westerly addition contains timber roof framing members that span in an East / West direction, 90 degrees to that of the original structure roof framing. There are substantial roof leaks in the addition. Water is saturating portions of the Northwesterly rear CMU block wall and Northwesterly side wall as shown in Photograph 7. Over

the years successive freeze / thaw cycles are deteriorating the masonry block wall assembly.

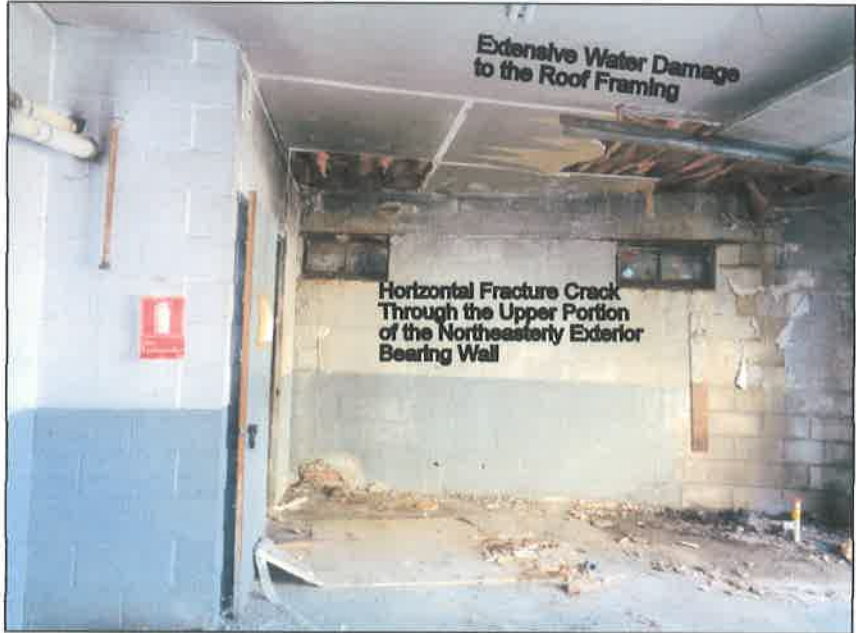
Photograph 6 shows a typical view of the Northeasterly rear bearing wall. The upper portion of this rear wall is in rotational failure as we indicate earlier in this report. There is extensive water damage and deterioration to the roof framing members.

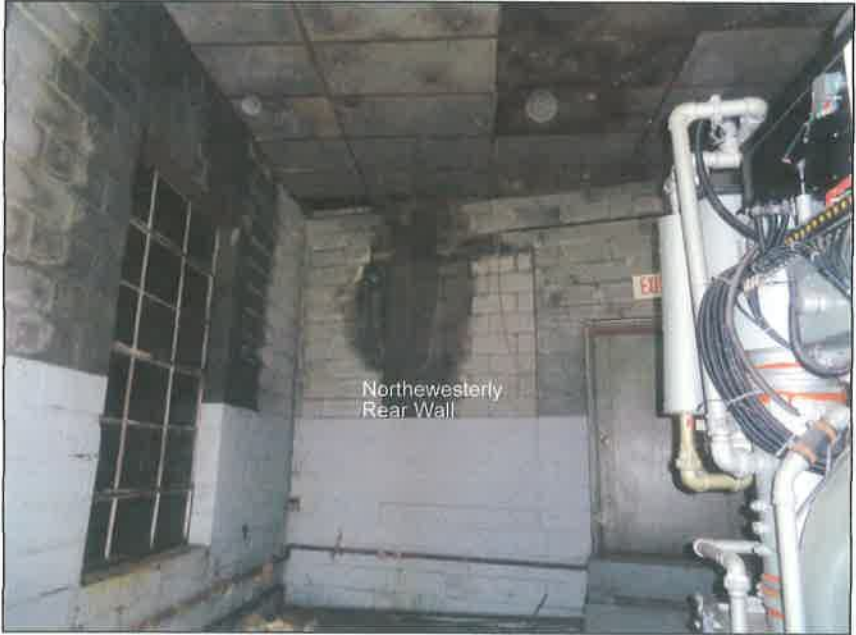
Photograph 7

The entire Northwesterly rear wall is separating from the adjacent bearing wall of the original building. There is no mechanical attachment of the rear Northwesterly CMU wall into the adjacent block bearing wall thus making a highly unstable condition. Daylight can be seen on the

interior portion of the building at this joint interface. The Northwestern rear wall is highly unstable.

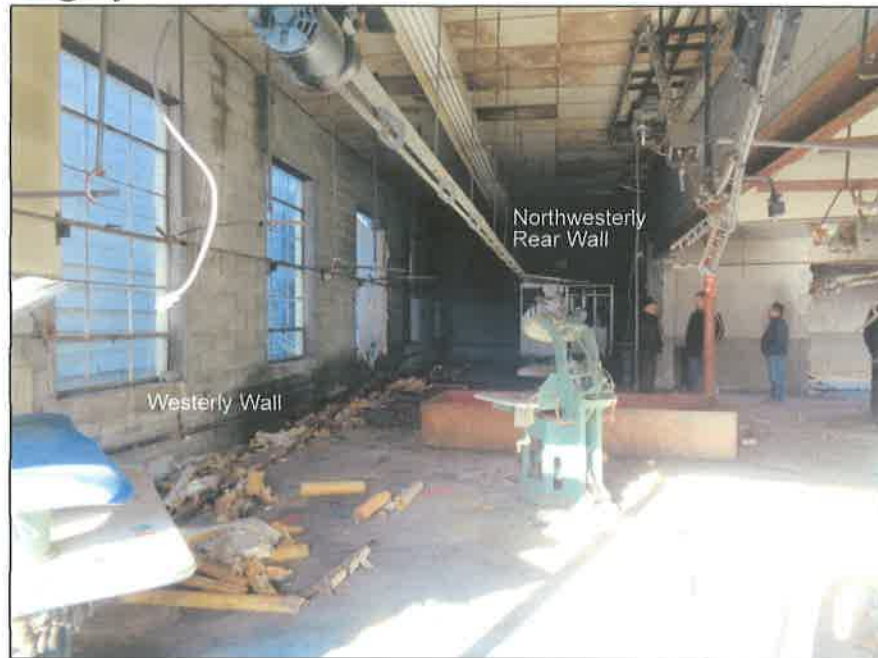
It shall be noted that there are lag screws connecting heavy mechanical equipment and assorted piping into water saturated and deteriorated roof joist members. Because of the deteriorated nature of the roof framing, some of the mechanical attachments are failing in a pull-out mode of failure thus creating an overhead hazard for falling mechanical framing and devices. Please refer to Photograph 8 for a typical view of the condition of some of the piping and mechanical tracks and devices that we found in these areas. It shall be further noted that any manipulation on the ceiling area could result in failure in the lag screw assembly of the supporting steel tracks, mechanical devices and clevis hangers that are screwed into the roof framing. Overall we find that there is a substantial hazard within the interior of the building for the failure of overhead devices that are secured into the deteriorated roof structure.

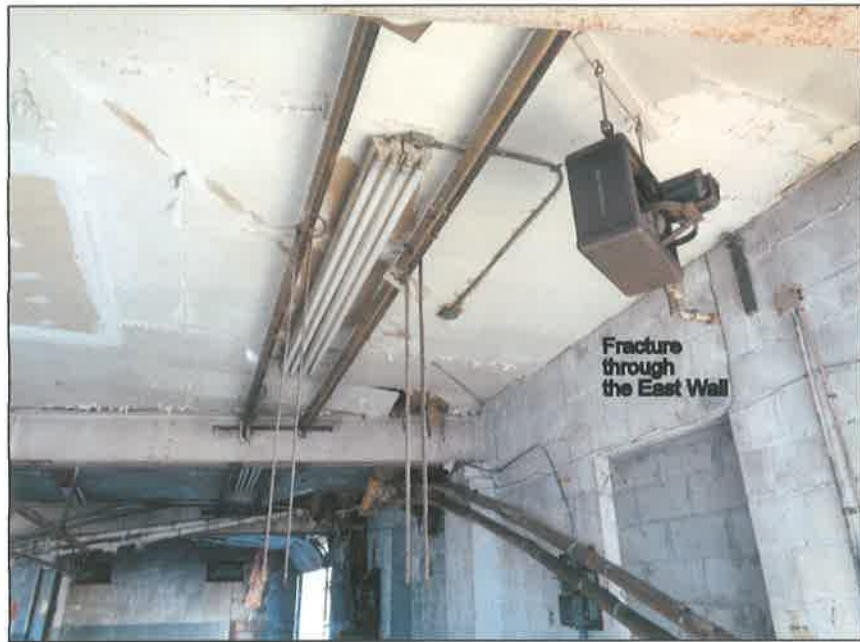
Photograph 9 was taken on the Easterly side of the original building. There is a vertical fracture crack through the East wall as can be seen in the photograph. This was due to improper reinforcing within this wall section and improper reinforcing of a lintel over a former opening which is also depicted in this photo. We are bringing this to your attention because the entire fracture lies over an unsupported edge of this former

window or door opening. Also shown in the photograph are improperly supported and failing piping and mechanical tracks that are pulling away from wall and roof framing members. Any personnel that are accessing the interior of the structure shall be mindful of these equipment fall hazards as well as the collapse hazards of the roof framing and rear wall assemblies.

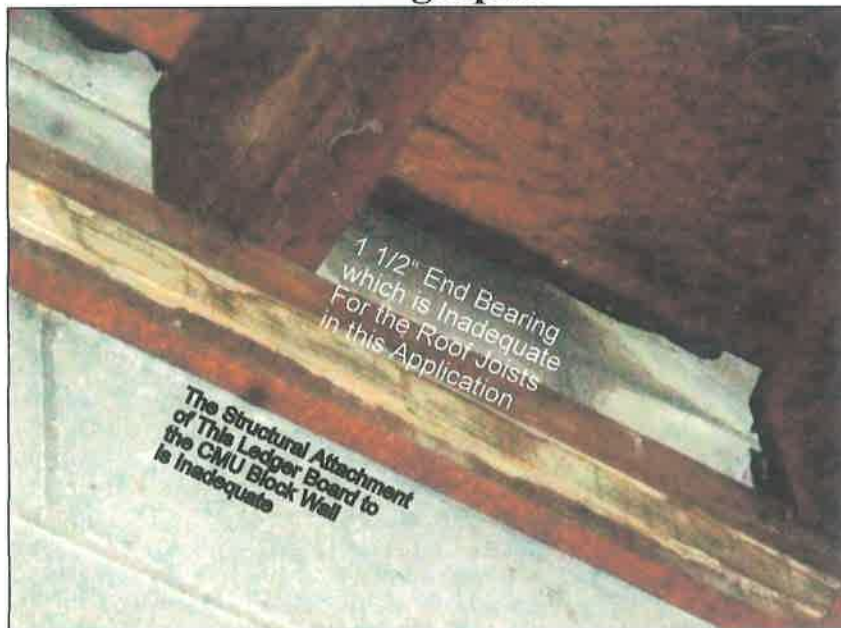
Photograph 10 shows a typical view of the roof framing members along the Westerly side of the building. Roof joists are not framed into and bearing on the exterior Westerly concrete block wall. The roof framing members bear on a 2" x 6" leger with 1 1/2" end bearing only as depicted in Photograph 10. This is inadequate and structurally deficient for this application. All legers used for structural applications of this type require an epoxy bolted threaded rod either 1/2" or 5/8" in diameter or if the masonry is reinforced with concrete placed in the interior cores, where expansive concrete bolt anchors can be used for this application. Instead, we find that powder actuated concrete nails were used in this instance which are not appropriate or sufficient to safely support the live and dead loads associated with this roof structure. With the impending snow, this will be problematic for a localized joist bearing failure which will be compounded by the deteriorated roof joist system.

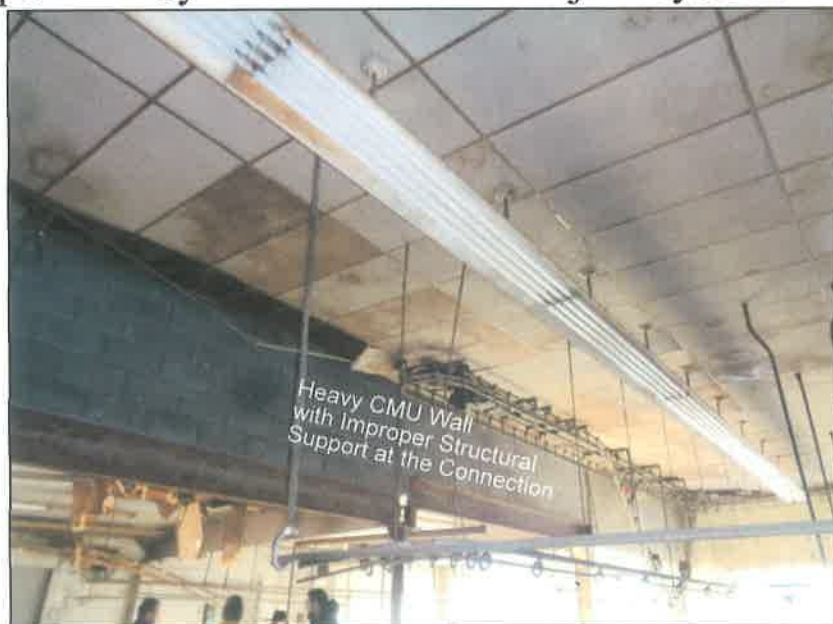
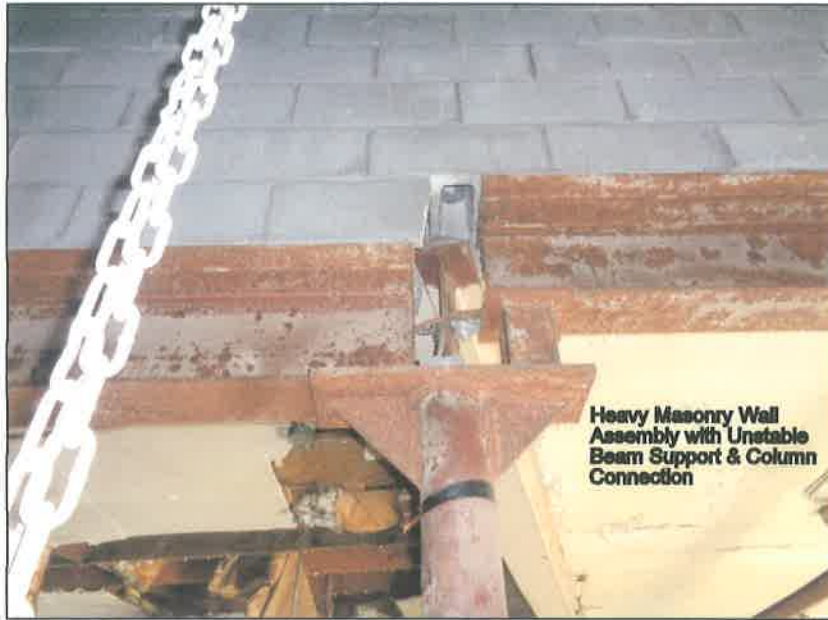
In order to obtain clear span openings between the original building and the addition, large wide flange steel beams were inserted to support the upper masonry wall sections of the original structure as shown in Photographs 11 and 12. These are heavy loads imposed on the beam sections, columns and connections. In addition to the weight of the upper concrete block bearing wall, roof framing members from the Westerly addition are supported by this steel beam and column assembly. During the course of our evaluation, we noted that some of the beam and column connections were improperly made and are highly structurally deficient. Eccentric loads have been placed on columns and improper beam shims have been installed as depicted in Photograph 12. These structural deficiencies that we have encountered are a concern because if a localized collapse of roof framing members occurred, this will induce lateral loads and a thrusting action against this masonry wall assembly which is shown in Photograph 11 and will result in a roll-over effect in the beams which are shown in Photograph 12 thus destabilizing the column support assembly. This collapse mechanism is a high hazard condition.

The present condition of the building is considered a hazard to public safety and shall be removed as soon as practicable under the City of Watervliet's Emergency Condemnation Procedures.
