FINAL Preliminary Assessment Report Albany Army Aviation Support Facility #3 Latham, New York

Perfluorooctanesulfonic Acid (PFOS) and Perfluorooctanoic
Acid (PFOA) Impacted Sites
ARNG Installations, Nationwide

April 2020

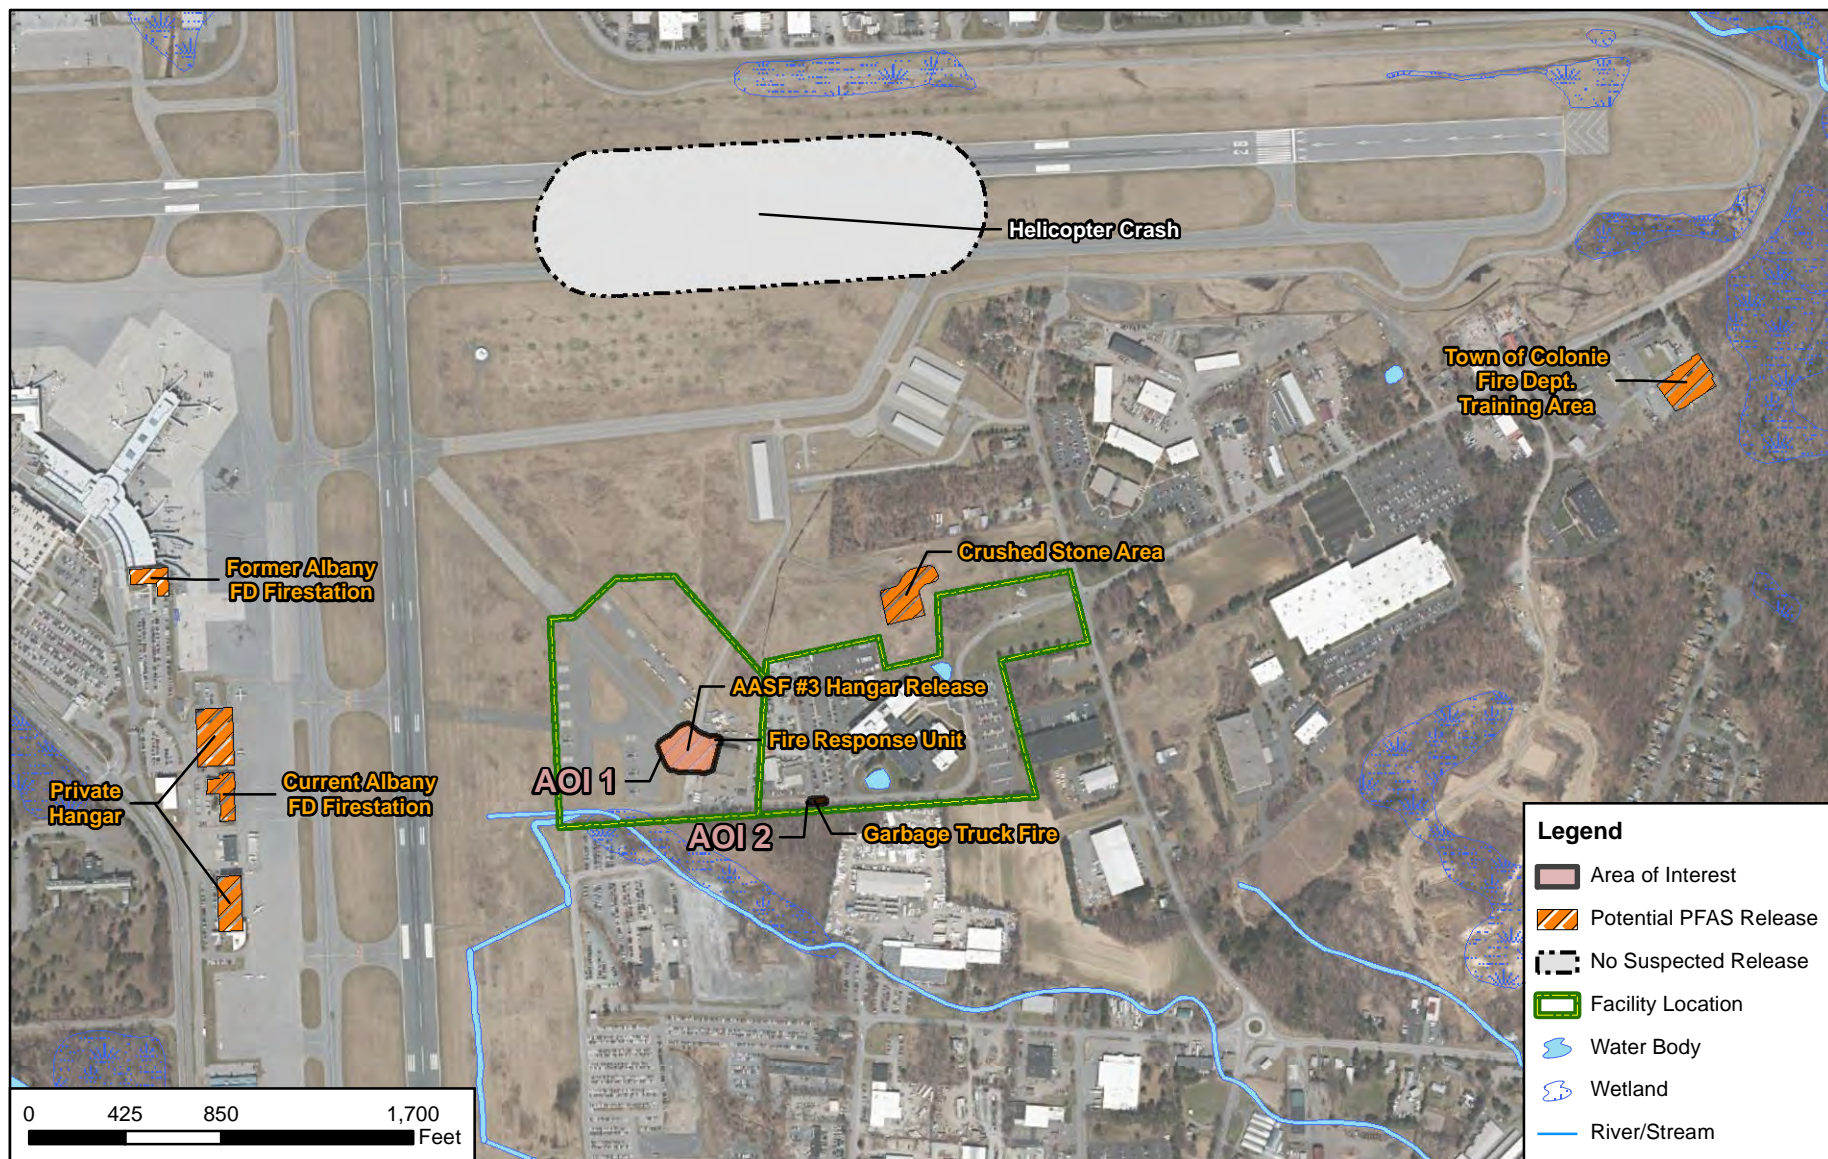
12420 Milestone Center Drive Germantown, MD 20876	Figure ES-1
SCALE	1:10,200	CHK BY	MB	1/31/2020			
Base Map: National Agricultural Imagery Program, 2016 Well Data: VT Dept of Environmental Conservation, Water Resource Section; ARNG		PM	RG	1/31/2020

Two AOIs related to potential PFAS releases was identified at the Albany AASF #3 during the PA. The AOIs are shown on **Figure ES-1** and described in the **Table ES-1** below.

Area of Interest	Name	Used by	Potential Release Dates
AOI 1	AASF #3 Hangar Release / Fire Response Unit	NYARNG	Initial testing of deluge system in 2012; emergency response unit operated 1983 to 1992
AOI 2	Garbage Truck Fire	NYARNG	Fire in back of garbage truck extinguished in 2017; use of AFFF unknown

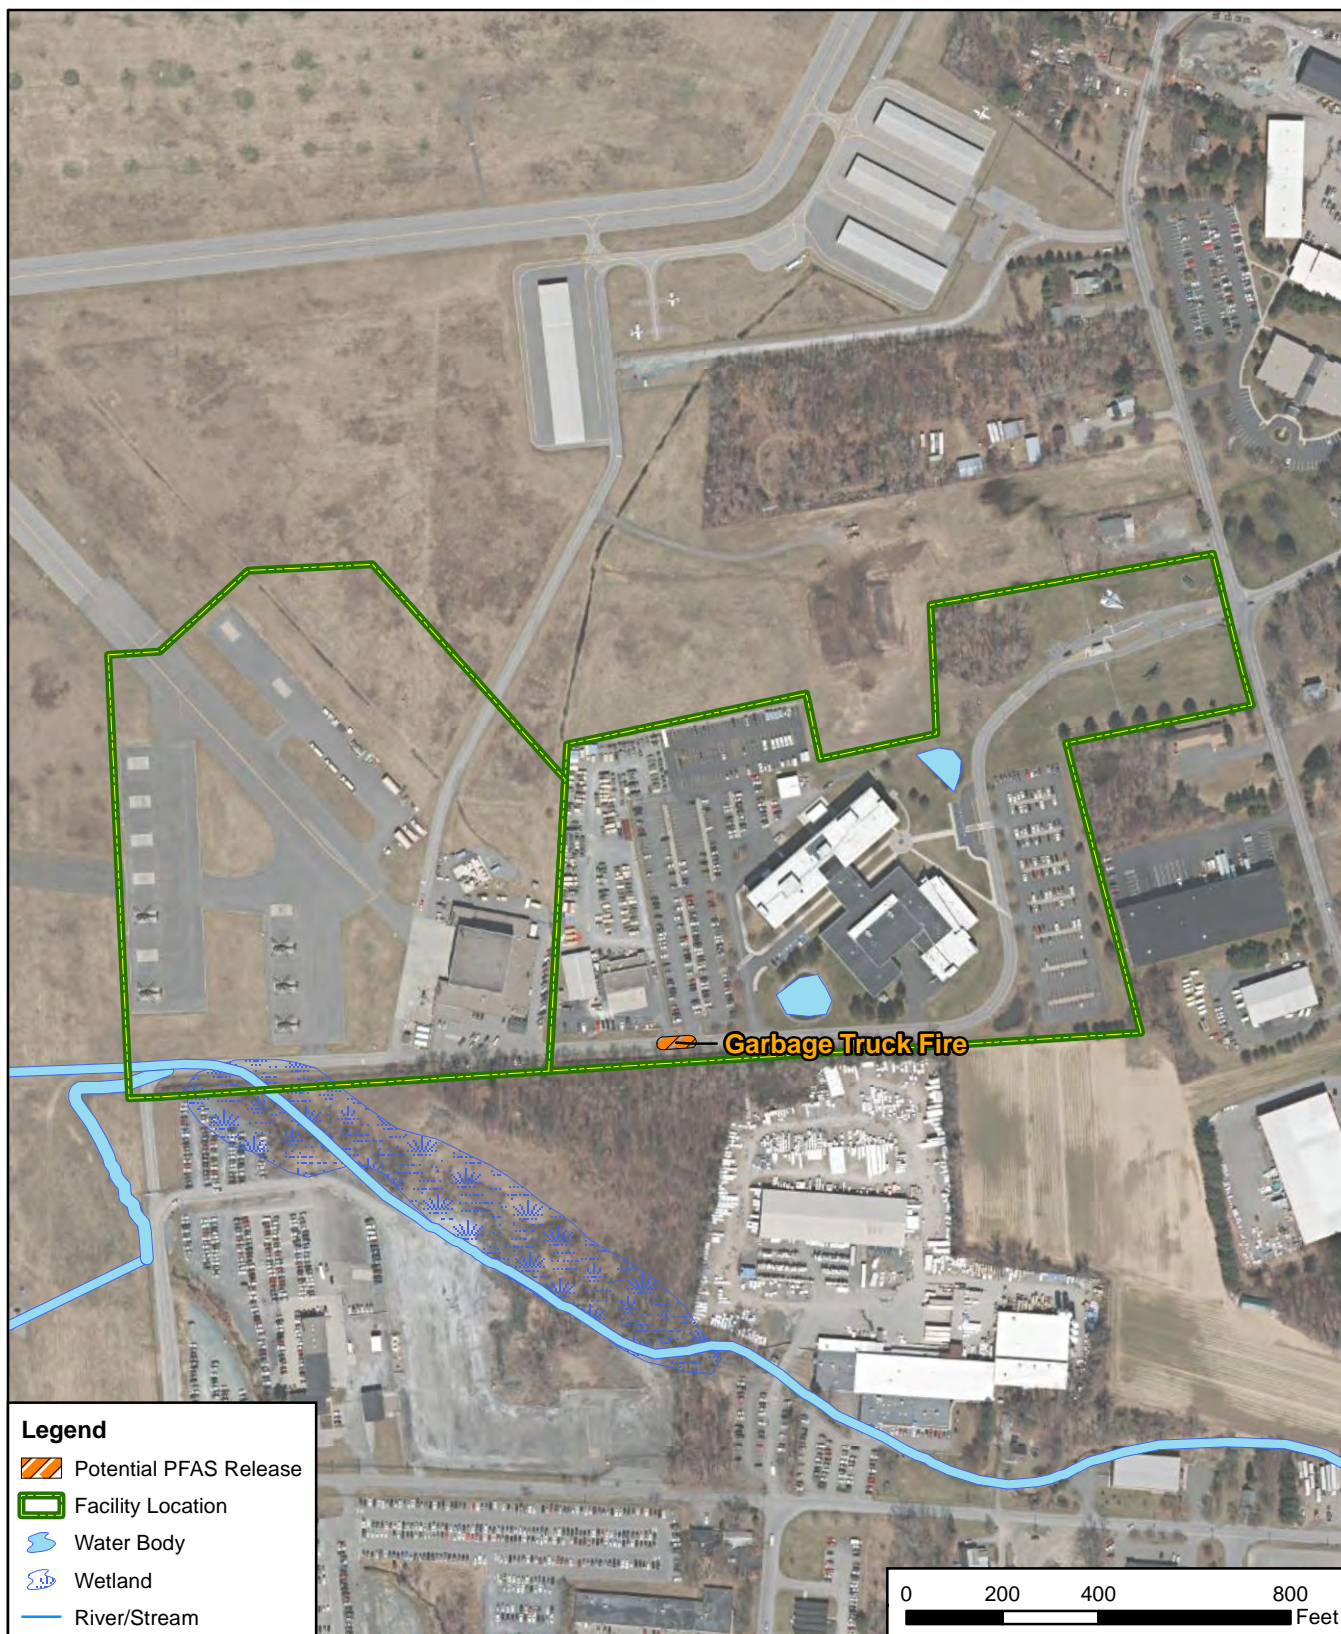
Figure 4-1

One instance of emergency response was identified at the Albany AASF #3 during the PA. A description of the response area is presented below, and the location is shown on **Figure 4-1**.

During the VSI, NYARNG staff stated that there was a fire in the back of a garbage truck in May 2017. The fire occurred southeast of the hangar. The CFD responded to the incident, but it is unknown if any AFFF were used during the emergency response.

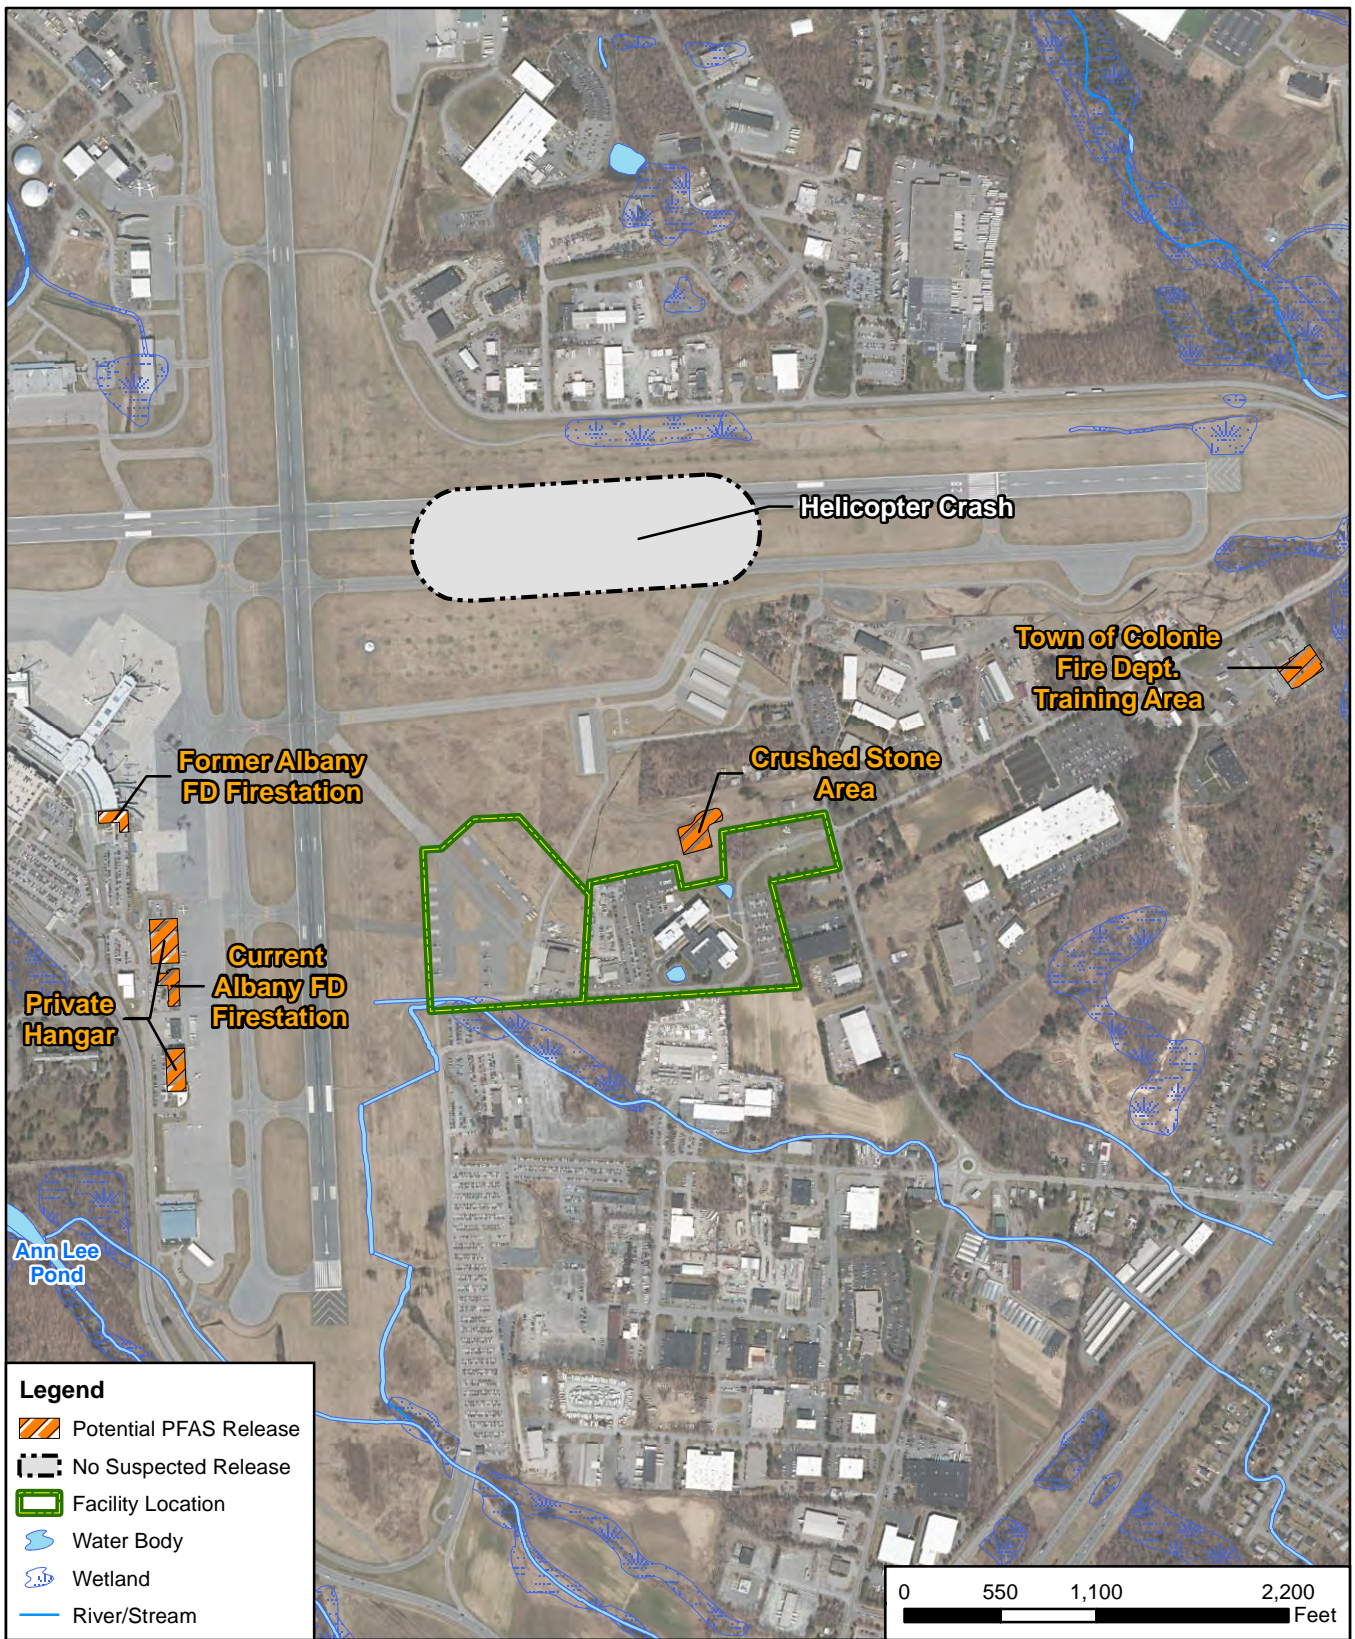
Adjacent Sources	
AECOM 12420 Milestone Center Drive Germantown, MD 20876	Figure 5-1

Roughly 0.20 miles northeast of the facility is the Crushed Stone Area, where the AFD and the NYARNG Fire Response Unit conducted joint live burn fire training once per year between 1983 and 1992 (**Figure 5-1**). There is some discrepancy regarding whether diesel fuels were used for the fire; however, more than one source said fuels were used during the training events. Interviews with NYARNG and AFD staff stated that during and after fire training activities, the AFFF used for training was left to dissipate on the grass and soil. Joint nozzle testing also occurred during this period twice per year. Records indicate 20 gallons of 3% AFFF were used during the activities. The Crushed Stone Area is downgradient from the facility, and based on northern groundwater flow direction, it is possible that potential PFAS contamination from these fire training activities is being carried into the residential and industrial areas to the north of Albany AASF #3.

A helicopter reportedly crashed sometime in the early 1980s, possibly 1983-1984, on Albany International Airport property roughly 0.45 miles north of the Albany AASF #3. The AFD responded to the incident. Based on an interview with the AFD chief, no AFFF was used at the crash site (**Appendix B**), and therefore has been identified as an area of “No Suspected Release” on **Figure 5-1**
