## DAILY FIELD ACTIVITY REPORT

| PROJECT | Former Bouchard Junkyard | WEATHER | TIME | TEMP. | PRECIP. | WIND (MPH) | WIND (DIR) |
| LOCATION | Town of New Lebanon, NY | M. Cloudy | 0700 | 55-60 F | None | Calm | NA |

**PHOTOGRAPHIC LOG**  
**June 17, 2008**  
**D&B JOB NO. 2605**  
**FORMER BOUCHARD JUNKYARD SITE**  
**TOWN OF NEW LEBANON, NEW YORK**

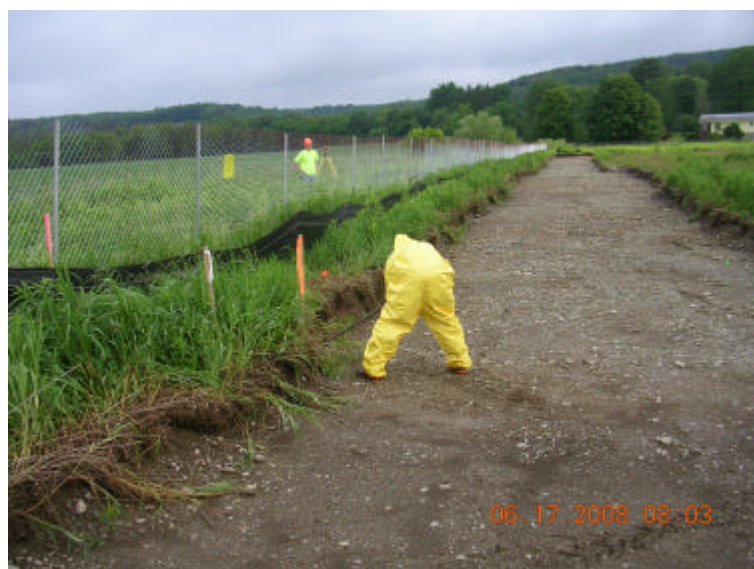
**DSCN3597.JPG**

| PHOTO | DATE | TIME | DESCRIPTION |
|---|---|---|---|
| DSCN 3597 | 6/17/2008 | 0803 | Collection of endpoint sidewall soil sample EP-PSW-01 at 0-0.5 ft bgs at Grid G-15 along W property boundary of Area 2; View looking N-NW. |

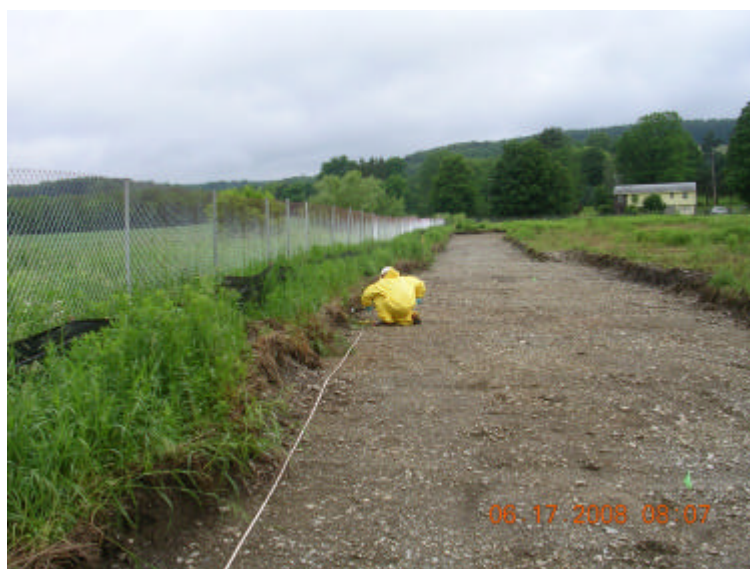
**DSCN3598.JPG**

| PHOTO | DATE | TIME | DESCRIPTION |
|---|---|---|---|
| DSCN 3598 | 6/17/2008 | 0807 | Collection of endpoint sidewall soil sample EP-PSW-02 at 0-0.5 ft bgs at Grid F-17 along W property boundary of Area 2; View looking N-NW. |

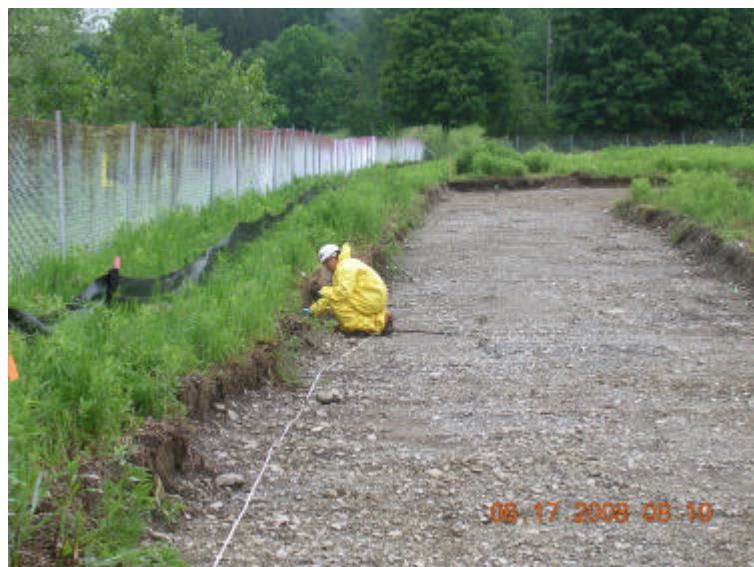
**DSCN3599.JPG**

| PHOTO | DATE | TIME | DESCRIPTION |
|---|---|---|---|
| DSCN 3599 | 6/17/2008 | 0810 | Collection of endpoint sidewall soil sample EP-PSW-03 at 0-0.5 ft bgs at Grid E-19 along W property boundary of Area 1; View looking N-NW. |

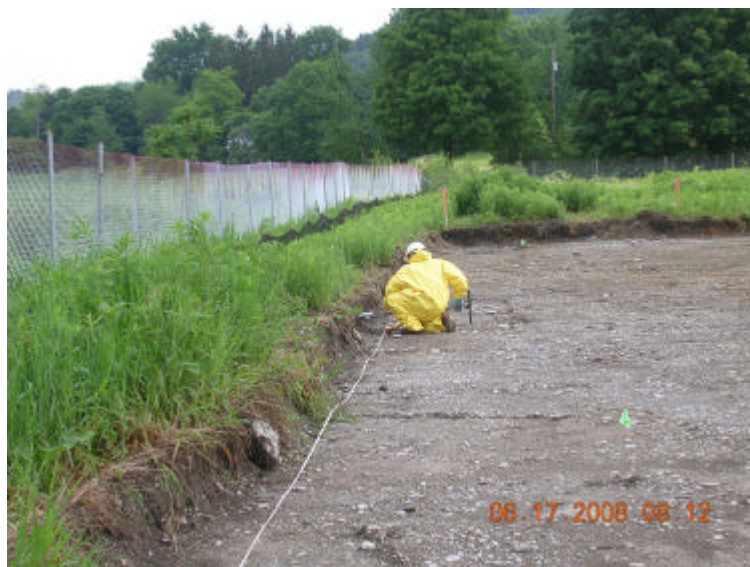
**DSCN3600.JPG**

| PHOTO | DATE | TIME | DESCRIPTION |
|---|---|---|---|
| DSCN 3600 | 6/17/2008 | 0812 | Collection of endpoint sidewall soil sample EP-PSW-04 at 0-0.5 ft bgs at Grid E-21 along W property boundary of Area 1; View looking N-NW. |

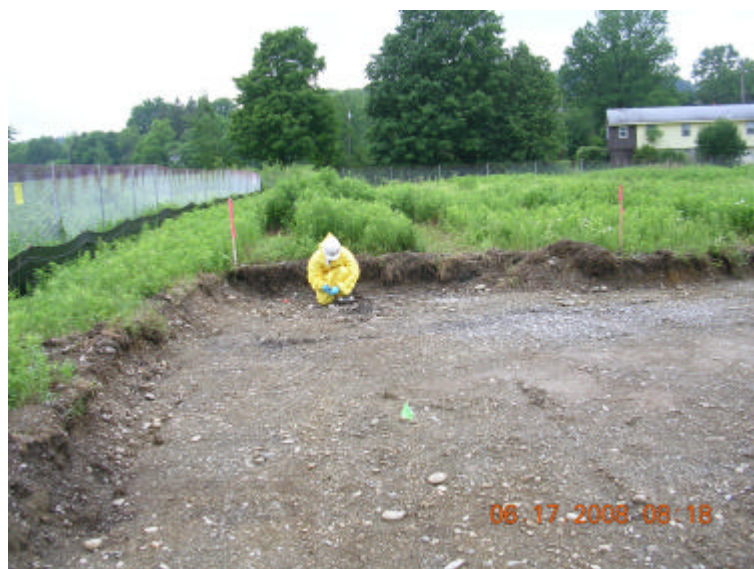
**DSCN3601.JPG**

| PHOTO | DATE | TIME | DESCRIPTION |
|---|---|---|---|
| DSCN 3601 | 6/17/2008 | 0818 | Collection of bottom soil sample at 1 ft bgs near the center of grid EP-M18; Area looking SE. |

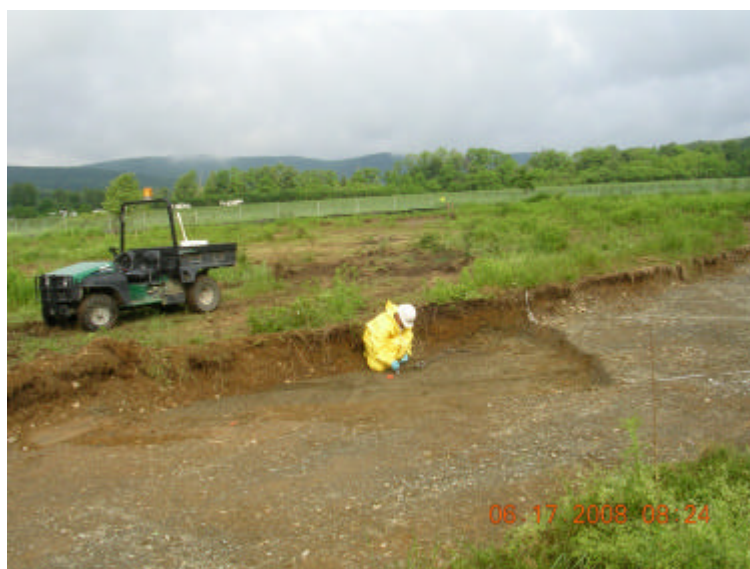
**DSCN3603.JPG**

| PHOTO | DATE | TIME | DESCRIPTION |
|---|---|---|---|
| DSCN 3603 | 6/17/2008 | 0824 | Collection of bottom soil sample at 1 ft bgs at the SE corner of grid EP-E22; Area 1 looking N-NW. |

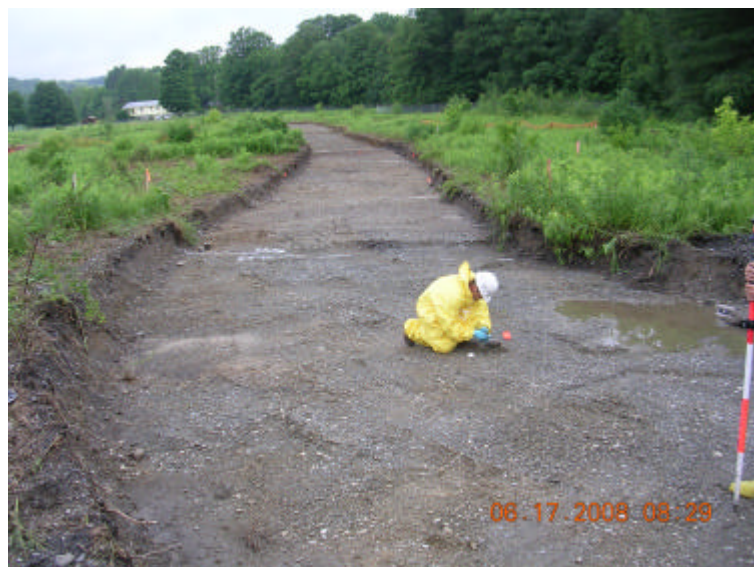
**DSCN3604.JPG**

| PHOTO | DATE | TIME | DESCRIPTION |
|---|---|---|---|
| DSCN 3604 | 6/17/2008 | 0829 | Collection of bottom soil sample at 1.5 ft bgs at the NE corner of grid EP-H21(1); Area 1 looking W. |

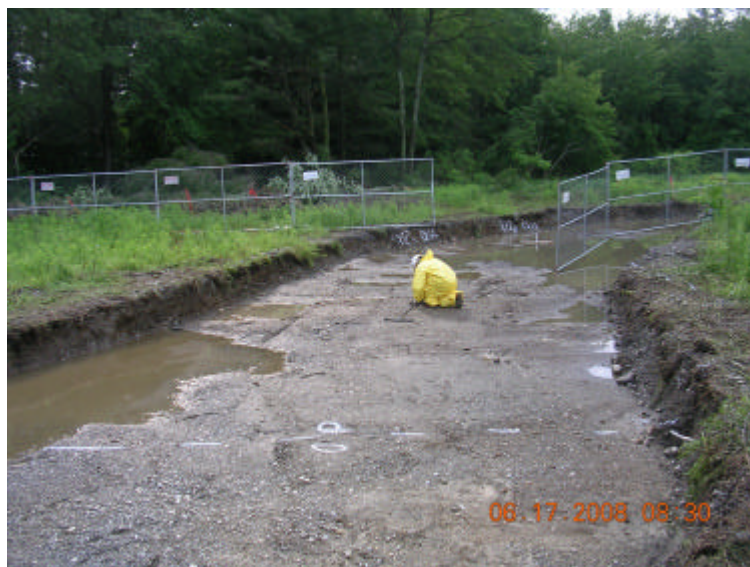
**DSCN3605.JPG**

| PHOTO | DATE | TIME | DESCRIPTION |
|---|---|---|---|
| DSCN 3605 | 6/17/2008 | 0830 | Collection of bottom soil sample at 1.5 ft bgs near the center of grid EP-P12; Area 8 looking E. |

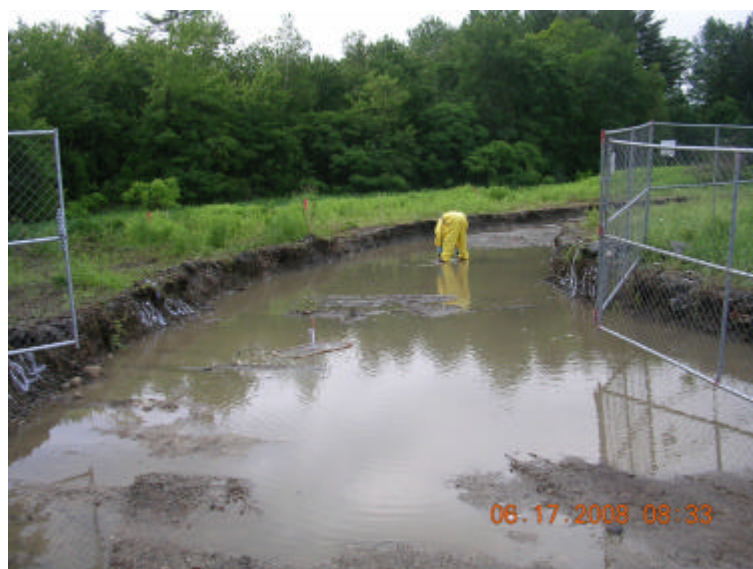
**DSCN3606.JPG**

| PHOTO | DATE | TIME | DESCRIPTION |
|---|---|---|---|
| DSCN 3606 | 6/17/2008 | 0833 | Collection of bottom soil sample at 1.5 ft bgs within grid EP-Q11; Area 8 looking SE. |

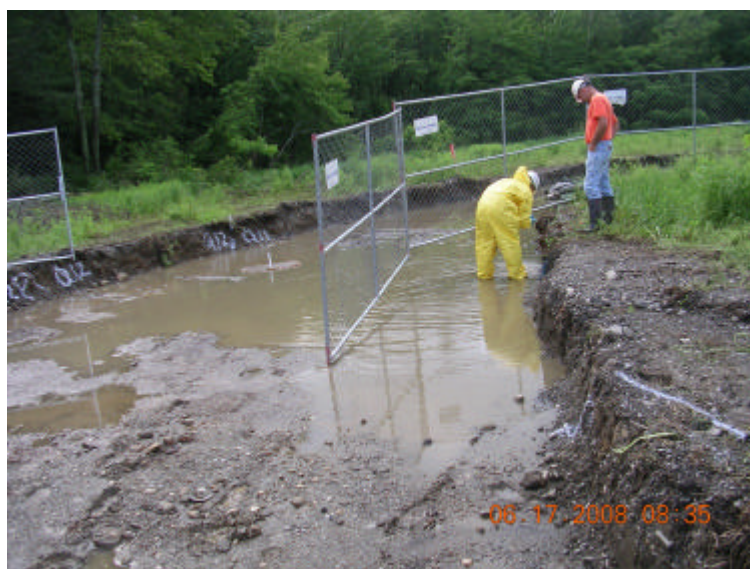
**DSCN3607.JPG**

| PHOTO | DATE | TIME | DESCRIPTION |
|---|---|---|---|
| DSCN 3607 | 6/17/2008 | 0835 | Collection of bottom soil sample at 1.5 ft bgs near the NE corner of grid EP-P11; Area 8 looking E. |

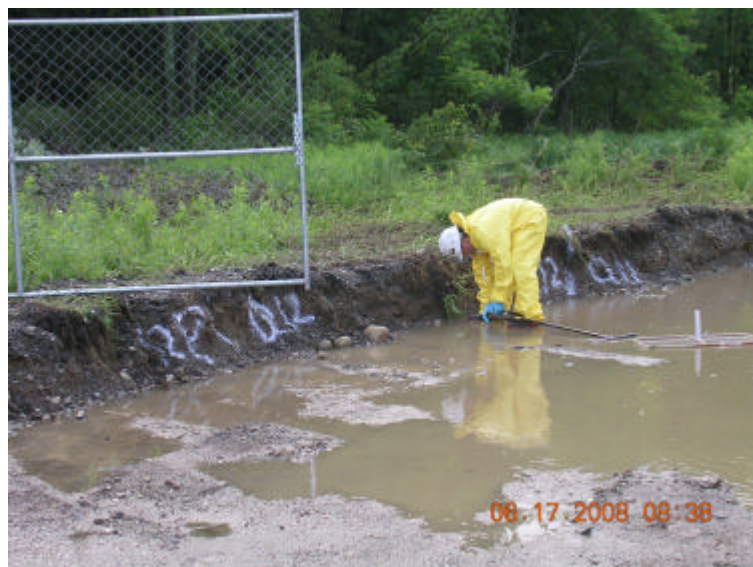
**DSCN3608.JPG**

| PHOTO | DATE | TIME | DESCRIPTION |
|---|---|---|---|
| DSCN 3608 | 6/17/2008 | 0838 | Collection of bottom soil sample at 1.5 ft bgs at the SW corner of grid EP-Q12; Area 8 looking E-NE. |

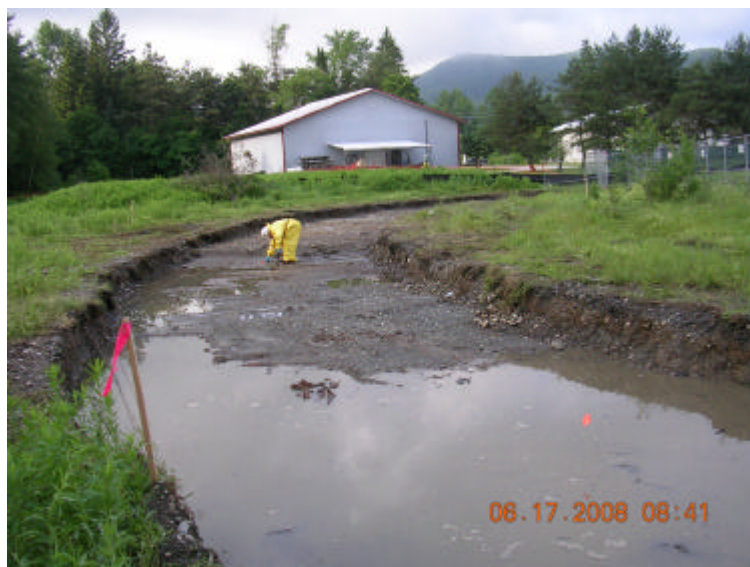
**DSCN3609.JPG**

| PHOTO | DATE | TIME | DESCRIPTION |
|---|---|---|---|
| DSCN 3609 | 6/17/2008 | 0841 | Collection of bottom soil sample at 1.5 ft bgs on the N side of grid EP-Q10; Area looking S-SE. |

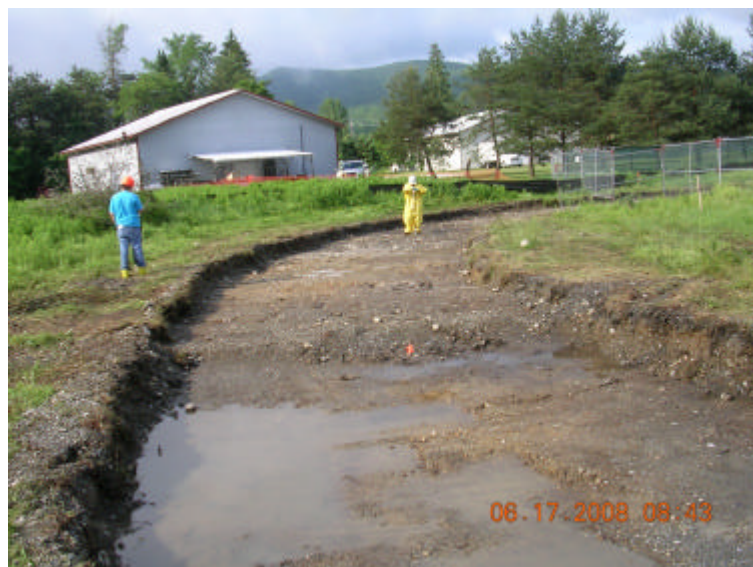
**DSCN3610.JPG**

| PHOTO | DATE | TIME | DESCRIPTION |
|---|---|---|---|
| DSCN 3610 | 6/17/2008 | 0843 | Collection of bottom soil sample at 1 ft bgs on the N side of grid EP-Q9; Area 8 looking S. |

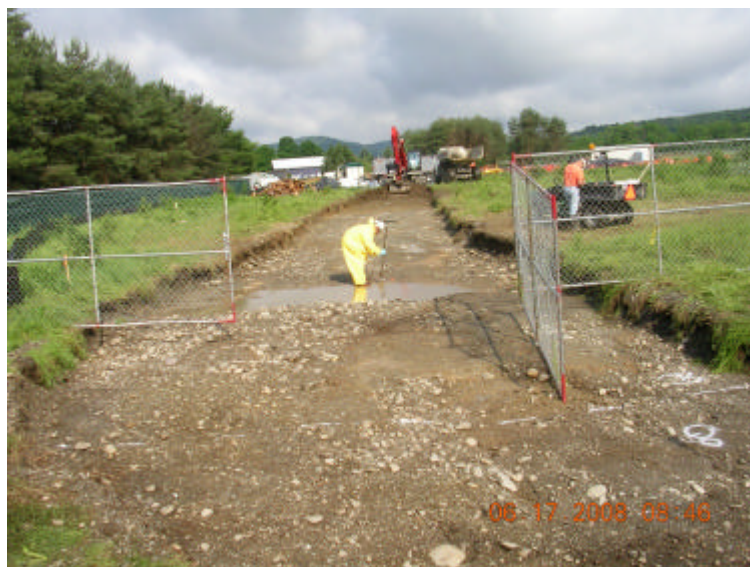
**DSCN3611.JPG**

| PHOTO | DATE | TIME | DESCRIPTION |
|---|---|---|---|
| DSCN 3611 | 6/17/2008 | 0846 | Collection of bottom soil sample at 1.5 ft bgs on the N side of grid EP-P9; Area 8 looking W; Active remedial excavation in distant background. |

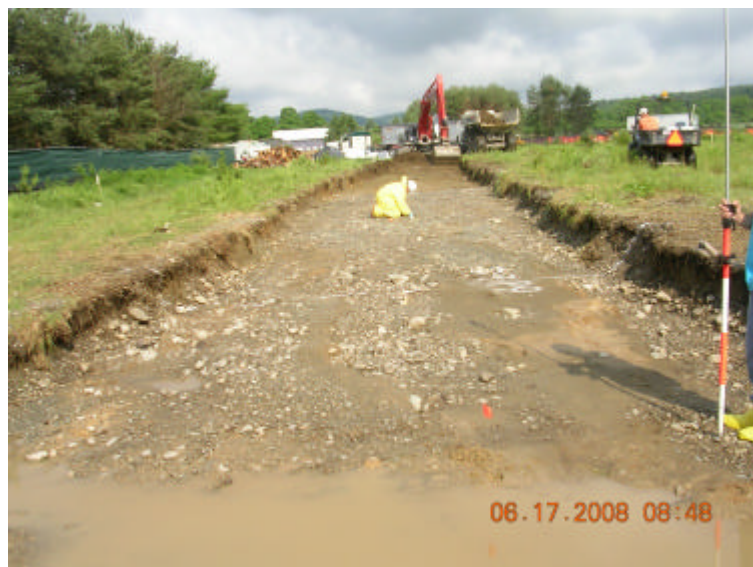
**DSCN3612.JPG**

| PHOTO | DATE | TIME | DESCRIPTION |
|---|---|---|---|
| DSCN 3612 | 6/17/2008 | 0848 | Collection of bottom soil sample at 1.5 ft bgs on the N side of grid EP-O9; Area 3 looking W; Active remedial excavation in distant background. |

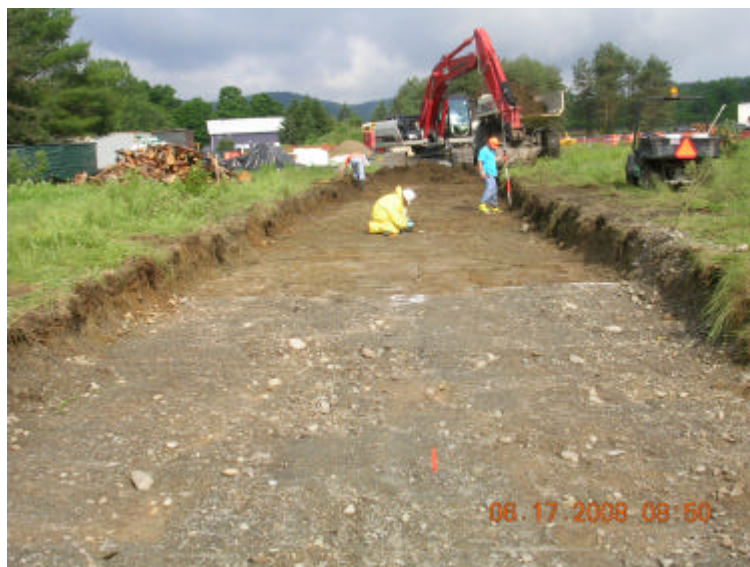
**DSCN3613.JPG**

| PHOTO | DATE | TIME | DESCRIPTION |
|---|---|---|---|
| DSCN 3613 | 6/17/2008 | 0850 | Collection of bottom soil sample at 1.5 ft bgs on the N side of grid EP-N9; Duplicate sample EP-DUP05 collected here; Area 3 looking W; Active remedial excavation in distant background. |

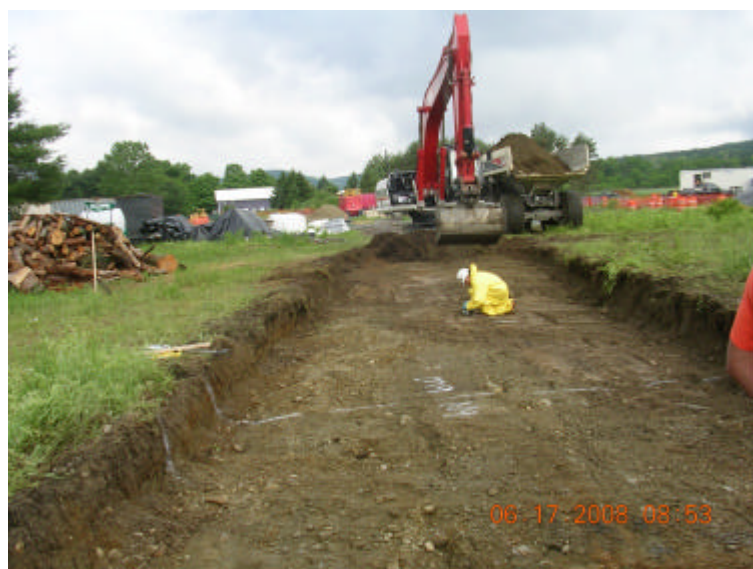
**DSCN3614.JPG**

| PHOTO | DATE | TIME | DESCRIPTION |
|---|---|---|---|
| DSCN 3614 | 6/17/2008 | 0853 | Collection of bottom soil sample at 1.5 ft bgs on the N side of grid EP-N9; MS/MSD/MSB collected here; Area 3 looking W; Active remedial excavation in background. |

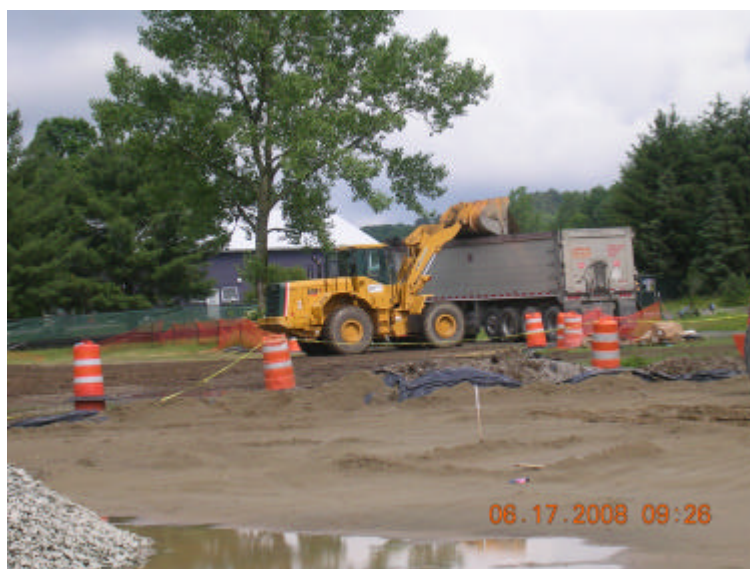
**DSCN3617.JPG**

| PHOTO | DATE | TIME | DESCRIPTION |
|---|---|---|---|
| DSCN 3617 | 6/17/2008 | 0926 | View of DAC loading an 18-wheel waste hauling truck with non-TSCA PCB contaminated soil in background using a Kawasaki 80ZV Front Loader at the western side of Area 4 looking NE. |

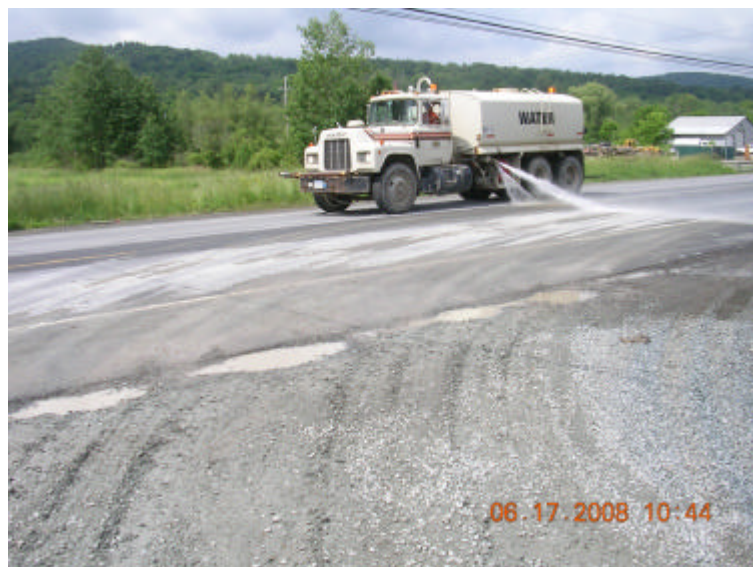
**DSCN3618.JPG**

| PHOTO | DATE | TIME | DESCRIPTION |
|---|---|---|---|
| DSCN 3618 | 6/17/2008 | 1044 | Cleaning of muddy tire tracks in progress onto Route 20 road surface at entrance to driveway to Building 666 using Mack Water Truck; View of Route 20 looking SW. |

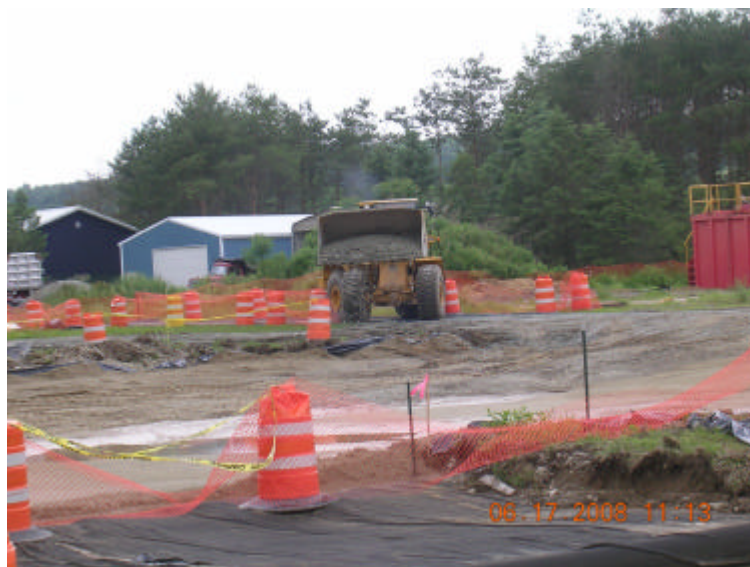
**DSCN3619.JPG**

| PHOTO | DATE | TIME | DESCRIPTION |
|---|---|---|---|
| DSCN 3619 | 6/17/2008 | 1113 | Truck access road maintenance; View of Kawasaki 80ZV Front Loader distributing a fresh layer of gravel to cover muddy areas; Area 4 looking NW. |

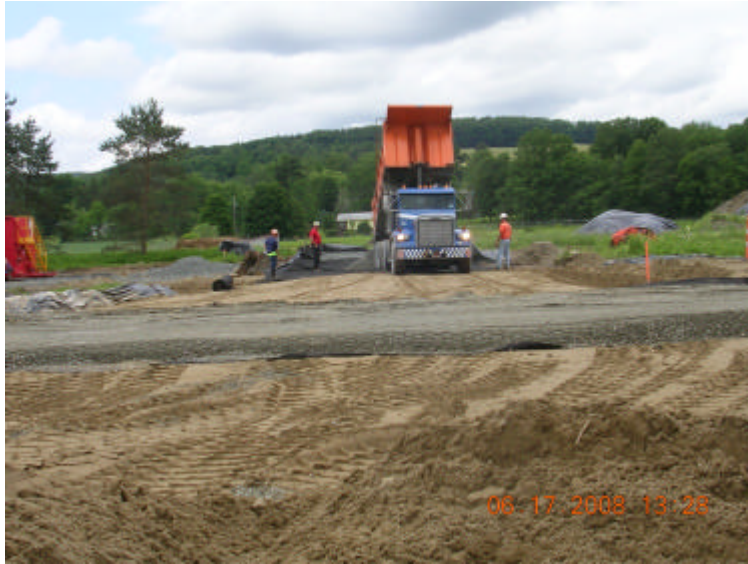
**DSCN3621.JPG**

| PHOTO | DATE | TIME | DESCRIPTION |
|---|---|---|---|
| DSCN 3621 | 6/17/2008 | 1328 | View of DAC constructing the S ramp to the decontamination pad along the western boundary of Area 3. |

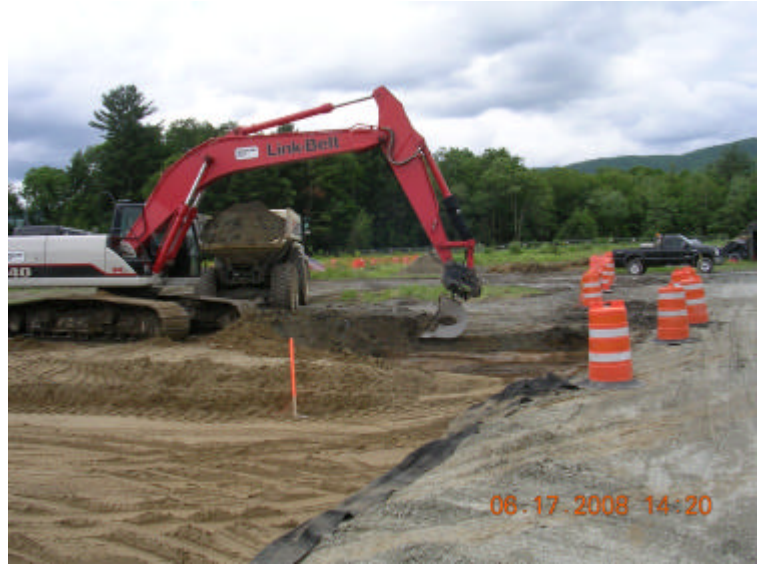
**DSCN3624.JPG**

| PHOTO | DATE | TIME | DESCRIPTION |
|---|---|---|---|
| DSCN 3624 | 6/17/2008 | 1420 | Remedial excavation activities at the southeast corner of Area 3 within Grid I-9 utilizing a Link-Belt 240 Trackhoe for excavation and a Terex End Dump TA30 for soil transport to a stockpile in Area 2; View of Area 1 looking E-NE. |
