## DAILY FIELD ACTIVITY REPORT

| <b>PROJECT</b> | <b>Former Bouchard Junkyard</b> | <b>WEATHER</b> | <b>TIME</b> | <b>TEMP.</b> | <b>PRECIP.</b> | <b>WIND (MPH)</b> | <b>WIND (DIR)</b> |
| <b>LOCATION</b> | <b>Town of New Lebanon, NY</b> | <b>Overcast</b> | <b>0630</b> | <b>50-55 F</b> | <b>Drizzle</b> | <b>0-5</b> | <b>W</b> |

**PHOTOGRAPHIC LOG**  
**June 20, 2008**  
**D&B JOB NO. 2605**  
**FORMER BOUCHARD JUNKYARD SITE**  
**TOWN OF NEW LEBANON, NEW YORK**

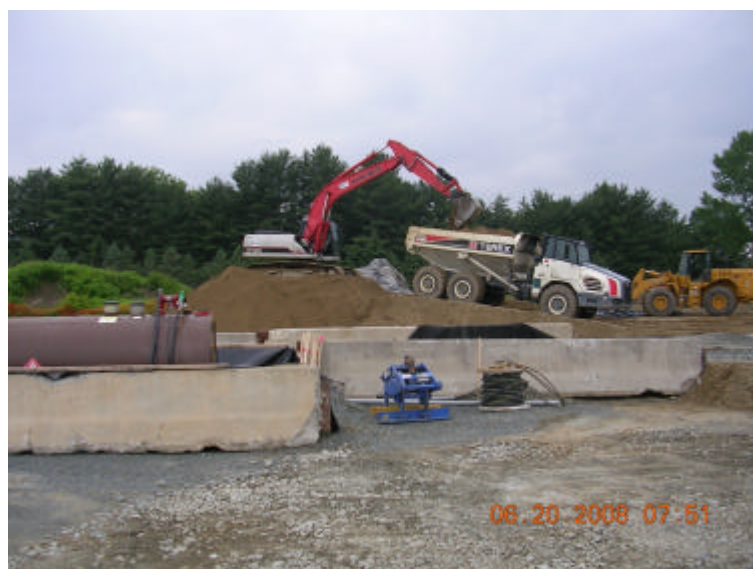
DSCN3679.JPG

| PHOTO | DATE | TIME | DESCRIPTION |
|---|---|---|---|
| DSCN 3679 | 6/20/2008 | 0751 | View of Link-Belt 240 Trackhoe loading Terex End Dump TA30 with common fill sand at a stockpile in Area 4, which was transported to Area 1 and 2 for access road construction; View of Area 4 looking W. |

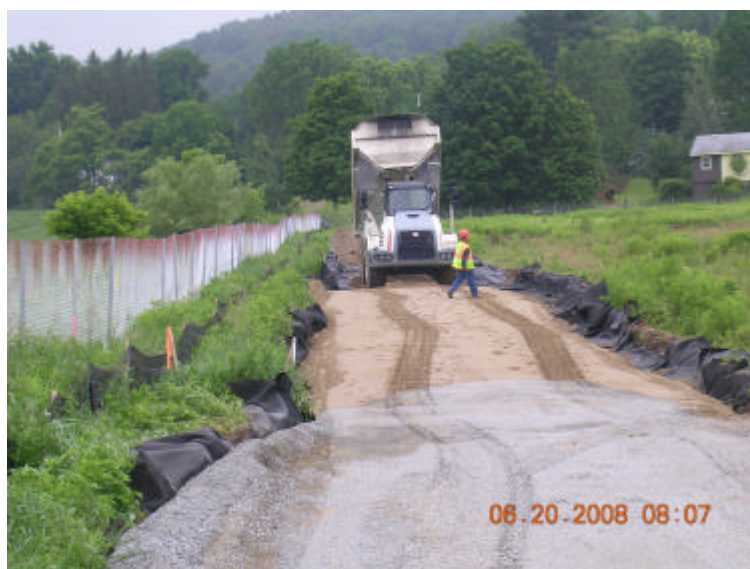
DSCN3680.JPG

| PHOTO | DATE | TIME | DESCRIPTION |
|---|---|---|---|
| DSCN 3680 | 6/20/2008 | 0807 | Access road construction in progress; Terex End Dump TA30 transported and dumped common fill sand along the access road in Area 1 and 2 looking N-NW. |

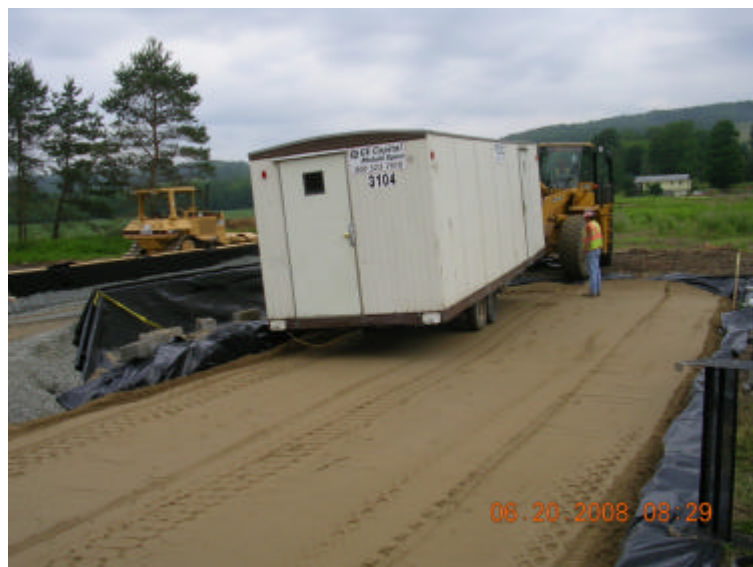
DSCN3681.JPG

| PHOTO | DATE | TIME | DESCRIPTION |
|---|---|---|---|
| DSCN 3681 | 6/20/2008 | 0829 | DAC crew moved the decontamination trailer beside the decontamination pad in Area 3 looking N-NW. |

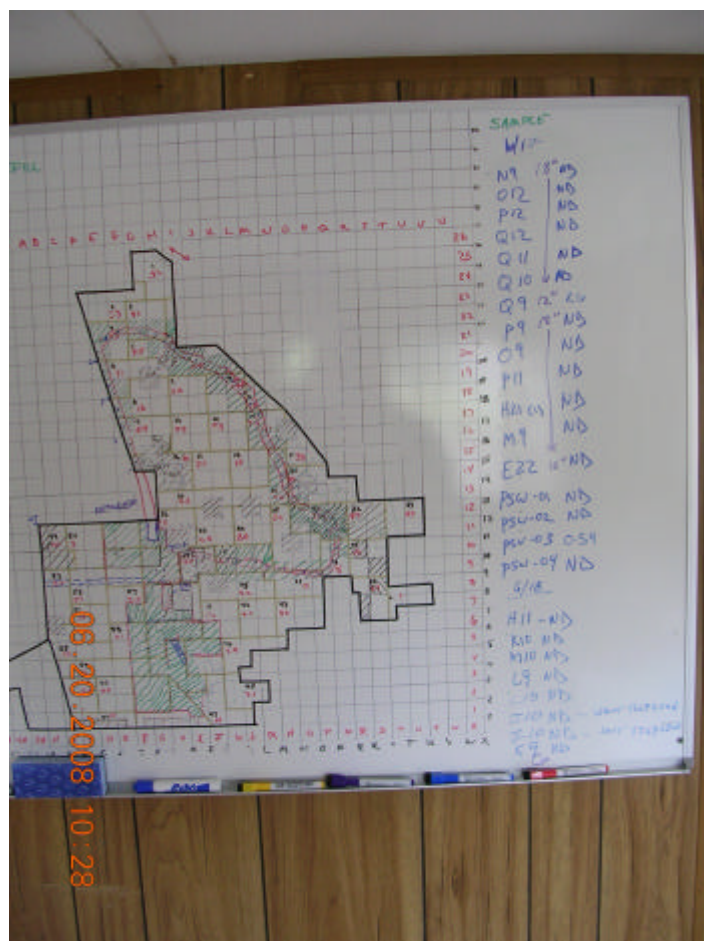
DSCN3682.JPG

| PHOTO | DATE | TIME | DESCRIPTION |
|---|---|---|---|
| DSCN 3682 | 6/20/2008 | 1028 | View of DAC's site meeting board showing current site progress including remedial excavations along the proposed access road. |

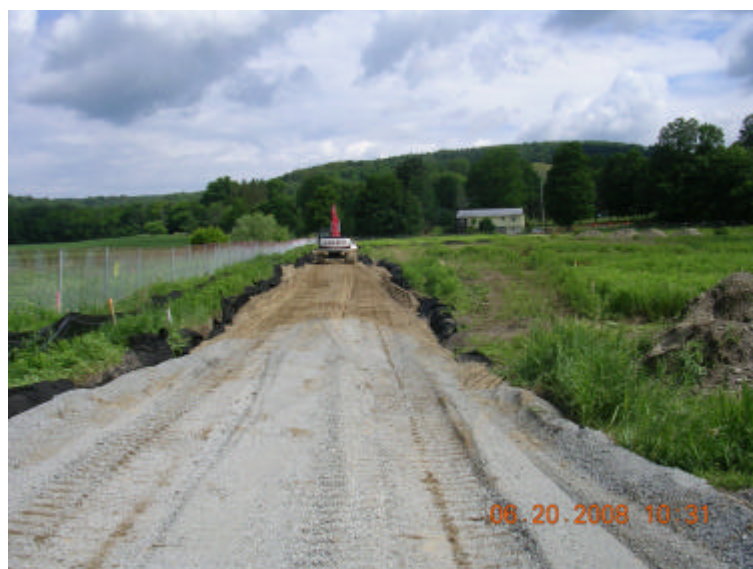
**DSCN3683.JPG**

| PHOTO | DATE | TIME | DESCRIPTION |
|---|---|---|---|
| DSCN 3683 | 6/20/2008 | 1031 | Construction of access road in progress along the western boundary of Areas 1 and 2 looking N-NW; Link-Belt 240 Trackhoe distributes common fill sand over 12 ounce Carthage Mills road fabric. |

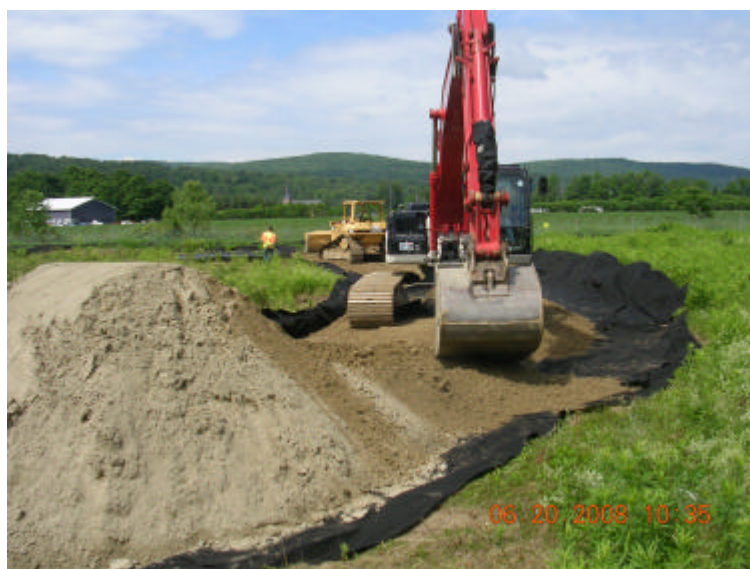
**DSCN3684.JPG**

| PHOTO | DATE | TIME | DESCRIPTION |
|---|---|---|---|
| DSCN 3684 | 6/20/2008 | 1035 | Construction of access road in progress in Grid F-22 in Area 1 looking W; Link-Belt 240 Trackhoe distributes common fill sand over 12 ounce Carthage Mills road fabric. |

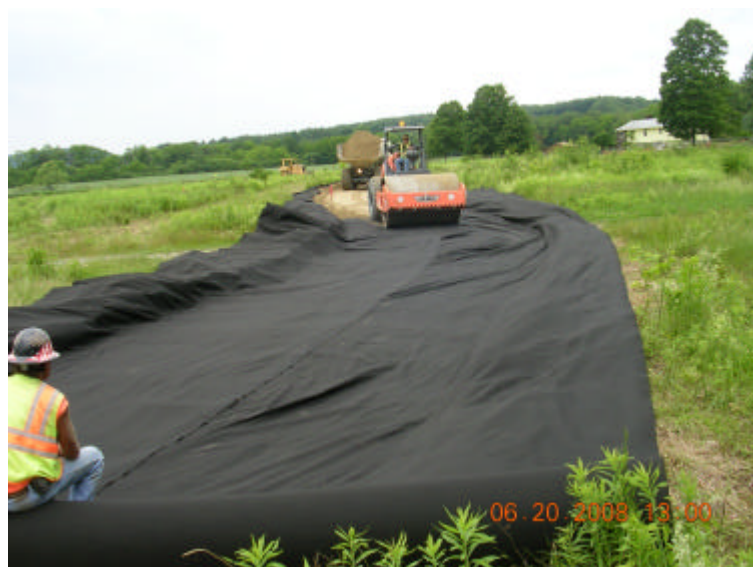
**DSCN3685.JPG**

| PHOTO | DATE | TIME | DESCRIPTION |
|---|---|---|---|
| DSCN 3685 | 6/20/2008 | 1300 | Construction of access road in progress along the eastern boundary of Area 2 looking NW; Common fill sand was placed, grated, and compacted with a Terex End Dump TA30, Caterpillar 6465 Bull Dozer, and Hamm 2593 Vibratory Compaction Roller. |

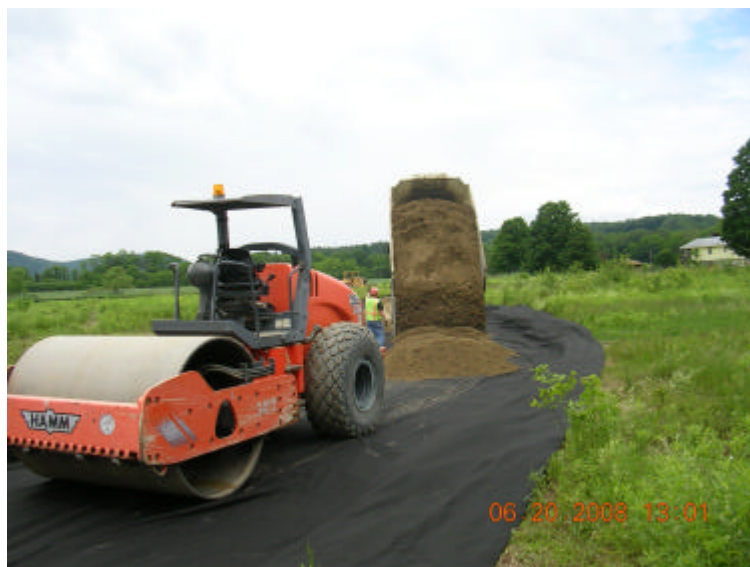
**DSCN3686.JPG**

| PHOTO | DATE | TIME | DESCRIPTION |
|---|---|---|---|
| DSCN 3686 | 6/20/2008 | 1301 | View of placement of common fill sand using a Terex End Dump TA30 at SE corner of Area 2 looking NW. |

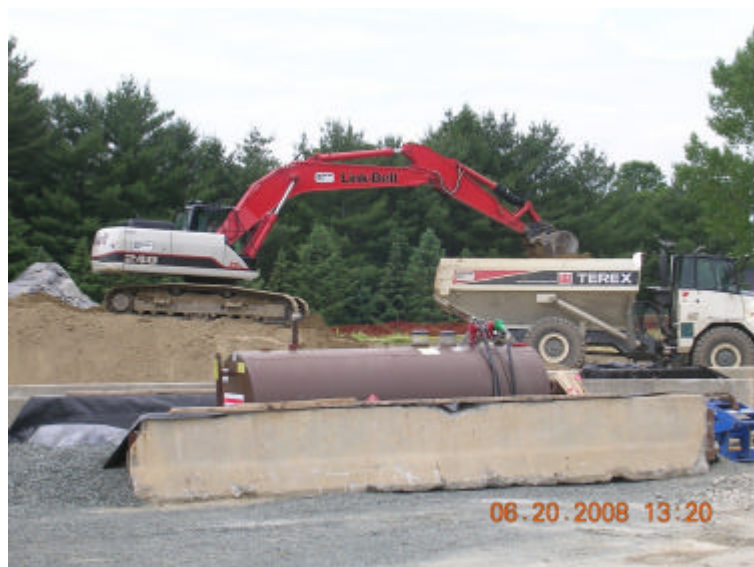
**DSCN3687.JPG**

| PHOTO | DATE | TIME | DESCRIPTION |
|---|---|---|---|
| DSCN 3687 | 6/20/2008 | 1320 | View of Link-Belt 240 Trackhoe loading Terex End Dump TA30 with common fill sand at a stockpile in Area 4, which was transported to Area 1 and 2 for access road construction; View of Area 4 looking W. |

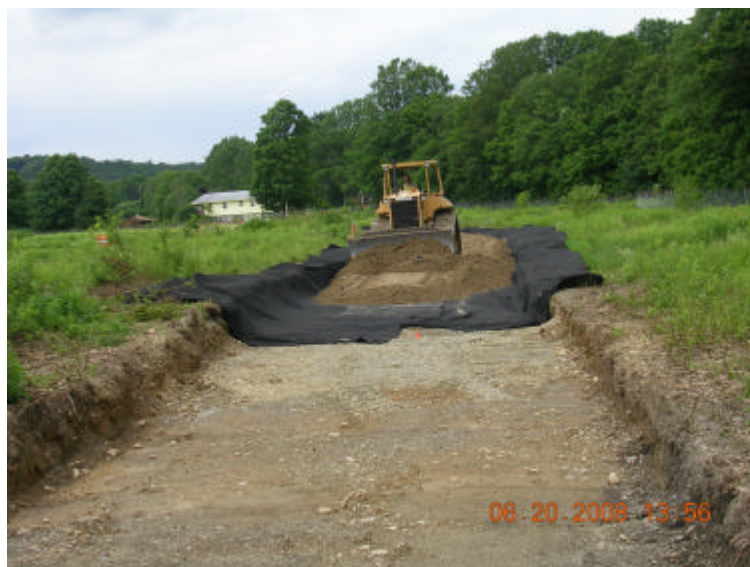
**DSCN3688.JPG**

| PHOTO | DATE | TIME | DESCRIPTION |
|---|---|---|---|
| DSCN 3688 | 6/20/2008 | 1356 | View of grading of common fill sand using a Caterpillar 6465 Bull Dozer at SE corner of Area 2 looking NW. |

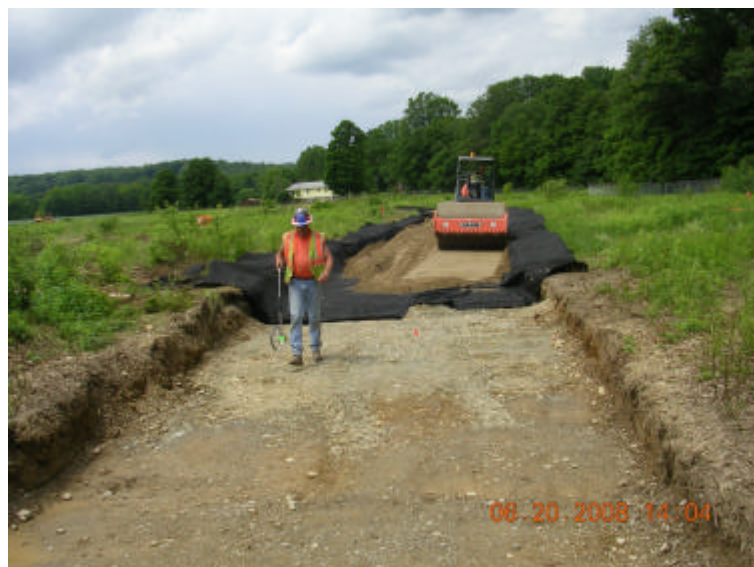
**DSCN3689.JPG**

| PHOTO | DATE | TIME | DESCRIPTION |
|---|---|---|---|
| DSCN 3689 | 6/20/2008 | 1404 | View of compaction of common fill sand using a Hamm 2593 Vibratory Compaction Roller at SE corner of Area 2 looking NW. |
