REPORT NO. 080623

## DAILY FIELD ACTIVITY REPORT

| PROJECT | Former Bouchard Junkyard | WEATHER | TIME | TEMP. | PRECIP. | WIND (MPH) | WIND (DIR) |
| LOCATION | Town of New Lebanon, NY | Overcast | 1100 | 75-80 F | Some Drizzle | Calm | NA |

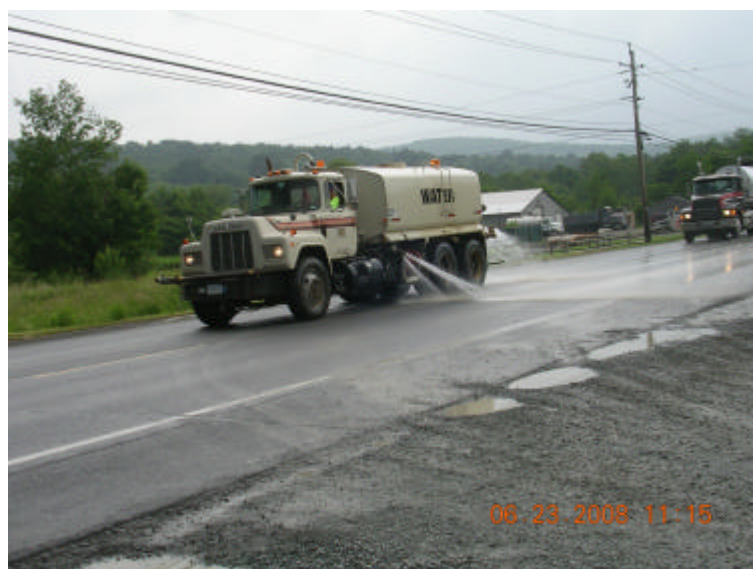
**DSCN3691.JPG**

| PHOTO | DATE | TIME | DESCRIPTION |
|---|---|---|---|
| DSCN 3691 | 6/23/2008 | 1115 | Cleaning of muddy tire tracks in progress onto Route 20 road surface at entrance t driveway to Building 666 using Water Truck; View of Route 20 looking SW. |

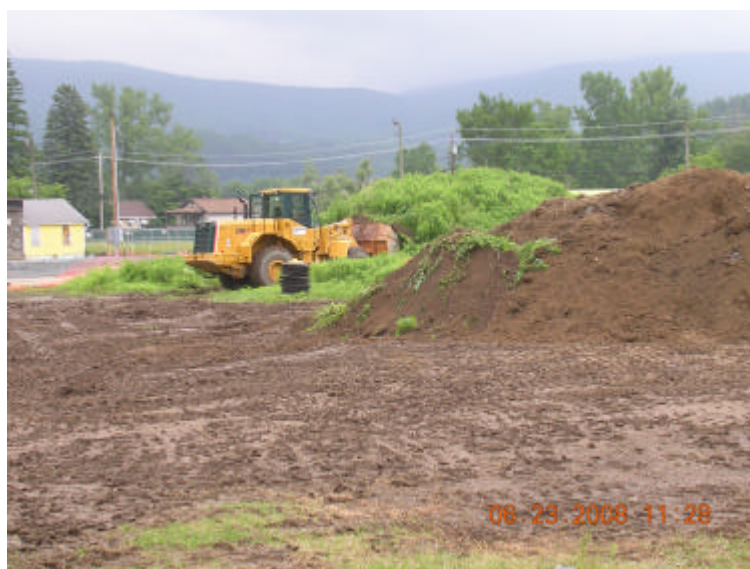
**DSCN3693.JPG**

| PHOTO | DATE | TIME | DESCRIPTION |
|---|---|---|---|
| DSCN 3693 | 6/23/2008 | 1128 | View of DAC loading of non-TSCA PCB contaminated soil using a Kawasaki 80ZV Front Loader from earthen mound at the western side of Area 4 looking SE. |

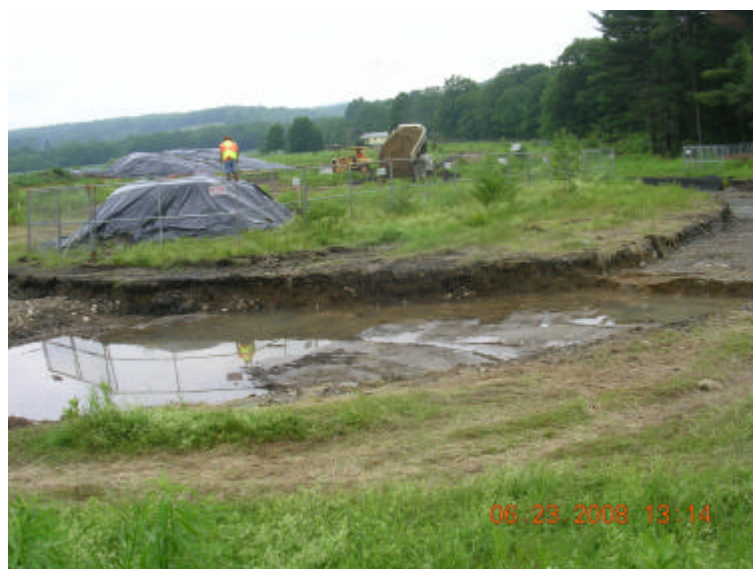
**DSCN3697.JPG**

| PHOTO | DATE | TIME | DESCRIPTION |
|---|---|---|---|
| DSCN 3697 | 6/23/2008 | 1314 | View of Grid Q-9 (foreground), which was excavated an additional 0.5 ft to a completion depth of 1.5 bgs due initial endpoint sample failure; View of placemer and grading of common fill sand using a Terex End Dump TA30 and Caterpillar 6465 Bull Dozer near N side of Area 8 (see background) looking NW. |

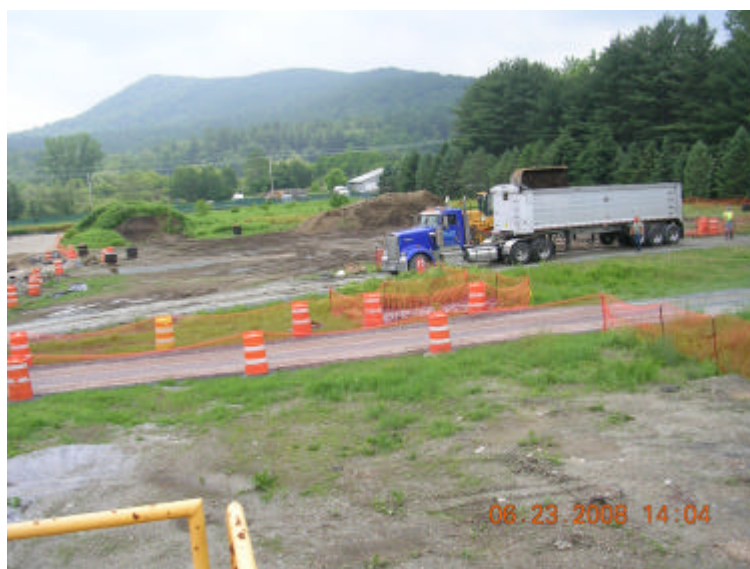
**DSCN3703.JPG**

| PHOTO | DATE | TIME | DESCRIPTION |
|---|---|---|---|
| DSCN 3703 | 6/23/2008 | 1404 | View of DAC loading 18-wheel waste hauling trucks with non-TSCA PCB contaminated soil using a Kawasaki 80ZV Front Loader from earthen mound at the western side of Area 4 looking SW. |

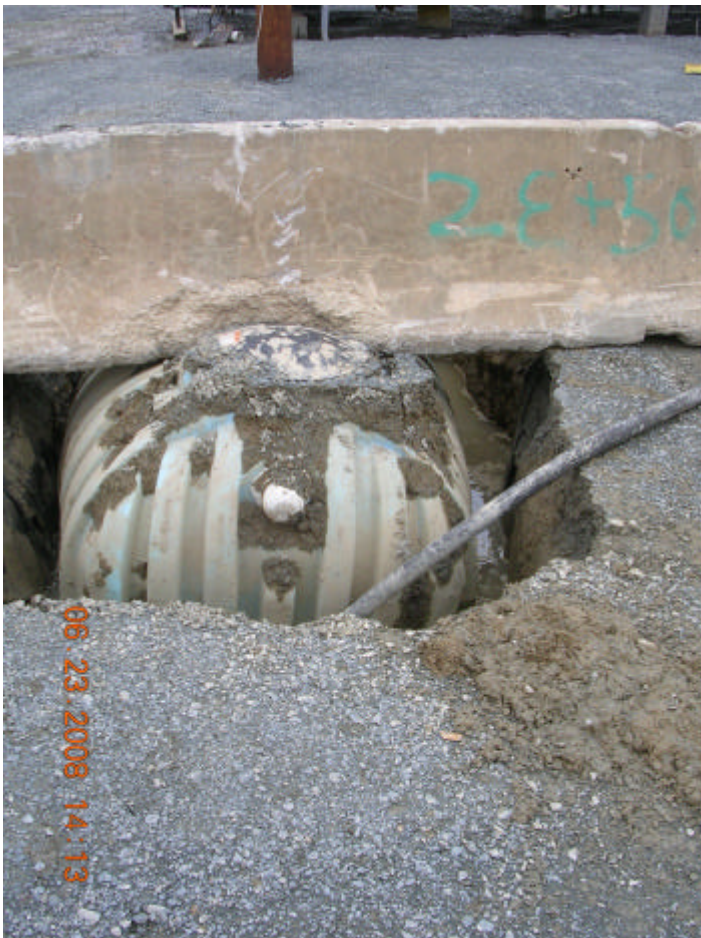
**DSCN3704.JPG**

2. D.A. Collins made repairs to the temporary septic system to the project trailers located at the W-central side of Area 9. During the overnight hours, the empty septic tank apparently floated upward on the rising groundwater table and penetrated the ground surface. The tank was re-installed below grade and temporarily held down with a concrete Jersey barrier until it could be partially filled with water as a countermeasure. Previously installed materials were re-used. However, an additional 1 yd<sup>3</sup> of crusher run was applied around the top and sides of the tank.

| PHOTO | DATE | TIME | DESCRIPTION |
|---|---|---|---|
| DSCN 3704 | 6/23/2008 | 1413 | View of re-positioning of septic tank in excavation near project trailers in Area 9 looking W; The empty tank apparently floated on the high groundwater table and pushed through overlying fill materials to the ground surface; Until the septic tank could be filled with water to hold it down, a concrete Jersey barrier was placed over the tank to hold it in place in the excavation. |

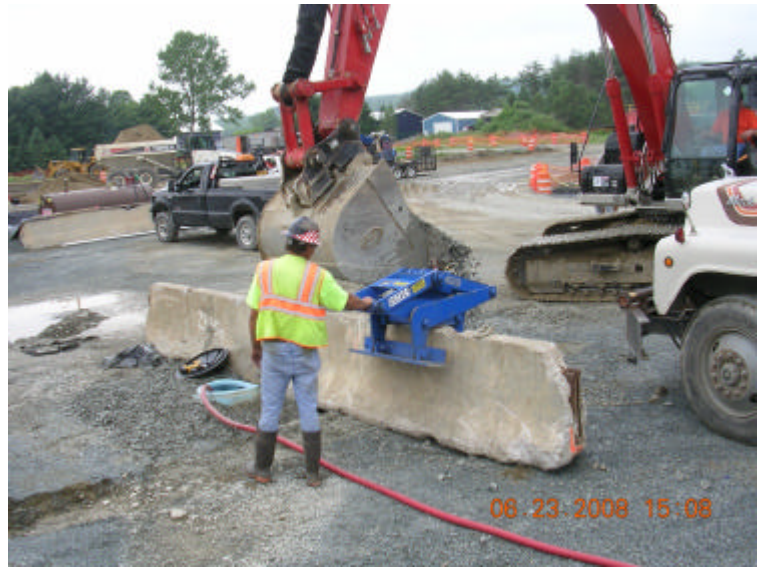
**DSCN3710.JPG**

| PHOTO | DATE | TIME | DESCRIPTION |
|---|---|---|---|
| DSCN 3710 | 6/23/2008 | 1508 | View of placement of crusher run stone over septic tank in excavation near project trailers in Area 9 looking W; The tank was also partially filled with water (left) to hold it in place in the excavation. |

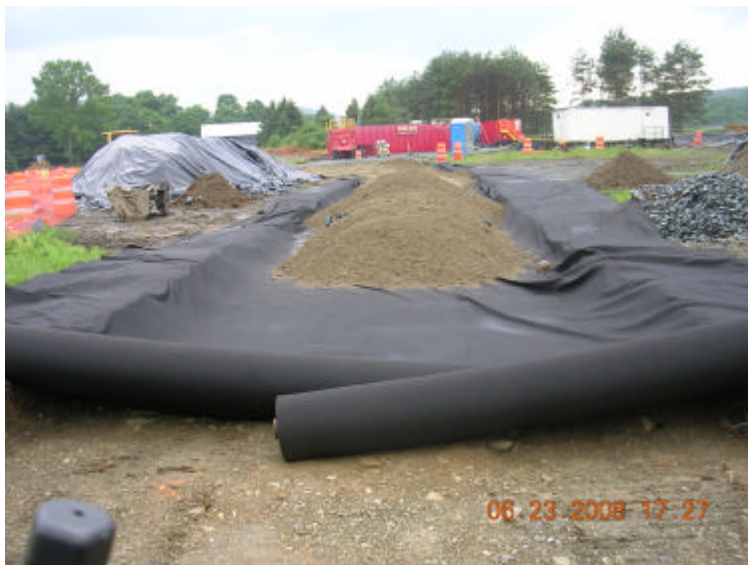
**DSCN3714.JPG**

| PHOTO | DATE | TIME | DESCRIPTION |
|---|---|---|---|
| DSCN 3714 | 6/23/2008 | 1727 | View of progress on construction of access road along the southern boundary of Area 3 looking W near Grid L-13; Common fill sand was placed, graded, and compacted with a Terex End Dump TA30, Caterpillar 6465 Bull Dozer, and Hamm 2593 Vibratory Compaction Roller. |
