REPORT NO. 080624

## DAILY FIELD ACTIVITY REPORT

| PROJECT | Former Bouchard Junkyard | WEATHER | TIME | TEMP. | PRECIP. | WIND (MPH) | WIND (DIR) |
| LOCATION | Town of New Lebanon, NY | Overcast | 0630 | 55-60 F | Some Drizzle | Calm | NA |

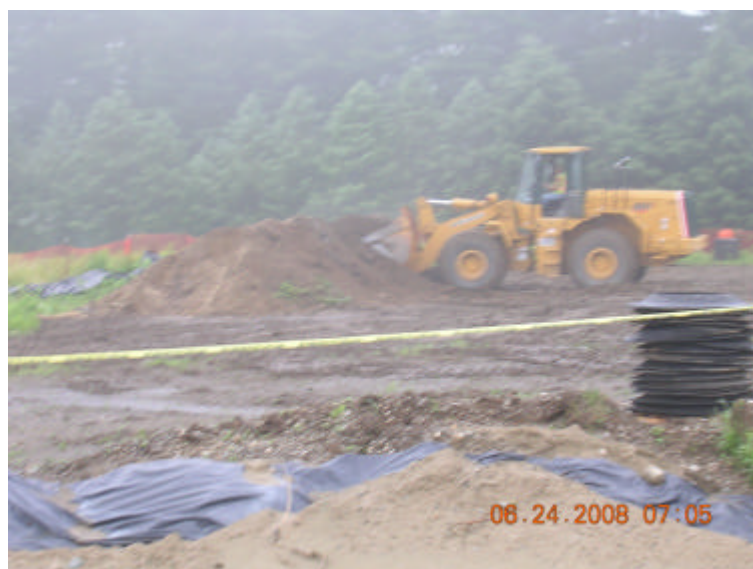
**DSCN3716.JPG**

| PHOTO | DATE | TIME | DESCRIPTION |
|---|---|---|---|
| DSCN 3716 | 6/24/2008 | 0705 | View of DAC loading of non-TSCA PCB contaminated soil using a Kawasaki 80ZV Front Loader from remaining small stockpile at the western side of Area 4 looking SW. |

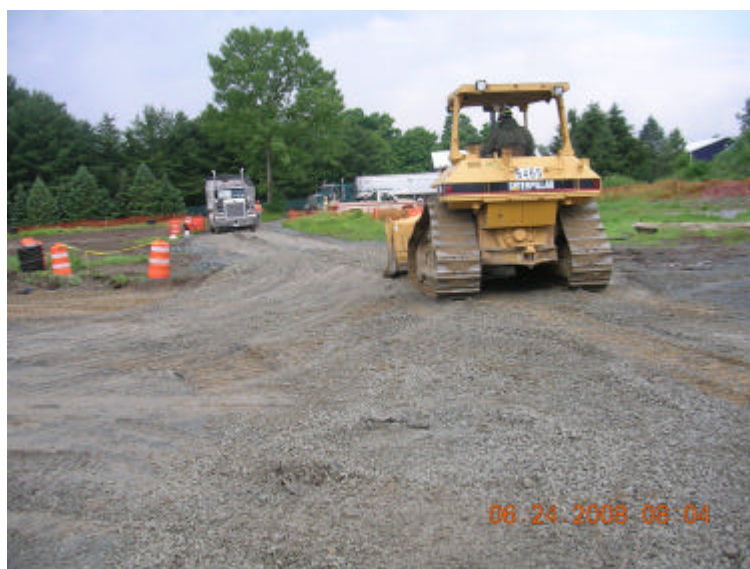
**DSCN3720.JPG**

| PHOTO | DATE | TIME | DESCRIPTION |
|---|---|---|---|
| DSCN 3720 | 6/24/2008 | 0804 | View of DAC performing road maintenance of the waste hauling road; Crusher run stone and Ledgerock stone were installed along the road course as needed in muddy areas and graded with the Caterpillar Bull Dozer; Areas 3/4 looking W. |

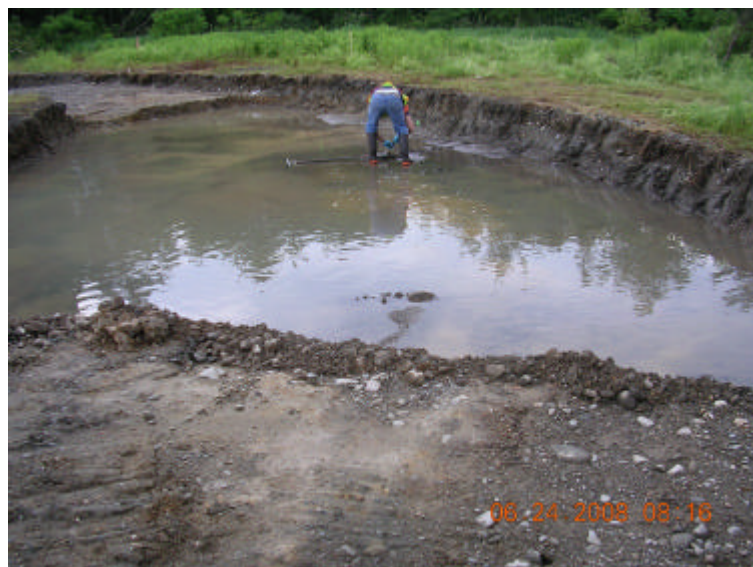
**DSCN3722.JPG**

4. Collected endpoint soil sample Q-9A at 1.5 ft bgs from Area 8 following an additional 0.5 ft of remedial excavation within grid Q-9, due to elevated analytical results of the original soil sample Q-9 at 1 ft.

| PHOTO | DATE | TIME | DESCRIPTION |
|---|---|---|---|
| DSCN 3722 | 6/24/2008 | 0816 | Re-collection of bottom soil sample in Grid Q-9 after additional 0.5 ft of remedial excavation to a completion depth of 1.5 ft bgs; Soil sample EP-Q9A was collected at 1.5 ft bgs; Area 8 looking E. |

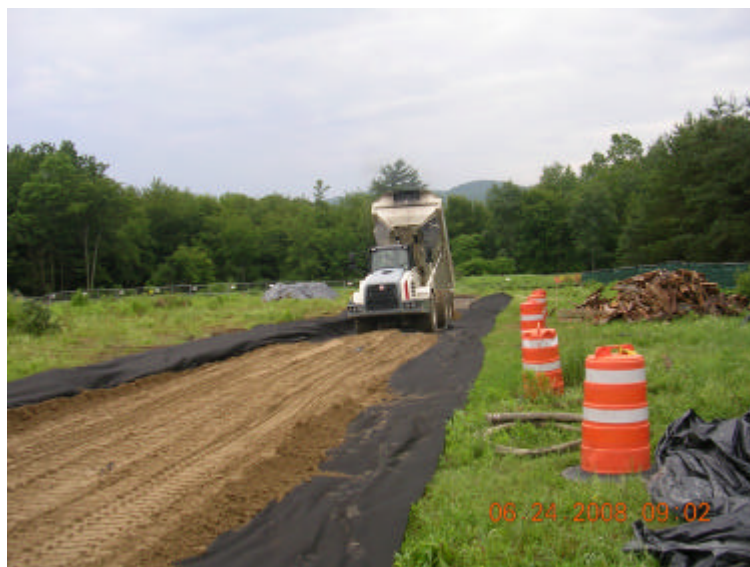
**DSCN3724.JPG**

| PHOTO | DATE | TIME | DESCRIPTION |
|---|---|---|---|
| DSCN 3724 | 6/24/2008 | 0902 | View of progress on construction of access road along the southern boundary of Area 3 looking W near Grid N-10; Common fill sand was placed, graded, and compacted with a Terex End Dump TA30, Caterpillar 6465 Bull Dozer, and Hamm 2593 Vibratory Compaction Roller. |

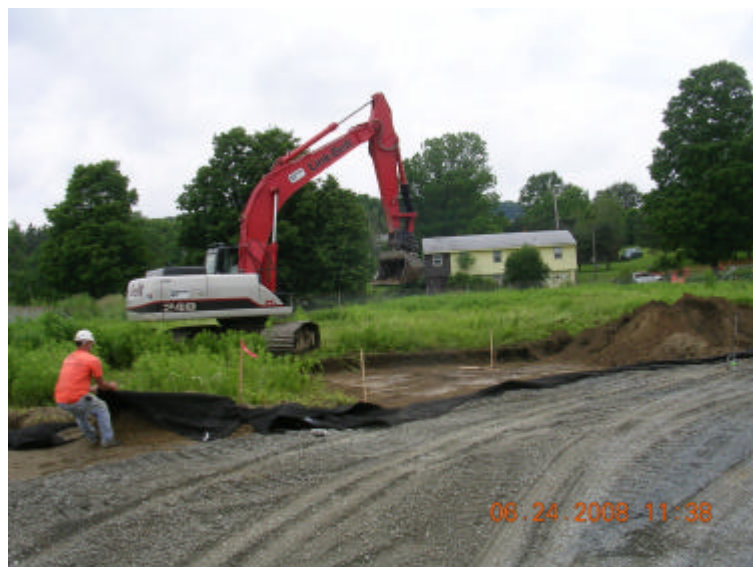
**DSCN3731.JPG**

| PHOTO | DATE | TIME | DESCRIPTION |
|---|---|---|---|
| DSCN 3731 | 6/24/2008 | 1138 | Remedial excavation activities at the NW corner of Area 1 within Grid F-22 utilizing a Link-Belt 240 Trackhoe for excavation; Non-TSCA soil was stockpiled in a on like-material in a centralized location in order to facilitate loading of trucks from the clean access road; View of Area 1 looking N. |

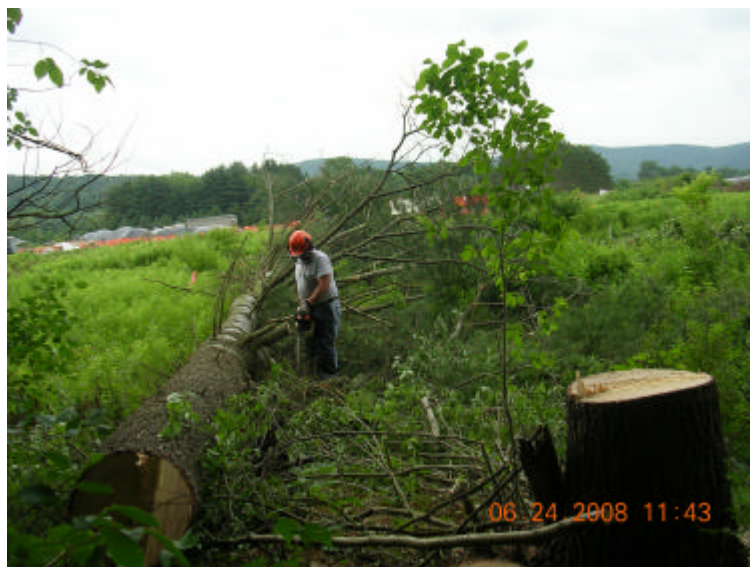
**DSCN3733.JPG**

| PHOTO | DATE | TIME | DESCRIPTION |
|---|---|---|---|
| DSCN 3733 | 6/24/2008 | 1143 | View of clearing and grubbing in Area 8 looking W; Large tree cut down and loaded onto flatbed trailer for off-site transport. |

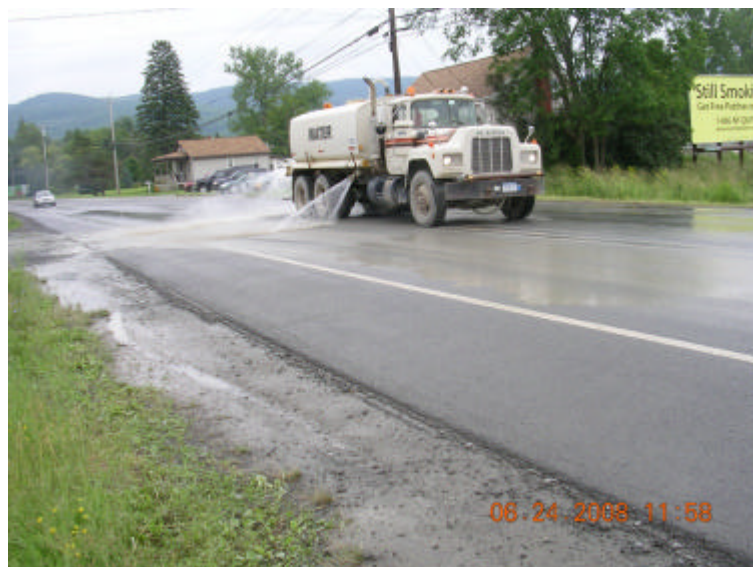
**DSCN3735.JPG**

| PHOTO | DATE | TIME | DESCRIPTION |
|---|---|---|---|
| DSCN 3735 | 6/24/2008 | 1158 | Cleaning of muddy tire tracks in progress onto Route 20 road surface at entrance to driveway to Building 666 using Mack Water Truck; View of Route 20 looking SW. |

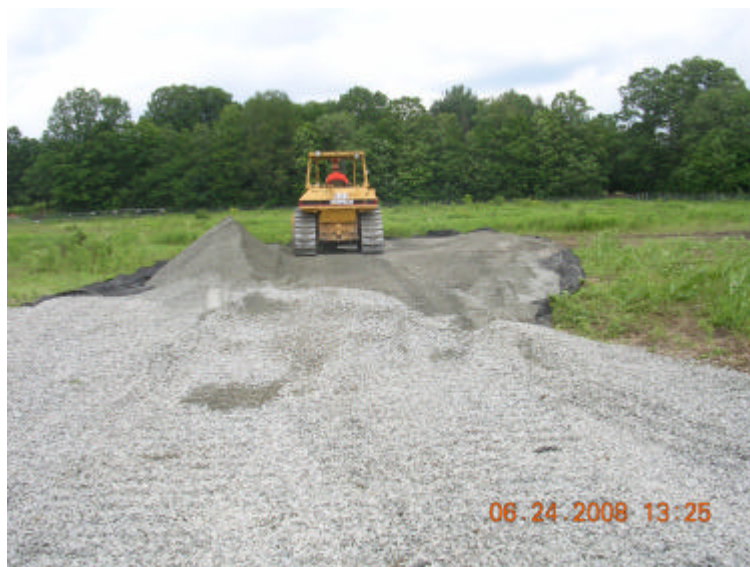
**DSCN3736.JPG**

| PHOTO | DATE | TIME | DESCRIPTION |
|---|---|---|---|
| DSCN 3736 | 6/24/2008 | 1325 | View of new temporary road spur construction for use by waste hauling trucks near non-TSCA and TSCA stockpiles in Area 2 looking NE; Layer of 12 ounce Carthage Mills road fabric was initially placed on non-TSCA grids and overlain with common fill sand and Type 2 sub-base crusher run gravel; Caterpillar Bull Dozer in background. |

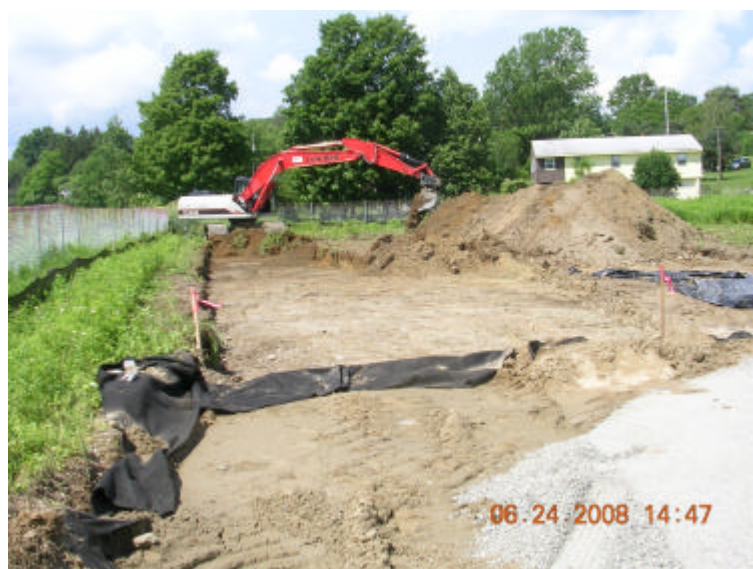
**DSCN3740.JPG**

| PHOTO | DATE | TIME | DESCRIPTION |
|---|---|---|---|
| DSCN 3740 | 6/24/2008 | 1447 | Remedial excavation activities at the NW corner of Area 1 within Grids E-23 and E-24 utilizing a Link-Belt 240 Trackhoe; Non-TSCA soil was stockpiled in a on like-material in a centralized location in order to facilitate loading of trucks from the clean access road; View of Area 1 looking N-NW. |

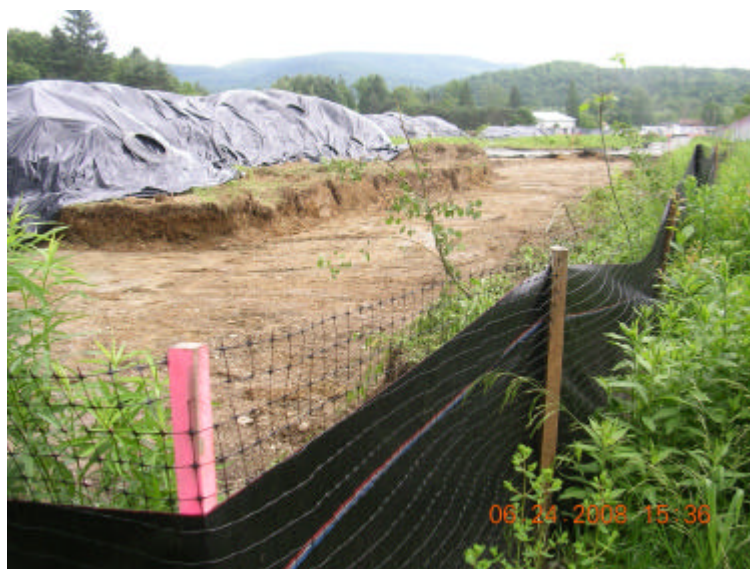
**DSCN3744.JPG**

| PHOTO | DATE | TIME | DESCRIPTION |
|---|---|---|---|
| DSCN 3744 | 6/24/2008 | 1536 | View of completed remedial excavation at close of business at the NW corner of Area 1 (Grids E-23 and E-24 in foreground) utilizing a Link-Belt 240 Trackhoe; Non-TSCA soil was stockpiled in a on like-material in a centralized location in order to facilitate loading of trucks from the clean access road; View of Area 1 looking S-SE from NW corner of planned remedial excavation. |
