## DAILY FIELD ACTIVITY REPORT

| <b>PROJECT</b> | <b>Former Bouchard Junkyard</b> | <b>WEATHER</b> | <b>TIME</b> | <b>TEMP.</b> | <b>PRECIP.</b> | <b>WIND (MPH)</b> | <b>WIND (DIR)</b> |
| <b>LOCATION</b> | <b>Town of New Lebanon, NY</b> | <b>Lifting Fog/Sun</b> | <b>0630</b> | <b>50-55 F</b> | <b>None</b> | <b>Calm</b> | <b>NA</b> |

**PHOTOGRAPHIC LOG**  
**June 25, 2008**  
**D&B JOB NO. 2605**  
**FORMER BOUCHARD JUNKYARD SITE**  
**TOWN OF NEW LEBANON, NEW YORK**

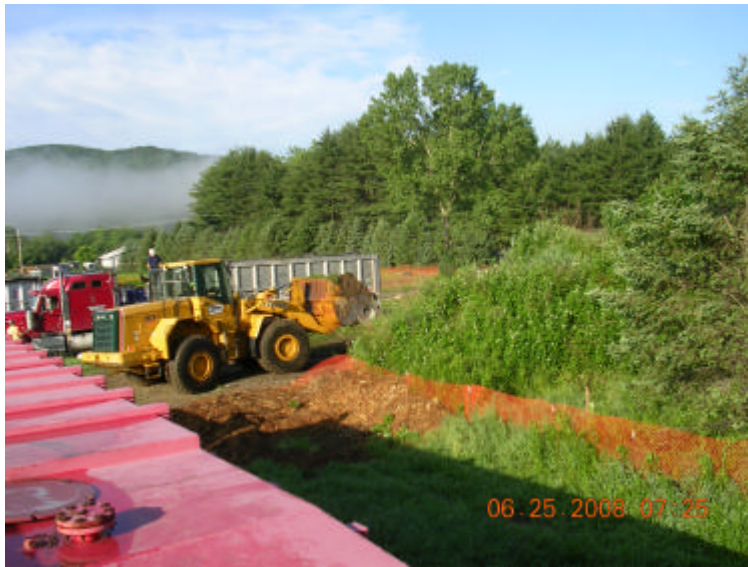
**DSCN3747.JPG**

| PHOTO | DATE | TIME | DESCRIPTION |
|---|---|---|---|
| DSCN 3747 | 6/25/2008 | 0725 | View of DAC loading of non-TSCA PCB contaminated soil using a Kawasaki 802V Front Loader from earthen mound at the northern side of Area 4 looking SW. |

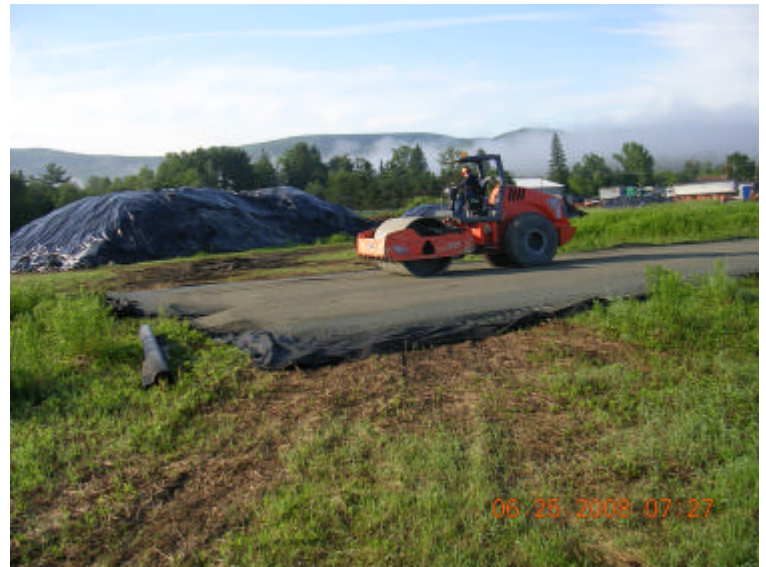
**DSCN3748.JPG**

| PHOTO | DATE | TIME | DESCRIPTION |
|---|---|---|---|
| DSCN 3748 | 6/25/2008 | 0727 | View of new temporary road spur construction for use by waste hauling trucks near non-TSCA and TSCA stockpiles in Area 2 looking SE; Hamm 2593 Vibratory Compaction Roller compacted Type 2 sub-base crusher run gravel. |

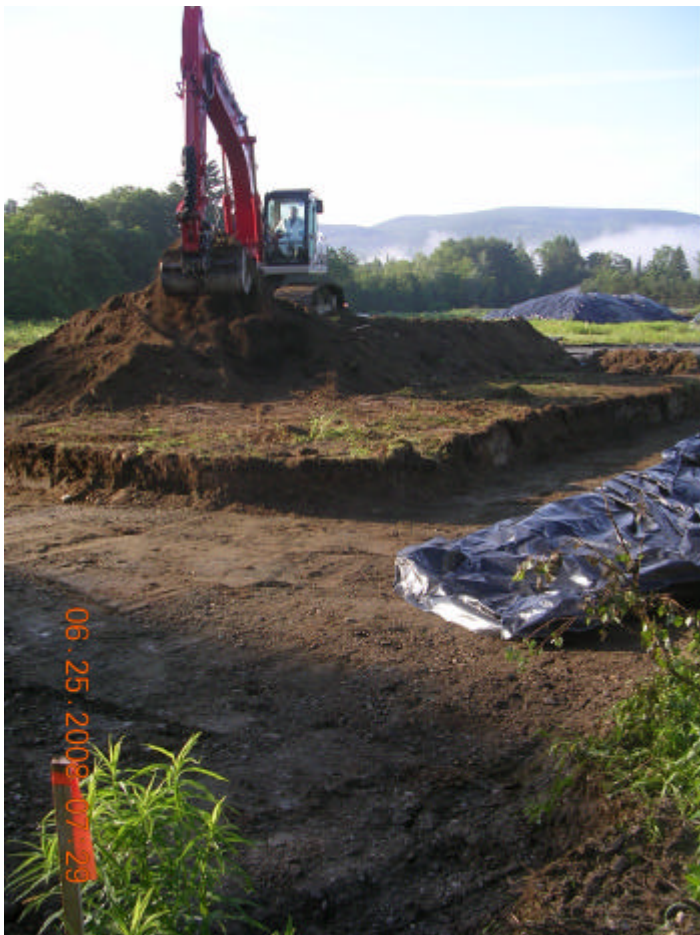
**DSCN3749.JPG**

| PHOTO | DATE | TIME | DESCRIPTION |
|---|---|---|---|
| DSCN 3749 | 6/25/2008 | 0729 | Remedial excavation activities at the NW corner of Area 1 utilizing a Link-Belt 240 Trackhoe; Non-TSCA soil was stockpiled in a on like-material in a centralized location in order to facilitate loading of trucks from the clean access road; Area 1 looking SE. |

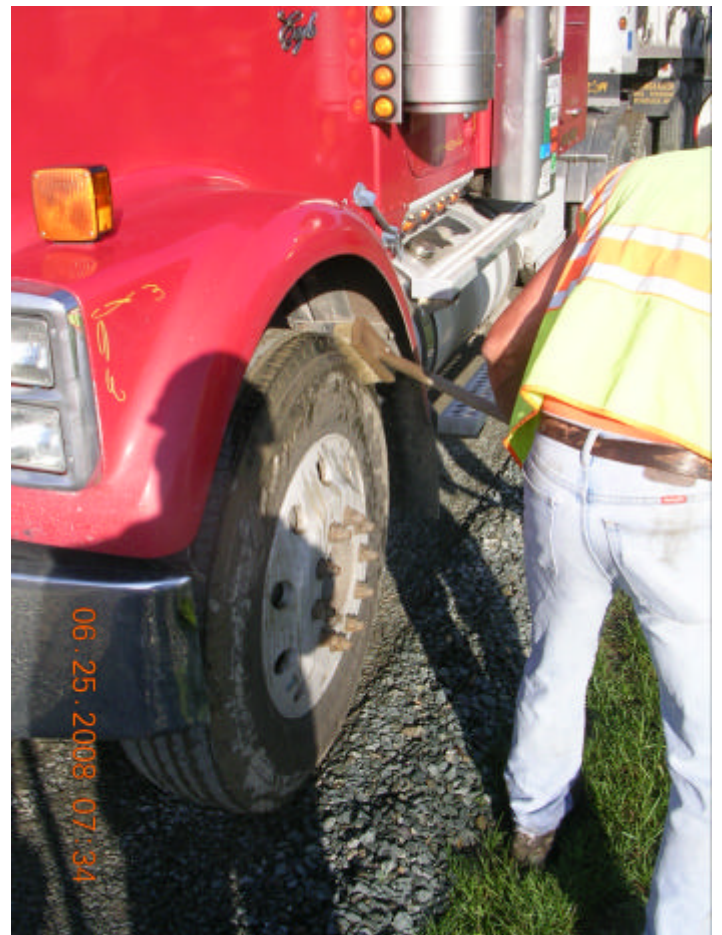
**DSCN3750.JPG**

| PHOTO | DATE | TIME | DESCRIPTION |
|---|---|---|---|
| DSCN 3750 | 6/25/2008 | 0734 | View of DAC removing soil adhered to the truck body, tires, and undercarriage using a wet brush method; Area 2 looking S. |

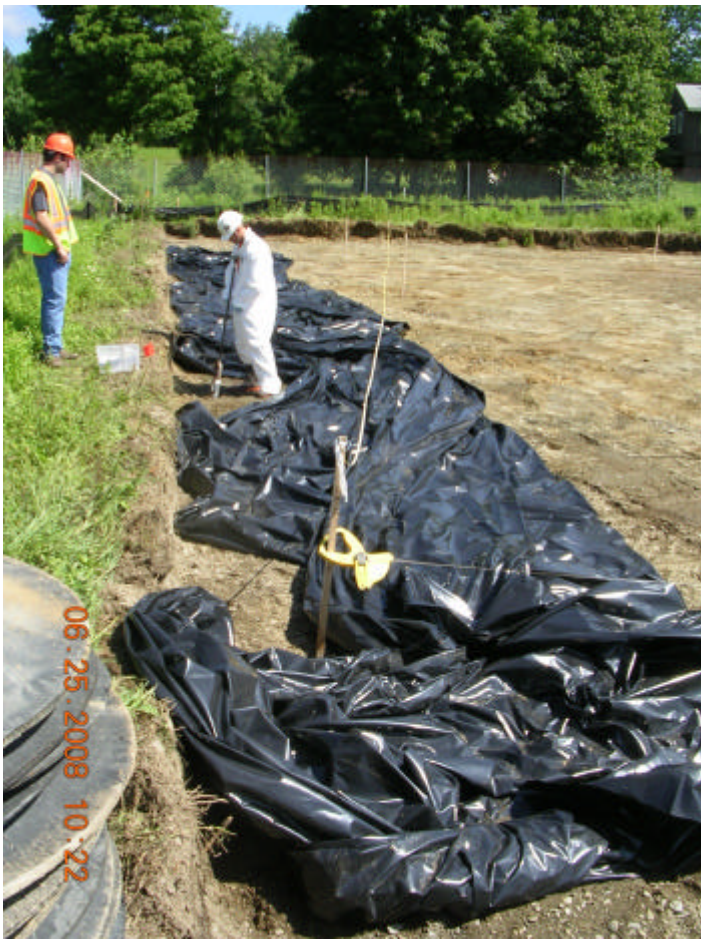
**DSCN3754.JPG**

| PHOTO | DATE | TIME | DESCRIPTION |
|---|---|---|---|
| DSCN 3754 | 6/25/2008 | 1022 | Collection of bottom soil sample at 1.5 ft bgs within grid EP-D23; Duplicate sample EP-DUP06 and MS/MSD/MSB collected here; Area 1 looking N-NW. |

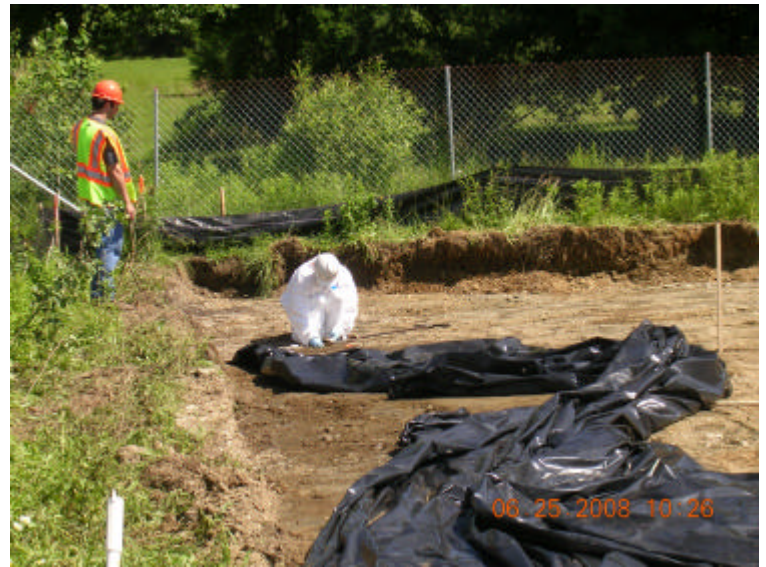
**DSCN3755.JPG**

| PHOTO | DATE | TIME | DESCRIPTION |
|---|---|---|---|
| DSCN 3755 | 6/25/2008 | 1026 | Collection of bottom soil sample at 1.5 ft bgs within grid EP-D24; Area 1 looking N-NW. |

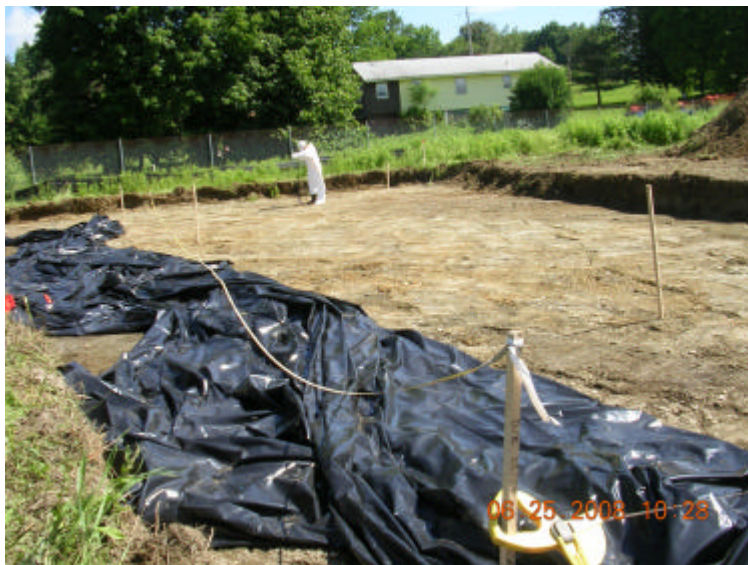
**DSCN3756.JPG**

| PHOTO | DATE | TIME | DESCRIPTION |
|---|---|---|---|
| DSCN 3756 | 6/25/2008 | 1028 | Collection of bottom soil sample at 1.5 ft bgs within grid EP-E24; Area 1 looking N-NE. |

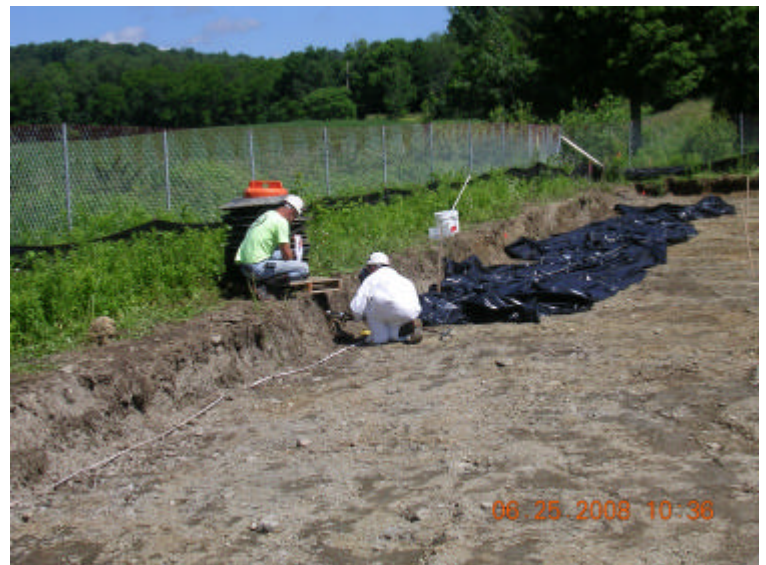
**DSCN3757.JPG**

| PHOTO | DATE | TIME | DESCRIPTION |
|---|---|---|---|
| DSCN 3757 | 6/25/2008 | 1036 | Collection of sidewall soil sample EP-PSW-05 at 0-0.5 ft bgs near the NW corner of Area 1 looking NW. |

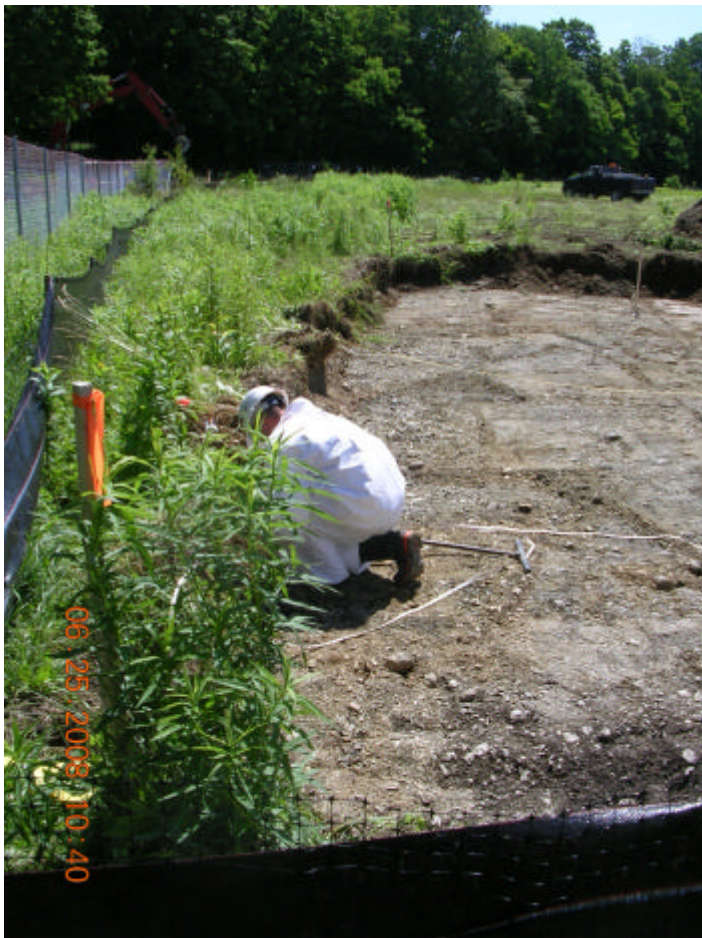
**DSCN3758.JPG**

| PHOTO | DATE | TIME | DESCRIPTION |
|---|---|---|---|
| DSCN 3758 | 6/25/2008 | 1040 | Collection of sidewall soil sample EP-PSW-06 at 0-0.5 ft bgs near the NW corner of Area 1 looking N-NW. |

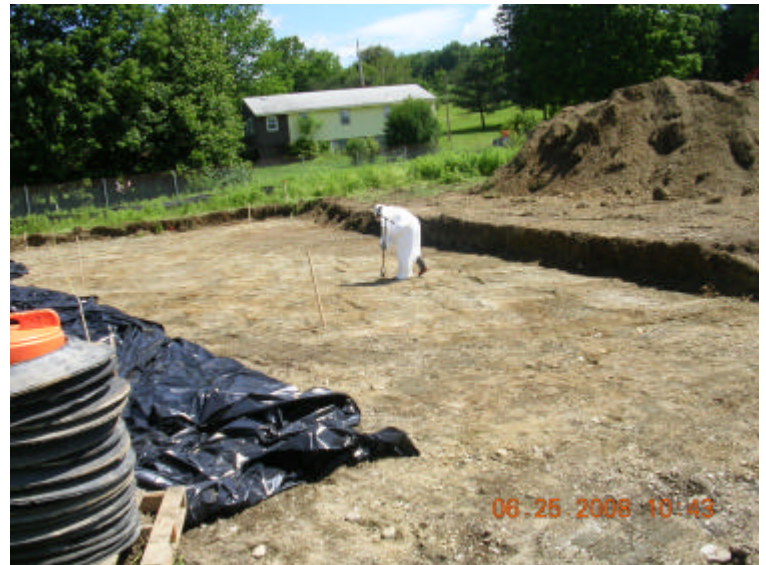
**DSCN3759.JPG**

| PHOTO | DATE | TIME | DESCRIPTION |
|---|---|---|---|
| DSCN 3759 | 6/25/2008 | 1043 | Collection of bottom soil sample at 1.5 ft bgs within grid EP-E23; Area 1 looking NE. |

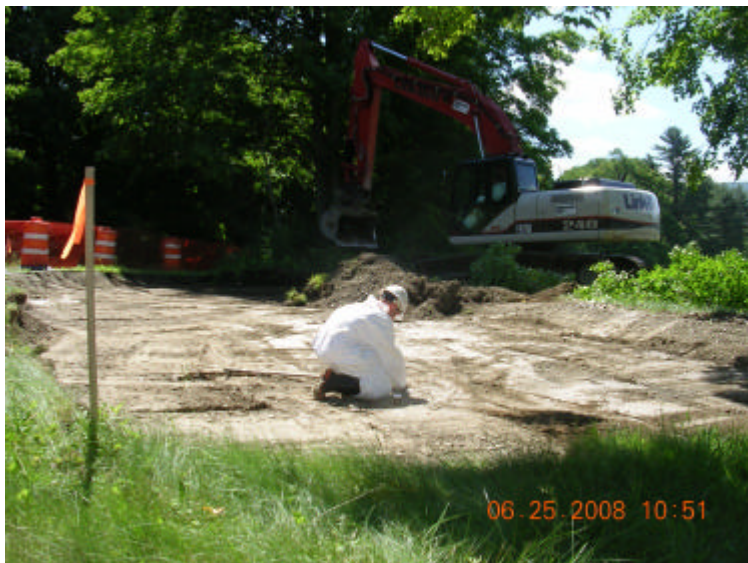
**DSCN3763.JPG**

| PHOTO | DATE | TIME | DESCRIPTION |
|---|---|---|---|
| DSCN 3763 | 6/25/2008 | 1051 | Collection of bottom soil sample at 1 ft bgs within grid EP-G26; Area 1 looking E. Active remedial excavation using a Link-Belt 240 Trackhoe in Grid H26 in the background. |

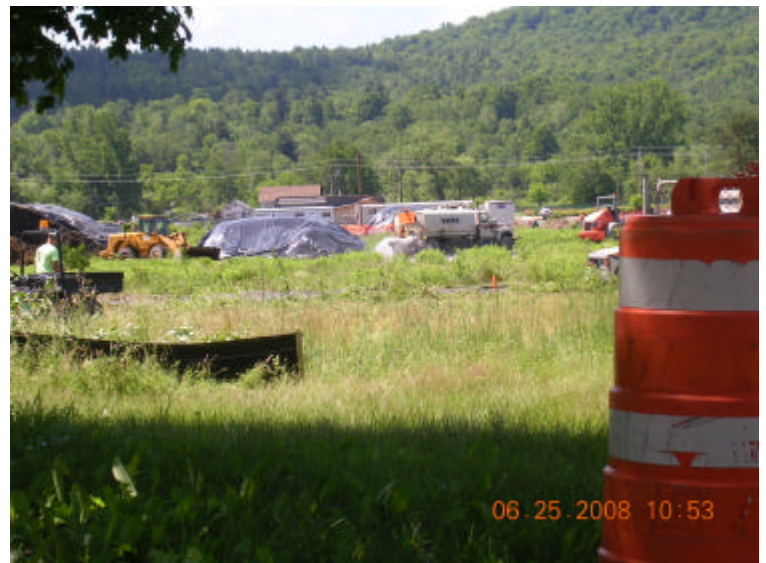
**DSCN3764.JPG**

| PHOTO | DATE | TIME | DESCRIPTION |
|---|---|---|---|
| DSCN 3764 | 6/25/2008 | 1053 | Active dust suppression in Area 2 using a Mack 6561 Water Truck looking S. |

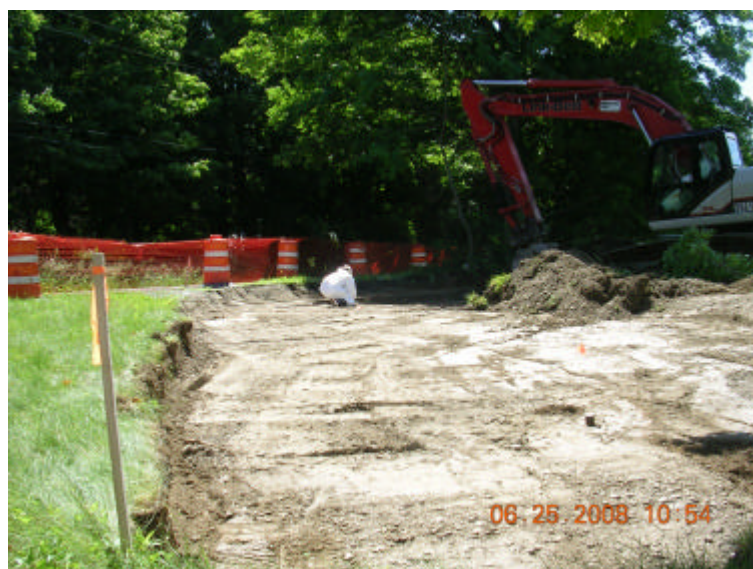
**DSCN3765.JPG**

| PHOTO | DATE | TIME | DESCRIPTION |
|---|---|---|---|
| DSCN 3765 | 6/25/2008 | 1054 | Collection of bottom soil sample at 1 ft bgs within grid EP-H26; Area 1 looking E. |

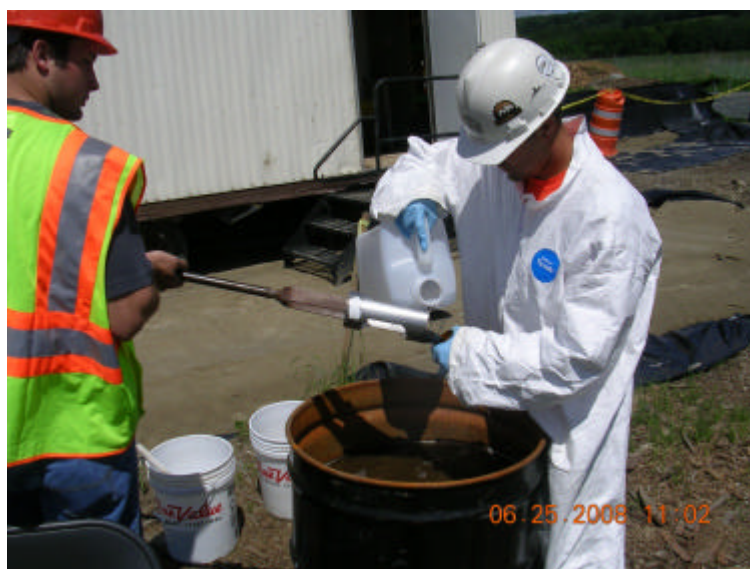
**DSCN3767.JPG**

| PHOTO | DATE | TIME | DESCRIPTION |
|---|---|---|---|
| DSCN 3767 | 6/25/2008 | 1102 | Collection of rinsate sample RINSATE-05 by allowing deionized water to flow across the soil sample corer. |

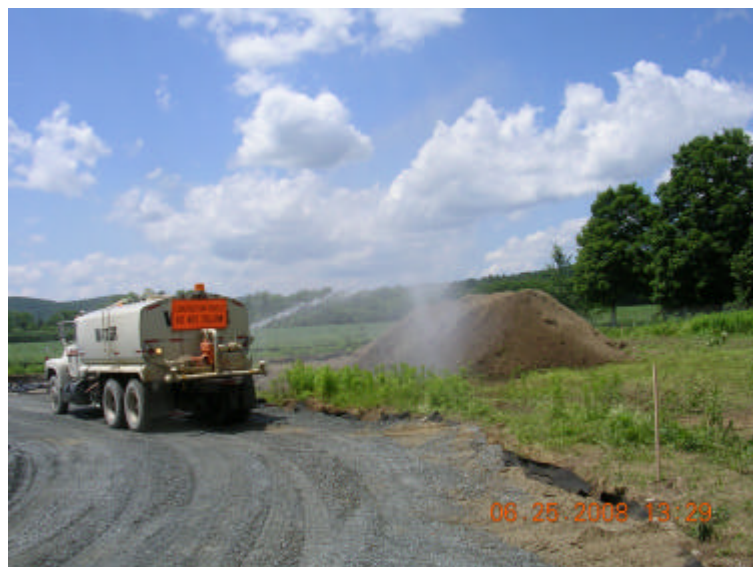
**DSCN3774.JPG**

| PHOTO | DATE | TIME | DESCRIPTION |
|---|---|---|---|
| DSCN 3774 | 6/25/2008 | 1329 | Active dust suppression of the non-TSCA soil stockpile and open remedial excavations in Area 1 using a Mack 6561 Water Truck looking W. |

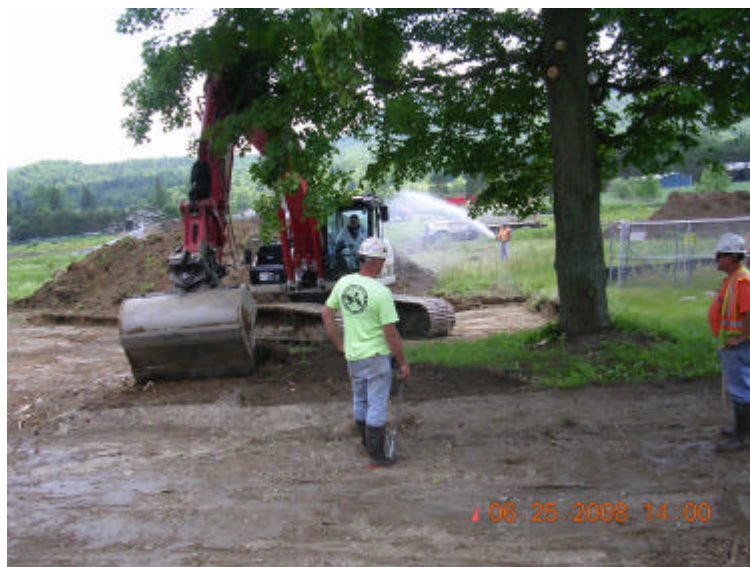
**DSCN3778.JPG**

| PHOTO | DATE | TIME | DESCRIPTION |
|---|---|---|---|
| DSCN 3778 | 6/25/2008 | 1400 | Careful remedial excavation of surface soil with a Link-Belt 240 Trackhoe across the top surface of the root mass of a large maple tree in the Petell residence yard; Active dust suppression of open remedial excavations in the central portion Area 1 in the background using a hose attached to a Mack 6561 Water Truck looking S. |

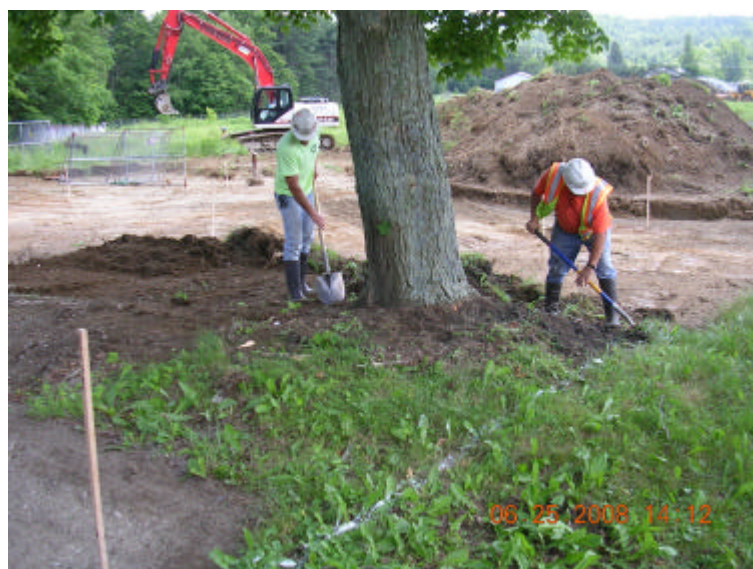
**DSCN3780.JPG**

| PHOTO | DATE | TIME | DESCRIPTION |
|---|---|---|---|
| DSCN 3780 | 6/25/2008 | 1412 | Careful hand digging of PCB-contaminated surface soil across the top surface of the root mass of a large maple tree in the Petell residence yard; Excavation varied from 3-6 inches across this area; Area 1 looking SE. |

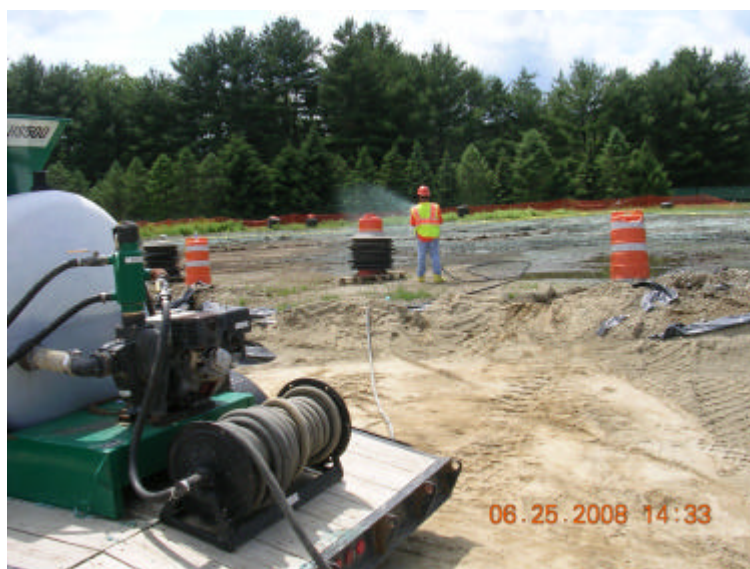
**DSCN3782.JPG**

| PHOTO | DATE | TIME | DESCRIPTION |
|---|---|---|---|
| DSCN 3782 | 6/25/2008 | 1433 | D.A. Collins applied hydroseed mulch with tackifier to the ground surface on the ground surface where the former non-TSCA PCB-contaminated soil stockpile was stage in Area 4 (Grids C-5 through C-7, D-3 through D-7, and D-10, and, E-5 through E-7) using a MS Sprayer Model HS500 Hydro-Seeding Unit Trailer; View of Area 4 looking W. |

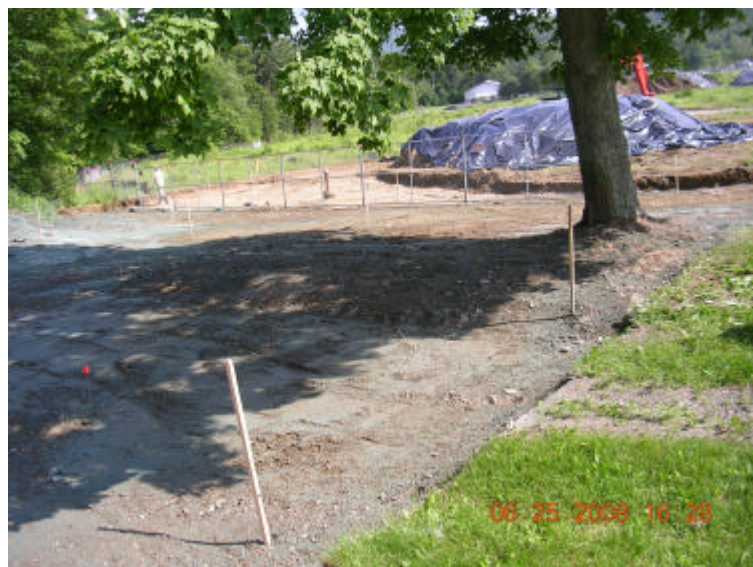
**DSCN3784.JPG**

| PHOTO | DATE | TIME | DESCRIPTION |
|---|---|---|---|
| DSCN 3784 | 6/25/2008 | 1628 | View of completed remedial excavation at close of business at the NW corner of Area 1 (Grid G-26 in foreground); Non-TSCA soil was stockpiled in a on like-material in a centralized location in order to facilitate loading of trucks from the clean access road; View of Area 1 looking SE from Patell residence. |
