DAILY FIELD ACTIVITY REPORT

PROJECT	Former Bouchard Junkyard	WEATHER	TIME	TEMP.	PRECIP.	WIND (MPH)	WIND (DIR)
LOCATION	Town of New Lebanon, NY	Overcast	0700	55-60 F	Few Sprinkles	Calm	NA
ATTACHMENTS	Photo Log and Photos	T-Storms	1630	70-75 F	Intense Rain	0-5	NE

PHOTOGRAPHIC LOG
June 26, 2008
D&B JOB NO. 2605
FORMER BOUCHARD JUNKYARD SITE
TOWN OF NEW LEBANON, NEW YORK

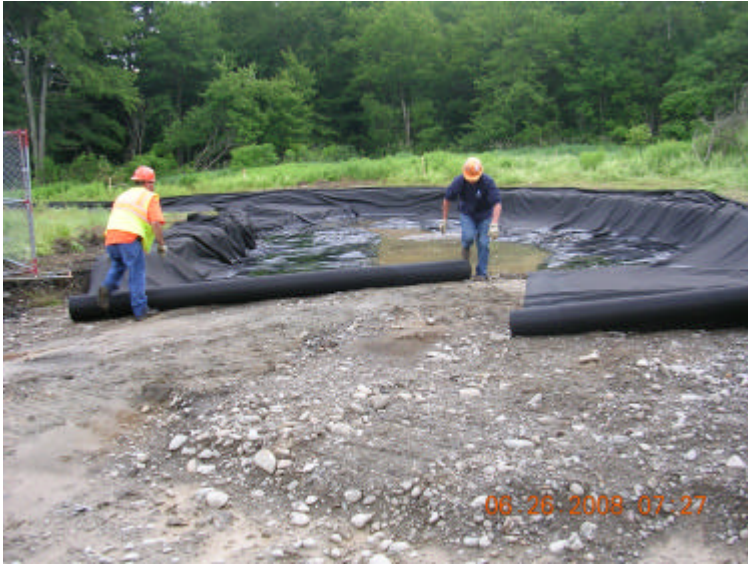
DSCN3790.JPG

PHOTO	DATE	TIME	DESCRIPTION
DSCN 3790	6/26/2008	0727	View of DAC placing 12 ounce Carthage Mills road fabric on the road bed of the hairpin turn located in the central part of Area 8 looking E.
DSCN 3793	6/26/2008	0944	Collection of bottom soil sample at 1 ft bgs within grid EP-F24; Area 1 looking E.
DSCN 3794	6/26/2008	0945	Collection of bottom soil sample at 1 ft bgs within grid EP-G24; Area 1 looking E.
DSCN 3795	6/26/2008	0949	Collection of bottom soil sample at 1 ft bgs within grid EP-I24; Area 1 looking E.
DSCN 3796	6/26/2008	0951	Collection of bottom soil sample at 1 ft bgs within grid EP-I25; Area 1 looking E.
DSCN 3797	6/26/2008	0953	Collection of bottom soil sample at 1 ft bgs within grid EP-H25; Area 1 looking E.
DSCN 3798	6/26/2008	0955	Collection of bottom soil sample at 1 ft bgs within grid EP-H24 (MS/MSD/MSB collected at this location); Area 1 looking E.
DSCN 3799	6/26/2008	0957	Collection of bottom soil sample at 1 ft bgs within grid EP-G25 (Duplicate sample EP-DUP07 collected at this location); Area 1 looking NE.

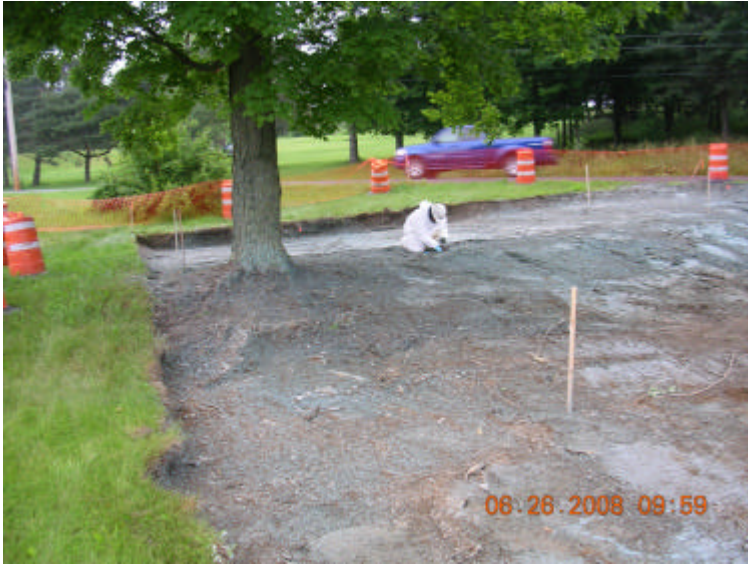
DSCN3800.JPG

DSCN 3800	6/26/2008	0959	Collection of bottom soil sample at 1 ft bgs within grid G-25 in area of remedial excavation within root system of existing maple tree left in place (Sample ID EP-G25TREE); Area 1 looking NE.
DSCN 3801	6/26/2008	1002	Collection of bottom soil sample at 1 ft bgs within grid EP-G24; Area 1 looking E.
DSCN 3802	6/26/2008	1004	Collection of sidewall soil sample EP-PSW-07 at 0-0.5 ft bgs adjacent to Grid F24 within Area 1 looking E.
DSCN 3803	6/26/2008	1007	Collection of sidewall soil sample EP-PSW-08 at 0-0.5 ft bgs adjacent to Grid G-2; within Area 1 looking N.
DSCN 3804	6/26/2008	1010	Collection of sidewall soil sample EP-PSW-09 at 0-0.5 ft bgs adjacent to Grid I-26 within Area 1 looking SE.
DSCN 3805	6/26/2008	1015	Collection of sidewall soil sample EP-PSW-10 at 0-0.5 ft bgs adjacent to Grid I-24 within Area 1 looking S.
DSCN 3806	6/26/2008	1038	Collection of surface soil sample SS-SMITH-0608 at 0-1 ft bgs from the backyard of the Smith residence at 663 Route 20; The agreed location of the sample by owner, D&B, and NYSDEC was selected adjacent to a small garden (right side of photo) between the backyard fenced area (background) and the swimming pool (immediately behind photographer's view), since this area is regarded as a high pedestrian traffic area; View to the N; Swimming pool pump to the right.

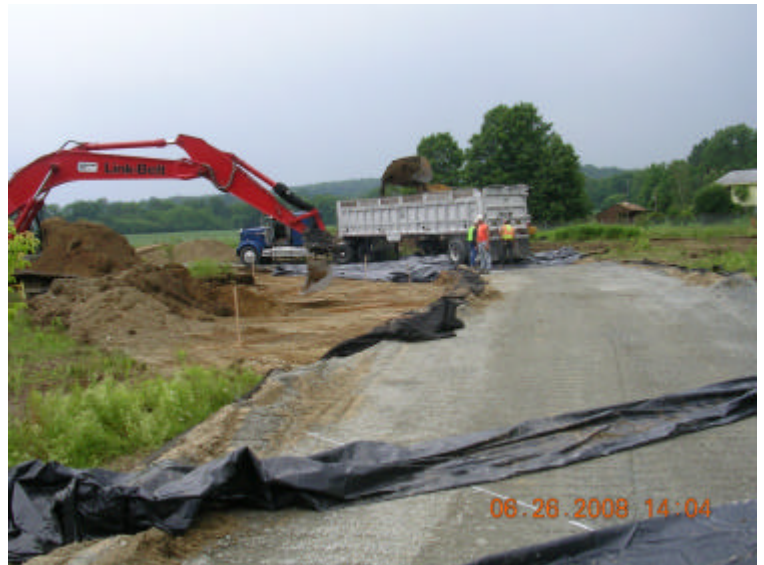
DSCN3810.JPG

DSCN 3810	6/26/2008	1404	View of DAC loading of non-TSCA PCB contaminated soil using a Kawasaki 80ZV Front Loader from a soil stockpile at the western side of Area 1 looking SW.
DSCN 3812	6/26/2008	1444	Cleaning of muddy tire tracks in progress onto Route 20 road surface at entrance to driveway to Building 666 using 4,000 gallon Water Truck; View of Route 20 looking SW.
DSCN 3813	6/26/2008	1544	Collection of treated water sample TW-01 from the tertiary FRAC tank in Area 4 looking W-NW.
DSCN 3816	6/26/2008	1556	View of progress on construction of access road along the hairpin turn in the central part of Area 8 looking SE near Grids P-9, P-10, and P-11; Common fill sand was placed, grated, and compacted with a Caterpillar 6465 Bull Dozer and Hamm 2593 Vibratory Compaction Roller.
DSCN 3817	6/26/2008	1740	View of DAC's site meeting board showing current site progress including remedial excavations along the proposed access road.
