## DAILY FIELD ACTIVITY REPORT

| <b>PROJECT</b> | <b>Former Bouchard Junkyard</b> | <b>WEATHER</b> | <b>TIME</b> | <b>TEMP.</b> | <b>PRECIP.</b> | <b>WIND (MPH)</b> | <b>WIND (DIR)</b> |

**PROJECT NO. 2605**

**PHOTOGRAPHIC LOG**  
**July 1, 2008**  
**D&B JOB NO. 2605**  
**FORMER BOUCHARD JUNKYARD SITE**  
**TOWN OF NEW LEBANON, NEW YORK**

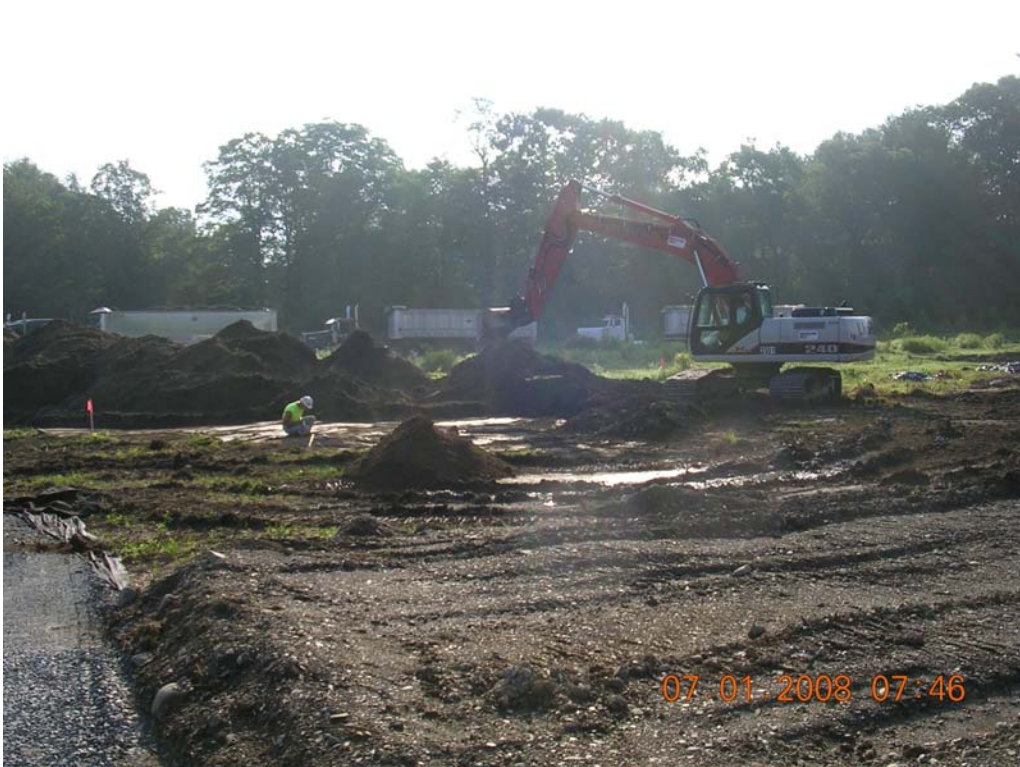
DSCN3870.JPG

| PHOTO | DATE | TIME | DESCRIPTION |
|---|---|---|---|
| DSCN 3870 | 7/1/2008 | 0746 | Remedial excavation activities within the central part of Area 1 within Grid I-18 utilizing a Link-Belt 240 Trackhoe for excavation; Non-TSCA soil was stockpiled in a on like-material in a centralized location in order to facilitate loading of trucks from the clean access road; View of Area 1 looking E. |

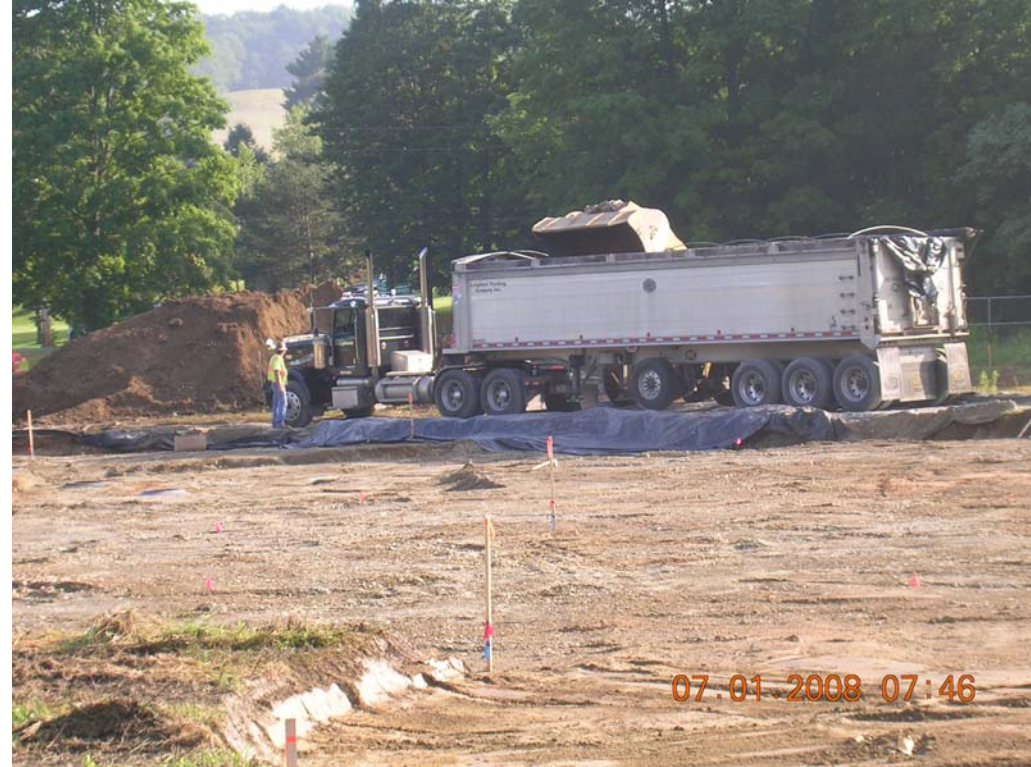
DSCN3871.JPG

| PHOTO | DATE | TIME | DESCRIPTION |
|---|---|---|---|
| DSCN 3871 | 7/1/2008 | 0746 | View of DAC loading of non-TSCA PCB contaminated soil using a Kawasaki 80ZV Front Loader from a soil stockpile at the central part of Area 1 looking N. |

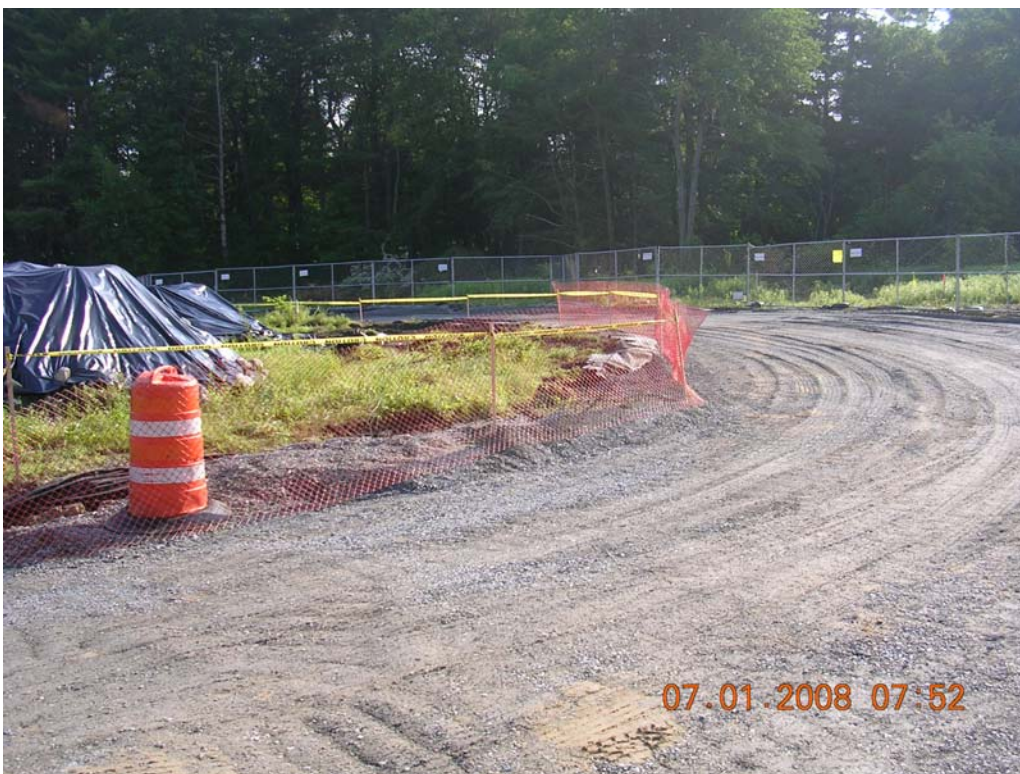
DSCN3872.JPG

| PHOTO | DATE | TIME | DESCRIPTION |
|---|---|---|---|
| DSCN 3872 | 7/1/2008 | 0752 | View of finished repairs to road on inside bend of the hairpin turn in central Area looking NE; Road was widened to make the road wider for trucks to make the turn without tires leaving the roadway; Tire tracks observed in photograph indicate vehicles are able to keep tires on road surface. |

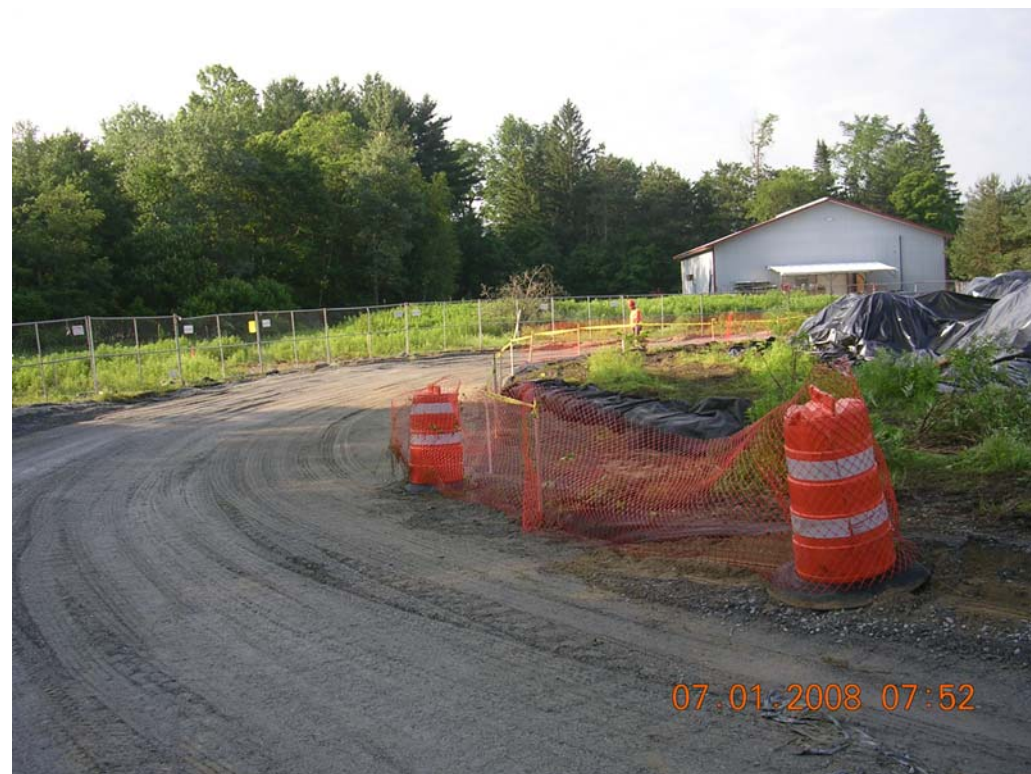
DSCN3873.JPG

| PHOTO | DATE | TIME | DESCRIPTION |
|---|---|---|---|
| DSCN 3873 | 7/1/2008 | 0752 | Another view of finished repairs to road on inside bend of the hairpin turn in central Area 8 looking SW; Road was widened to make the road wider for trucks to make the turn without tires leaving the roadway; Tire tracks observed in photograph indicate vehicles are able to keep tires on road surface. |

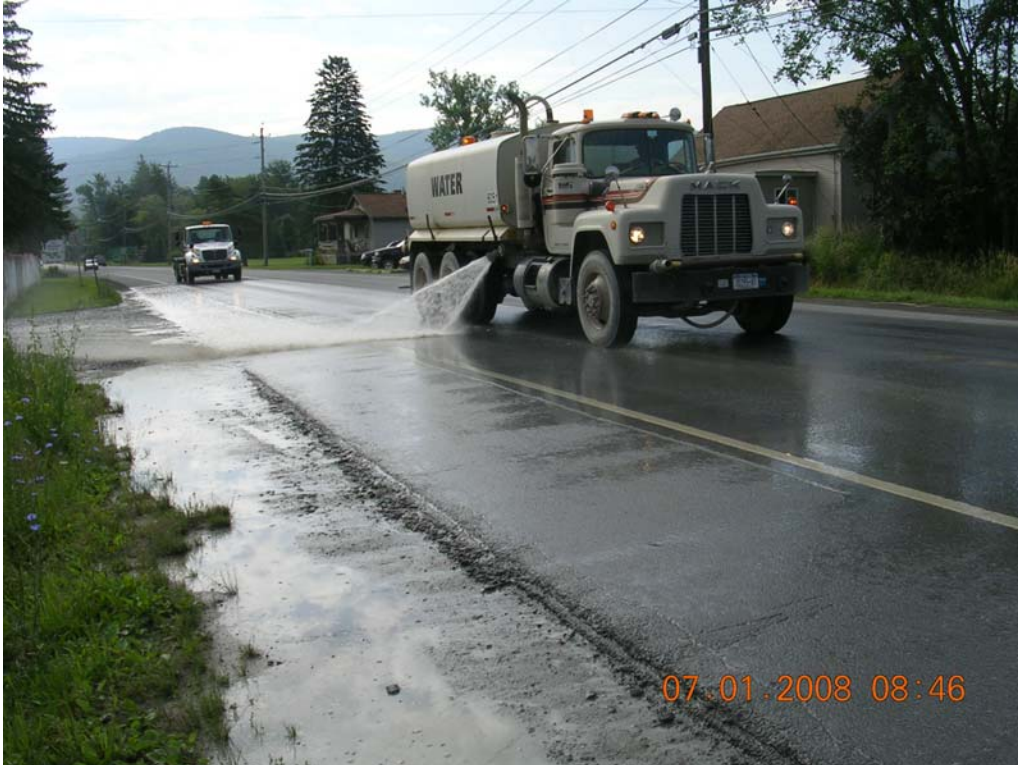
DSCN3874.JPG

| PHOTO | DATE | TIME | DESCRIPTION |
|---|---|---|---|
| DSCN 3874 | 7/1/2008 | 0846 | Cleaning of muddy tire tracks in progress onto Route 20 road surface at entrance to driveway to Building 666 using 4,000 gallon Roscoe Water Truck; View of Route 20 looking SE. |

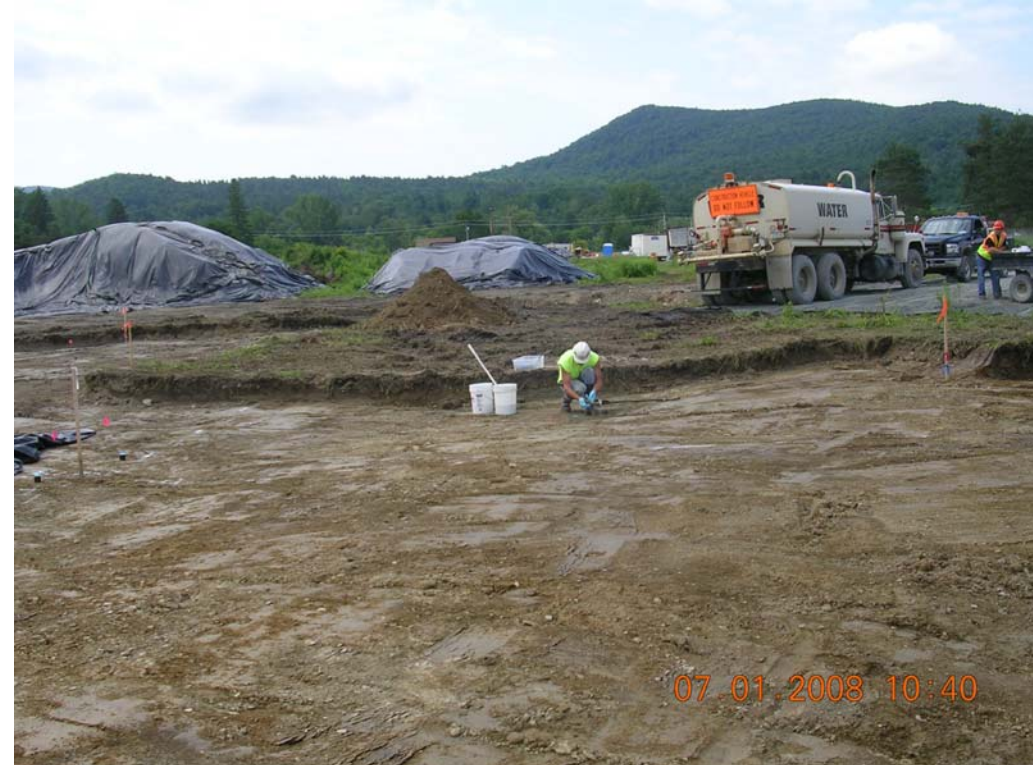
DSCN3879.JPG

| PHOTO | DATE | TIME | DESCRIPTION |
|---|---|---|---|
| DSCN 3879 | 7/1/2008 | 1040 | Collection of bottom soil sample at 1 ft bgs within grid EP-H18; Area 1 looking S. |

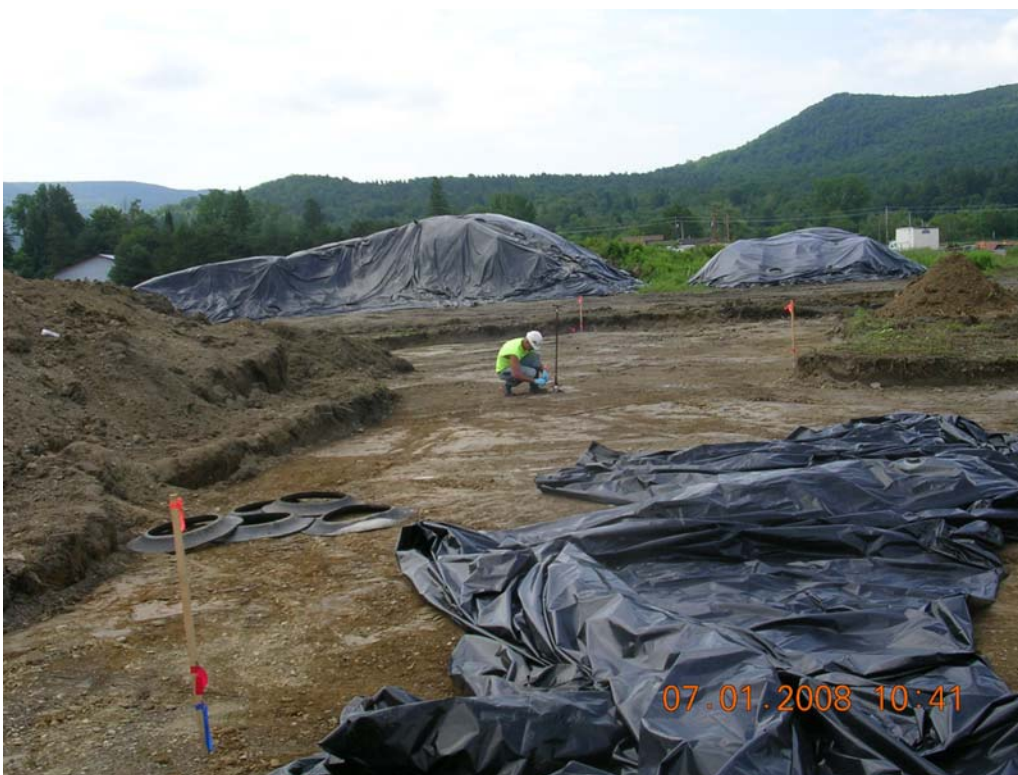
DSCN3880.JPG

| PHOTO | DATE | TIME | DESCRIPTION |
|---|---|---|---|
| DSCN 3880 | 7/1/2008 | 1041 | Collection of bottom soil sample at 1 ft bgs within grid EP-I18; Area 1 looking S. |

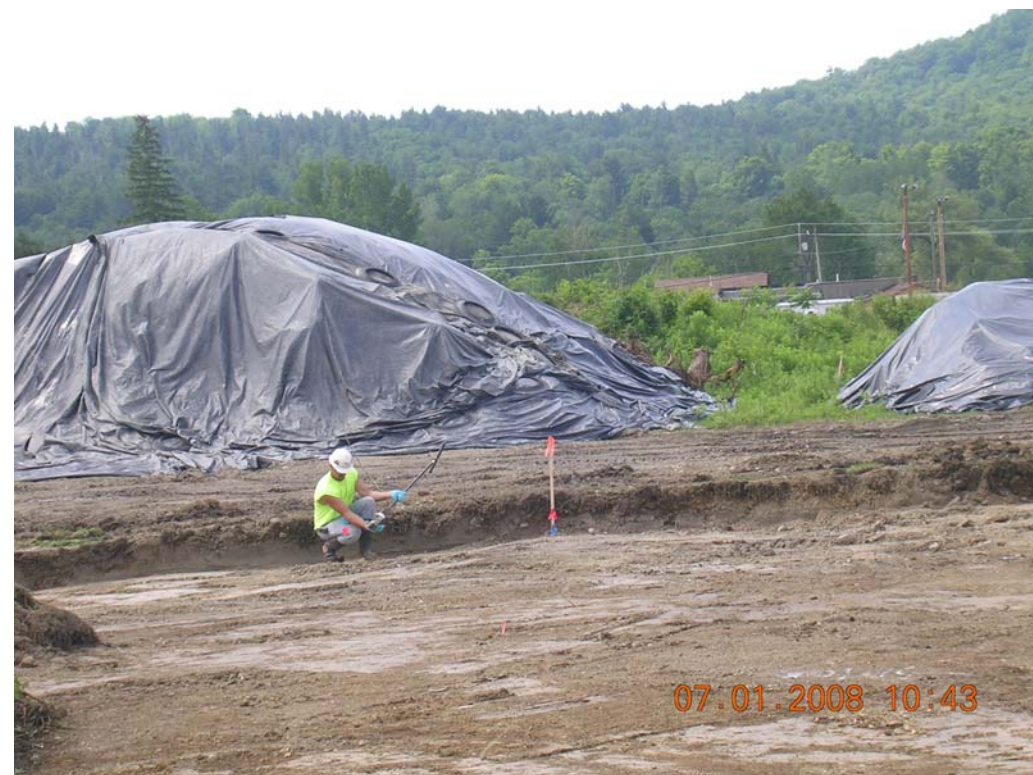
DSCN3881.JPG

| PHOTO | DATE | TIME | DESCRIPTION |
|---|---|---|---|
| DSCN 3881 | 7/1/2008 | 1043 | Collection of bottom soil sample at 1 ft bgs within grid EP-I17; Area 1 looking S. |

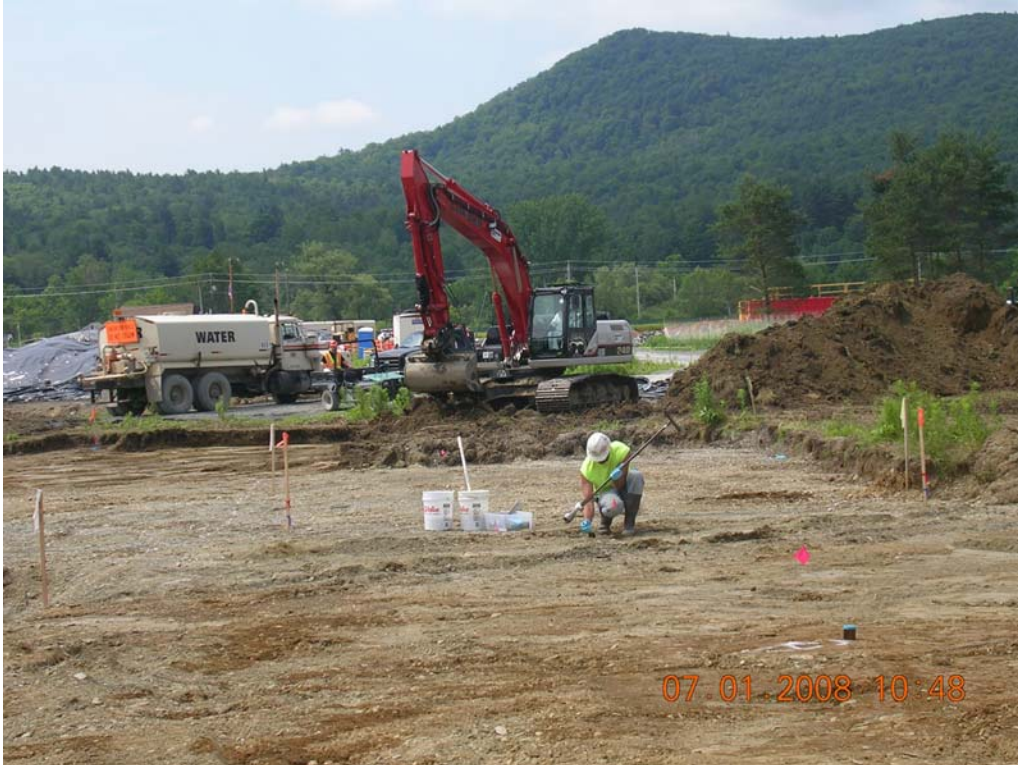
DSCN3883.JPG

| PHOTO | DATE | TIME | DESCRIPTION |
|---|---|---|---|
| DSCN 3883 | 7/1/2008 | 1048 | Collection of bottom soil sample at 1 ft bgs within grid EP-G20 (Non-TSCA portion of grid); Area 1 looking S. |

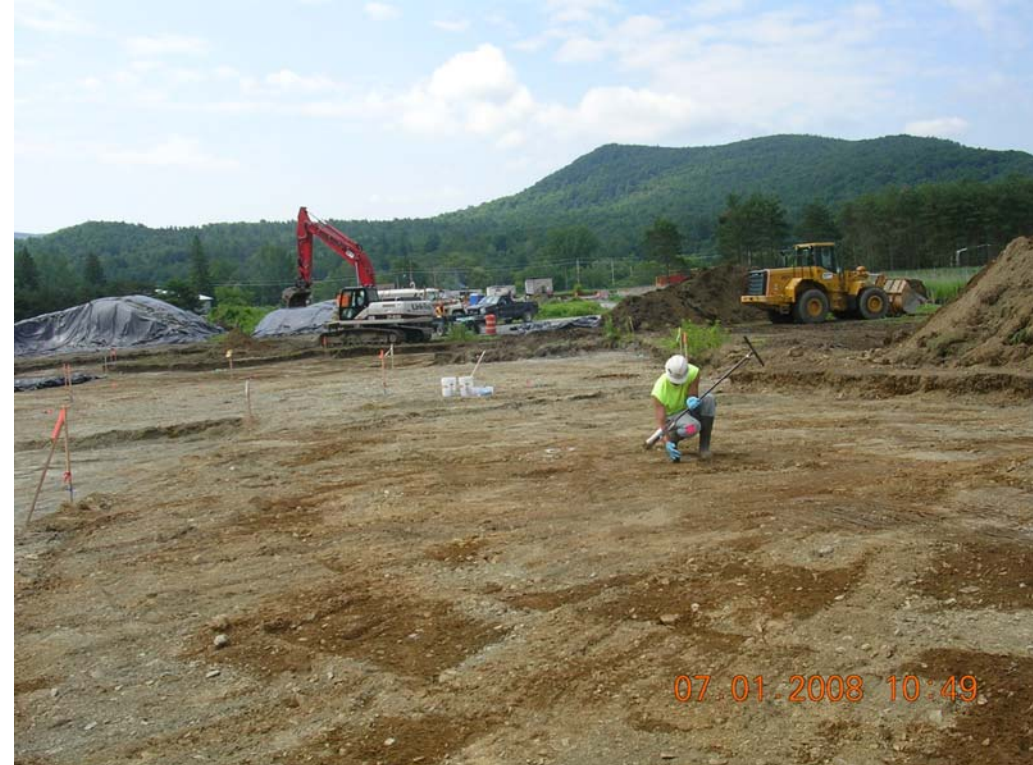
DSCN3884.JPG

| PHOTO | DATE | TIME | DESCRIPTION |
|---|---|---|---|
| DSCN 3884 | 7/1/2008 | 1049 | Collection of bottom soil sample at 1 ft bgs within grid EP-G21; Area 1 looking S. |

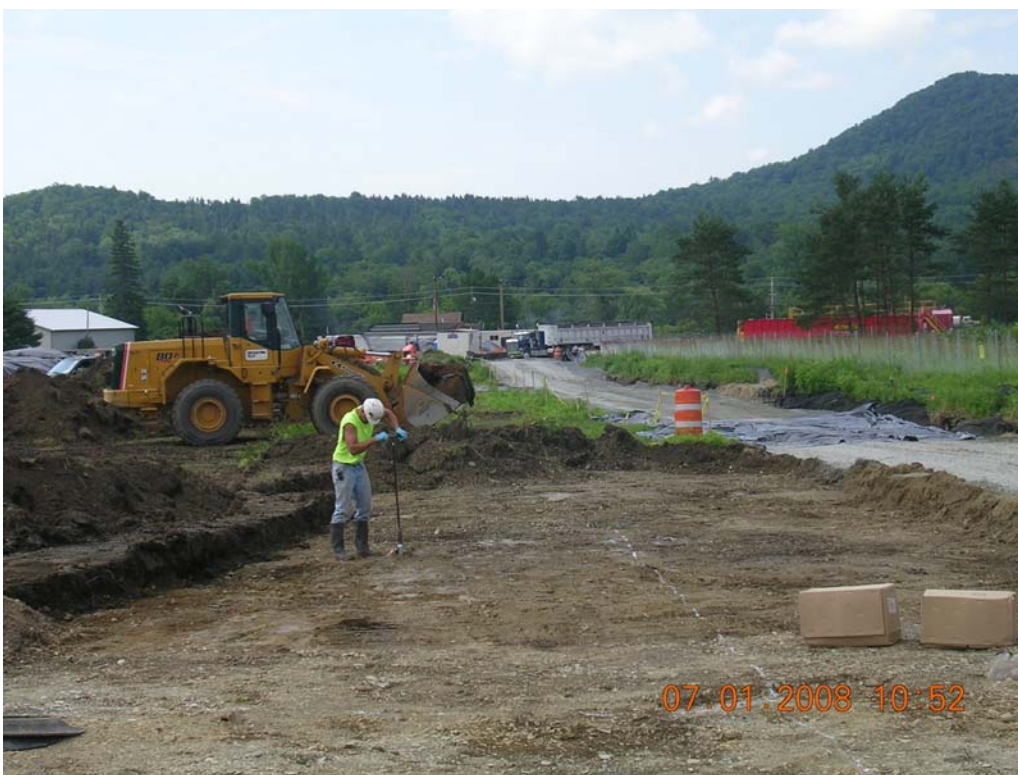
DSCN3885.JPG

| PHOTO | DATE | TIME | DESCRIPTION |
|---|---|---|---|
| DSCN 3885 | 7/1/2008 | 1052 | Collection of bottom soil sample at 1 ft bgs within grid EP-F20; Area 1 looking S. |

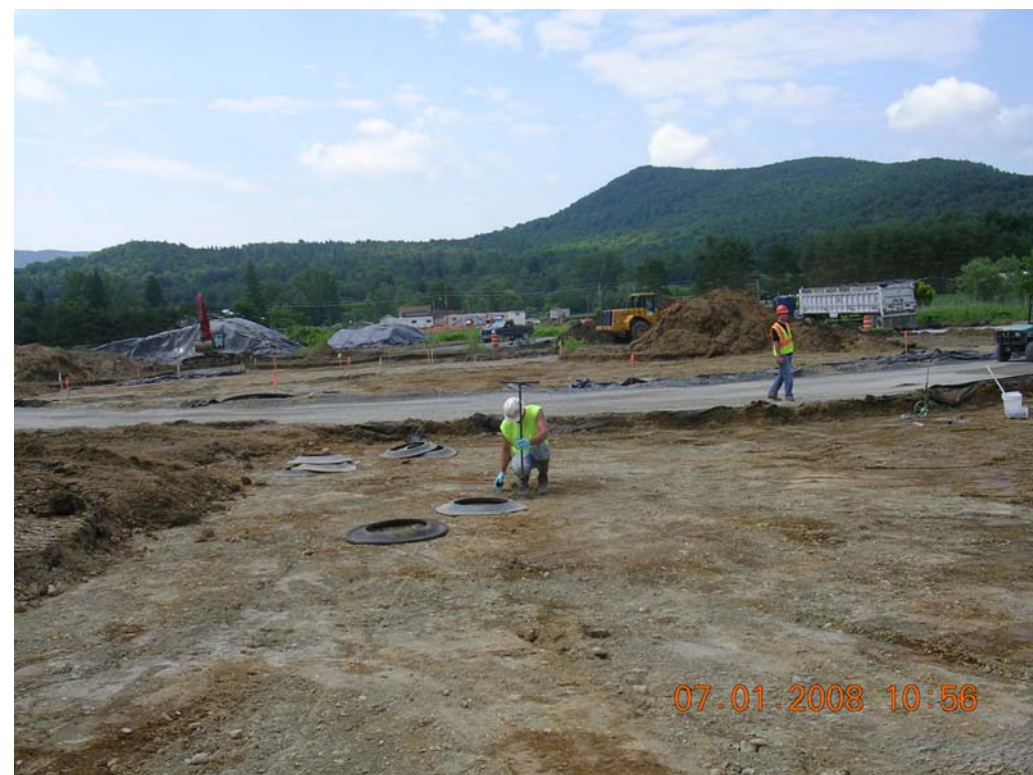
DSCN3886.JPG

| PHOTO | DATE | TIME | DESCRIPTION |
|---|---|---|---|
| DSCN 3886 | 7/1/2008 | 1056 | Collection of bottom soil sample at 1 ft bgs within grid EP-G23; Area 1 looking S. |

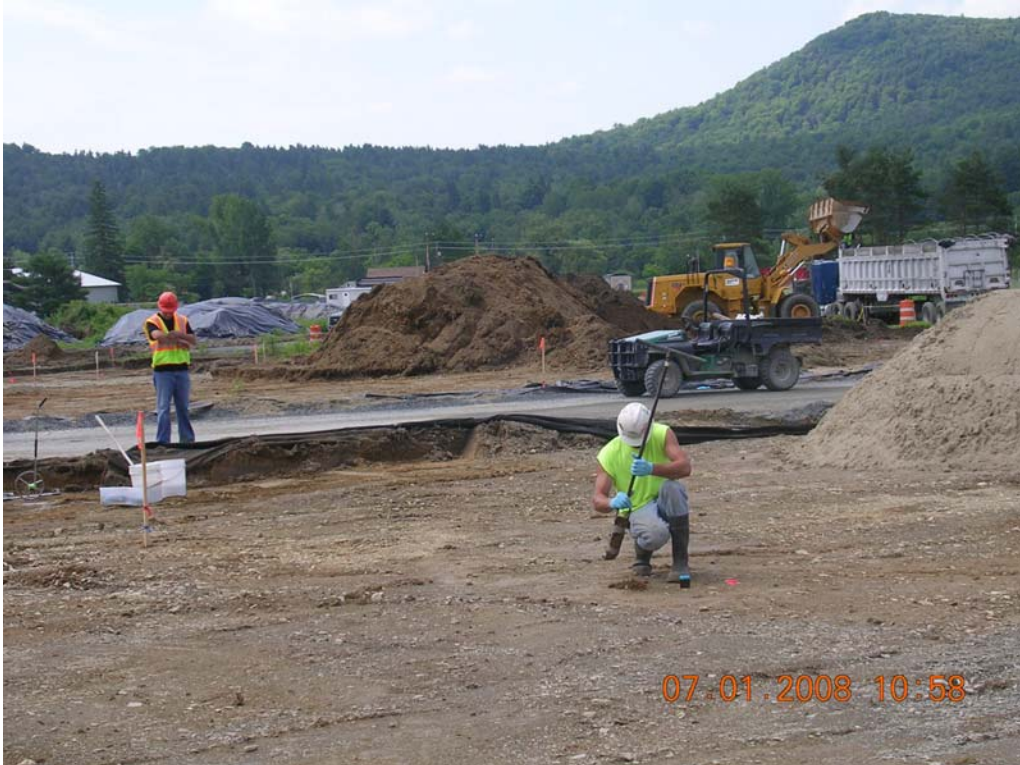
DSCN3887.JPG

| PHOTO | DATE | TIME | DESCRIPTION |
|---|---|---|---|
| DSCN 3887 | 7/1/2008 | 1058 | Collection of bottom soil sample at 1 ft bgs within grid EP-F23; Area 1 looking S. |

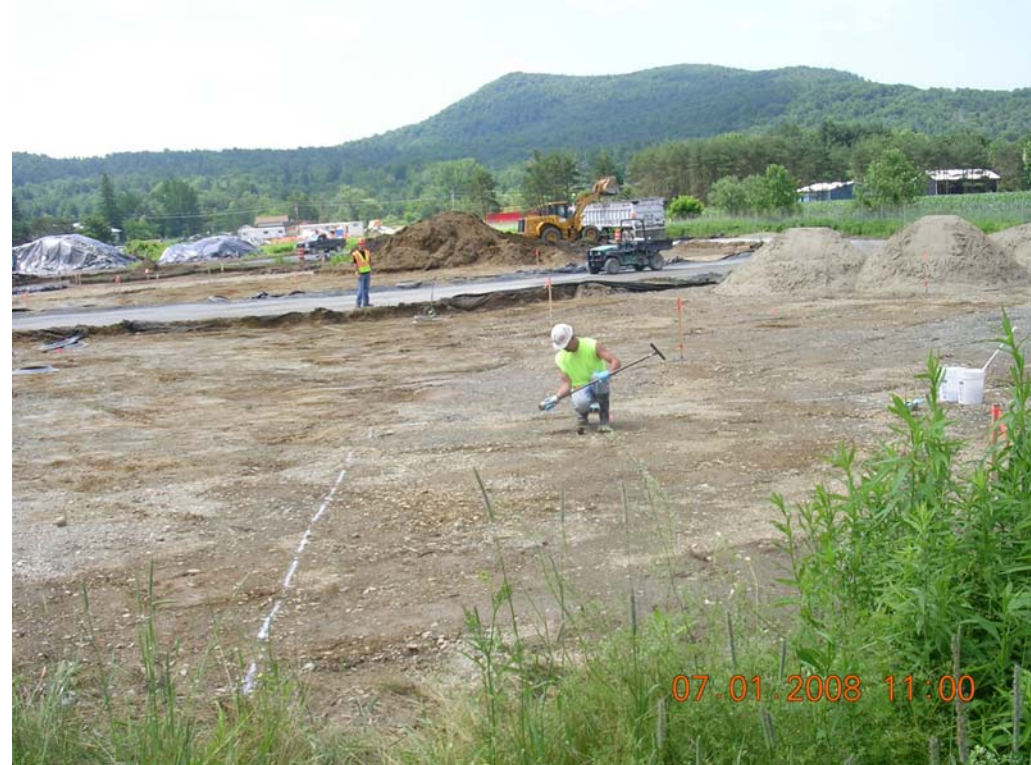
DSCN3888.JPG

| PHOTO | DATE | TIME | DESCRIPTION |
|---|---|---|---|
| DSCN 3888 | 7/1/2008 | 1100 | Resampled Grid F-24 due to analytical results indicating a minor exceedance of PCBs at 1.3 ppm; Employed 4-point quadrant re-sampling protocol established for grid re-sampling; Collection of bottom soil sample at 1 ft bgs within grid EP-F24(1) at SE quadrant of Grid F-24; Area 1 looking S. |

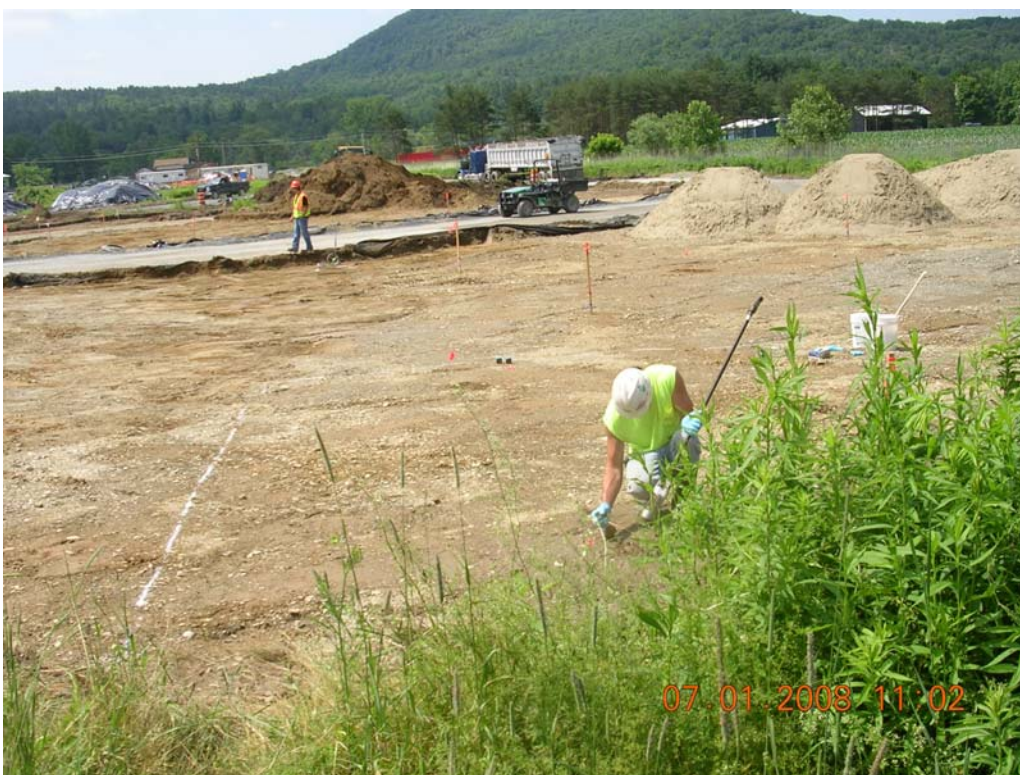
DSCN3889.JPG

| PHOTO | DATE | TIME | DESCRIPTION |
|---|---|---|---|
| DSCN 3889 | 7/1/2008 | 1102 | Resampled Grid F-24 due to analytical results indicating a minor exceedance of PCBs at 1.3 ppm; Employed 4-point quadrant re-sampling protocol established for grid re-sampling; Collection of bottom soil sample at 1 ft bgs within grid EP-F24(2) at NE quadrant of Grid F-24; Area 1 looking S. |

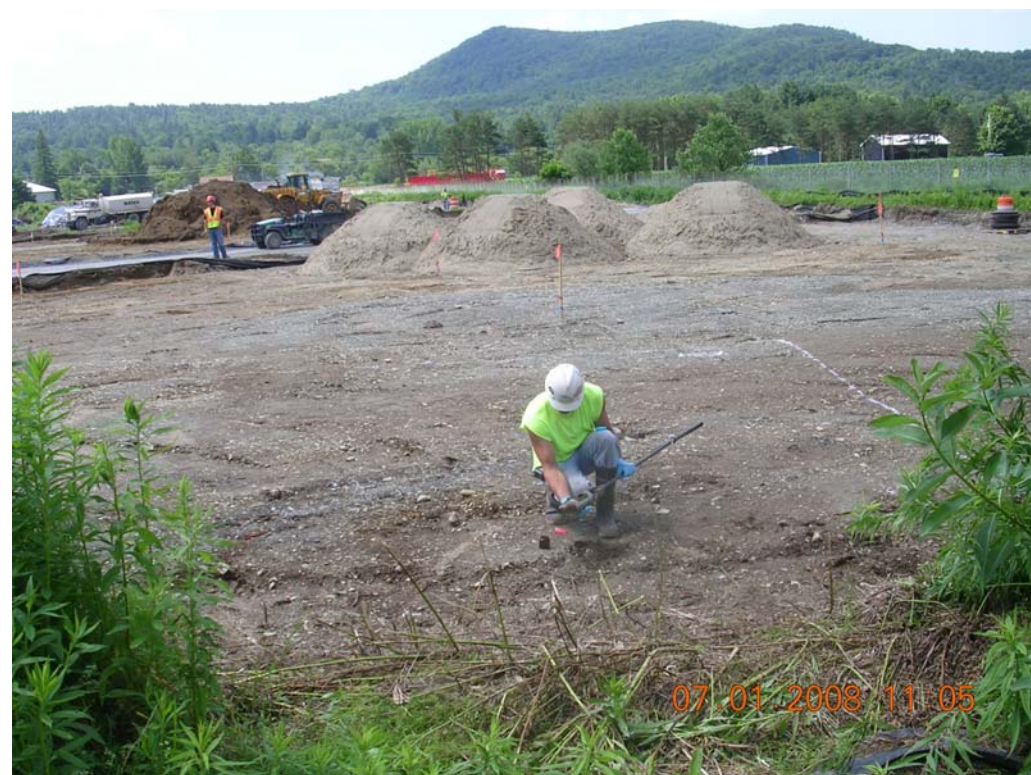
DSCN3890.JPG

| PHOTO | DATE | TIME | DESCRIPTION |
|---|---|---|---|
| DSCN 3890 | 7/1/2008 | 1105 | Resampled Grid F-24 due to analytical results indicating a minor exceedance of PCBs at 1.3 ppm; Employed 4-point quadrant re-sampling protocol established for grid re-sampling; Collection of bottom soil sample at 1 ft bgs within grid EP-F24(3) at NW quadrant of Grid F-24; Area 1 looking S. |

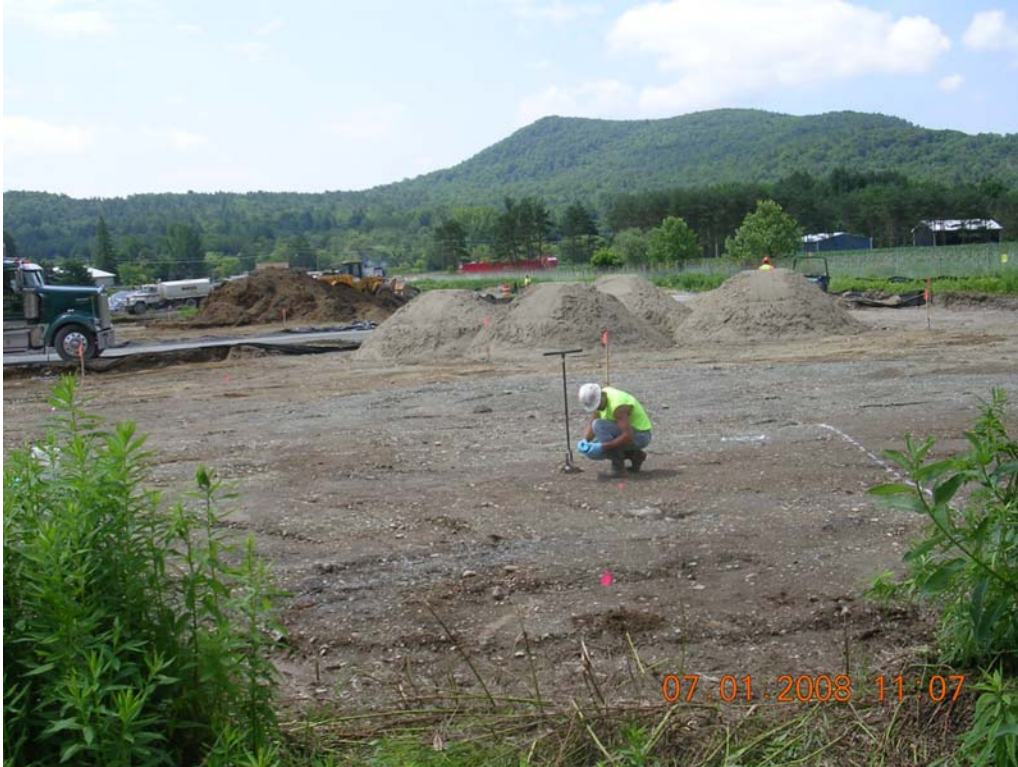
DSCN3891.JPG

| PHOTO | DATE | TIME | DESCRIPTION |
|---|---|---|---|
| DSCN 3891 | 7/1/2008 | 1107 | Resampled Grid F-24 due to analytical results indicating a minor exceedance of PCBs at 1.3 ppm; Employed 4-point quadrant re-sampling protocol established for grid re-sampling; Collection of bottom soil sample at 1 ft bgs within grid EP-F24(4) at SW quadrant of Grid F-24; Area 1 looking S. |

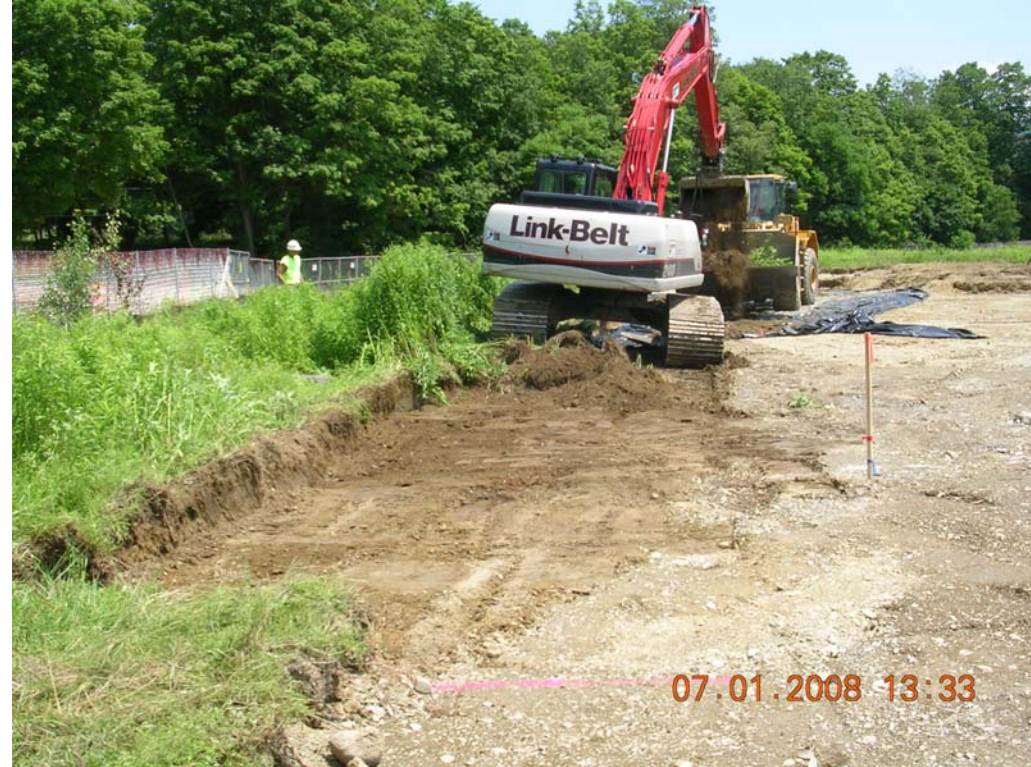
DSCN3892.JPG

| PHOTO | DATE | TIME | DESCRIPTION |
|---|---|---|---|
| DSCN 3892 | 7/1/2008 | 1333 | View of Link-Belt 240 Trackhoe over-excavating perimeter sidewall 5 ft back from its original position at sample location EP-PSW-07; The sidewall was excavated a distance of 50 ft to each side of the EP-PSW07 sampling point (100 ft length cut total); Area 1 looking E-NE. |

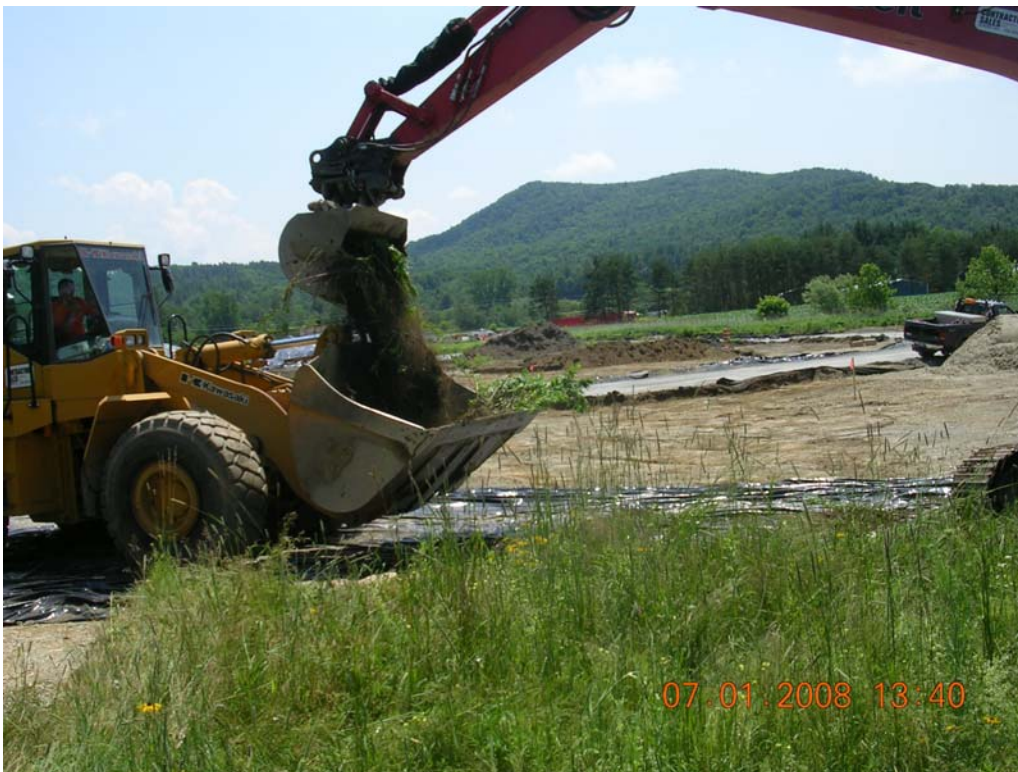
DSCN3893.JPG

| DSCN 3893 | 7/1/2008 | 1340 | View of Link-Belt 240 Trackhoe loading Kawasaki Front Loader with PCB-contaminated soil over-excavating from perimeter sidewall; Area 1 looking S. |

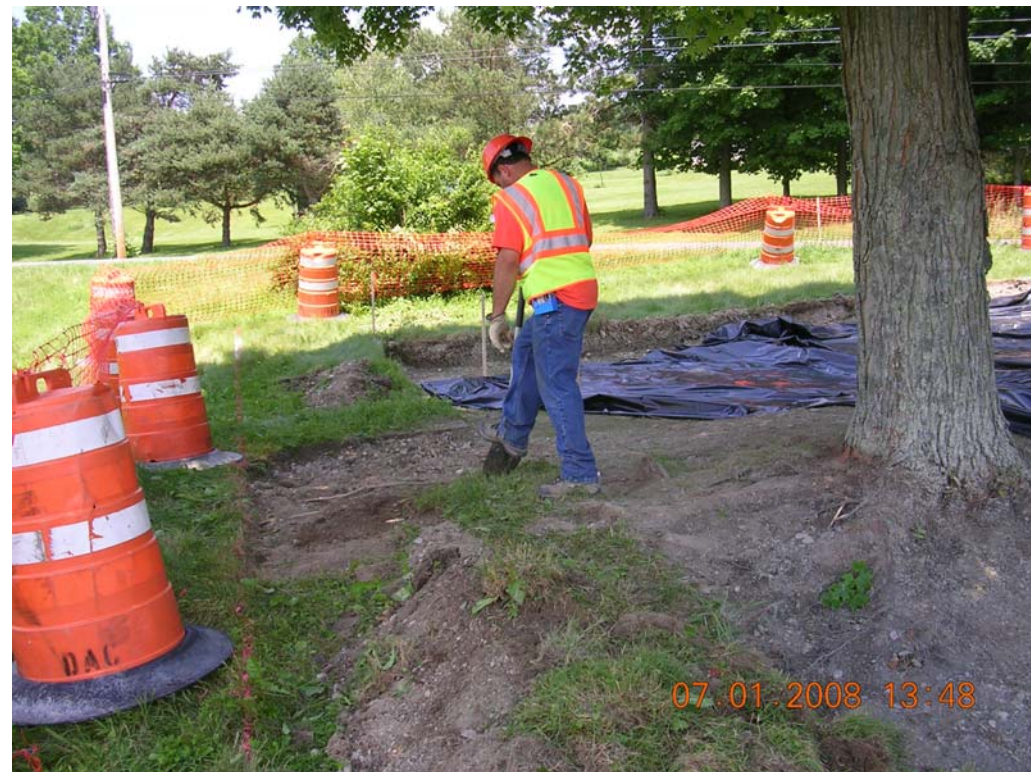
DSCN3894.JPG

| DSCN 3894 | 7/1/2008 | 1348 | Careful hand digging of PCB-contaminated surface soil in overdig section of perimeter sidewall PSW-08 across the top surface of the root mass of a large maple tree in the Patell residence yard; Excavation varied from 3-6 inches across this area; Area 1 looking SE. |

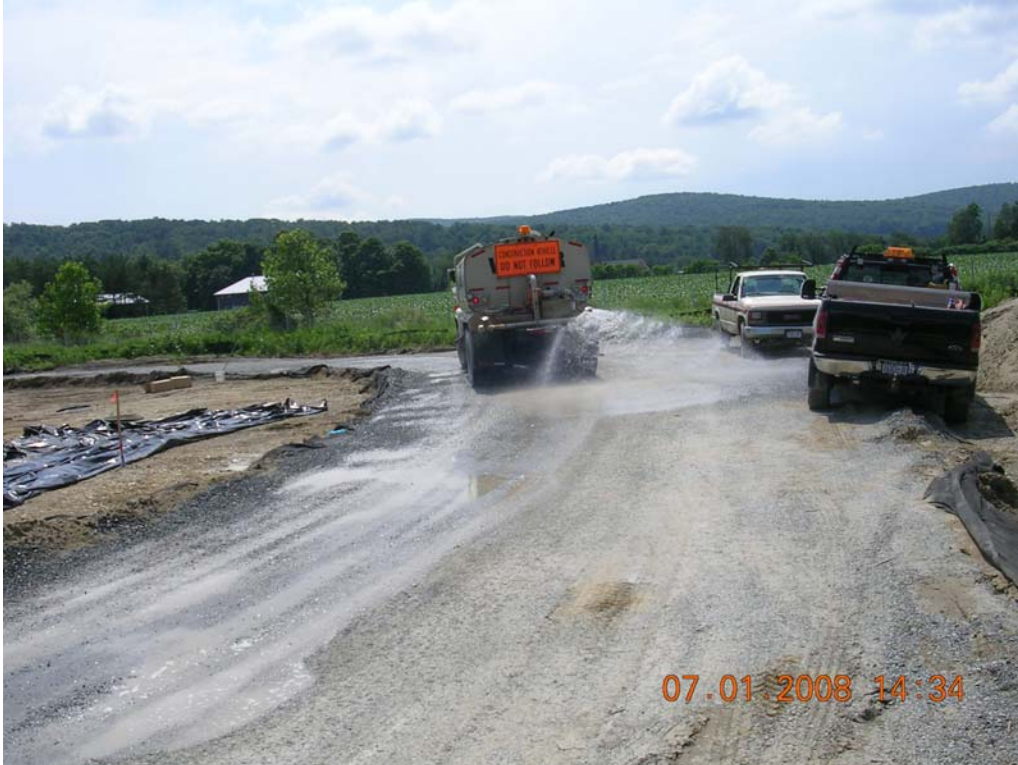
DSCN3895.JPG

| DSCN 3895 | 7/1/2008 | 1434 | Active dust suppression of the ground surface across the site interior and truck access road using a Mack 6561 Water Truck; Area 1 looking W. |

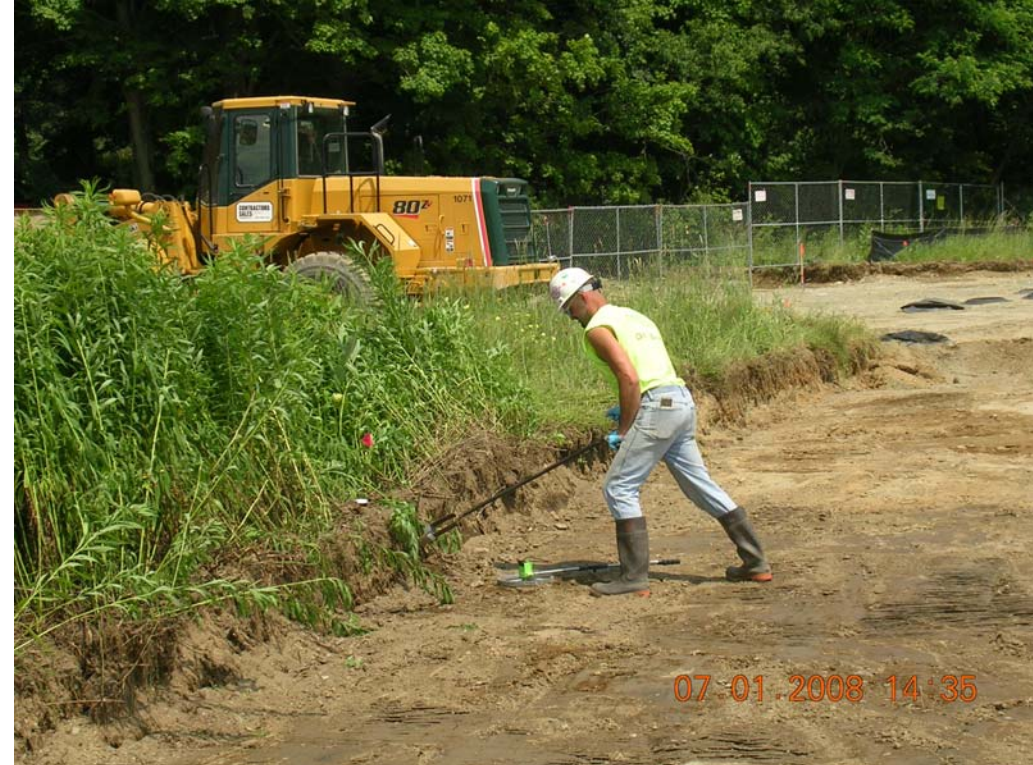
DSCN3896.JPG

| DSCN 3896 | 7/1/2008 | 1435 | Perimeter sidewall PSW-07 was over-excavated 5 ft back from its original position and a distance of 50 ft to each side of the original sampling point (100 ft length cut total); Collection of sidewall soil sample at new sidewall position at EP-PSW-07A at 0-0.5 ft bgs adjacent to Grid G-25 within Area 1 looking N. |

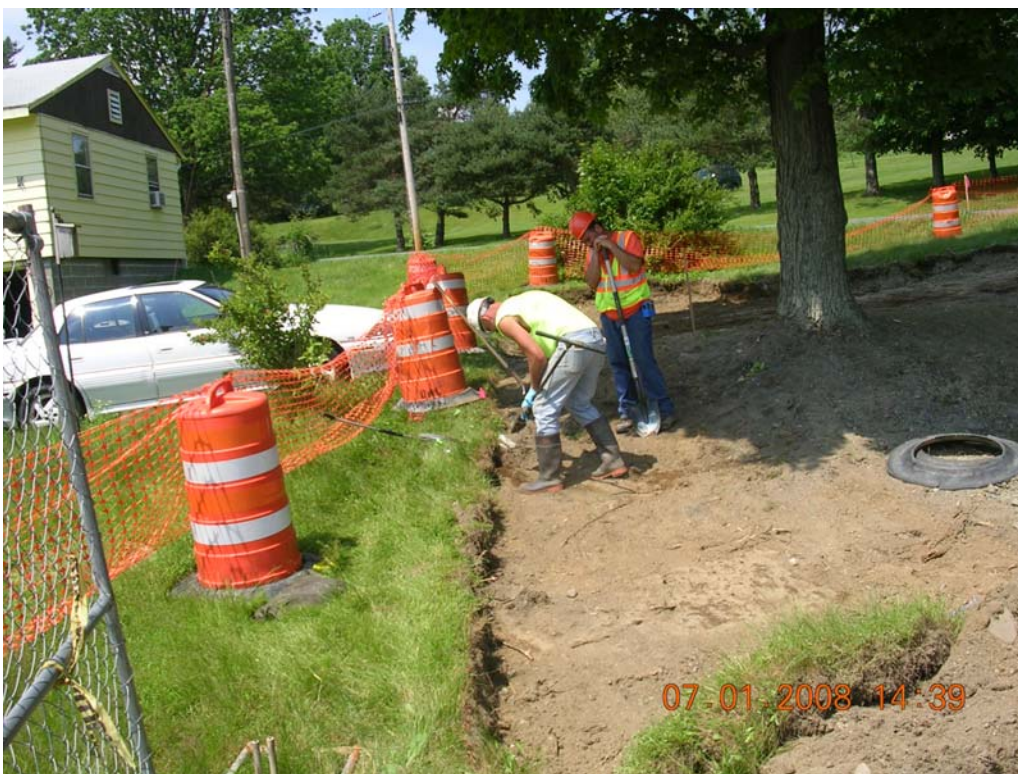
DSCN3897.JPG

| DSCN 3897 | 7/1/2008 | 1439 | Perimeter sidewall PSW-08 was over-excavated 5 ft back from its original position and a distance of 50 ft to each side of the original sampling point (100 ft length cut total); Collection of sidewall soil sample at new sidewall position at EP-PSW-08A at 0-0.5 ft bgs adjacent to Grid G-25 within Area 1 looking N. |

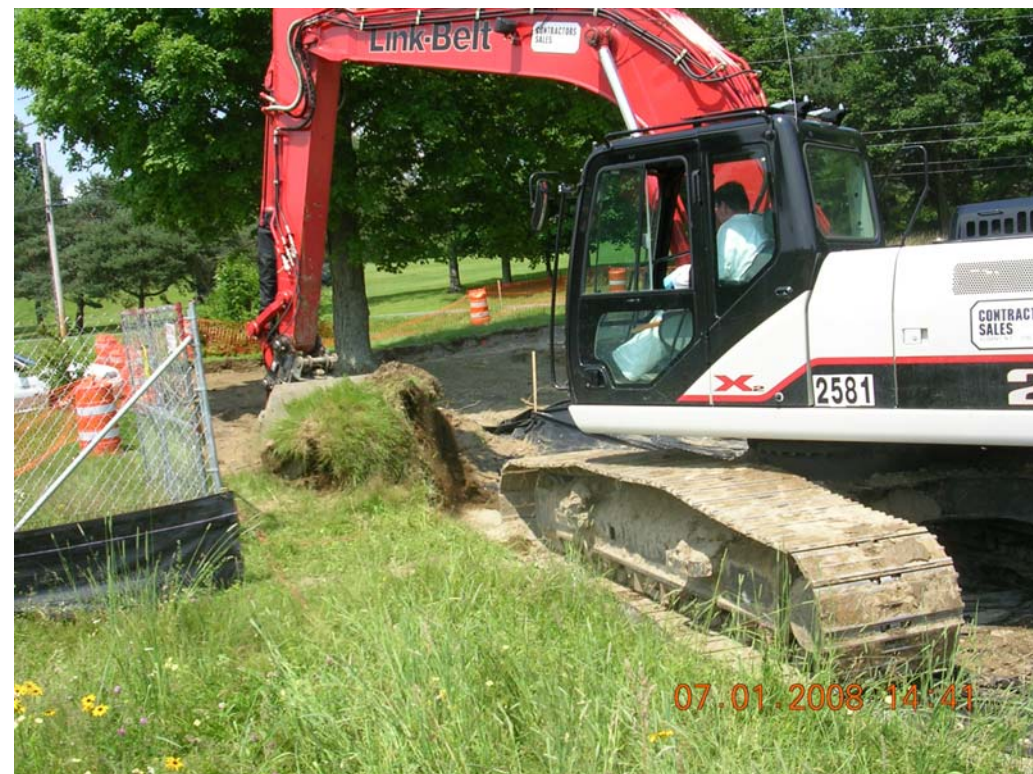
DSCN3898.JPG

| DSCN 3898 | 7/1/2008 | 1441 | View of Link-Belt 240 Trackhoe over-excavating perimeter sidewall 5 ft back from its original position at sample location EP-PSW-08; The sidewall was excavated a distance of 50 ft to each side of the EP-PSW08 sampling point (100 ft length cut total); Area 1 looking N. |

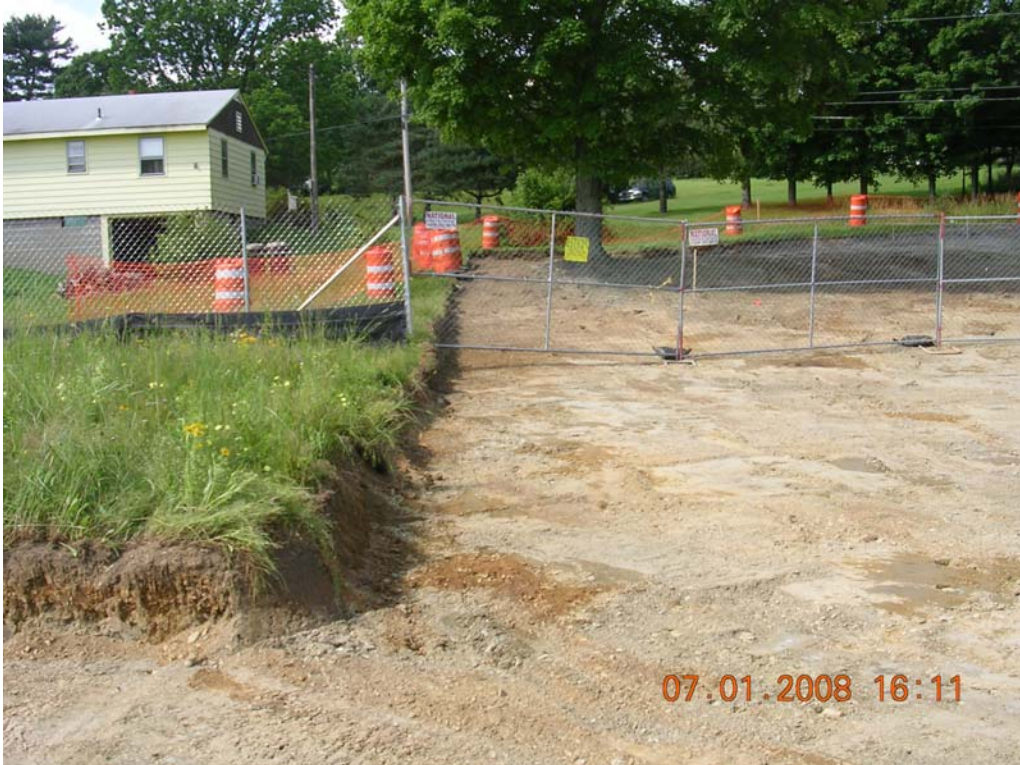
DSCN3899.JPG

| DSCN 3899 | 7/1/2008 | 1611 | Completed overdig on perimeter sidewall PSW-08 in Area 1 looking N. |

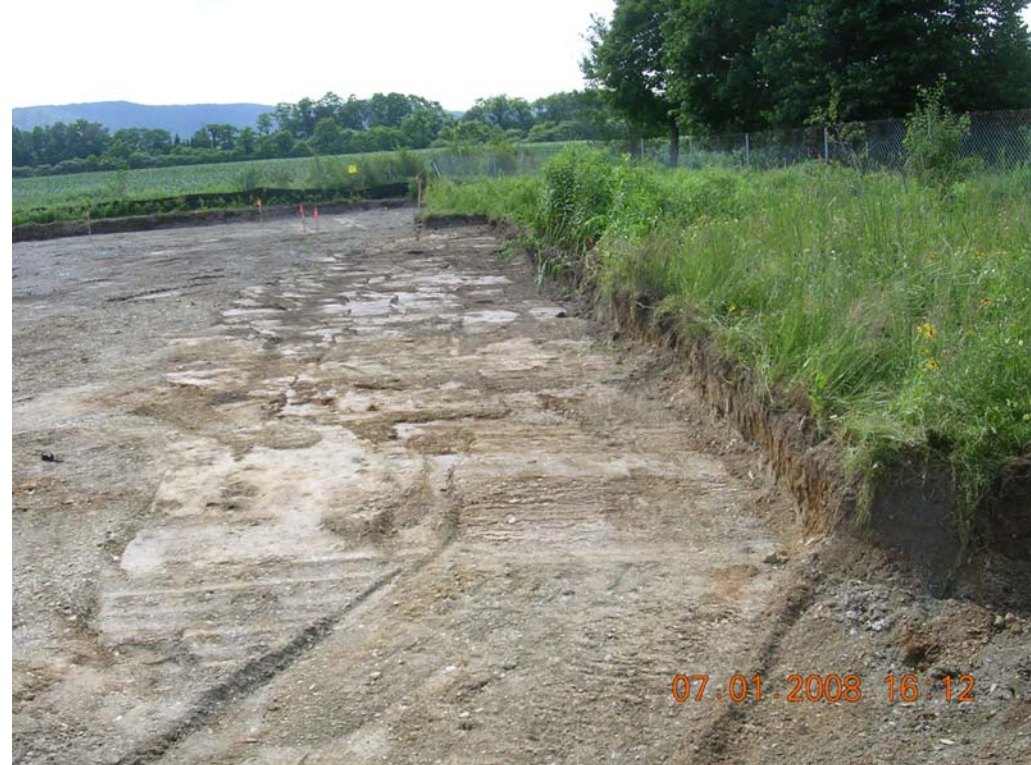
DSCN3900.JPG

| DSCN 3900 | 7/1/2008 | 1612 | Completed overdig on perimeter sidewall PSW-07 in Area 1 looking W. |
