## DAILY FIELD ACTIVITY REPORT

| <b>PROJECT</b> | <b>Former Bouchard Junkyard</b> | <b>WEATHER</b> | <b>TIME</b> | <b>TEMP.</b> | <b>PRECIP.</b> | <b>WIND (MPH)</b> | <b>WIND (DIR)</b> |

**PROJECT NO. 2605**

**PHOTOGRAPHIC LOG**  
**July 1, 2008**  
**D&B JOB NO. 2605**  
**FORMER BOUCHARD JUNKYARD SITE**  
**TOWN OF NEW LEBANON, NEW YORK**

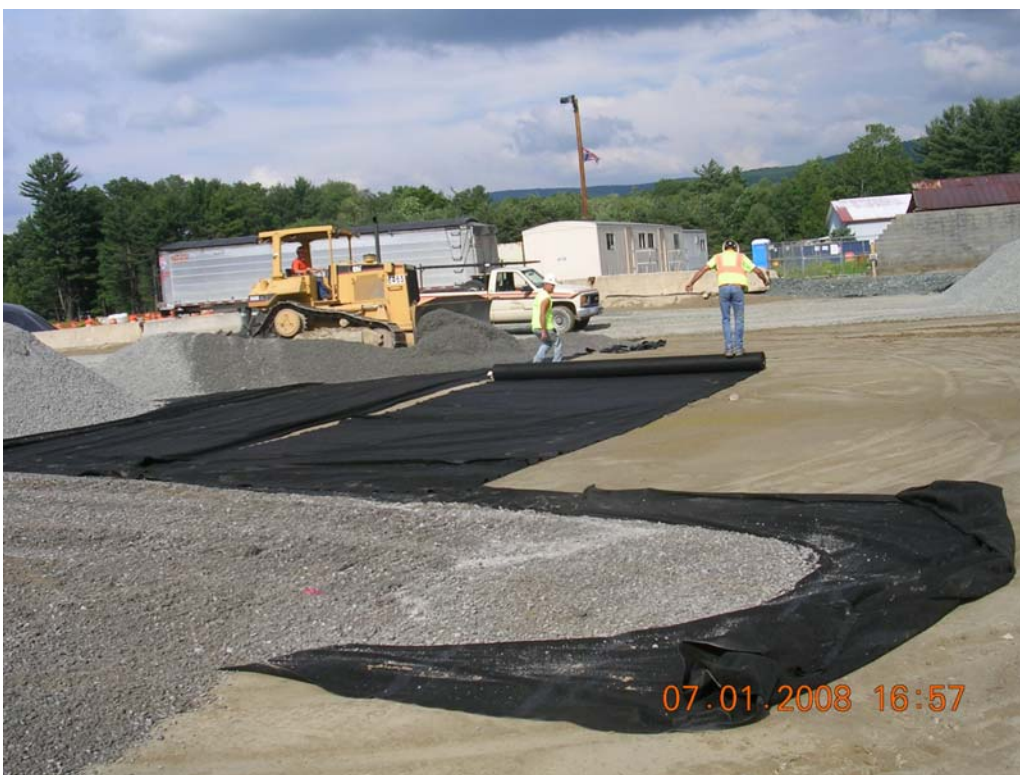
DSCN3903.JPG

| DSCN 3903 | 7/1/2008 | 1657 | View of new parking lot construction for use by DAC vehicles near Grids F-4 and F-5 in Area 4 looking NE; Caterpillar 6465 Bull Dozer placed Type 2 sub-base crusher run gravel over a basal layer of 12 ounce Carthage Mills road fabric. |

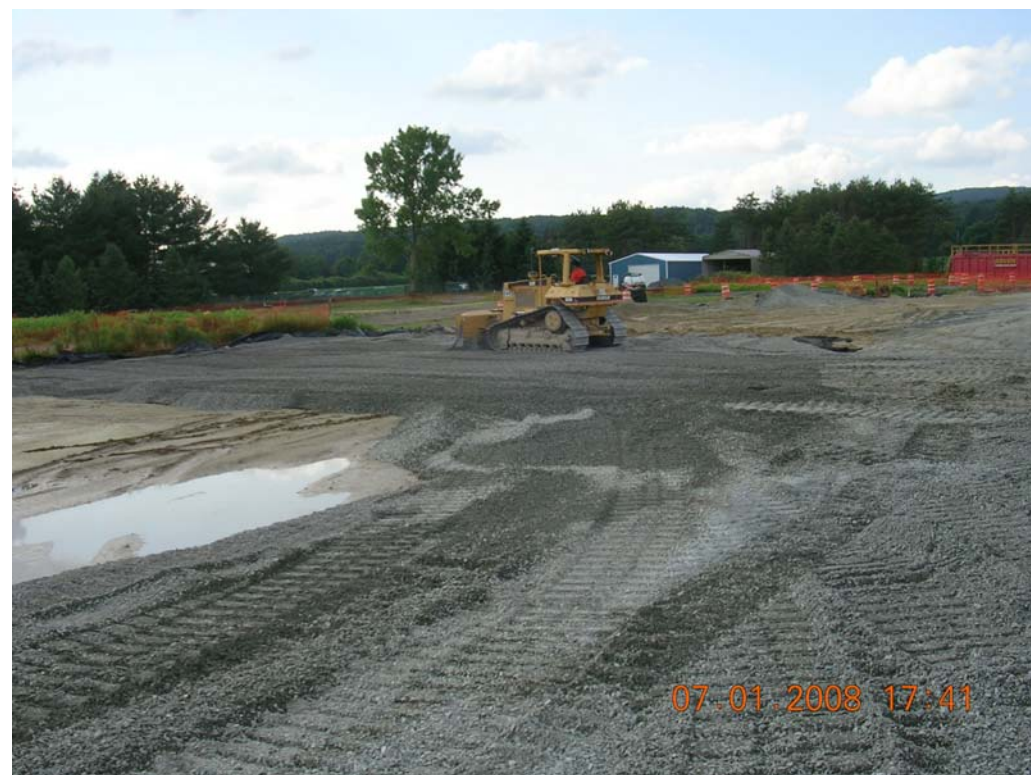
DSCN3904.JPG

| DSCN 3904 | 7/1/2008 | 1741 | View of status of parking lot construction at close of business near Grids F-4 and F-5 in Area 4 looking NW; Caterpillar 6465 Bull Dozer placed Type 2 sub-base crusher run gravel over a basal layer of 12 ounce Carthage Mills road fabric. |
