DAILY FIELD ACTIVITY REPORT

PROJECT	Former Bouchard Junkyard	WEATHER	TIME	TEMP.	PRECIP.	WIND (MPH)	WIND (DIR)
LOCATION	Town of New Lebanon, NY	Sunny	0700	60-65 F	None	Calm	NA
ATTACHMENTS	Photo Log and Photos	Sunny	1700	75-80 F	None	5-10	SW

PHOTOGRAPHIC LOG
July 2, 2008
D&B JOB NO. 2605
FORMER BOUCHARD JUNKYARD SITE
TOWN OF NEW LEBANON, NEW YORK

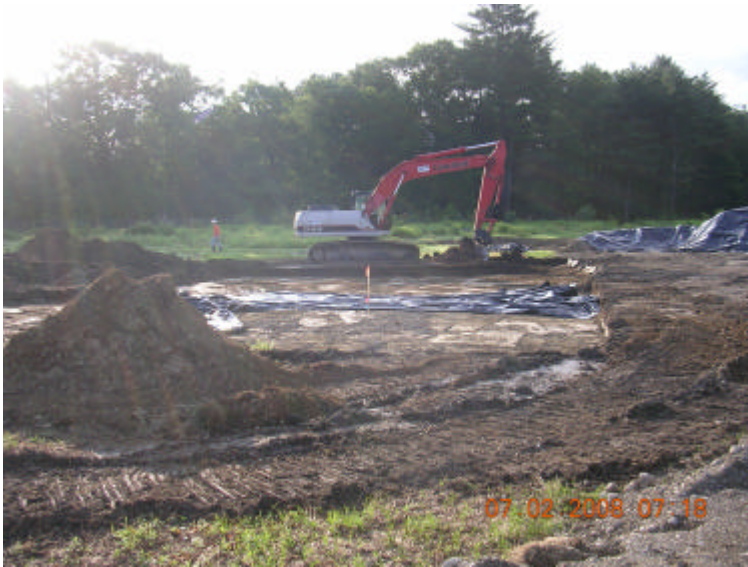
DSCN3908.JPG

PHOTO	DATE	TIME	DESCRIPTION
DSCN 3908	7/2/2008	0718	Remedial excavation activities within the central part of Area 1 within Grid I-17 utilizing a Link-Belt 240 Trackhoe for excavation; Non-TSCA soil was stockpiled on like-material in a centralized location in order to facilitate loading of trucks from the clean access road; View of Area 1 looking E.
DSCN 3909	7/2/2008	0722	View of DAC loading of non-TSCA PCB contaminated soil using a Kawasaki 80ZV Front Loader from a soil stockpile at the central part of Area 1 looking SE.
DSCN 3911	7/2/2008	0807	Cleaning of muddy tire tracks in progress onto Route 20 road surface at entrance to driveway to Building 666 using Mack Water Truck; View of Route 20 looking SW.
DSCN 3912	7/2/2008	1044	Remedial excavation activities within the central part of Area 1 within Grid J-18 utilizing a Link-Belt 240 Trackhoe for excavation; Abundant tires and metallic debris were uncovered in this area and segregated from the soil into individual stockpiles; Gray to dark gray stained soil was stockpiled on 6 mil polyethylene sheeting. View of Area 1 looking E.

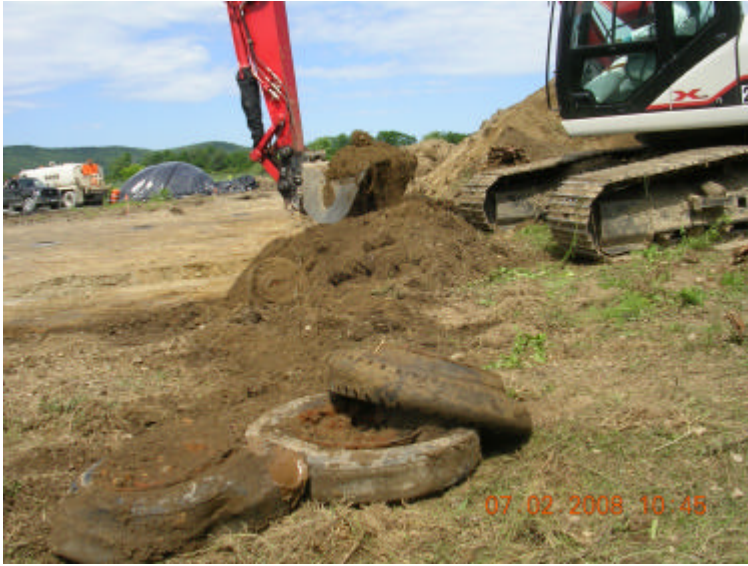
DSCN3913.JPG

2. During excavation of the 1.5 ft deep benches at grids J-18 and K-18, abundant rubber tires, metallic debris, and gray to dark gray stained soil, visually similar in nature to TSCA PCB-contaminated soil excavated from TSCA grids on-site, were encountered at the 1-1.5 ft level. This area was evidently a shallow burial pit for junkyard debris, which was subsequently covered with suspect contaminated soil. Upon consultation with the D&B East Syracuse office and NYSDEC, the area of stained soil and debris was excavated until staining ceased to an approximate depth of 3.5-4 ft bgs. Within the debris field, a 55 gallon steel drum was found in poor condition with rust and corrosion and several large holes. D.A. Collins donned Saranex suits and respirators and checked if the drum was off-gassing with a photoionization detector. No concentrations of volatile organic compounds were detected. The drum contents were observed to be still fully intact, which appeared to be ¾-full of a mottled rusty orange and yellow solid substance with visual evidence of yellow paint chips. The drum was not immediately removed from the excavation due to its condition. D.A. Collins decided to wait until a shipment of over-pack salvage drums arrived to remove the drum. An attempt to remove the drum from the excavation may occur as early as tomorrow. The excavation pit at Grid J-18 and the associated drum were secured with temporary fencing and covered with 6 mil polyethylene sheeting. In addition, gray to dark gray stained soil was staged on and covered with 6 mil polyethylene sheeting near the truck access road adjacent to K-18 and recovered rubber tires and metallic debris were stockpiled separately near the western side of Area 2.

DSCN 3913	7/2/2008	1045	Another view remedial excavation activities within the central part of Area 1 within Grid J-18 utilizing a Link-Belt 240 Trackhoe for excavation; Abundant tire and metallic debris were uncovered in this area; View of Area 1 looking W.
DSCN 3915	7/2/2008	1050	View of tire stockpile at the SW corner of Area 2 looking NE, which was segregated from soil excavated from grid J-18 as seen in the distant background; Areas 1 and 2 looking NE.
DSCN 3916	7/2/2008	1141	Active dust suppression of the ground surface across the site interior and truck access road using a Mack 6561 Water Truck; Area 1 looking N.
DSCN 3917	7/2/2008	1141	Remedial excavation activities within the central part of Area 1 within Grid J-18 utilizing a Link-Belt 240 Trackhoe for excavation; Abundant tires and metallic debris were uncovered in this area and segregated from the soil into individual stockpiles; Gray to dark gray stained soil was stockpiled on 6 mil polyethylene sheeting; View of Area 1 looking N.

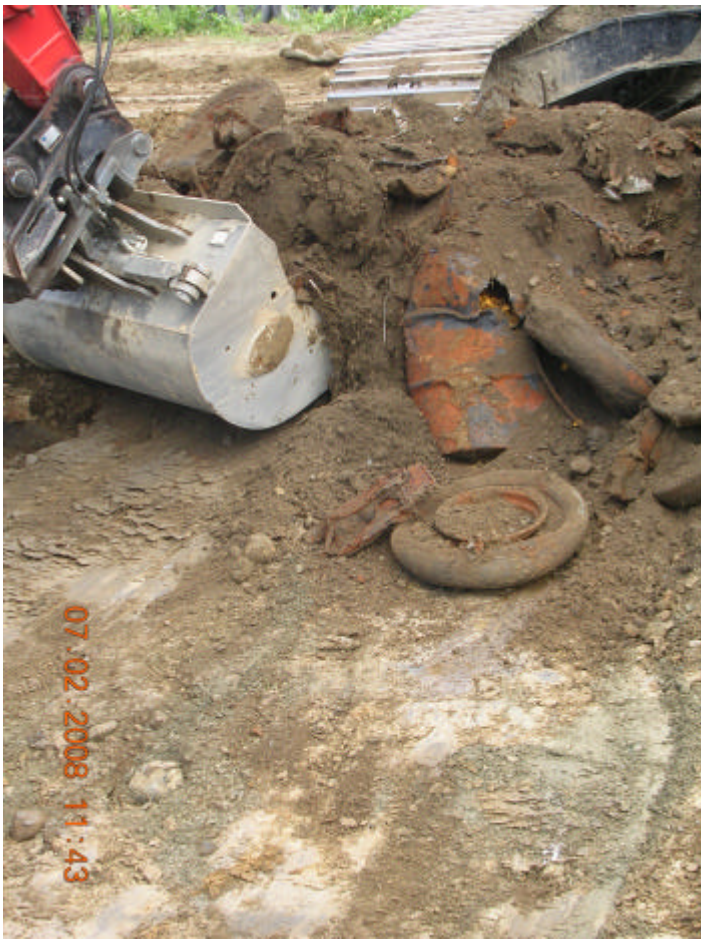
DSCN3918.JPG

DSCN 3918	7/2/2008	1143	Closeup of remedial excavation activities within the central part of Area 1 within Grid J-18 utilizing a Link-Belt 240 Trackhoe for excavation; An unknown, corroded 55-gallon drum was uncovered within the excavation; Proper PPE was used to approach and assess the drum; Abundant tires and metallic debris can be readily seen within the excavation; View of Area 1 looking NW.
DSCN 3921	7/2/2008	1314	Active dust suppression of the ground surface across the site interior and truck access road using a Mack 6561 Water Truck; Area 3 and 9 looking N.
DSCN 3924	7/2/2008	1450	View of DAC loading of TSCA PCB-contaminated soil using a Link-Belt 240 Trackhoe from a TSCA soil stockpile near the southwest corner of Area 2 looking S.
DSCN 3926	7/2/2008	1621	View of grid J-18 remedial excavation at the site of the unknown drum looking E; The debris and drum were covered with 6 mil polyethylene sheeting for the overnight hours; The drum is scheduled to be removed upon receipt of a delivery of overpack drums.
