REPORT NO. 080703

## DAILY FIELD ACTIVITY REPORT

| PROJECT | Former Bouchard Junkyard | WEATHER | TIME | TEMP. | PRECIP. | WIND (MPH) | WIND (DIR) |

**PHOTOGRAPHIC LOG**  
**July 3, 2008**  
**D&B JOB NO. 2605**  
**FORMER BOUCHARD JUNKYARD SITE**  
**TOWN OF NEW LEBANON, NEW YORK**

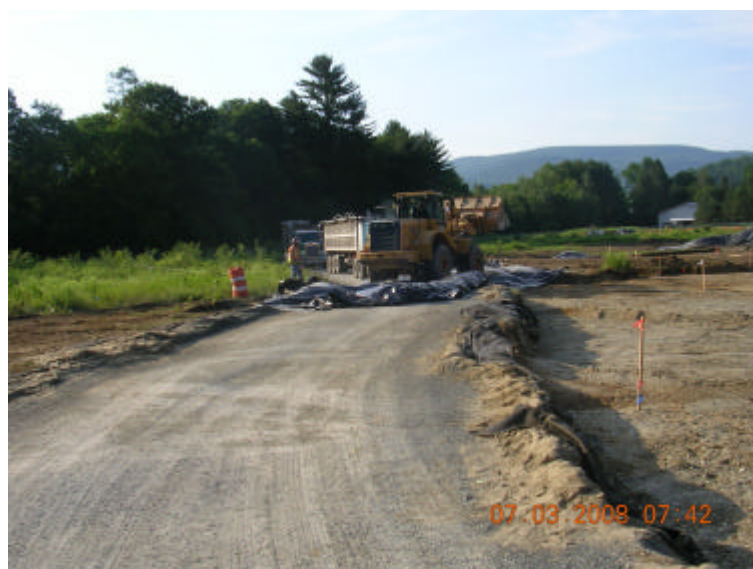
**DSCN3929.JPG**

| PHOTO | DATE | TIME | DESCRIPTION |
|---|---|---|---|
| DSCN 3929 | 7/3/2008 | 0742 | View of Kawasaki 80ZV Front Loader crossing the clean truck access road across a layer of 6 mil polyethylene sheeting to avoid cross-contamination at the central part of Area 1 looking SW. |

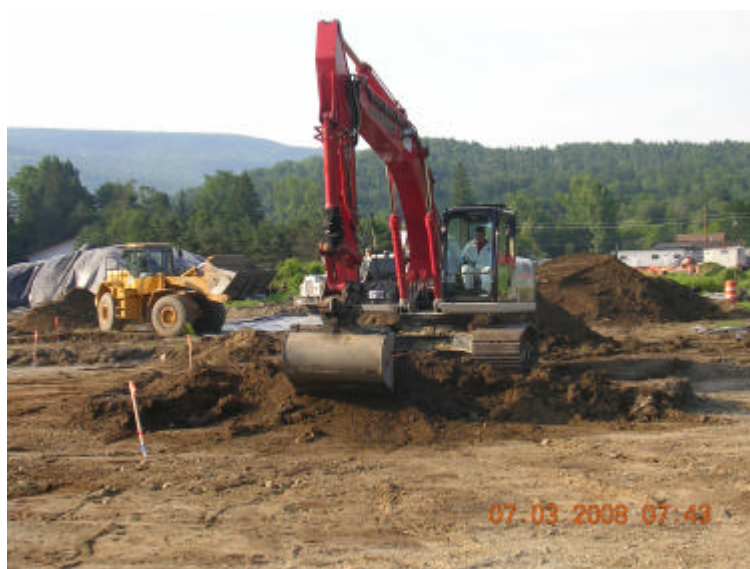
**DSCN3930.JPG**

| PHOTO | DATE | TIME | DESCRIPTION |
|---|---|---|---|
| DSCN 3930 | 7/3/2008 | 0743 | Remedial excavation activities within the central part of Area 1 within Grid F-21 utilizing a Link-Belt 240 Trackhoe for excavation; Non-TSCA soil was stockpiled on like-material in a centralized location in order to facilitate loading of trucks from the clean access road; View of Area 1 looking S-SW. |

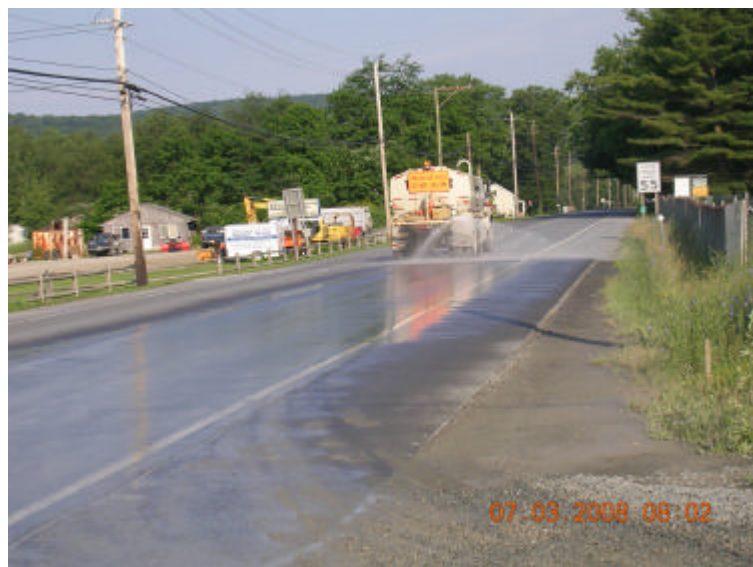
**DSCN3931.JPG**

| PHOTO | DATE | TIME | DESCRIPTION |
|---|---|---|---|
| DSCN 3931 | 7/3/2008 | 0802 | Cleaning of muddy tire tracks in progress onto Route 20 road surface at entrance to driveway to Building 666 using 4,000 gallon Mack Water Truck; View of Route 20 looking W. |

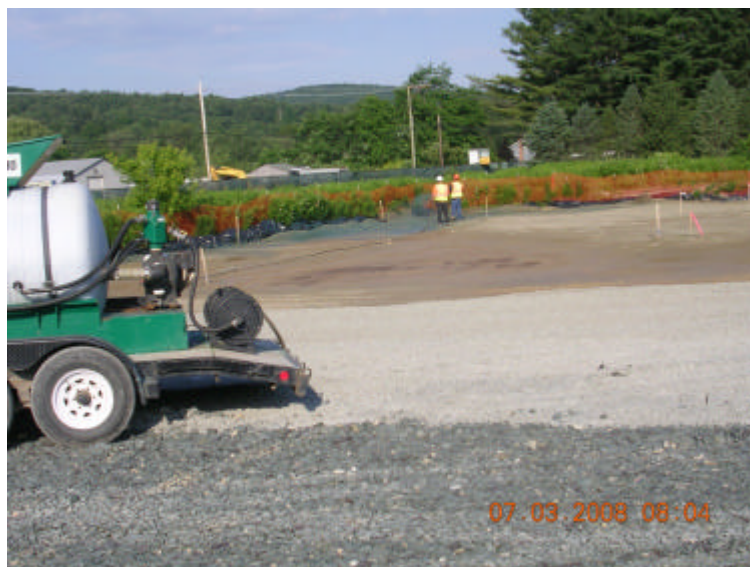
**DSCN3933.JPG**

| PHOTO | DATE | TIME | DESCRIPTION |
|---|---|---|---|
| DSCN 3933 | 7/3/2008 | 0804 | Application of hydroseed, paper mulch, and associated tackifier to the revegetated ground surface in Area 5 looking W-SW. |

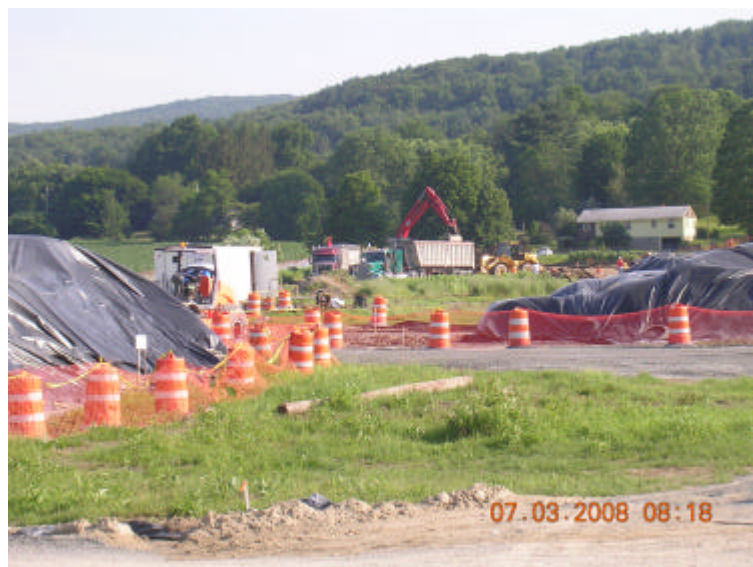
**DSCN3934.JPG**

| PHOTO | DATE | TIME | DESCRIPTION |
|---|---|---|---|
| DSCN 3934 | 7/3/2008 | 0818 | View of DAC loading of non-TSCA PCB contaminated soil using a Link-Belt 240 Trackhoe and a Kawasaki 80ZV Front Loader from soil stockpiles in Areas 1 and 2 looking N. |

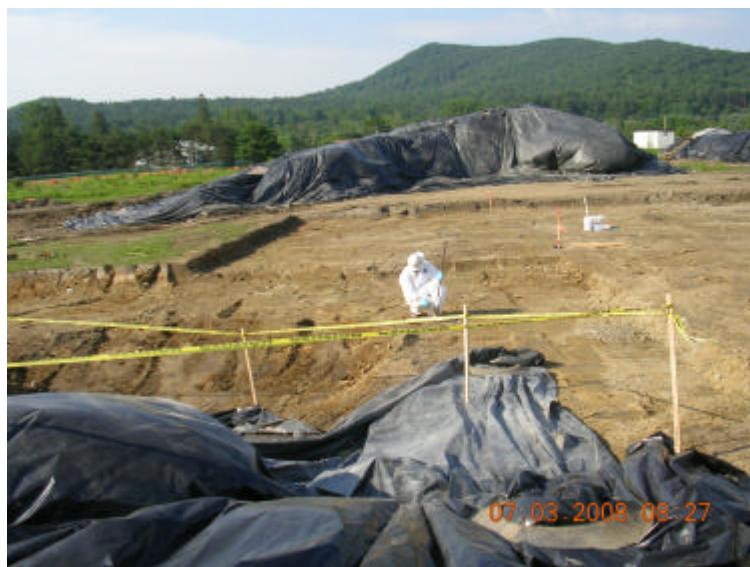
**DSCN3936.JPG**

| PHOTO | DATE | TIME | DESCRIPTION |
|---|---|---|---|
| DSCN 3936 | 7/3/2008 | 0827 | Collection of bottom soil sample at 1.5 ft bgs within grid EP-J18(18-inch); Area 1 looking S. |

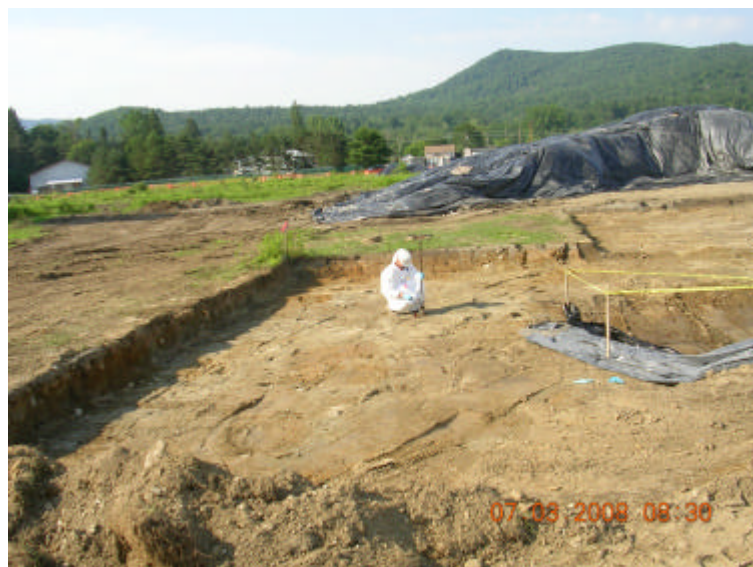
**DSCN3937.JPG**

| PHOTO | DATE | TIME | DESCRIPTION |
|---|---|---|---|
| DSCN 3937 | 7/3/2008 | 0830 | Collection of bottom soil sample at 1.5 ft bgs within grid EP-K18; Area 1 looking S. |

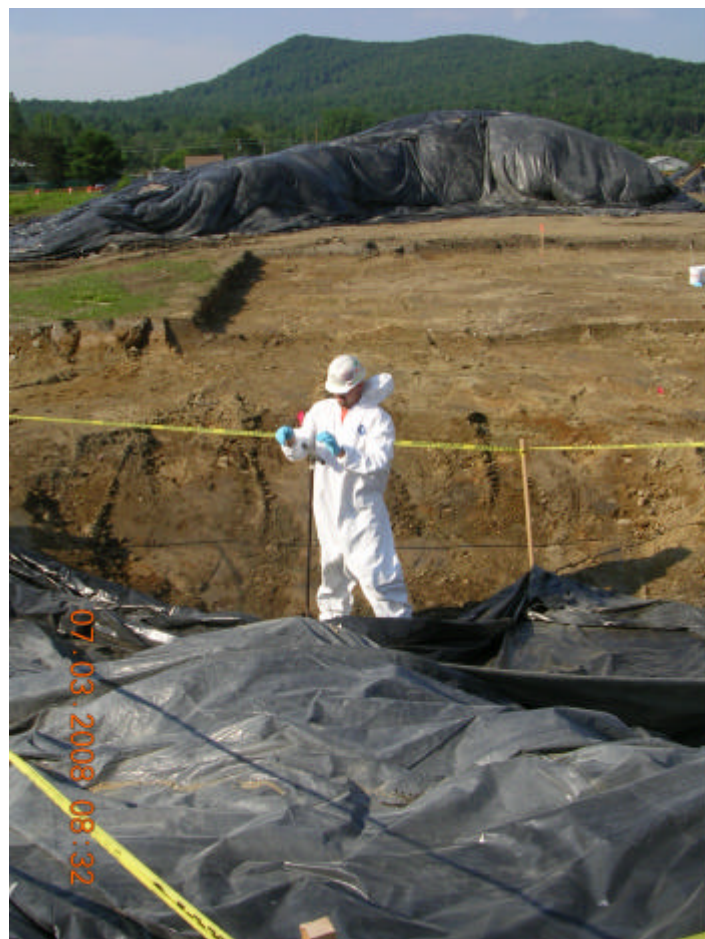
**DSCN3938.JPG**

| PHOTO | DATE | TIME | DESCRIPTION |
|---|---|---|---|
| DSCN 3938 | 7/3/2008 | 0832 | Collection of bottom soil sample at 3.5-4 ft bgs within grid EP-J18(Overdig); Area 1 looking S; The sample was collected adjacent to the unknown 55-gallon steel drum uncovered within the excavation. |

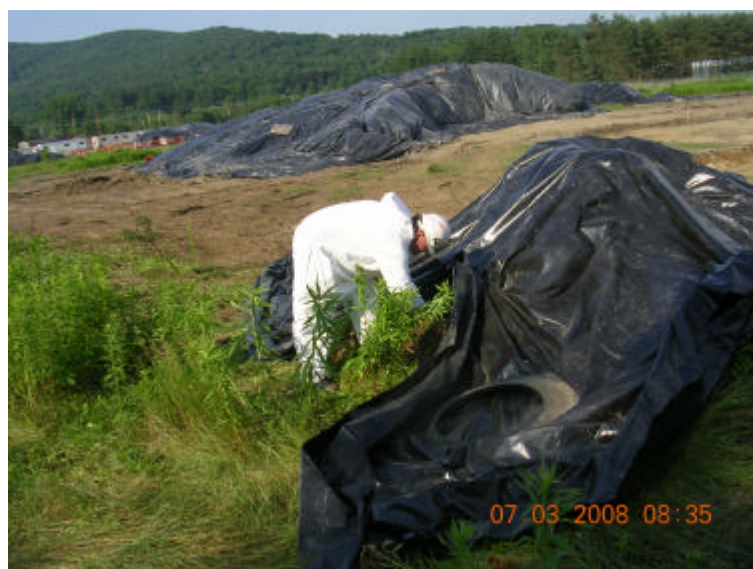
**DSCN3940.JPG**

| PHOTO | DATE | TIME | DESCRIPTION |
|---|---|---|---|
| DSCN 3940 | 7/3/2008 | 0835 | Collection of grab 1 of 4 of a composite soil sample of the grid J-18 overdig stockpile (i.e., gray-stained soil); Area 1 looking SW. |

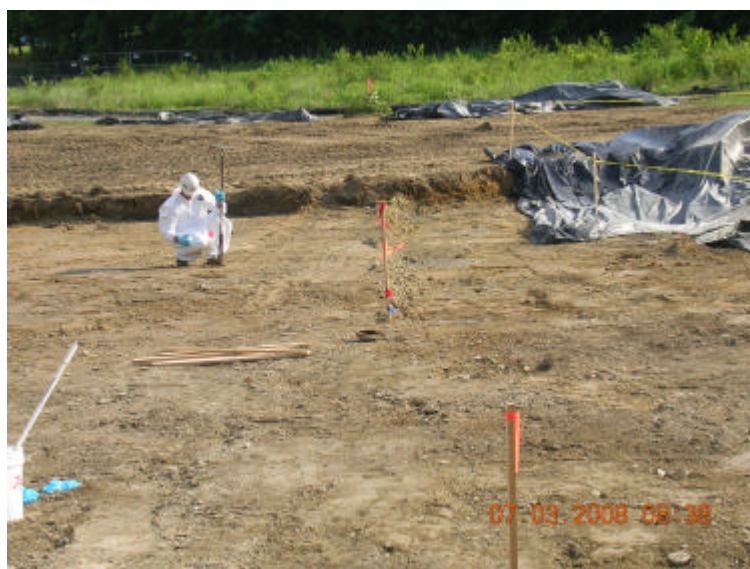
**DSCN3941.JPG**

| PHOTO | DATE | TIME | DESCRIPTION |
|---|---|---|---|
| DSCN 3941 | 7/3/2008 | 0838 | Collection of bottom soil sample at 1 ft bgs within grid EP-J18(12-inch); Area 1 looking N; Extra volume was collected at this location for MS/MSD/MSB quality control analysis. |

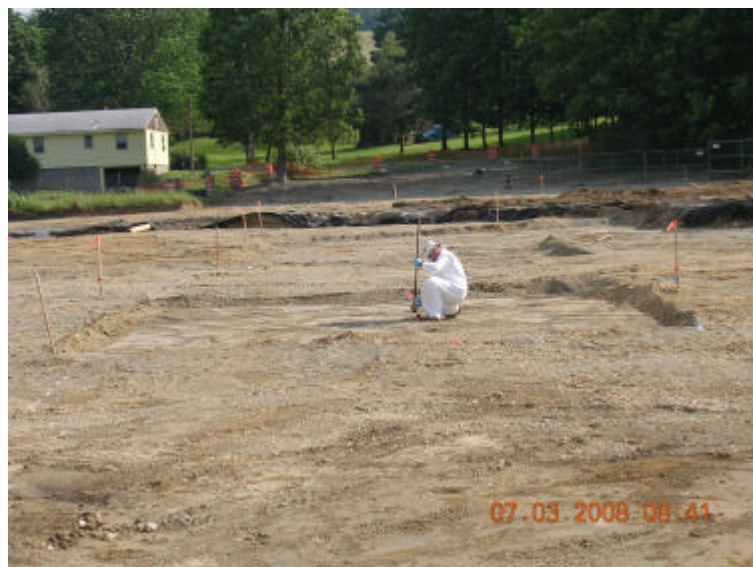
**DSCN3942.JPG**

| PHOTO | DATE | TIME | DESCRIPTION |
|---|---|---|---|
| DSCN 3942 | 7/3/2008 | 0841 | Re-collection of bottom soil sample at 1.5 ft bgs following removal of an additional 0.5 ft of soil within grid H-20; Sample EP-H20(Overdig) is located near the samplers feet; Area 1 looking N. |

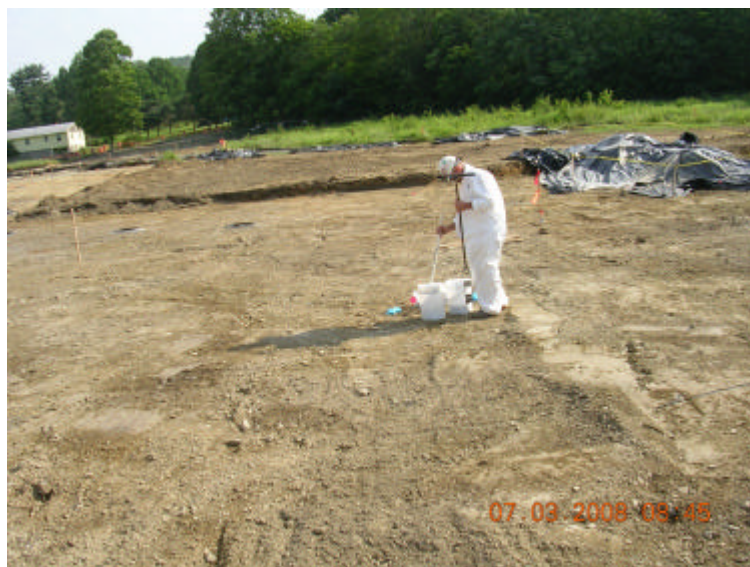
**DSCN3943.JPG**

| PHOTO | DATE | TIME | DESCRIPTION |
|---|---|---|---|
| DSCN 3943 | 7/3/2008 | 0845 | Collection of bottom soil sample at 1 ft bgs within grid EP-J17; Area 1 looking S; Duplicate EP-DUP09 was collected at this location. |

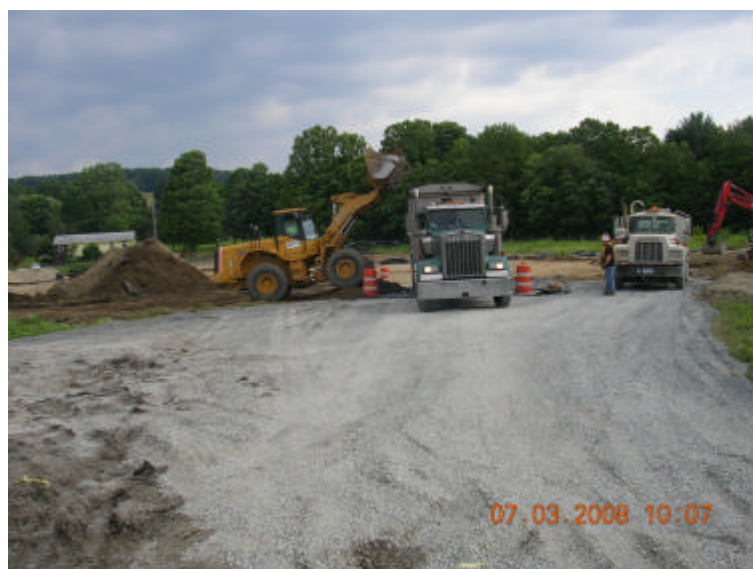
**DSCN3944.JPG**

| PHOTO | DATE | TIME | DESCRIPTION |
|---|---|---|---|
| DSCN 3944 | 7/3/2008 | 1007 | View of DAC loading of non-TSCA PCB contaminated soil using a Link-Belt 240 Trackhoe and a Kawasaki 80ZV Front Loader from soil stockpiles in Areas 1 and 2 looking NE. |

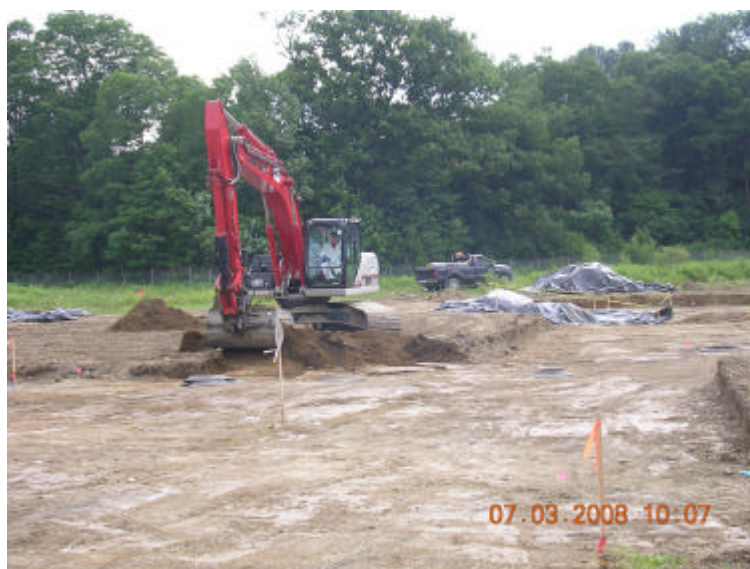
**DSCN3945.JPG**

| PHOTO | DATE | TIME | DESCRIPTION |
|---|---|---|---|
| DSCN 3945 | 7/3/2008 | 1007 | Remedial excavation activities within the central part of Area 1 within Grid I-19 utilizing a Link-Belt 240 Trackhoe for excavation; Non-TSCA soil was stockpiled on like-material in a centralized location in order to facilitate loading of trucks from the clean access road; View of Area 1 looking E-NE. |

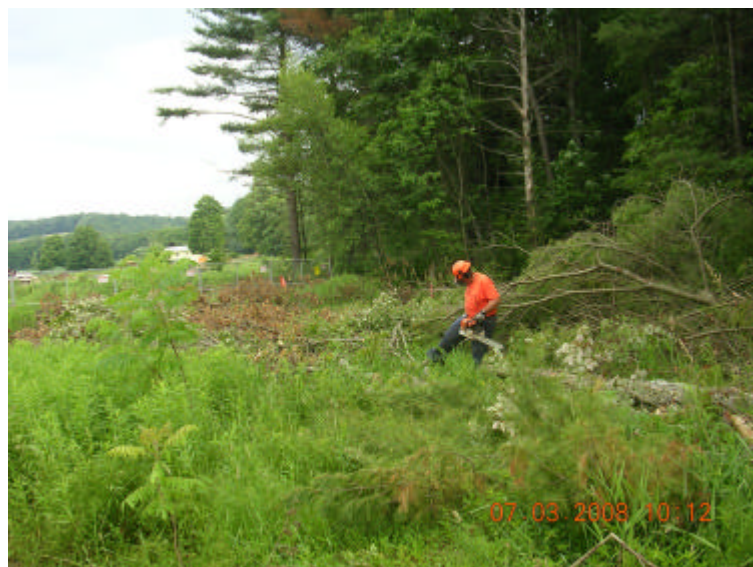
**DSCN3946.JPG**

| PHOTO | DATE | TIME | DESCRIPTION |
|---|---|---|---|
| DSCN 3946 | 7/3/2008 | 1012 | View of DAC crew clearing and grubbing in Area 8 looking N-NW. |

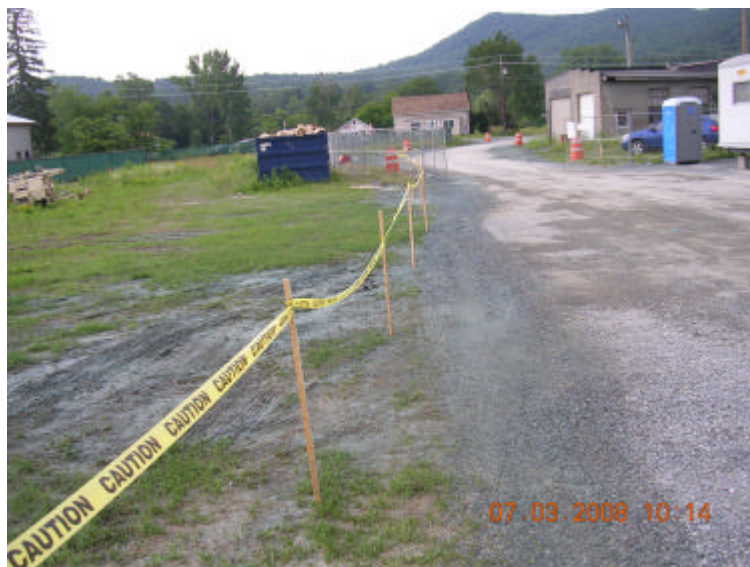
**DSCN3947.JPG**

| PHOTO | DATE | TIME | DESCRIPTION |
|---|---|---|---|
| DSCN 3947 | 7/3/2008 | 1014 | At the request of D&B, D.A. Collins marked off the personal vehicle parking area located in the central part of Area 9 with wooden stakes and yellow caution tape; Area 9 looking S-SE. |

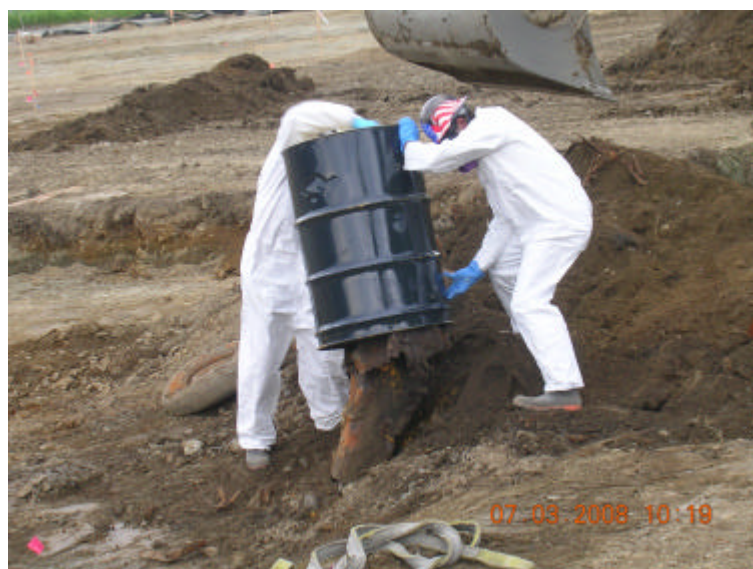
**DSCN3948.JPG**

2. The unknown, corroded 55-gallon steel drum, uncovered in the grid J-18 excavation yesterday, was placed in a 90-gallon steel overpack drum and hoisted from the excavation. The drum lid was tightened to provide an air tight seal. The drum was then staged on a layer of 6 mil polyethylene sheeting near the truck access road adjacent to K-18 pending waste characterization.

| PHOTO | DATE | TIME | DESCRIPTION |
|---|---|---|---|
| DSCN 3948 | 7/3/2008 | 1019 | View of DAC crew placing the unknown, 55-gallon steel drum inside a 90-gallon steel overpack drum at grid J-18 looking NW; Drum was buried approximately 2-4 ft bgs; Respirators and proper PPE were worn. |

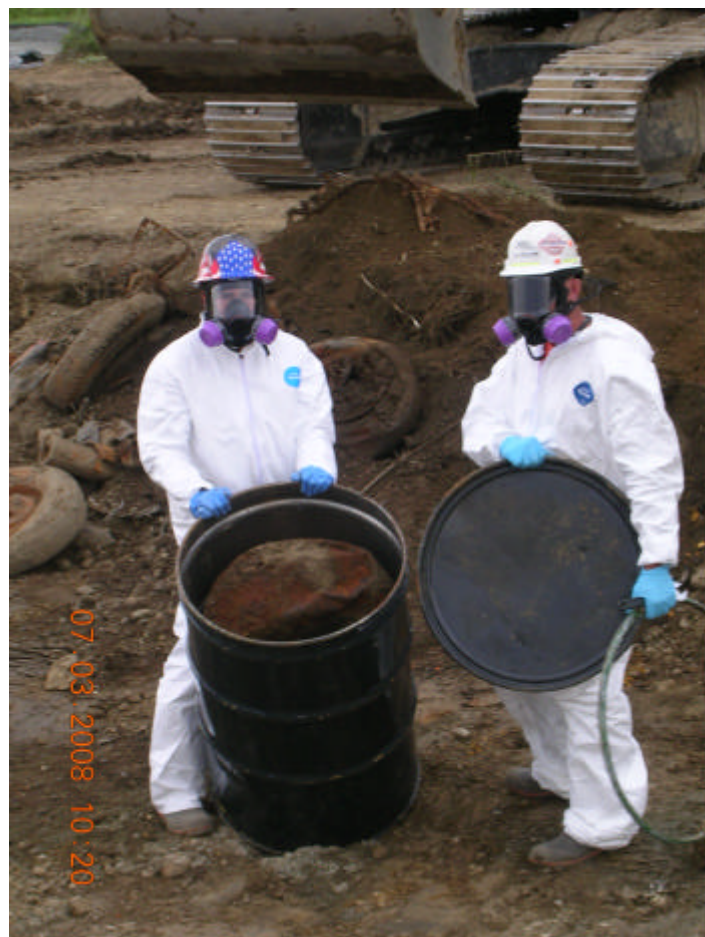
**DSCN3950.JPG**

| PHOTO | DATE | TIME | DESCRIPTION |
|---|---|---|---|
| DSCN 3950 | 7/3/2008 | 1020 | View of unknown, 55-gallon steel drum inside 90-gallon steel overpack drum prior to sealing at grid J-18 looking N; Respirators and proper PPE were worn. |

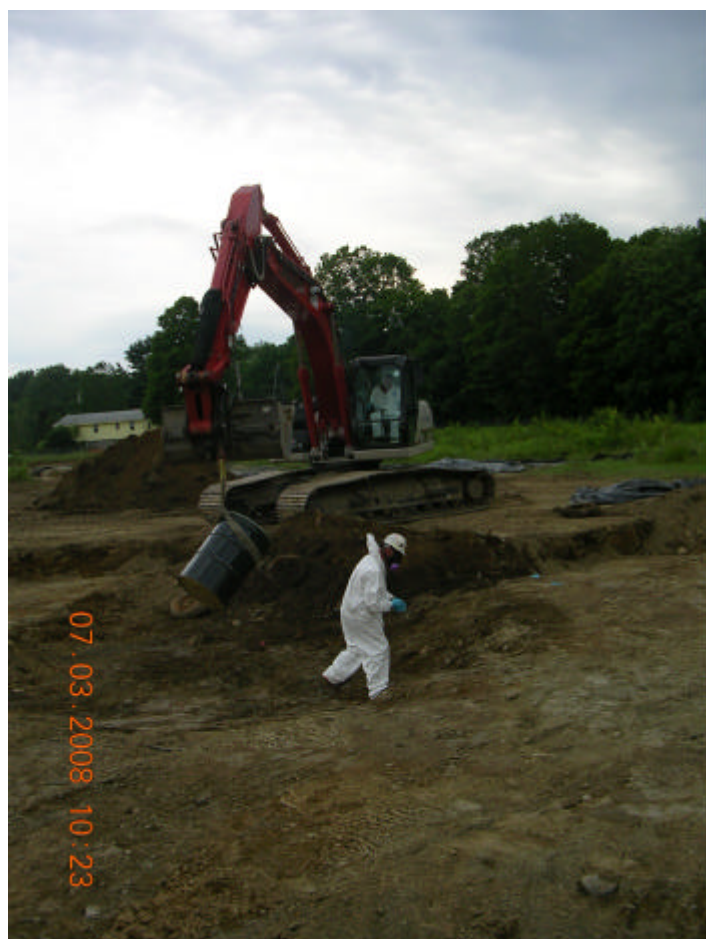
**DSCN3951.JPG**

| PHOTO | DATE | TIME | DESCRIPTION |
|---|---|---|---|
| DSCN 3951 | 7/3/2008 | 1023 | View of Link-Belt 240 Trackhoe hoisting the 90-gallon steel overpack drum from the J-18 excavation looking N; Respirators and proper PPE were worn. |

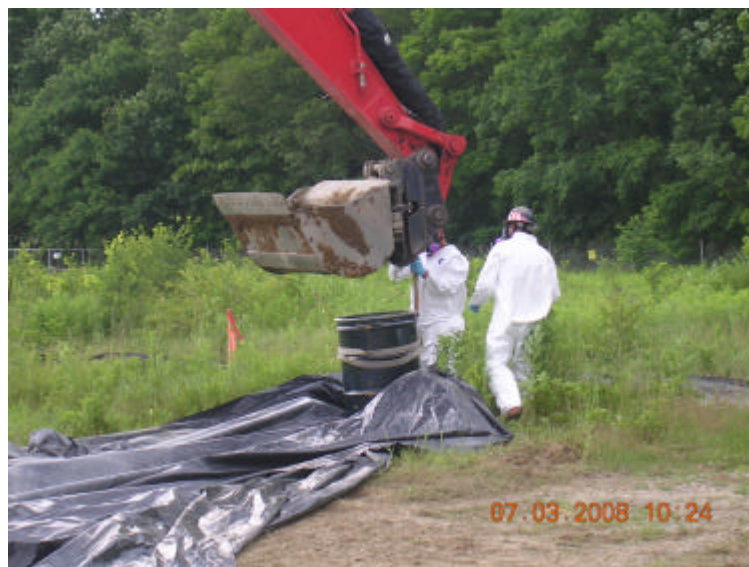
**DSCN3952.JPG**

| PHOTO | DATE | TIME | DESCRIPTION |
|---|---|---|---|
| DSCN 3952 | 7/3/2008 | 1024 | The 90-gallon steel overpack drum was staged on a layer of 6 mil polyethylene sheeting near the truck access road adjacent to K-18 pending waste characterization; View of Area 1 looking NE; Respirators and proper PPE were worn by DAC crew. |

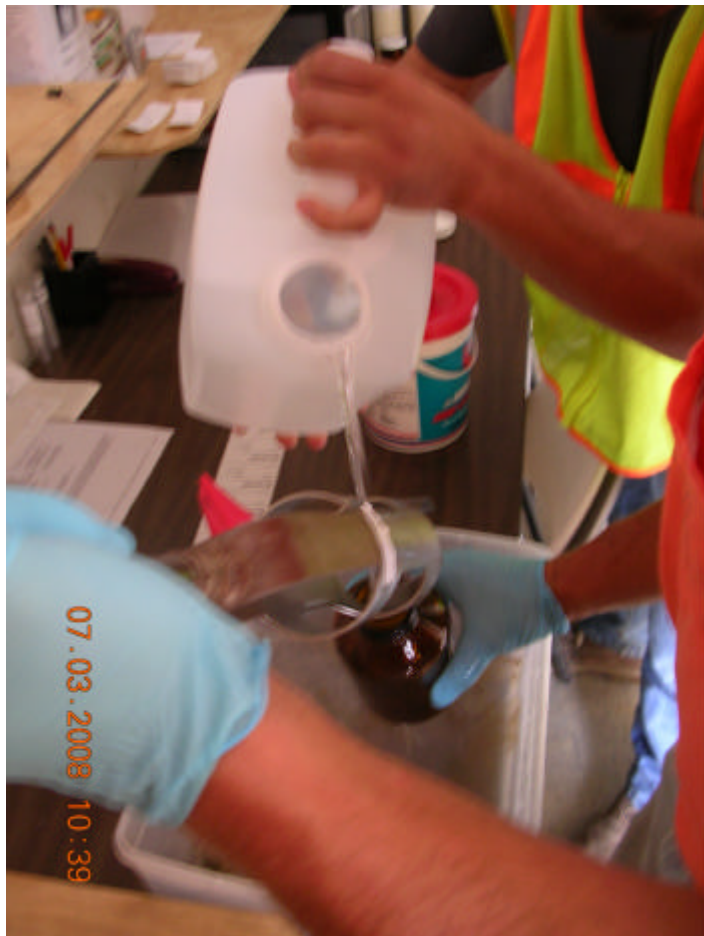
**DSCN3953.JPG**

| PHOTO | DATE | TIME | DESCRIPTION |
|---|---|---|---|
| DSCN 3953 | 7/3/2008 | 1039 | Rinsate sample Rinsate-07 was collected by DAC crew by pouring deionized water over the soil sampling corer and submitted for laboratory analysis of PCBs; Area 9 within sampling supply trailer. |

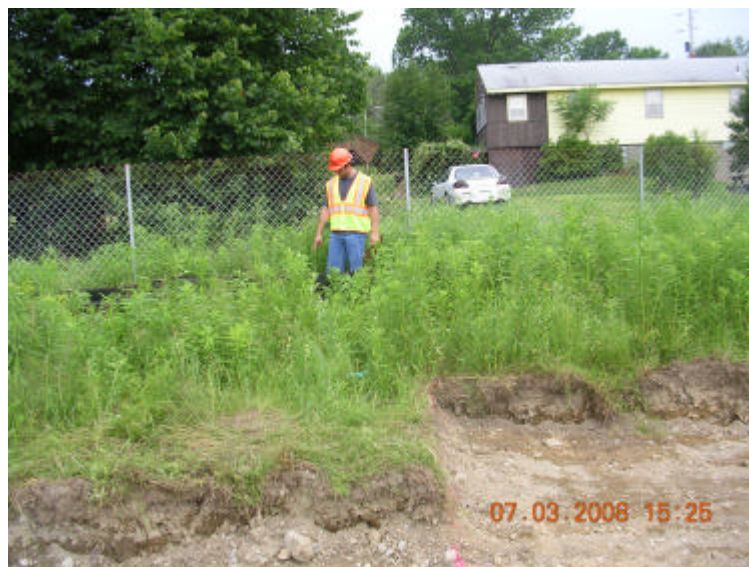
**DSCN3959.JPG**

| PHOTO | DATE | TIME | DESCRIPTION |
|---|---|---|---|
| DSCN 3959 | 7/3/2008 | 1525 | Collection of surface soil sample Petell-01 from 0-1 ft bgs in the backyard of the Petell residence; Area 1 looking N. |

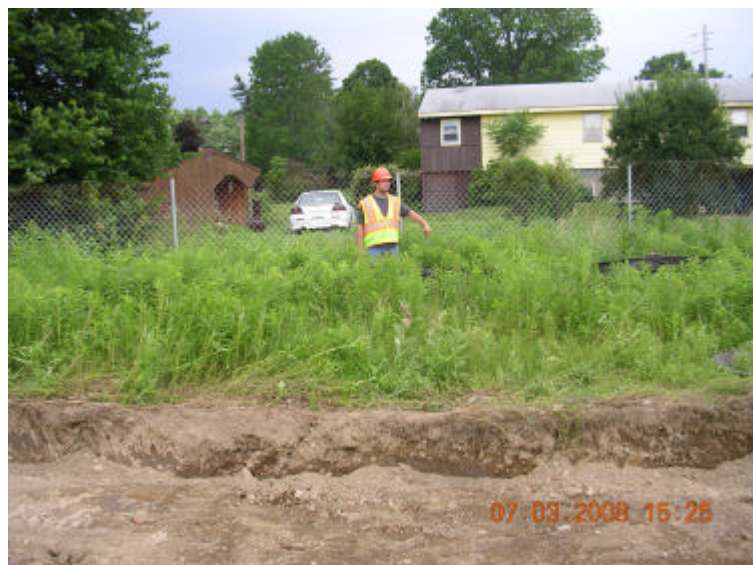
**DSCN3960.JPG**

| PHOTO | DATE | TIME | DESCRIPTION |
|---|---|---|---|
| DSCN 3960 | 7/3/2008 | 1525 | Collection of surface soil sample Petell-02 from 0-1 ft bgs in the backyard of the Petell residence; Area 1 looking N. |

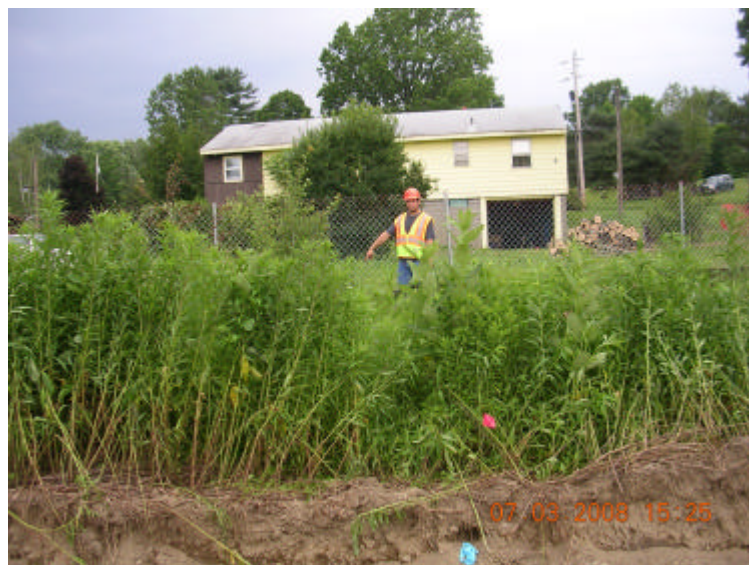
**DSCN3961.JPG**

| PHOTO | DATE | TIME | DESCRIPTION |
|---|---|---|---|
| DSCN 3961 | 7/3/2008 | 1525 | Collection of surface soil sample Petell-03 from 0-1 ft bgs in the backyard of the Petell residence; Area 1 looking N. |

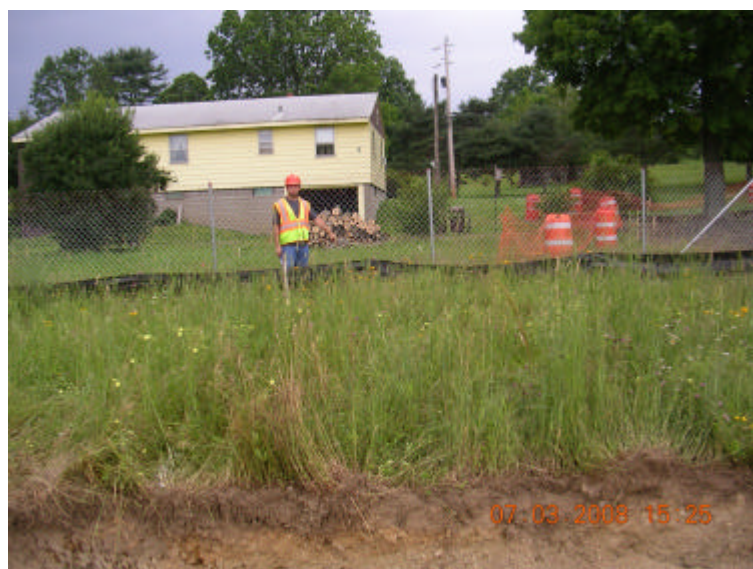
**DSCN3962.JPG**

| PHOTO | DATE | TIME | DESCRIPTION |
|---|---|---|---|
| DSCN 3962 | 7/3/2008 | 1525 | Collection of surface soil sample Petell-04 from 0-1 ft bgs in the backyard of the Petell residence; Area 1 looking N. |

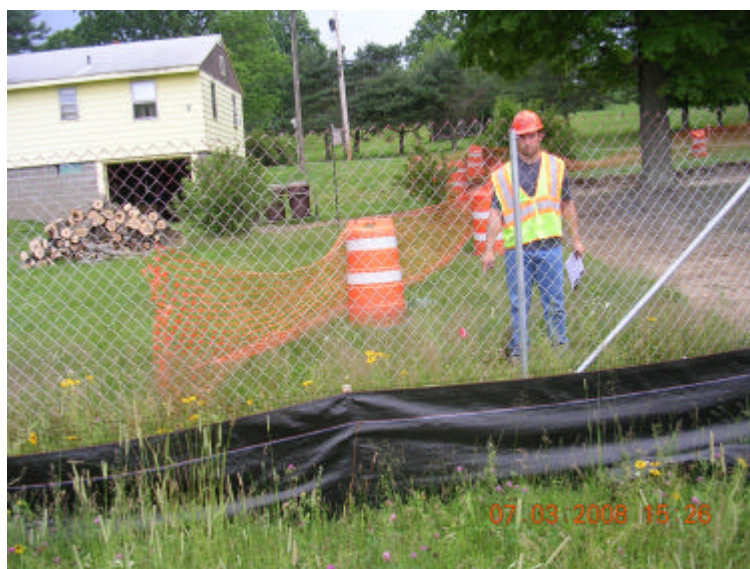
**DSCN3963.JPG**

| PHOTO | DATE | TIME | DESCRIPTION |
|---|---|---|---|
| DSCN 3963 | 7/3/2008 | 1526 | Collection of surface soil sample Petell-05 from 0-1 ft bgs in the backyard of the Petell residence; Area 1 looking N. |

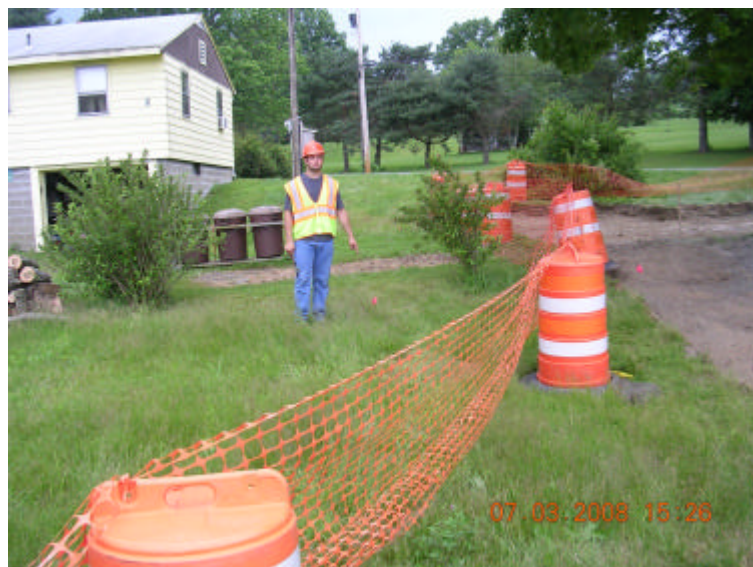
**DSCN3964.JPG**

| PHOTO | DATE | TIME | DESCRIPTION |
|---|---|---|---|
| DSCN 3964 | 7/3/2008 | 1526 | Collection of surface soil sample Petell-06 from 0-1 ft bgs in the backyard of the Petell residence; Area 1 looking N. |

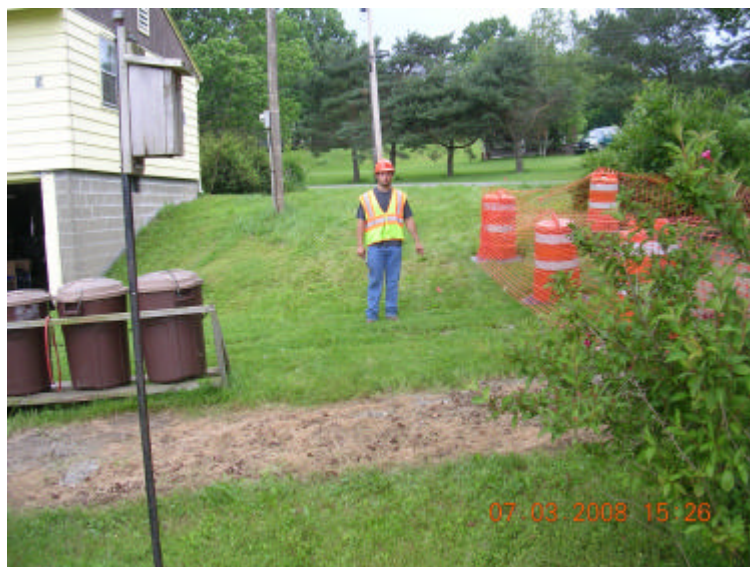
**DSCN3965.JPG**

| PHOTO | DATE | TIME | DESCRIPTION |
|---|---|---|---|
| DSCN 3965 | 7/3/2008 | 1526 | Collection of surface soil sample Petell-06 from 0-1 ft bgs in the backyard of the Petell residence; Area 1 looking N. |

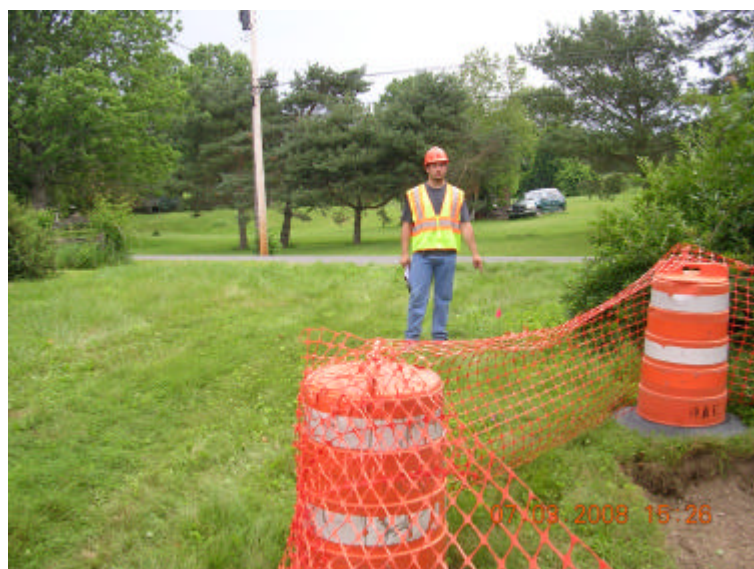
**DSCN3966.JPG**

| PHOTO | DATE | TIME | DESCRIPTION |
|---|---|---|---|
| DSCN 3966 | 7/3/2008 | 1526 | Collection of surface soil sample Petell-07 from 0-1 ft bgs in the backyard of the Petell residence; Area 1 looking N. |

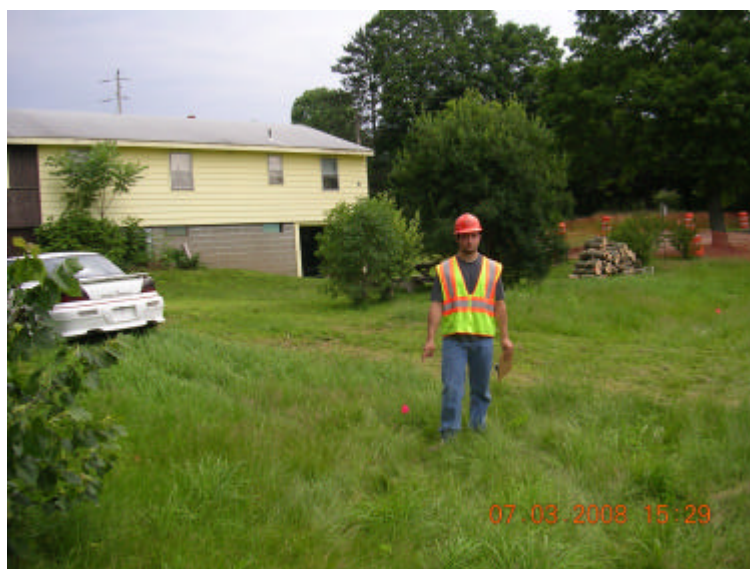
**DSCN3967.JPG**

| PHOTO | DATE | TIME | DESCRIPTION |
|---|---|---|---|
| DSCN 3967 | 7/3/2008 | 1529 | Collection of surface soil sample Petell-08 from 0-1 ft bgs in the backyard of the Petell residence; Area 1 looking N. |

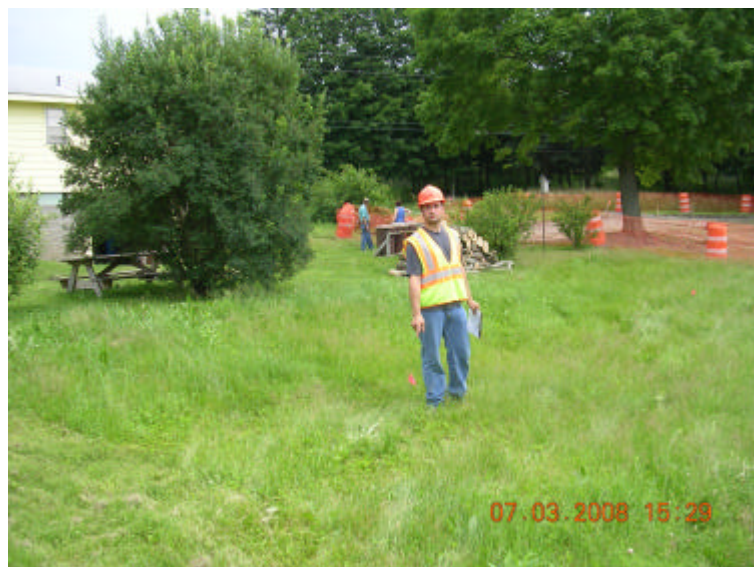
**DSCN3968.JPG**

| PHOTO | DATE | TIME | DESCRIPTION |
|---|---|---|---|
| DSCN 3968 | 7/3/2008 | 1529 | Collection of surface soil sample Petell-09 from 0-1 ft bgs in the backyard of the Petell residence; Area 1 looking NE. |

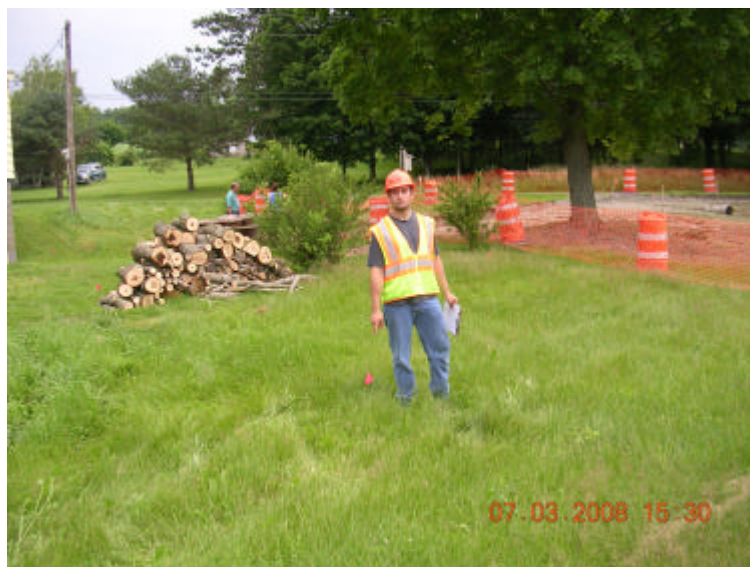
**DSCN3969.JPG**

| PHOTO | DATE | TIME | DESCRIPTION |
|---|---|---|---|
| DSCN 3969 | 7/3/2008 | 1530 | Collection of surface soil sample Petell-10 from 0-1 ft bgs in the backyard of the Petell residence; Area 1 looking NE. |

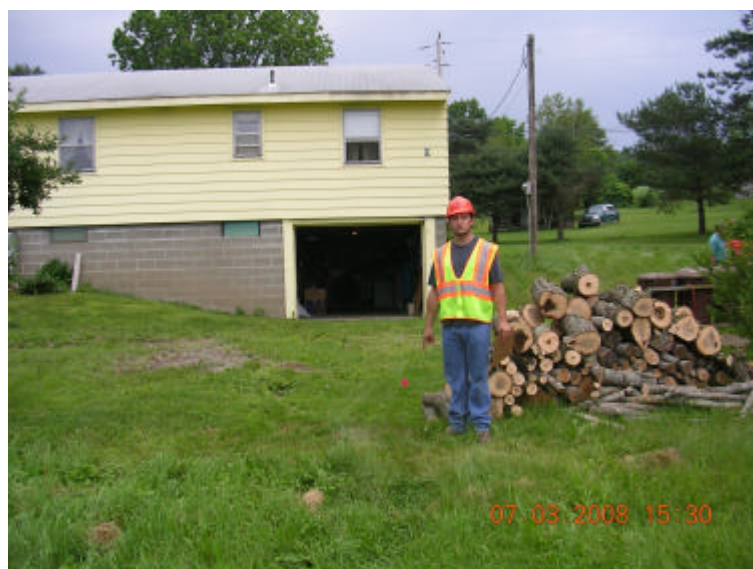
**DSCN3970.JPG**

| PHOTO | DATE | TIME | DESCRIPTION |
|---|---|---|---|
| DSCN 3970 | 7/3/2008 | 1530 | Collection of surface soil sample Petell-11 from 0-1 ft bgs in the backyard of the Petell residence; Area 1 looking NE. |

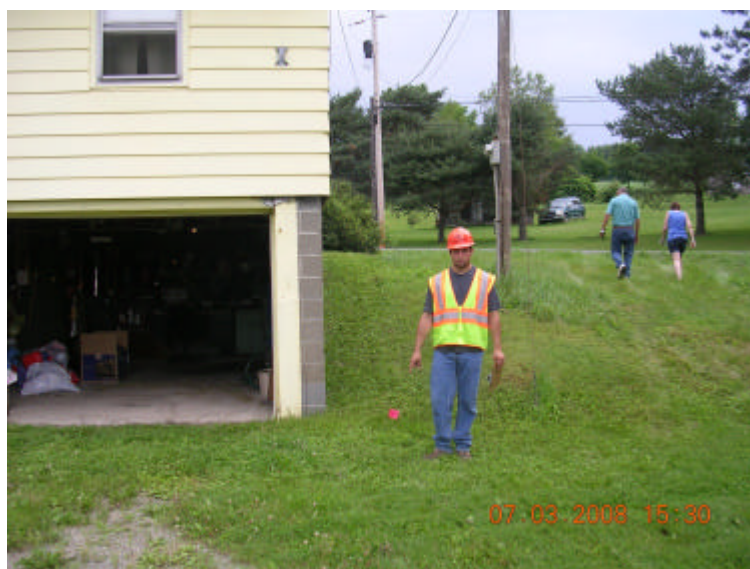
**DSCN3971.JPG**

| PHOTO | DATE | TIME | DESCRIPTION |
|---|---|---|---|
| DSCN 3971 | 7/3/2008 | 1530 | Collection of surface soil sample Petell-12 from 0-1 ft bgs in the backyard of the Petell residence; Area 1 looking N. |

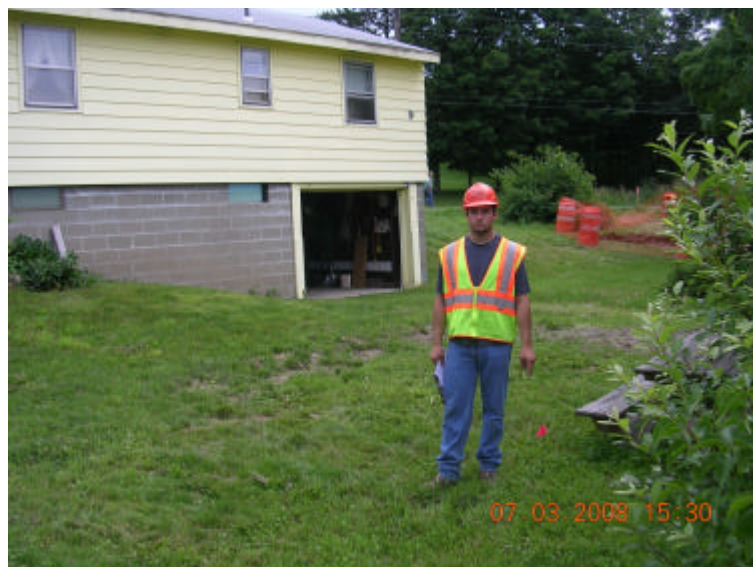
**DSCN3972.JPG**

| PHOTO | DATE | TIME | DESCRIPTION |
|---|---|---|---|
| DSCN 3972 | 7/3/2008 | 1530 | Collection of surface soil sample Petell-13 from 0-1 ft bgs in the backyard of the Petell residence; Area 1 looking N. |

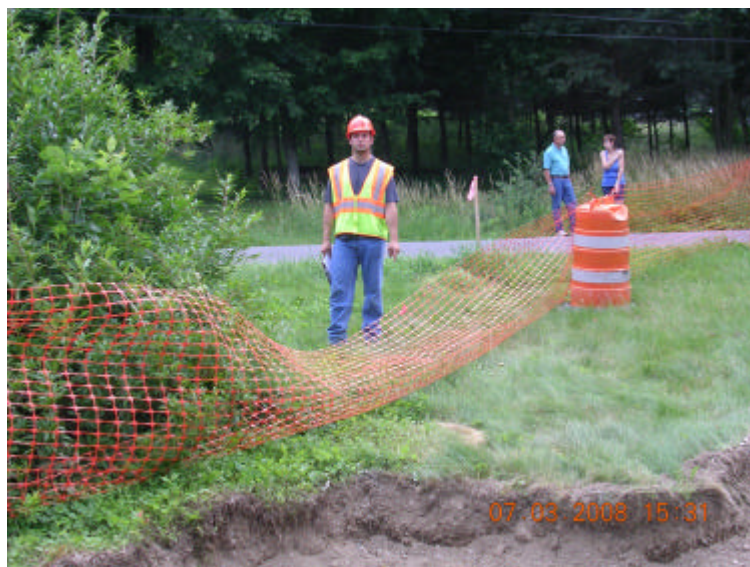
**DSCN3973.JPG**

| PHOTO | DATE | TIME | DESCRIPTION |
|---|---|---|---|
| DSCN 3973 | 7/3/2008 | 1531 | Collection of surface soil sample Petell-14 from 0-1 ft bgs in the backyard of the Petell residence; Area 1 looking N. |

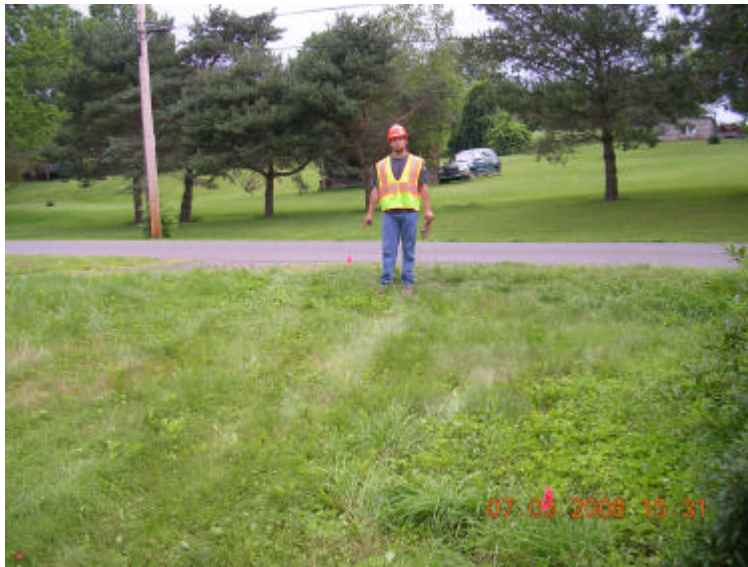
**DSCN3974.JPG**

| PHOTO | DATE | TIME | DESCRIPTION |
|---|---|---|---|
| DSCN 3974 | 7/3/2008 | 1531 | Collection of surface soil sample Petell-15 from 0-1 ft bgs in the backyard of the Petell residence; Area 1 looking N. |

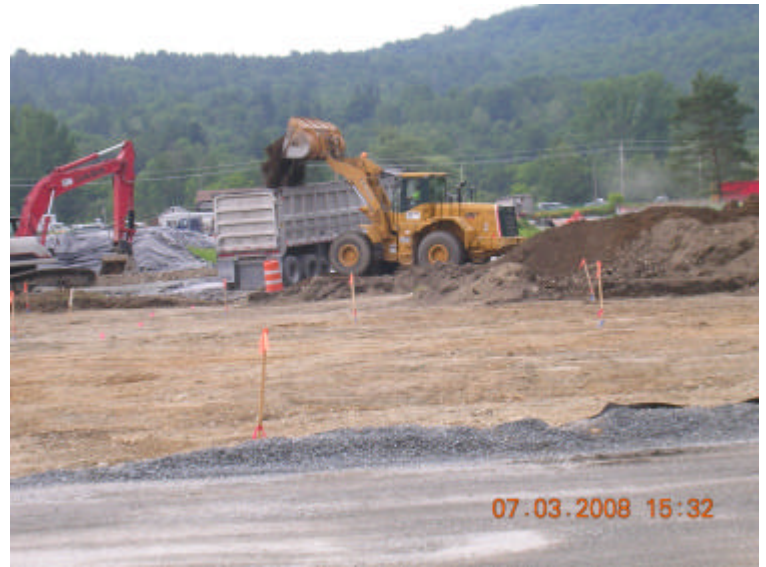
**DSCN3975.JPG**

| PHOTO | DATE | TIME | DESCRIPTION |
|---|---|---|---|
| DSCN 3975 | 7/3/2008 | 1532 | View of DAC loading of PCB contaminated soil using a Link-Belt 240 Trackhoe and a Kawasaki 80ZV Front Loader looking S. |
