## DAILY FIELD ACTIVITY REPORT

| PROJECT | Former Bouchard Junkyard | WEATHER | TIME | TEMP. | PRECIP. | WIND (MPH) | WIND (DIR) |
| LOCATION | Town of New Lebanon, NY | Overcast<br>HHH | 1000 | 70-75 F | None | 0-5 | SW |

**PHOTOGRAPHIC LOG**  
**July 7, 2008**  
**D&B JOB NO. 2605**  
**FORMER BOUCHARD JUNKYARD SITE**  
**TOWN OF NEW LEBANON, NEW YORK**

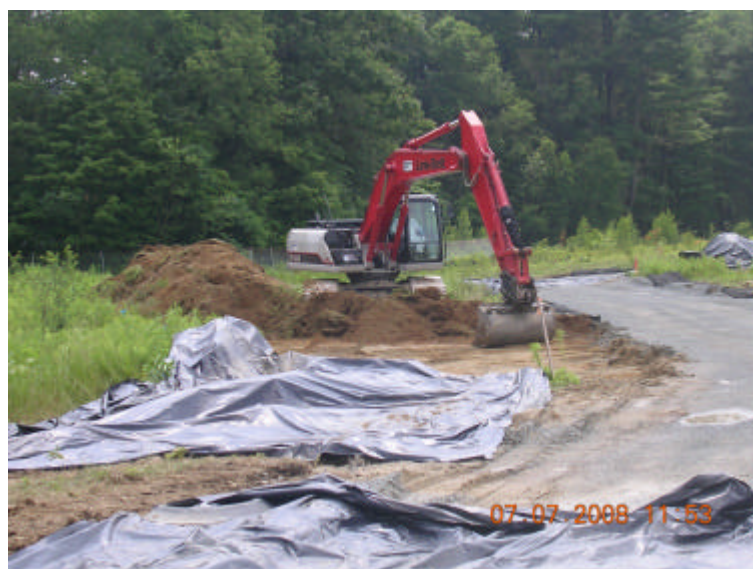
**DSCN3977.JPG**

| PHOTO | DATE | TIME | DESCRIPTION |
|---|---|---|---|
| DSCN 3977 | 7/7/2008 | 1153 | Remedial excavation activities within the central part of Area 1 within Grid I-21 utilizing a Link-Belt 240 Trackhoe for excavation; Non-TSCA soil was stockpiled on like-material in a centralized location in order to facilitate loading of trucks from the clean access road; View of Area 1 looking E. |

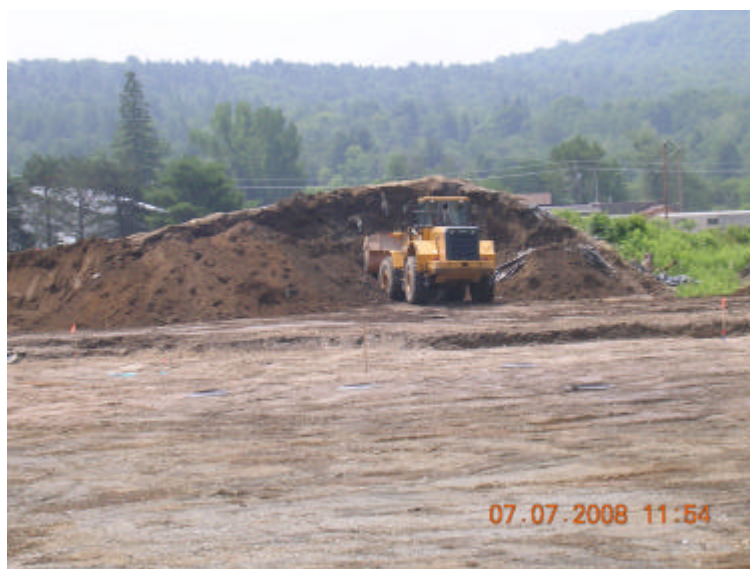
**DSCN3978.JPG**

| PHOTO | DATE | TIME | DESCRIPTION |
|---|---|---|---|
| DSCN 3978 | 7/7/2008 | 1154 | View of DAC loading of non-TSCA PCB contaminated soil using a Kawasaki 80ZV Front Loader from the main soil stockpile in Area 3 looking S. |

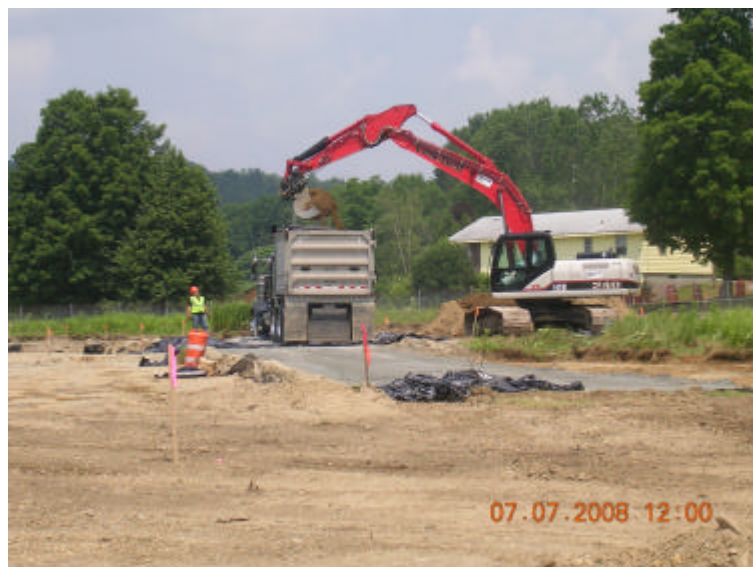
**DSCN3979.JPG**

| PHOTO | DATE | TIME | DESCRIPTION |
|---|---|---|---|
| DSCN 3979 | 7/7/2008 | 1200 | View of DAC loading of non-TSCA PCB contaminated soil using a Link-Belt 240 Trackhoe directly from soil excavated from grid J-21 in Area 1 looking NW. |

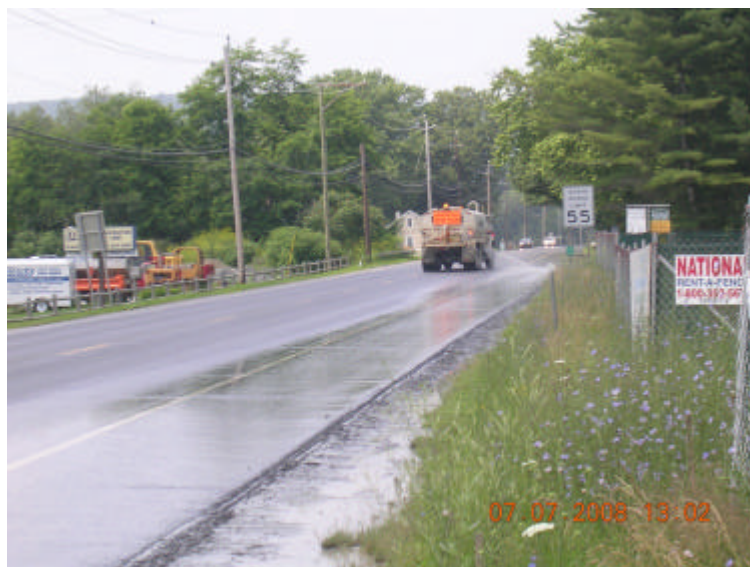
**DSCN3980.JPG**

| PHOTO | DATE | TIME | DESCRIPTION |
|---|---|---|---|
| DSCN 3980 | 7/7/2008 | 1302 | Cleaning of muddy tire tracks in progress onto Route 20 road surface at entrance to driveway to Building 666 using 4,000 gallon Mack Water Truck; View of Route 20 looking W. |

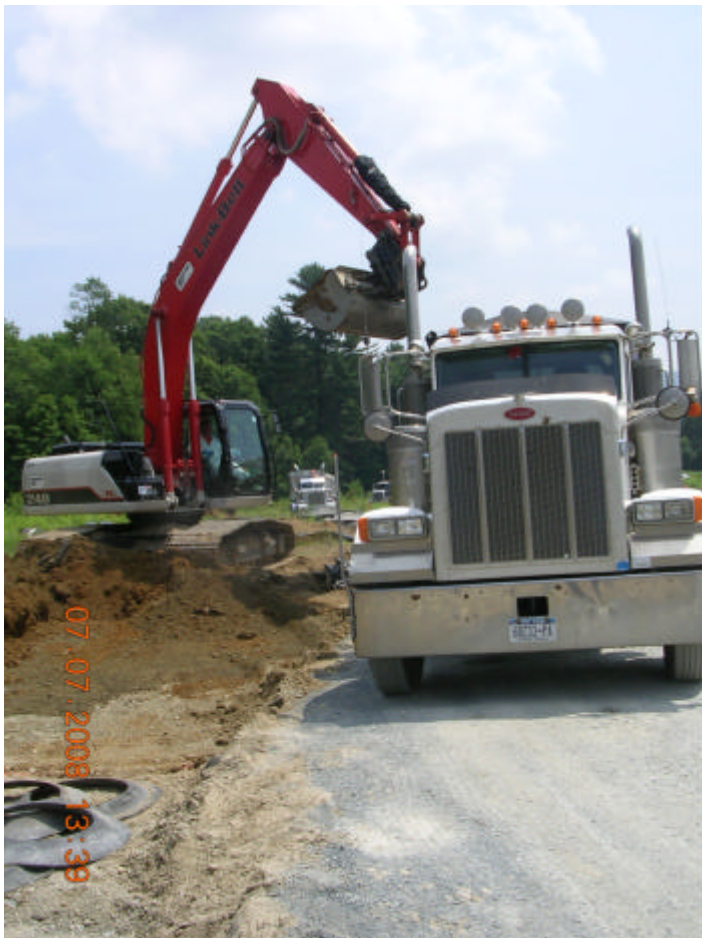
**DSCN3981.JPG**

| PHOTO | DATE | TIME | DESCRIPTION |
|---|---|---|---|
| DSCN 3981 | 7/7/2008 | 1340 | View of continued loading of non-TSCA PCB contaminated soil using a Link-Belt 240 Trackhoe directly from soil excavated from grid J-21 in Area 1 looking NW. |

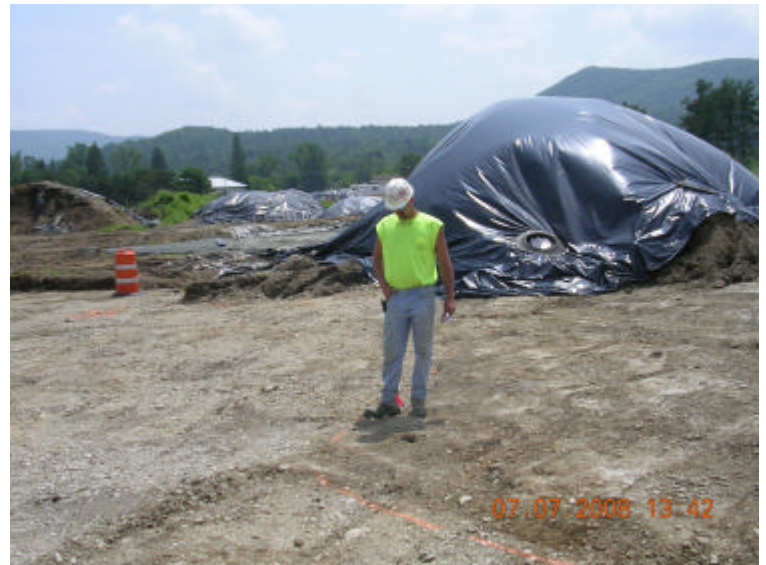
**DSCN3982.JPG**

| PHOTO | DATE | TIME | DESCRIPTION |
|---|---|---|---|
| DSCN 3982 | 7/7/2008 | 1342 | Collection of bottom soil sample EP-G19(Non-TSCA) at 1 ft bgs within grid G-19; Area 1 looking S. |

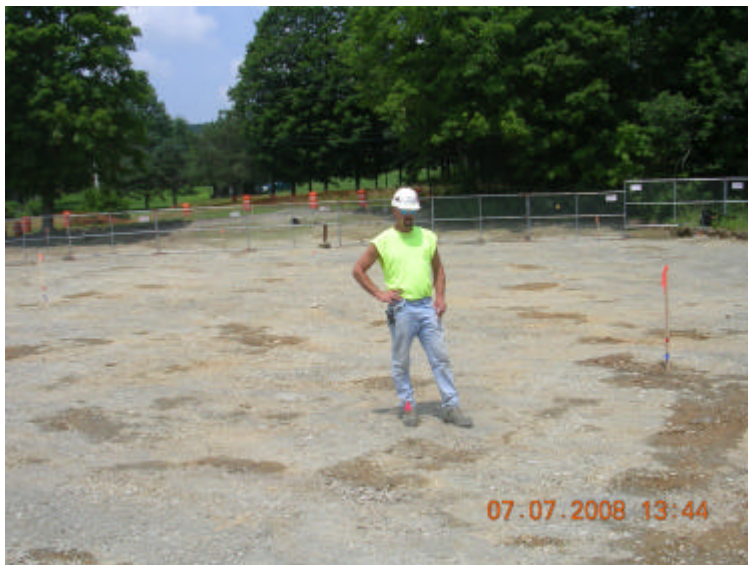
**DSCN3983.JPG**

| PHOTO | DATE | TIME | DESCRIPTION |
|---|---|---|---|
| DSCN 3983 | 7/7/2008 | 1344 | Collection of bottom soil sample EP-G23 at 1 ft bgs within grid G-23; Area 1 looking N. |

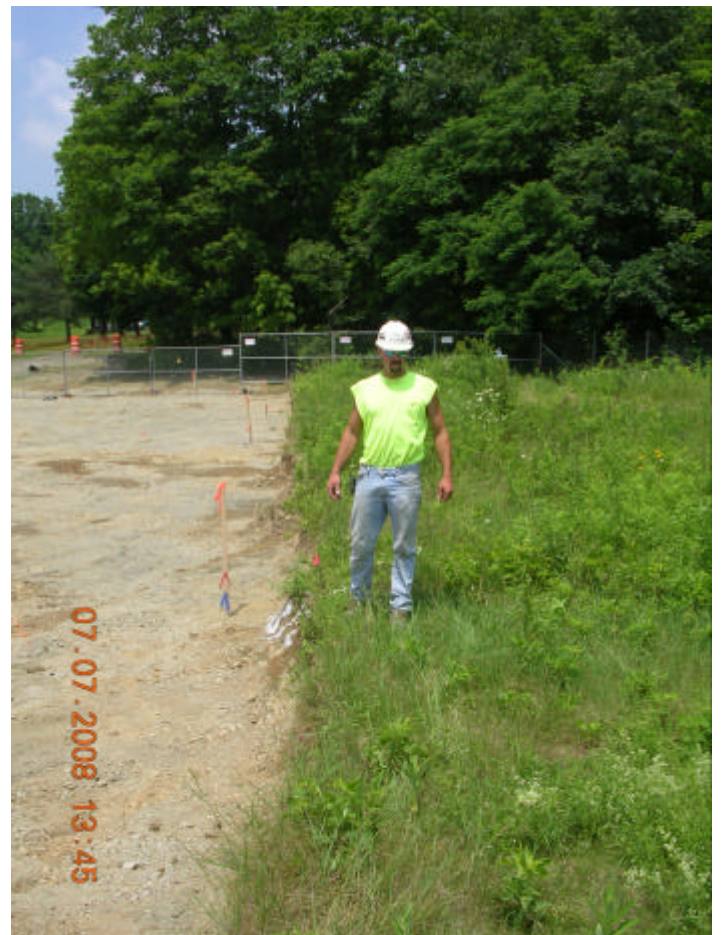
**DSCN3984.JPG**

| PHOTO | DATE | TIME | DESCRIPTION |
|---|---|---|---|
| DSCN 3984 | 7/7/2008 | 1345 | Collection of perimeter sidewall soil sample EP-PSW-11 at 0-0.5 ft bgs adjacent to grid I-22; Area 1 looking N. |

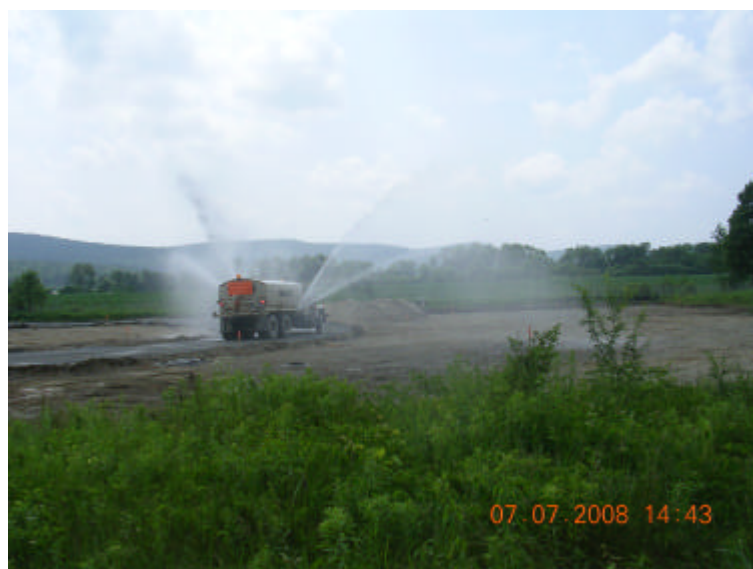
**DSCN3986.JPG**

| PHOTO | DATE | TIME | DESCRIPTION |
|---|---|---|---|
| DSCN 3986 | 7/7/2008 | 1443 | View of dust suppression in progress onto truck access road and ground surfaces across Area 1 using 4,000 gallon Mack Water Truck; The dust suppression was prompted by an elevated dust concentration detected at the NE air monitoring station positioned near grid J-24; View of Area 1 looking W. |

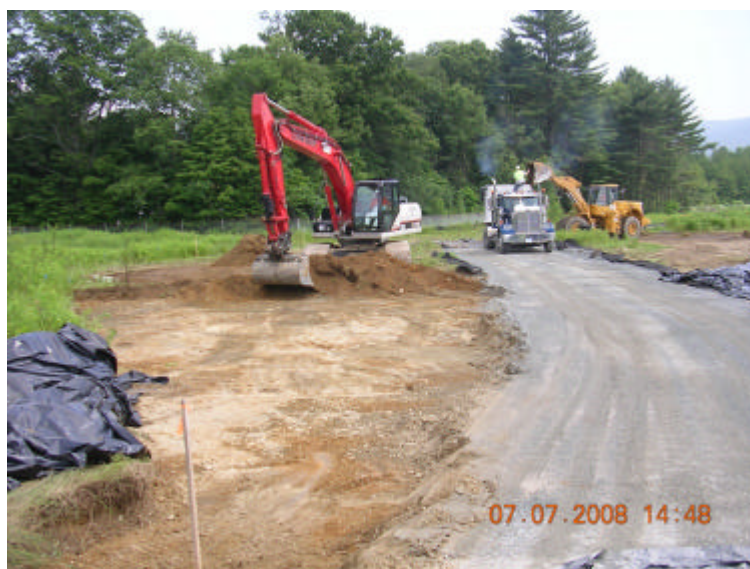
**DSCN3989.JPG**

| PHOTO | DATE | TIME | DESCRIPTION |
|---|---|---|---|
| DSCN 3989 | 7/7/2008 | 1448 | Remedial excavation activities within the central part of Area 1 within Grid J-21 utilizing a Link-Belt 240 Trackhoe (foreground); Non-TSCA soil was stockpiled on like-material in a centralized location in order to facilitate loading of trucks from the clean access road; View of DAC loading of non-TSCA PCB contaminated soil in the distant background using a Kawasaki 80ZV Front Loader shuttled from the main soil stockpile in Area 3; View of Area 1 looking E-SE. |

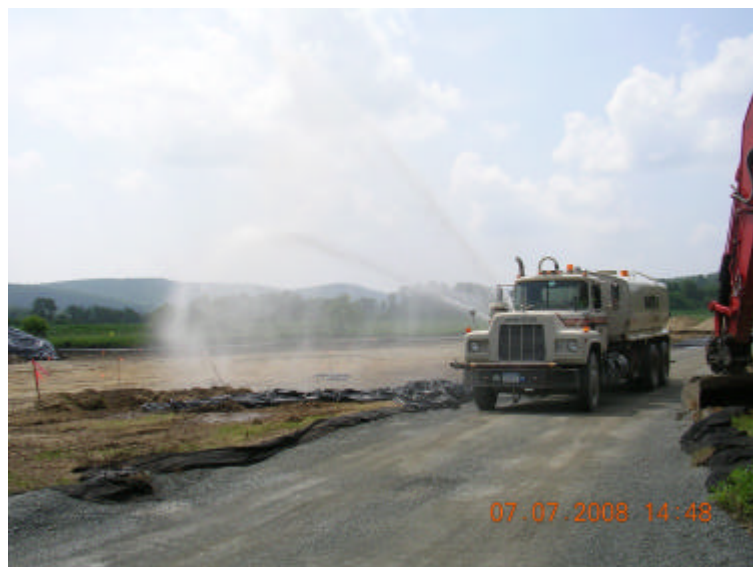
**DSCN3990.JPG**

| PHOTO | DATE | TIME | DESCRIPTION |
|---|---|---|---|
| DSCN 3990 | 7/7/2008 | 1448 | View of continued dust suppression in progress on truck access road and ground surfaces across Area 1 using 4,000 gallon Mack Water Truck; The dust suppression was prompted by an elevated dust concentration detected at the NE air monitoring station positioned near grid J-24; View of Area 1 looking W. |

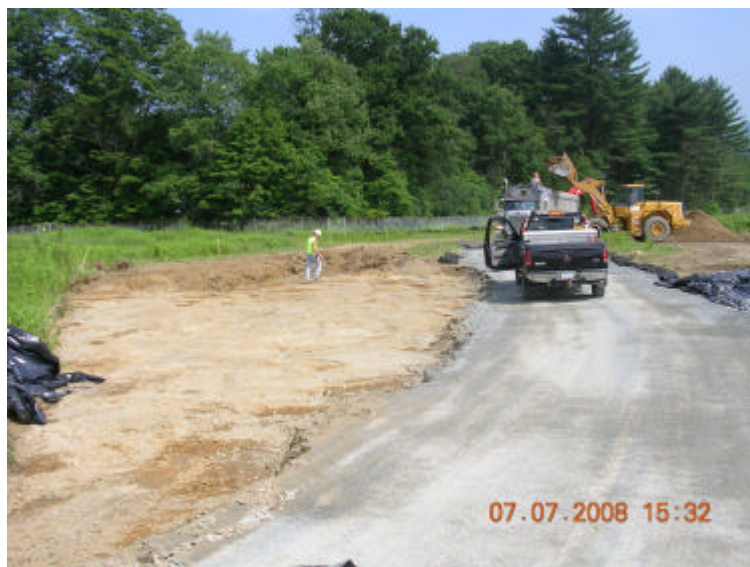
**DSCN3991.JPG**

| PHOTO | DATE | TIME | DESCRIPTION |
|---|---|---|---|
| DSCN 3991 | 7/7/2008 | 1532 | View of remedial excavation progress at the close of business where the excavation was terminated at the eastern fringe of grid J-21; View of DAC loading of non-TSCA PCB contaminated soil in the distant background using a Kawasaki 80ZV Front Loader shuttled from the main soil stockpile in Area 3; Area 1 looking E-SE. |
