## DAILY FIELD ACTIVITY REPORT

| PROJECT | Former Bouchard Junkyard | WEATHER | TIME | TEMP. | PRECIP. | WIND (MPH) | WIND (DIR) |
| LOCATION | Town of New Lebanon, NY | Overcast<br>Some Haze | 0700 | 70-75 F | None | Calm | NA |

**PHOTOGRAPHIC LOG**  
**July 8, 2008**  
**D&B JOB NO. 2605**  
**FORMER BOUCHARD JUNKYARD SITE**  
**TOWN OF NEW LEBANON, NEW YORK**

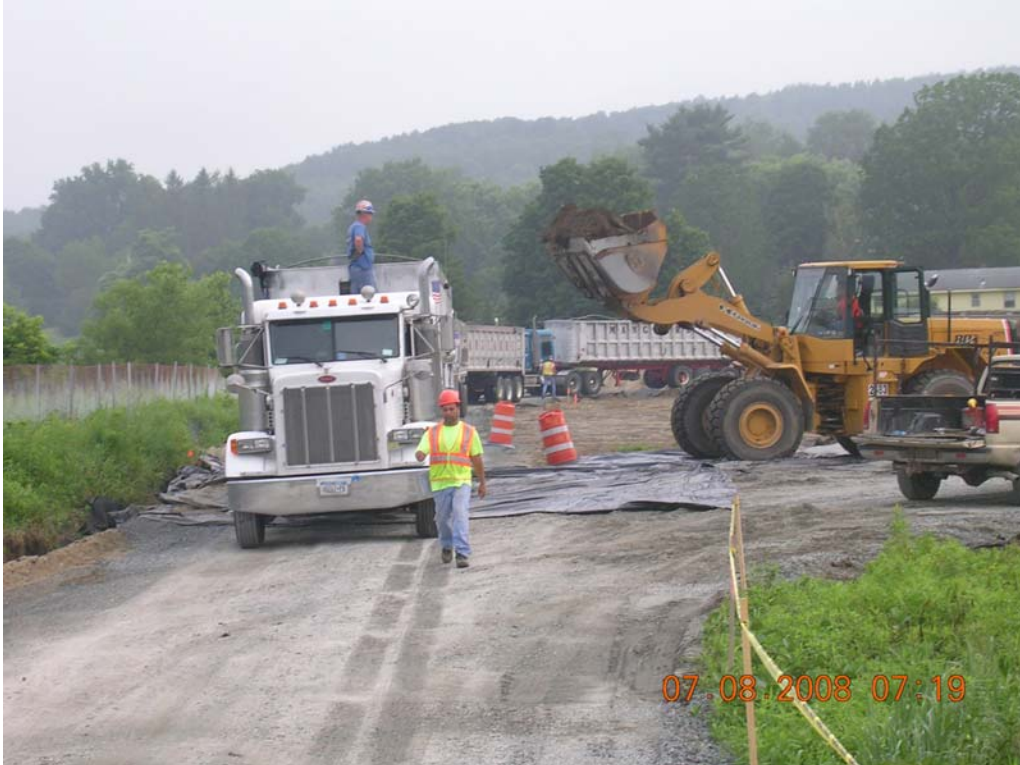
DSCN3992.JPG

| PHOTO | DATE | TIME | DESCRIPTION |
|---|---|---|---|
| DSCN 3992 | 7/8/2008 | 0719 | View of DAC loading of non-TSCA PCB contaminated soil using a Kawasaki 80ZV Front Loader from the main soil stockpile in Area 2 looking N. |

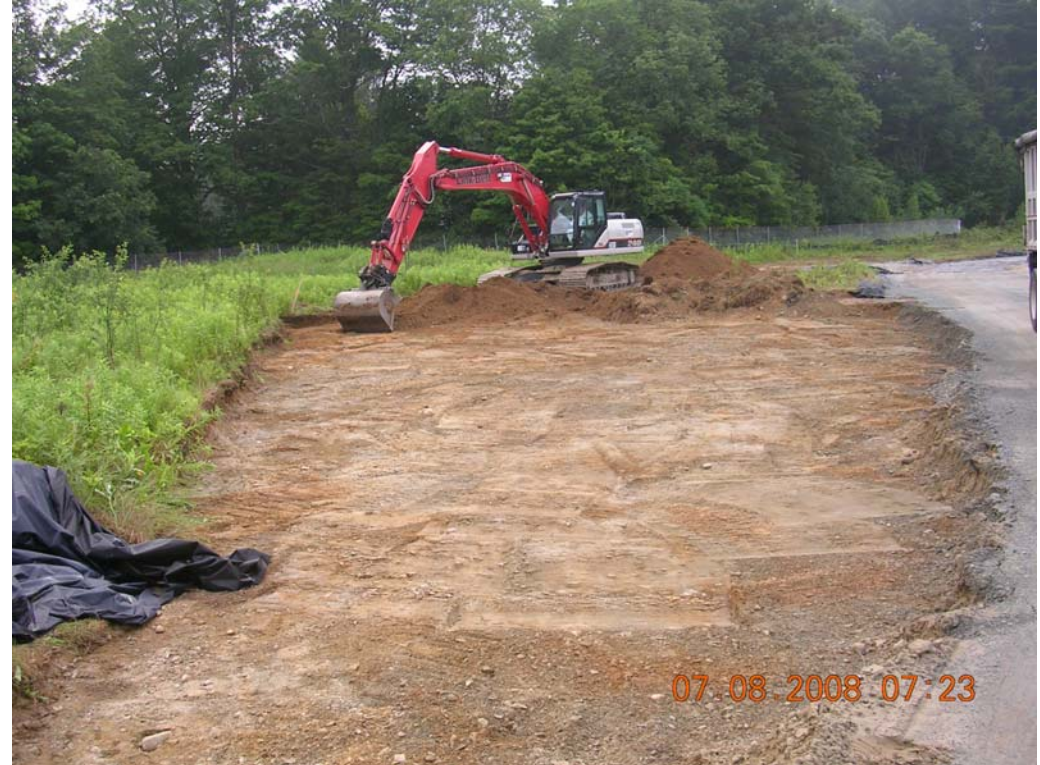
DSCN3993.JPG

| PHOTO | DATE | TIME | DESCRIPTION |
|---|---|---|---|
| DSCN 3993 | 7/8/2008 | 0723 | Remedial excavation activities within the central part of Area 1 within Grid K-20 utilizing a Link-Belt 240 Trackhoe; Non-TSCA soil was stockpiled on like-material in a centralized location in order to facilitate loading of trucks from the clean access road; View of Area 1 looking E-SE. |

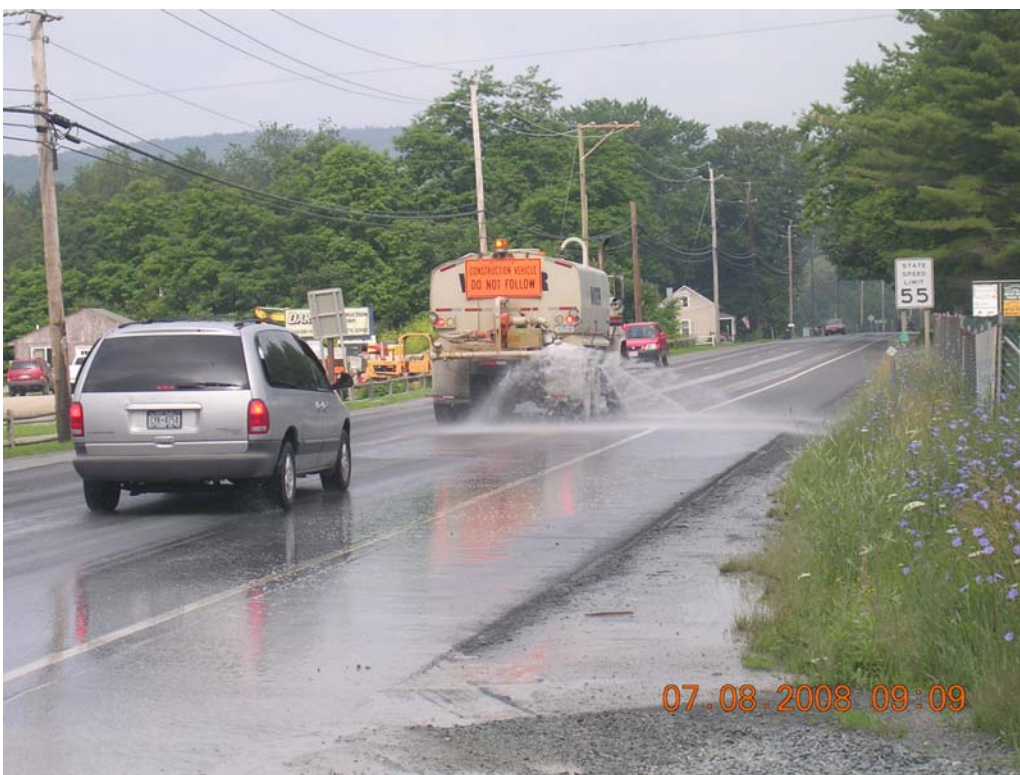
DSCN3994.JPG

| PHOTO | DATE | TIME | DESCRIPTION |
|---|---|---|---|
| DSCN 3994 | 7/8/2008 | 0909 | Cleaning of muddy tire tracks in progress onto Route 20 road surface at entrance to driveway to Building 666 using 4,000 gallon Mack Water Truck; View of Route 20 looking W. |

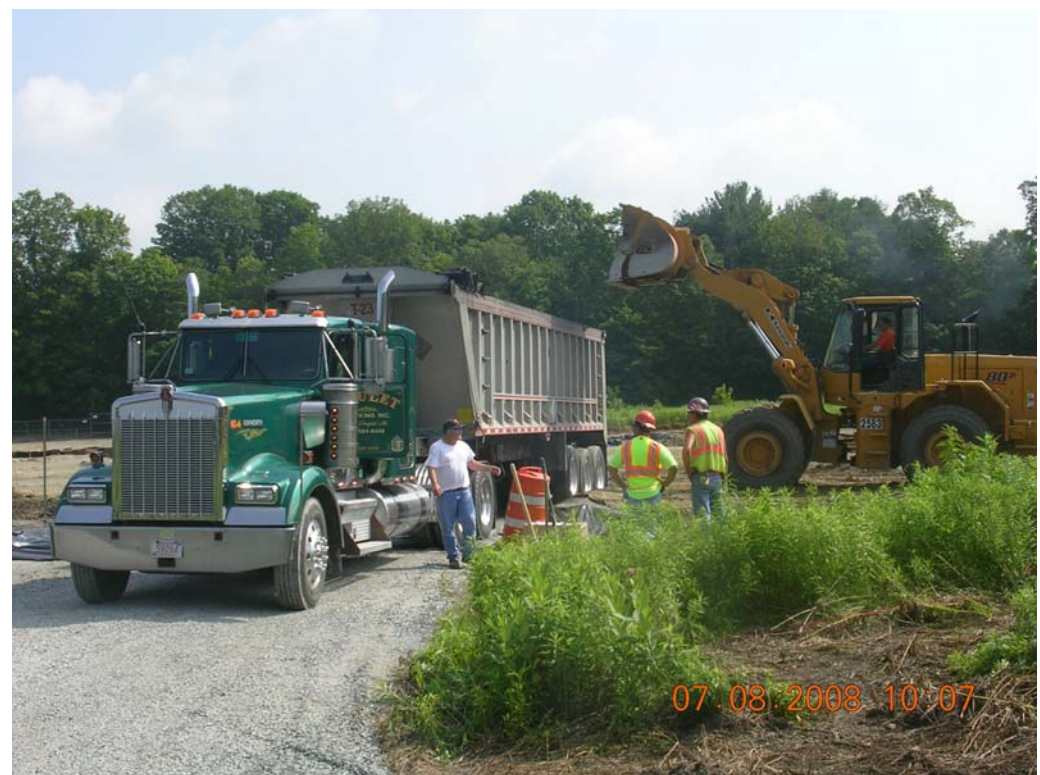
DSCN3995.JPG

| PHOTO | DATE | TIME | DESCRIPTION |
|---|---|---|---|
| DSCN 3995 | 7/8/2008 | 1007 | View of DAC loading of non-TSCA PCB contaminated soil using a Kawasaki 80ZV Front Loader from the main soil stockpile in Area 2 looking NE. |

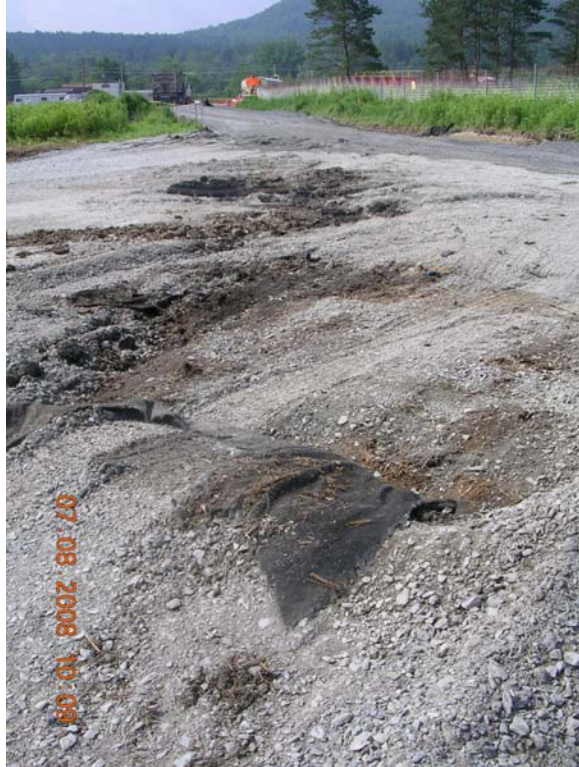
DSCN3996.JPG

| PHOTO | DATE | TIME | DESCRIPTION |
|---|---|---|---|
| DSCN 3996 | 7/8/2008 | 1009 | View of tire ruts in spur driveway surface on the west side of Area 2 looking SW; The weight of the trucks has pushed up the road fabric through the crusher run gravel and has torn in several places, which has exposed non-TSCA PCB-contaminated soil; D&B requested that the driveway be either repaired or covered with 6 mil polyethylene sheeting over the damaged section of driveway. |

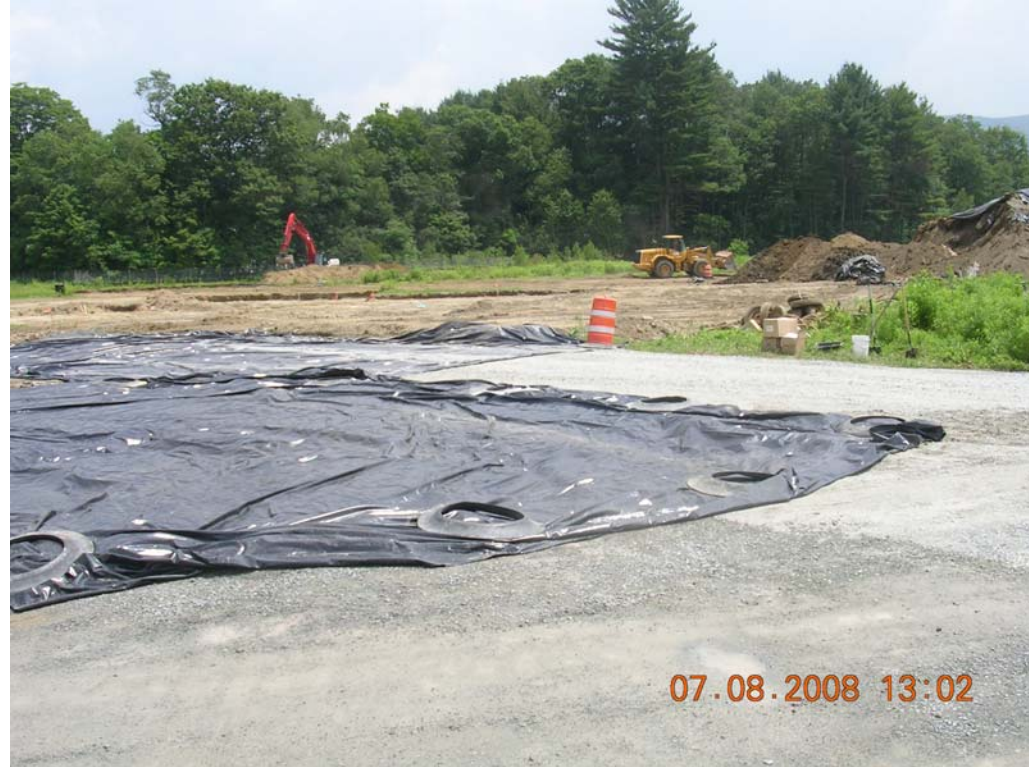
DSCN3997.JPG

| PHOTO | DATE | TIME | DESCRIPTION |
|---|---|---|---|
| DSCN 3997 | 7/8/2008 | 1302 | As requested by D&B, the damaged section of spur driveway in Area 2 was covered with 6 mil polyethylene sheeting; Area 2 looking NE. |

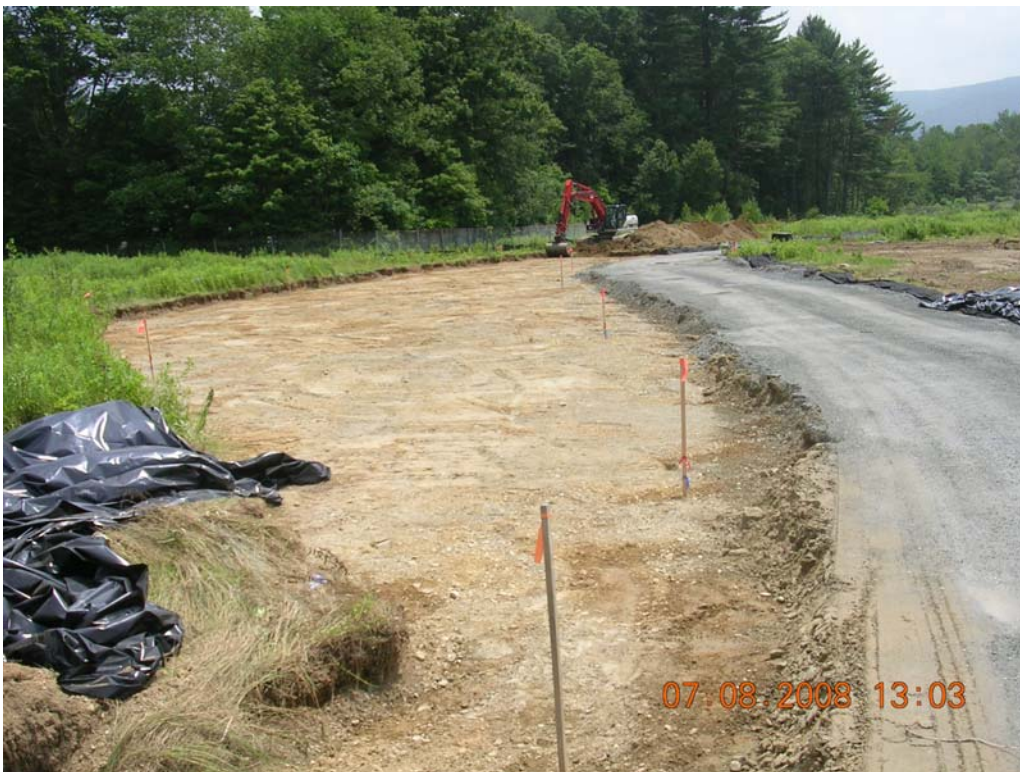
DSCN3998.JPG

| PHOTO | DATE | TIME | DESCRIPTION |
|---|---|---|---|
| DSCN 3998 | 7/8/2008 | 1303 | Remedial excavation activities within the central part of Area 1 within Grid N-18 utilizing a Link-Belt 240 Trackhoe; Non-TSCA soil was stockpiled on like-material in a centralized location in order to facilitate loading of trucks from the clean access road; View of Area 1 looking E-SE. |

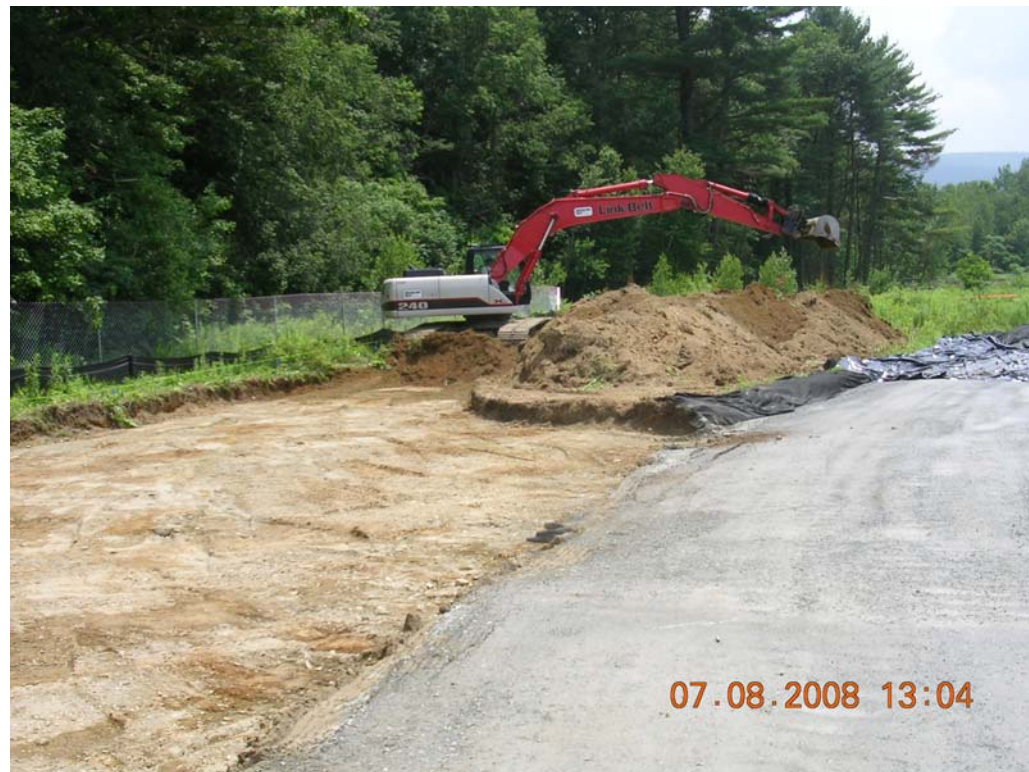
DSCN3999.JPG

| PHOTO | DATE | TIME | DESCRIPTION |
|---|---|---|---|
| DSCN 3999 | 7/8/2008 | 1304 | Closeup view of remedial excavation activities within the central part of Area 1 within Grid N-18 utilizing a Link-Belt 240 Trackhoe; View of Area 1 looking E-SE. |

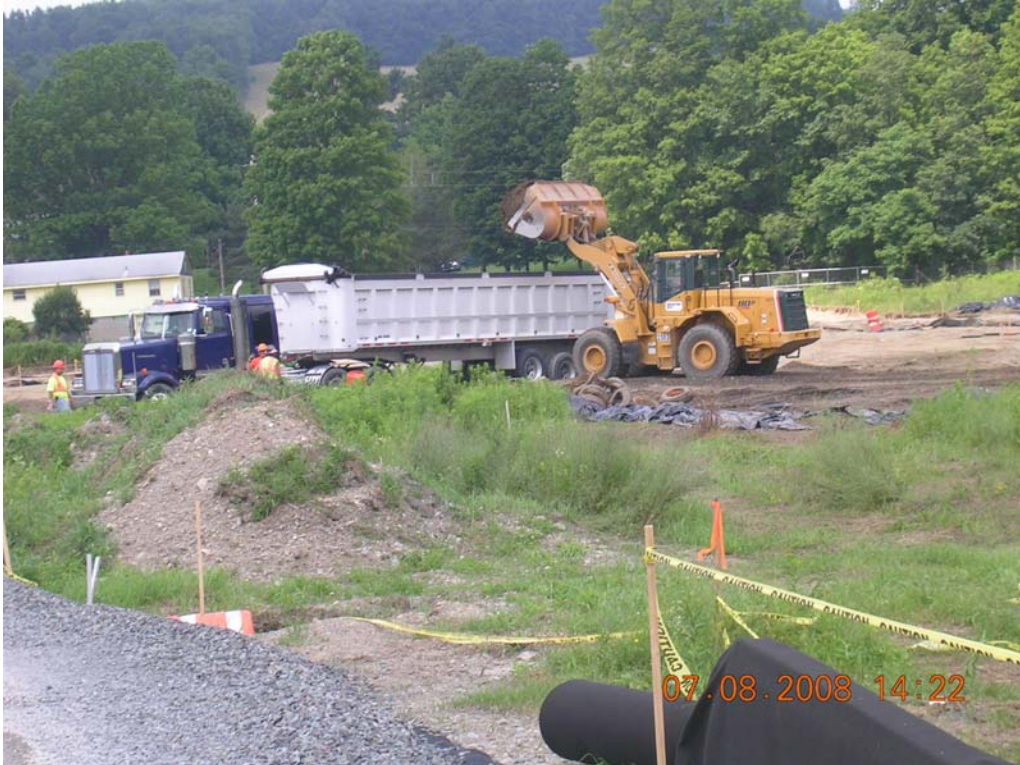
DSCN4000.JPG

| PHOTO | DATE | TIME | DESCRIPTION |
|---|---|---|---|
| DSCN 4000 | 7/8/2008 | 1422 | View of dust suppression in progress onto truck access road and ground surfaces across Area 1 using 4,000 gallon Mack Water Truck; The dust suppression was prompted by an elevated dust concentration detected at the NE air monitoring station positioned near grid J-24; View of Area 1 looking W. |

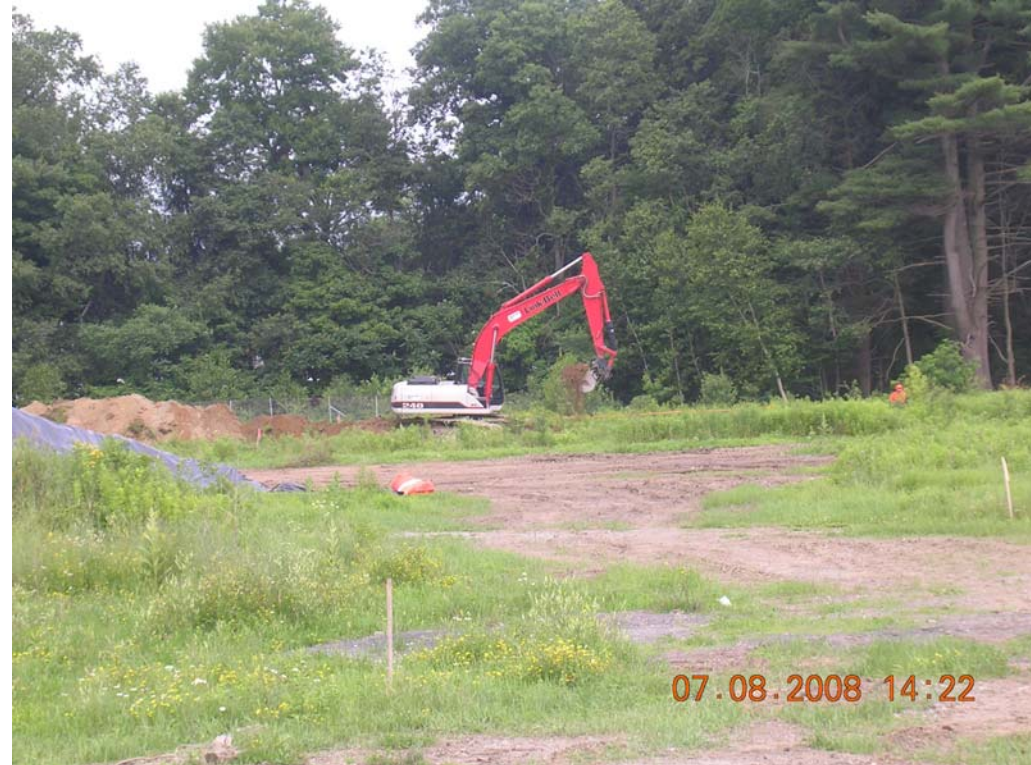
DSCN4001.JPG

| PHOTO | DATE | TIME | DESCRIPTION |
|---|---|---|---|
| DSCN 4001 | 7/8/2008 | 1422 | Remedial excavation activities within the central part of Area 1 within Grid J-21 utilizing a Link-Belt 240 Trackhoe (foreground); Non-TSCA soil was stockpiled on like-material in a centralized location in order to facilitate loading of trucks from the clean access road; View of DAC loading of non-TSCA PCB contaminated soil in the distant background using a Kawasaki 80ZV Front Loader shuttled from the main soil stockpile in Area 3; View of Area 1 looking E-SE. |

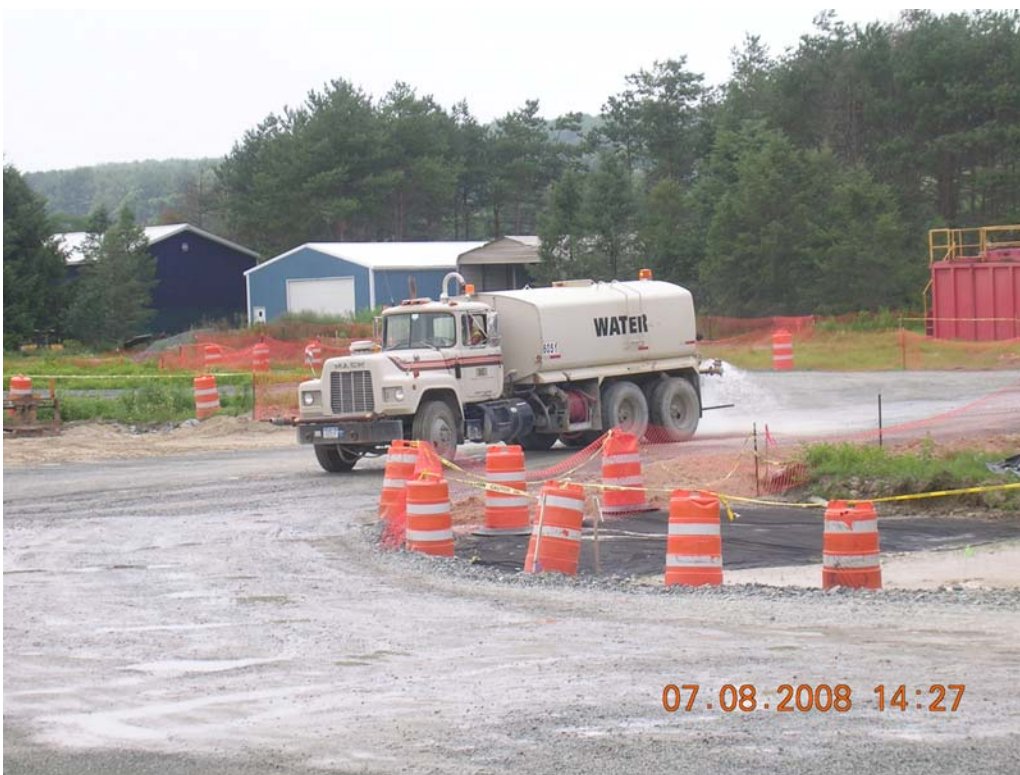
DSCN4002.JPG

| PHOTO | DATE | TIME | DESCRIPTION |
|---|---|---|---|
| DSCN 4002 | 7/8/2008 | 1427 | View of continued dust suppression in progress onto truck access road and ground surfaces across Area 9 using 4,000 gallon Mack Water Truck to help alleviate visible dust generated by waste hauling truck cooling fans; View of Area 9 looking NW. |

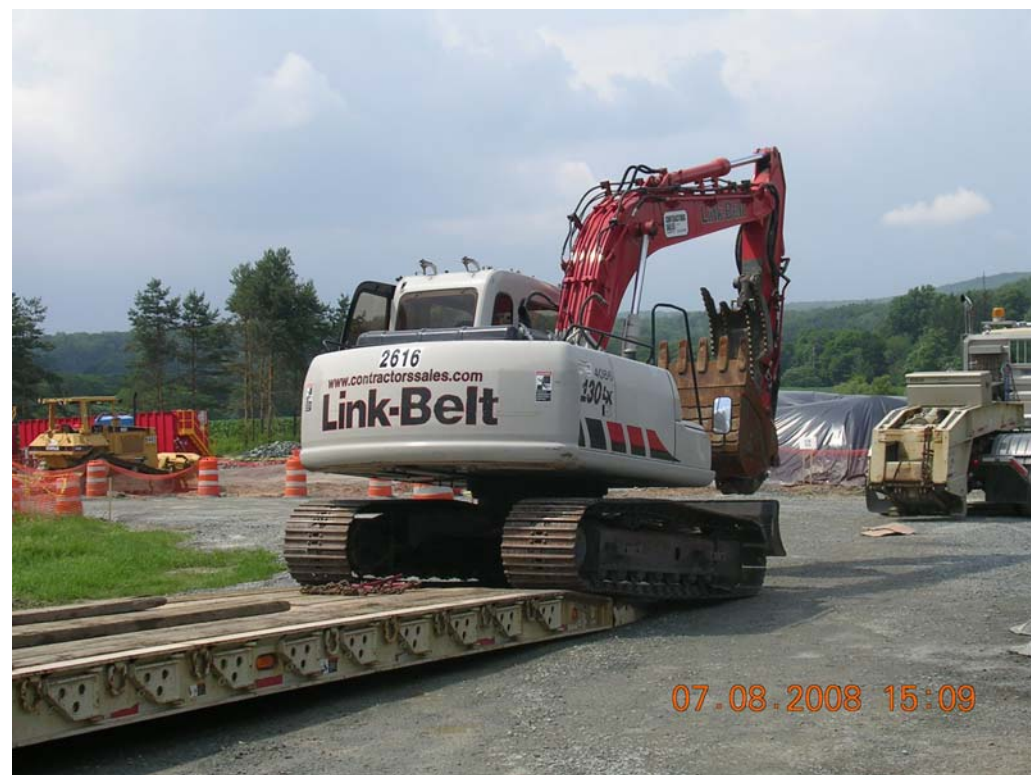
DSCN4003.JPG

| PHOTO | DATE | TIME | DESCRIPTION |
|---|---|---|---|
| DSCN 4003 | 7/8/2008 | 1509 | View of delivery of a Link-Belt 130 LX Trackhoe with a retractable thumb to Area 9 looking N-NW; The trackhoe will help pick up the pace on remedial excavation activities. |

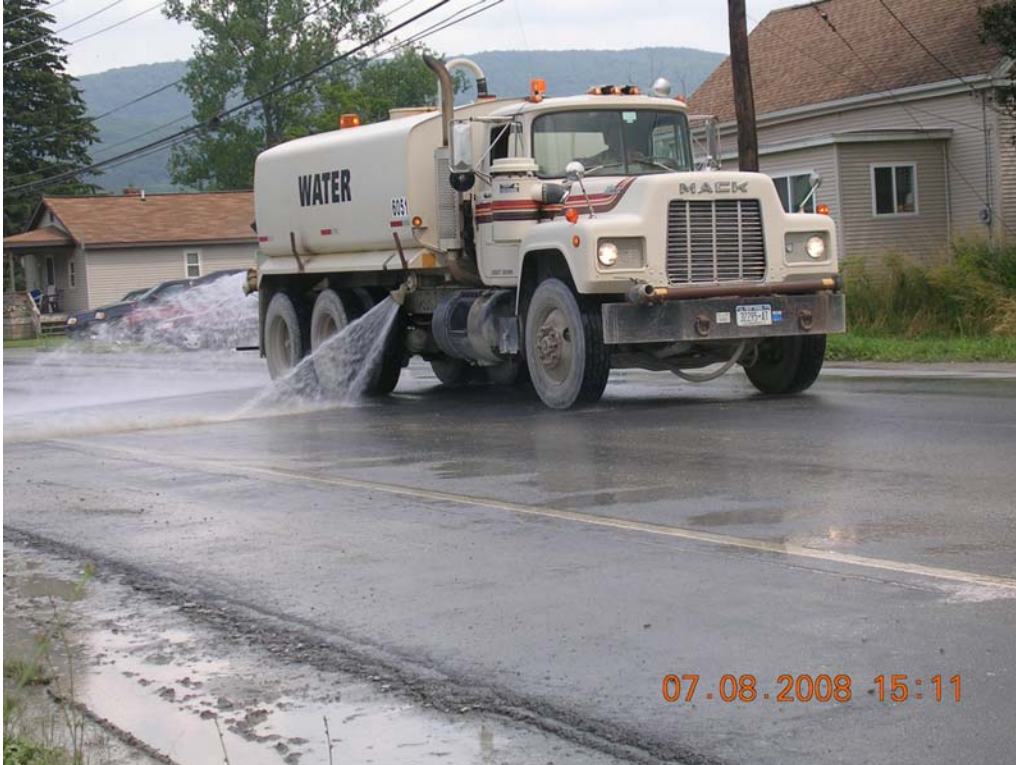
DSCN4004.JPG

| PHOTO | DATE | TIME | DESCRIPTION |
|---|---|---|---|
| DSCN 4004 | 7/8/2008 | 1511 | Cleaning of muddy tire tracks in progress onto Route 20 road surface at entrance to driveway to Building 666 using 4,000 gallon Mack Water Truck; View of Route 20 looking SE. |

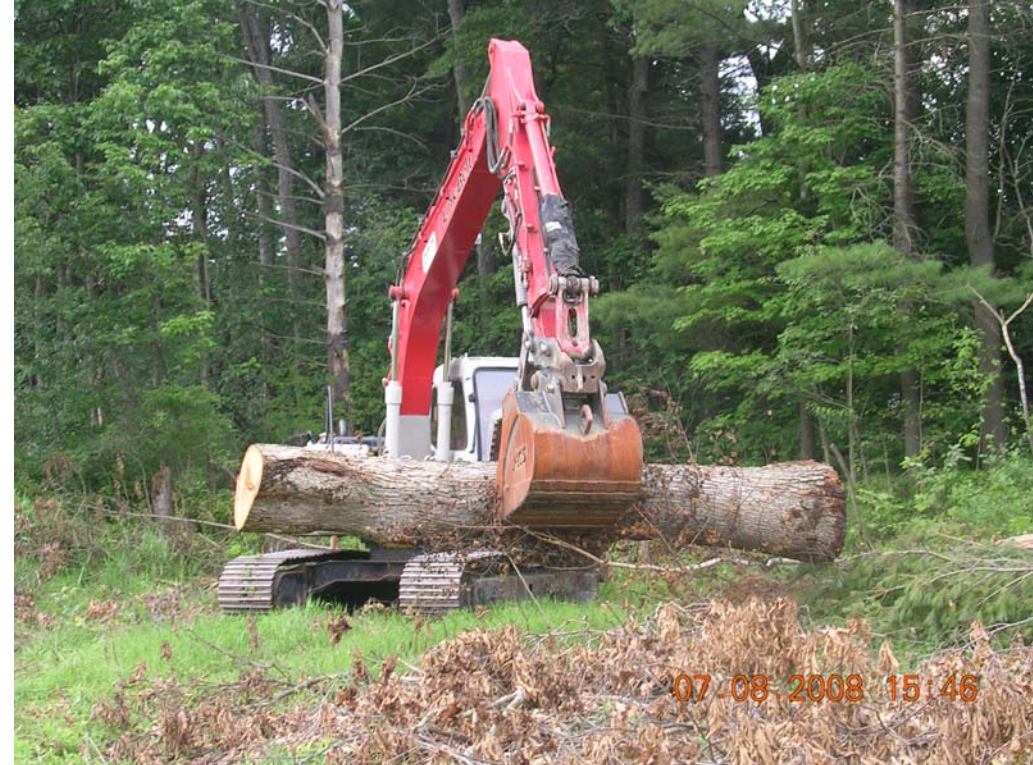
DSCN4005.JPG

| PHOTO | DATE | TIME | DESCRIPTION |
|---|---|---|---|
| DSCN 4005 | 7/8/2008 | 1546 | View of Link-Belt 130 LX Trackhoe picking up tree trunks with a retractable thumb in Area 8 looking N-NW; The logs were stockpiled in grid P-12. |

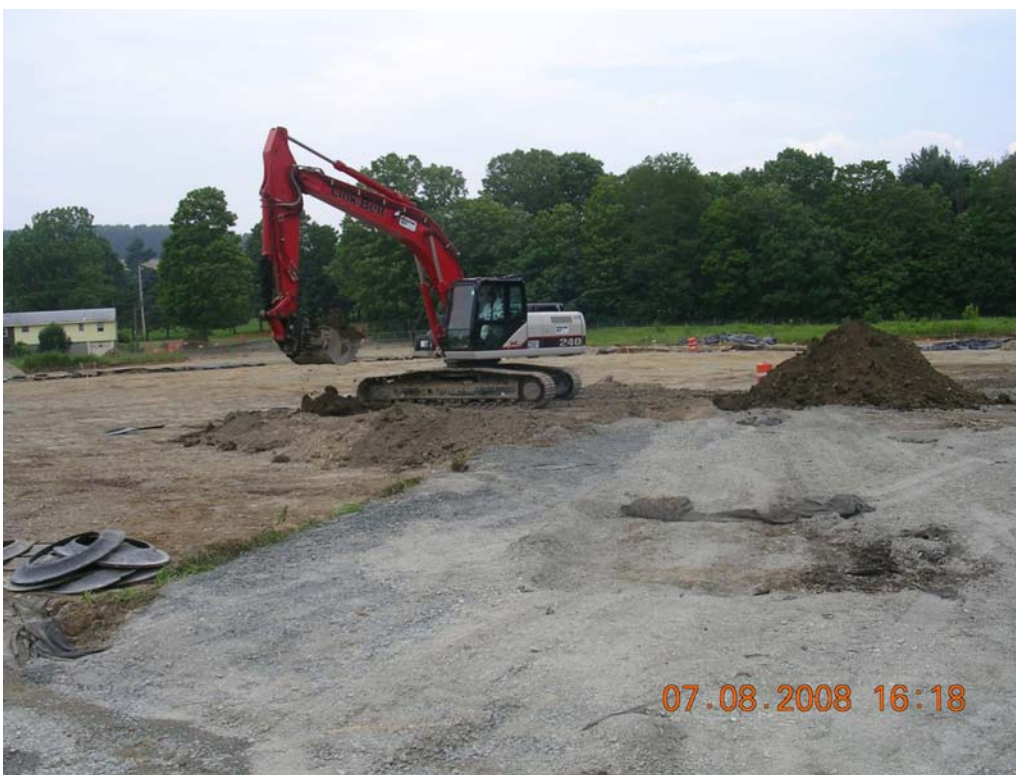
DSCN4006.JPG

| PHOTO | DATE | TIME | DESCRIPTION |
|---|---|---|---|
| DSCN 4006 | 7/8/2008 | 1618 | Remedial excavation activities within the central part of Area 1 within Grid G-17 utilizing a Link-Belt 240 Trackhoe; Non-TSCA soil was stockpiled on like-material in a centralized location in order to facilitate loading of trucks from the clean spur driveway; View of Area 2 looking NE. |

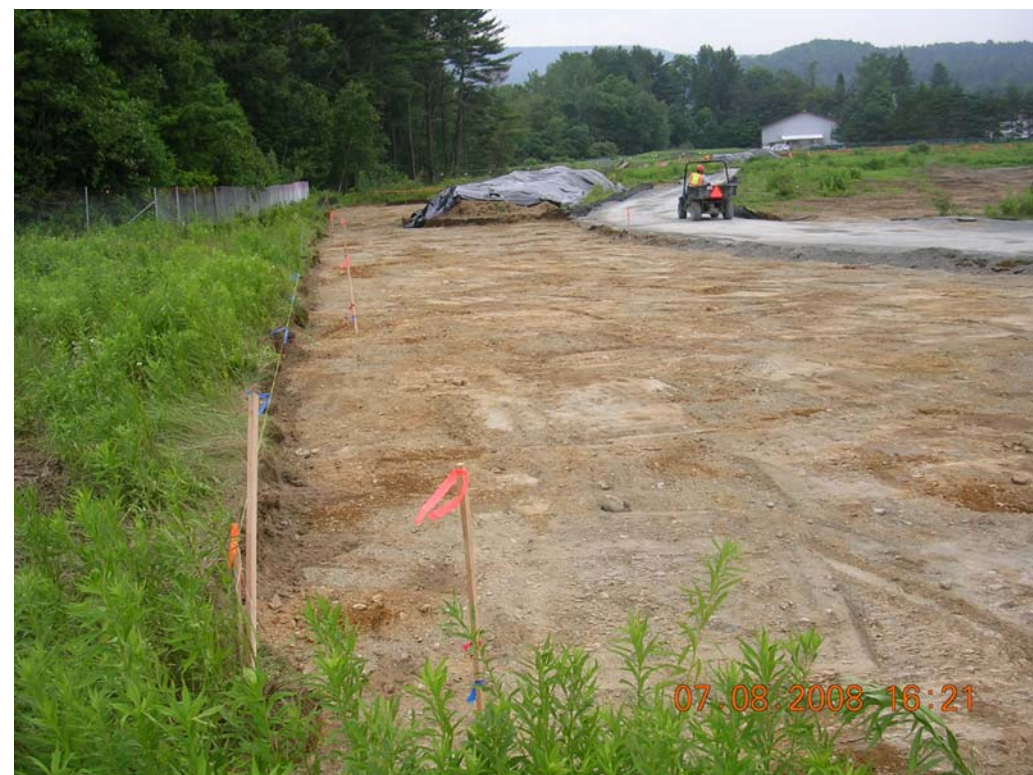
DSCN4007.JPG

| PHOTO | DATE | TIME | DESCRIPTION |
|---|---|---|---|
| DSCN 4007 | 7/8/2008 | 1621 | View of remedial excavation progress at the close of business where the excavation was terminated at grids O-17 and O-18; Area 1 looking SE. |

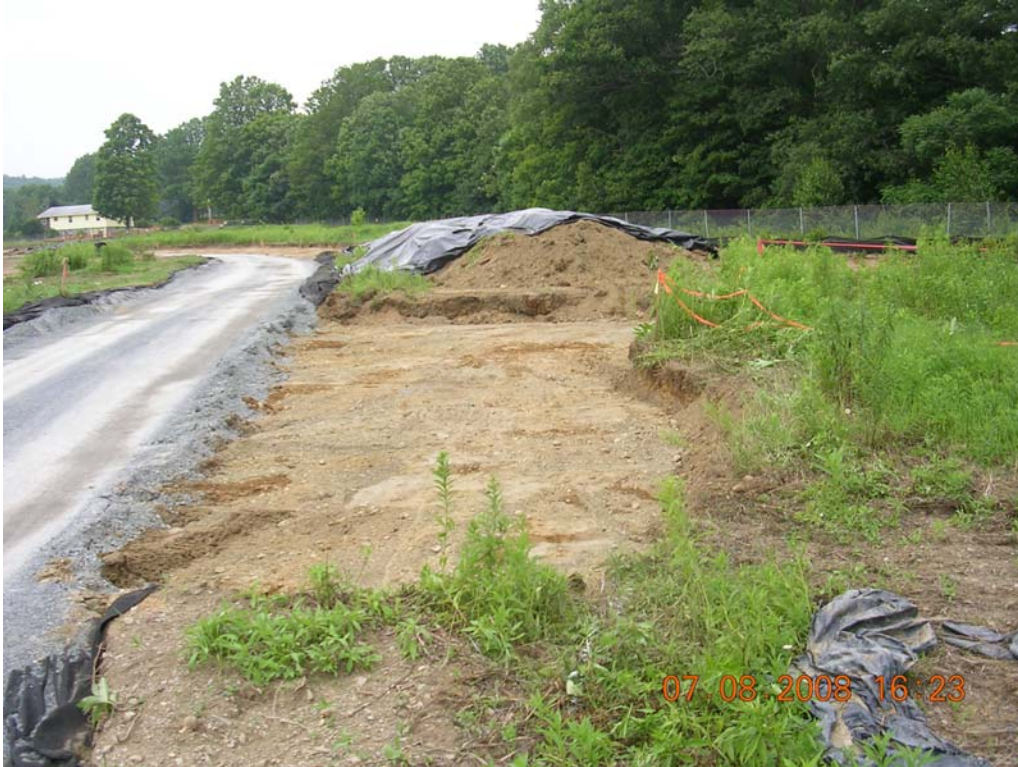
DSCN4008.JPG

| PHOTO | DATE | TIME | DESCRIPTION |
|---|---|---|---|
| DSCN 4008 | 7/8/2008 | 1623 | Another view of remedial excavation progress at the close of business where the excavation was terminated at grids O-17 and O-18; Area 1 looking N-NW. |

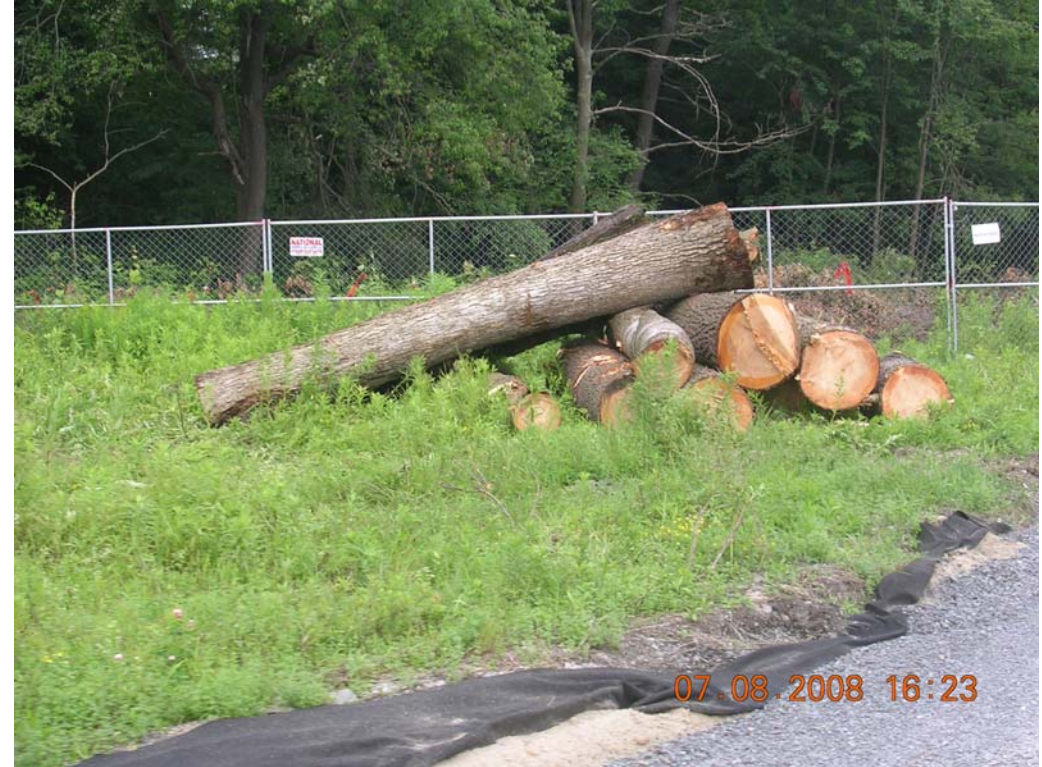
DSCN4009.JPG

| PHOTO | DATE | TIME | DESCRIPTION |
|---|---|---|---|
| DSCN 4009 | 7/8/2008 | 1623 | View of stockpile of tree trunks placed in stockpiled in grid P-12 in Area 8 looking N-NW. |

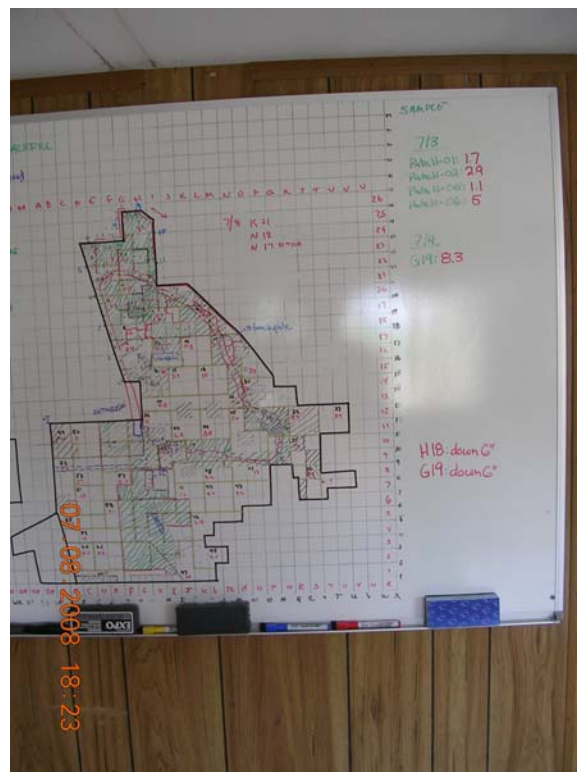
DSCN4010.JPG

| PHOTO | DATE | TIME | DESCRIPTION |
|---|---|---|---|
| DSCN 4010 | 7/8/2008 | 1823 | View of DAC's site meeting board showing current site progress including remedial excavations along the proposed access road. |
