## DAILY FIELD ACTIVITY REPORT

| <b>PROJECT</b> | <b>Former Bouchard Junkyard</b> | <b>WEATHER</b> | <b>TIME</b> | <b>TEMP.</b> | <b>PRECIP.</b> | <b>WIND (MPH)</b> | <b>WIND (DIR)</b> |
| <b>LOCATION</b> | <b>Town of New Lebanon, NY</b> | <b>P. Cloudy</b> | <b>0700</b> | <b>60-65 F</b> | <b>None</b> | <b>10-15</b> | <b>WNW</b> |

**PHOTOGRAPHIC LOG**  
**July 10, 2008**  
**D&B JOB NO. 2605**  
**FORMER BOUCHARD JUNKYARD SITE**  
**TOWN OF NEW LEBANON, NEW YORK**

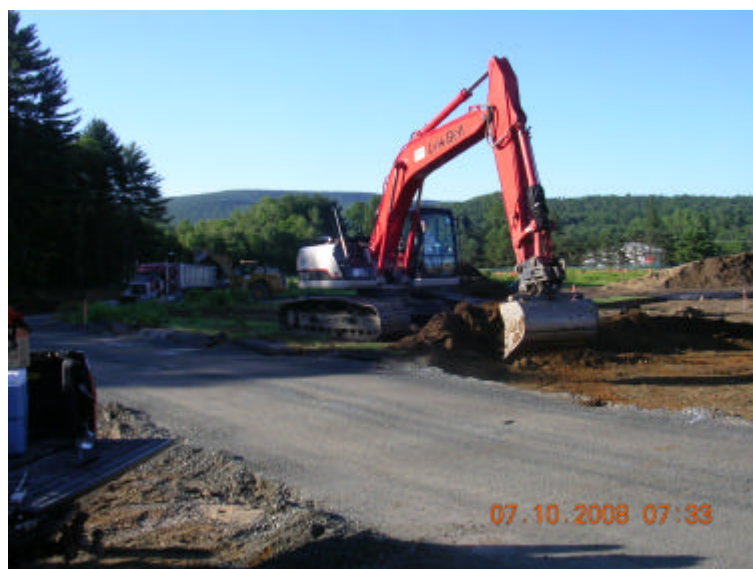
**DSCN4038.JPG**

| PHOTO | DATE | TIME | DESCRIPTION |
|---|---|---|---|
| DSCN 4038 | 7/10/2008 | 0733 | Remedial excavation activities within the eastern part of Area 2 within Grid M-17 utilizing a Link-Belt 240 Trackhoe; Non-TSCA soil was stockpiled on like-material in a centralized location in order to facilitate loading of trucks from the clean truck access road; View of Area 2 looking SE. |

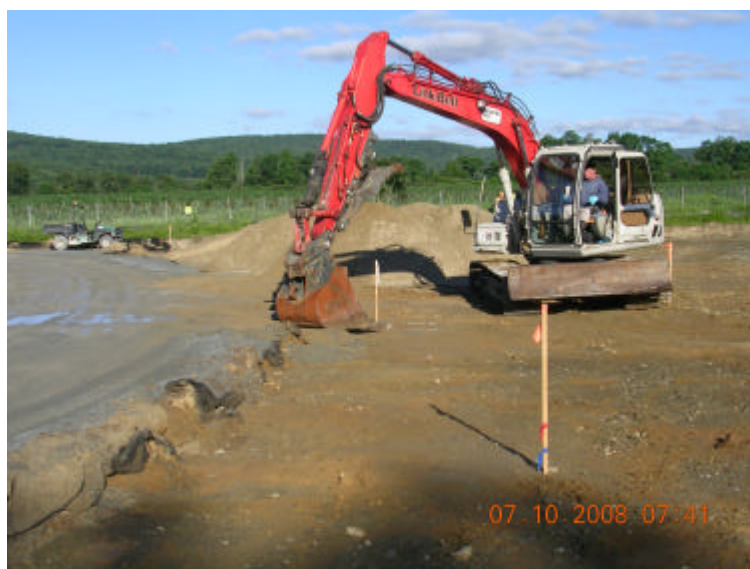
**DSCN4039.JPG**

| PHOTO | DATE | TIME | DESCRIPTION |
|---|---|---|---|
| DSCN 4039 | 7/10/2008 | 0741 | View of Link-Belt 130 LX Trackhoe shaping a bevelled edge to the northern shoulder of the truck access road in central Area 1 to allow fill trucks to dump common fill sand onto remediated areas; View of Area 1 looking W. |

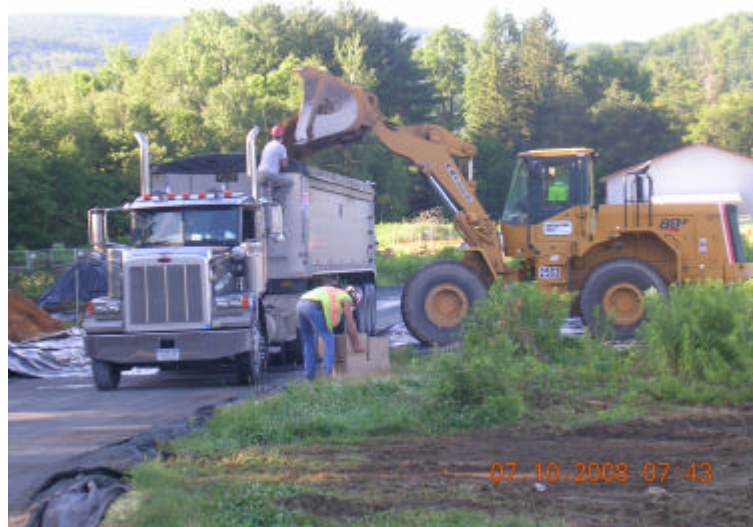
**DSCN4040.JPG**

| PHOTO | DATE | TIME | DESCRIPTION |
|---|---|---|---|
| DSCN 4040 | 7/10/2008 | 0743 | View of DAC loading of non-TSCA PCB contaminated soil using a Kawasaki 80ZV Front Loader from the main soil stockpile in Area 2 looking SE. |

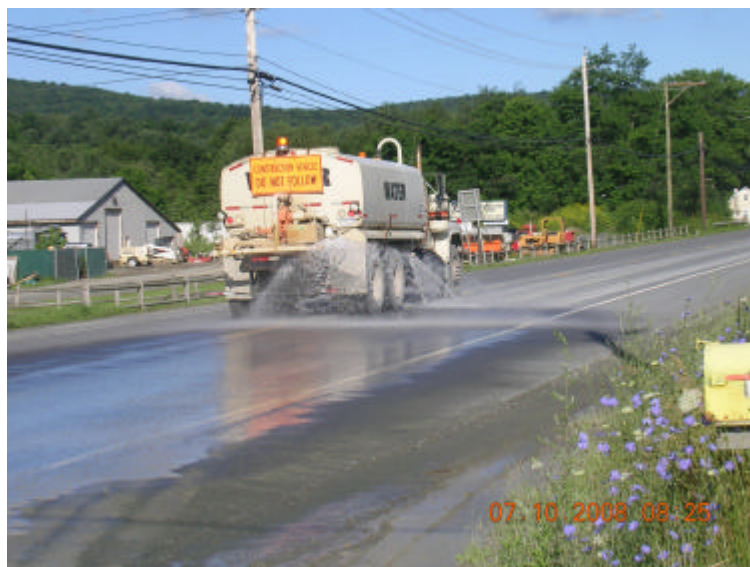
**DSCN4041.JPG**

| PHOTO | DATE | TIME | DESCRIPTION |
|---|---|---|---|
| DSCN 4041 | 7/10/2008 | 0825 | Cleaning of muddy tire tracks in progress onto Route 20 road surface at entrance to driveway to Building 666 using 4,000 gallon Mack Water Truck; View of Route 20 looking WSW. |

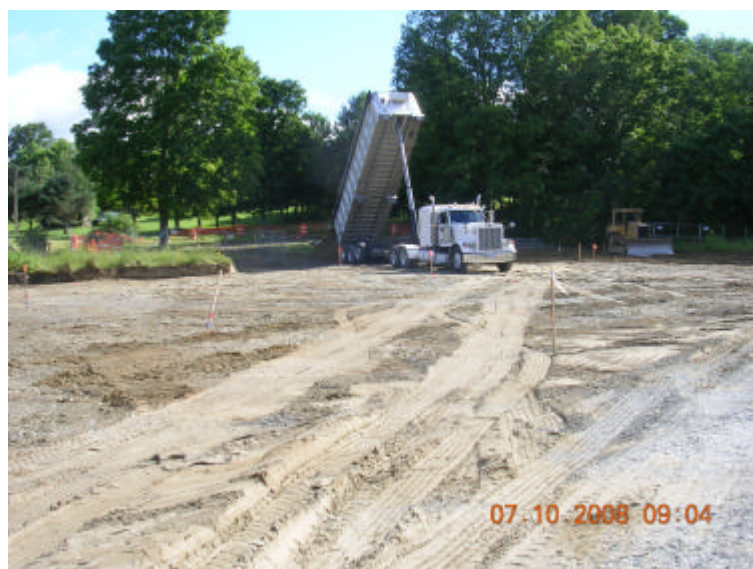
**DSCN4042.JPG**

| PHOTO | DATE | TIME | DESCRIPTION |
|---|---|---|---|
| DSCN 4042 | 7/10/2008 | 0904 | View of truck dumping common fill sand onto remediated areas in Area 1 looking NE. |

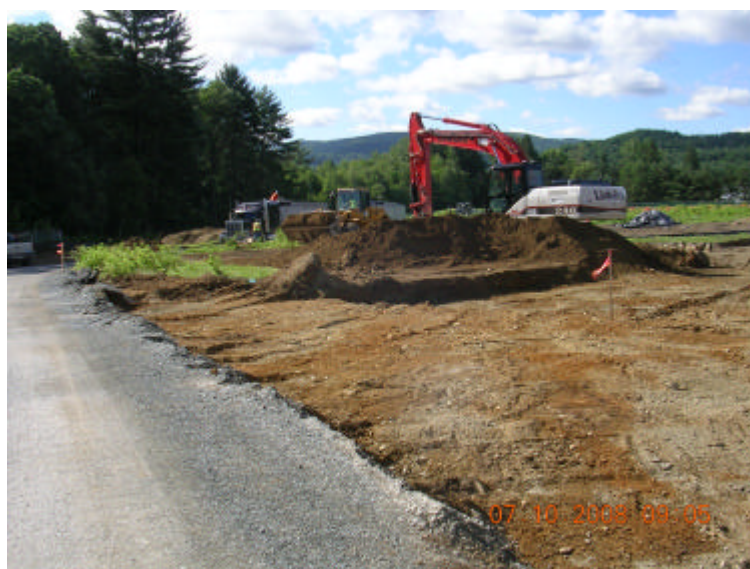
**DSCN4043.JPG**

| PHOTO | DATE | TIME | DESCRIPTION |
|---|---|---|---|
| DSCN 4043 | 7/10/2008 | 0905 | View of DAC loading of non-TSCA PCB contaminated soil in the background of photo using a Kawasaki 80ZV Front Loader from the main soil stockpile in Area 2 looking 3; Link Belt 240 Trackhoe is excavating non-TSCA soil from grid N-15 in the foreground. |

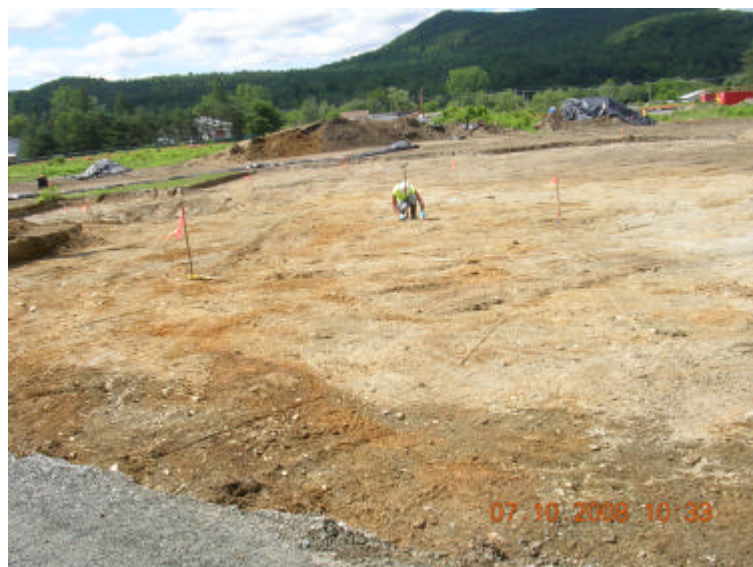
**DSCN4045.JPG**

| PHOTO | DATE | TIME | DESCRIPTION |
|---|---|---|---|
| DSCN 4045 | 7/10/2008 | 1033 | Collection of bottom soil sample EP-J19(12-in.) at 1 ft bgs within grid J-19 (MS/MSD/MSB collected here); Area 1 looking S. |

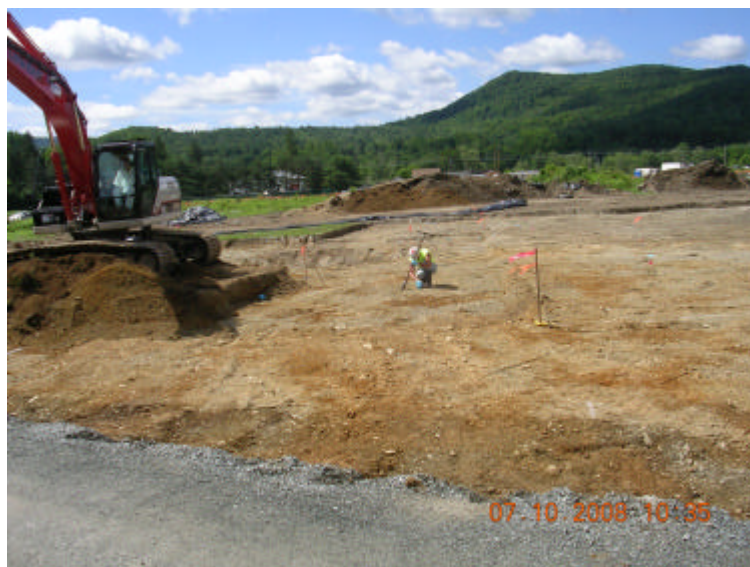
**DSCN4046.JPG**

| PHOTO | DATE | TIME | DESCRIPTION |
|---|---|---|---|
| DSCN 4046 | 7/10/2008 | 1035 | Collection of bottom soil sample EP-J19(18-in.) at 1.5 ft bgs within grid J-19; Area 1 looking S. |

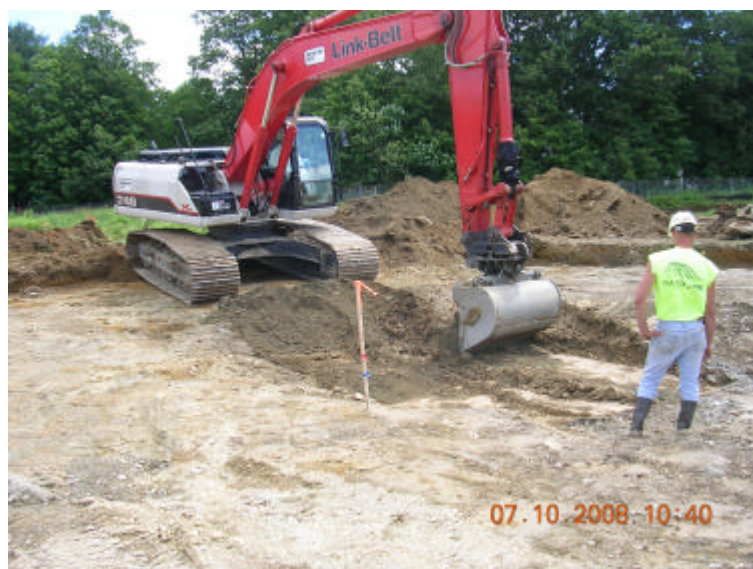
**DSCN4047.JPG**

| PHOTO | DATE | TIME | DESCRIPTION |
|---|---|---|---|
| DSCN 4047 | 7/10/2008 | 1040 | View of Link Belt 240 Trackhoe removing non-TSCA soil from deep excavation in grid J-18 looking NE; Additional excavation was requested to remove additional metallic debris and stained soil from the excavation; In addition, the bottom of the excavation was flattened to a common level of 3.5-4 ft bgs. |

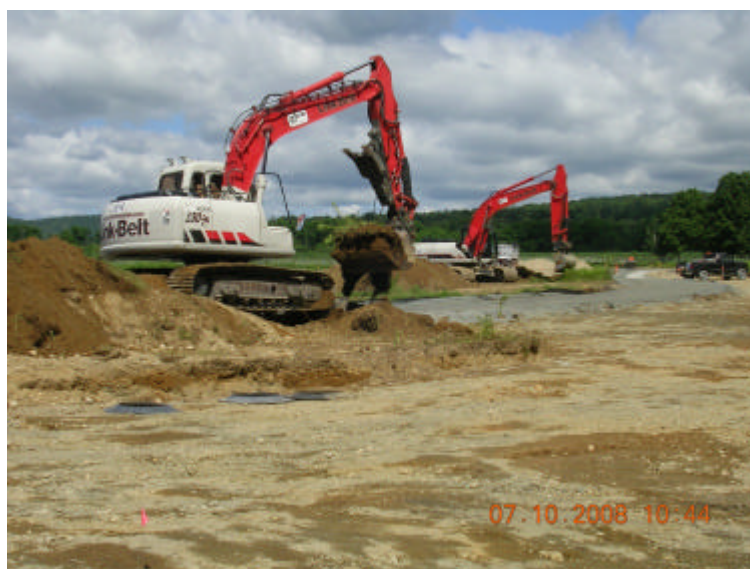
**DSCN4048.JPG**

| PHOTO | DATE | TIME | DESCRIPTION |
|---|---|---|---|
| DSCN 4048 | 7/10/2008 | 1044 | Remedial excavation activities within the eastern part of Area 2 within Grid N-17 utilizing a Link-Belt 240 Trackhoe (background) and within Grid O-16; Non-TSCA soil was stockpiled on like-material in a centralized location in order to facilitate loading of trucks from the clean truck access road; View of Area 2 looking NW. |

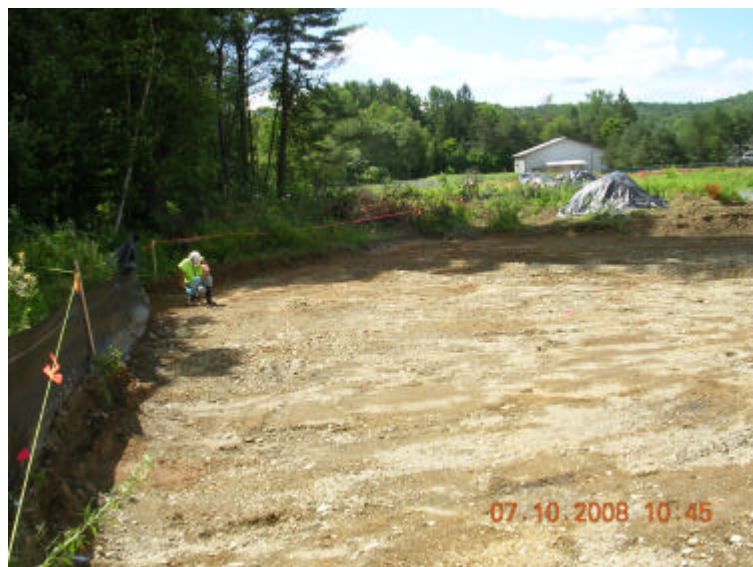
**DSCN4049.JPG**

| PHOTO | DATE | TIME | DESCRIPTION |
|---|---|---|---|
| DSCN 4049 | 7/10/2008 | 1045 | Collection of bottom soil sample EP-O17(Non-TSCA) at 1 ft bgs within grid O-17; Area 1 looking SSE. |

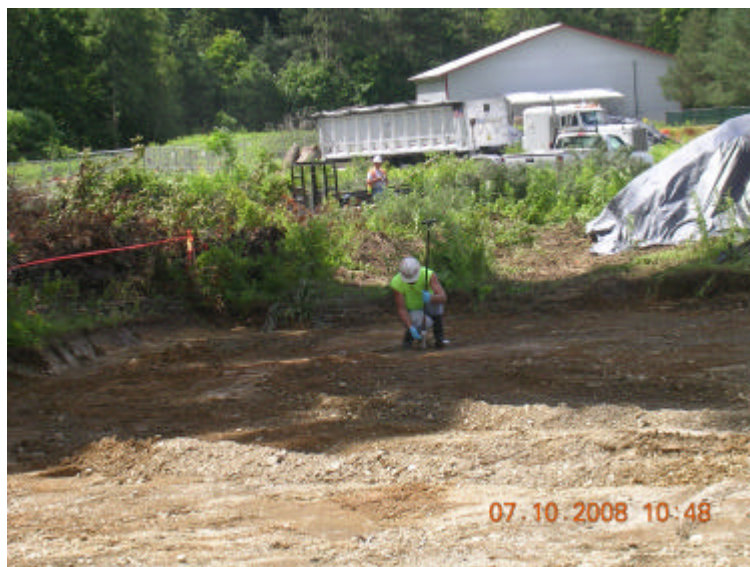
**DSCN4050.JPG**

| PHOTO | DATE | TIME | DESCRIPTION |
|---|---|---|---|
| DSCN 4050 | 7/10/2008 | 1048 | Collection of bottom soil sample EP-O16(TSCA) at 1 ft bgs within TSCA grid 3 (O-16); Area 1 looking SSE. |

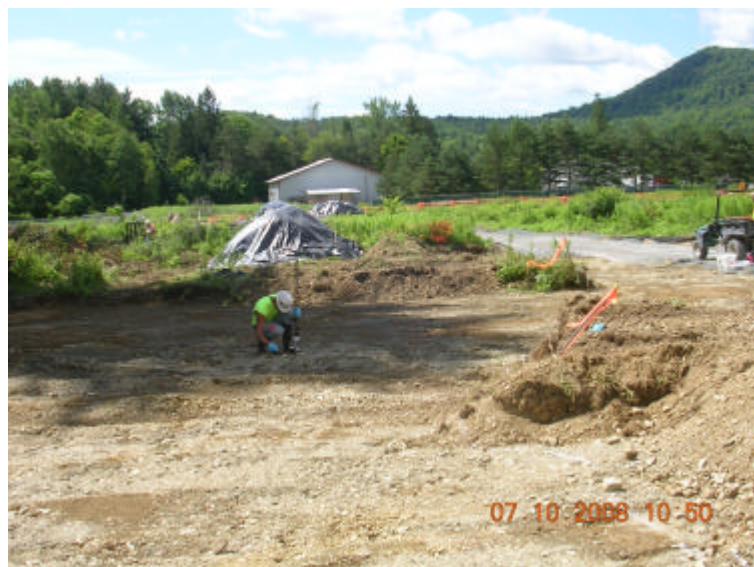
**DSCN4051.JPG**

| PHOTO | DATE | TIME | DESCRIPTION |
|---|---|---|---|
| DSCN 4051 | 7/10/2008 | 1050 | Collection of bottom soil sample EP-N17(TSCA) at 1 ft bgs within TSCA grid 3 (N-17); Area 1 looking SSE. |

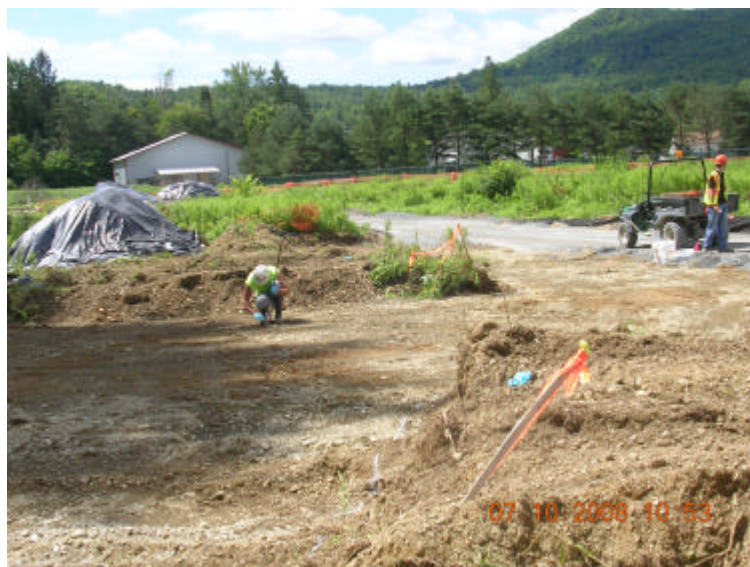
**DSCN4052.JPG**

| PHOTO | DATE | TIME | DESCRIPTION |
|---|---|---|---|
| DSCN 4052 | 7/10/2008 | 1053 | Collection of bottom soil sample EP-N16(TSCA) at 1 ft bgs within TSCA grid 3 (N-16); Area 1 looking SSE. |

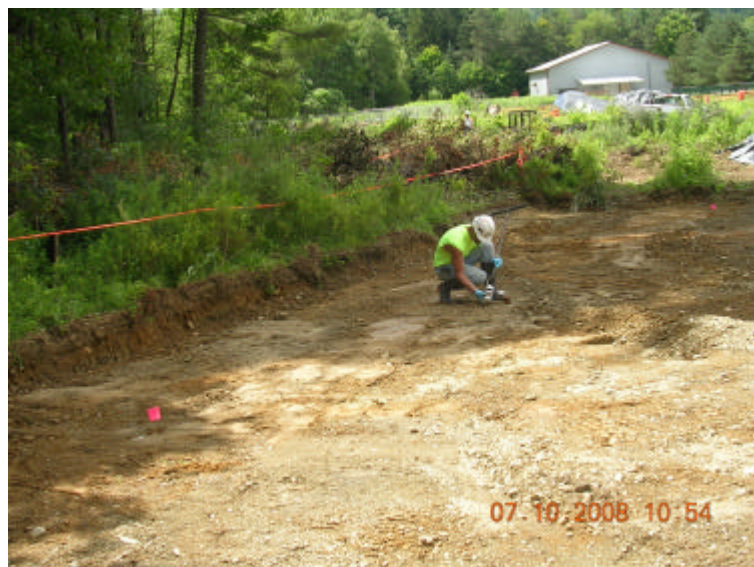
**DSCN4053.JPG**

| PHOTO | DATE | TIME | DESCRIPTION |
|---|---|---|---|
| DSCN 4053 | 7/10/2008 | 1054 | Collection of bottom soil sample EP-O17(TSCA) at 1 ft bgs within TSCA grid 3 (O-17); Area 1 looking SSE. |

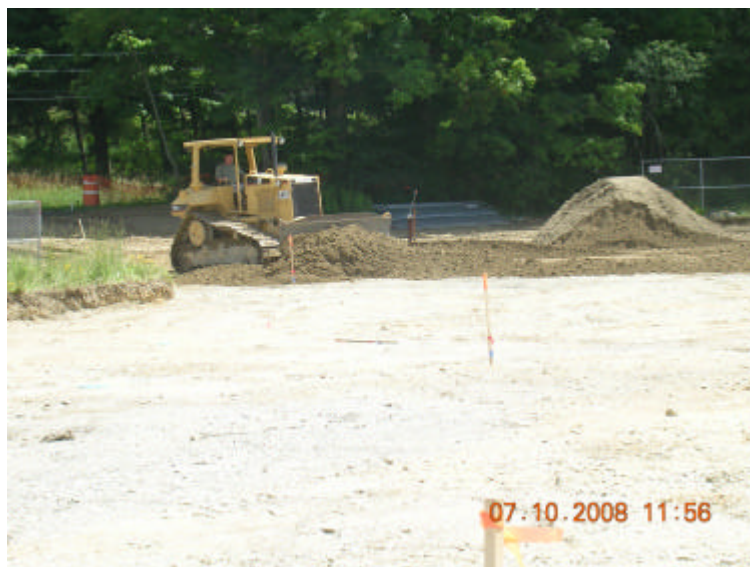
**DSCN4060.JPG**

| PHOTO | DATE | TIME | DESCRIPTION |
|---|---|---|---|
| DSCN 4060 | 7/10/2008 | 1156 | View of Caterpillar 6465 bulldozer distributing common fill sand across remediated areas of Area 1 looking NE. |

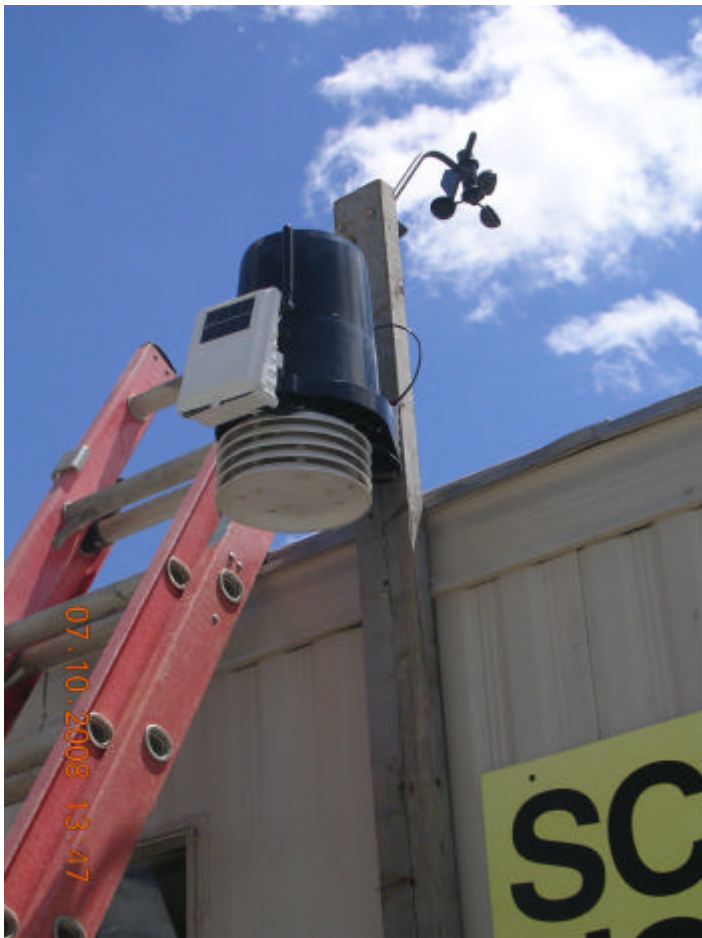
**DSCN4062.JPG**

| PHOTO | DATE | TIME | DESCRIPTION |
|---|---|---|---|
| DSCN 4062 | 7/10/2008 | 1347 | View of installation of portable weather station on the roof of the D.A.Collins project trailer. |

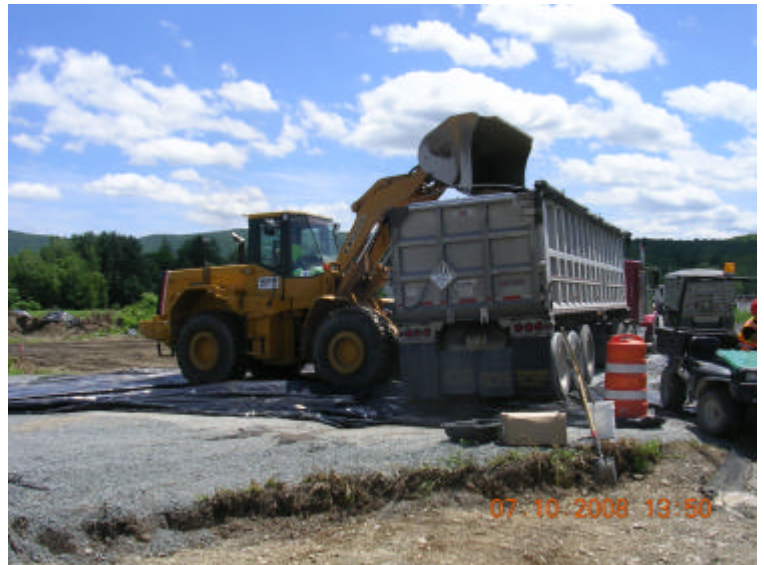
**DSCN4063.JPG**

| PHOTO | DATE | TIME | DESCRIPTION |
|---|---|---|---|
| DSCN 4063 | 7/10/2008 | 1350 | View of DAC loading of TSCA PCB contaminated soil using a Kawasaki 80ZV Front Loader from the TSCA stockpile on TSCA grid 4 in Area 2 looking SE. |

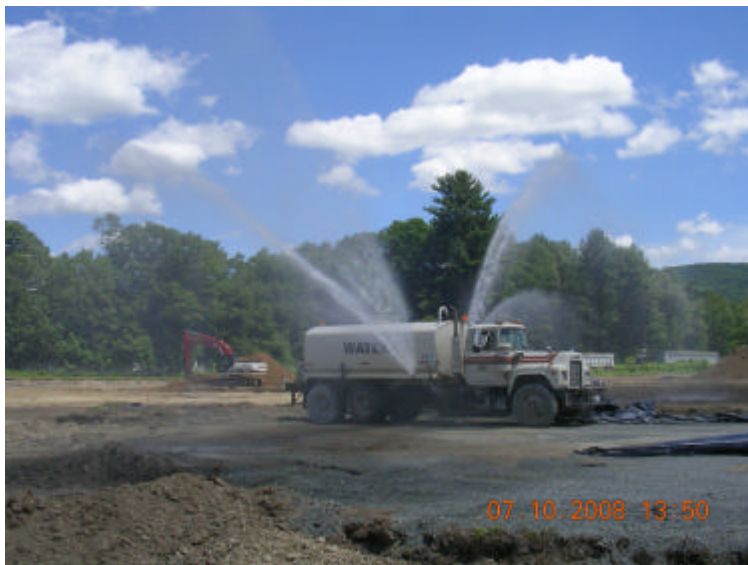
**DSCN4064.JPG**

| PHOTO | DATE | TIME | DESCRIPTION |
|---|---|---|---|
| DSCN 4064 | 7/10/2008 | 1350 | View of dust suppression in progress onto truck access road and ground surfaces across Area 2 using 4,000 gallon Mack Water Truck to help alleviate visible dust in area where trucks are loaded; View of Area 1 looking E. |

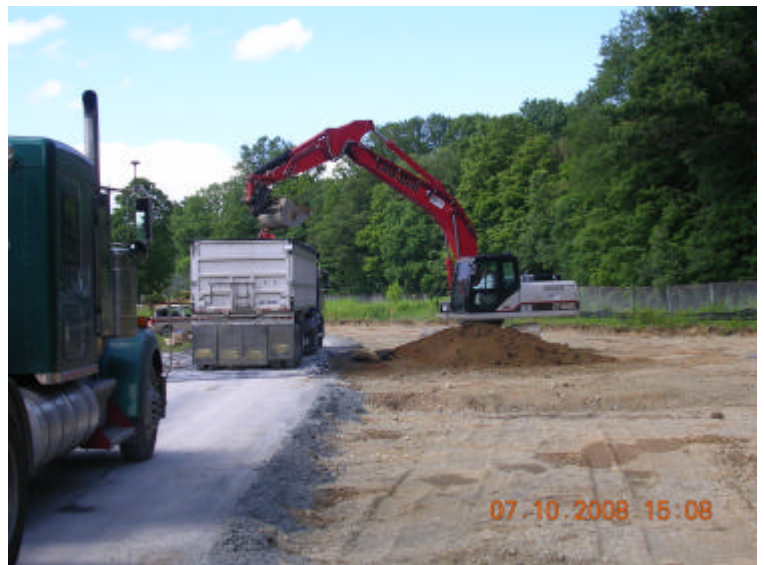
**DSCN4067.JPG**

| PHOTO | DATE | TIME | DESCRIPTION |
|---|---|---|---|
| DSCN 4067 | 7/10/2008 | 1508 | View of DAC loading of TSCA PCB contaminated soil using a Link Belt 130 LX Trackhoe from TSCA grid 3 in Area 2 looking N. |

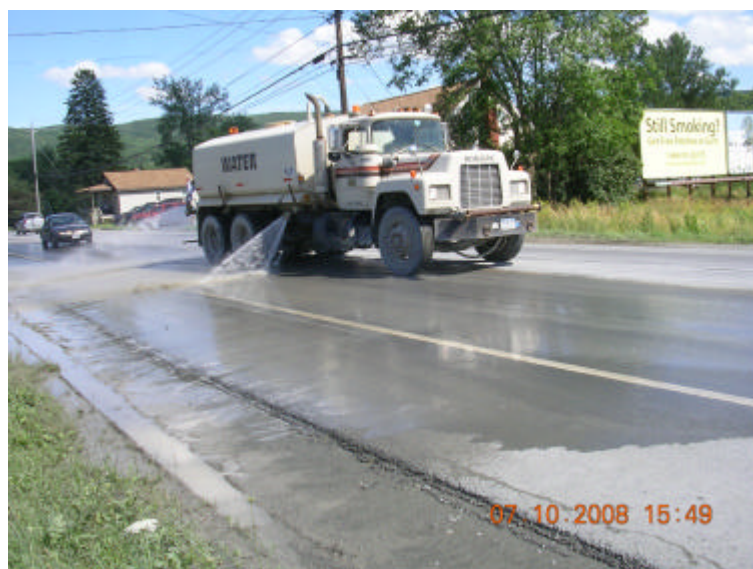
**DSCN4072.JPG**

| PHOTO | DATE | TIME | DESCRIPTION |
|---|---|---|---|
| DSCN 4072 | 7/10/2008 | 1549 | Cleaning of muddy tire tracks in progress onto Route 20 road surface at entrance to driveway to Building 666 using 4,000 gallon Mack Water Truck; View of Route 20 looking SE. |

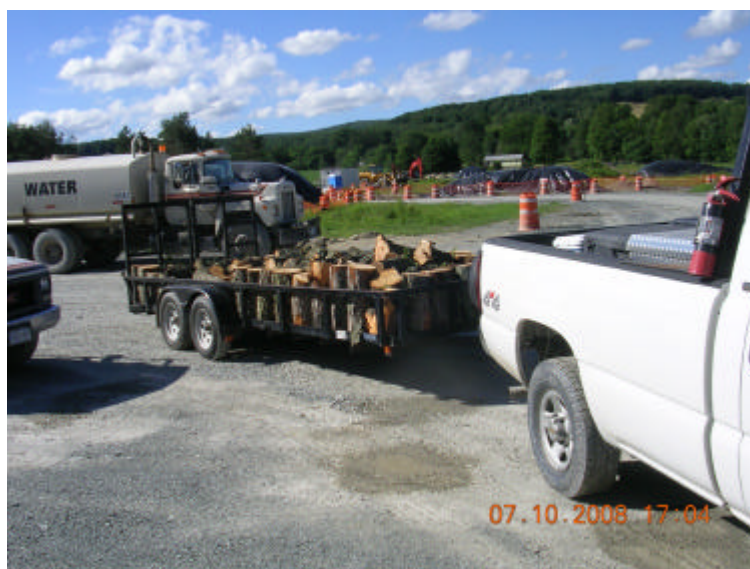
**DSCN4073.JPG**

| PHOTO | DATE | TIME | DESCRIPTION |
|---|---|---|---|
| DSCN 4073 | 7/10/2008 | 1704 | View of DAC trailer loaded with 1-1.5 cord of wood, which will be transported off-site; Area 9 looking N. |
