## DAILY FIELD ACTIVITY REPORT

| PROJECT | Former Bouchard Junkyard | WEATHER | TIME | TEMP. | PRECIP. | WIND (MPH) | WIND (DIR) |
| LOCATION | Town of New Lebanon, NY | Mostly Cloudy | 0655 | 61 F | None | Calm | NA |

**PHOTOGRAPHIC LOG**  
**July 11, 2008**  
**D&B JOB NO. 2605**  
**FORMER BOUCHARD JUNKYARD SITE**  
**TOWN OF NEW LEBANON, NEW YORK**

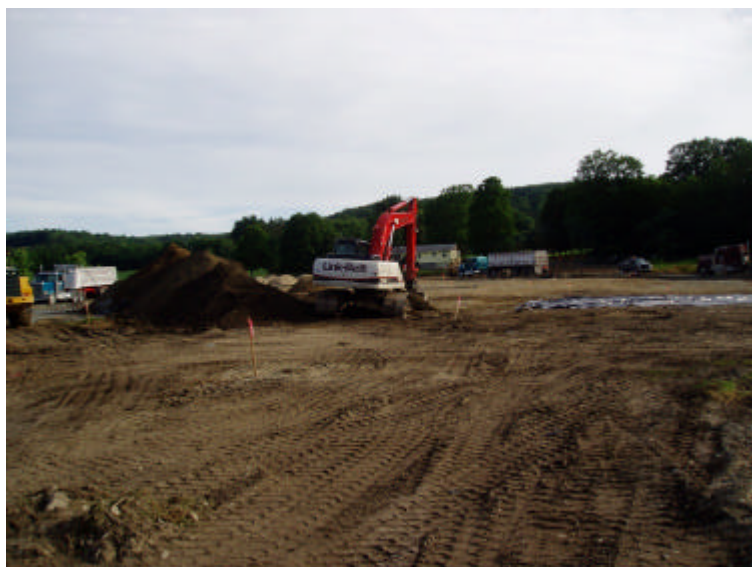
**P7110001.JPG**

| PHOTO | DATE | TIME | DESCRIPTION |
|---|---|---|---|
| P7 110001 | 7/11/2008 | 7:50 | View to north showing excavation at non-TSCA grid station I-17 at west side of Area 2 |

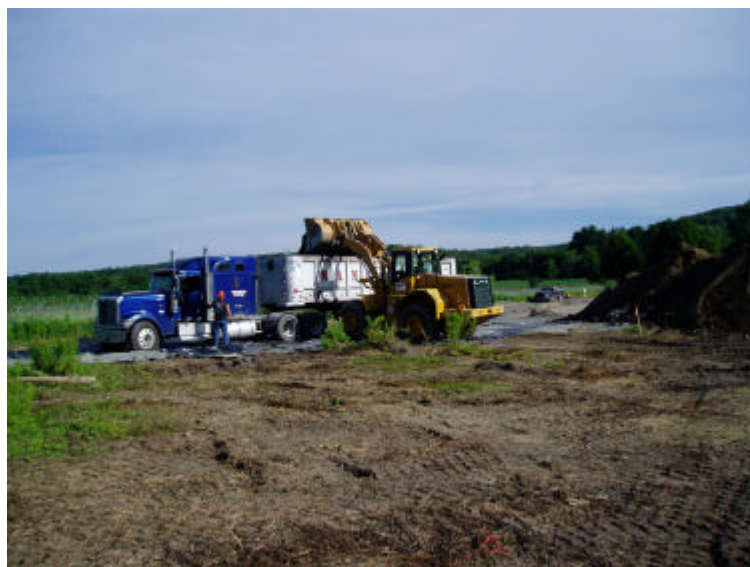
**P7110002.JPG**

| PHOTO | DATE | TIME | DESCRIPTION |
|---|---|---|---|
| P7 110002 | 7/11/2008 | 8:17 | View to northwest showing front end loader loading non-TSCA PCB contaminated soil into truck at west side of Area 2 for off-site disposal |

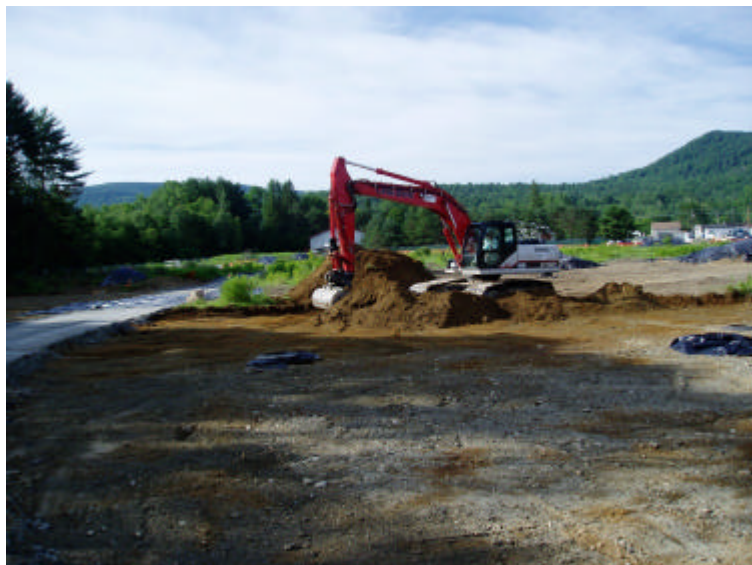
**P7110003.JPG**

| PHOTO | DATE | TIME | DESCRIPTION |
|---|---|---|---|
| P7 110003 | 7/11/2008 | 8:25 | View to south showing excavation at non-TSCA grid station M-17 at east side of Area 2 |

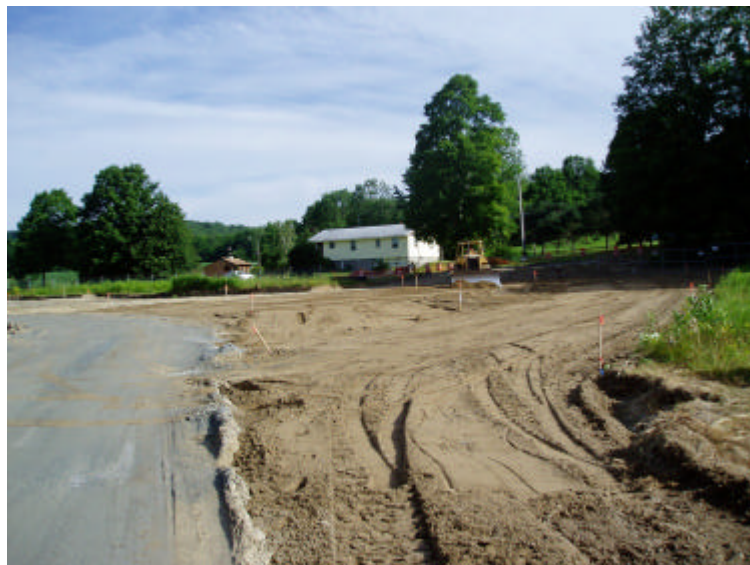
**P7110004.JPG**

| PHOTO | DATE | TIME | DESCRIPTION |
|---|---|---|---|
| P7 110004 | 7/11/2008 | 8:34 | View to northwest showing dozer grading backfill material at east side of Area 1 (adjacent Petell residence) |

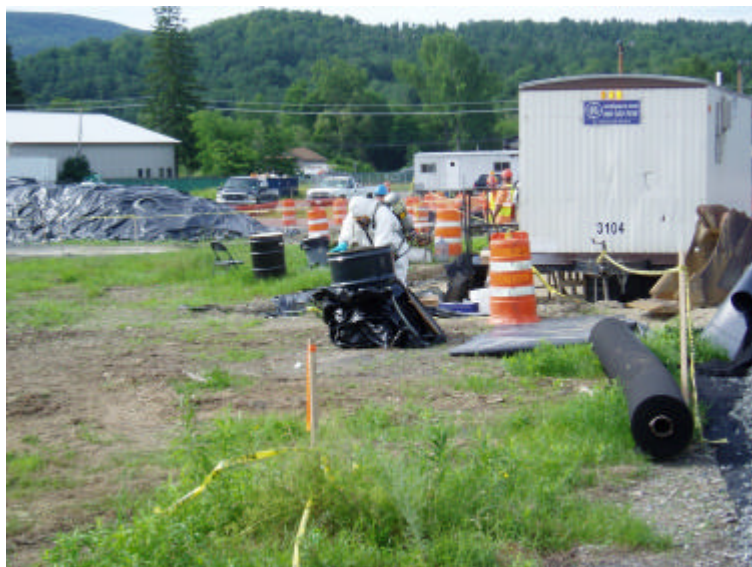
**P7110005.JPG**

| PHOTO | DATE | TIME | DESCRIPTION |
|---|---|---|---|
| P7 110005 | 7/11/2008 | 9:08 | View to southeast showing Vequa Environmental Services collecting waste characterization sample from drum |

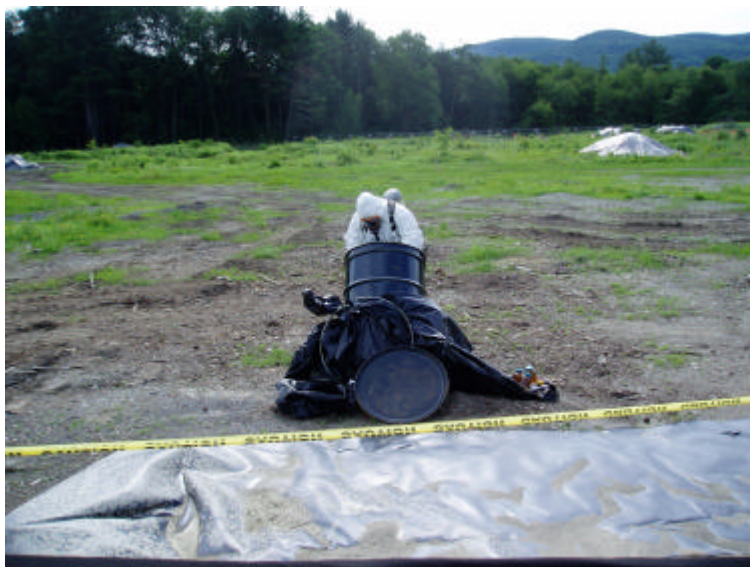
**P7110006.JPG**

| PHOTO | DATE | TIME | DESCRIPTION |
|---|---|---|---|
| P7 110006 | 7/11/2008 | 9:09 | View to east showing Vequa Environmental Services collecting waste characterization sample from drum |

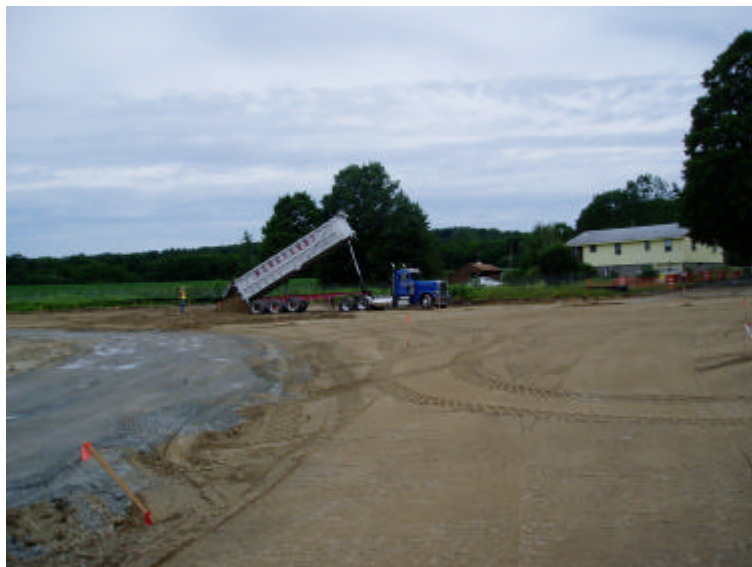
**P7110007.JPG**

| PHOTO | DATE | TIME | DESCRIPTION |
|---|---|---|---|
| P7 110007 | 7/11/2008 | 11:07 | View to northwest showing truck unloading backfill material at northwest corner of Area 1 |

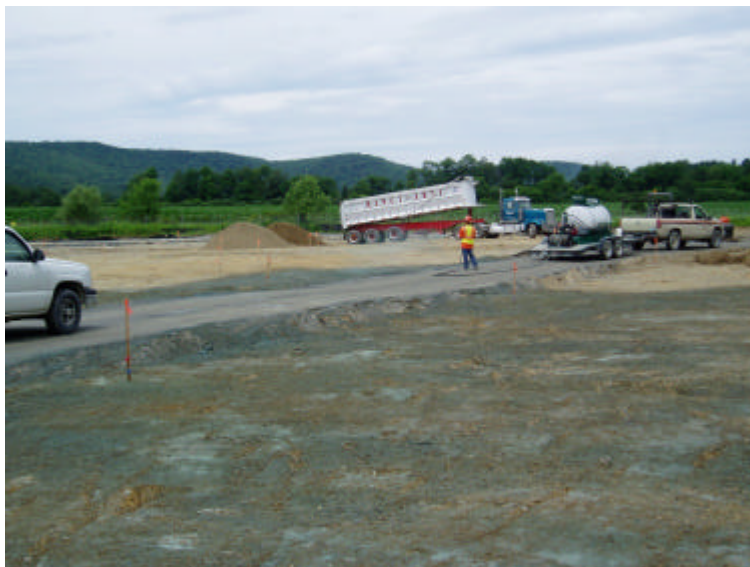
**P7110008.JPG**

| PHOTO | DATE | TIME | DESCRIPTION |
|---|---|---|---|
| P7 110008 | 7/11/2008 | 11:25 | View to west showing D. A. Collins installing hydromulch to exposed excavation areas along truck access road at east side of Area 1 for dust control |

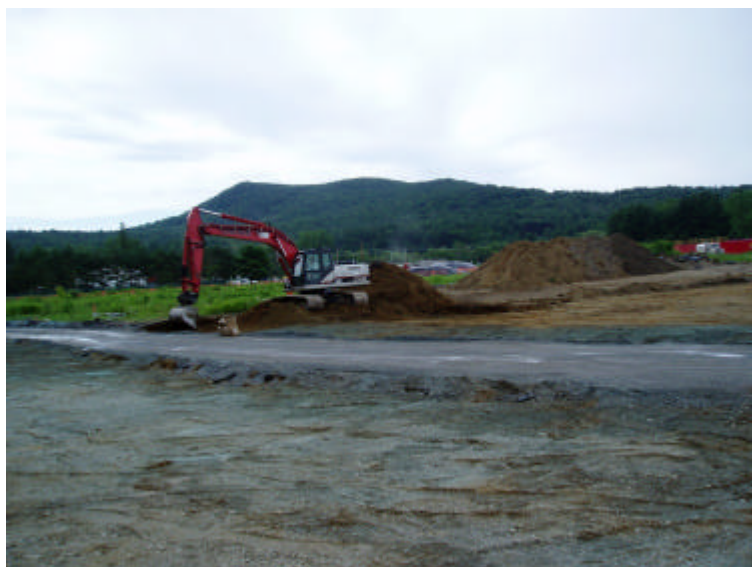
**P7110009.JPG**

| PHOTO | DATE | TIME | DESCRIPTION |
|---|---|---|---|
| P7 110009 | 7/11/2008 | 13:40 | View to southwest showing excavation at non-TSCA grid station M-17 at east side of Area 2 |

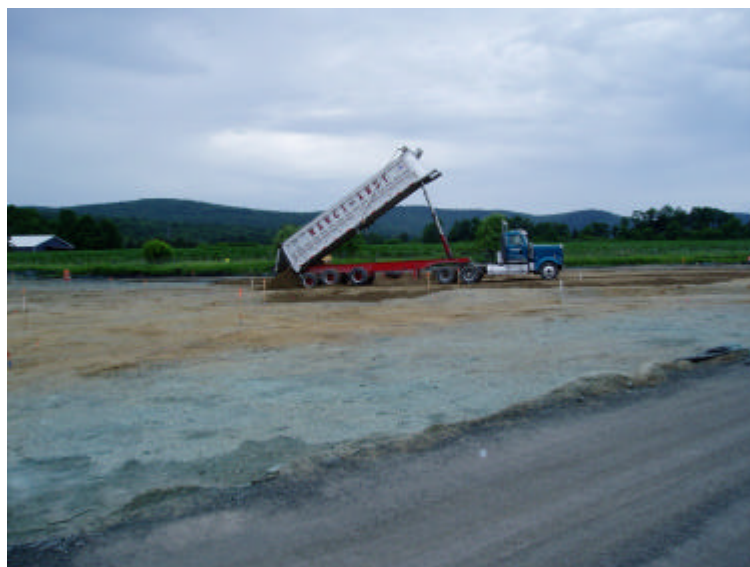
**P7110010.JPG**

| PHOTO | DATE | TIME | DESCRIPTION |
|---|---|---|---|
| P7 110010 | 7/11/2008 | 14:59 | View to west showing truck unloading backfill material at west side of Area 1 |

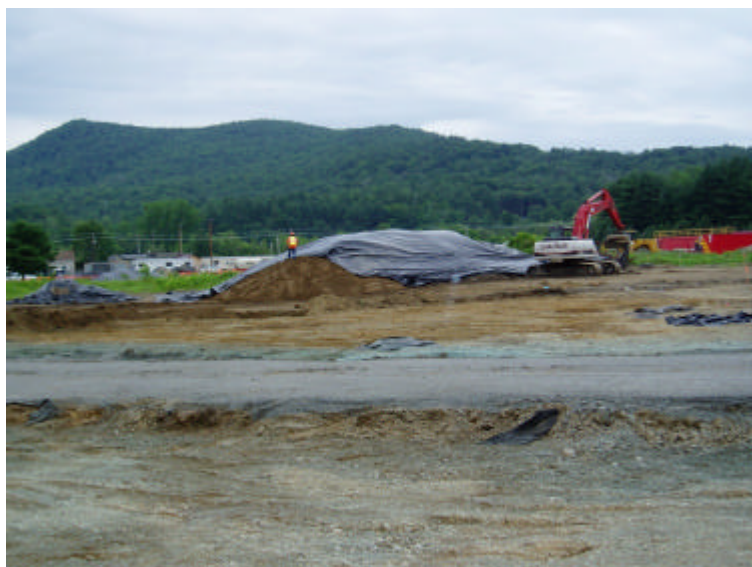
**P7110011.JPG**

| PHOTO | DATE | TIME | DESCRIPTION |
|---|---|---|---|
| P7 110011 | 7/11/2008 | 15:37 | View to southwest showing D. A. Collins covering non-TSCA soil pile with poly sheeting in Area #2 |

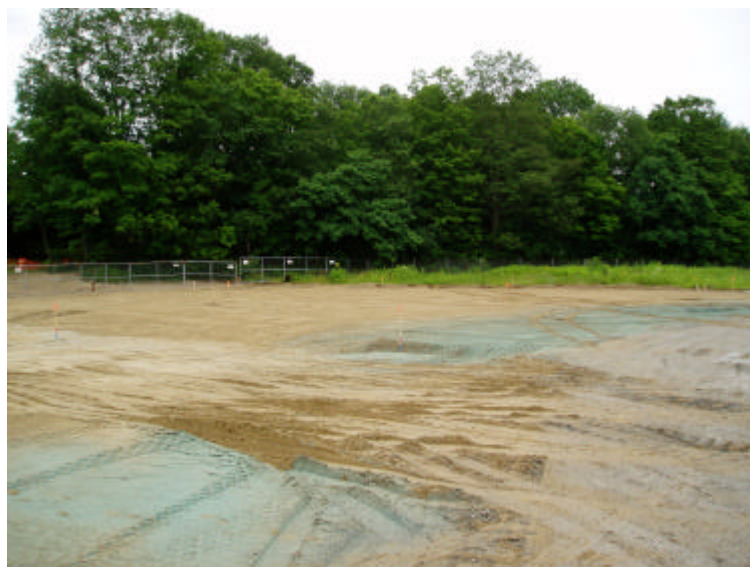
**P7110012.JPG**

| PHOTO | DATE | TIME | DESCRIPTION |
|---|---|---|---|
| P7 110012 | 7/11/2008 | 15:42 | View to northeast showing backfill material installed at northeast corner of Area 1 |

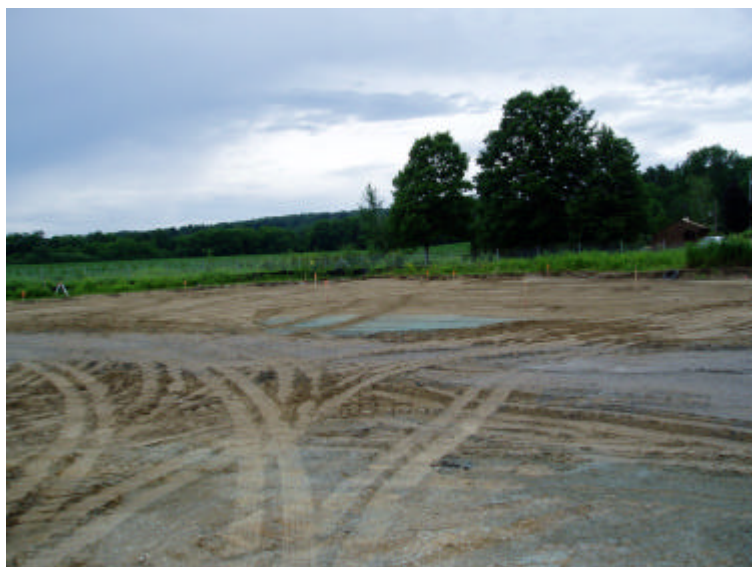
**P7110013.JPG**

| PHOTO | DATE | TIME | DESCRIPTION |
|---|---|---|---|
| P7 110013 | 7/11/2008 | 15:43 | View to northwest showing backfill material installed at northwest corner of Area 1 |

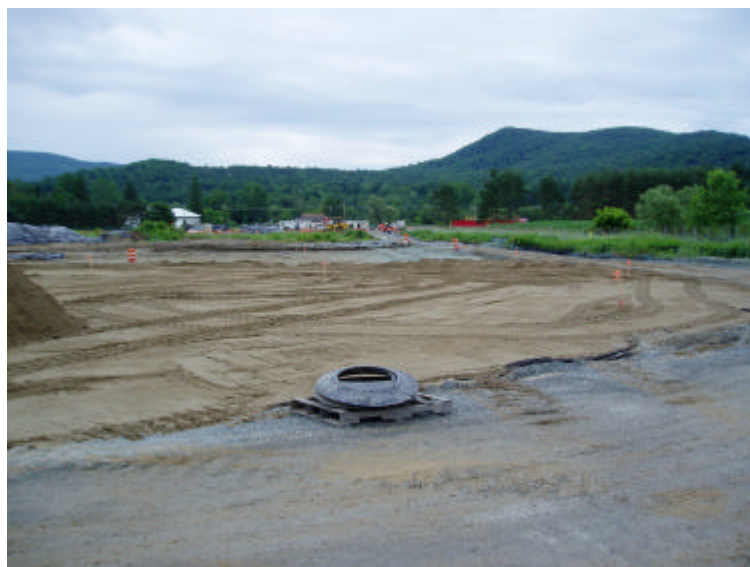
**P7110014.JPG**

| PHOTO | DATE | TIME | DESCRIPTION |
|---|---|---|---|
| P7 110014 | 7/11/2008 | 15:43 | View to south showing backfill material installed at west side of Area 1 |

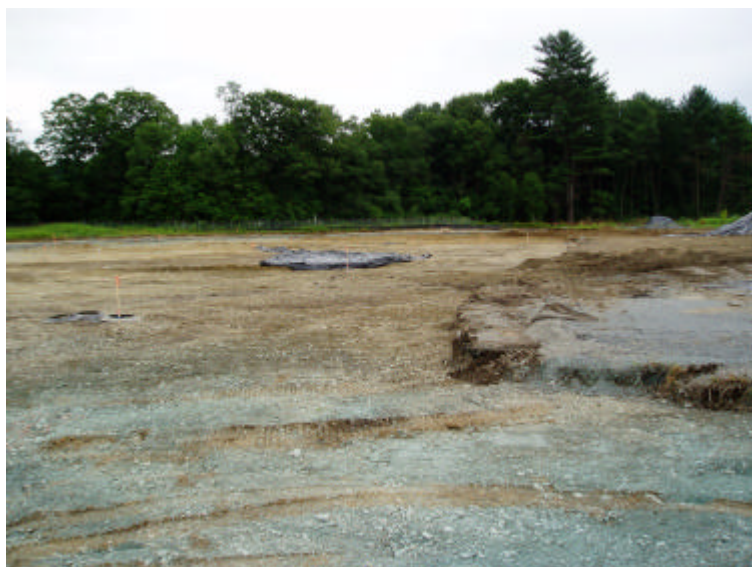
**P7110015.JPG**

| PHOTO | DATE | TIME | DESCRIPTION |
|---|---|---|---|
| P7 110015 | 7/11/2008 | 15:49 | View to east showing excavated areas at west side Areas 1 and 2 (non-TSCA grid stations G-17/18, H-17/18, I-17 and M-17) |

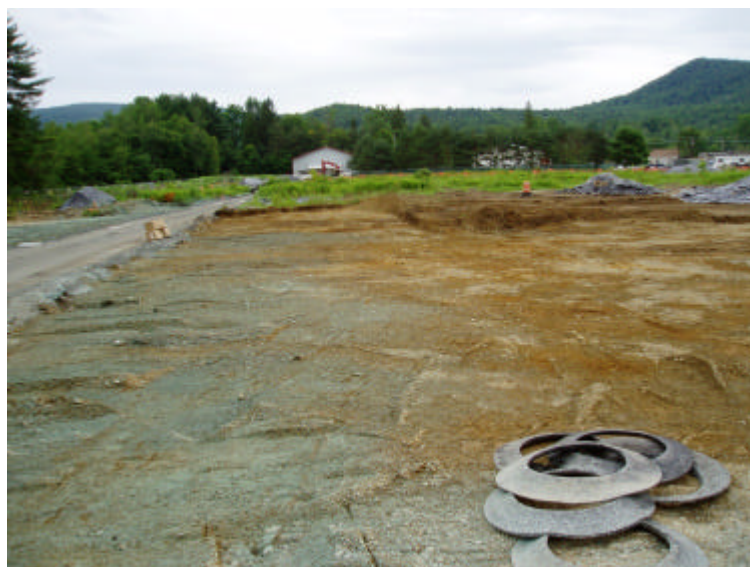
**P7110016.JPG**

| PHOTO | DATE | TIME | DESCRIPTION |
|---|---|---|---|
| P7 110016 | 7/11/2008 | 15:50 | View to south showing excavated areas at east side of Area 2 (non-TSCA grid stations L-17 and M-17) |

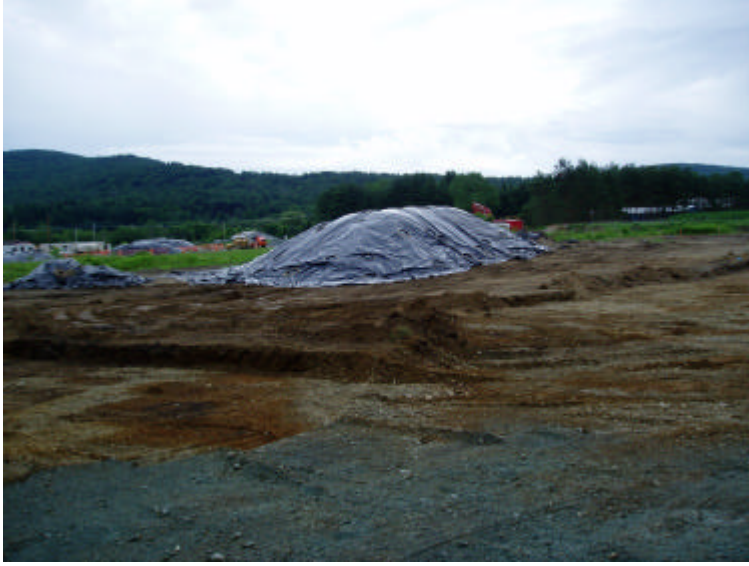
**P7110017.JPG**

| PHOTO | DATE | TIME | DESCRIPTION |
|---|---|---|---|
| P7 110017 | 7/11/2008 | 15:53 | View to southwest showing non-TSCA soil pile covered with poly sheeting in Area #2 |
