## DAILY FIELD ACTIVITY REPORT

| <b>PROJECT</b> | <b>Former Bouchard Junkyard</b> | <b>WEATHER</b> | <b>TIME</b> | <b>TEMP.</b> | <b>PRECIP.</b> | <b>WIND (MPH)</b> | <b>WIND (DIR)</b> |
| <b>LOCATION</b> | <b>Town of New Lebanon, NY</b> | <b>M. Cloudy</b> | <b>1000</b> | <b>70-75 F</b> | <b>None</b> | <b>0-10</b> | <b>W</b> |

**PHOTOGRAPHIC LOG**  
**July 14, 2008**  
**D&B JOB NO. 2605**  
**FORMER BOUCHARD JUNKYARD SITE**  
**TOWN OF NEW LEBANON, NEW YORK**

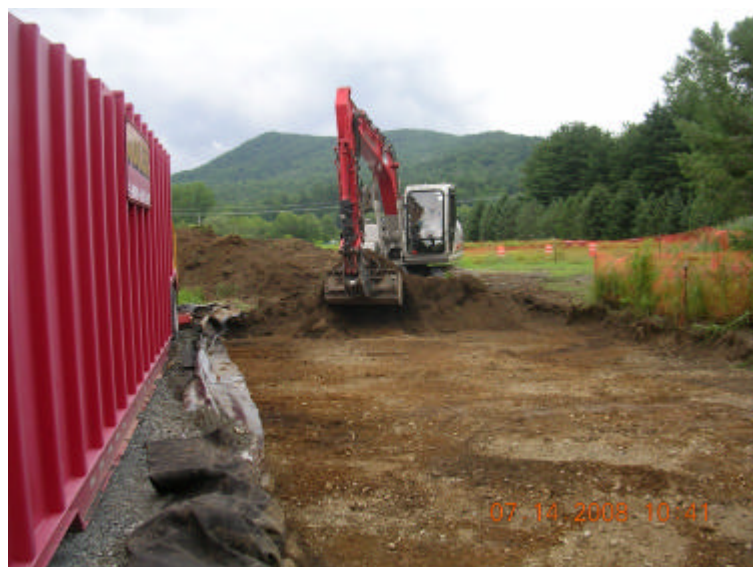
**DSCN4074.JPG**

| PHOTO | DATE | TIME | DESCRIPTION |
|---|---|---|---|
| DSCN 4074 | 7/14/2008 | 1041 | Remedial excavation activities within the NE part of Area 4 within Grid E-10 utilizing a Link-Belt 130 LX Trackhoe; Non-TSCA soil was stockpiled on like-material in a centralized location in order to facilitate loading of trucks from the truck access road; View of Area 4 looking S. |

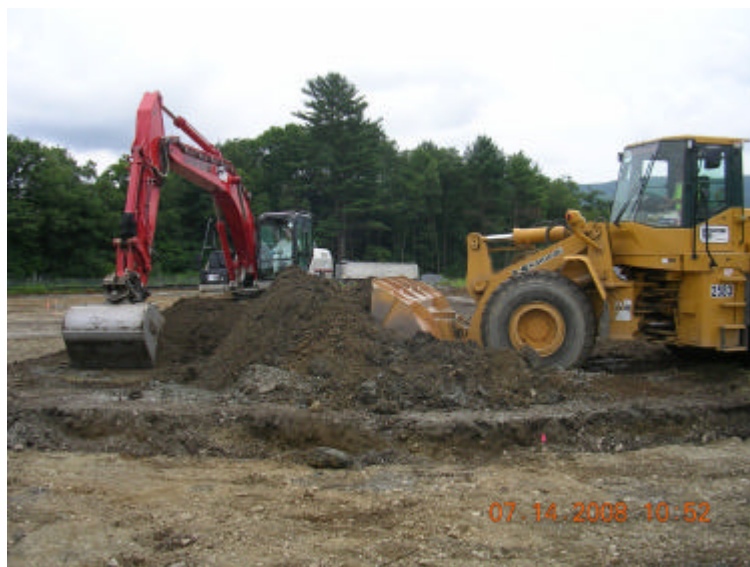
**DSCN4077.JPG**

| PHOTO | DATE | TIME | DESCRIPTION |
|---|---|---|---|
| DSCN 4077 | 7/14/2008 | 1052 | View of Link-Belt 240 Trackhoe excavating soil at grid I-16 and shaping of non-TSCA soil pile to facilitate immediate loading of Kawasaki 80ZV Front Loader and delivery to waste hauling trucks along the truck access road; View of Area 2 looking W. |

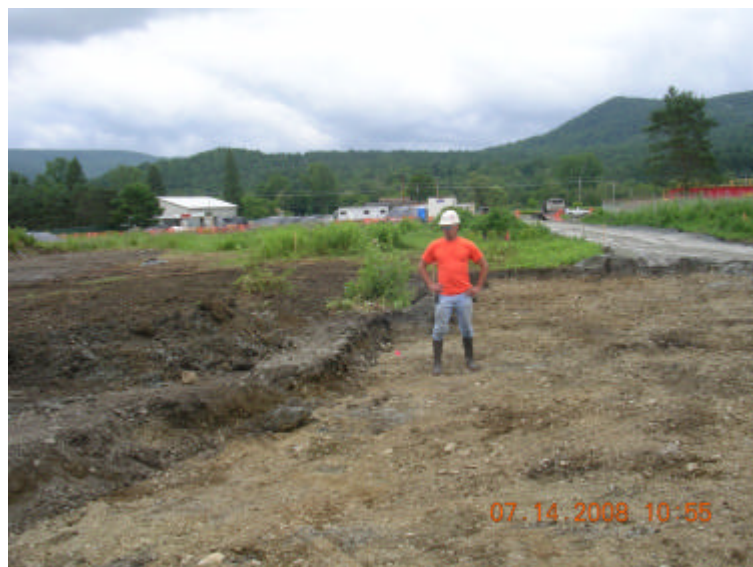
**DSCN4078.JPG**

| PHOTO | DATE | TIME | DESCRIPTION |
|---|---|---|---|
| DSCN 4078 | 7/14/2008 | 1055 | Collection of bottom soil sample EP-G16 at 1 ft bgs within grid G-16; Area 2 looking S. |

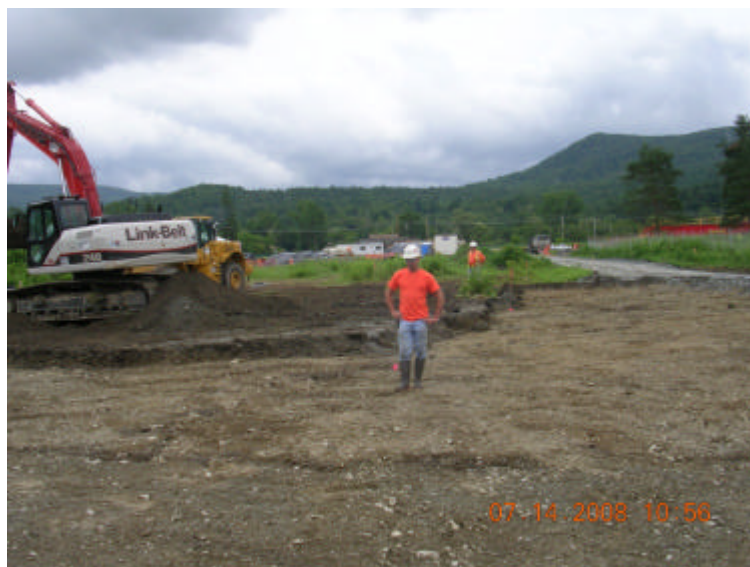
**DSCN4079.JPG**

| PHOTO | DATE | TIME | DESCRIPTION |
|---|---|---|---|
| DSCN 4079 | 7/14/2008 | 1056 | Collection of bottom soil sample EP-G17 at 1 ft bgs within grid G-17 (MS/MSD/MSB collected here); Area 2 looking S. |

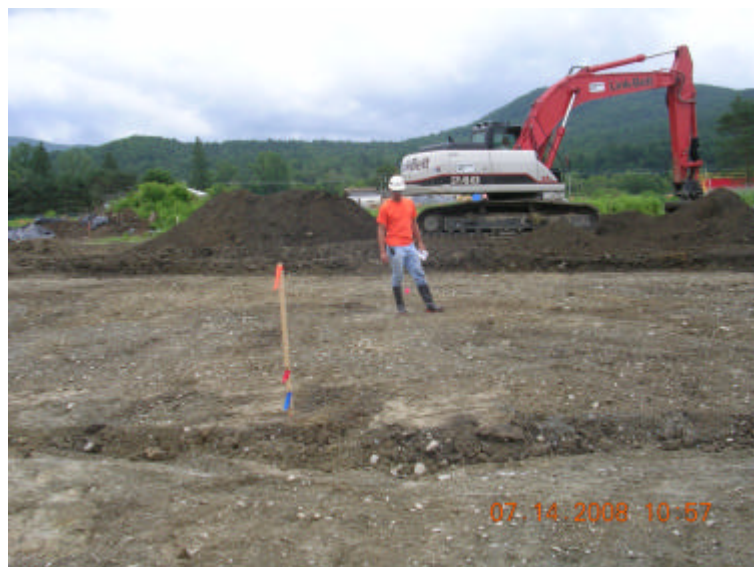
**DSCN4080.JPG**

| PHOTO | DATE | TIME | DESCRIPTION |
|---|---|---|---|
| DSCN 4080 | 7/14/2008 | 1057 | Collection of bottom soil sample EP-H17 at 1 ft bgs within grid H-17; Area 2 looking S. |

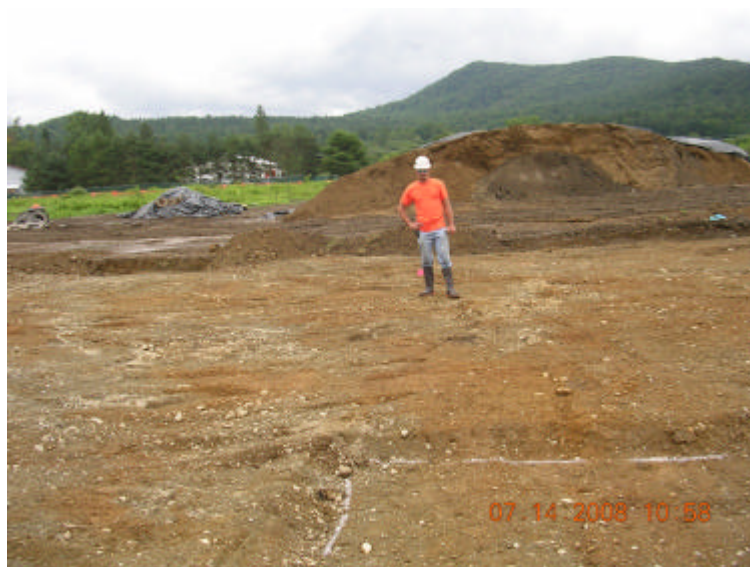
**DSCN4081.JPG**

| PHOTO | DATE | TIME | DESCRIPTION |
|---|---|---|---|
| DSCN 4081 | 7/14/2008 | 1058 | Collection of bottom soil sample EP-K17 at 1 ft bgs within grid K-17; Area 2 looking S. |

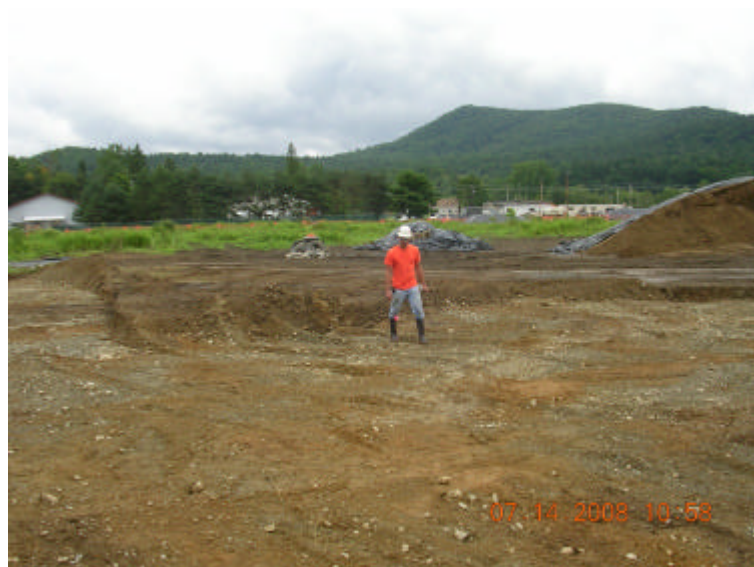
**DSCN4082.JPG**

| PHOTO | DATE | TIME | DESCRIPTION |
|---|---|---|---|
| DSCN 4082 | 7/14/2008 | 1058 | Collection of bottom soil sample EP-L17 at 1 ft bgs within grid L-17; Area 2 looking S. |

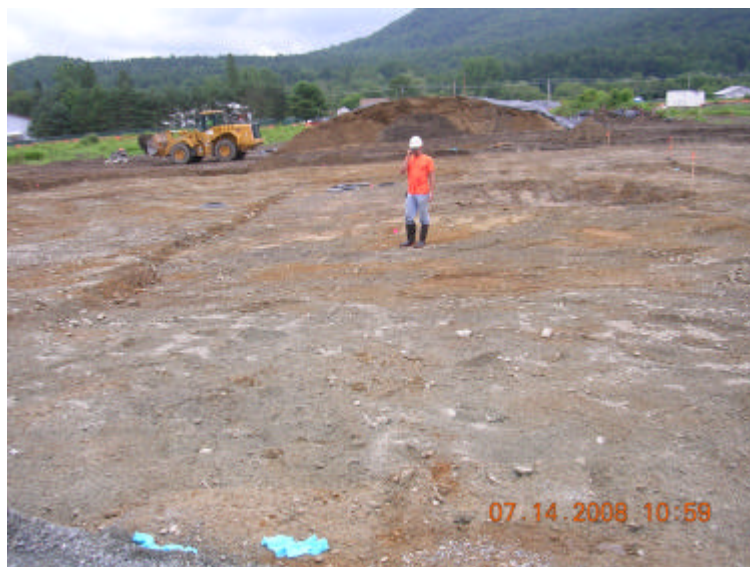
**DSCN4083.JPG**

| PHOTO | DATE | TIME | DESCRIPTION |
|---|---|---|---|
| DSCN 4083 | 7/14/2008 | 1059 | Collection of bottom soil sample EP-K19 at 1.5 ft bgs within grid K-19 (Duplicate EP-DUP11 collected here); Area 1 looking S. |

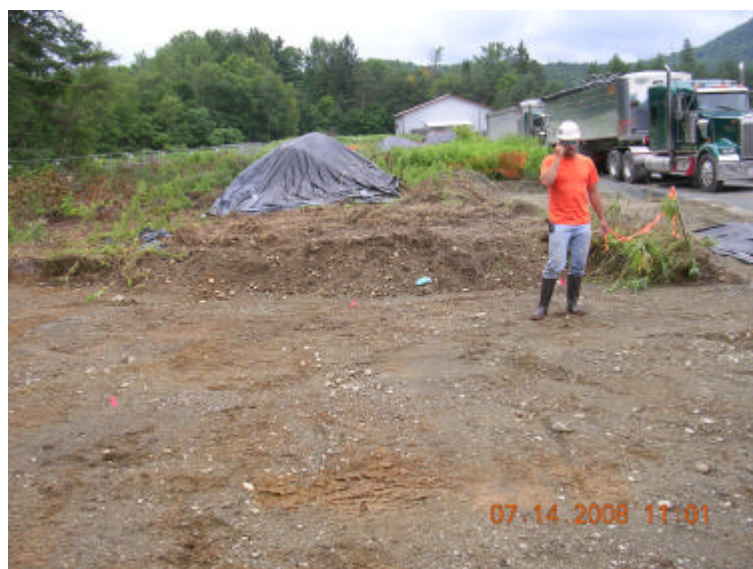
**DSCN4084.JPG**

| PHOTO | DATE | TIME | DESCRIPTION |
|---|---|---|---|
| DSCN 4084 | 7/14/2008 | 1101 | Collection of bottom soil sample EP-T3(1) at 1 ft bgs within TSCA grid 3 (NE corner of N-16); The sample was 1 of 2 grab samples collected in response to failed analytical results associated with the original soil sample [EP-N16(TSCA)] to further characterize this area and identify the need for additional excavation; Area 2 looking S. |

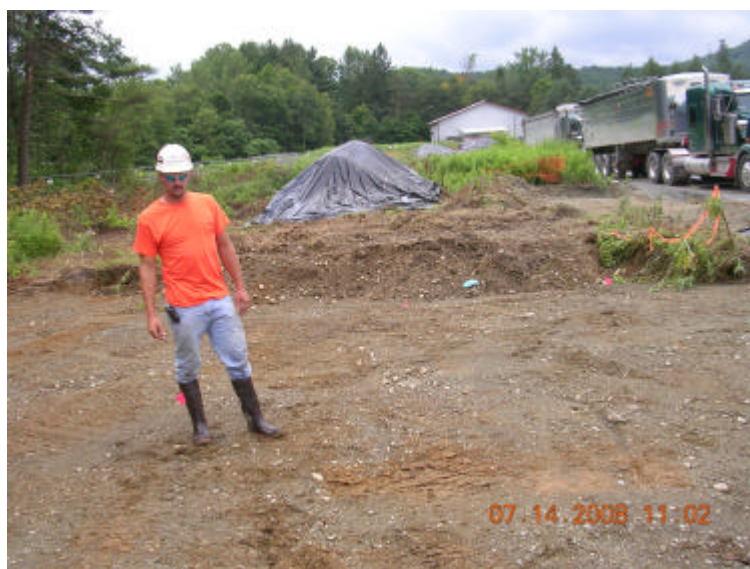
**DSCN4085.JPG**

| PHOTO | DATE | TIME | DESCRIPTION |
|---|---|---|---|
| DSCN 4085 | 7/14/2008 | 1102 | Collection of bottom soil sample EP-T3(2) at 1 ft bgs within TSCA grid 3 (NE corner of N-16); The sample was 2 of 2 grab samples collected in response to failed analytical results associated with the original soil sample [EP-N16(TSCA)] to further characterize this area and identify the need for additional excavation; Area 2 looking S. |

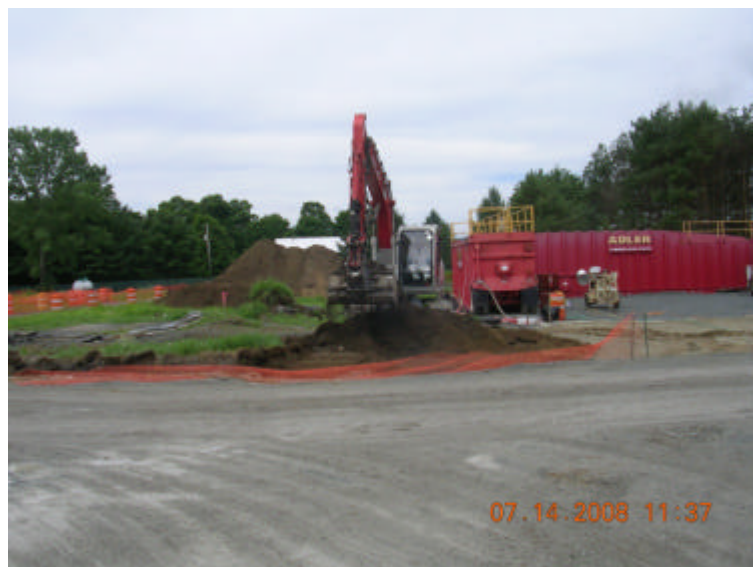
**DSCN4086.JPG**

| PHOTO | DATE | TIME | DESCRIPTION |
|---|---|---|---|
| DSCN 4086 | 7/14/2008 | 1137 | Remedial excavation activities within the NE part of Area 4 within Grid G-10 utilizing a Link-Belt 130 LX Trackhoe; Non-TSCA soil was stockpiled on like-material in a centralized location in order to facilitate loading of trucks from the truck access road; View of Area 4 looking W. |

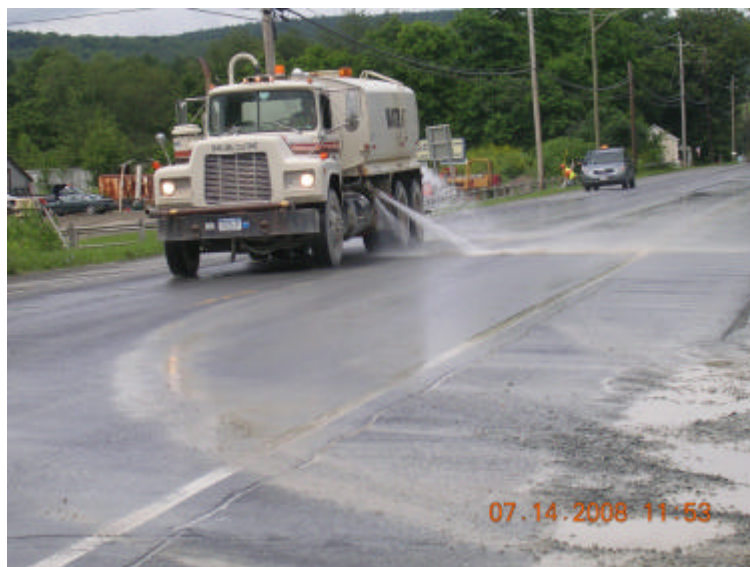
**DSCN4087.JPG**

| PHOTO | DATE | TIME | DESCRIPTION |
|---|---|---|---|
| DSCN 4087 | 7/14/2008 | 1153 | Cleaning of muddy tire tracks in progress onto Route 20 road surface at entrance to driveway to Building 666 using 4,000 gallon Mack Water Truck; View of Route 20 looking WSW. |

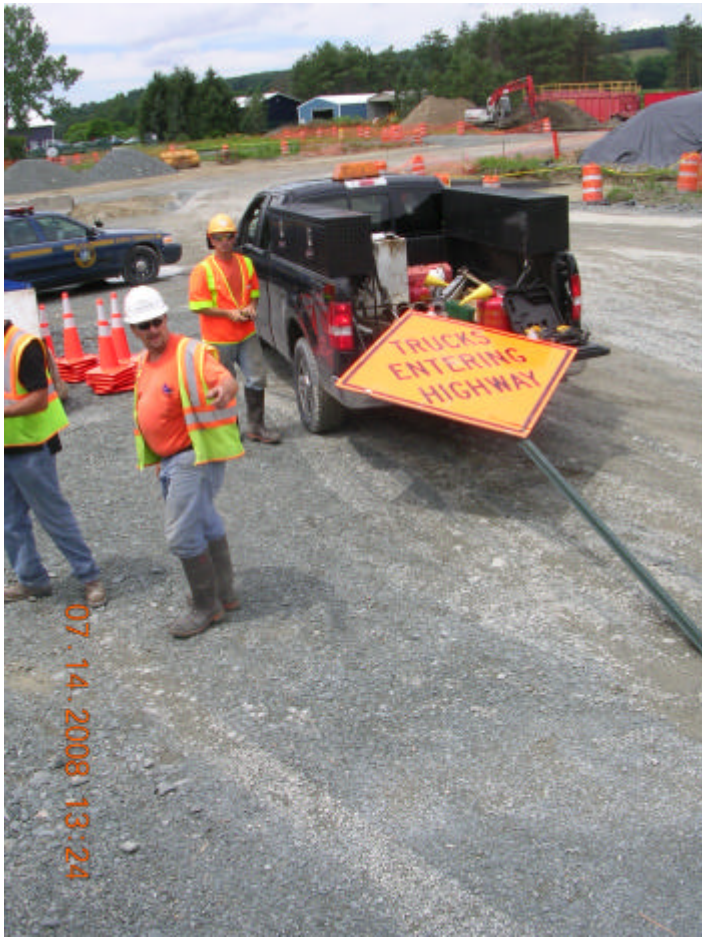
**DSCN4088.JPG**

| PHOTO | DATE | TIME | DESCRIPTION |
|---|---|---|---|
| DSCN 4088 | 7/14/2008 | 1324 | View of DAC crew assembling "Trucks Entering Highway" in accordance with NYSDOT Highway Permit for future placement onto shoulders of Route 20; Area 9 looking NW. |

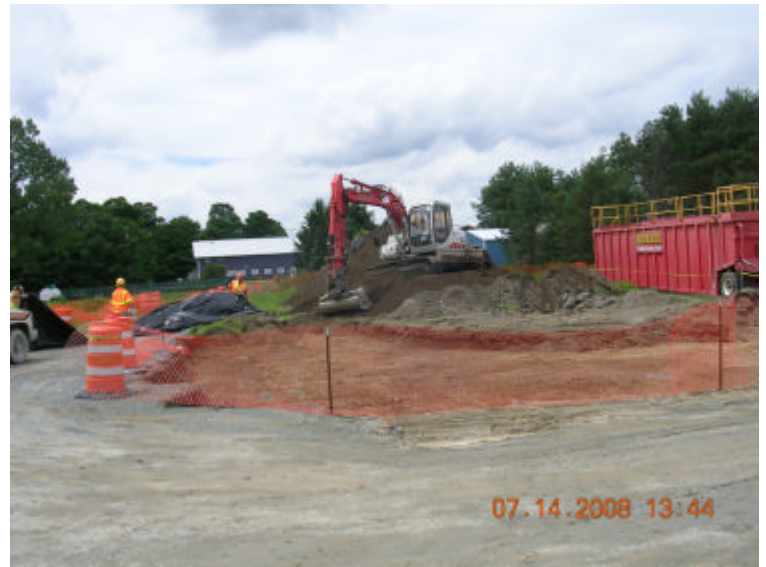
**DSCN4090.JPG**

| PHOTO | DATE | TIME | DESCRIPTION |
|---|---|---|---|
| DSCN 4090 | 7/14/2008 | 1344 | Remedial excavation activities within the NE part of Area 4 within Grid F-10 utilizing a Link-Belt 130 LX Trackhoe; Non-TSCA soil stockpile was shaped into a flat-topped mound to facilitate loading of trucks at the truck access road by the shorter Link-Belt 130 LX Trackhoe; View of Area 4 looking W. |

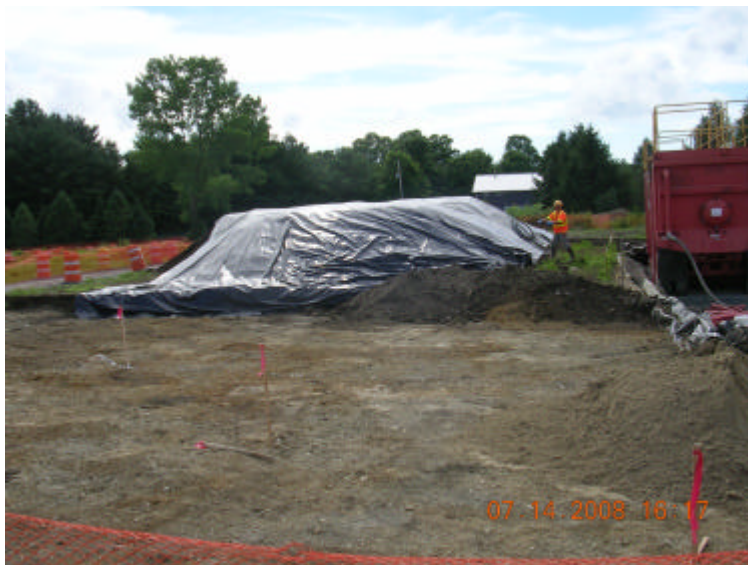
**DSCN4097.JPG**

| PHOTO | DATE | TIME | DESCRIPTION |
|---|---|---|---|
| DSCN 4097 | 7/14/2008 | 1617 | Covered non-TSCA soil stockpile at close of business with 6 mil polyethylene sheeting at grid F-10 in Area 4 looking W. |
